Presented by Mindy Niedermeyer MSFC

Aerospace Materials, Processes, and Environmental Technology Conference 9/22/00 September 18 - 20, 2000

#### X-33 LH2 Proto-Flight Tank Test

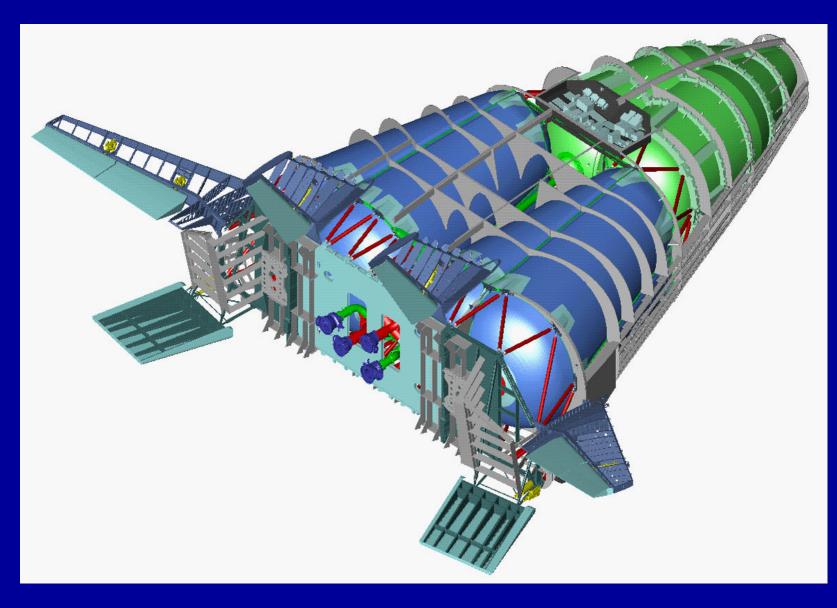
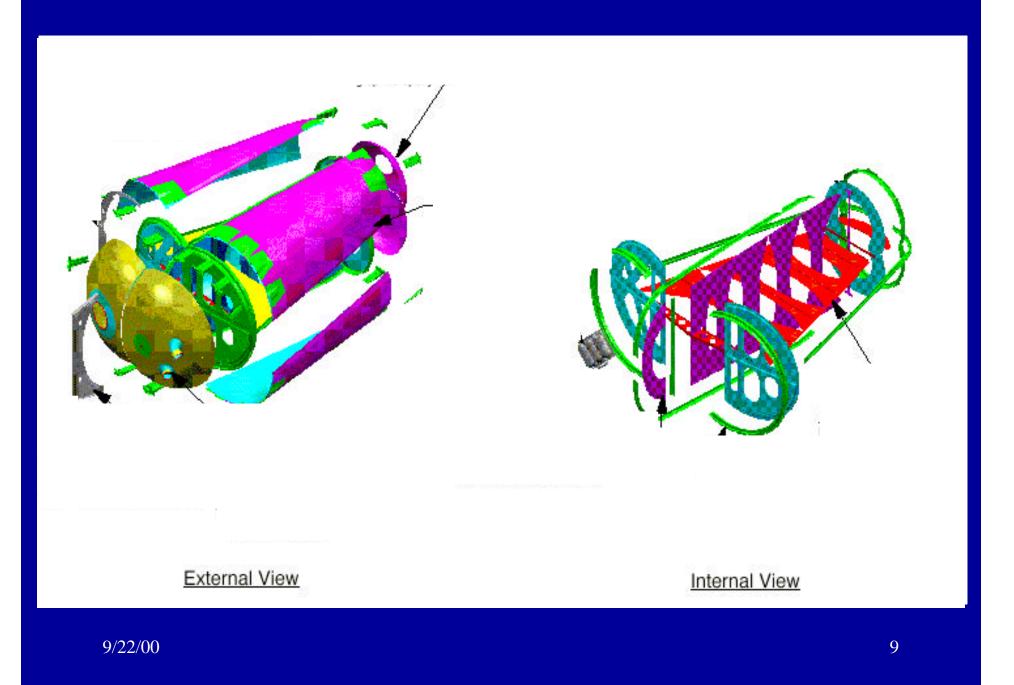
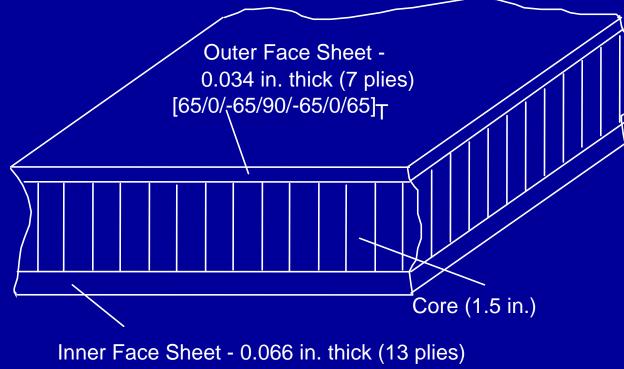
**Geometry of sandwich structure**

- Structural component of the aft body
- Quad-lobe design

Sandwich - honeycomb graphite epoxy construction

[45/90<sub>3</sub>/-45/0<sub>3</sub>/-45/90<sub>3</sub>/45]<sub>T</sub>

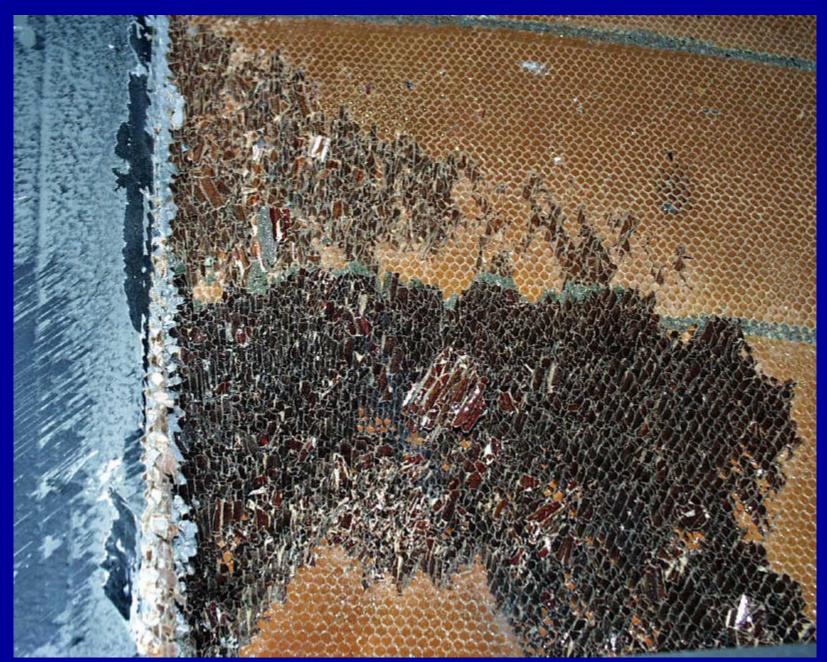
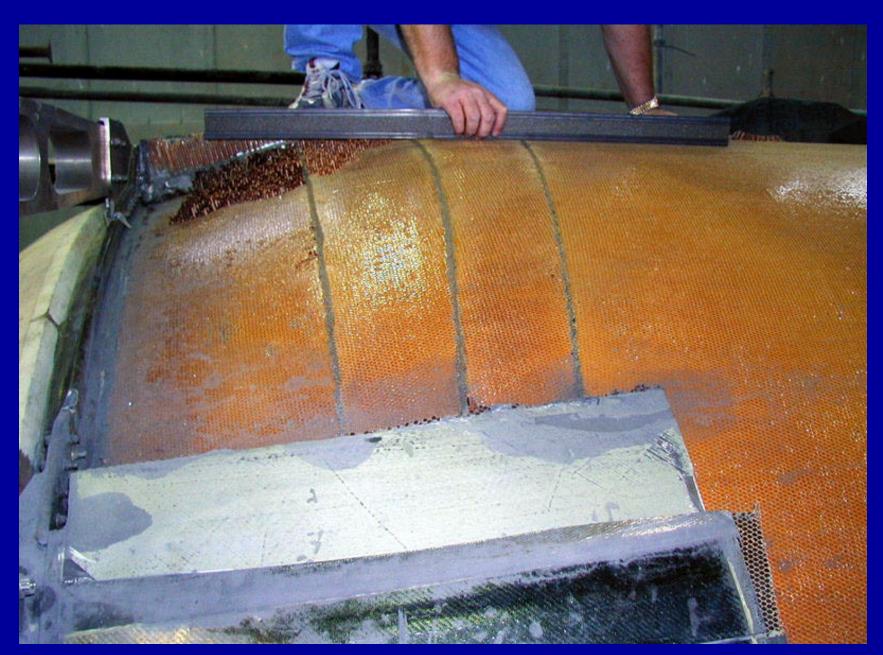
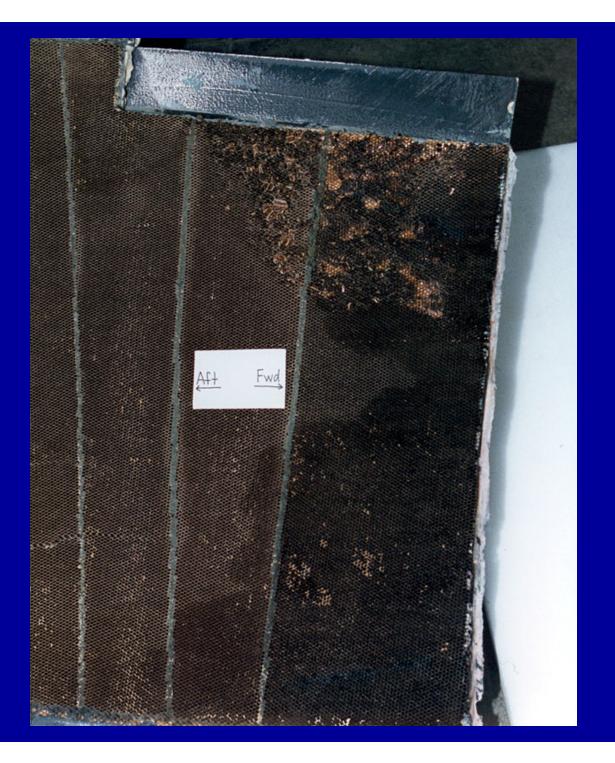
- Peel Failure
  - Outer skin and core peeled away from inner skin

#### Core Failure

- Core is 'mangled'
- Hydraulic fluid on test article
- Foreign Object Debris (FOD)
- Poor bondlines
- Pressure in core above ambient 13 hours after failure

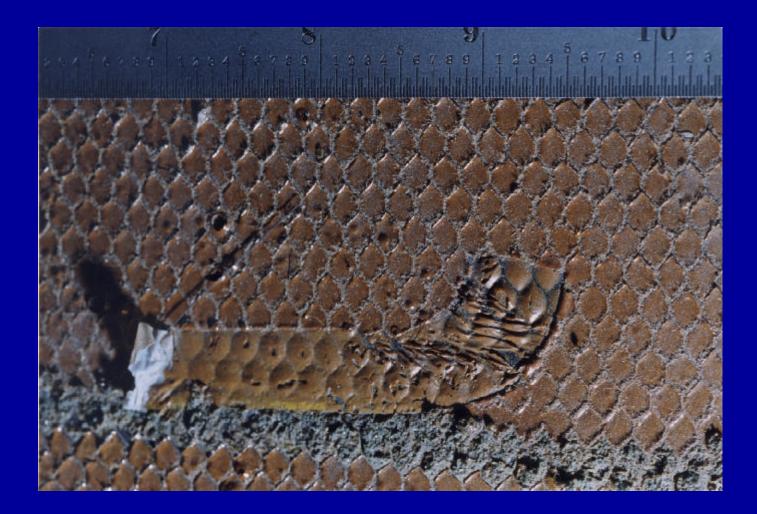
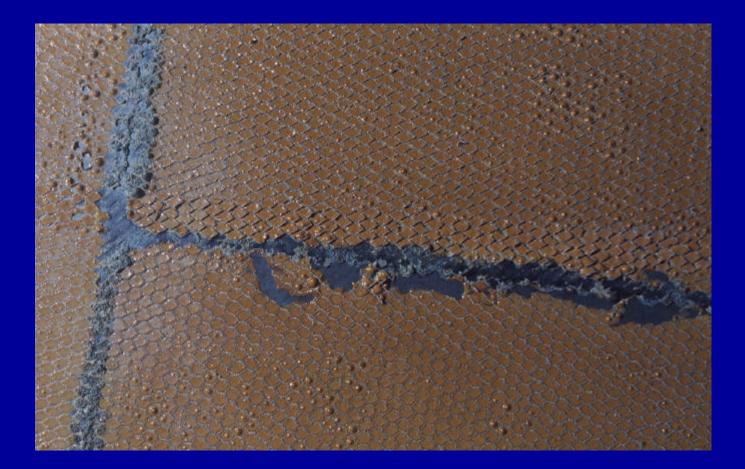
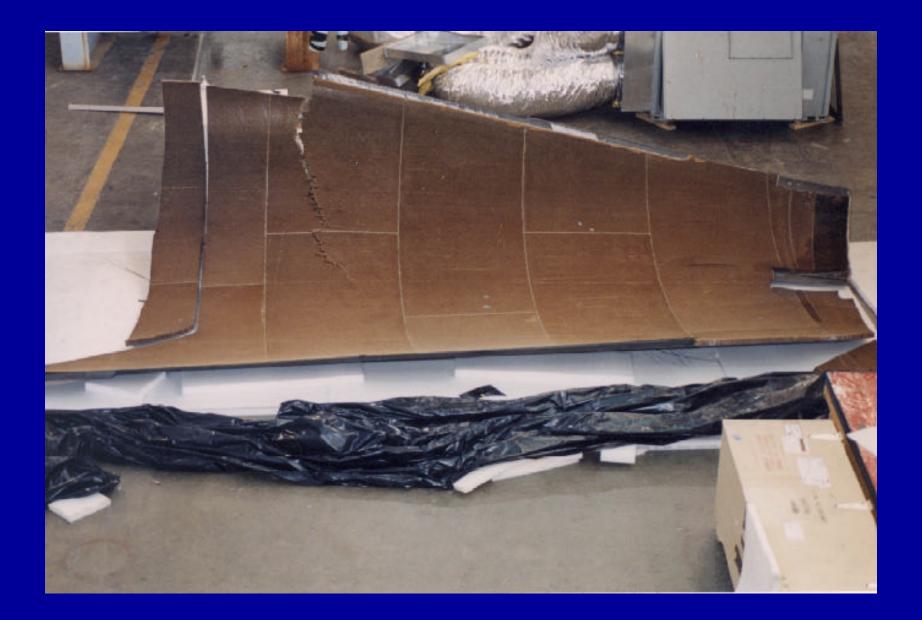
### **Subsequent Findings**

- Core pressures behaved unexpectedly
- Microcracking

- The inner skin microcracked and hydrogen infiltrated
- The cracks grew larger under pressure
- When pressure was removed cracks closed slightly
- When tank was drained and warmed, cracks closed and blocked leak path
- FOD and debond areas provided an opportunity for a leak path
- There is still hydrogen in the other 3 lobes today
