**2001 NASA/ASEE Summer Faculty Fellowship Program  
John F. Kennedy Space Center  
University of Central Florida**

**Improved Quick Disconnect (QD) Interface Through  
Fail Safe Parts Identification**

**KSC Colleagues, Deborah Carstens, Ph.D. and Damon Stambolian  
Spaceport Engineering & Technology Directorate/YA-D4**

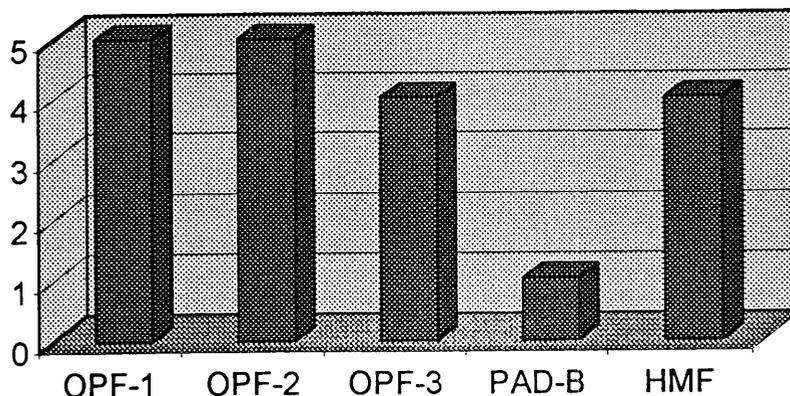
### Errors While Mating and Demating Air Half Couplings

human factor errors do occur while mating and demating QDs. The chart provides a summary of documented errors with the frequency and facility location.
