Technical Findings, Lessons Learned, and Recommendations Resulting from the Helios Prototype Vehicle Mishap

Abstract

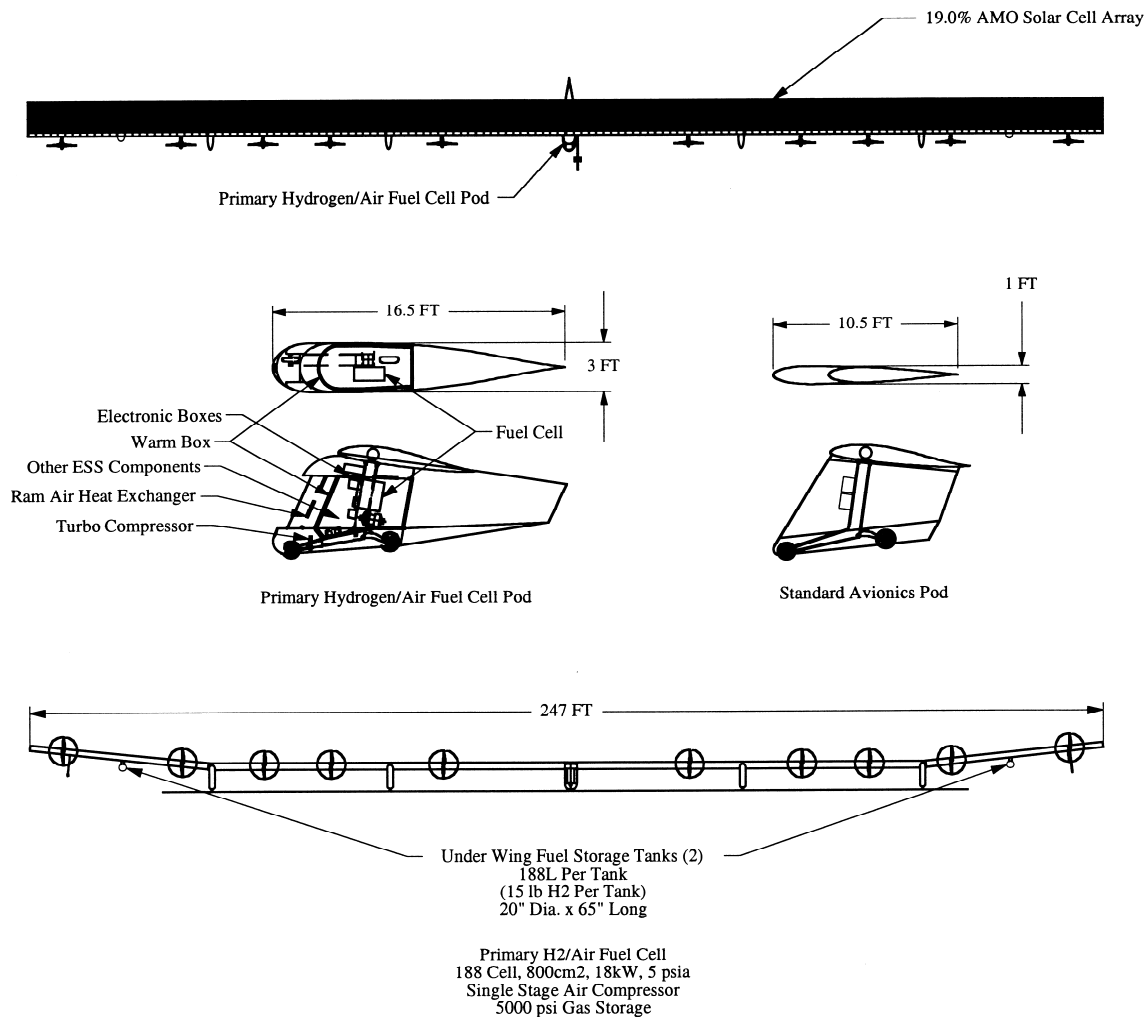
Figure 3: Schematic of HP03 hydrogen-air fuel cell configuration.

Based on recommendations during the HP03 Preliminary Design and Critical Design Reviews, a decision was made to strengthen the wing tip spars so that their structural margins would be consistent with the structural margins along the rest of the wing spar under the design load conditions. NASA and AV also recognized that the structural, stability and control, and aeroelastic margins of safety were less on the HP03 than on the HP01. However, these margins were still sufficient to conduct the 2003 long-endurance flight demonstration. It was also recognized that the mass distribution for HP03 was significantly different than the mass distribution of the initially proposed demonstrator with a RFCS system. The aircraft with the RFCS would have required two regenerative fuel cell pods located at about 1/3 the distance from the vehicle centerline to the wing tip. The HP03 vehicle, with the PFCS installed, was more point loaded in that 3 pods were required. The heavy primary hydrogen-air fuel cell pod (520 lbs) was located at the centerline of the aircraft and the 2 high-pressure hydrogen fuel tanks (165 lbs each) were located at the center of each wing tip panel. A schematic of the PFCS is provided in Figure 3.
