NASA/TM-2009-215575

Terahertz NDE of Stressed Composite Overwrapped Pressure Vessels – Initial Testing

*Eric I. Madaras
Langley Research Center, Hampton, Virginia*

February 2009

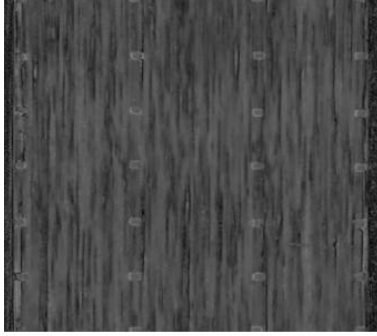
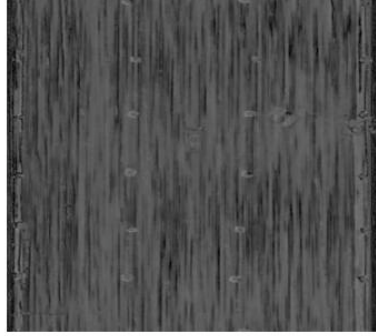
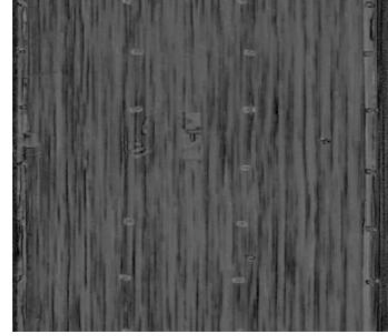
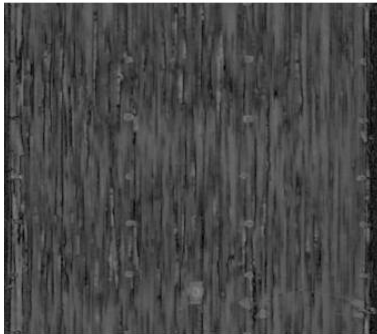
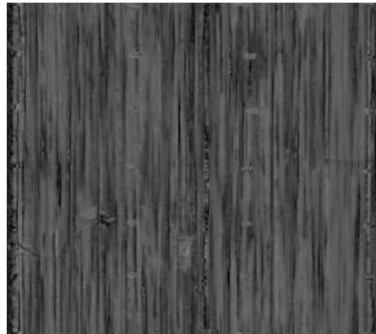
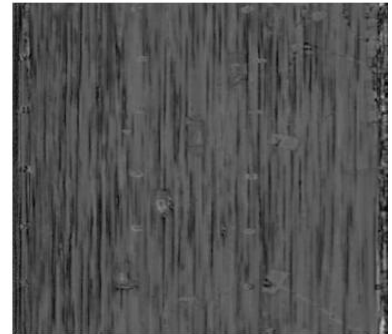
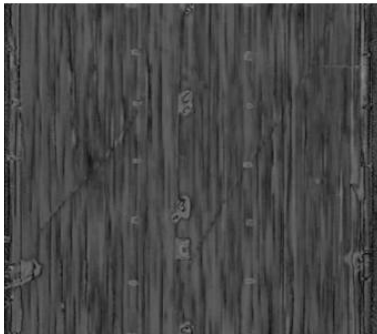
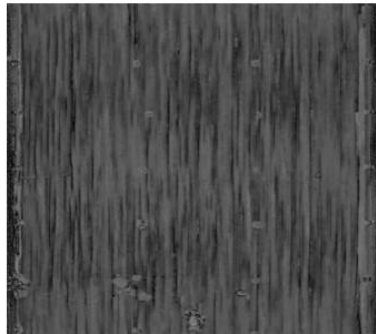
Figure 22: 325GHz images of high stress aged bottles.

Frequency domain spectral ratio images were generated from the high temperature and high stress data. It was postulated that a shift in the spectral minima observed for Kevlar and epoxy would highlight aging dependencies. Selected spectral ratio images are shown for the high temperature data in Figure 4 through 14 and for the high stress data in Figure 15 through 25. The images in each figure are on the same scale for comparison. The metallic markers on the Kevlar surface show up as dots in a regular grid pattern. In some cases strain gauges, strain gauge wire, and thermocouples can be seen. Overall, a striated pattern corresponds with the Kevlar windings; however, there is no visually apparent demarcation in these images to suggest aging.

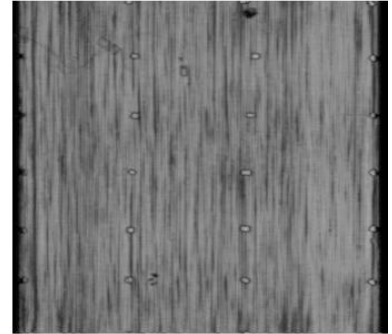
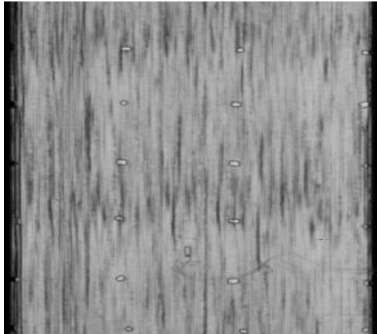
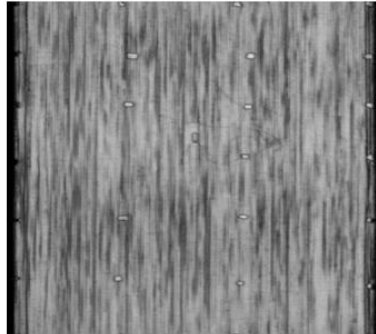
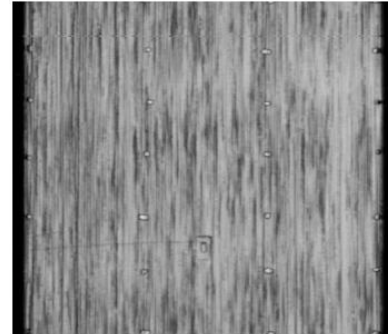
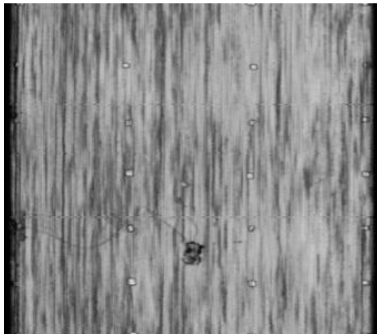
Figure 27: Peak-to-peak images of high temperature aged bottles.

Standard signal amplitude images from the high temperature and high stress data are shown in Figure 27 and Figure 28. In general, amplitude images are subject to many influences such as material electrical properties, thickness of the part under test, and surface roughness, texture and orientation. These influences make it difficult to make quantitative assessments of an object, but allow for qualitative evaluations. The amplitude images showed general features of the COPV bottles, but did not show indications of aging.

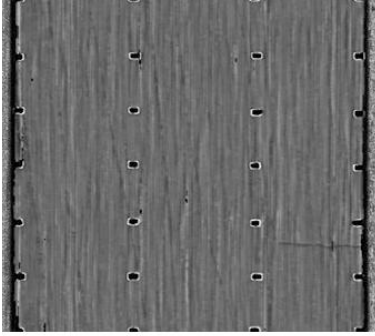
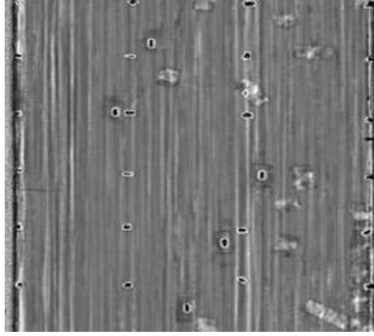
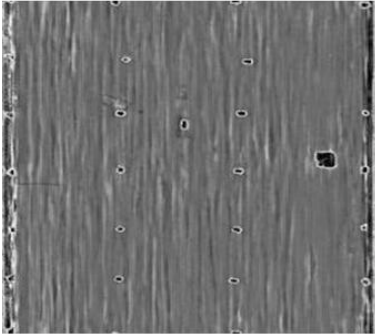
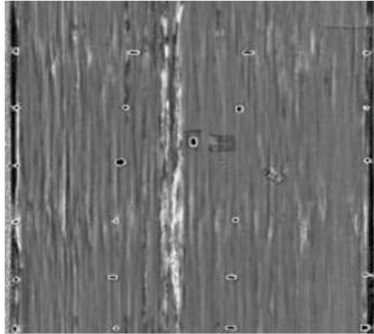
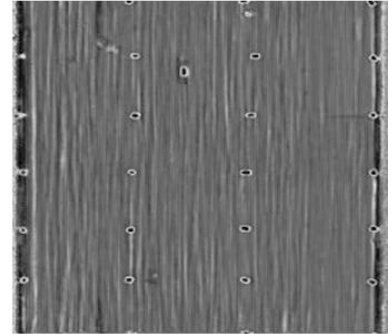
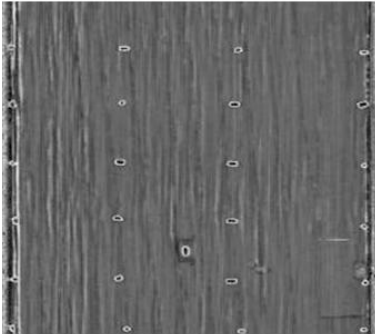
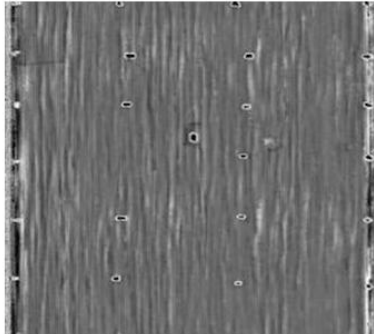
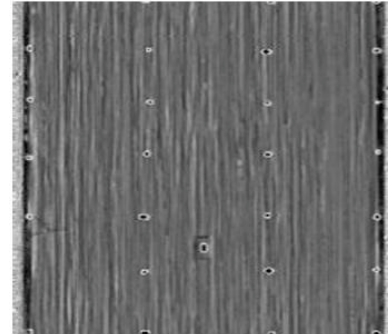
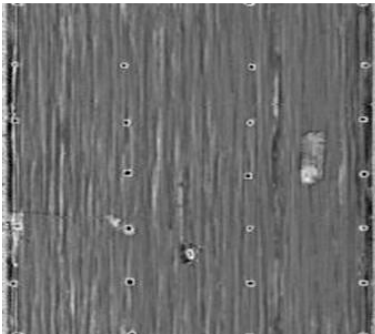
Figure 29: Peak-to-peak ratio images of high temperature aged bottles.

Kevlar front wall to back wall amplitude ratio images from the high temperature and high stress data are shown in Figure 29 and Figure 30. The front wall echo is the reflection from the outside of the Kevlar overwrap. The back wall echo is the reflection from the Kevlar overwrap to liner interface. The echo ratio depends on the signal loss due to the Kevlar overwrap material. The images are fairly uniform and do not show any dependency on the state of the Kevlar and thus aging trends.

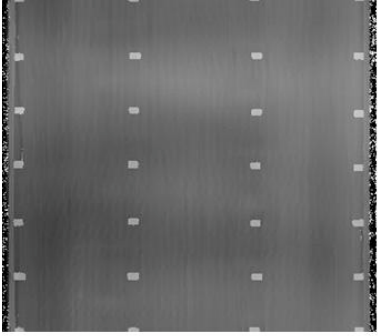
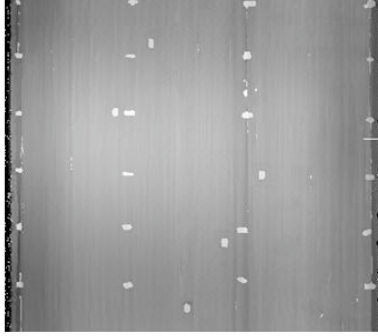
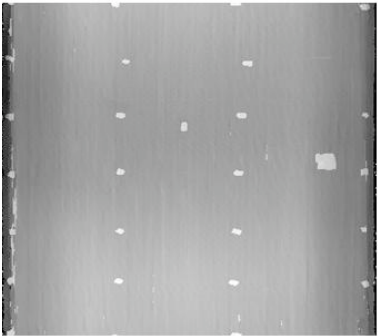
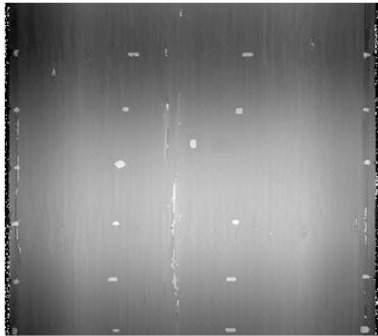
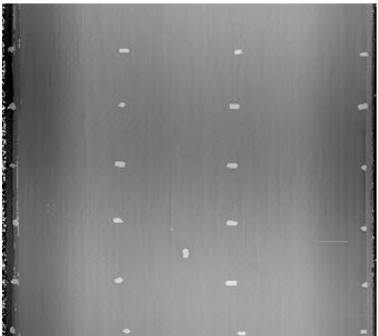
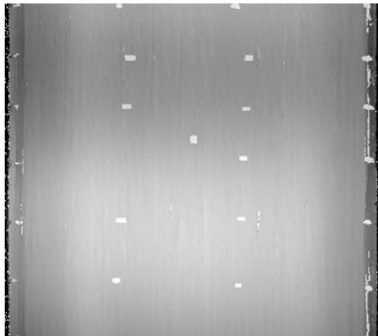
Figure 33: Time of flight images of high temperature aged bottles.

Kevlar back wall time of flight images made from the high temperature and high stress data are shown in Figure 33 and Figure 34. This data combines the effects of the Kevlar and resin index of refraction with the thickness of the layer. The data generally reflects the thickness of the layer with the dark range in the gray scale indicating thinner material and the brighter range indicating thicker material. The images are displayed on the same scale for comparison. There are bottles with significant variations and some with little variation but neither correlated with aging trends. In addition, it is not clear how the thickness variations affect the bottle's life condition without additional data indicating the bottle's effective age.

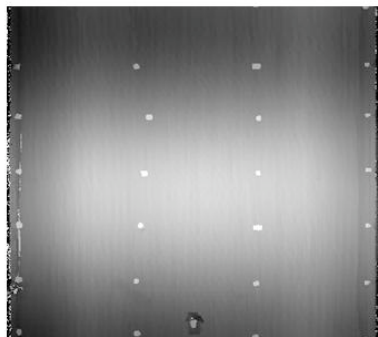
S/N 75, 362 hours

Figure 34: Time of flight images of high stress aged bottles.

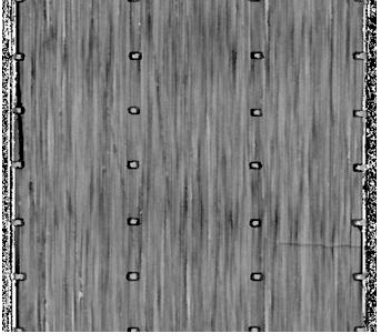
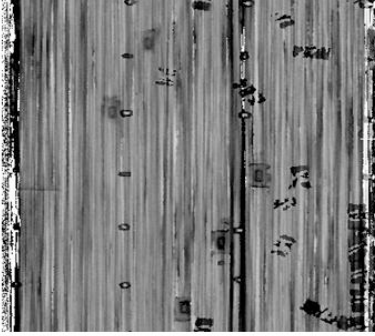
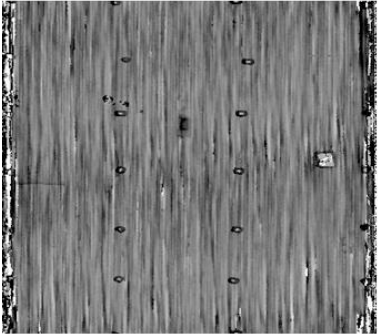
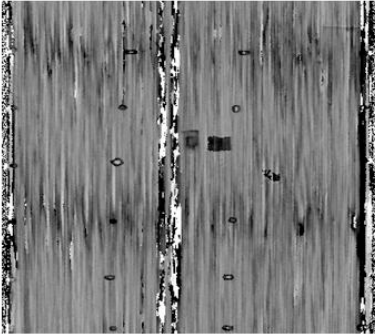
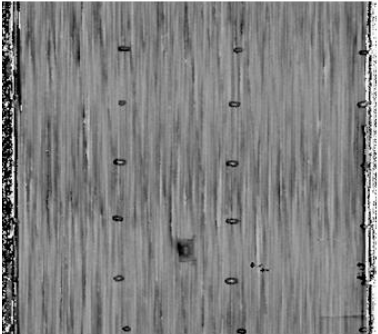
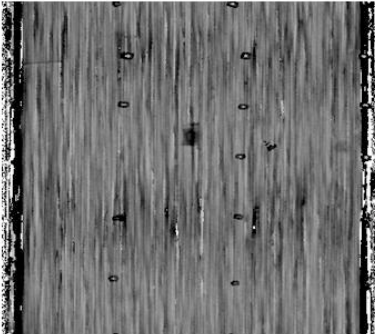
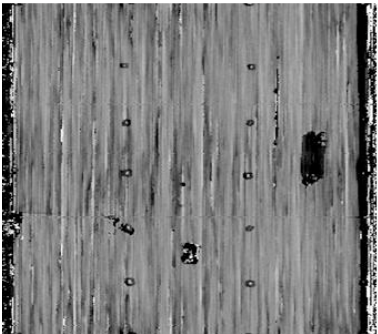
Positive peak delta images of the time difference between the front and back wall echo from the high temperature and high stress data are shown in Figure 35 and Figure 36. This processing is similar to the peak ratio method but does not correct for interface effects. As before, the images are on the same scale and there is no discernable trend with aging.

Figure 35: Positive Peak Delta images of high temperature aged bottles.

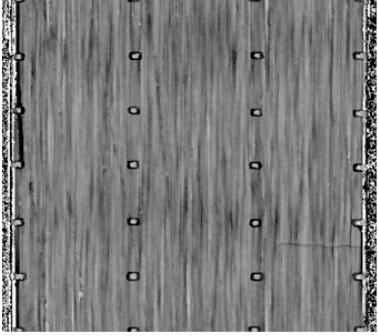
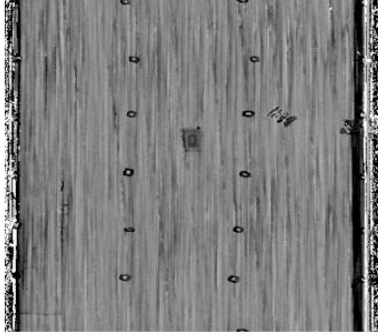
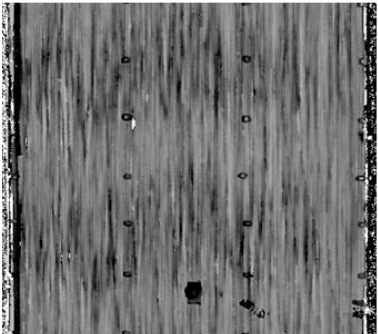
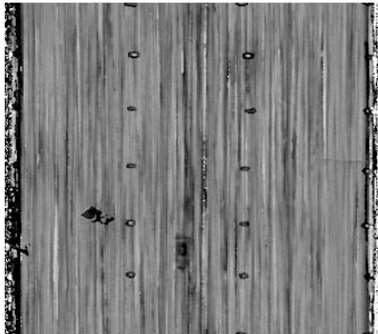
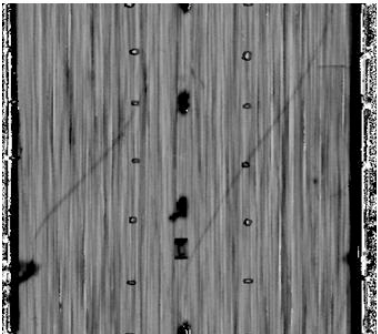
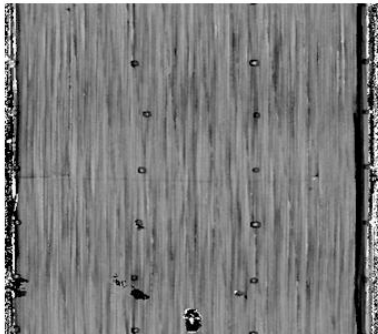
Figure 36: Positive Peak Delta images of high stress aged bottles.

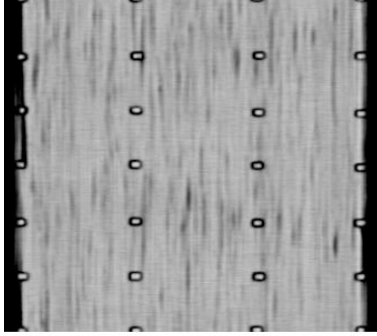
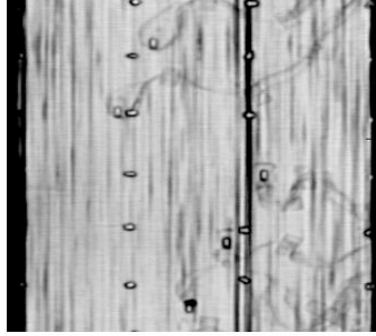
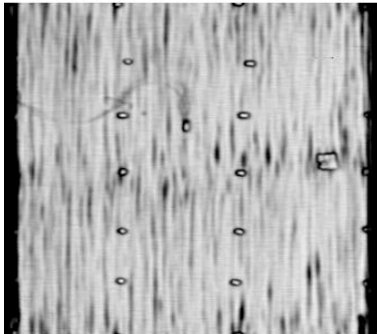
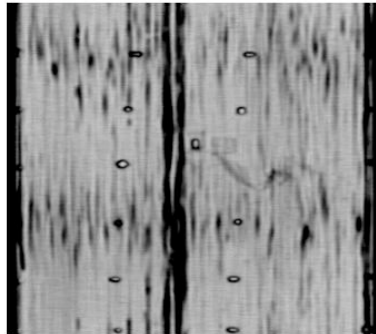
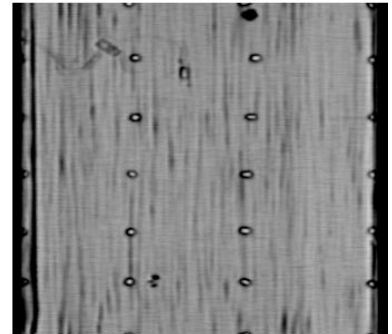
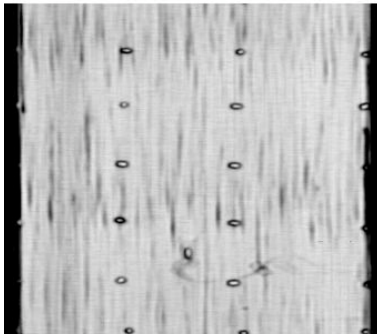
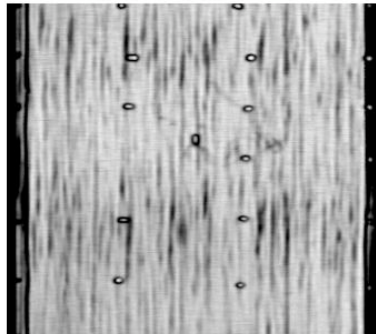
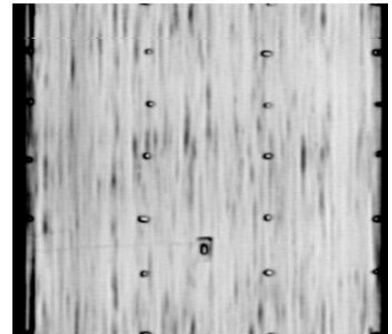
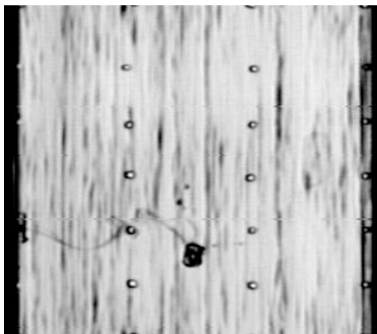
Narrow band frequency amplitude images from the high temperature and high stress data are shown in Figure 37 and Figure 38. Frequency amplitude images were generated from the time domain terahertz data after applying a 150GHz narrow band filter to mimic MSFC's Millimeter Wave (microwave) inspection results. This was done to investigate the origins of the anomalous short dark streaks in their images. Microscopic inspection of the bottles after identifying this anomaly indicated surface variations corresponding to the dark streaks. In particular, periodic thickness variations and small bumps resulting from manufacturing processes were observed. At 150GHz, the front to back wall phase front interference is maximized as the over wrap thickness approaches 1mm. Further examination of this anomaly is required to determine any contribution to bottle failure.

Figure 37: Peak-to-peak images of high temperature aged bottles at 150GHz.

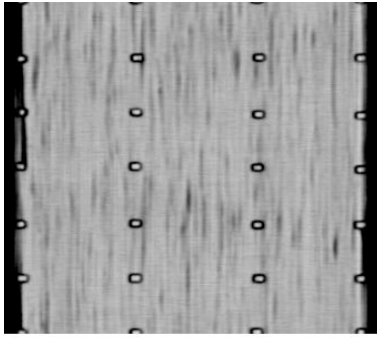
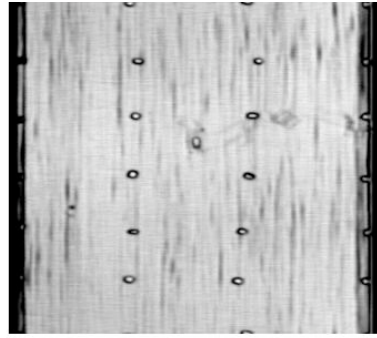
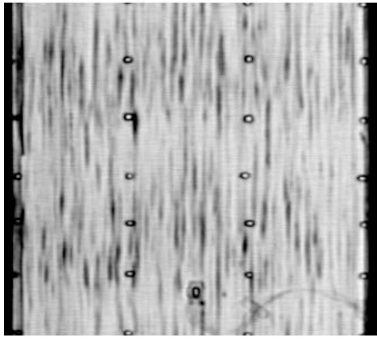
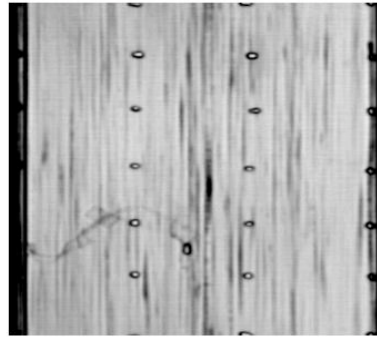
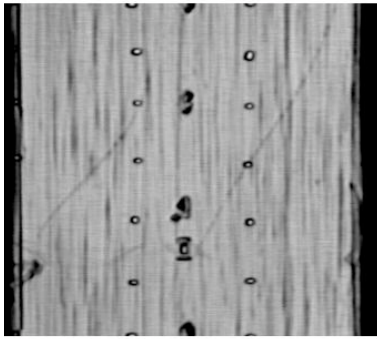
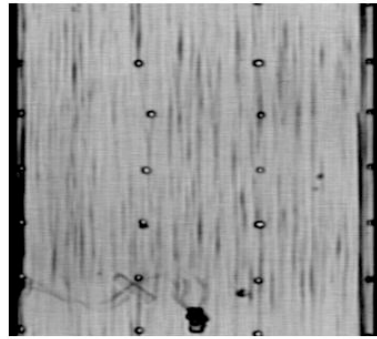
Figure 38: Peak-to-peak images of high stress aged bottles at 150GHz.
