# Full-Scale Crash Test of an MD-500 Helicopter

Justin Littell  
ATK Space Systems  
NASA Langley Research Center  
12 W. Bush Rd  
Hampton Virginia, 236881  
[Justin.D.Littell@nasa.gov](mailto:Justin.D.Littell@nasa.gov)

## Abstract

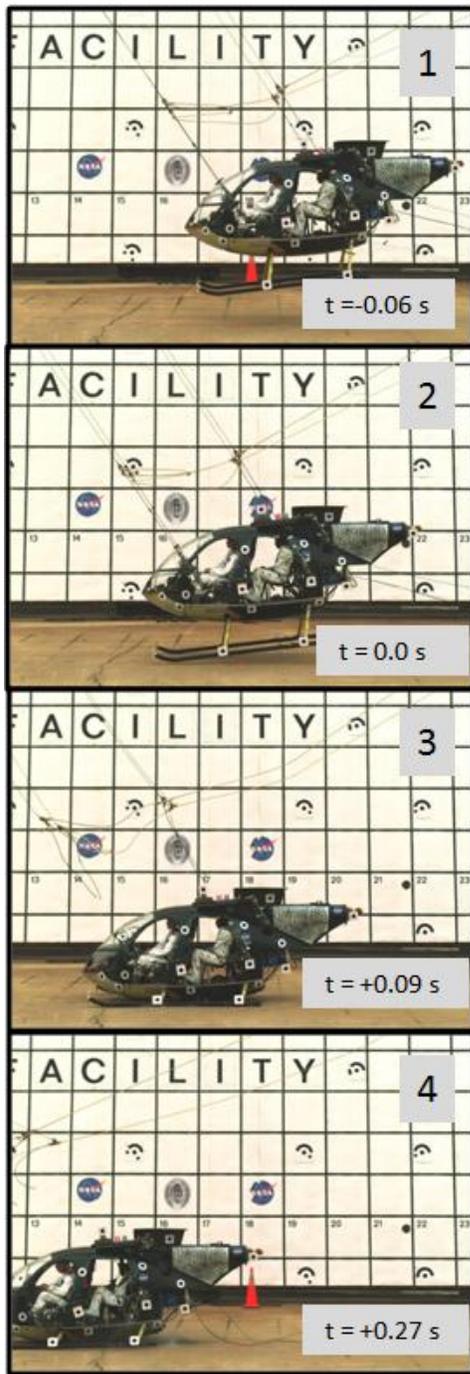
Figure 6 – View from South camera

In figure 6, picture 1 shows the helicopter 0.06 sec before impact. Note that due to the minimal roll and yaw present, the tips of the near skid gear are slightly lower than the tips of the far skid gear. Picture 2 shows the helicopter at the point of first skid gear impact ( $t=0.0$  sec). The far (right) gear impacts the ground first which is due to the minor amount of yaw and roll present. Picture 3 shows the point of maximum vertical displacement, noting the helicopter still has a nose down pitch. Picture

4 shows a post-impact rebound. After the point of maximum vertical deflection, the nose is seen to pitch forward on the rebound, presumably due to the downward pitch of the nose at impact. Figure 7 shows the same four impact times from a camera located on the flight path, in front of the test article.

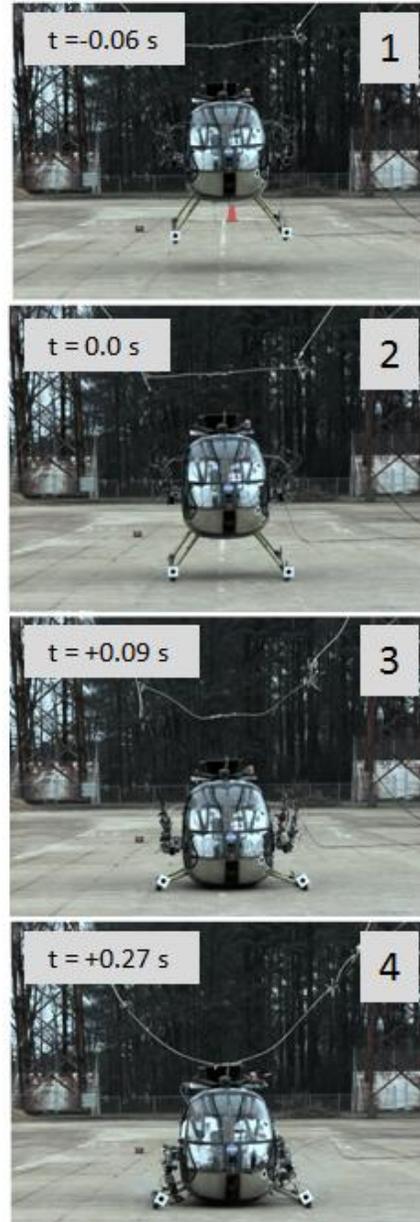
Figure 7 – View from West Camera

Picture 1 in figure 7 shows the MD-500 before impact. Again, the helicopter has a slight yaw, noting the difference between the orange tape on the plexi-glass nose of the test article and the white dotted LandIR centerline extending from the bottom of each picture. Also note the roll present by examining the difference in vertical

position between the left and right skid gear tips. Picture 2 shows skid gear contact with the right gear contacting the ground shortly before the left gear. Picture 3 shows the maximum vertical deflection of the helicopter, while picture 4 shows the helicopter post-impact rebound, where it has pitched down. Ripples in the nose on the pilot side can be seen in pictures 3 and 4, suggesting that parts of the nose structure have failed. Figure 8 shows the MD-500's post test final position.
