Degradation of Multi-Layer Insulation (MLI) Retrieved from the Hubble Space Telescope

2011 Contamination, Coatings, &
Materials Workshop

Jelila S. Mohammed
Materials Engineering Branch
NASA Goddard Space Flight Center

Kim K. de Groh
Space Environment & Experiments Branch
NASA Glenn Research Center

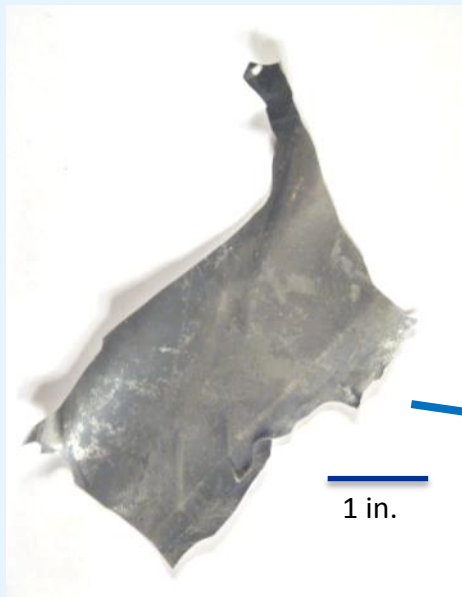
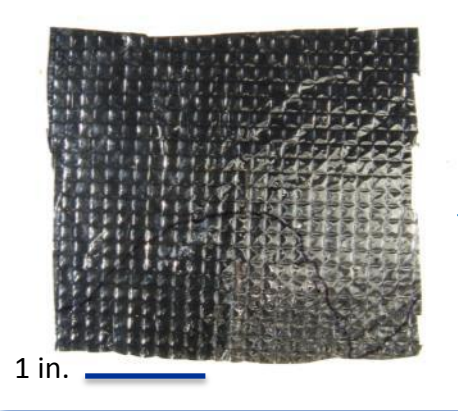
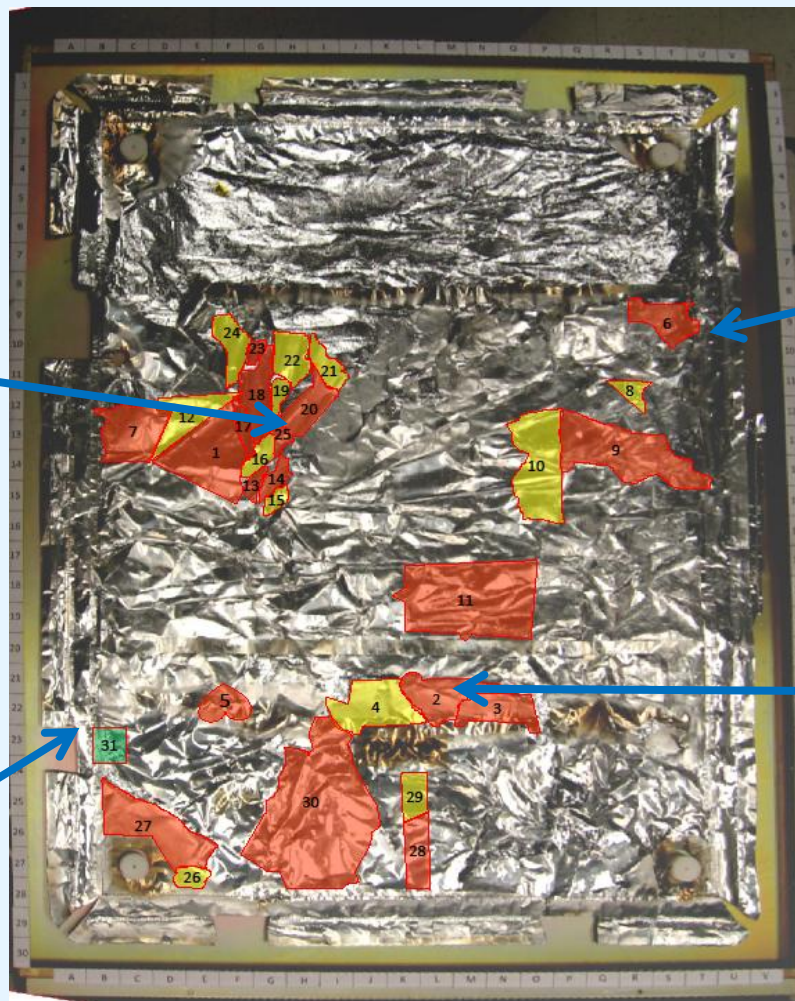
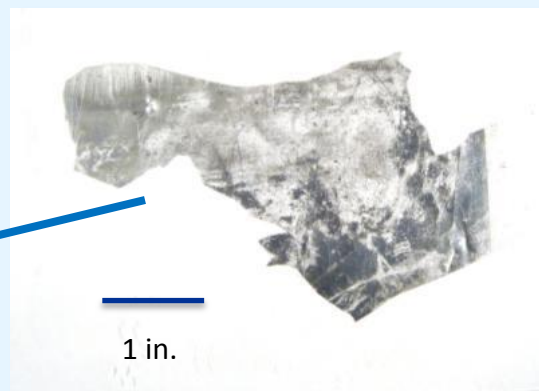
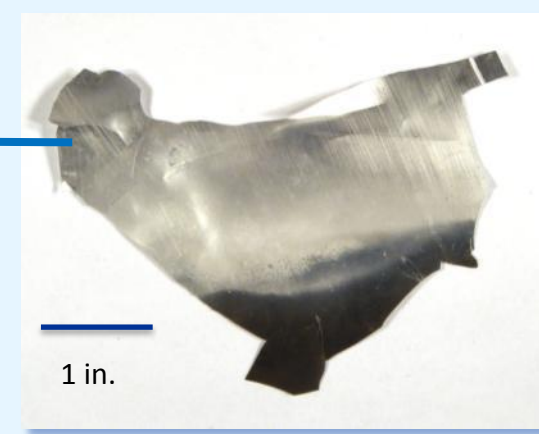
Bay 8 MLI in the lab for sectioning

Severely damaged areas were patched with single layer Al-FEP during SM2 (1997). These became damaged as well, but some areas remained patched until SM4 (2009).

The blankets had received a wide range of environmental exposure levels on orbit, based on alignment with the sun and whether or not the material was patched.

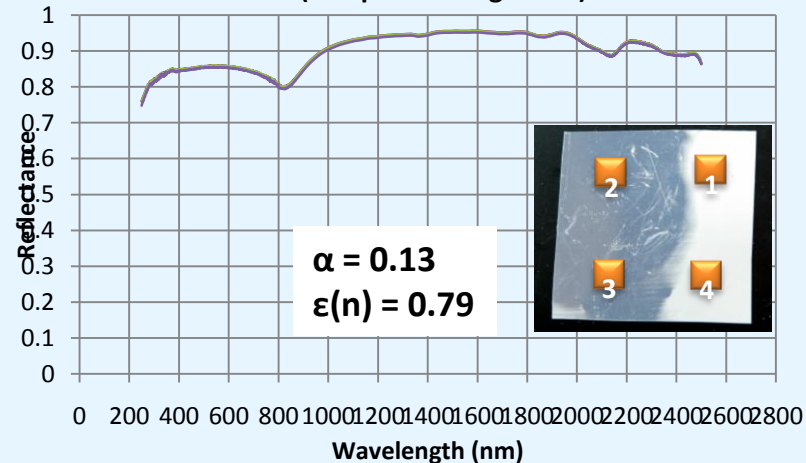
Pristine

Reflectance Graphs showing thermal property calculations

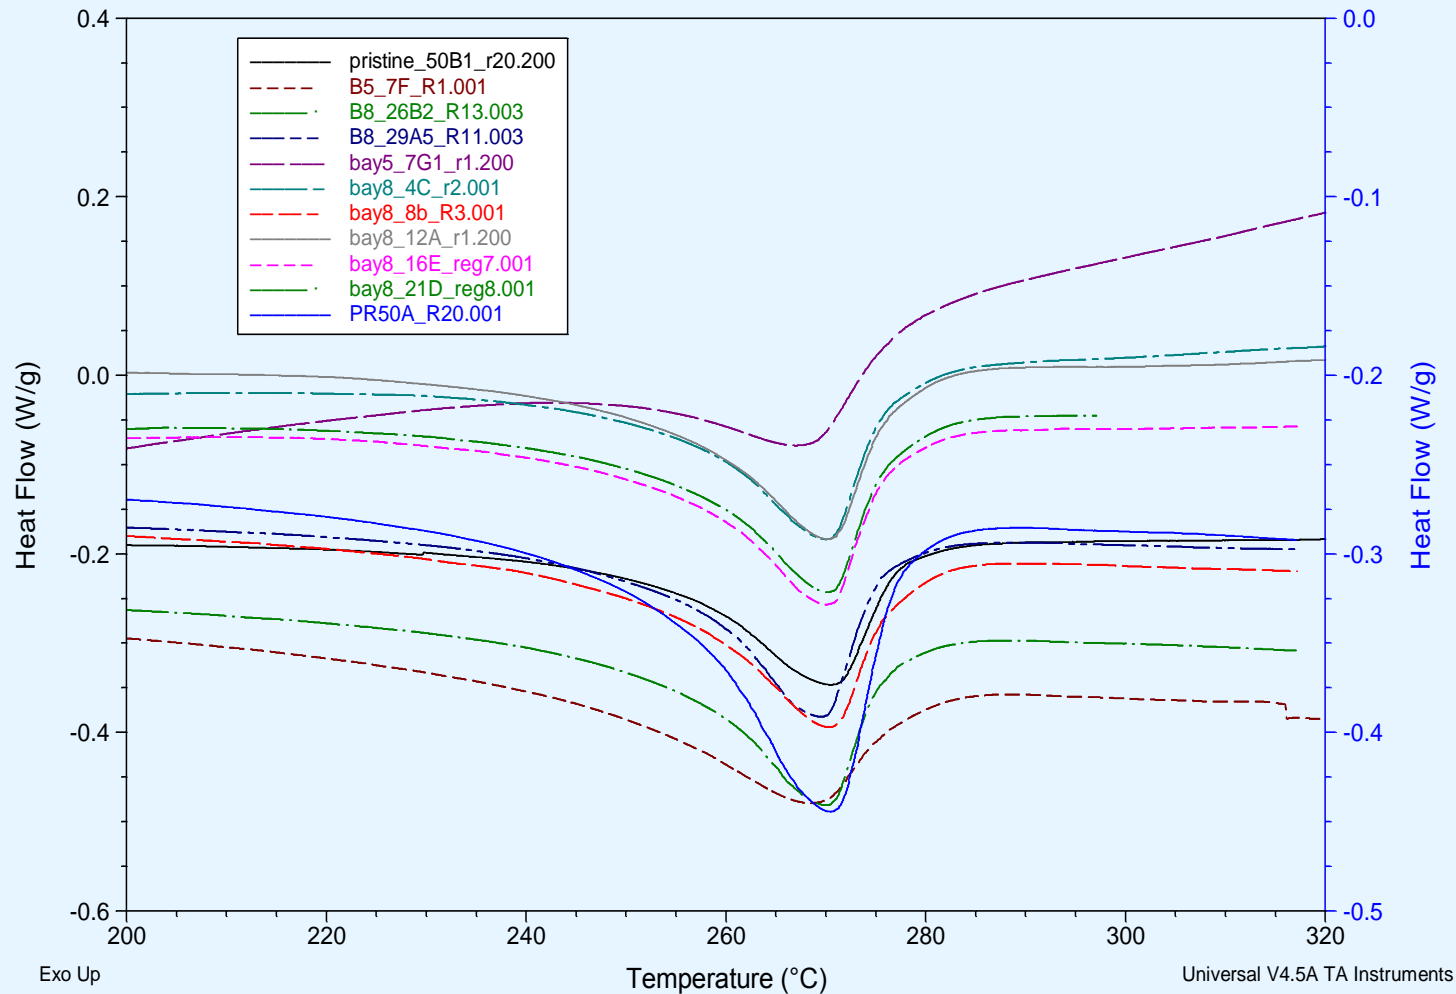
Differential Scanning Calorimetry (DSC)

Bay #	Abbreviation	Description	ΔH_m , cal/g	Melt T, °C
8	B8 MOL N S	Shiny+V3	6.24	251.36
	B8 MOL NH (hazy)	white hazy +V3	6.12	252.62
	B8 MOL N D	Al delaminated FEP +V3	6.41	251.82
	B8 MOL TC	Tight curl	8.13	253.07
	B8 MOL LC	Loose curl	6.45	253.24
	B8 MOL P	MLI Area patched during SM2 - stayed covered - mostly under velcro	5.62	254.42
	B8 MOL P SM3B	MLI patched and exposed at SM3B	5.88	254.60
5	B5 MOL N S	Shiny +V2	5.50	243.06
			5.57	244.28
Pristine	Pristine	5-mil Al FEP	2.75	272.59
			2.60	271.23
