NASA/TM-2011-217318
NESC-RP-10-00680

Space Transportation System (STS)-133/ External Tank (ET)-137 Intertank (IT) Stringer Cracking Issue and Repair Assessment: Proximate Cause Determination and Material Characterization Study

*Robert S. Piascik/NESC
Langley Research Center, Hampton, Virginia*

December 2011

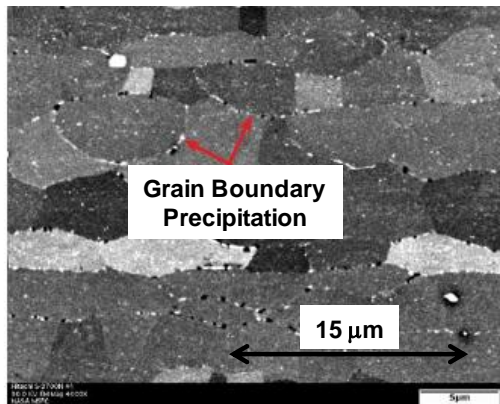
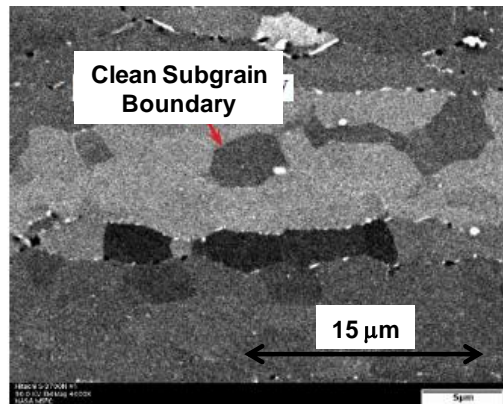
Initial fracture toughness testing of specimens extracted from the ET-137 cracked stringers showed that suspect lots 620853 and 620854 exhibited brittle behavior in the form of low toughness and little or no stable crack growth. In addition, microstructural examinations revealed that the amount of grain and subgrain boundary precipitation was abnormally high in the suspect lots when compared to that observed in the control lots, as shown in Figure 5.0-6. The materials shown in the micrographs of Figure 5.0-6 were in the -T83 temper following cold forming and hot forming.

Excessive grain boundary precipitation suggested that off-nominal thermo-mechanical processing (high temperature and/or excessive time at temperature) resulted in poor fracture toughness without substantial influence on tensile properties. Subtle changes in aging temperature or time, temperature excursions during the hot forming process, and/or thermal excursions prior to delivery of the coil could account for the anomalous boundary precipitation.

Figure 5.0-6. Example of Grain Boundary Precipitation in Lot 620853 and a Control Lot [ref. 3]

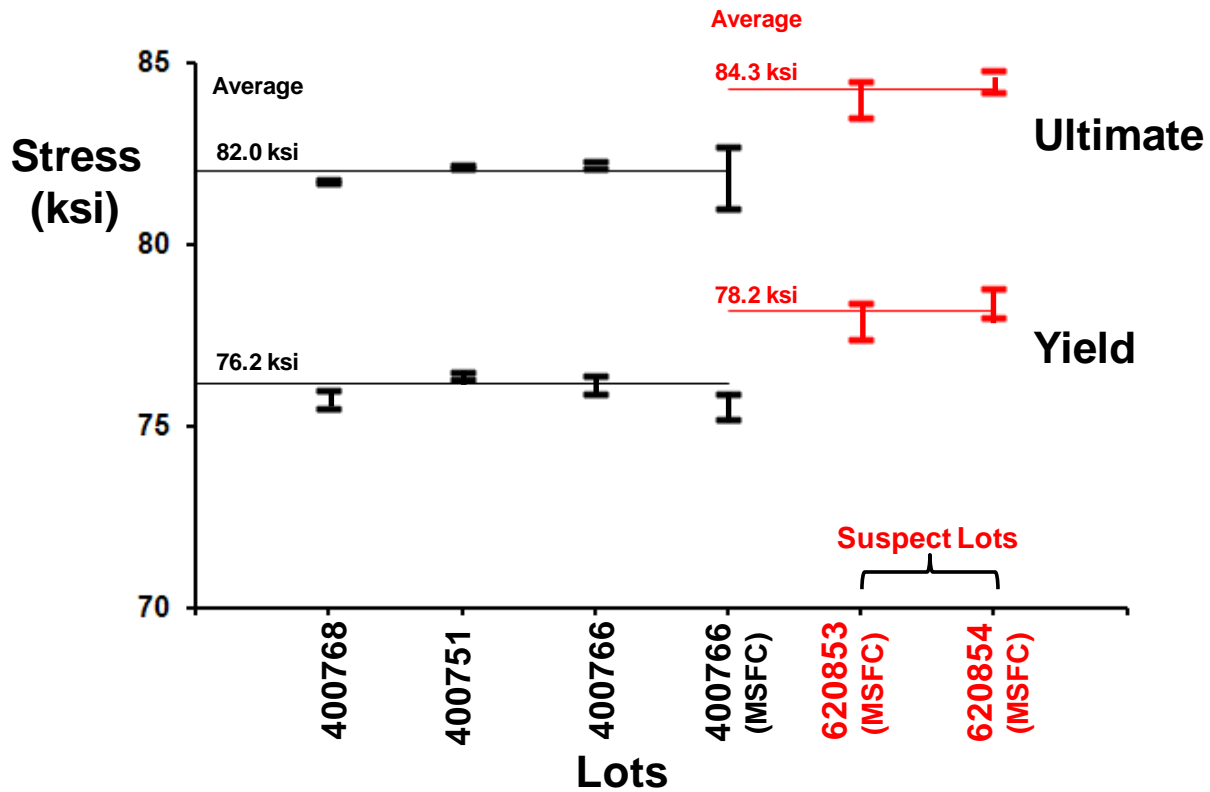
A summary of the measured yield and ultimate strengths for long-transverse orientation data for the control and suspect lots [ref. 3] is shown in Figure 5.3-2. The average yield and ultimate strengths for the suspect lot materials were about 2 ksi higher than the corresponding averages for the control lot materials. **Comparisons of the tensile test results indicate that the suspect material had higher yield and ultimate strengths than the control material (Observation 1).**

Figure 5.3-2. Summary of Tensile Test Results for All Lots (Long-transverse Orientation)

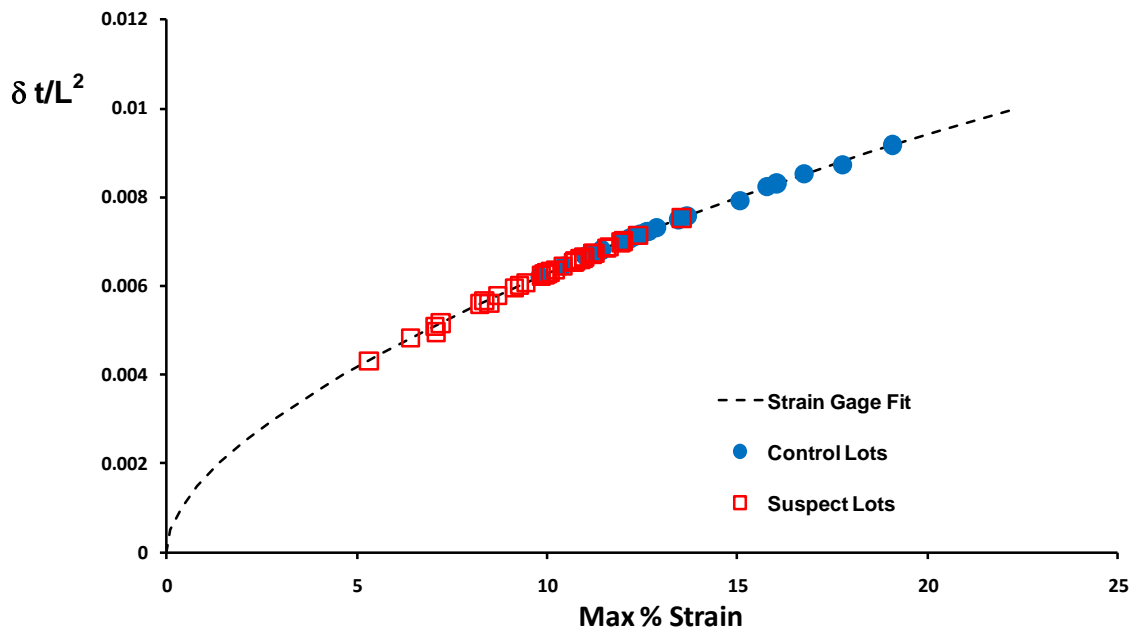
The specimens were oriented with the rolling direction perpendicular to the long side of the specimen. This bending orientation produces cracking in the same plane (short longitudinal) as the stringer cracking plane. The distance between the two fixed boundaries was defined as “L” and the displacement of the center mandrel was defined as “ δ ”, as shown in Figure 5.3-4. The tests were conducted by applying a constant displacement rate of 0.05 inches/minute until the specimen either failed suddenly into two pieces (defined as brittle behavior) or emitted an audible sound that indicated damage, producing an intact ligament and rapidly dropping the load, without complete failure (defined as less-brittle behavior). The applied displacement and load were measured for each test. Several tests had strain gages on the specimen tensile side opposite the mandrel. The strain to failure, or cracking, was noted for each test and was plotted as a function of the normalized displacement (δ/L^2) in Figure 5.3-5. The open square symbols represent the maximum strain observed in individual tests on suspect lot material and likewise, the solid circular symbols represent tests on control lot materials. The failure strains of the control and suspect lots overlap on the lower end of the control lot and the upper end of the suspect lot failure strains. **The 3-point bend tests demonstrated that the suspect lot materials were more brittle and had lower strains to failure than the control lot materials (Observation 2).**

Figure 5.3-5. Strain to Failure from 3-point Bend Tests

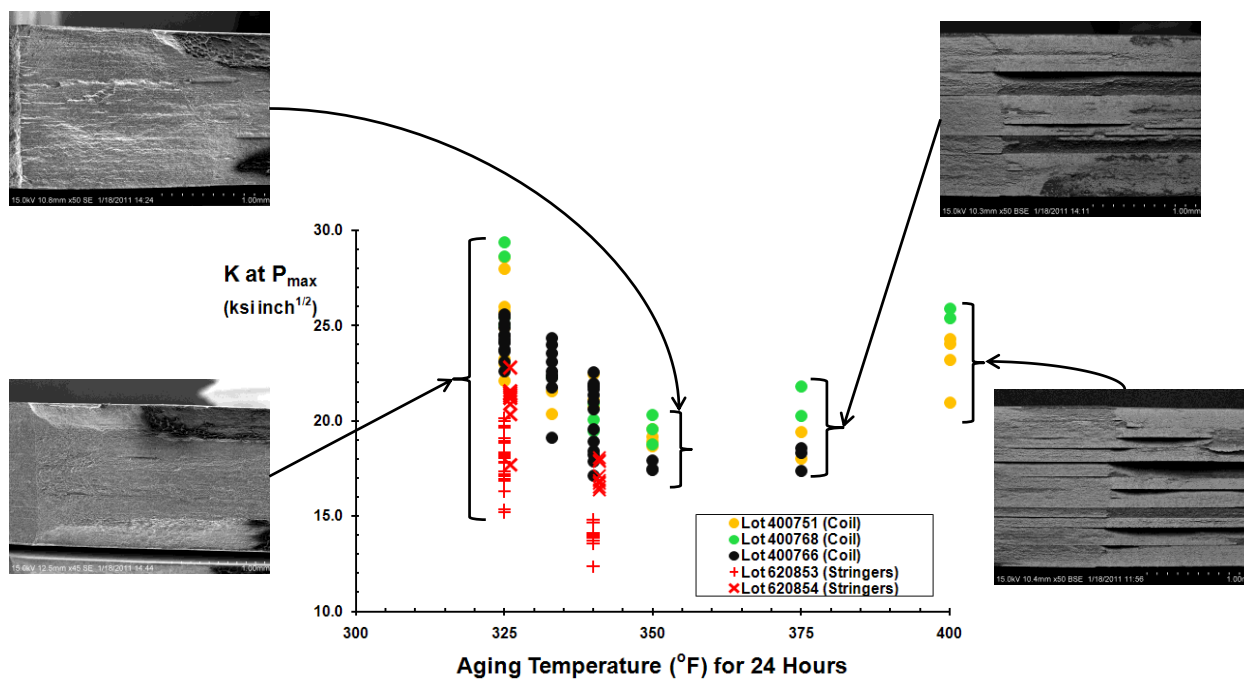
The measured fracture index (i.e., K at P_{max}) decreased with increasing temperatures for aging temperatures between 325 and 350°F. The micrographs in Figure 5.4-2 show representative crack surfaces for fracture specimens that were aged at different temperatures. Examinations of these micrographs reveal a general increase in grain boundary delamination with aging temperature (i.e., straight and parallel microstructural features along the crack length). For aging temperatures above 350°F (toughness minima), there is a dramatic increase in boundary delamination. The correlation of increasing toughness and boundary delamination with increasing thermal aging temperatures above 350°F suggests that the increase in toughness for aging temperatures greater than 350°F is the result of delamination toughening. The toughness increase is the result of the increased crack driving force required to propagate delamination cracking. **The suspect lot materials exhibited lower fracture toughness values compared to the control lot materials at elevated aging temperatures (Observation 5). Above 350°F, the observed increase in fracture toughness is related to delamination fracture mechanism (Observation 6).**

Figure 5.4-2. Fracture Test Results from the Thermal Aging Study

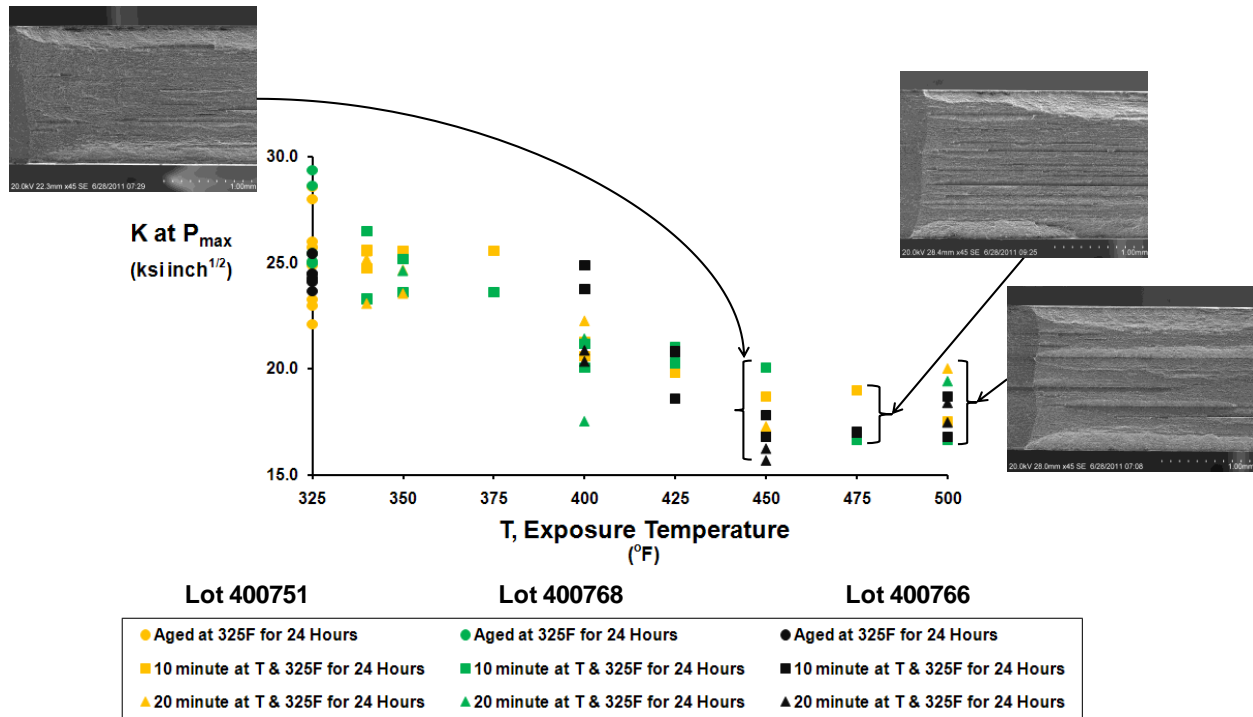
The thermal exposure study was performed by heating the 2090-T3 coil materials to temperatures above the nominal aging temperature (325°F) for a brief period (10 and 20 minutes), as summarized in Table 5.4-2. The results for the individual tests are provided in Appendix D. The goal of the tests was to determine if short duration temperature anomalies during the hot forming process could influence the microstructure or material behavior. The specimens were aged for 24 hours at the nominal aging temperature after the brief thermal exposures. Multiple tests were conducted at each temperature and material combination, and K at P_{max} was plotted for each exposure temperature, as shown in Figure 5.4-3. The control material did not show a reduction in toughness until the exposure temperature exceeded 375°F. The toughness minima occurred at about 450°F, where delaminations were becoming visible on the fracture surfaces. **Further increases in the exposure temperature resulted in a higher density of fracture surface delaminations and little measureable change in the toughness index (Observation 7).**

Figure 5.4-3. Fracture Test Results for the Thermal Exposure Study

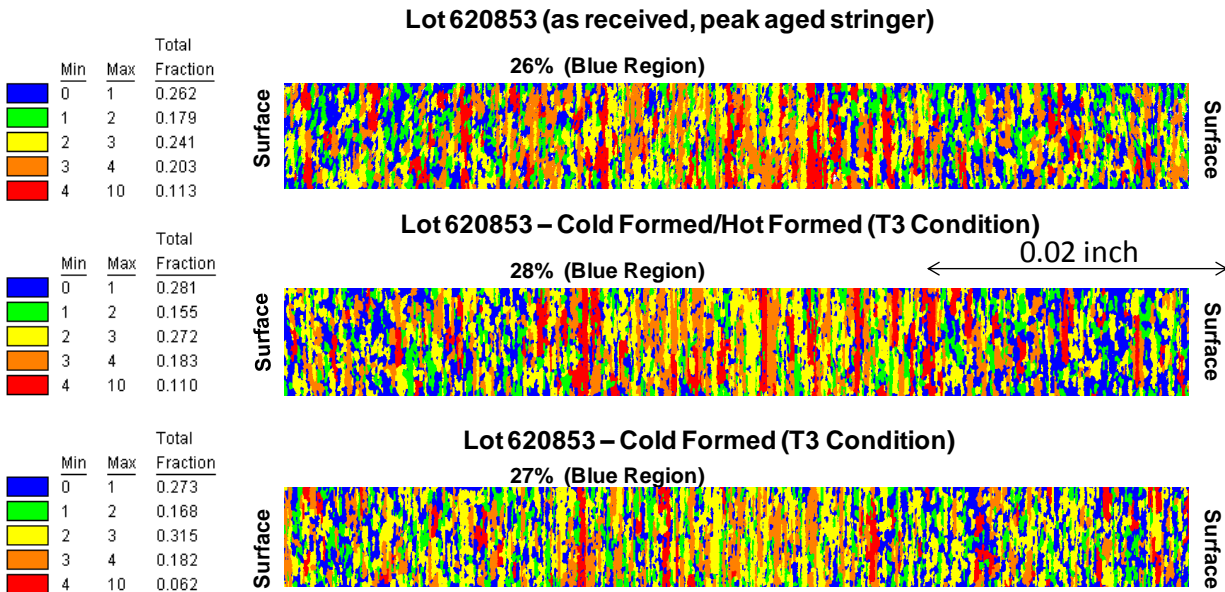
formed stringers. All the suspect materials showed a higher percentage material that exhibited recovery; the interior of the sheet (middle 1/3) had fewer blue regions compared to the exterior regions (remaining 2/3). Conversely, a comparison of the suspect lot material EBSD results compared to the control lot (Figures 5.5-6 and 5.5-5, respectively) revealed a dramatic difference in misorientation or dislocation morphology.

The EBSD data revealed that the suspect material exhibits evidence of grain recovery parallels the TEM observations 8, 9, and 10. Grain recovery (removal or redistribution of dislocations) reduces or changes the number of energetic sites for precipitation; removal or redistribution of dislocations could alter precipitate morphology (alter precipitate size, number, and location). **Thus, the EBSD analysis revealed that the as-received suspect lot microstructure exhibits grain recovery (reduced dislocation density) and confirms the TEM observations relative to differences in precipitate morphology (Observation 12).**

Figure 5.5-6. GOS Values for a Through-the-Thickness Strip of Stringer Lot 620853 in the as-received Peak-Aged, Cold-Formed + Hot-Formed, and Cold-Formed Conditions
