Failure Analysis of T-38 Aircraft Burst Hydraulic Aileron Return Line

J. E. Martinez¹, J. D. Figert¹, R.M. Paton¹, S.D. Nguyen², A. Flint²

Microscopy & Microanalysis 2012

Symposium P06 – Failure Analysis of Structural Materials

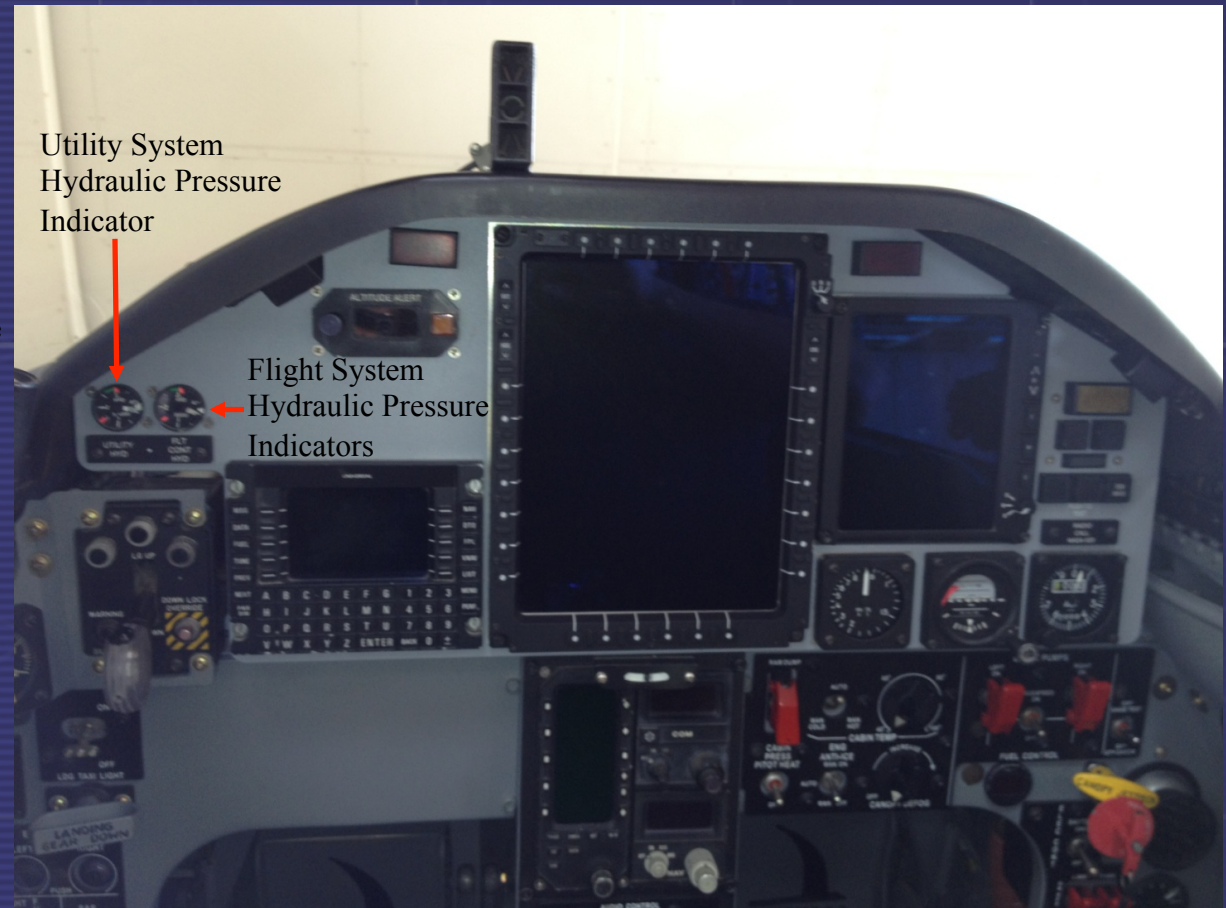
They two systems are identical in operation and provide redundancy in the event either system should fail.

Both systems operate at 3,000 PSI. All hydraulic pressure lines are corrosion resistant steel. Return and suction rigid lines are aluminum alloy, except in landing gear wheel wells and aft of engine firewall.

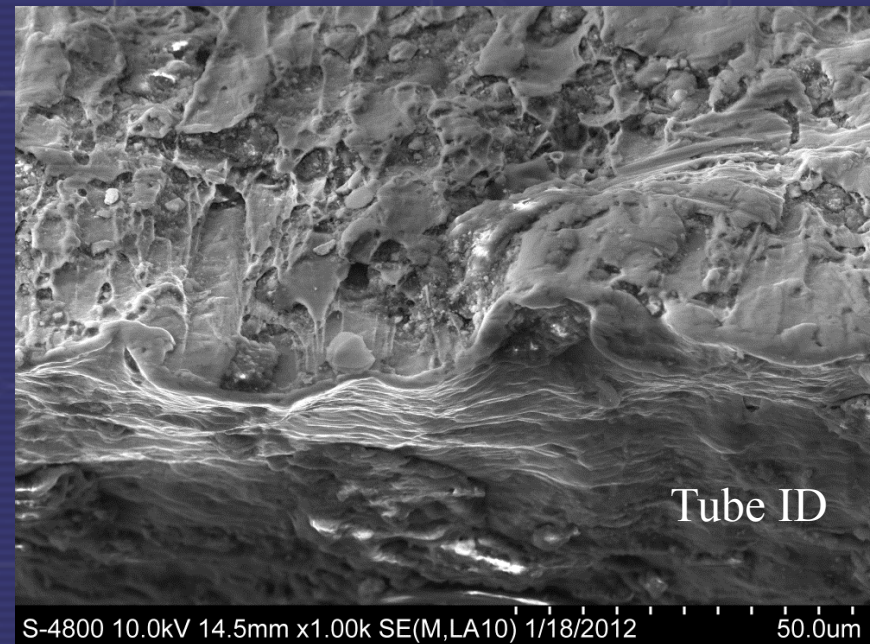
Ductile dimple mode fracture adjacent to cleavage facets indicate a high level of stress (above the yield strength) at the origin surface.

Tear ridges originate on the tube ID and progress towards the OD.

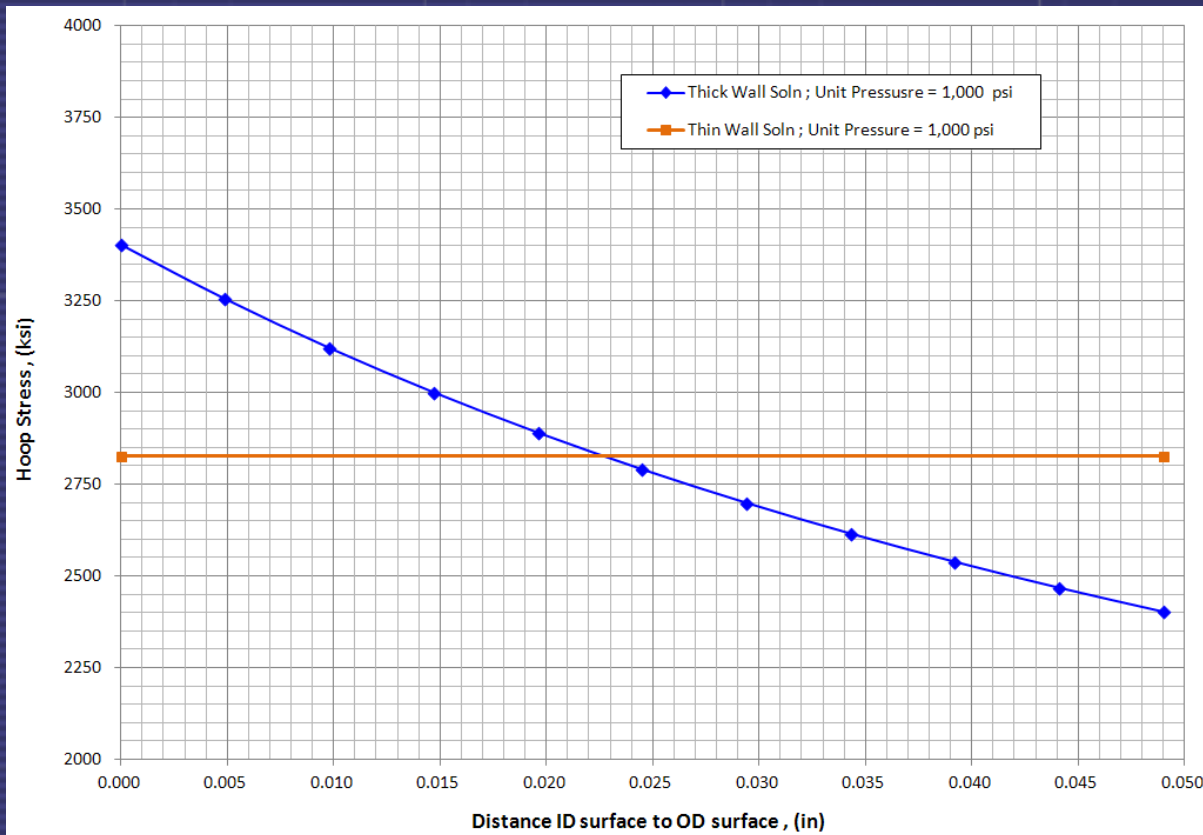
The thin and thick wall peak stress result for a unit internal pressure of 1,000 psi is 2.826 and 3.401 ksi respectively. A plot of the thin and thick wall stress distribution for the unit pressure load of 1,000 psi is provided below.
