Boiling Experiment Facility (BXF): Post Flight Assessment Anomaly Investigation Report

*Wendell H. Booth
ZIN Technologies, Incorporated, Middleburg Heights, Ohio*

This document serves as the report for presenting the results and conclusions of investigation activities that were performed to determine the root causes of the anomaly, camera misalignment, and dissolved gas concentration issues and to verify the calibration and accuracy of the pressure and temperature measurements.

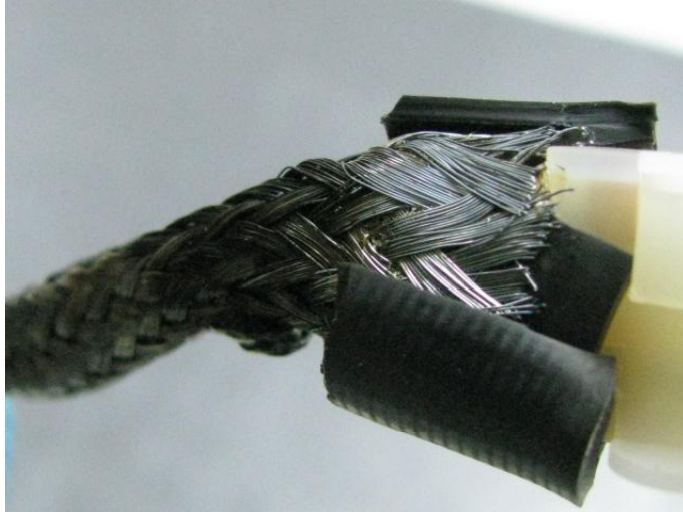
Figure D.5.—Heater 1 Molex connector, strain relief sliced open, note discoloration on wire braid.

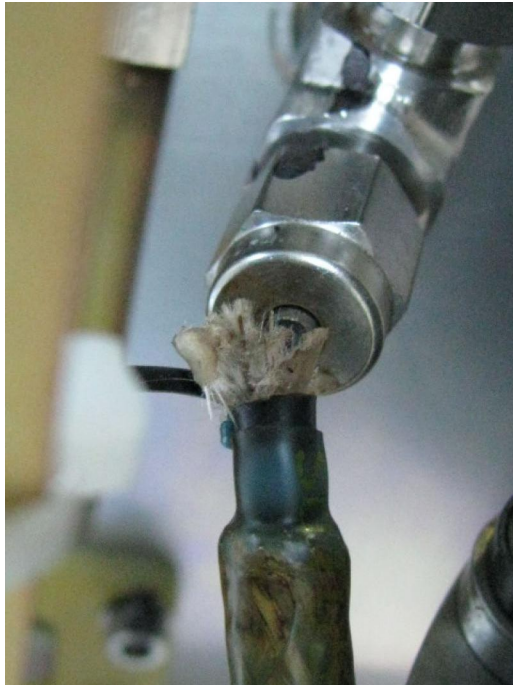
Figure D.7.—Heater 1 feedthrough into TC.
Note melted shrink wrap.

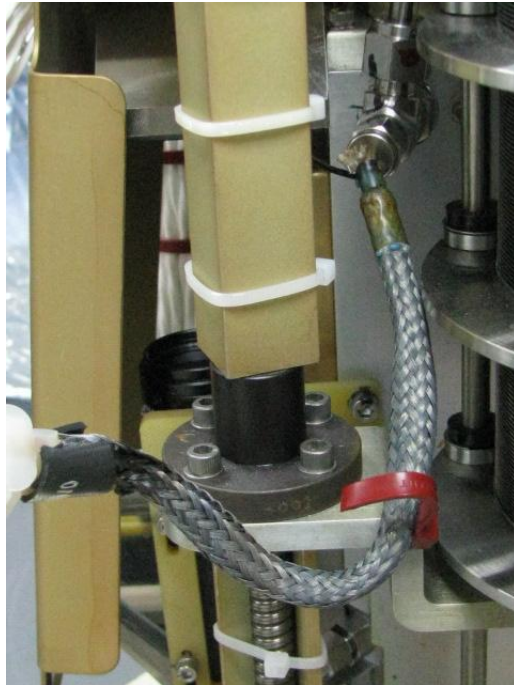
It can be concluded from the investigation results that Cartridge Heater S/N 010 (Bulk Fluid Heater 1) overheated. The heater temperature had to have reached at least 1400 °C in order to melt the Incoloy 800 and NiCr materials of the heater. The heat that was generated probably transferred via thermal conduction down the cartridge heater wiring causing the burn and melt damage observed near the connector. The

Figure D.9.—Heater 1 power cable, note discoloration on wire braid by Molex connector and melted ty-rap.

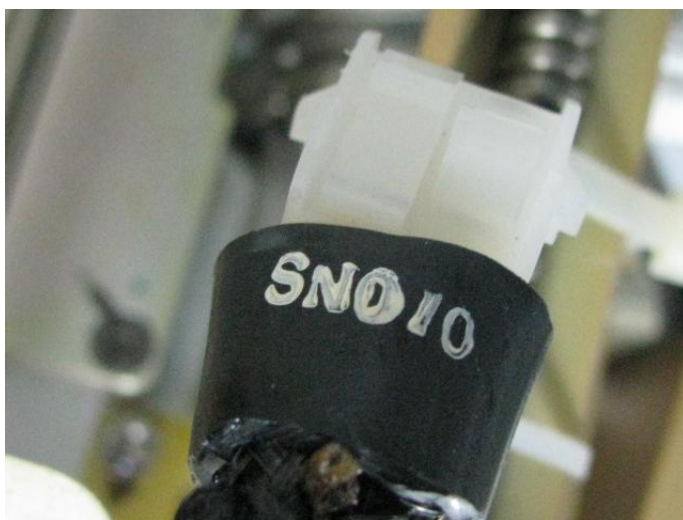
Figure D.12.—Heater 1 Molex connector, note discoloration on wire braid.

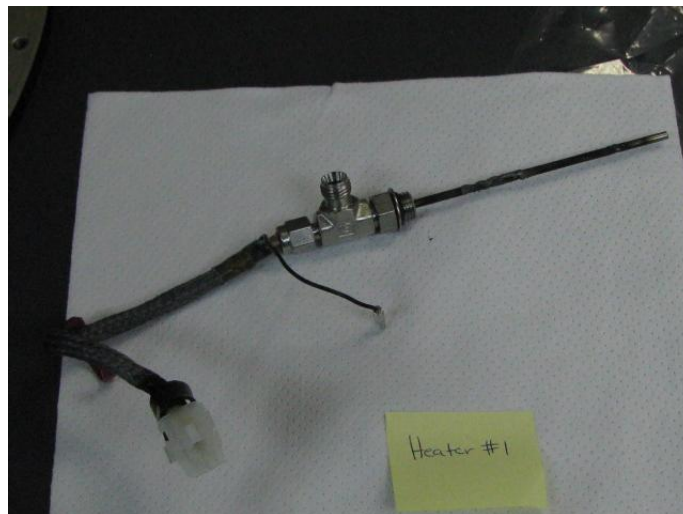
Cartridge Heater S/N 010 (Bulk Fluid Heater 1) could not be extracted from its port fitting on the Test Chamber. So, the entire fitting was removed from the chamber and left in place on the heater. Heater 1 showed extreme damage at two locations along the sheath. Melting of the Incoloy 800 is evident in both locations. The brownish magnesium oxide (MgO) insulating material and greenish remains of the nickel chromium (NiCr) wiring inside are also visible. Melting points of the various materials are listed below.

The damage observed on Bulk Fluid Heater 1 proves that temperatures in excess of 1400 °C were achieved on-orbit.

Figure D.14.—Heater 1 extracted with tee from TC, note melted and blackened surface.

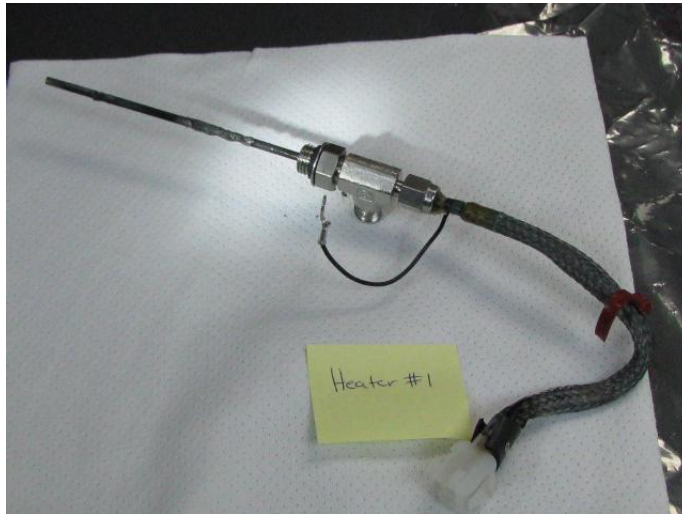
Figure D.15.—Heater 1 extracted with tee from TC, note melted and blackened surface.

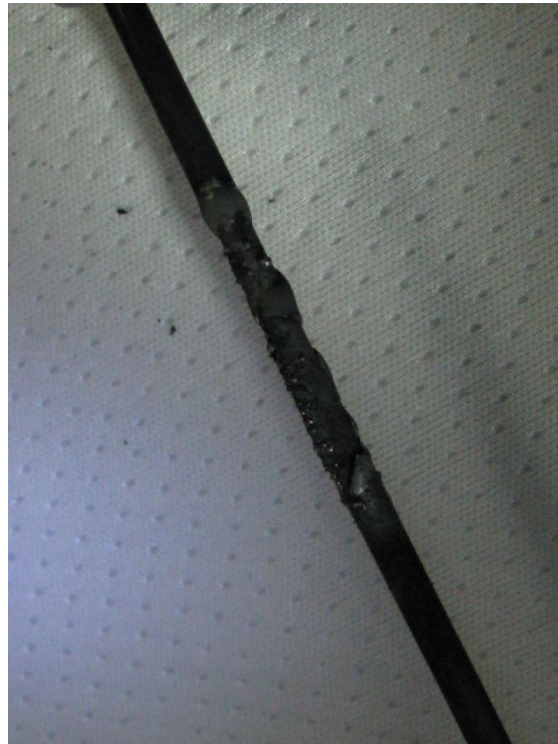
Figure D.16.—Close-up of Heater 1 melted surface.

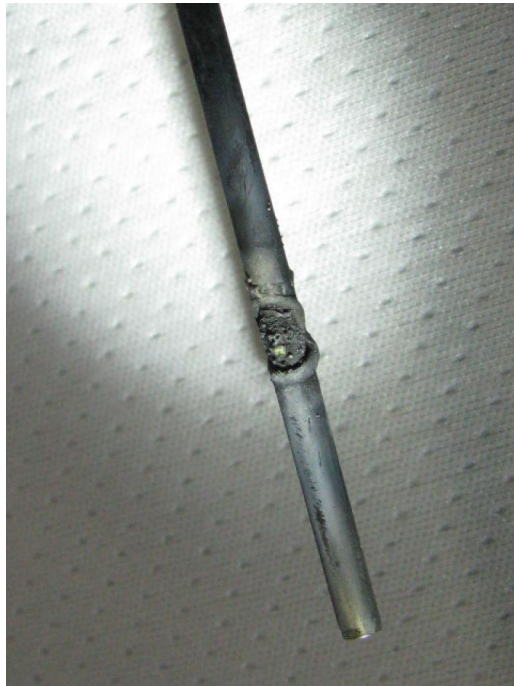
Figure D.17.—Close-up of Heater 1 melted surface near tip of heater.

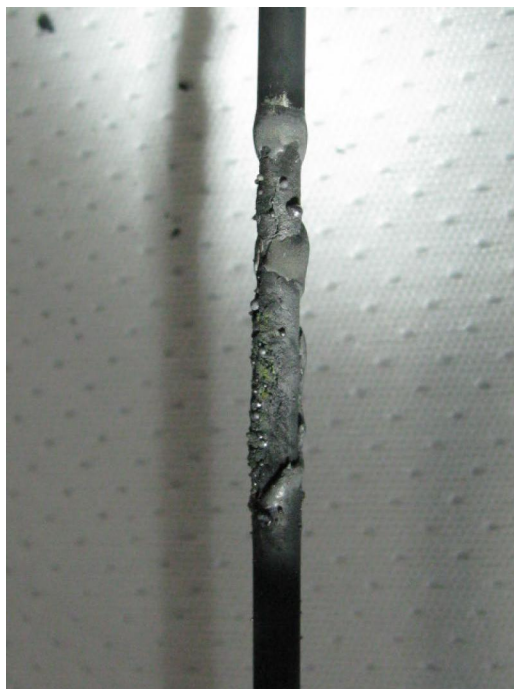
Figure D.18.—Close-up of Heater 1 melted surface.

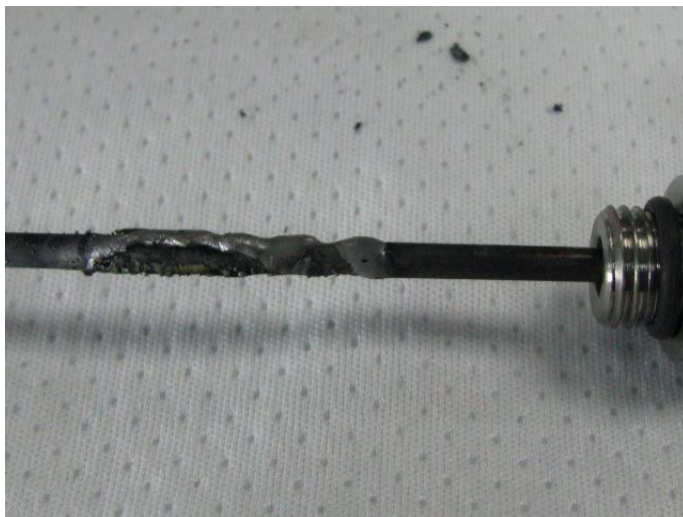
Figure D.24.—Close-up of Heater 1 melted surface.

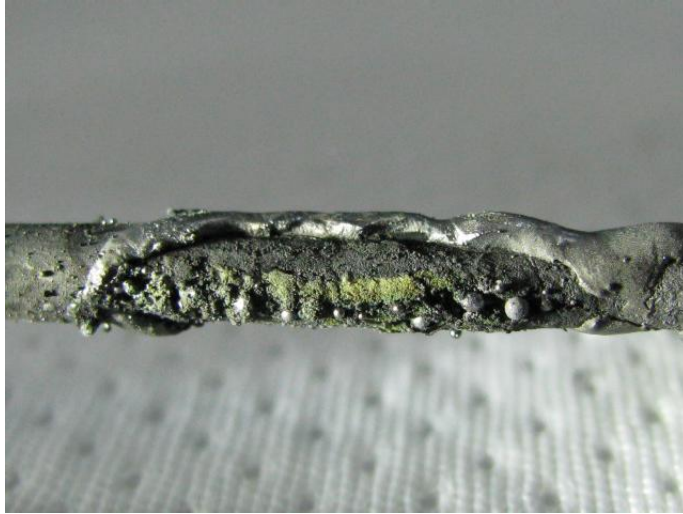
Figure D.25.—Close-up of Heater 1 melted surface.

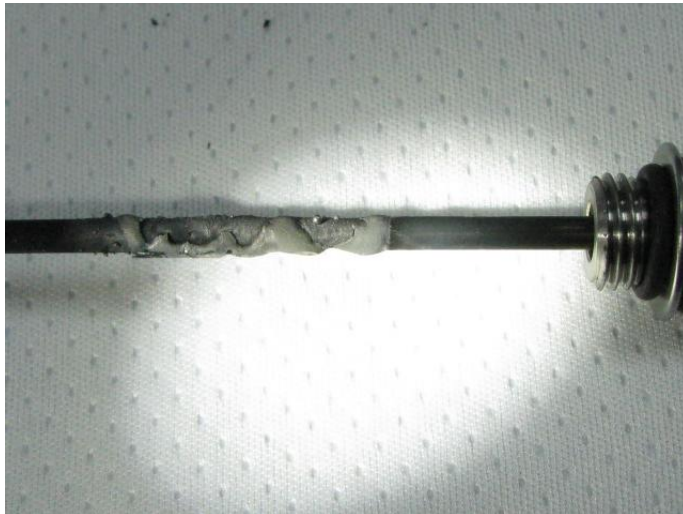
Figure D.28.—Close-up of melted surface near Heater 1 tip.

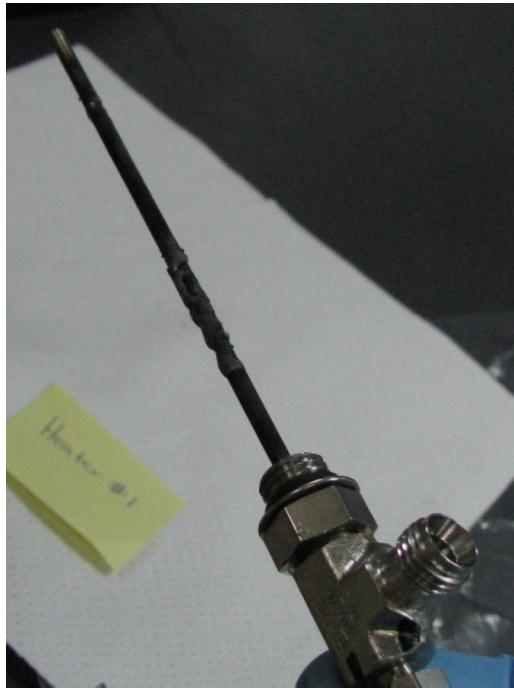
Figure D.30.—Close-up of Heater 1 melted surface.

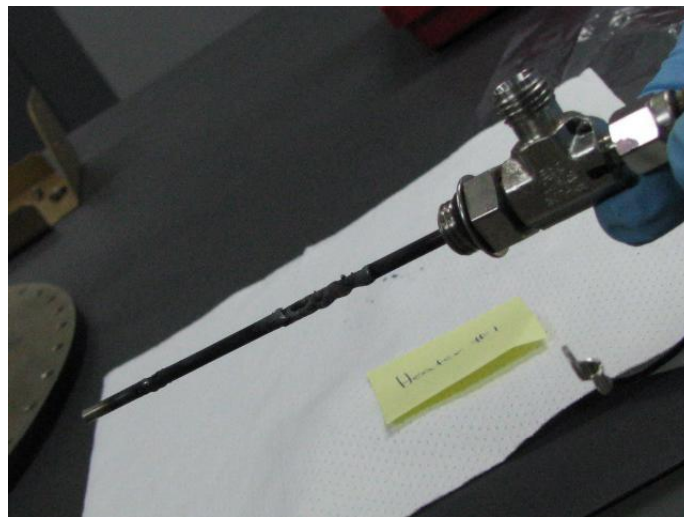
Figure D.31.—Fluid immersed portion of Heater 1: Note two melted areas of Heater 1

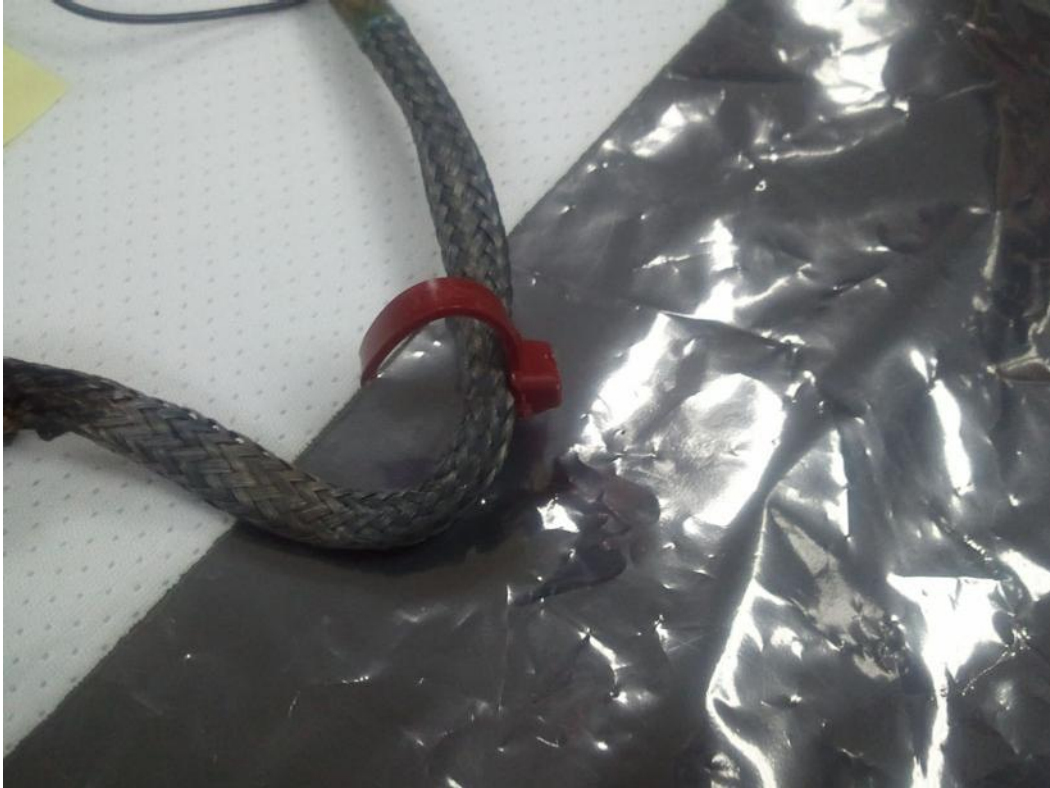
Difficulties were encountered during the dissection of Heater 1. The wiring shield braid could not be pulled back from the connector, because the shield was fused with the internal insulation sleeving. Cutting open the shield braid proved to be a slow process, as it was found that the shield had been hardened. After the shield was cut open, it was observed that the internal insulation sleeving was carbonized near the connector. The sleeving crumbled apart easily as the dissection proceeded. The insulation of the internal wiring appeared blackened overall, but whitened over the crimped area. The wire insulation near the connector was melted away leaving bare exposed wire. When the insulation sleeving was finally removed from around the connector, it was observed that the connector was melted and completely encasing the internal contacts. The contacts could not be extracted. During the dissection, the wiring separated from the heater sheath on its own without the need for cutting it, and the heater sheath became bent at one of the damaged portions of the sheath. The heater resistance was unstable and varied greatly as the assembly was handled. A stable value of 7.08Ω was finally measured during the Post-Dissection Resistance Check. Shorts of $\approx 8 \Omega$ each were found between the heater sheath and both power and return lines. The wiring that separated from the heater sheath failed continuity testing.

Figure D.50.—Wire harness for Heater 1: Note melted ty-rap.

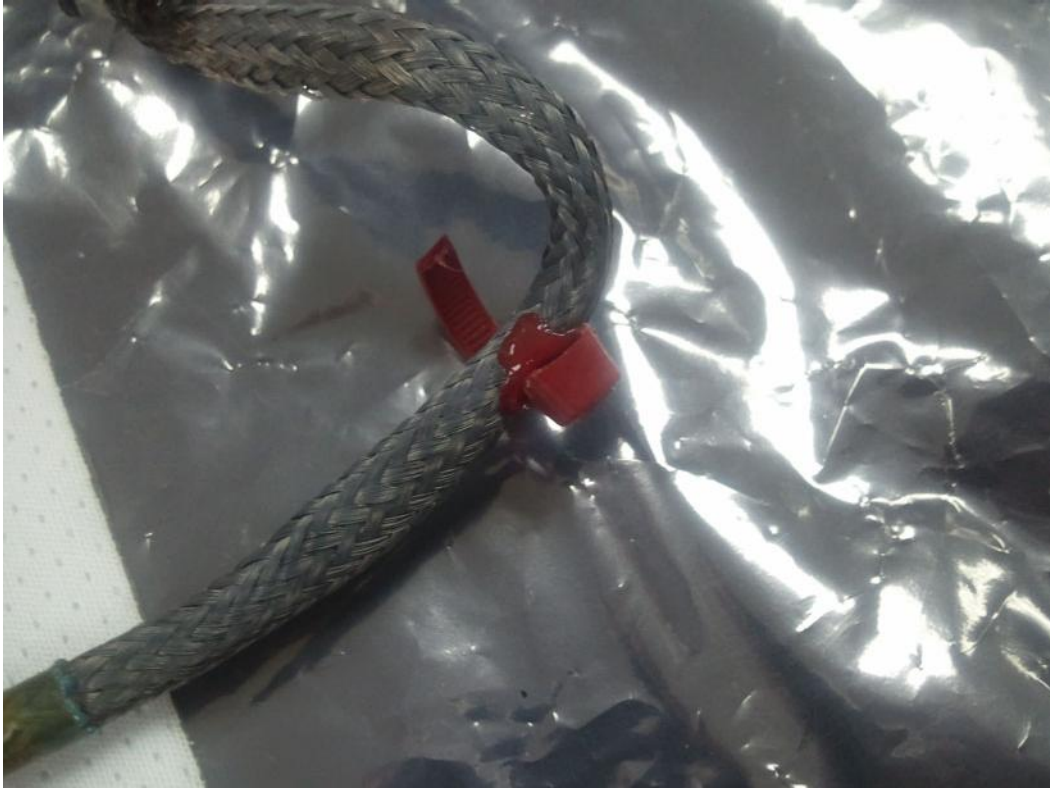
Figure D.52.—Wire harness for Heater 1: Note melted ty-rap.

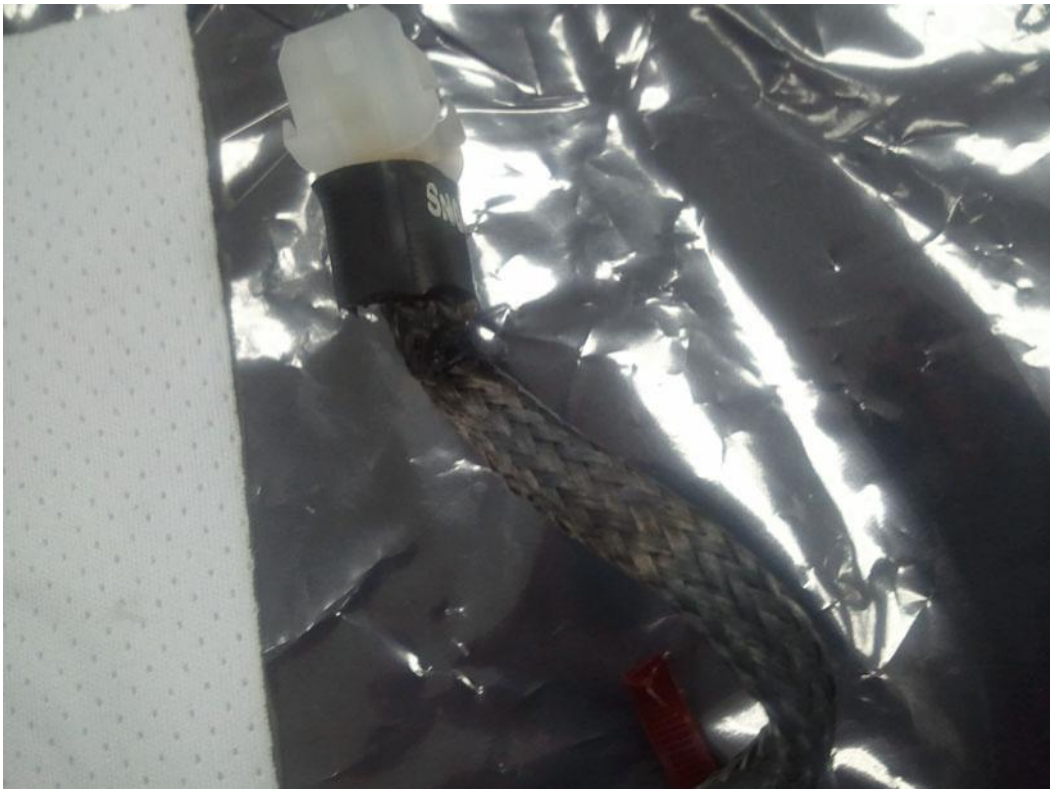
Figure D.53.—Wire harness for Heater 1: Note melted ty-rap.

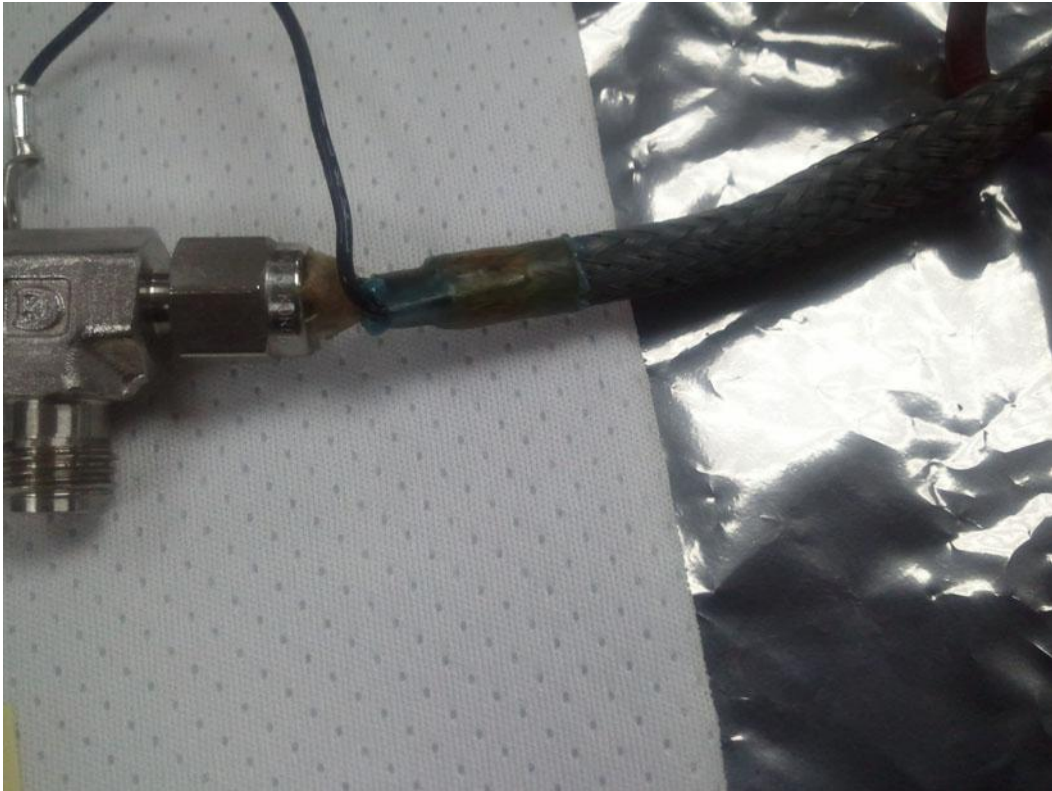
Figure D.54.—Wire harness for Heater 1: Note melted ty-rap and discoloration on wire braid.

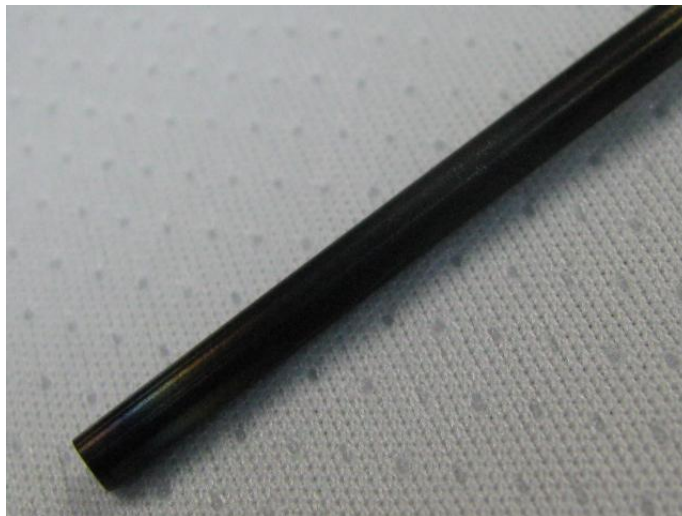
Figure D.63.— Heater 2 assembly: Note discoloration on fluid immersed portion.

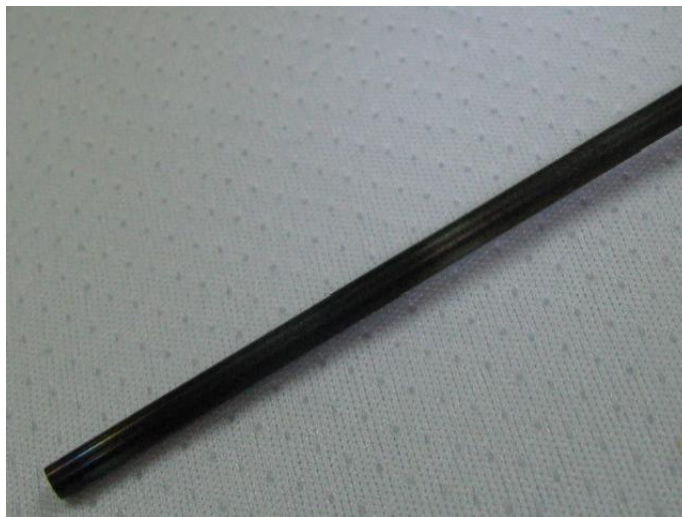
Figure D.64.—Heater 2 fluid immersed portion: Note bluing and blackening.

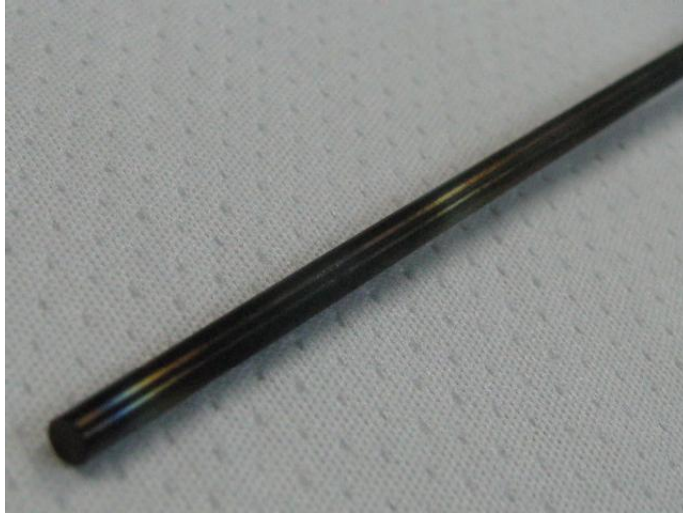
Figure D.65.—Heater 2 fluid immersed portion: Note bluing and blackening.

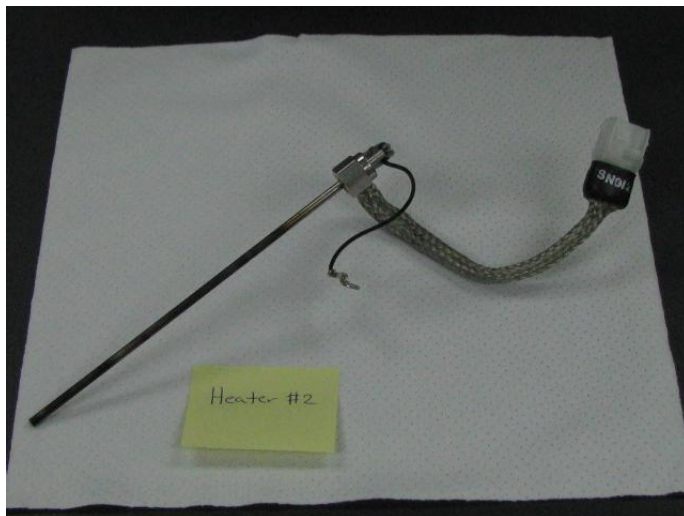
Figure D.68.—Heater 2 fluid immersed portion: Note bluing and blackening.

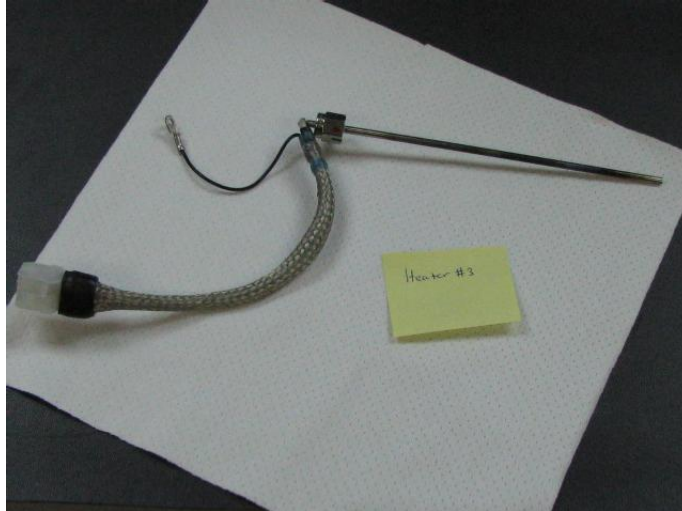
Figure D.82.—Heater 3 assembly: Note bluing and blackening on fluid immersed portion.

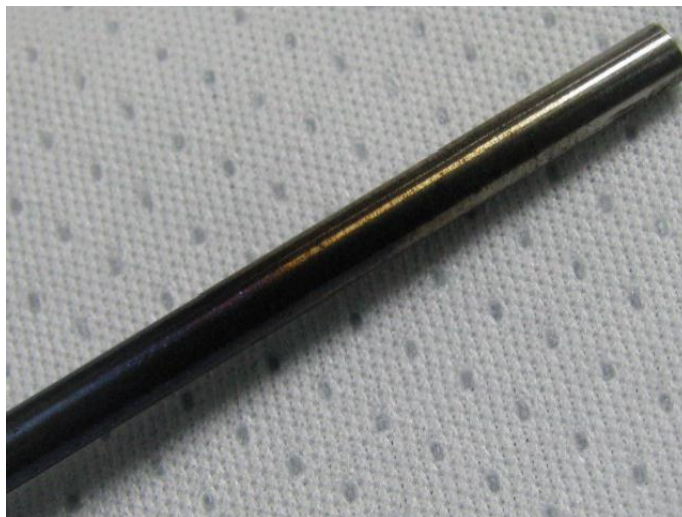
Figure D.84.—Heater 3 fluid immersed portion: Note bluing and blackening.

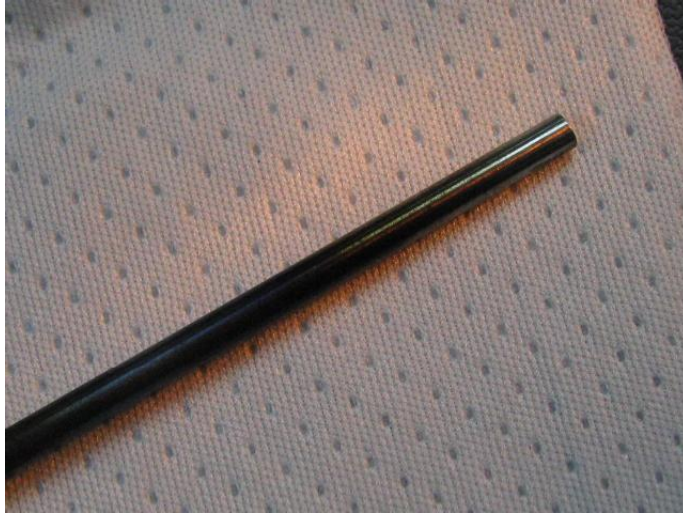
Figure D.85.—Heater 3 fluid immersed portion: Note bluing and blackening.

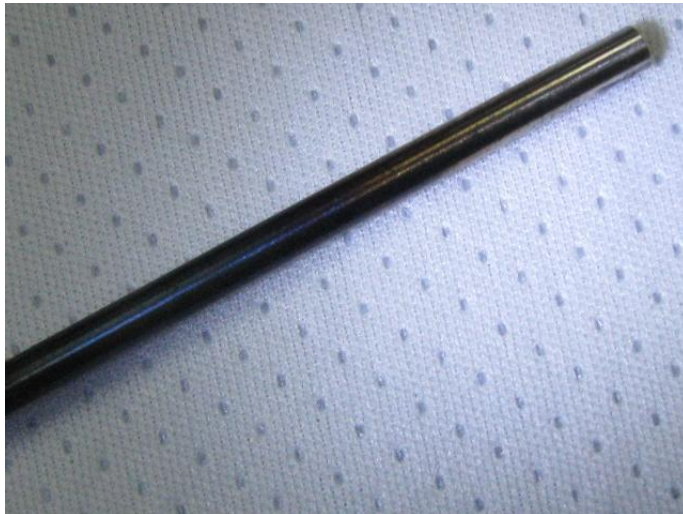
Figure D.87.—Heater 3 fluid immersed portion: Note bluing and blackening.

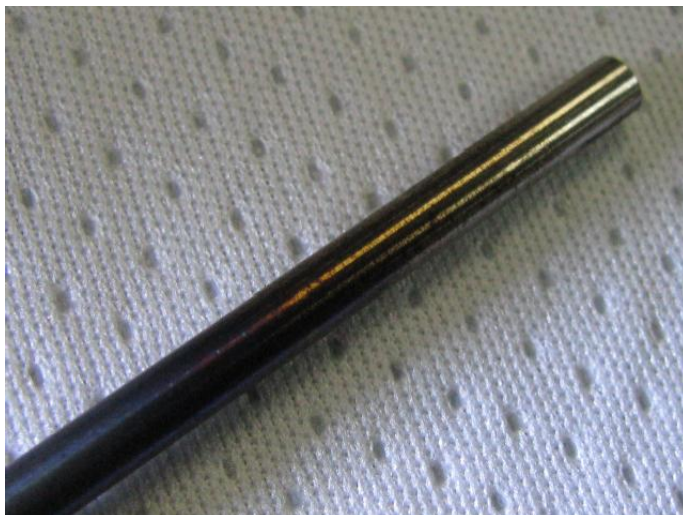
Figure D.88.—Heater 3 fluid immersed portion: Note bluing and blackening.

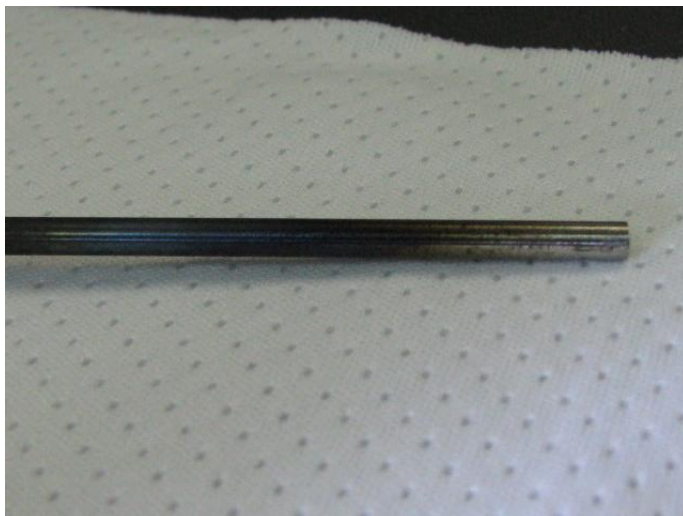
Figure D.89.—Heater 3 fluid immersed portion: Note bluing and blackening.

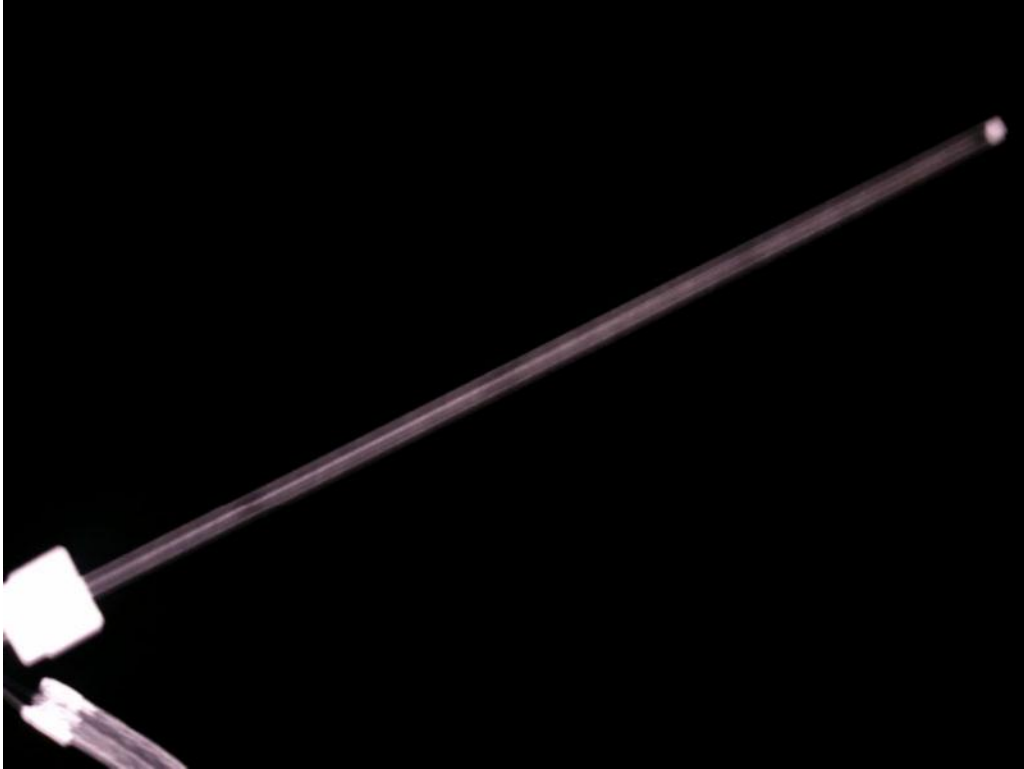
Throughout all stages of dissection for Heater 2, observations were nominal, and the heater resistance was stable at $\approx 9.63 \Omega$. The Post-Dissection Resistance Check of Heater 2 found two partial shorts, each $\approx 40 \Omega$, between the heater sheath and both the power and return lines going into the sheath. This is in agreement with prior investigation results.

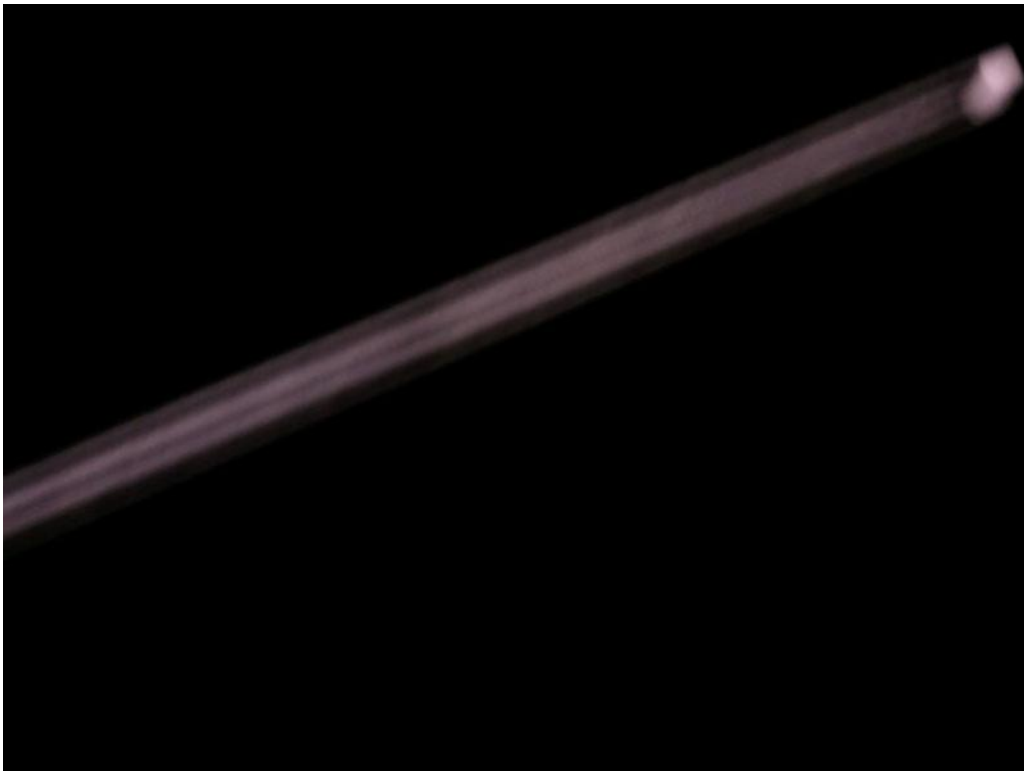
Figure E.51.—Close-up of heating element for Bulk Fluid Heater 2. Note irregularities.

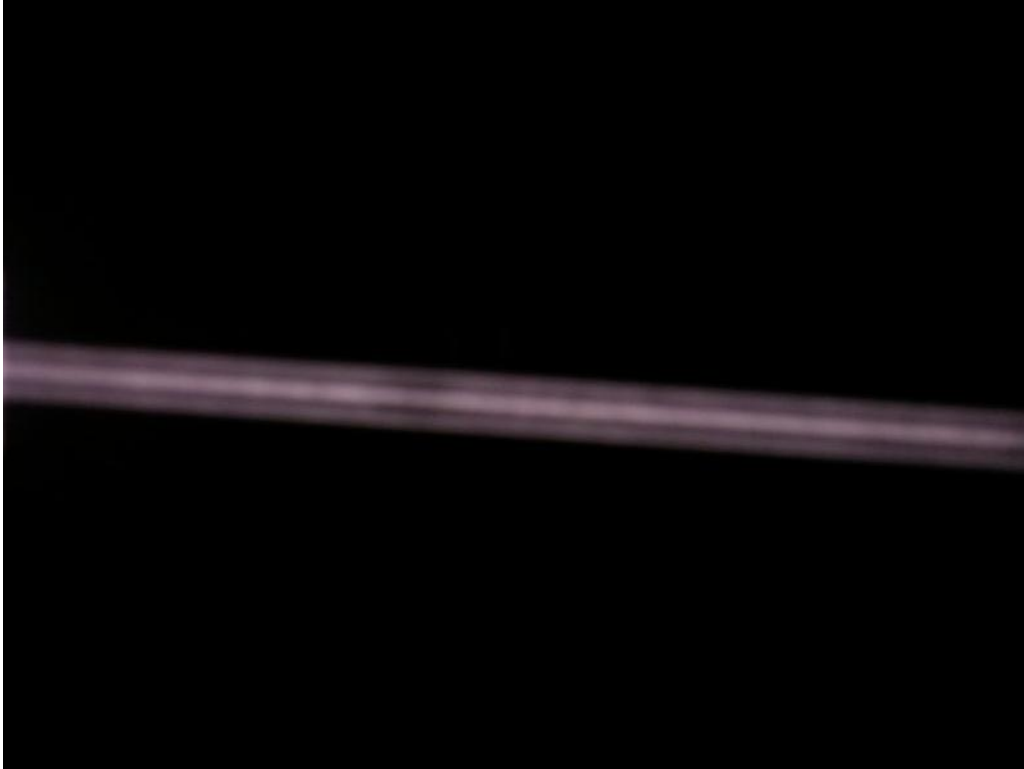
Figure E.52.—Close-up of heating element for Bulk Fluid Heater 2. Note irregularities.

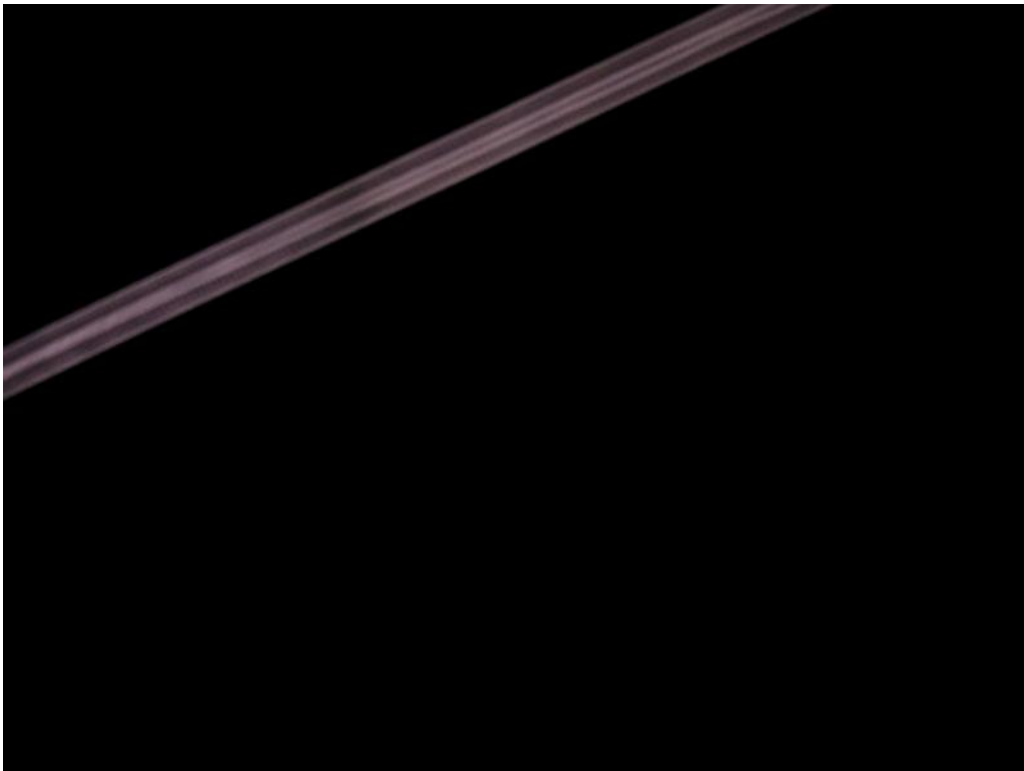
Figure E.53.—Close-up of heating element for Bulk Fluid Heater 2. Note irregularities.

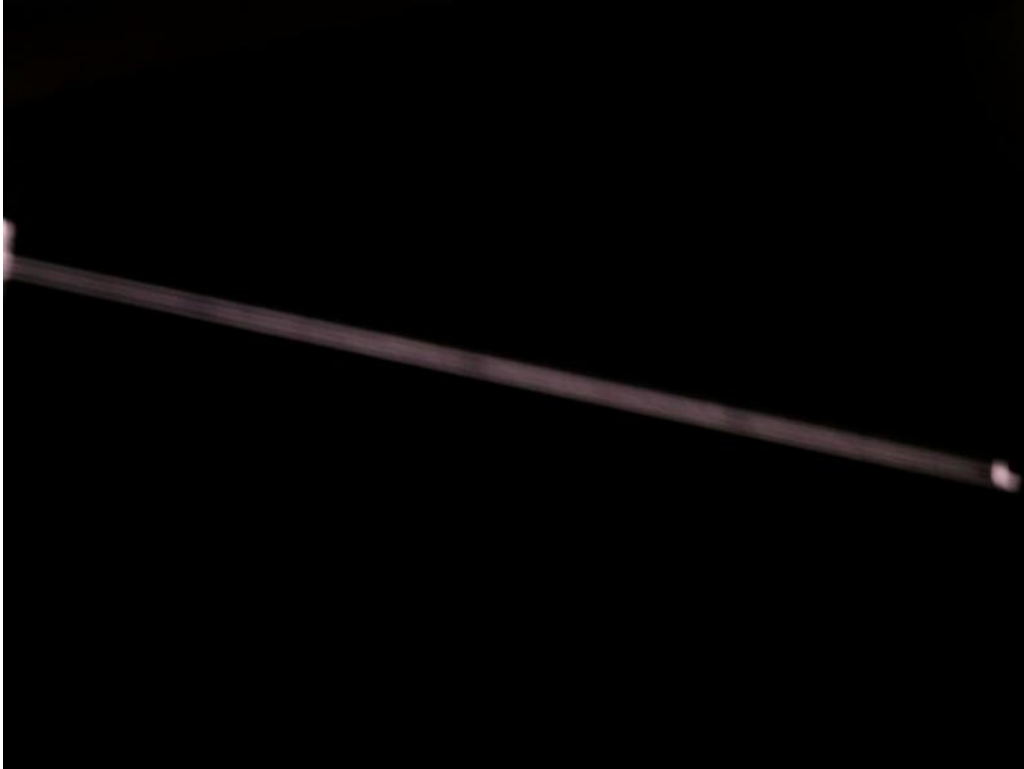
Figure E.72.—Heating element for Bulk Fluid Heater 3. Note irregularities.

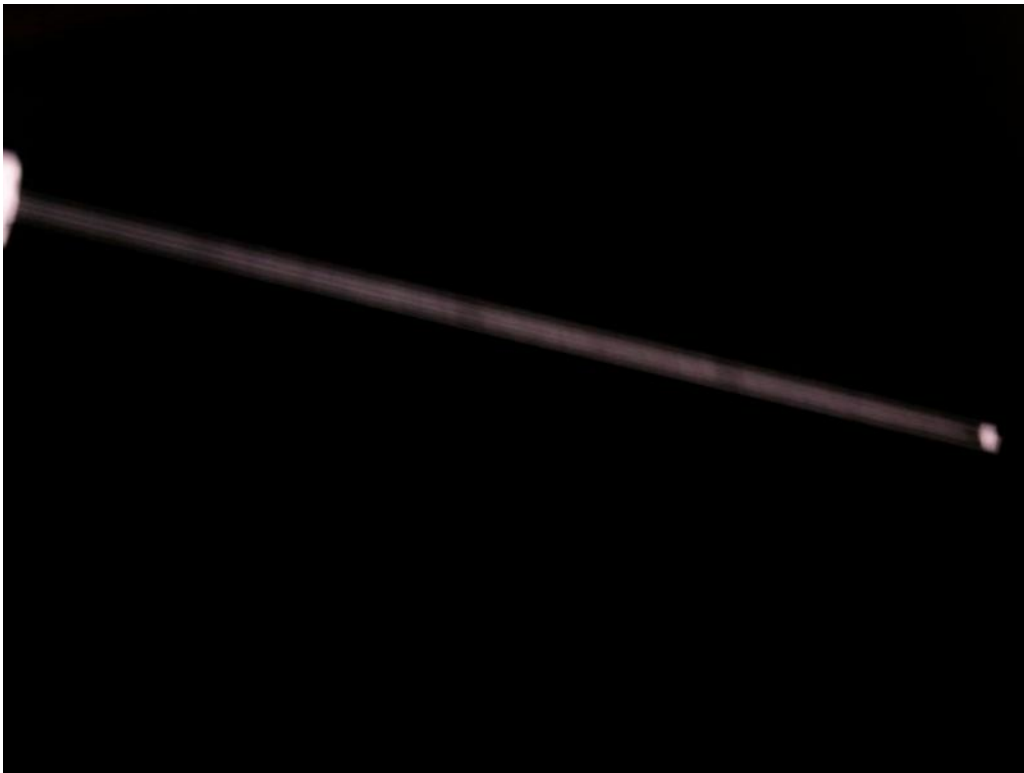
Figure E.73.—Heating element for Bulk Fluid Heater 3. Note irregularities.

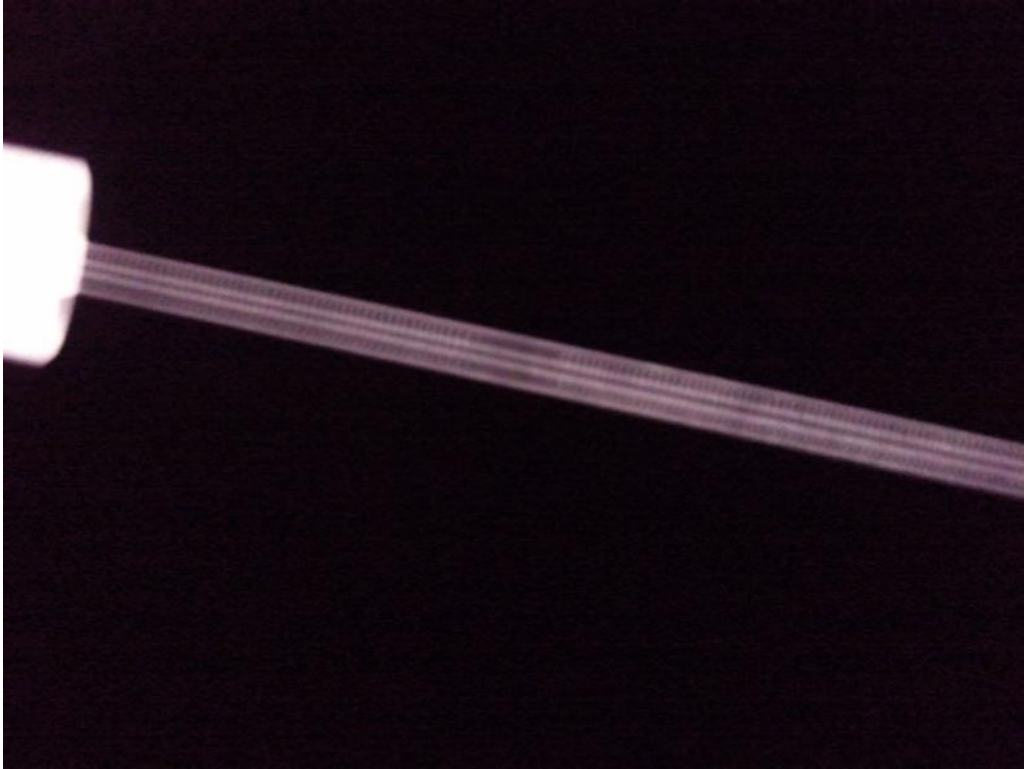
Figure E.76.—Close-up of heating element for Bulk Fluid Heater 3. Note irregularities.

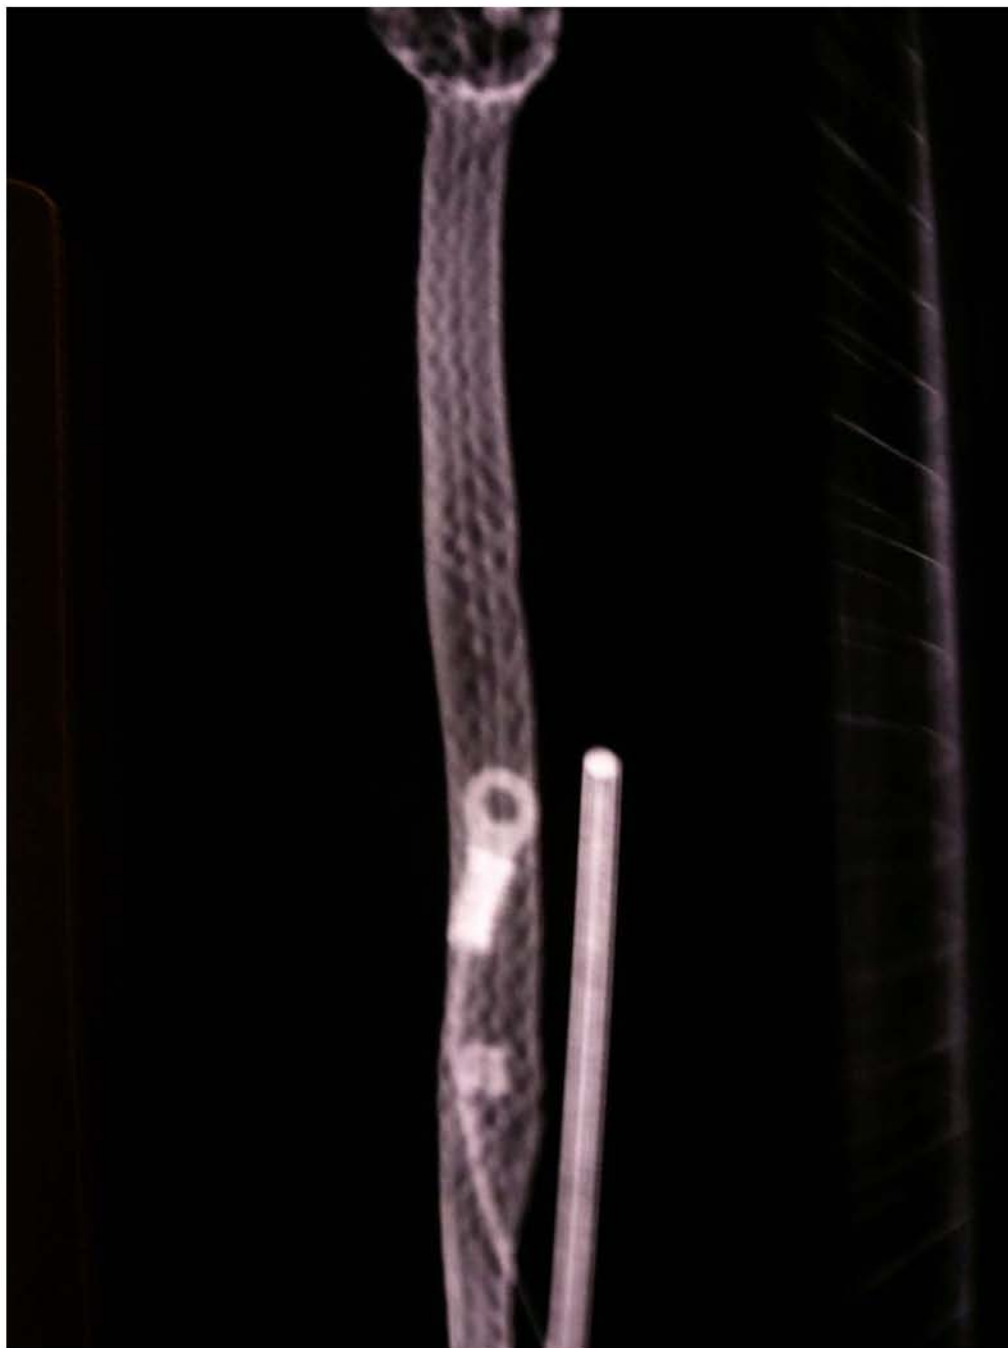
Figure E.95.—Grounding connection for Bulk Fluid Heater 3.
