International Space Station Crew Quarters On-Orbit Performance and Sustaining

The International Space Station (ISS) Crew Quarters (CQ) is a permanent personal space for crew members to sleep, perform personal recreation and communication, as well as provide on-orbit stowage of personal belongings. The CQs provide visual, light, and acoustic isolation for the crew member. Over a 2-year period, four CQs were launched to the ISS and currently reside in Node 2. Since their deployment, all CQs have been occupied and continue to be utilized. This paper will review failures that have occurred after 4 years on-orbit, and the investigations that have resulted in successful on-orbit operations. This paper documents the on-orbit performance and sustaining activities that have been performed to maintain the integrity and utilization of the CQs.

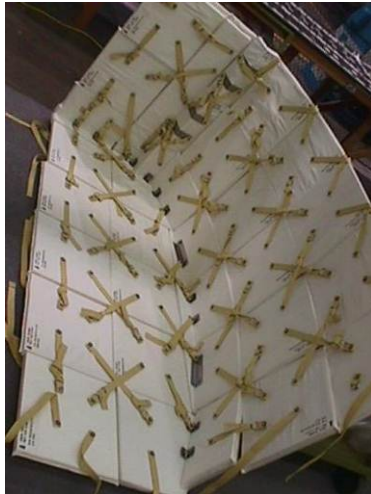
Figure 9. TeSS radiation shield (assembled).

The TeSS radiation shield (Fig. 9) is assembled from eight custom brick assemblies and 20 flat brick assemblies (Fig. 10). Each brick assembly is composed of 5.08 cm of High-Density Polyethylene. Two 2.54-cm blocks are pinned together to make the 5.08-cm brick. Each block is wrapped in a Nomex® sleeve and then assembled into the 5.08-cm brick that is then wrapped in aluminum tape.

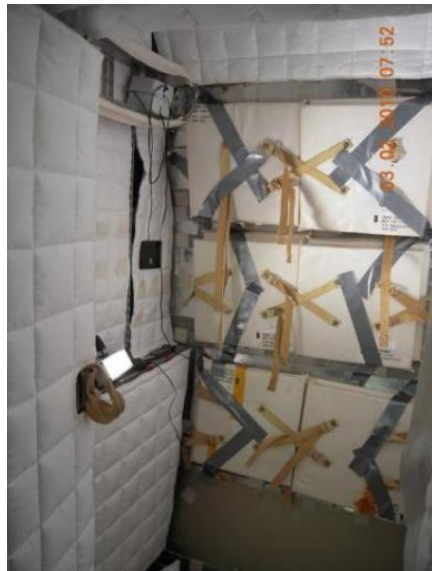
Figure 11. Six TeSS bricks installed on CQ back wall.

the best use of the material and there is a clear benefit to integrating the additional radiation protection inside the CQ. Deploying six TeSS bricks on the back wall of each of the CQs can achieve approximately 16% of additional radiation reduction in nominal conditions. Furthermore, if the bricks are placed in other configurations that were analyzed, additional radiation reduction in nominal conditions can range from approximately 4% to 16%.

The integration assessment evaluated five different configurations of six flat brick assemblies inside the CQ volume. The CQ trainer that is located at JSC was used for the evaluation. The five different configurations included permutations of attaching the bricks to the CQ back wall (Fig. 11), back wall and floor, and sleep wall and floor. Additionally, the evaluation considered whether the radiation bricks could be deployed on the CQ back wall underneath the CQ blankets. Installing the bricks in this manner would keep the integrity of the crew attachment points (Velcro®) for personal items on the back wall, as well as eliminate the abrasion points from the TeSS brick pins.

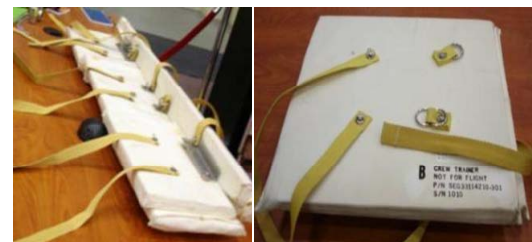
Figure 10. TeSS brick assemblies – custom and flat bricks.
