Li-ion Soft Short Test & Cell Defect Correlation

by Eric Darcy NASA-JSC

NASA Aerospace Battery Workshop Huntsville, AL

5-7 Nov 2013

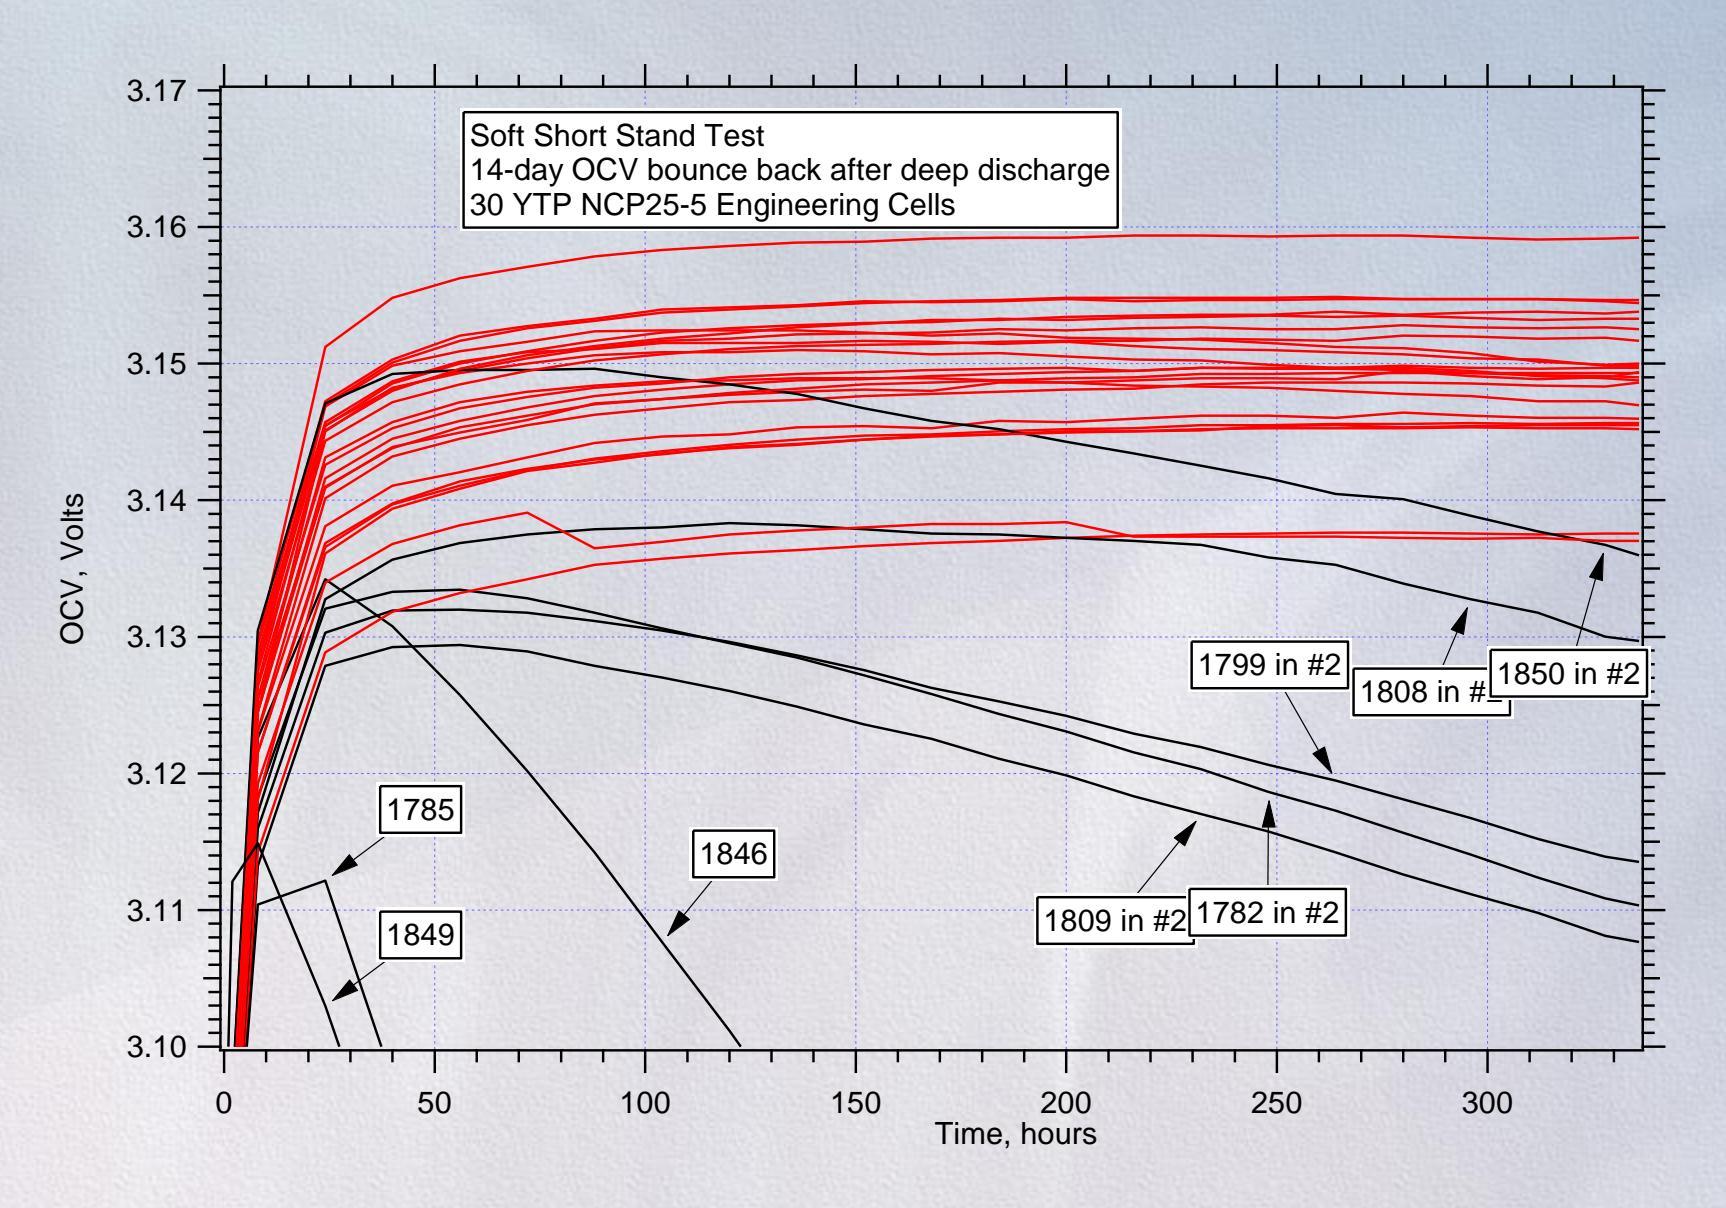
YTP 14-day Soft Short Test Results

- Recent lot of YTP 30Ah flight cells are failing the soft short test at an alarming rate
 - 41/156 cells or 26% had $\Delta V > 2mV$
 - 31/156 cells or 20% had $\Delta V > 5mV$
 - 23/156 cells or 15% had $\Delta V > 10mV$
 - Test was repeated twice on cells with suspect curves
- Questions
 - Is the test validly identifying cells with shorting defects?
 - Are some cell designs predisposed to fail this test?
 - Should it be included in our revised battery safety standard

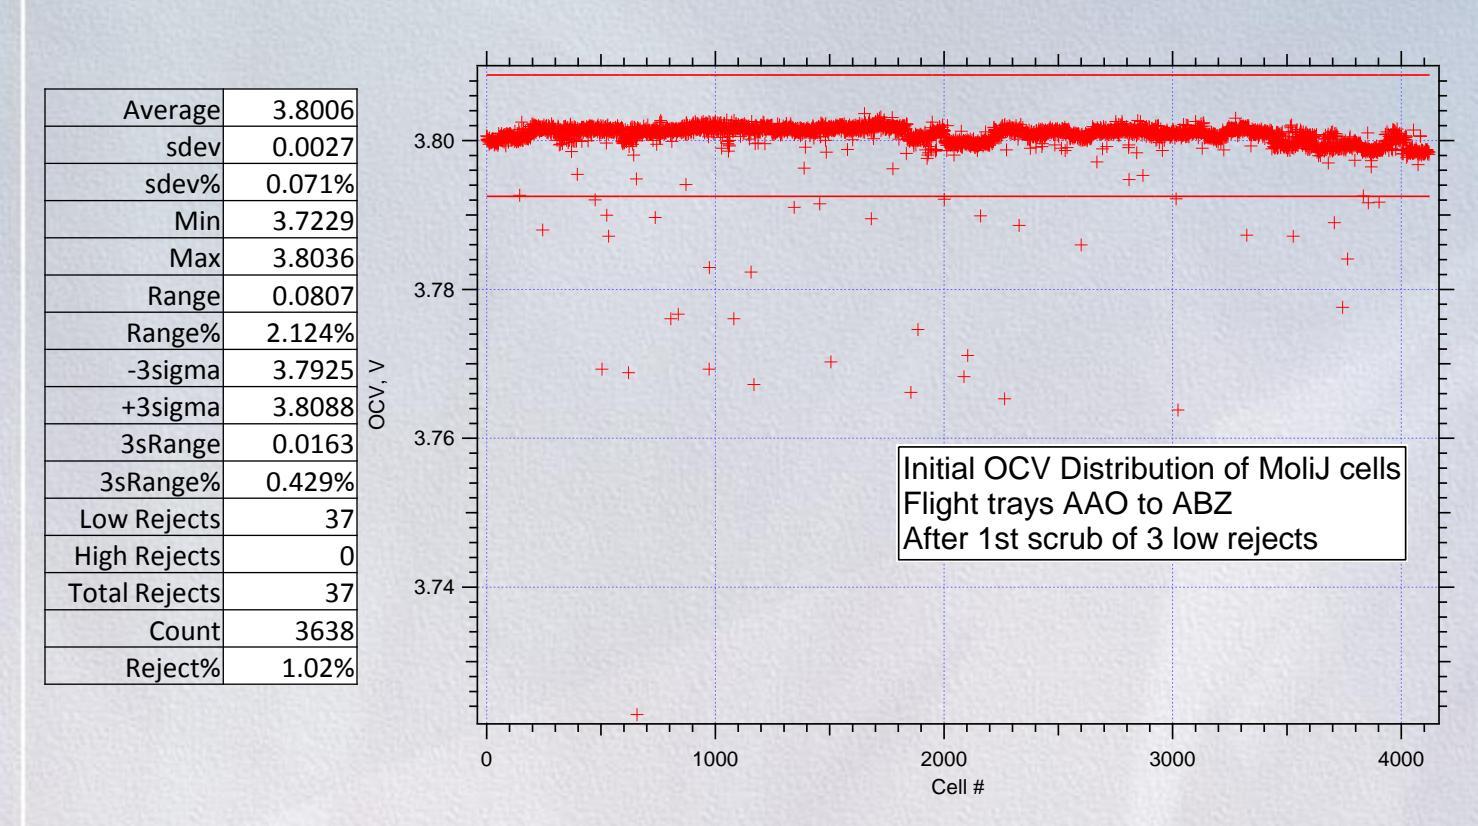
As Received OCVs after 1st scrub

37 new outliers found outside new -3 sigma range of 16.3 mV (0.43%) Note that none +3 sigma outliers suggests capacity cycler errors are small

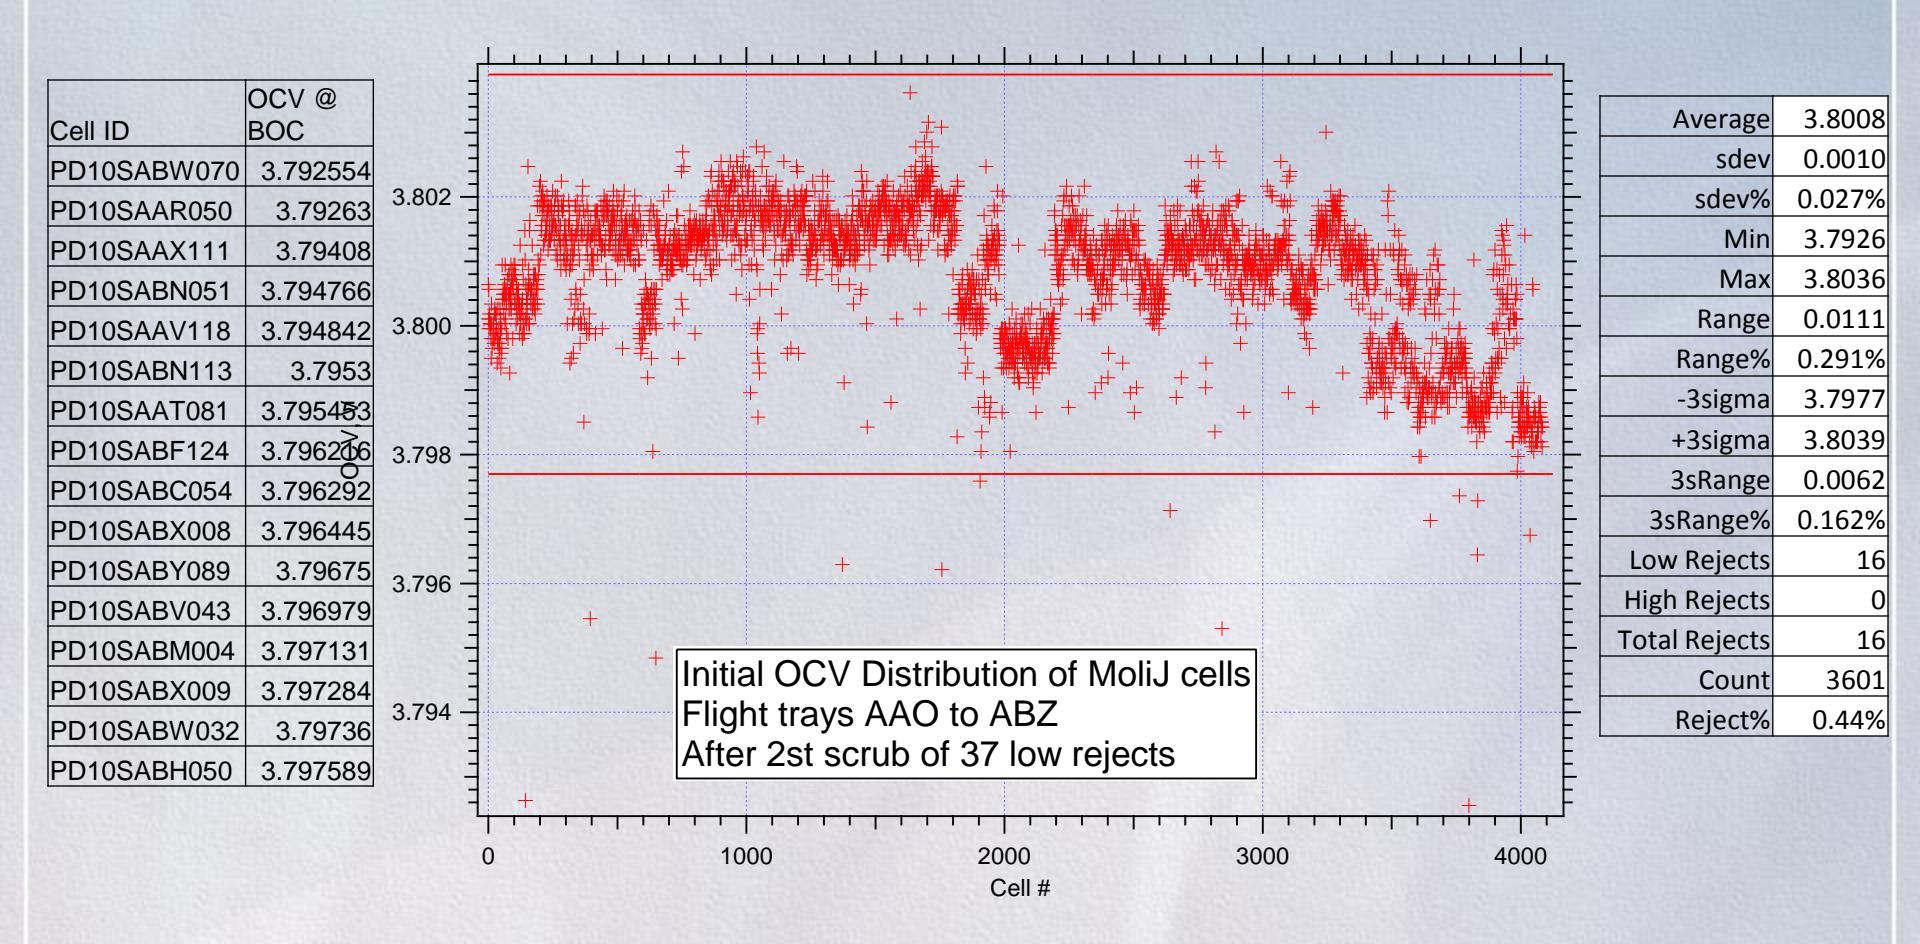
As Received OCVs after 2nd scrub

Another 16 outliers found outside of recalculated 6σ range of <u>6.2 mV (0.16%)</u> These 16 were rejected, but a new 6σ range was not recalculated. In all, a total of 56 OCV outliers were removed from flight cell population

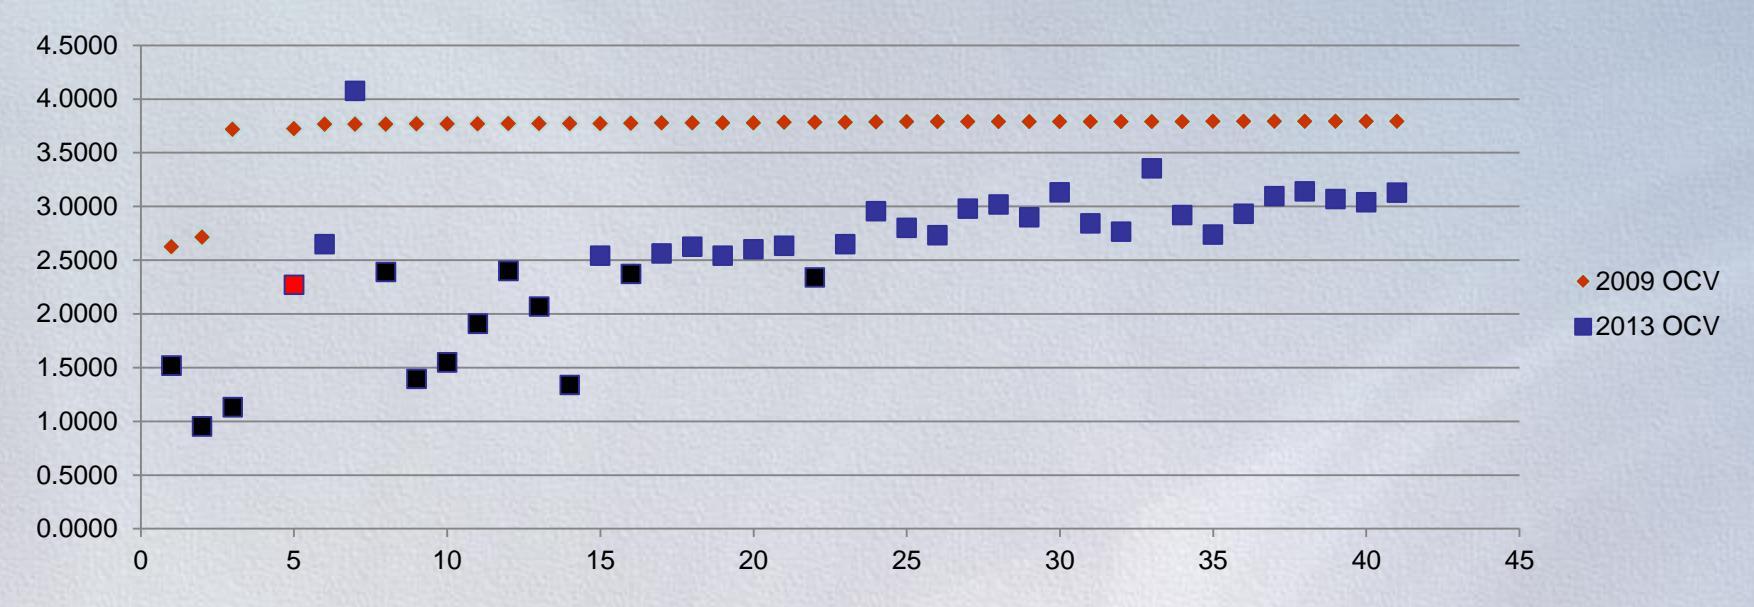
OCV History

- After the 2009 OCV measurement, cells were capacity cycled and stored at 0% SOC
- Squares are the 2013 OCVs on the 40 cells
- 12 cells with OCVs < 2.5V (shown as black squares) would not accept a charge
 - Exception was cell #120 in red whose OCV was 2.2719V and it cycled

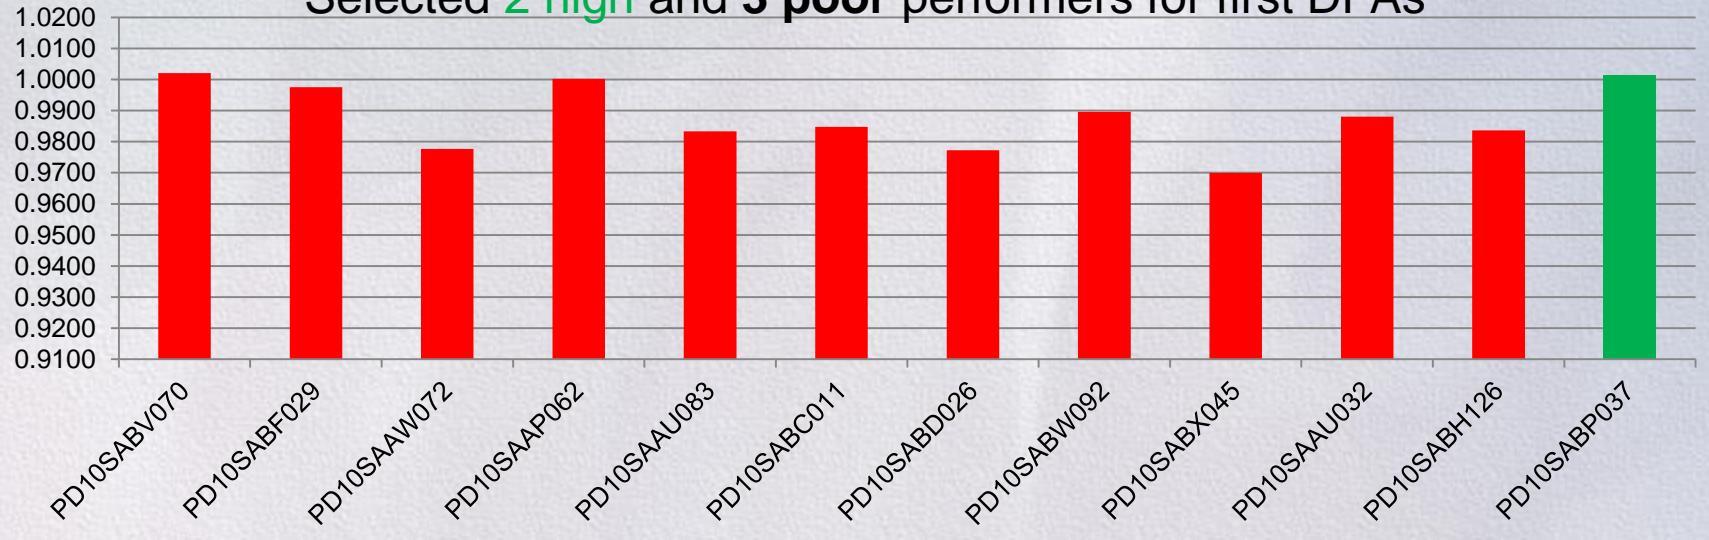
Selected 2 high and 3 poor performers for first DPAs
