NASA/TM-2016-219217

# Emergency Locator Transmitter System Performance During Three Full-Scale General Aviation Crash Tests

*Justin D. Littell and Chad M. Stimson  
Langley Research Center, Hampton, Virginia*

July 2016

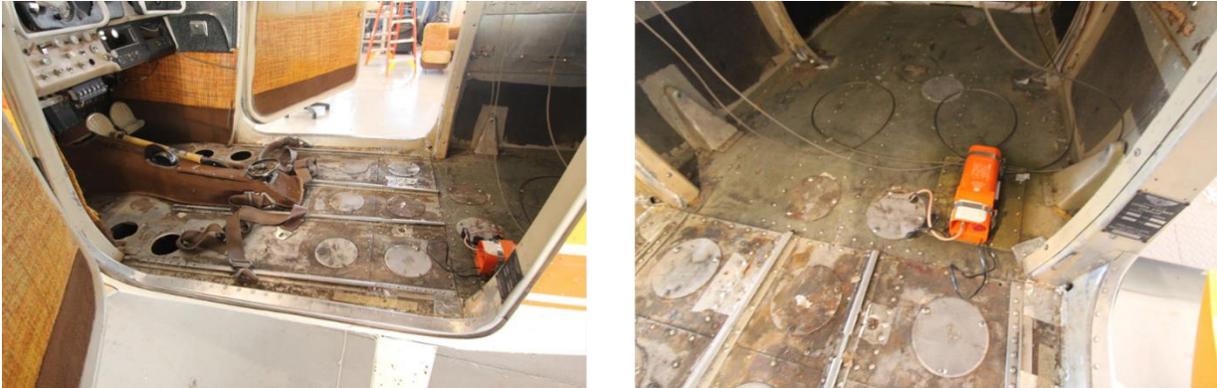
The original ELT for the Test 1 airplane was still present when the airplane was delivered to LaRC. The beacon was floor mounted beneath the rear bench seat on the pilot side of the cabin and the antenna cable was routed through an access hole in the cabin subfloor and into the external antenna located in the tail, directly behind station 108. The beacon was mounted onto an aluminum doubler plate, which was riveted into the subfloor support channels. Figure 6 shows the original ELT installation after removal of the aircraft interior components.

Figure 6 - Test 1 original airplane ELT beacon installation as viewed from the pilot door (left) and pilot seat looking aft (right)

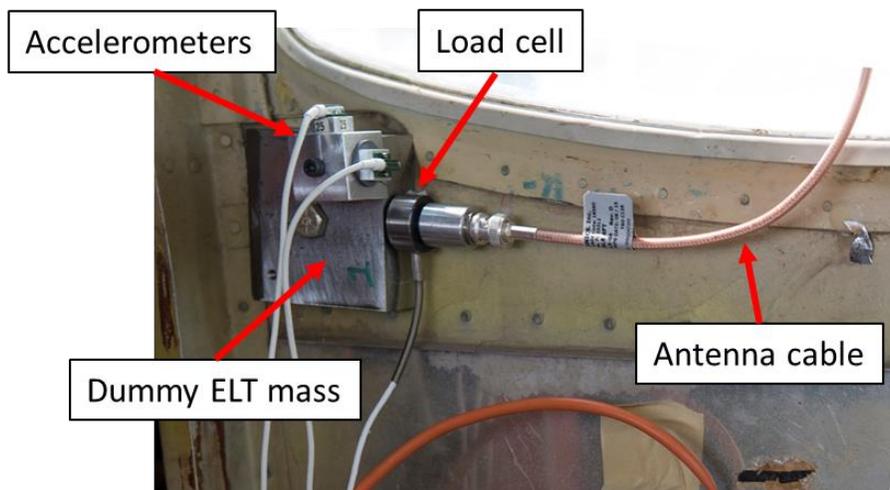
Figure 8 - Dummy ELT beacon installation for Test 1 (pilot side shown)

This scenario is plausible because the antenna cable was attached into the BNC end which was attached to the load cell, which then attached to the dummy ELT weighted block. This configuration created a long moment arm extending from the load cell. Referring to Figure 8, both the load cell and BNC end were pointed forward, as they would be in a typical ELT beacon configuration. The antenna cabling attached to the dummy beacon, and then made a 180 degree change in direction turn after which it was subsequently routed under the assembly to an antenna in the tail of the airplane and pulled taught. During the crash when the airplane experienced the tail fracture, the subsequent hinging relative motion between the tail and cabin created tension on the cable, which pulled down on the dummy ELT 2 fixture. This downward motion created a bending moment at the load cell to dummy mass attachment location, and caused the load cell to register a negative reading. Dummy ELT 1 also experienced signs of cable pullout; however, during the timeframe of data collection, the pullout load was not able to be measured.

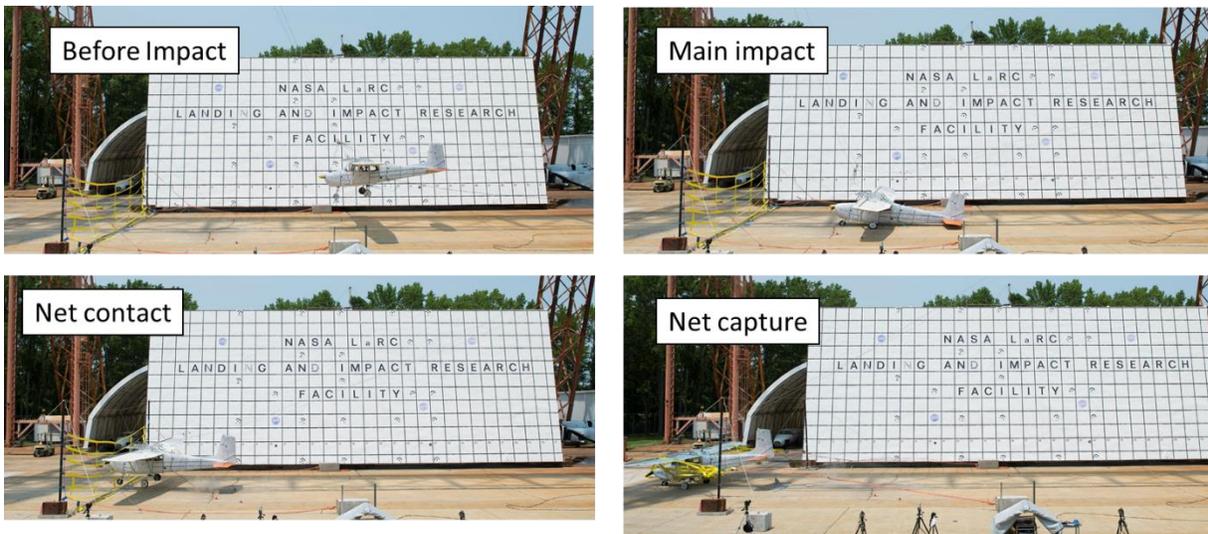
then stopped by the catch net. The time between the initial impact and the first catch net contact was 0.475 sec., however the net capture occurred at approximately 0.800 sec. after initial impact. At a point during the net capture, the airplane tail impacted the ground a second time, causing a small portion of the lower tail to break free from the airplane. The airplane came to rest approximately 5.85 sec. after initial ground impact. Figure 10 shows the impact sequence.

Figure 10 - Test 1 impact sequence

Other than minor damage in the nose gear mounting location and rear tail piece which broke free, the airplane appeared to be largely undamaged after the impact. Visual inspections confirmed that all ELT beacons remained seated in their mounting trays, with no structural failures detected on the mounting tray, aircraft attachment plates or beacons due to the ground impact or net capture events. Acceleration data captured from accelerometers mounted directly to the beacons are plotted in Figure 11. Accelerations for all beacons and aircraft attachment plates presented in this report are filtered at a SAE Channel Filter Class (CFC) 60 low-pass filter [15].

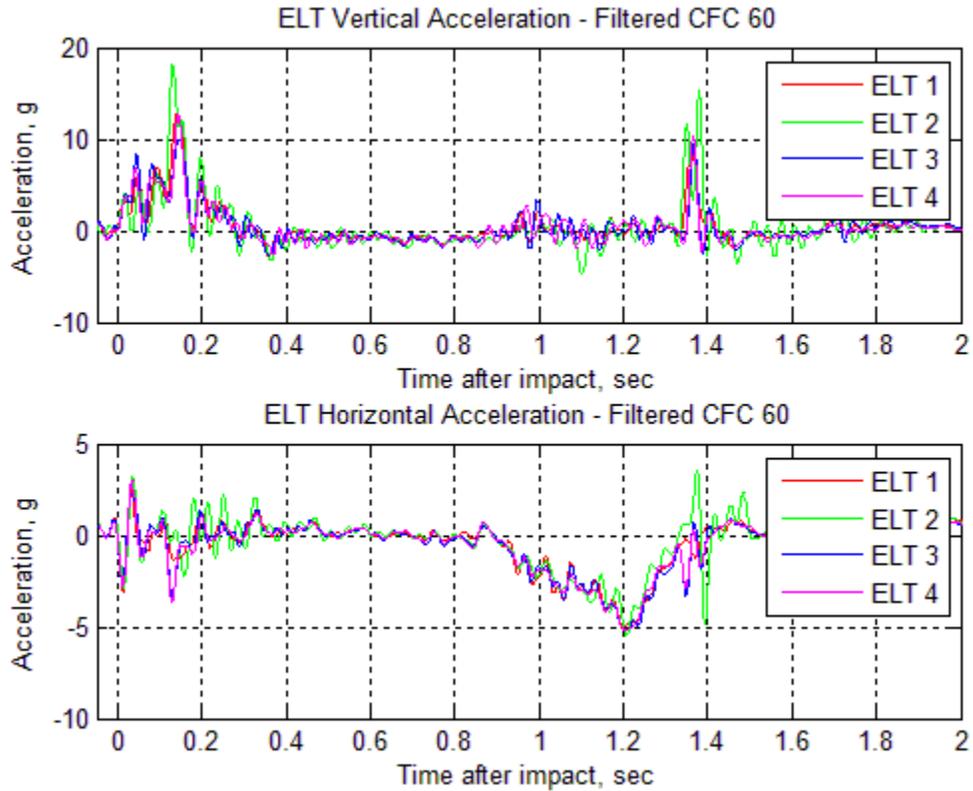
Figure 11 – ELT beacon accelerations from Test 1

Vertical accelerations during the ground impact event reached peak values of 12.7, 18.1, 10.1 and 12.7 g for ELT beacons 1, 2, 3 and 4, respectively. The maximum values occur 0.125 sec. after impact, and are due to the tail strike condition. ELT beacon 2 is closest to the tail and has the highest maximum peak accelerations. All peaks resemble a trapezoidal pulse shape with a sharp spike at the end. The duration of the pulse was 0.300 sec. with rise and fall times of 0.050 sec., and a sustained time of 0.200 sec. Another spike in acceleration occurs at 1.36 sec. after impact. This spike is due to a second tail strike which occurred during the net catch. The duration of this impact was approximately 0.030 sec. with maximums close to 10 g for ELT beacons 1, 3 and 4, and 15 g for ELT beacon 2.

Horizontal accelerations, which are shown in the lower plot in Figure 11 are mainly concentrated between 0.800 and 1.600 sec. There are short spikes which occur during the ground contact portion of the impact event, and oscillate between -3 and 3 g initially. The main portion of horizontal acceleration is evidenced from the net capture. The ground impact event is complete by 0.475 sec. after impact, after which the airplane makes contact with the net. Little acceleration is seen between 0.475 and 0.800 sec. after impact, mainly due to the net breaking away from the supports and beginning to wrap around the airplane. The actual capture begins 0.800 sec. after impact where the net tension begins to pull the drag weights in order to decelerate the airplane. The deceleration reaches maximums of 5.1, 5.5, 5.1 and 5.2 g for ELT beacons 1, 2, 3, and 4, respectively. The pulse is triangular in shape.

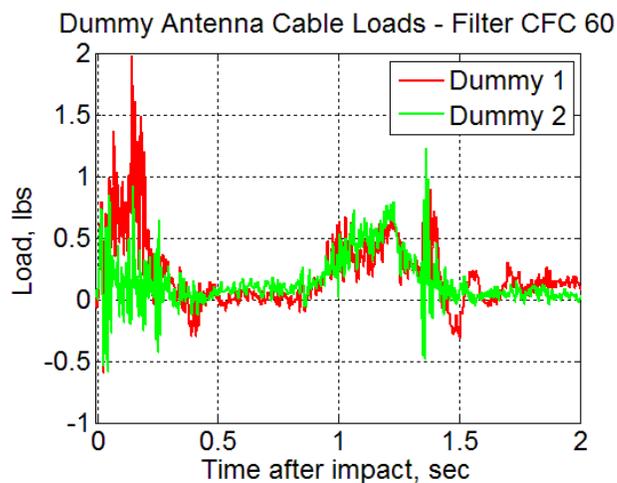
Cable loads were minimal in the dummy antenna cables due to the large amount of slack present in both of the dummy cable lengths. Since cables were slack, maximum loads developed were less than 2 lb. for both cables. No antenna cabling showed signs of damage or pullout from the attachment points. Figure 14 shows the results.

Figure 14 - Test 1 dummy antenna cable loads

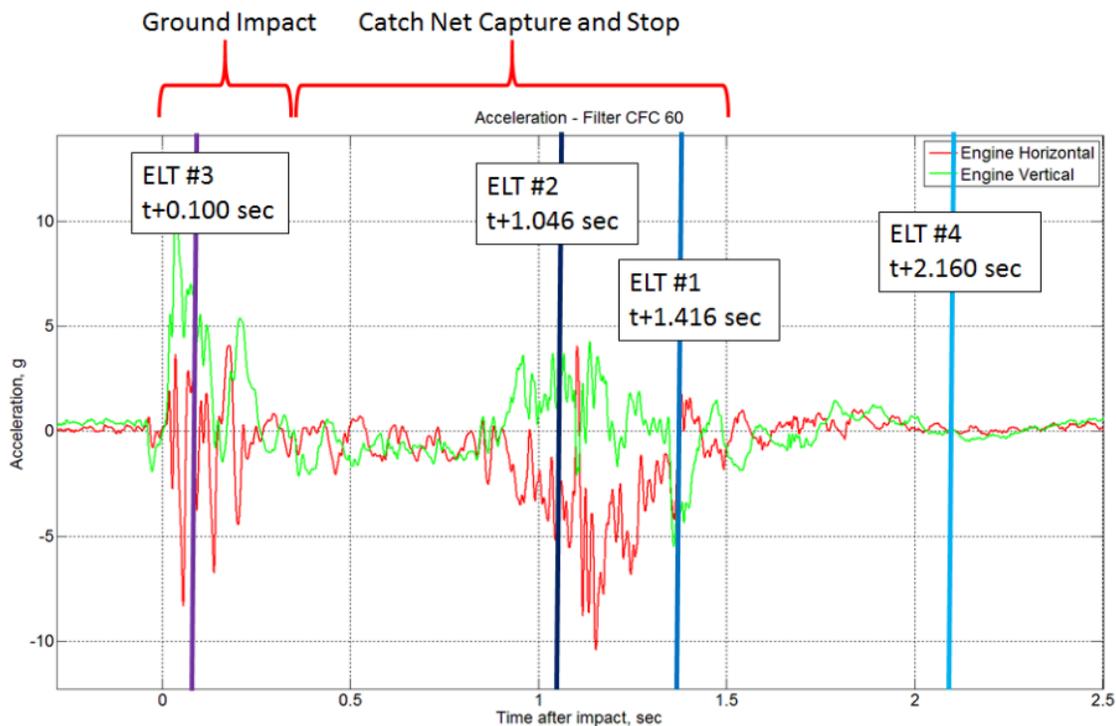
Figure 16 - Test 1 LED illumination timing

ELT beacon 3 was the only beacon that clearly sensed the initial ground impact event, consisting of the high vertical (cross-axis with respect to the sensitive direction of the crash sensor) acceleration. The light illumination occurred at 0.100 sec. after impact, which is in the middle of the ground contact acceleration pulse. ELT beacon 3 was a single axis sensing beacon which had undergone vibration tests, which are described in more detail below, prior to being used for the crash test. The other three ELT beacons showed LED illumination occurring more than 1 sec. after impact, either during or after the net capture.

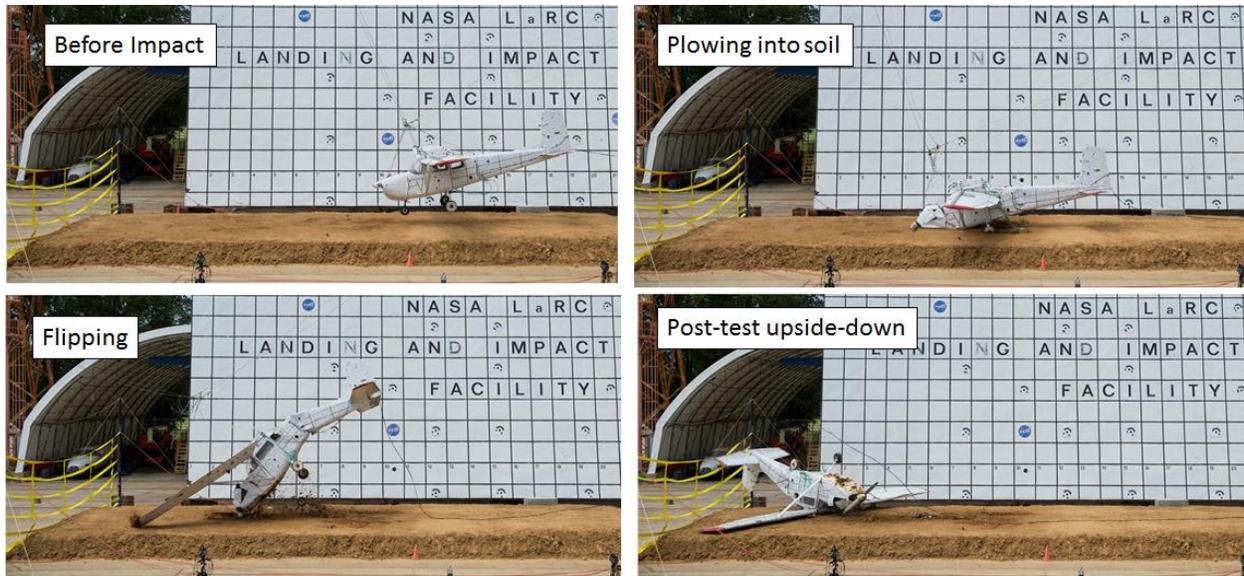
Test 2 occurred on July 29, 2015. The airplane CG impacted the soil at a flight path velocity of 74.4 ft./sec., consisting of a 68.6 ft./sec. horizontal and 28.7 ft./sec. vertical velocity components, resulting in an impact velocity vector angled at 21.6 degrees. The AoA was 12.2 degrees nose down with a pitch rate of +16.1 deg./sec. The airplane nose gear impacted the soil first, and then immediately began plowing into the soil. After 0.111 sec., the left wing separated away from the fuselage, and 0.169 sec. after impact, buckling initiated in the tail near the station 108 frame section. The airplane started to flip over 0.240 sec. after the initial impact. At some point during the flip, the nose gear broke away from the nose section of the airplane. At 1.976 sec. after the impact, the airplane orientation was upside-down. The airplane rocked back and forth for a few seconds before finally coming to rest 6.790 sec. after impact. Figure 20 shows the impact sequence.

Figure 20 – Test 2 impact sequence

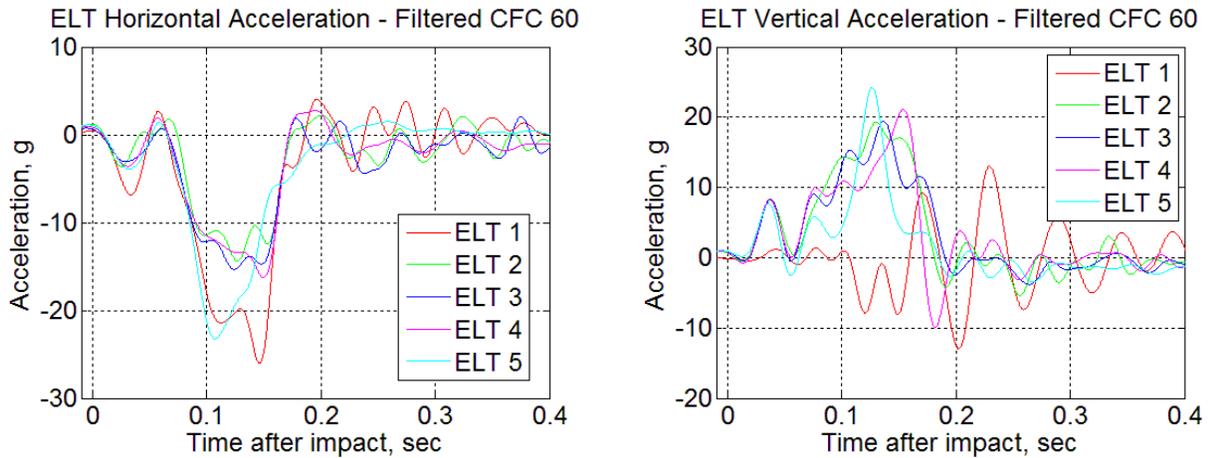
As shown in Figure 21, ELT beacons 1 and 5 show the highest horizontal accelerations during the impact, with peaks of 26.1 and 23.2 g, occurring at 0.145 sec. and 0.107 sec. after impact. It should be noted that both ELT beacons 1 and 5 were mounted in the cabin of the airplane, on the ceiling for ELT beacon 1 and on the floor for ELT beacon 5. ELT beacon 1 was the only ELT used in all tests which did not follow instrumentation orientation consistent with the airframe coordinate system. Instead, the two accelerometers mounted on ELT beacon 1 were mounted in the ELT beacon sensing direction and perpendicular to the ELT beacon sensing direction, respectively. For purposes of reporting, the ELT beacon accelerations are not transformed into the airplane coordinate system because it is important to show the accelerations experienced by the ELT in the beacon sensing direction. Therefore, the results from ELT beacon 1 shown in Figure 21 do not follow the acceleration traces acquired from the other ELT beacons.

ELT beacons 2, 3, and 4 show similar results, both in magnitude and in shape of horizontal accelerations from the impact. The accelerations are presumably similar due to the close proximity of mounting locations of the beacons in the tail. These accelerations approximate a trapezoidal shaped pulse, with a sustained acceleration duration of 0.63 sec. at average values of 10.3, 12.0 and 10.7 g, for ELT beacons 2, 3 and 4, respectively.

Figure 21 – ELT beacon accelerations from Test 2

Vertical accelerations, as shown in Figure 21, from the test closely matched between ELT beacons 2 through 5. The vertical accelerometer orientation on ELT beacon 1 was oriented at a 45 degree angle. Combined with a 12.2 degree nose down impact angle, the vertical accelerometer mounted on ELT beacon 1 was actually measuring accelerations at a 57.2 degree angle from the vertical, relative to the ground. It is because of this angle offset that the vertical accelerometer was measuring the complementary angle of acceleration relative to the flight path angle of 21.6 degrees, and thus, not registering high accelerations.

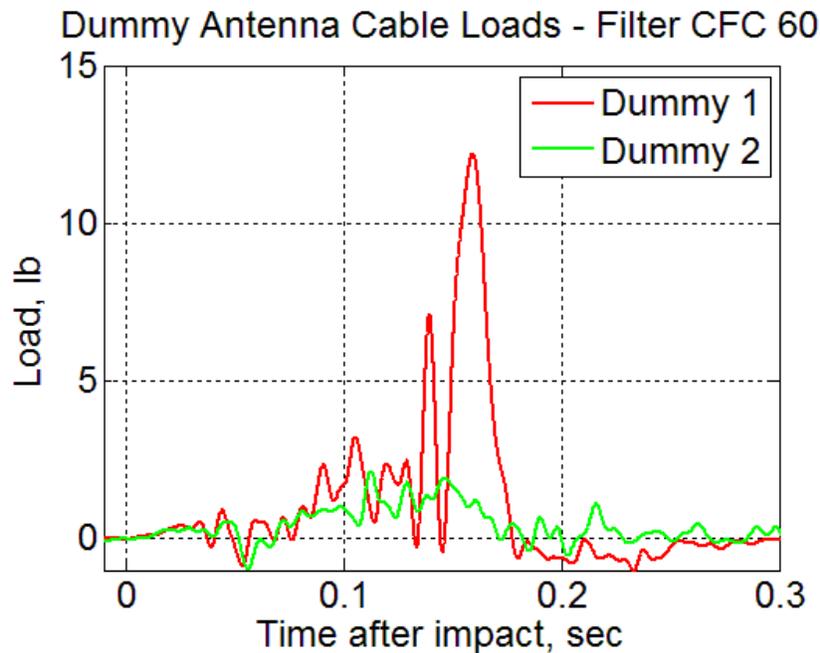
Figure 23 - Test 2 dummy antenna cable loads

The cable loads developed in the dummy ELT cables are shown in Figure 23. As with Test 1, the loads measured in the dummy cables were very low, reaching peaks of 12.2 and 2.1 lb. for dummy 1 and 2, respectively. These loads occur in the first 0.200 sec. of the crash, which follows when the ELT beacons saw the acceleration pulses from the crash.

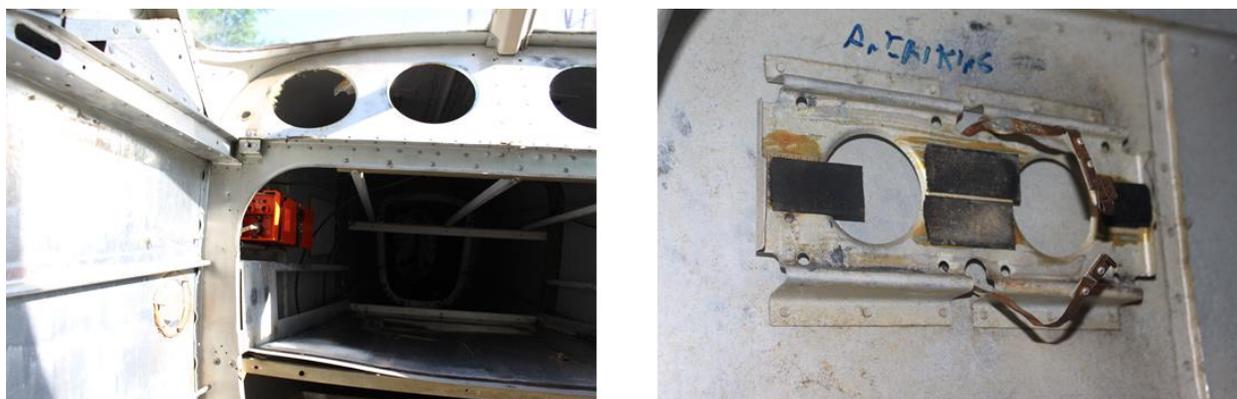
Figure 25 - Test 3 original airplane ELT location (left) and aircraft attachment plate (right)

As with the Test 1 aircraft, the Test 3 aircraft arrived at LaRC with the original ELT installation present. As shown in Figure 25, the beacon was installed on the co-pilot side, in the forward tail section, directly behind the cabin-to-tail transition area. The aircraft attachment plate did not follow current installation standard [4], and was riveted directly onto the skin, and not attached to any primary structural elements. The beacon was secured in its mount via a tie wrap located at the forward end and a leather buckle in the middle. The antenna was located near the beacon, centered on the tail at the same approximate station location. Note the tie wrap has been removed from the aircraft attachment plate view.

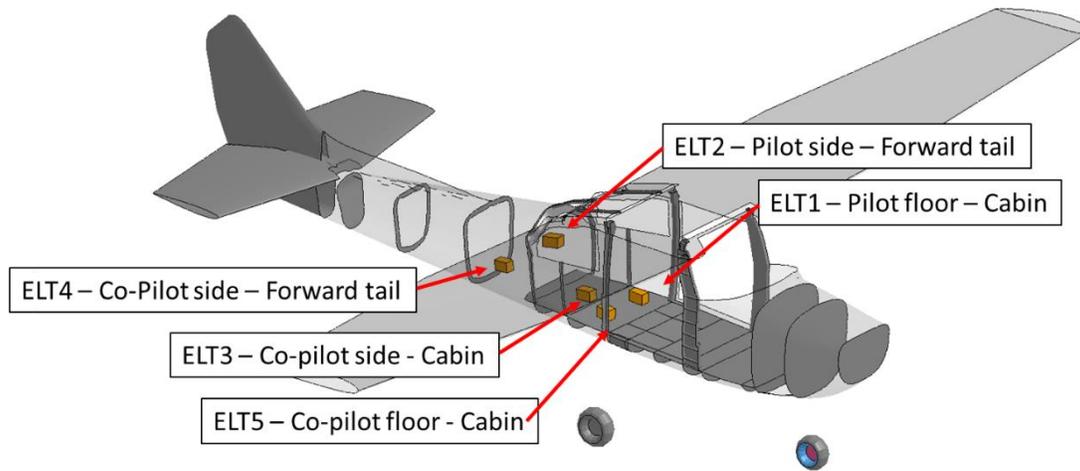
Figure 26 - Test 3 ELT beacon configuration

Five ELTs were installed for Test 3. ELT beacons 1 and 5 made were in a symmetric configuration, behind the pilot and co-pilot, under the location where the rear seats would have been located at station 65. ELT beacon 2 was mounted in the forward tail, on the pilot sidewall. ELT beacon 3 was wall mounted on the co-pilot sidewall, at a location just aft of station 65. ELT beacon 4 was installed in the approximate location as the original beacon, on the co-pilot side just aft of station 108. The original mounting plate was removed and a new mounting plate was used, which fastened to the airplane skin stiffeners in the tail. ELT beacons 2 and 4 were mounted such that they were in a symmetric arrangement along the airplane centerline. Dummy beacon 1 was located on the floor next to ELT beacon 1. Dummy beacon 2 was located on the co-pilot wall just below the rear window, next to ELT beacon 3. These ELT locations are highlighted in Figure 26.

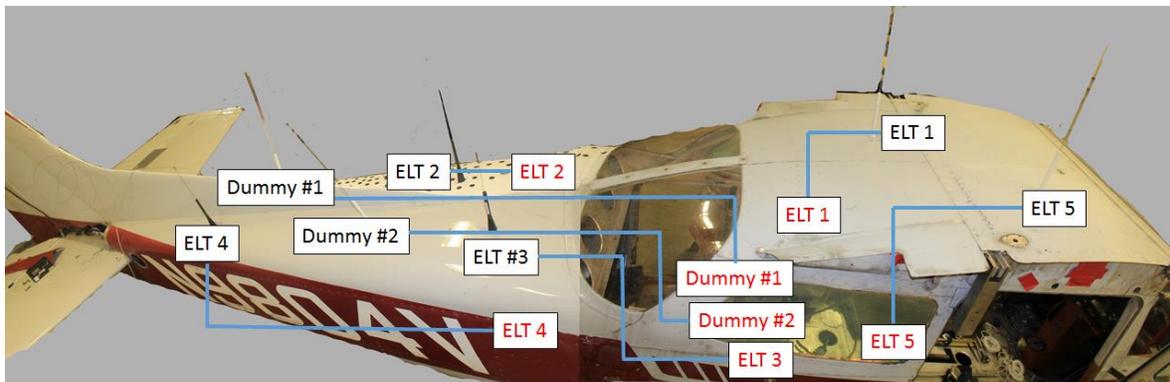
Figure 27 – Antenna locations for Test 3 with cable runs annotated

For ELTs 1, 2 and 5, the shortest cable run distance was implemented. The ELT 4 cable originated at the beacon location just aft of station 108, ran through frames at stations 140 and 172, and terminated at an antenna located aft of station 172. ELT 3 antenna cabling crossed frames located at stations 90 and 108. The longest runs were the two dummy ELTs. Dummy ELT 1 cabling ran under the floor of the cabin, crossed frames at stations 108, 140 and 172 and terminated at an antenna aft of station 172. The cable length was chosen such that the cable developed significant tension when attached to the beacon and antenna. Dummy ELT 2 included an antenna located forward of station 140. The cable, while having more slack than Dummy ELT 1, was purposely chosen to be almost the exact length as the run needed, causing very little slack to be present. Figure 27 shows an illustration of the ELT beacon (in red) and antenna locations (in black), with the cable runs noted.

When examining the cabling layout diagram in Figure 27, the three connections that failed are the only ones that had crossed a production break between the cabin and tail of the airplane. The connections failed due to the large amount of deformation which occurred in the tail after the fracture initiated during the crash sequence. The long length of these connections was intentional, and specifically made in an attempt to magnify the failure response exhibited in Test 2. All other cable runs were made as short as practical, with one exception made for ELT 4. The cable spanned the entire tail length, originating from the beacon in the forward tail to the antenna in the rear tail. The loads measured from the dummy ELT cables are plotted, and shown in Figure 31.

Critical data were obtained from examining the different types of antenna cable run conditions. Cables which intentionally did not use best practice guidelines were much more susceptible to damage, especially under large aircraft deformation. Four cases of cable pullouts were observed, and all occurred on long cable runs. Some type of cabling damage occurred on almost all instances where a long run was present, and where the antenna cable spanned the cabin/tail junction. It was also noted that the damage to the cabling was insensitive to cable brand or type. In general, crashworthiness of cabling system was improved when the antenna was installed in the same longitudinal station of the airframe as the beacon and when best practice guidelines were followed for including cable slack and usage of tethers.

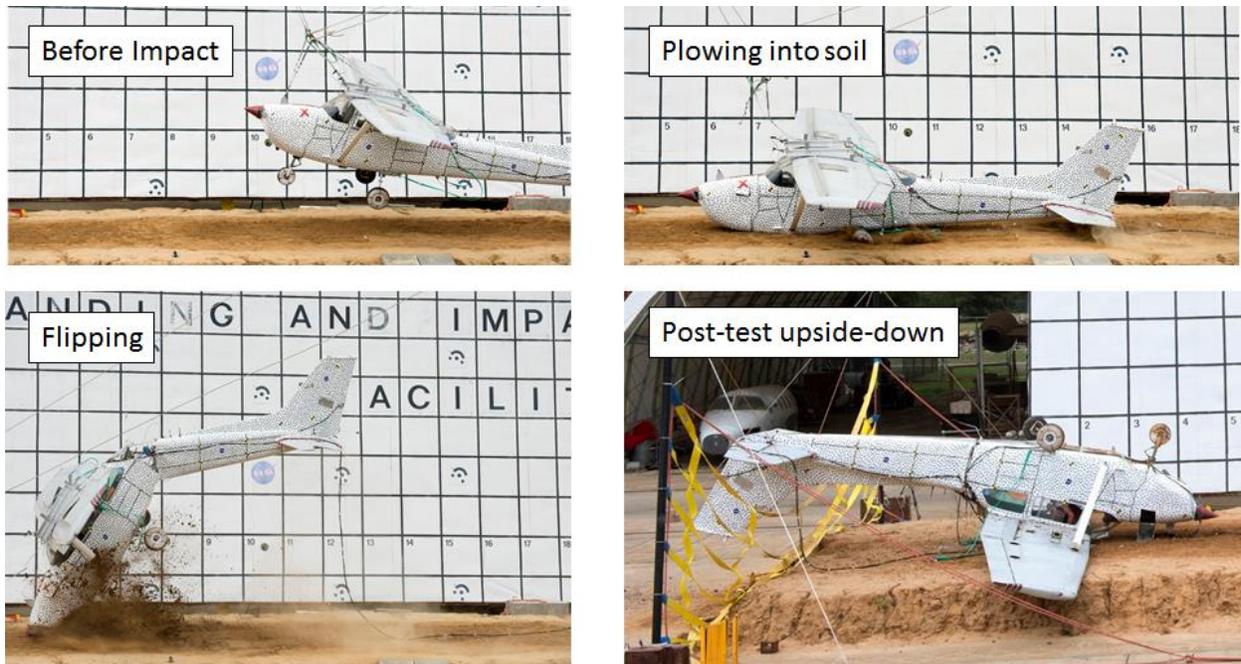
Figure 28 - Test 3 impact sequence

There was a slight amount of roll (co-pilot high) and yaw (nose left) at impact. Due to these conditions, the pilot main gear impacted the soil initially. The tail contacted the soil 0.030 sec. after initial gear impact and the nose contacted the surface 0.116 sec. after impact. Similar to Test 2, the nose gear penetrated the soil surface and acted as a pivot point for the airplane to rotate around. The airplane started to exhibit noticeable rotation shortly after nose contact. At 0.138 sec. after impact, tail failure occurred, causing a large fracture at the tail-cabin junction to appear. The airplane landed upside-down 1.53 sec. after impact and rocked back and forth for an additional 3 seconds. The airplane came to rest approximately 5 sec. after initial impact. This sequence is depicted in Figure 28.

The airplane sustained major damage from the impact. Large amounts of deformation were seen in the engine area by the nose and firewall. The most noticeable failure that occurred was the tail separation from the cabin section. A fracture occurred at the tail-to-cabin transition area in the skin of the aircraft, causing the skin to fail on three sides. The only material holding the tail onto the rest of the airplane was a small section on the bottom of this area, and the tail hinged about this section. This fracture occurred very early in the crash event, during the time the airplane was plowing into the soil. During the flip over, the hinging caused the tail to become oriented at a 90 degree angle perpendicular to the fuselage creating a large opening at what would be the top of the tail/cabin connection.

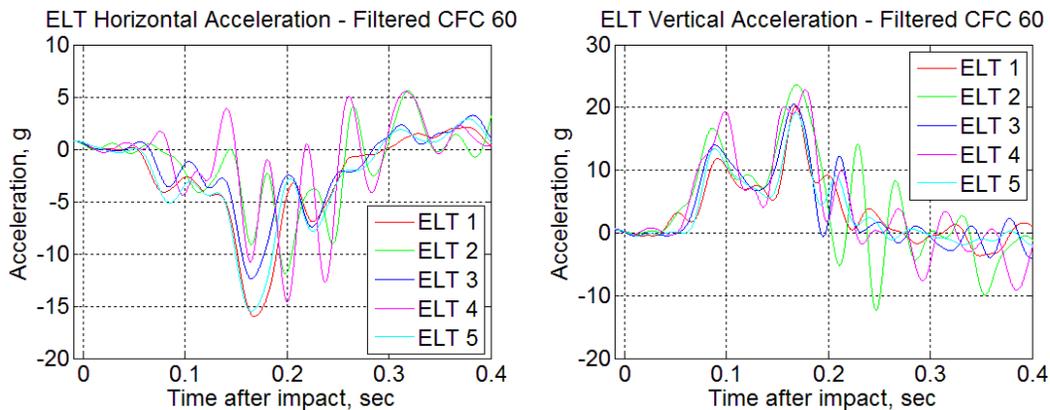
Figure 29 ELT beacon accelerations from Test 3

As shown in Figure 29, horizontal accelerations were triangular in shape, with a pulse duration of 0.300 sec. The peak acceleration values occurred for ELT beacons 1, 2, 3, and 5 at approximately 0.168 sec. after impact, with the peak for ELT beacon 4 occurring a short time later at 0.200 sec. ELT beacon 4 showed more oscillations than the other ELT beacons, which affected its peak value. Visual inspections of the ELT beacon-to-mounting tray and aircraft attachment plate connections post-test revealed nothing unusual or loose regarding the instrumentation. The noise was attributed

As shown in Figure 29, the vertical accelerations resembled a trapezoidal shape of approximately 0.250 sec. in duration, with two defined peaks at the beginning and end of the plateau. The first peak occurs between 0.085 and 0.98 sec. after impact, depending on which ELT beacon is examined. The second peak occurs at an average time of 0.167 sec after impact. The first peak is due to the initial impact of the fuselage structure with the soil. The airplane rotation in which the nose finally impacts the soil causes the second peak a short time later. Maximum accelerations for the first peak range between 11.9 g for ELT beacon 1 and reach 19.4 g for ELT beacon 4. For the second peak, accelerations are more uniform but slightly higher, ranging between 19.2 g for ELT beacon 5 and 23.7 for ELT beacon 4.

Note that ELT beacons 2 and 4 are in symmetric arrangement in the forward tail, but experience large differences in the first peak of vertical accelerations. This finding is likely due to the slight amount of roll at impact. For the second peaks, which occur during the nose contact and plowing, the accelerations are more closely matched.
