# Flight Motor Set 360L001 (STS-26R) Final Report

## Volume V (Nozzle Component)

360L001 (STS-26R)  
Final Report  
Nozzle Component

A review of the performance and post-flight condition of the STS-26 Redesigned Solid Rocket Motor (RSRM) nozzles is presented in this document. Applicable Discrepancy Reports (DRs) and Process Departures (PDs) are presented in Section 5.0. The Nozzle Component Program Team (NCPT) performance evaluation and the Redesign Program Review Board (RPRB) assessment is included in Section 6.0.

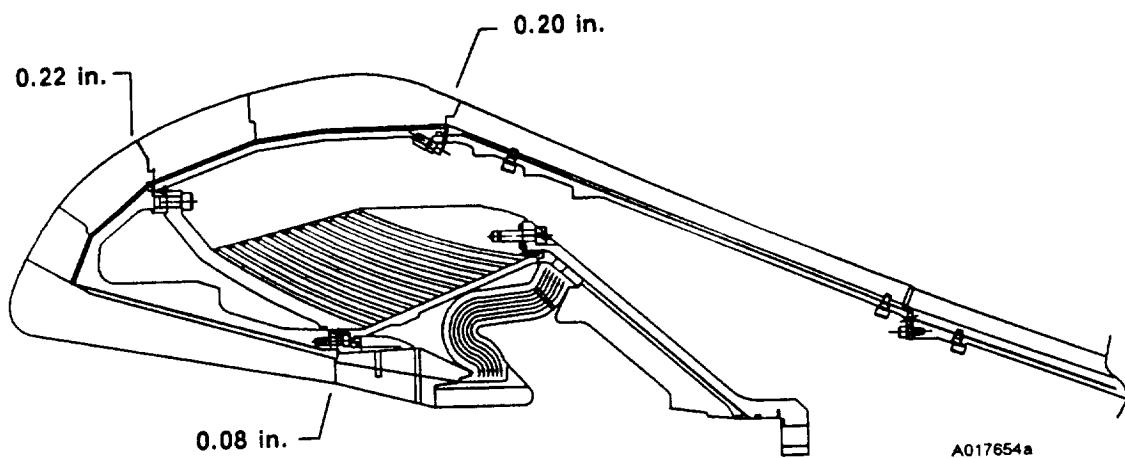
Figure 3 STS-26A Joint Flow Surface Gap Openings

Post-flight subassembly flow surface gaps are shown in Figure 3. Overall views of the nozzle are shown in Figures 4 through 9.

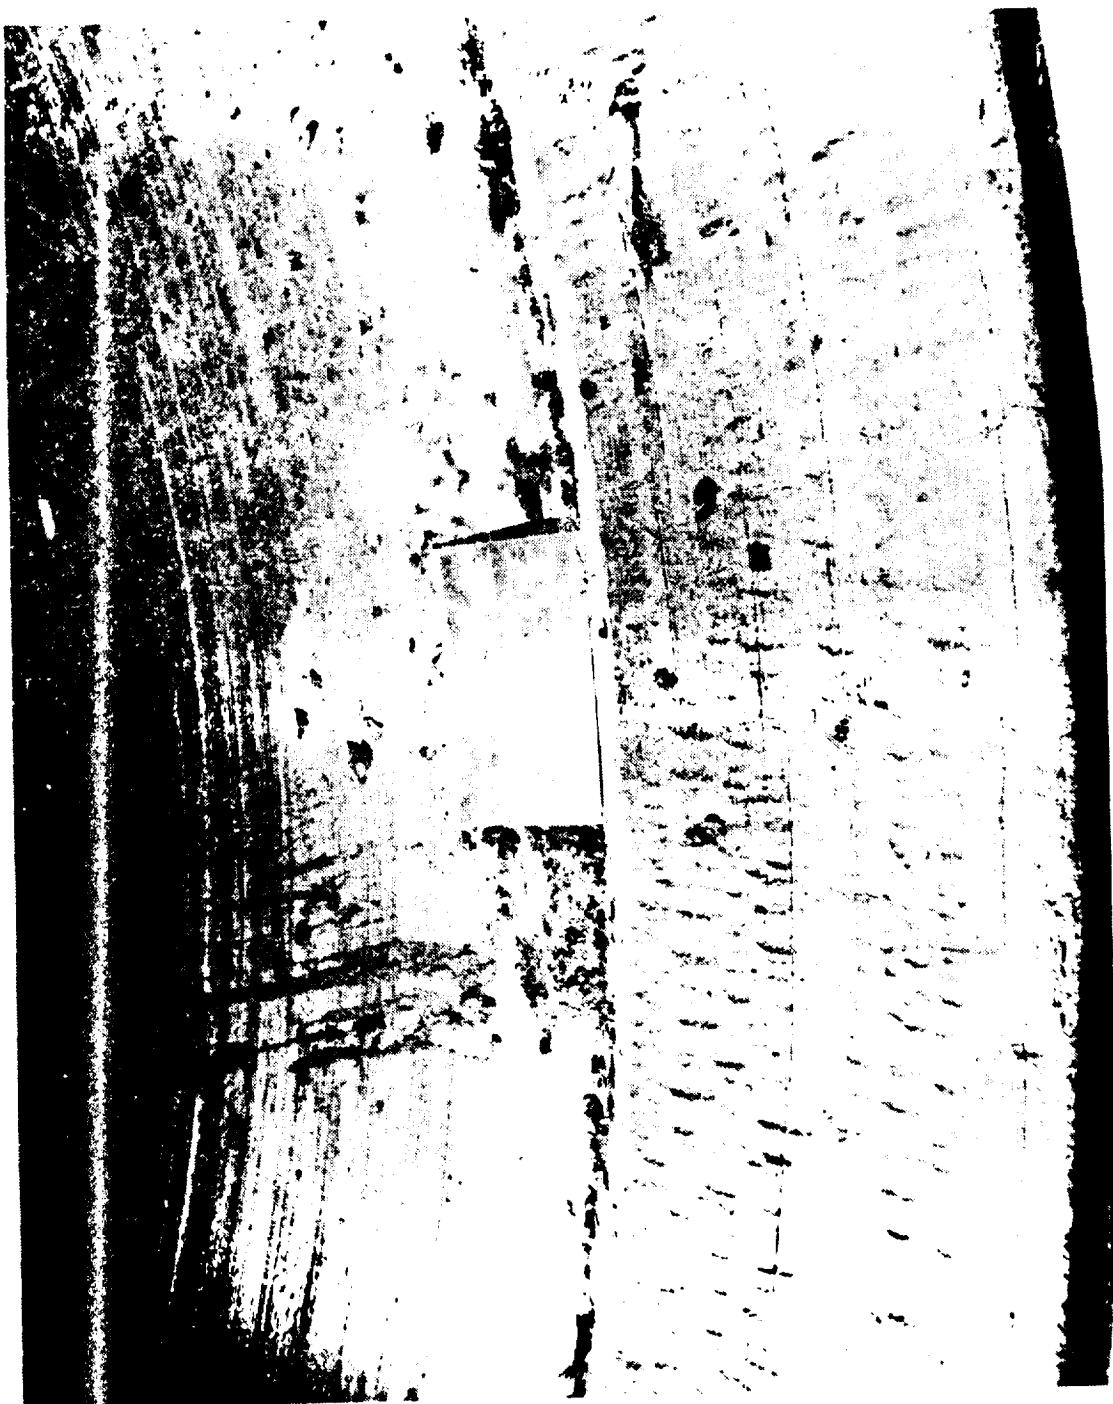
Figure 12 STS-26A Forward Exit Cone Dimpled Erosion (270 Degrees)

on the aft 8 inches of the cone. These portions showed nominal erosion with no major washing or pocketing. The aft 8 inches of the liner showed the typical dimpled erosion pattern that has occurred on all flight and static test forward exit cones (see Figure 12). The maximum radial depth of the dimpled erosion was 0.15 inch.

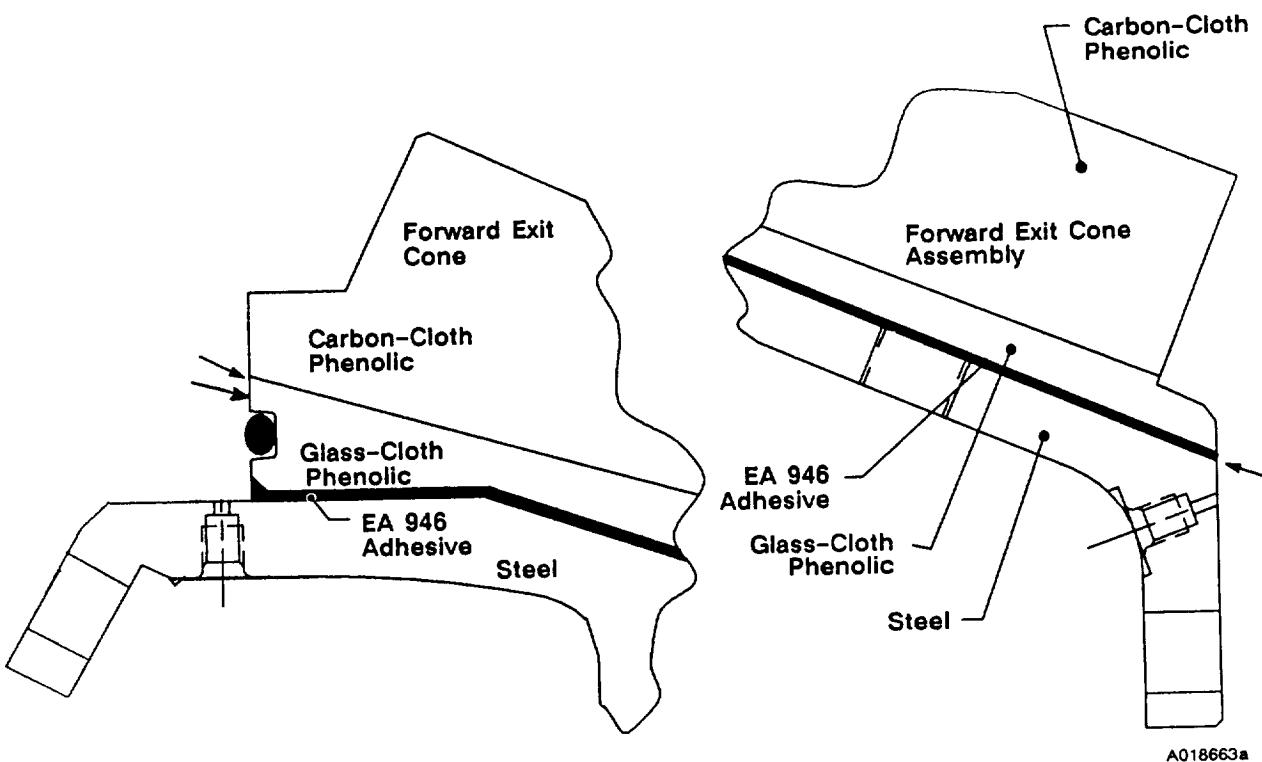
Figure 13 STS-26A Forward Exit Cone Bondline Separations

The aft end of the forward exit cone showed bondline separations between the EA946 adhesive and the steel housing from 30 to 60 degrees and from 124 to 148 degrees. The maximum radial width of the separations was 0.025 inch. The forward end of the forward exit cone showed bondline separations between the GCP and CCP (0.04 inch maximum radial width), and cohesive separations within the GCP (0.04 inch maximum radial width) intermittently around the circumference. Figure 13 lists the location and radial width measurements of all separations on the forward exit cone. These separations are typical observations which have been seen on previous static test and flight nozzles, and have been shown to occur post-burn.

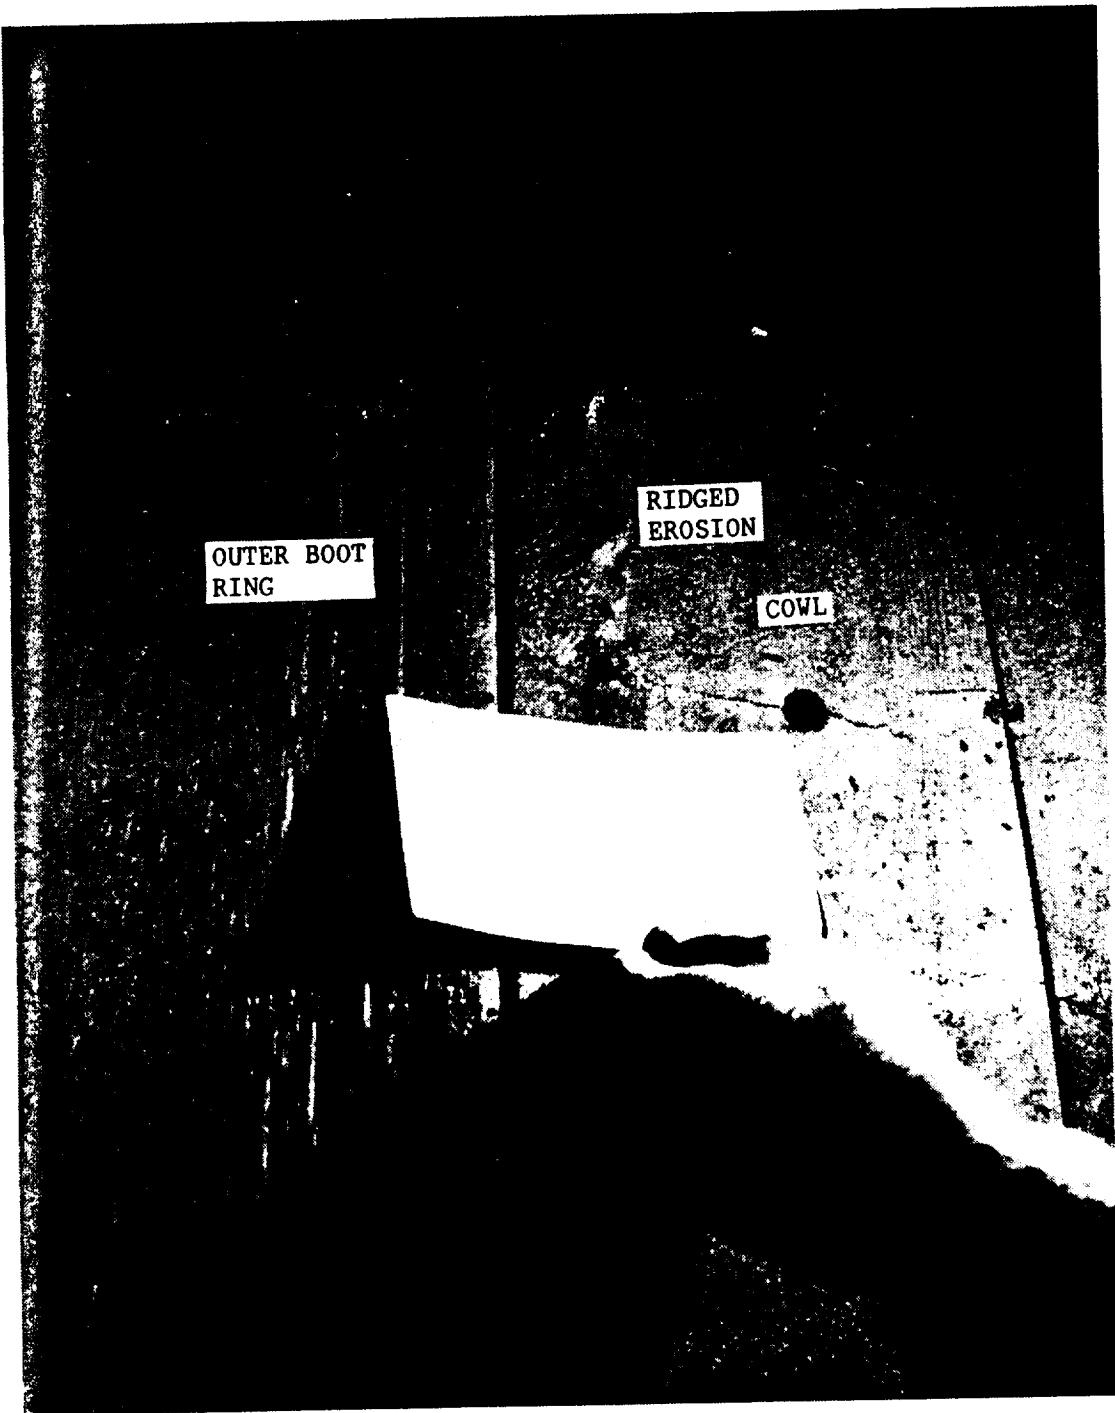
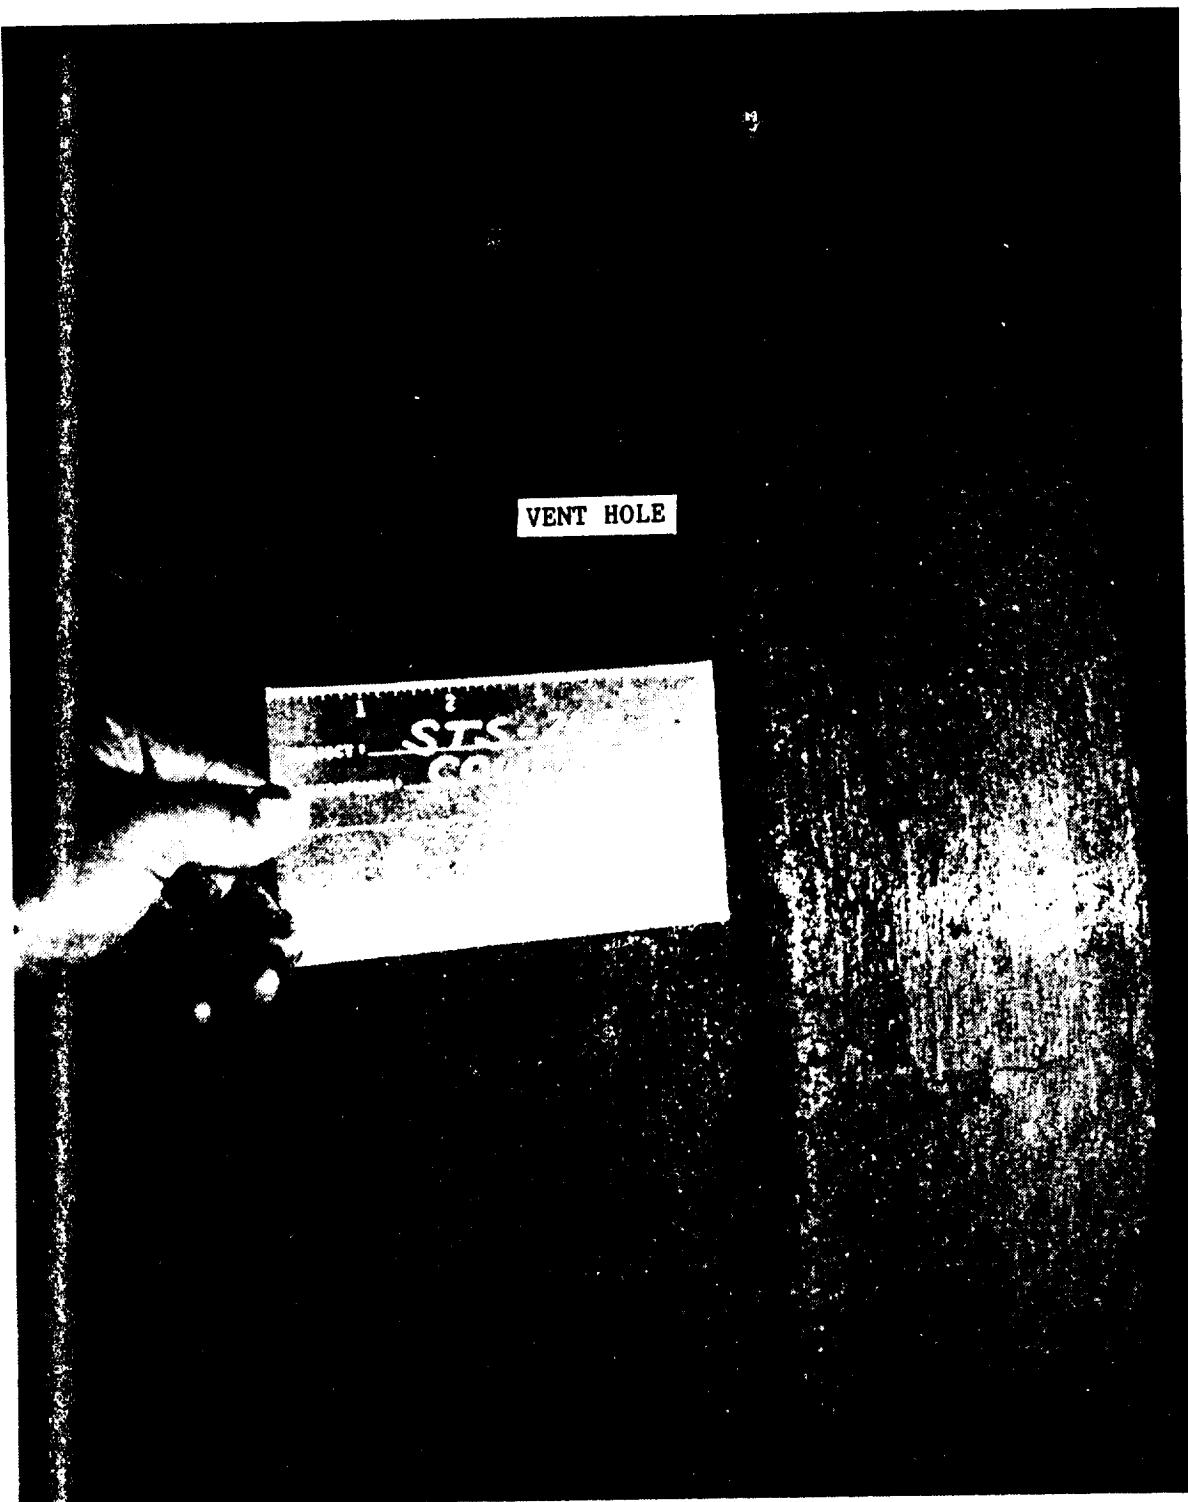
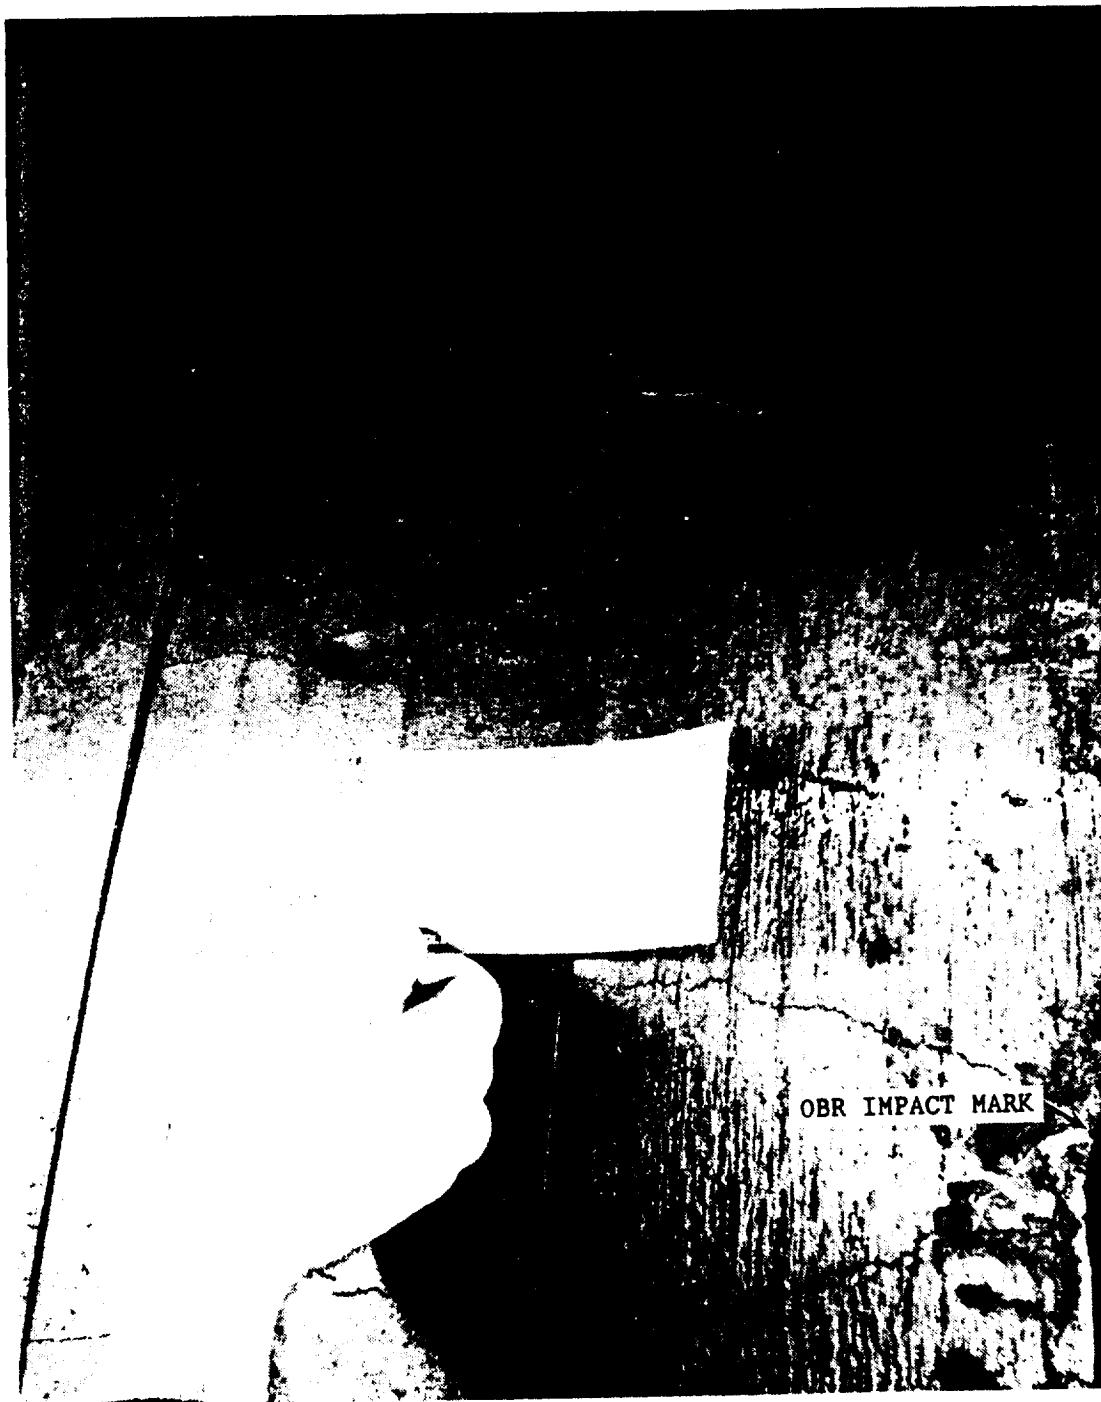
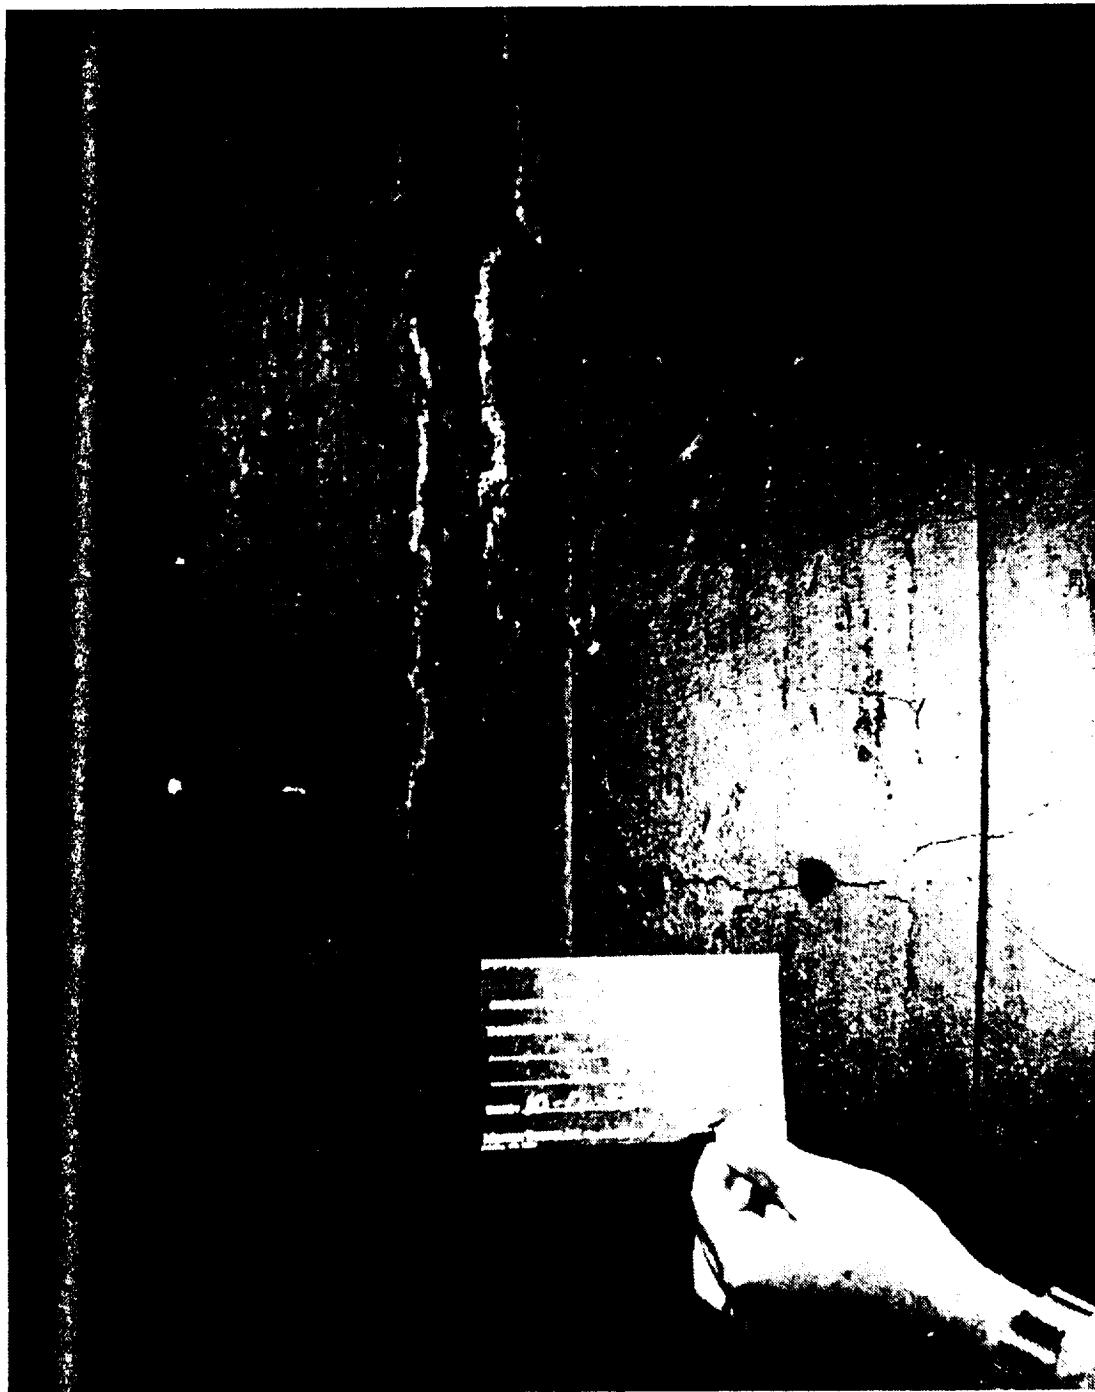
Overall views of the STS-26A OBR and flex boot are shown in Figures 6 and 7. Close-up views of the OBR are shown in Figures 47 through 50. The bondline between the OBR and cowl ring remained intact with no indications of flow. The flow surface bondline gap was 0.18 inch and is typical of past static test and flight nozzles.

Figure 47 STS-26A Cowl/OBR Closeup (0 Degrees)

Figure 48 STS-26A Cowl/OBR Closeup (160 Degrees)

Figure 49 STS-26A Cowl/OBR Closeup (180 Degrees)

Figure 50 STS-26A Cowl/OBR Closeup (320 Degrees)

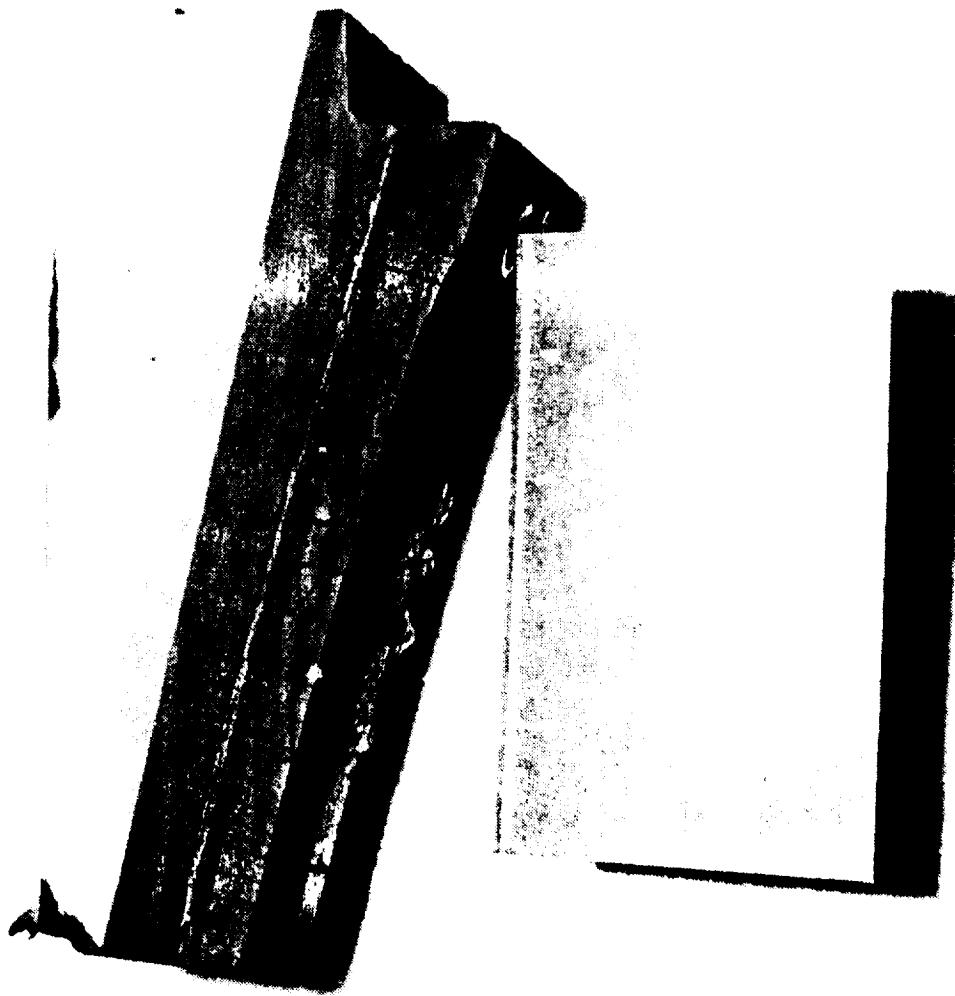
Photographs of the sectioned cowl ring are presented in Figures 51 through 54. Typical subsurface ply lifting was observed intermittently around the circumference along the forward 2 inches of the cowl. The largest ply lift separation was 0.10 inch at 0 degrees (Figure 51). There was no evidence of flow or erosion within the delaminations.

Figure 51 STS-26A Cowl Ring Section (0 Degrees)

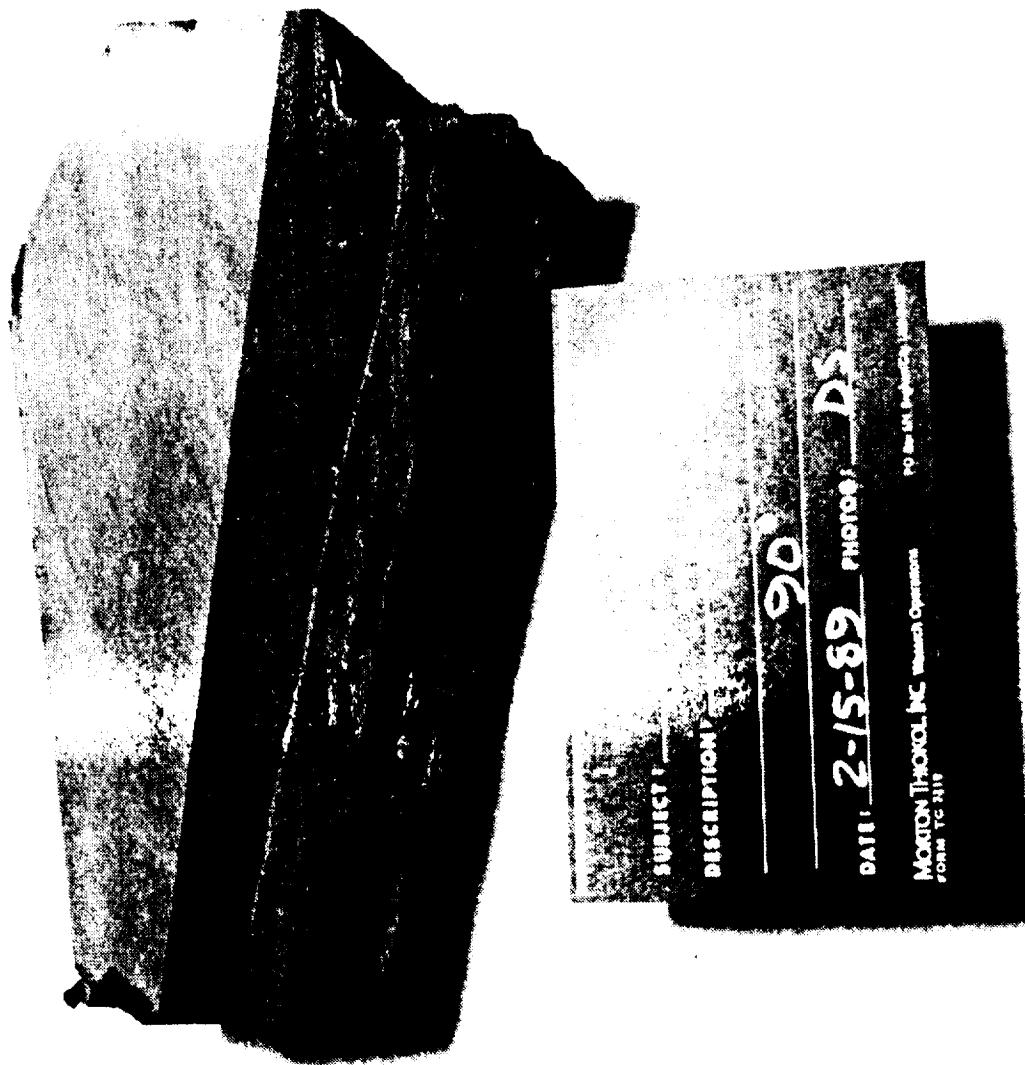
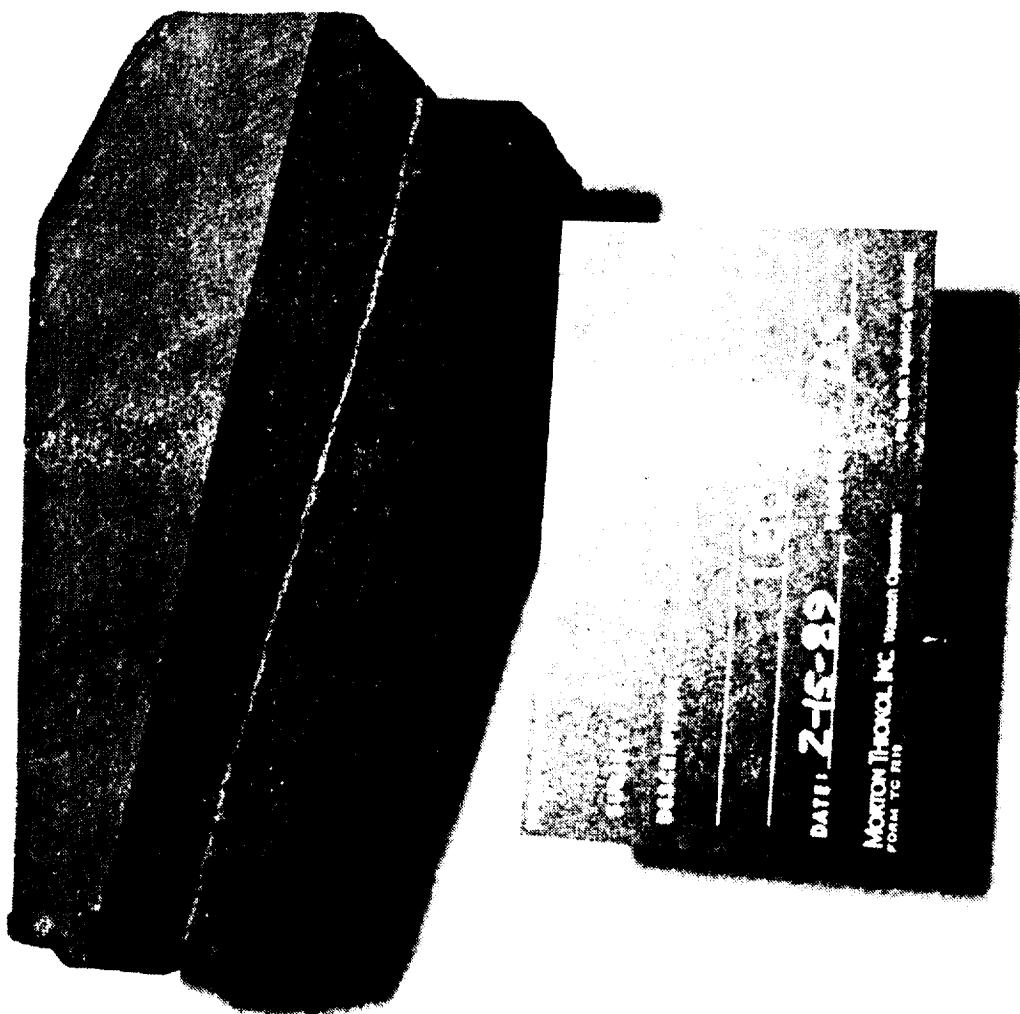
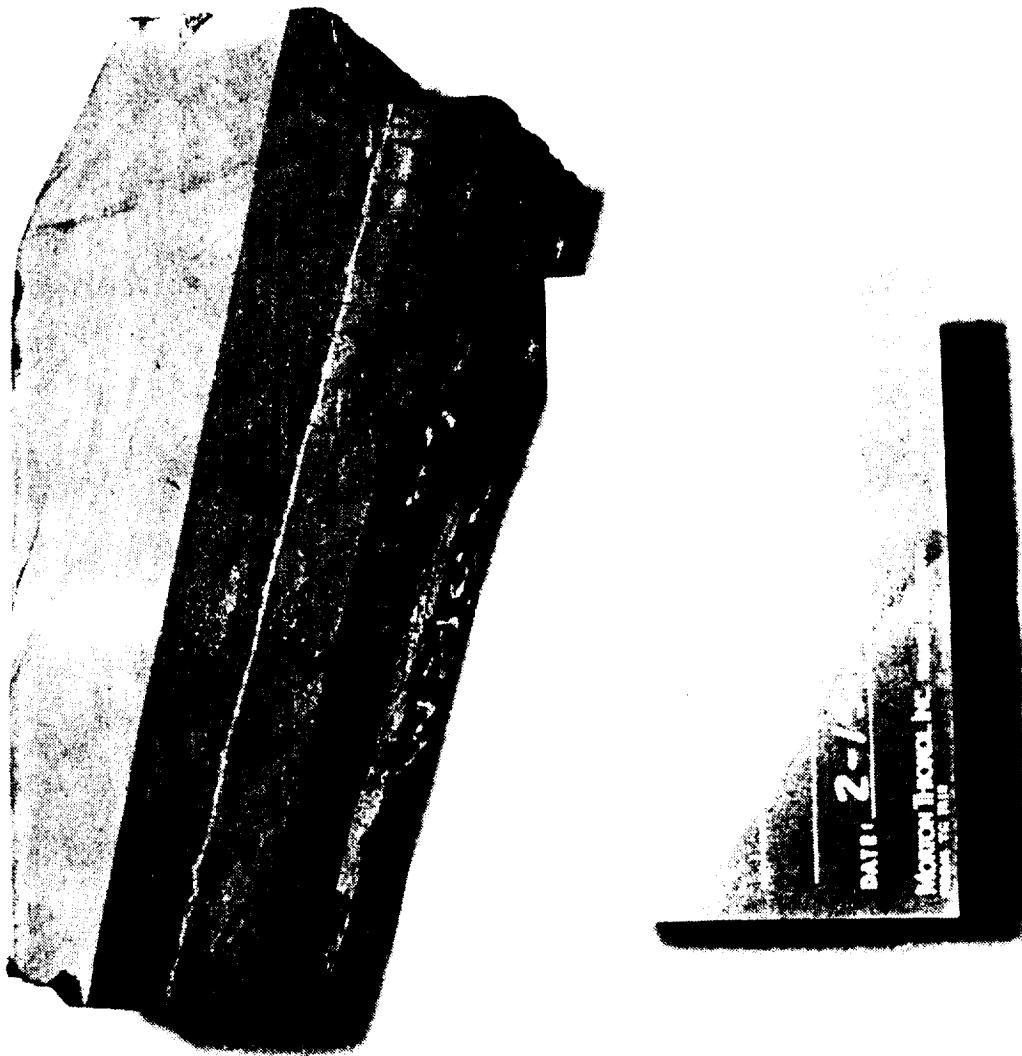
Figure 52 STS-26A Cowl (90 Degrees)

Figure 53 STS-26A Cowl (180 Degrees)

Figure 54 STS-26A Cowl (270 Degrees)

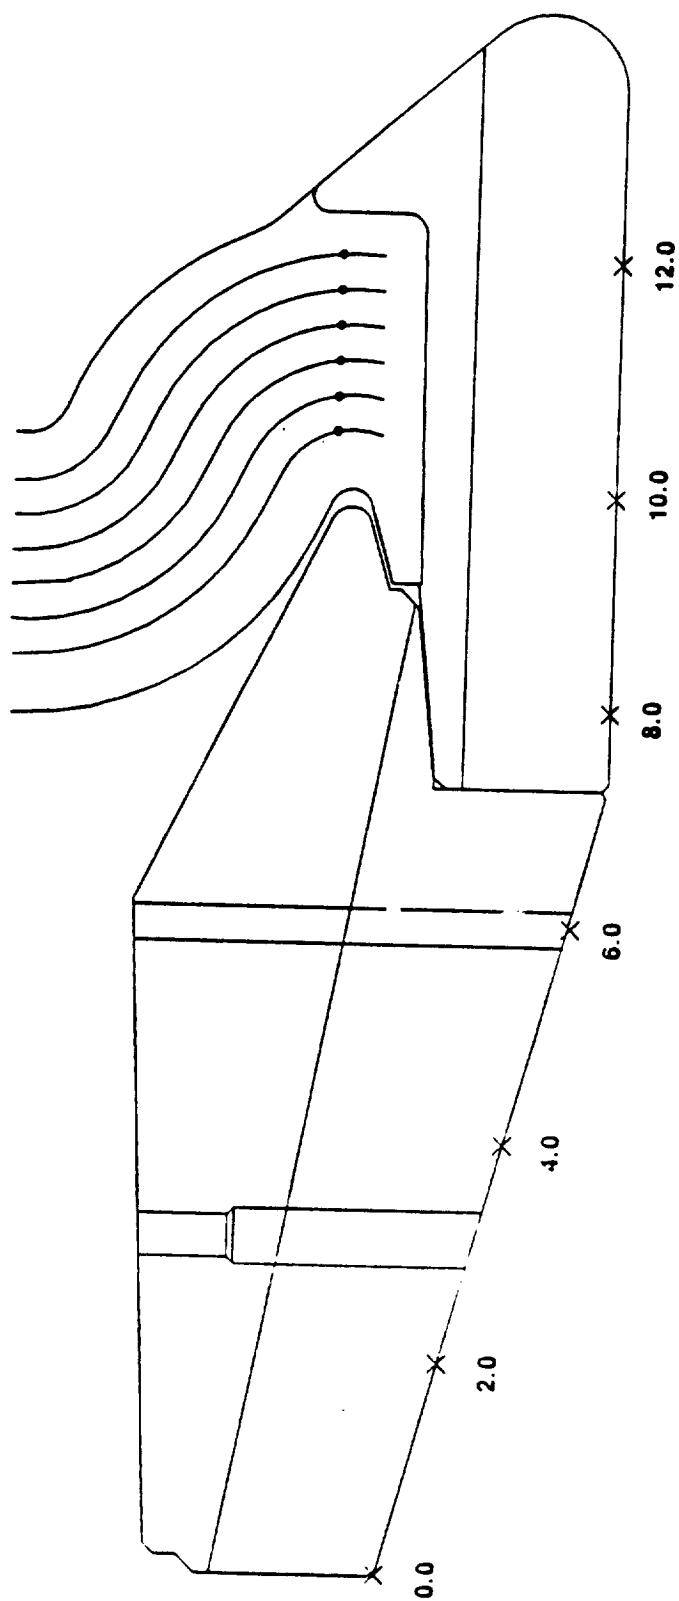
Figure 55 Covl Ring and Outer Boot Ring Erosion Measurement Stations

Char and erosion analysis of the sections is presented in Table 6 (Stations 0 through 7). Figure 55 shows the location of the measurement stations. All margins of safety were positive, with a minimum of 0.19 occurring at station 2 (90 degrees).

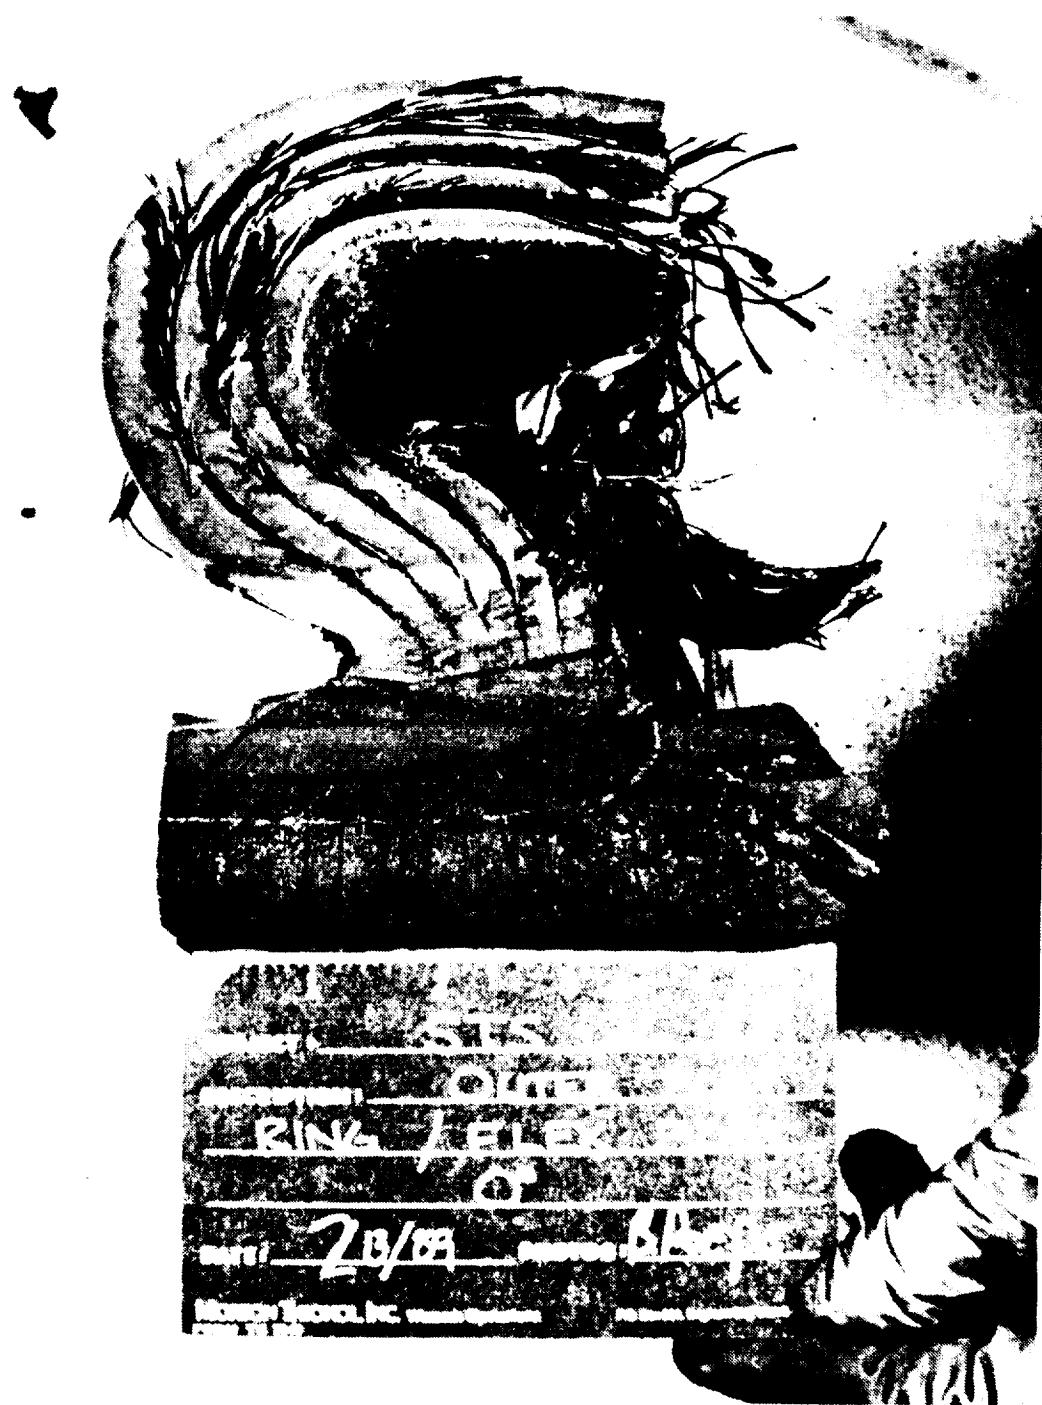
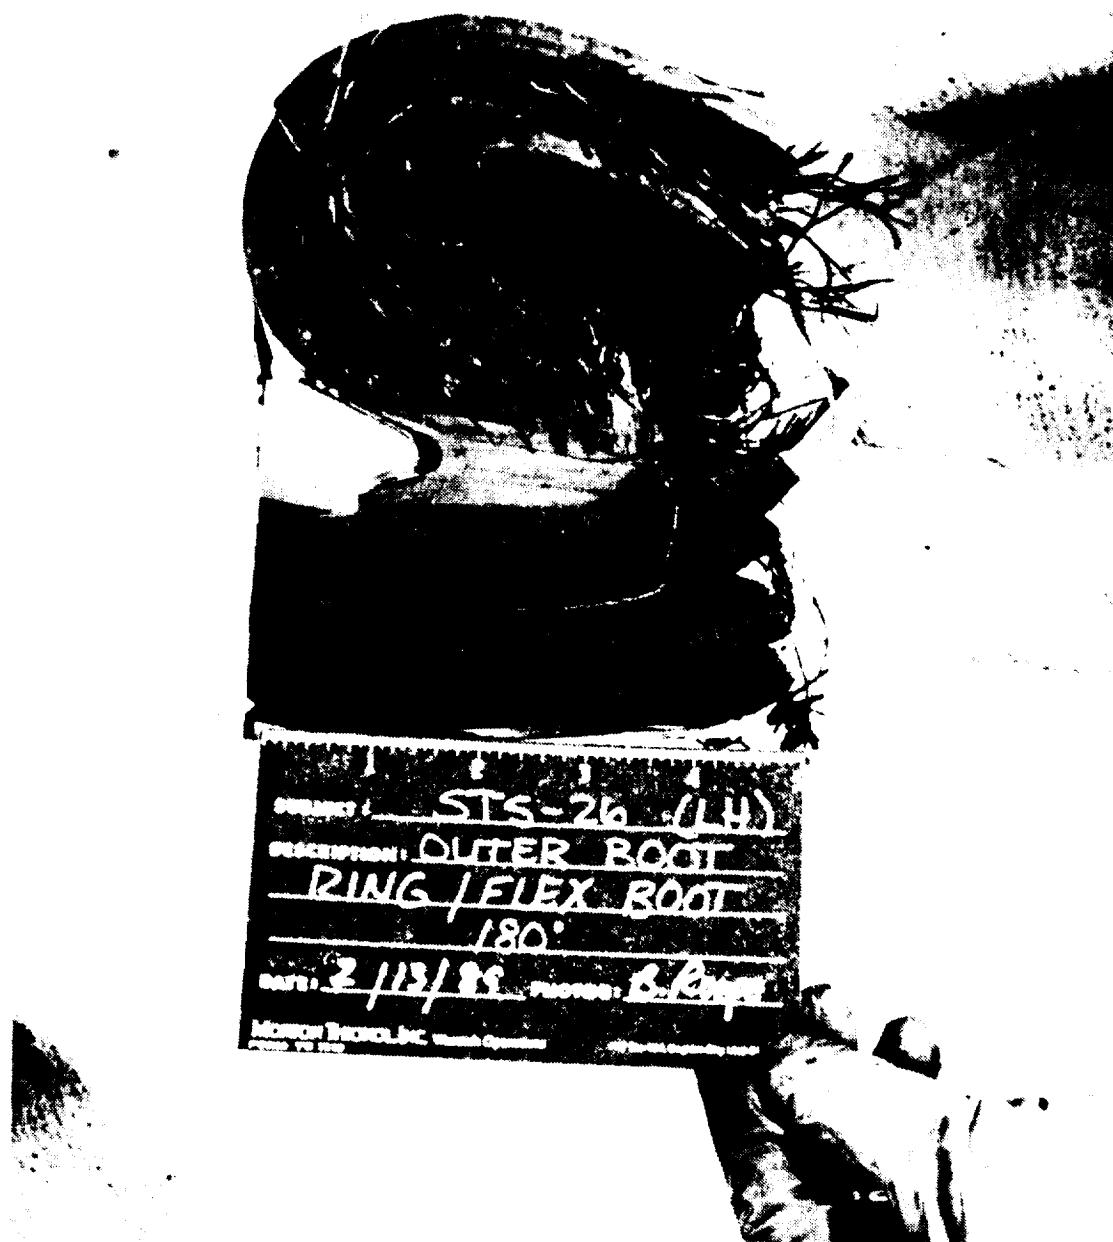
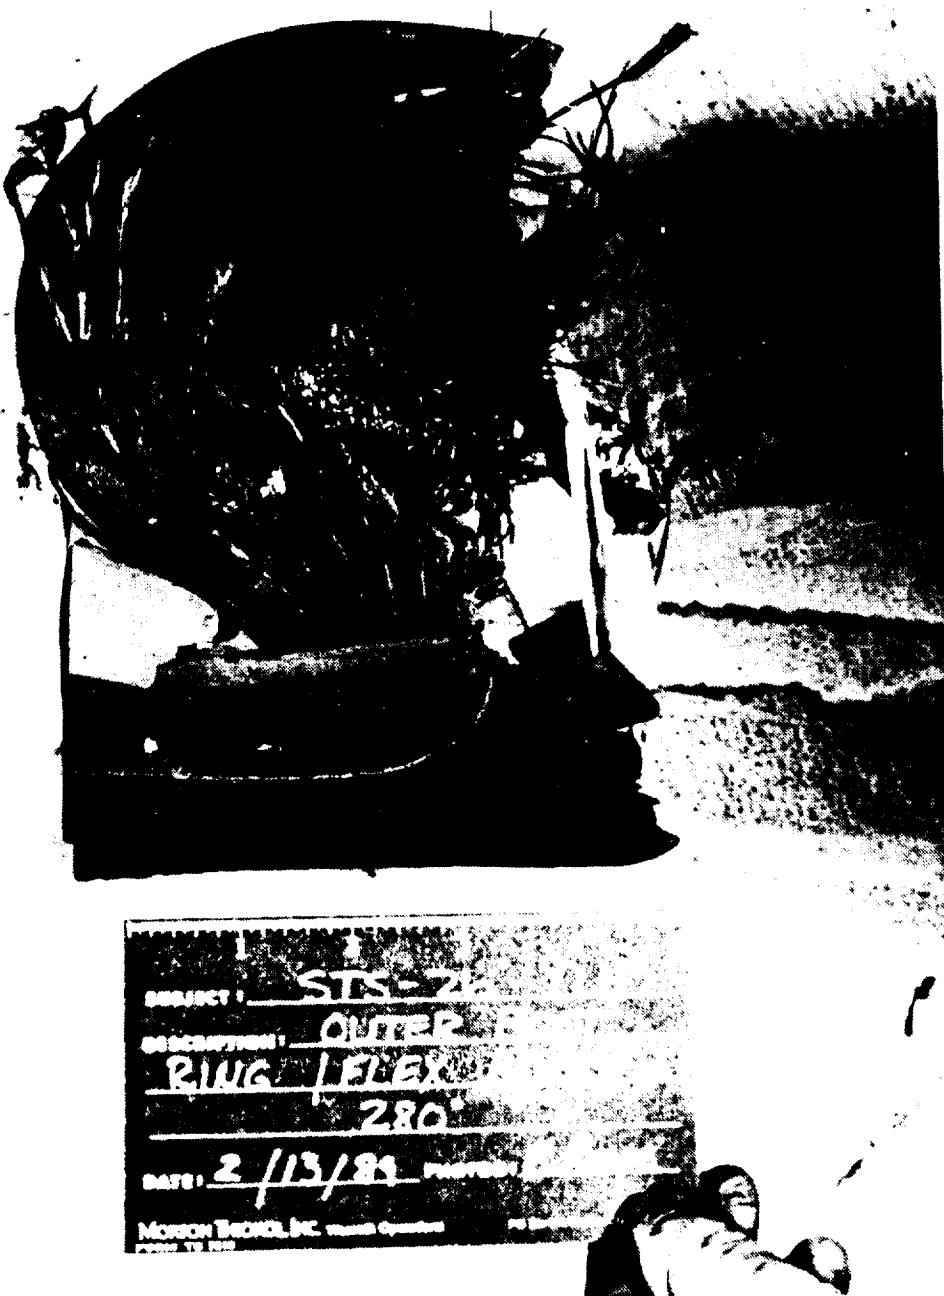
Photographs of the sectioned OBR are presented in Figures 58 through 61. Char and erosion analysis of the sections is presented in Table 6 (Stations 8 through 12). Figure 55 shows the location of the measurement stations. All margins of safety were positive, with a minimum of 0.58 occurring at station 9 (90 degrees).

Figure 58 STS-26A Outer Boot Ring Section (0 Degrees)

Figure 59 STS-26A Outer Boot Ring/Flex Boot (90 Degrees)

Figure 60 STS-26A Outer Boot Ring/Flex Boot (180 Degrees)

Figure 61 STS-26A Outer Boot Ring/Flex Boot (280 Degrees)
