# Flight Motor Set 360L001 (STS-26R) Final Report

## Volume V (Nozzle Component)

360L001 (STS-26R)  
Final Report  
Nozzle Component

A review of the performance and post-flight condition of the STS-26 Redesigned Solid Rocket Motor (RSRM) nozzles is presented in this document. Applicable Discrepancy Reports (DRs) and Process Departures (PDs) are presented in Section 5.0. The Nozzle Component Program Team (NCPT) performance evaluation and the Redesign Program Review Board (RPRB) assessment is included in Section 6.0.

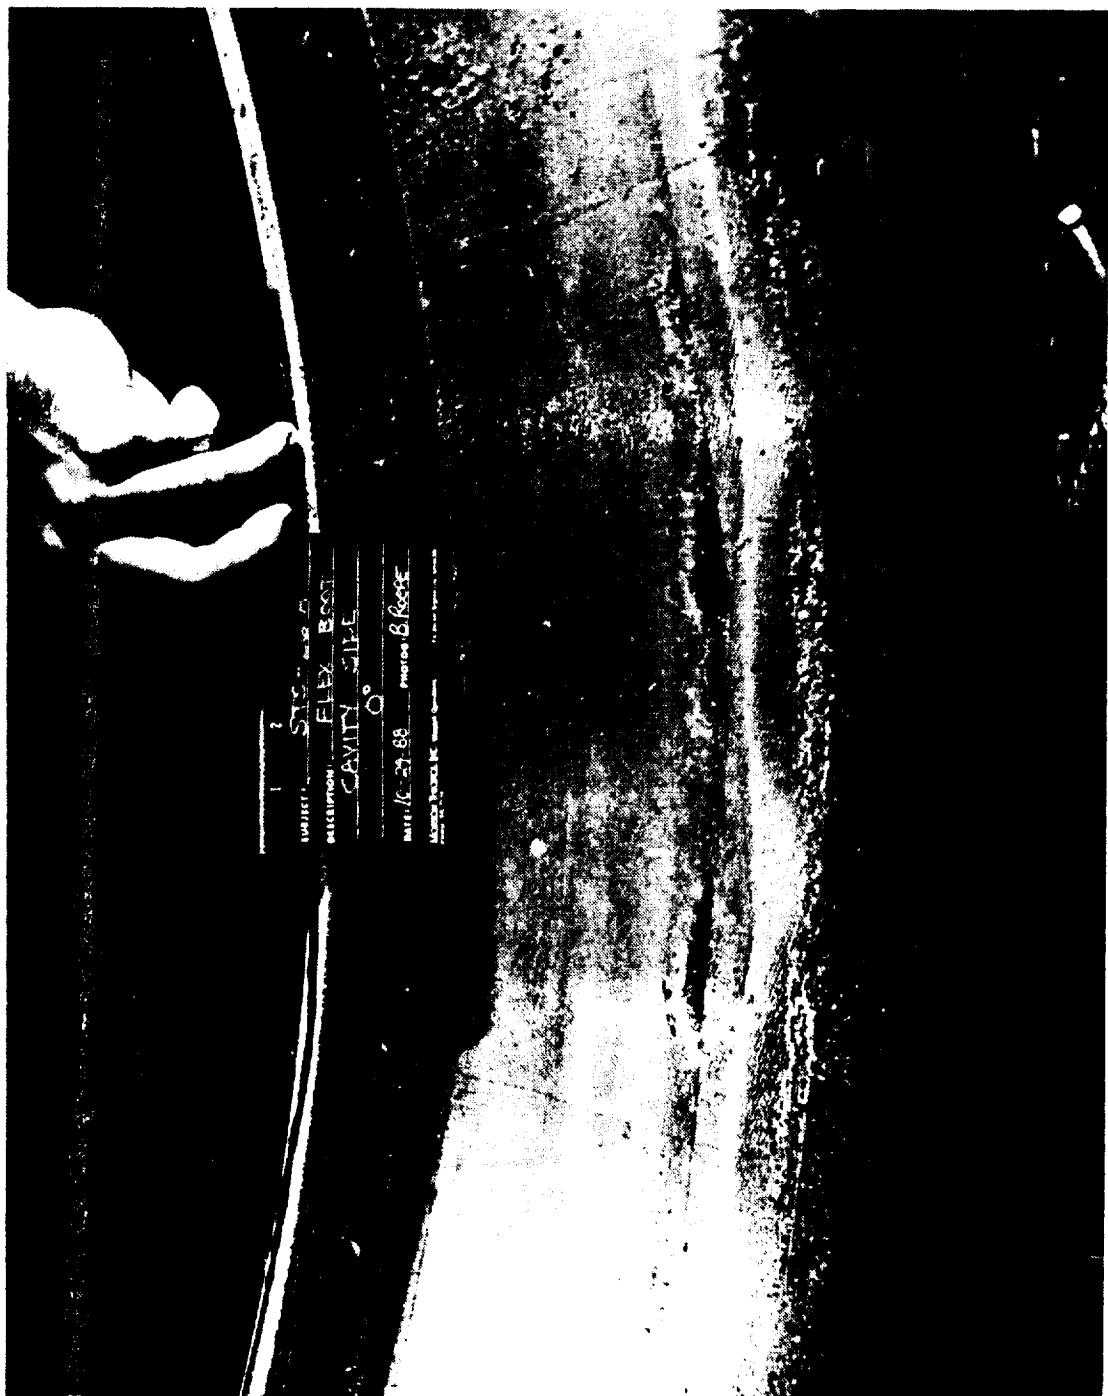
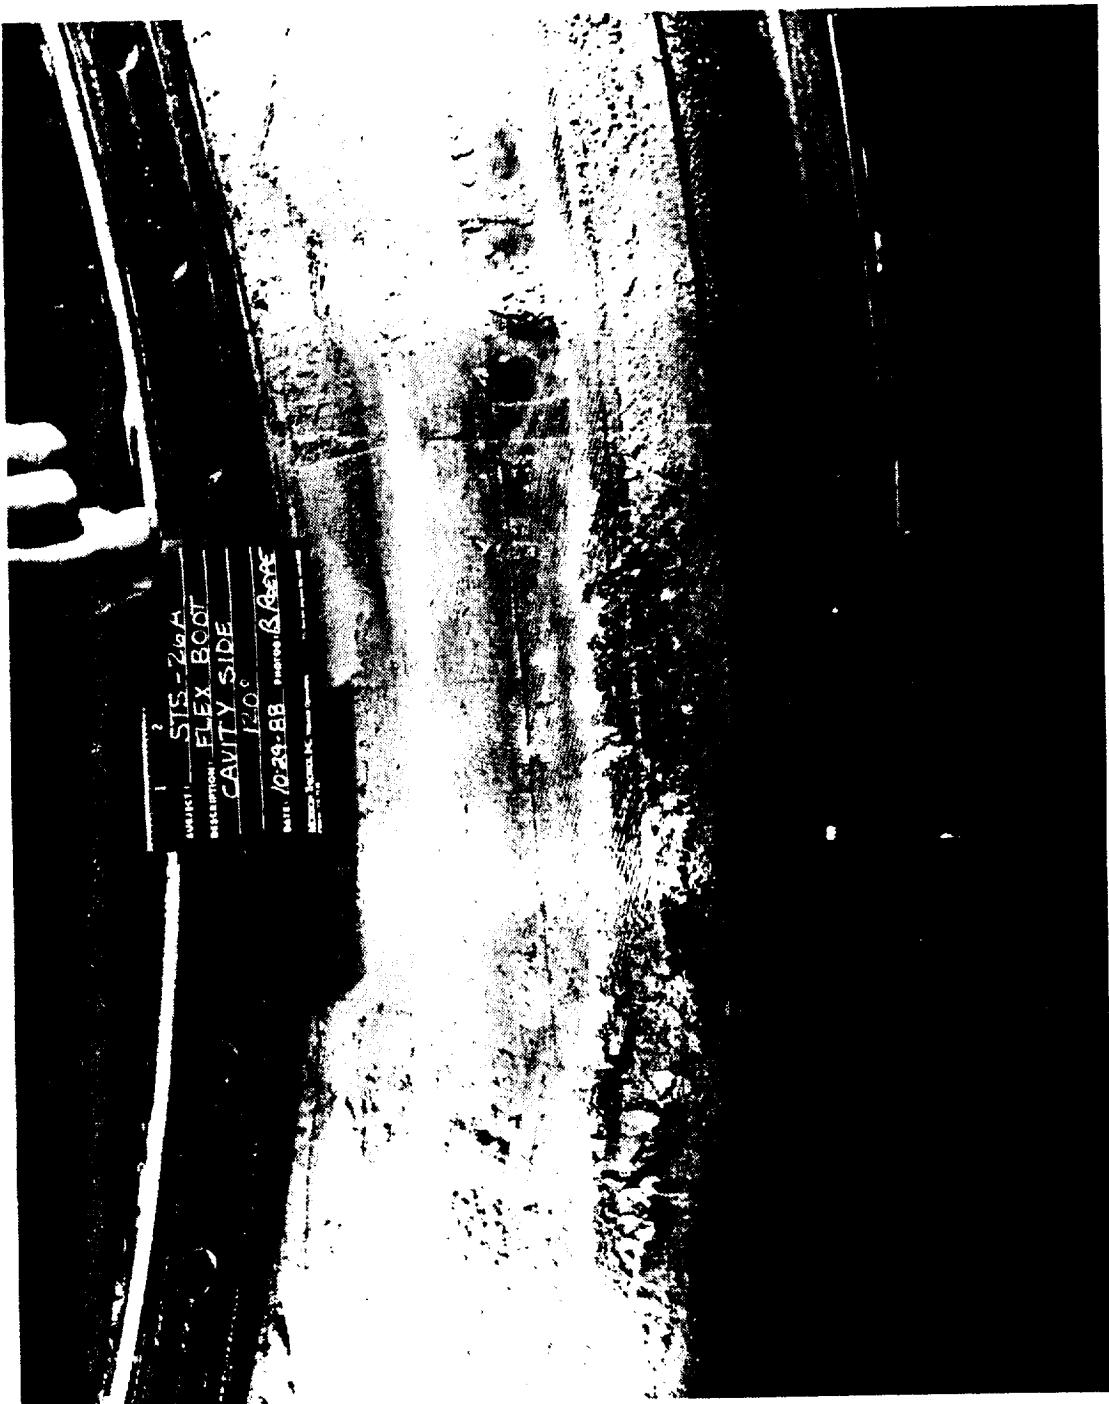
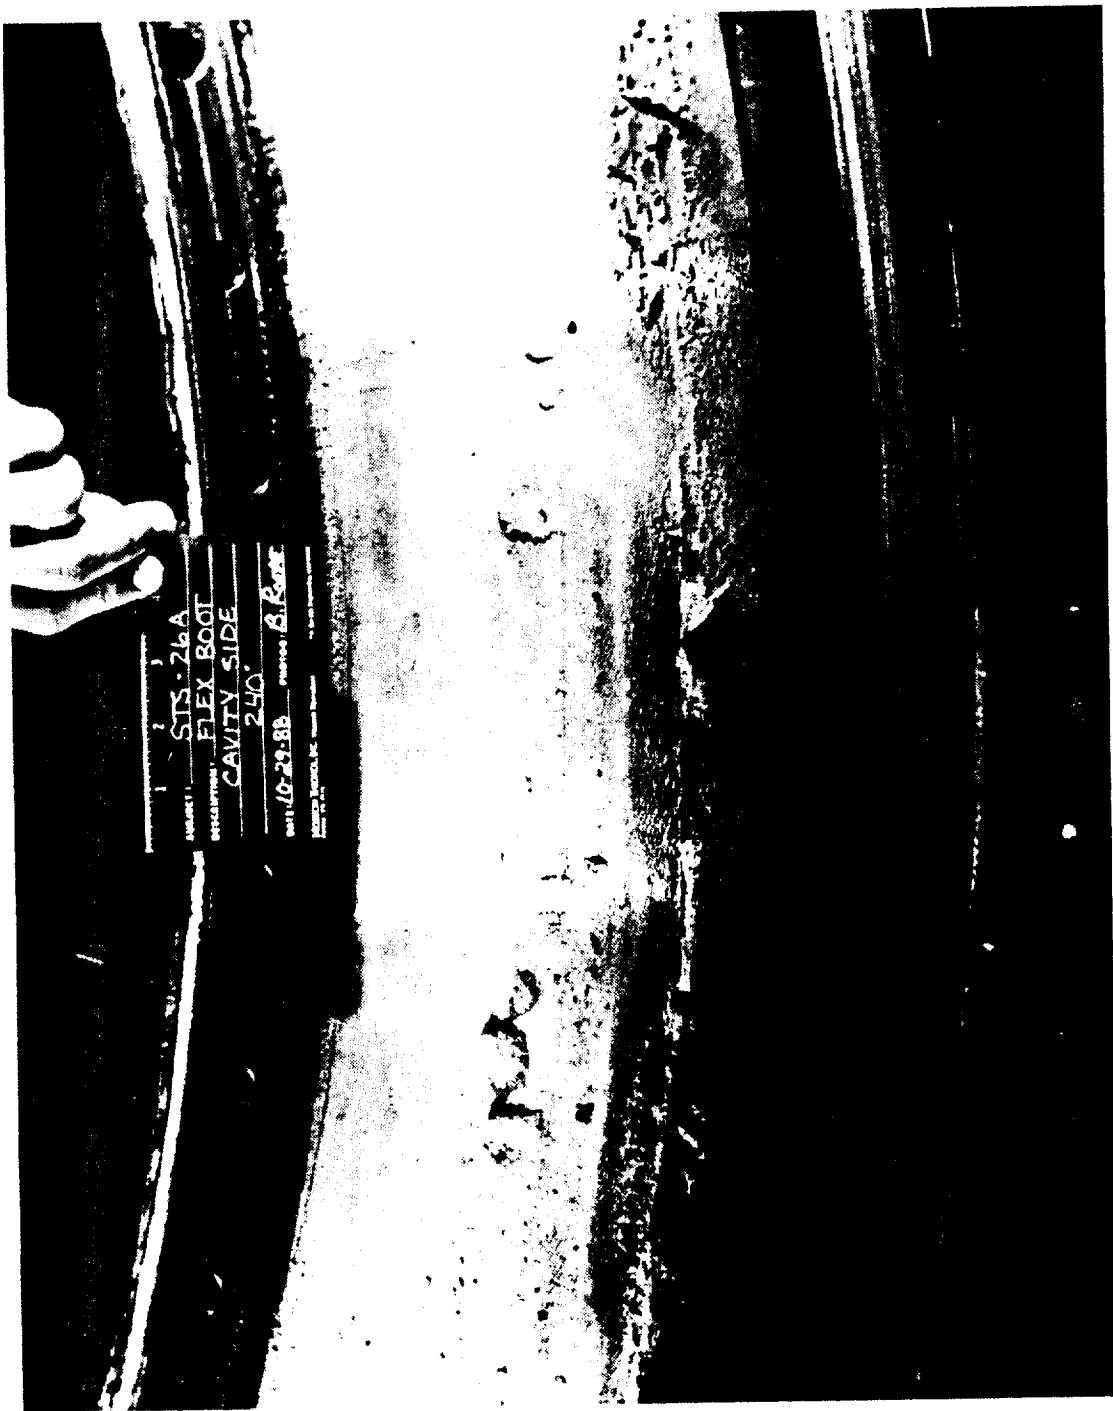
The flex boot remained attached to the outer boot ring 360 degrees circumferentially, and showed no bonline separations. The cavity side of the flex boot was evenly sooted and showed no evidence of flow or erosion (Figures 62 through 64). It appeared typical of previous flight and static test motor flex boots. A minimum of 3 NBR plies remained around the circumference after motor burn. Table 7 presents the flex boot material affected depths and performance margins of safety (PMS). The worst case PMS was 0.19 at 280 degrees.

Figure 62 STS-26A Flex Boot (Cavity Side - 0 Degrees)

Figure 63 STS-26A Flex Boot (Cavity Side - 120 Degrees)

Figure 64 STS-26A Flex Boot (Cavity Side - 240 Degrees)

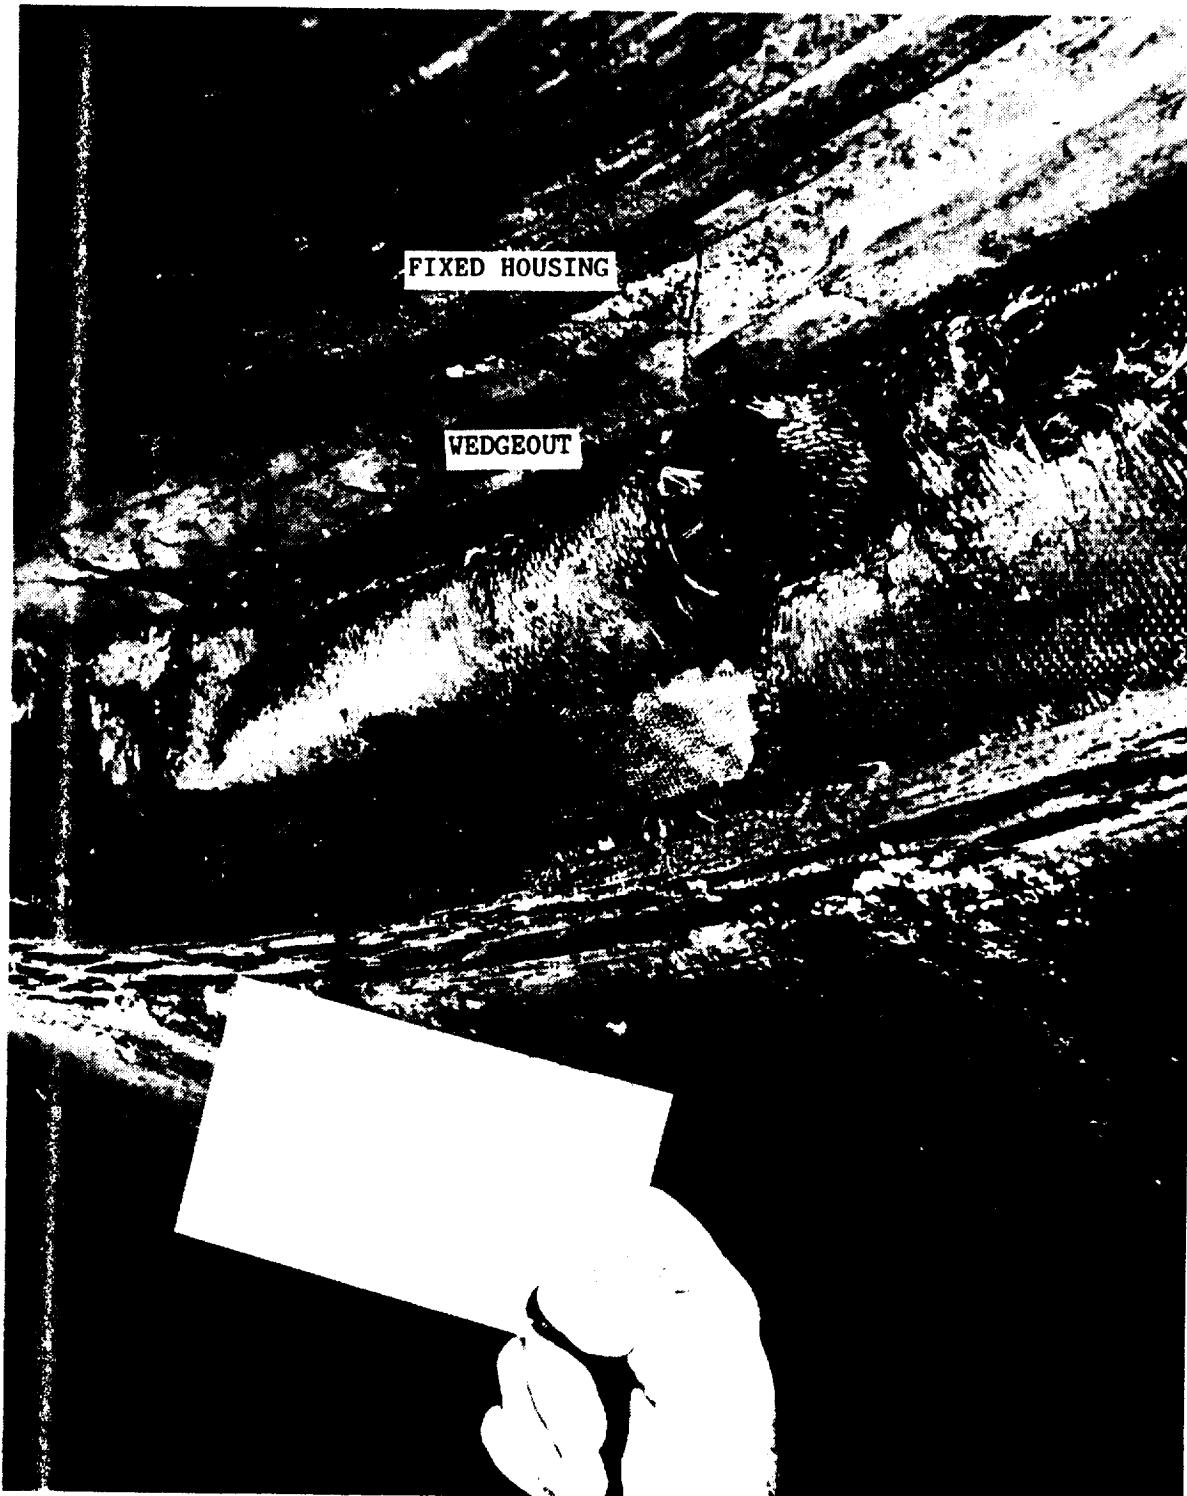
The fixed housing insulation erosion was smooth and uniform. Post-burn wedgeouts of charred CCP material were observed on the forward 2 inches intermittently around the circumference (Figure 65). The maximum radial depth of these wedgeouts was 0.5 inch. There was no heat effect to the GCP.

Figure 65 STS-26A Fixed Housing Wedgeout (280 Degrees)

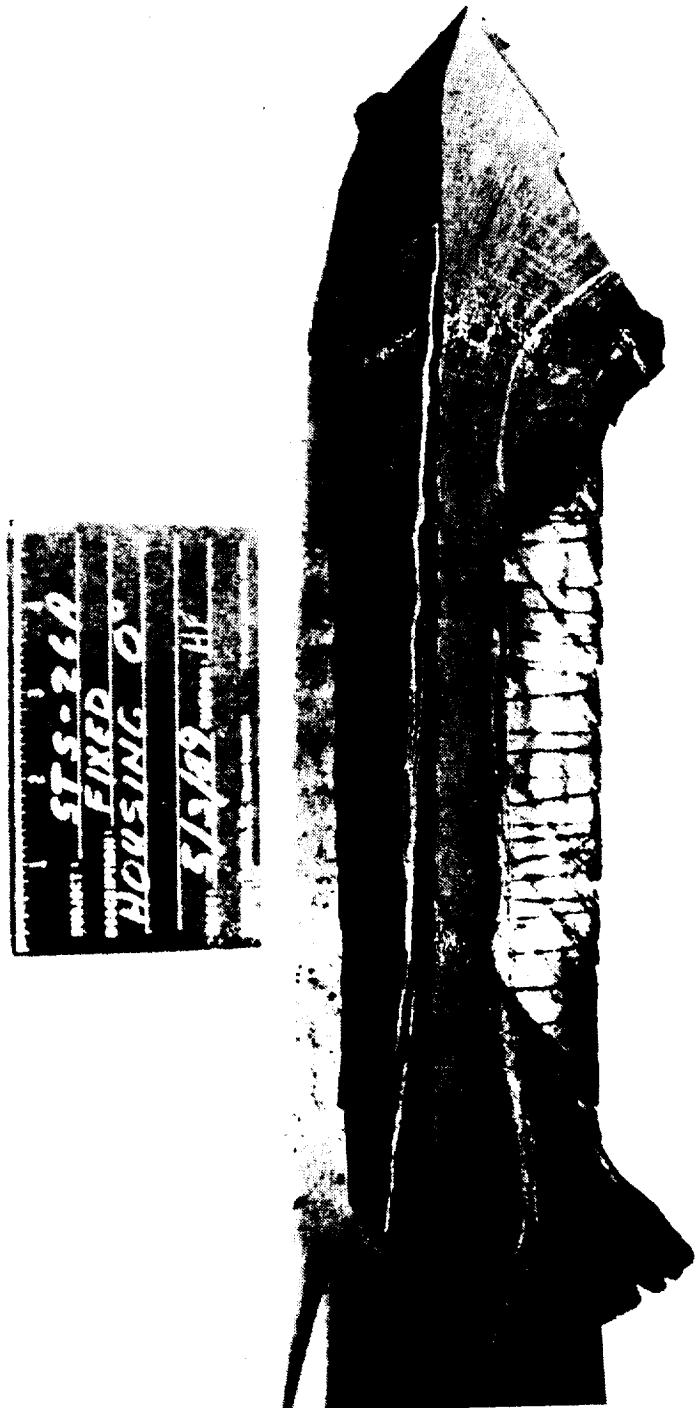
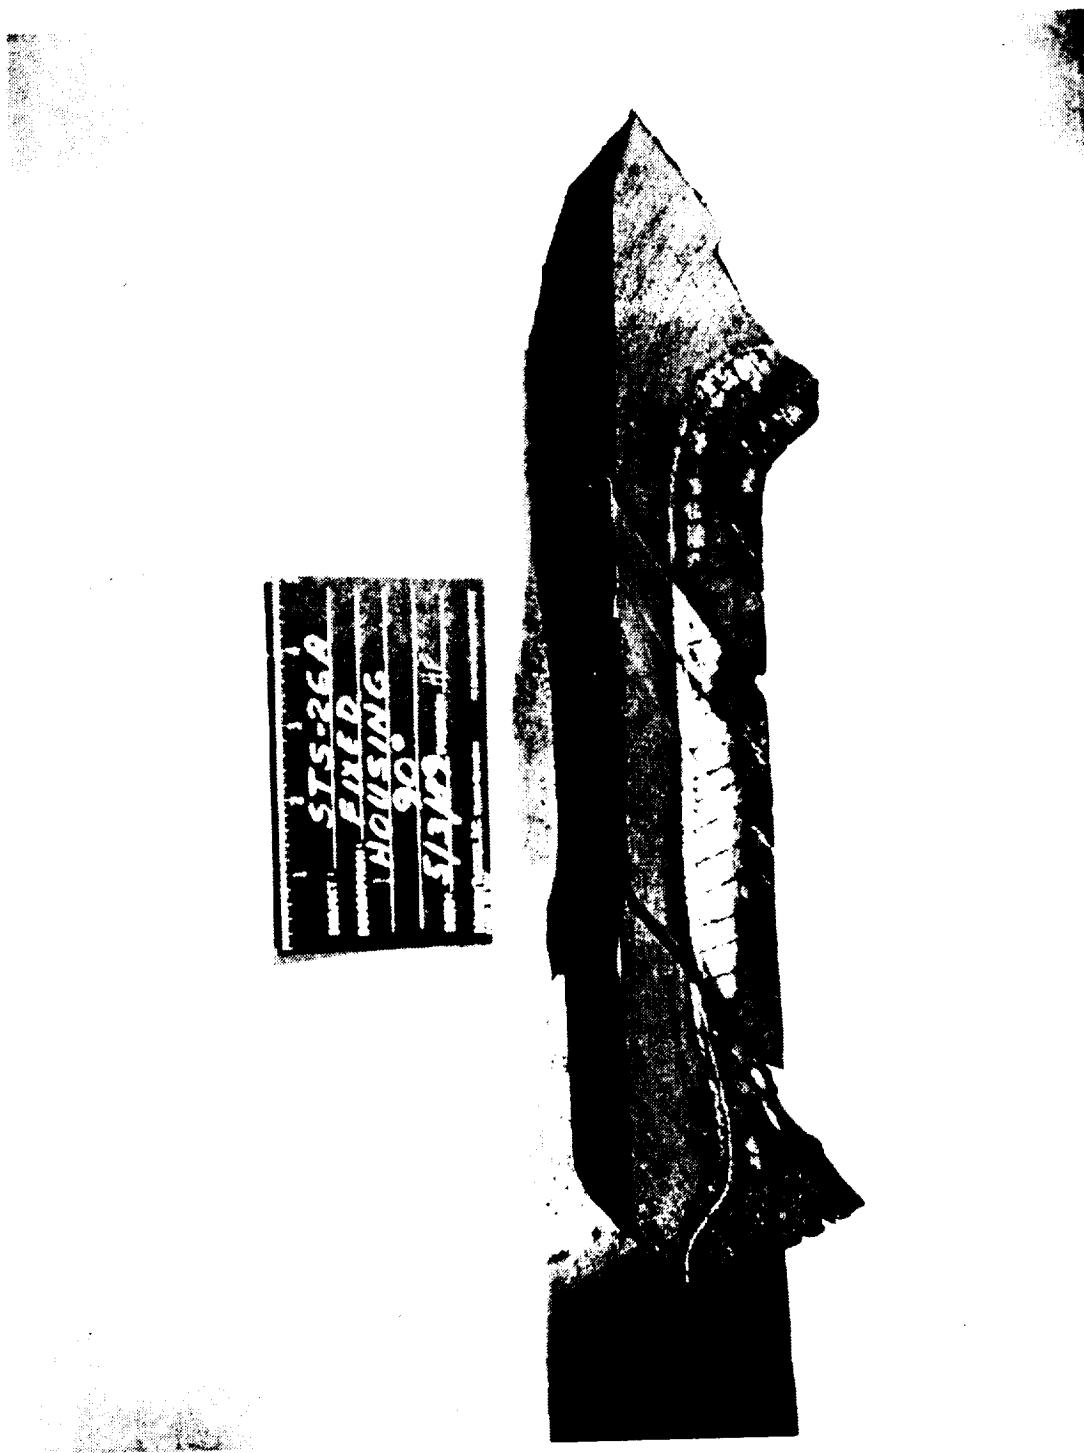
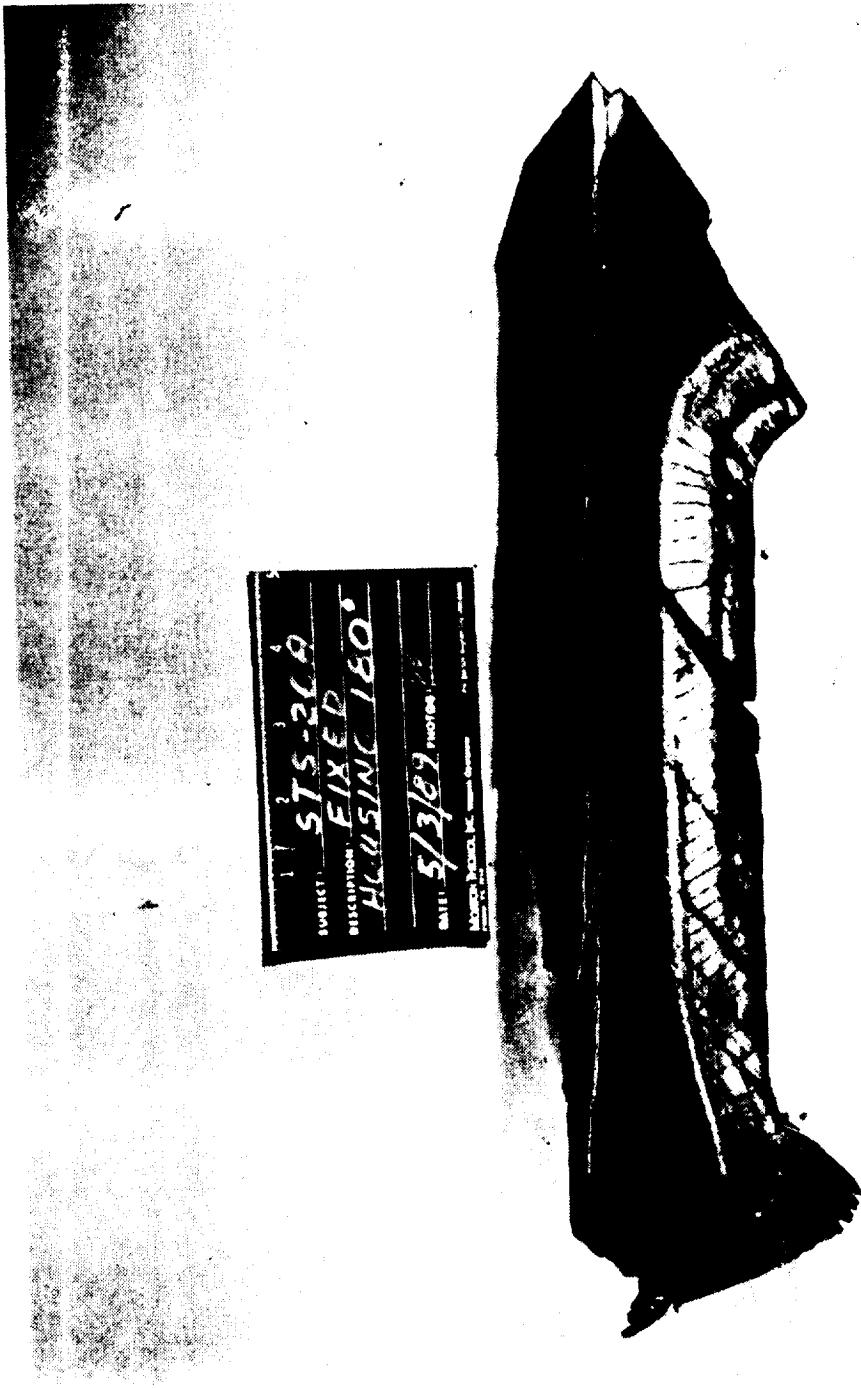
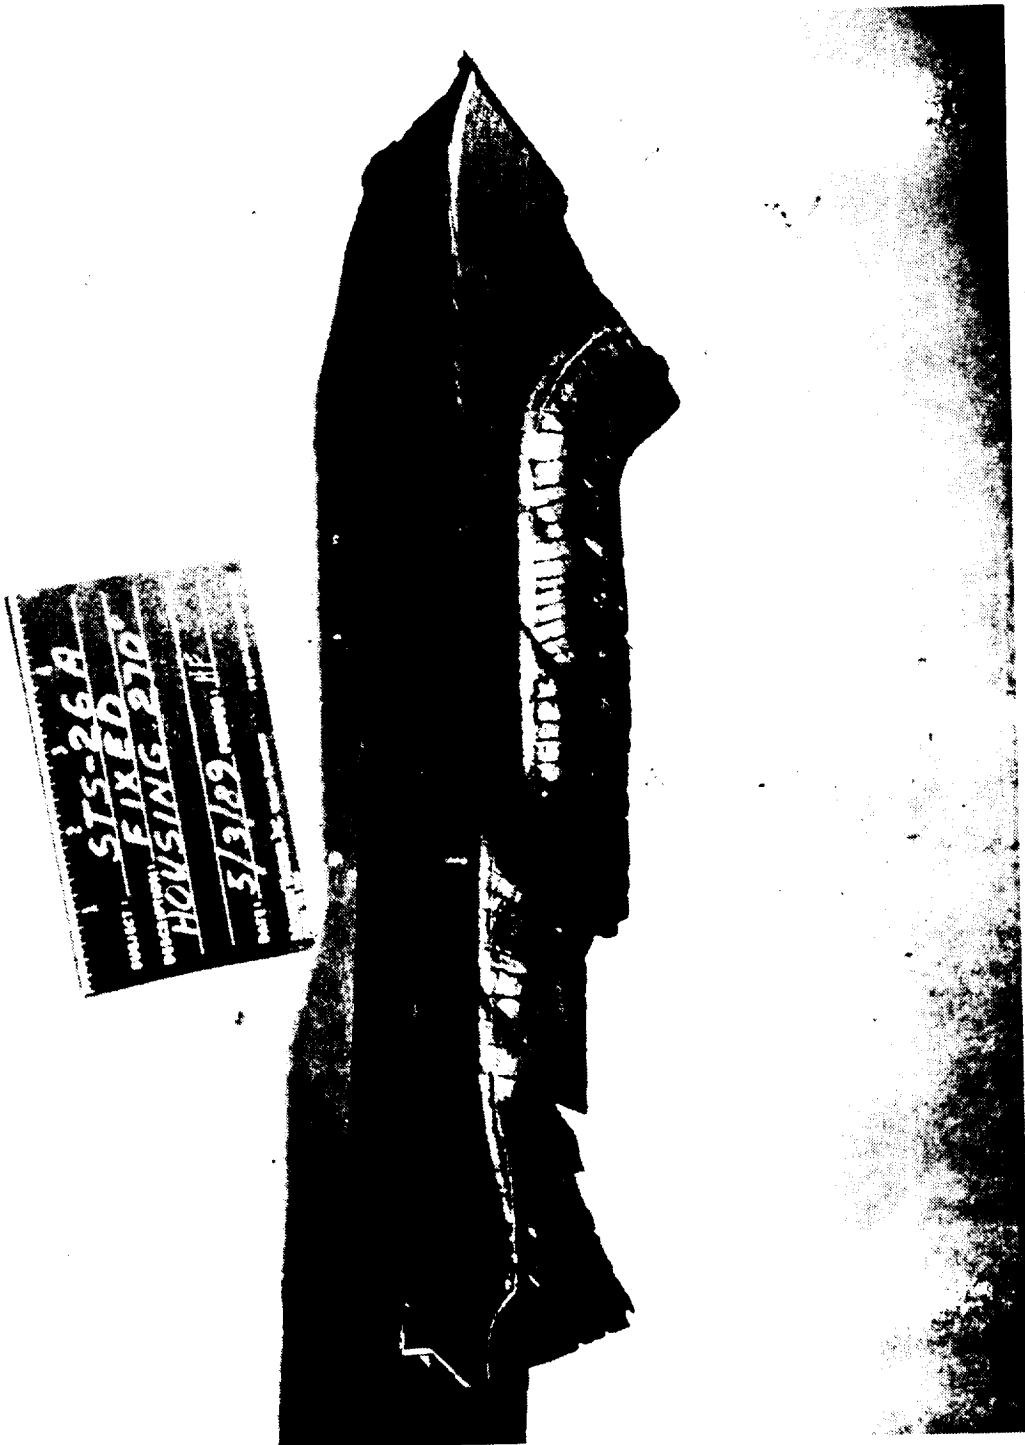
Photographs of the sectioned fixed housing assembly liner are presented in Figures 66 through 69. Char and erosion analysis of the sections is presented in Table 8. Figure 70 shows the location of the measurement stations. All margins of safety were positive, with a minimum of 0.56 occurring at station 11 (0 degrees).

Figure 66 STS-26A Fixed Housing Section (0 Degrees)

Figure 67 STS-26A Fixed Housing Section (90 Degrees)

Figure 68 STS-26A Fixed Housing Section (180 Degrees)

Figure 69 STS-26A Fixed Housing Section (270 Degrees)

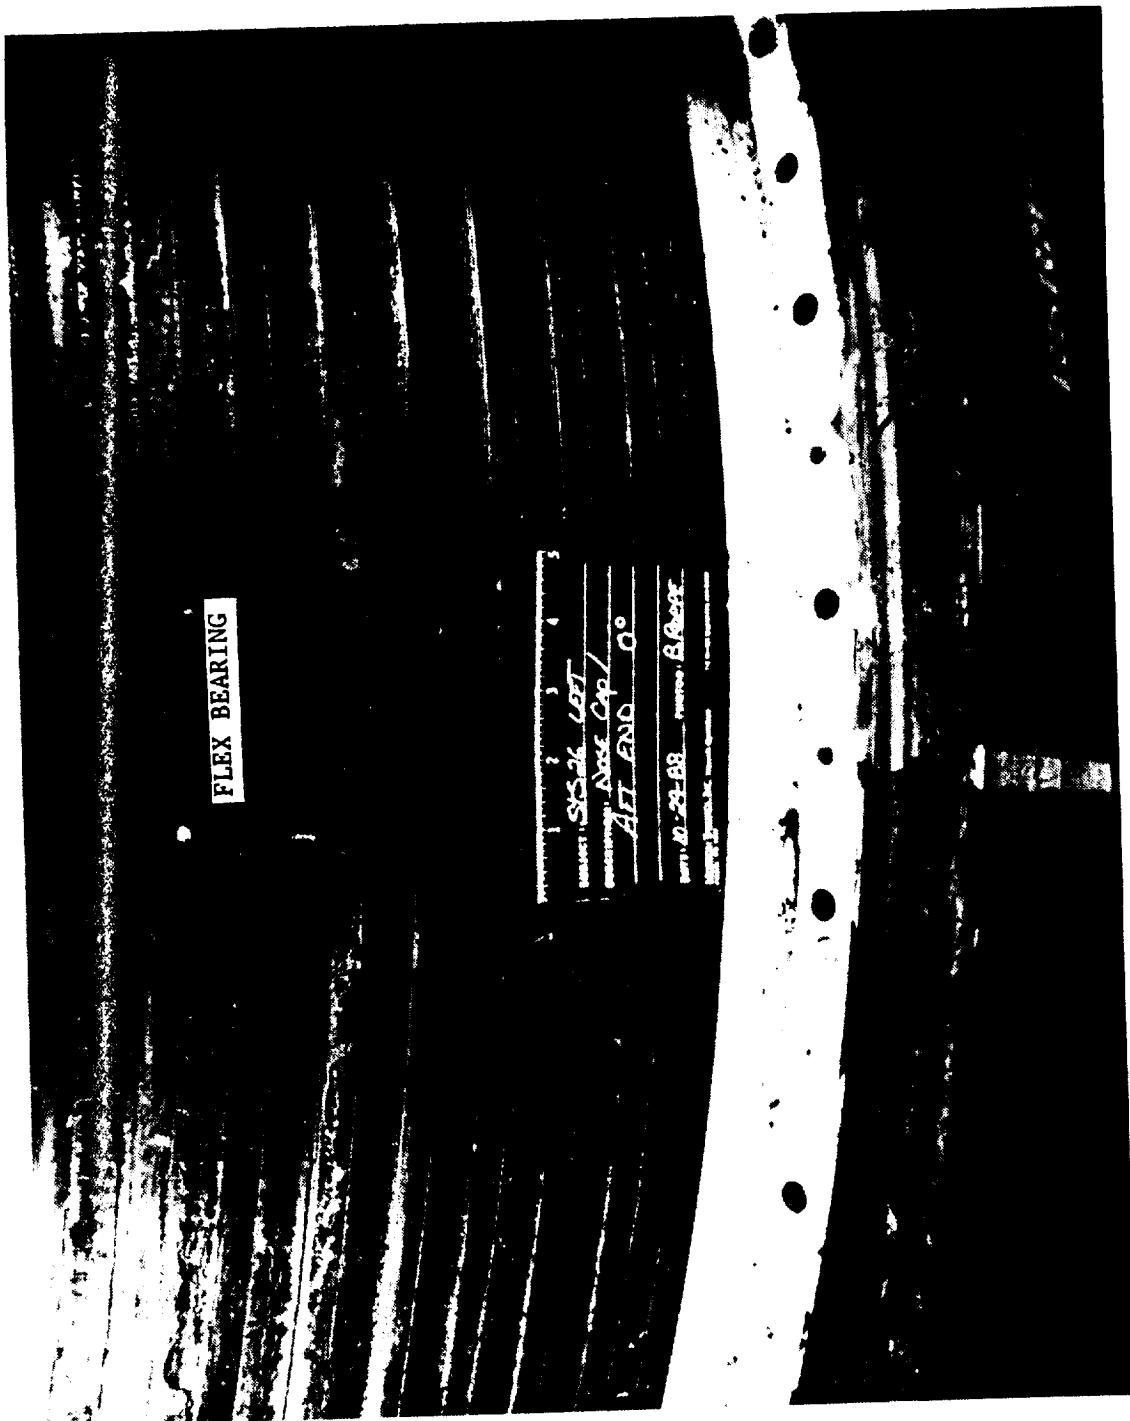
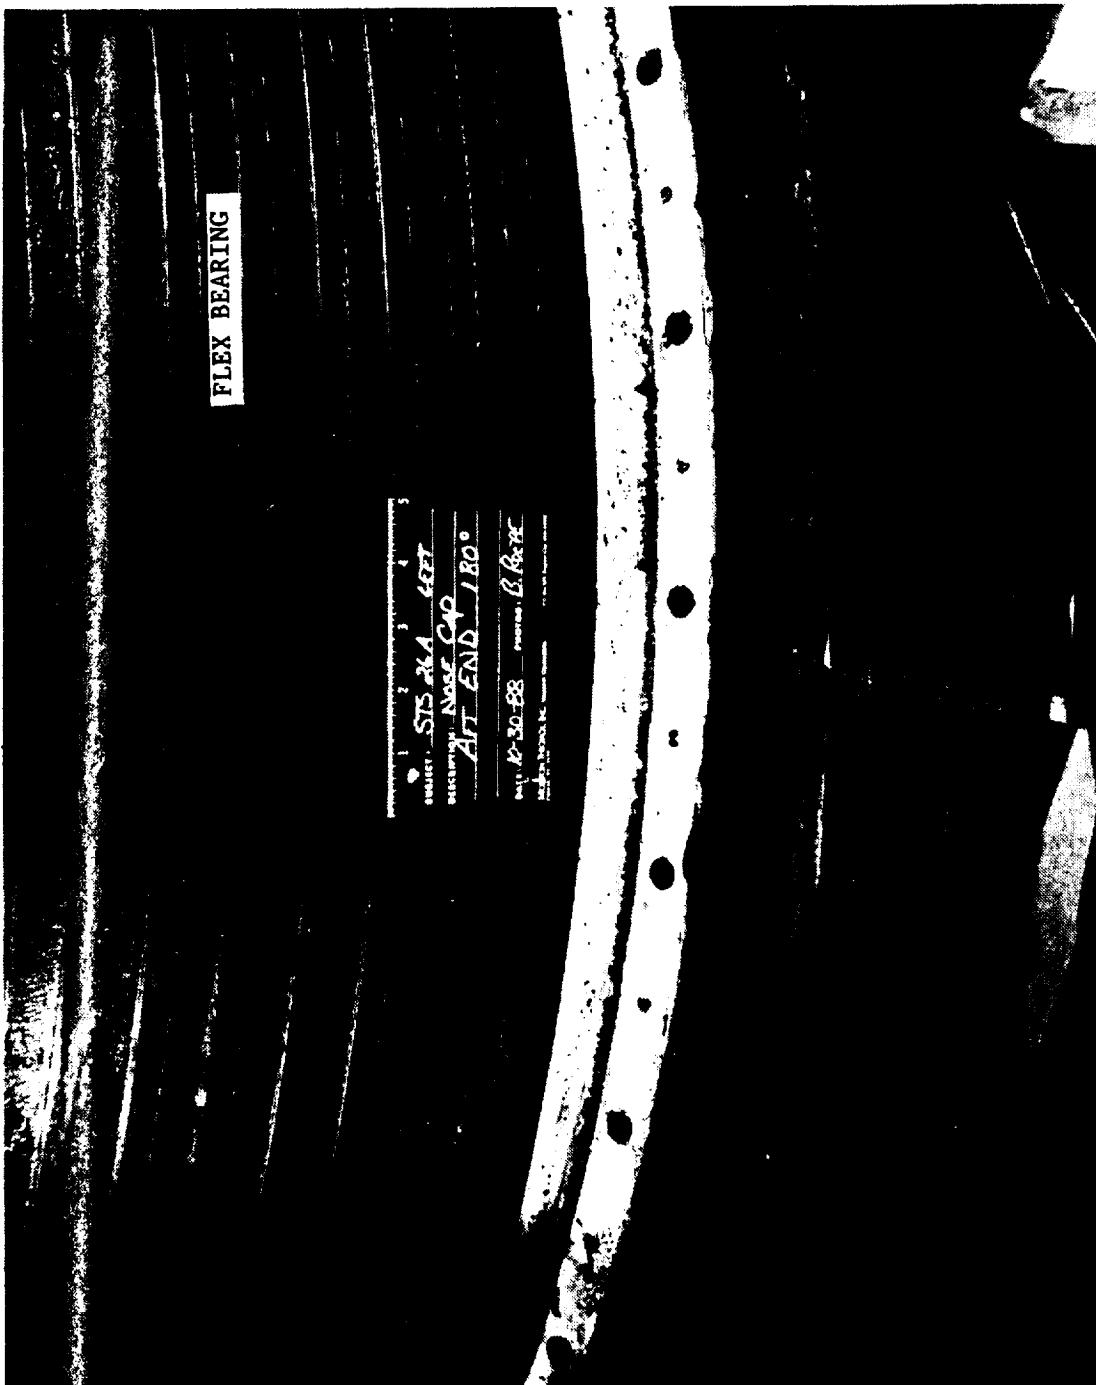
Examination of the flex bearing revealed no damage, soot, heat effect, or flow indications (see Figures 74 and 75). All rubber pads, metal shims, and end rings appeared to be in nominal condition. Subsequent refurbishment and testing has verified that the flex bearing is acceptable for reuse.

Figure 74 STS-26A Flex Bearing (0 Degrees)

Figure 75 STS-26A Flex Bearing (180 Degrees)

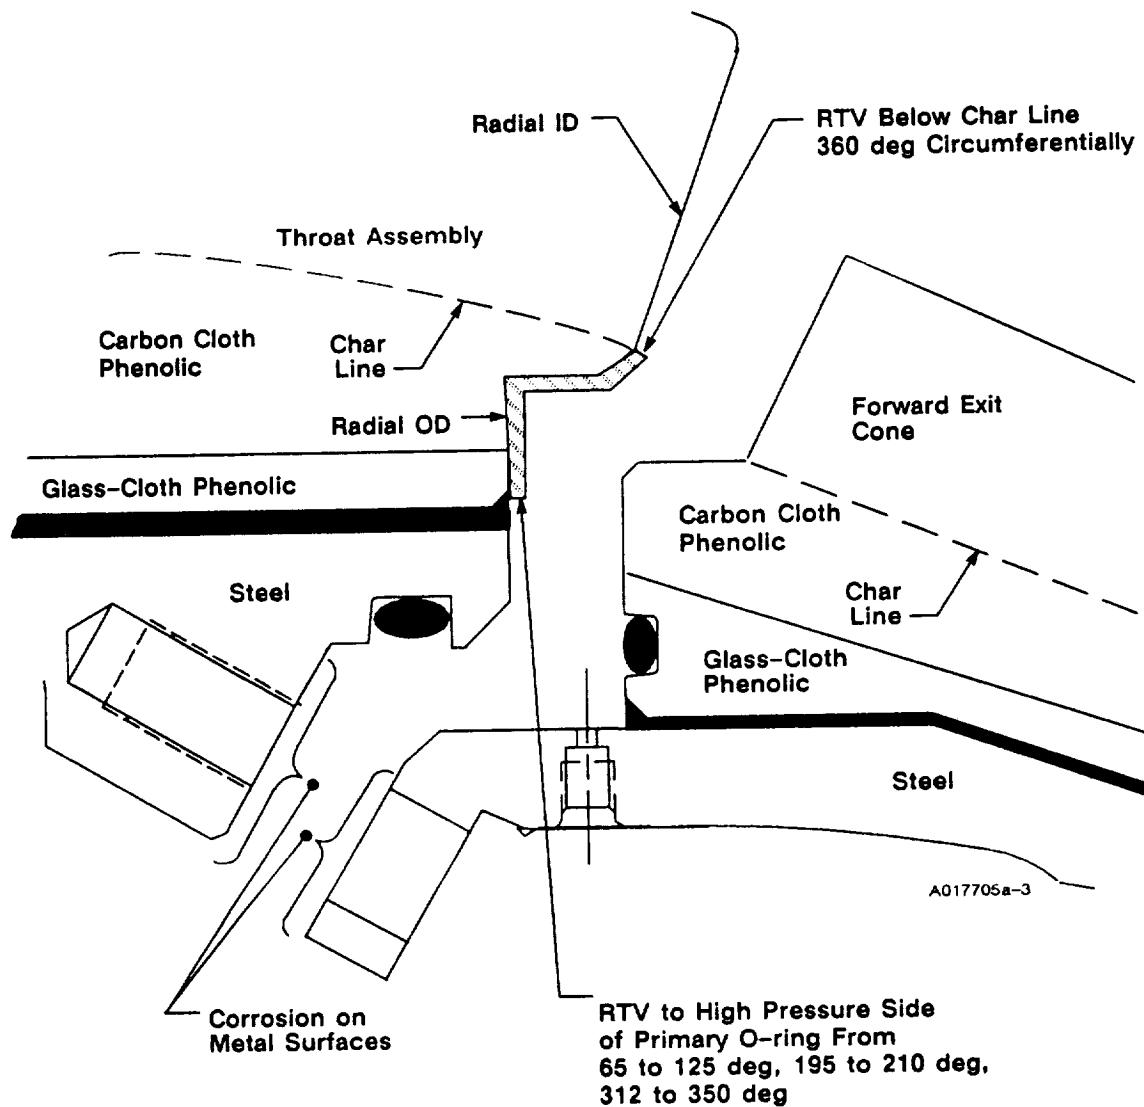
Figure 86 STS-26A Throat/Forward Exit Cone Joint

A cross-sectioned view of the STS-26A throat/forward exit cone joint is presented in Figure 86. Photographs of the post-flight joint are shown in Figures 87 through 92.

The RTV backfill extended below the joint char line and filled the axial portion of the joint 360 degrees circumferentially. RTV reached the high pressure side of the primary O-ring from 65 to 125, 195 to 210, and 312 to 350 degrees. One blow path measuring 1.0 inch circumferentially was found at 310 degrees on the radial OD portion of the joint (Figure 93). The GCP was sooted at this location, but not heat affected. The primary O-ring saw pressure, but there was no evidence of blowby, erosion, or heat effect. Soot was not evident on the radial ID or the axial portions of the joint.

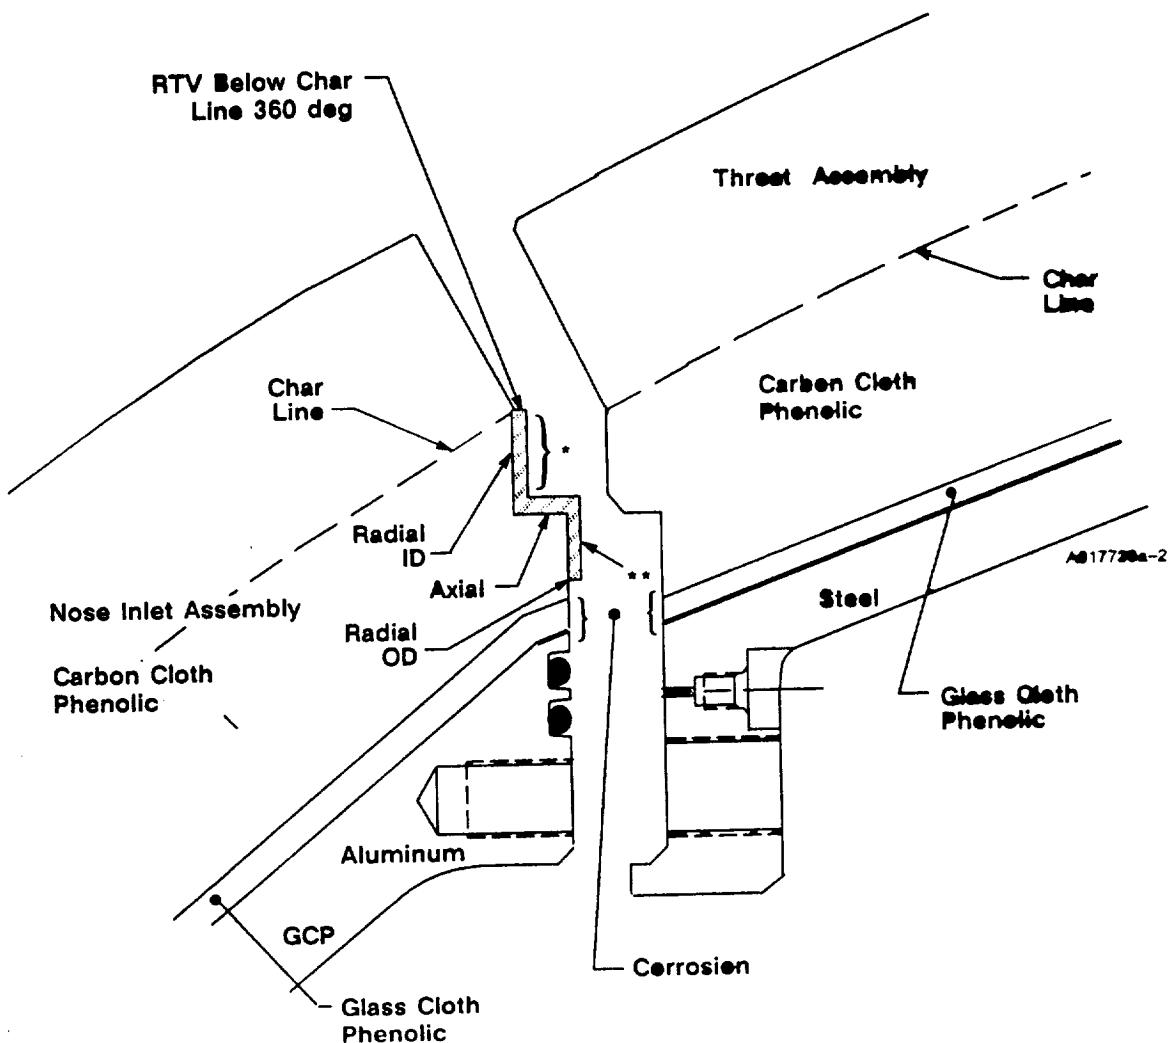
Figure 94 STS-26A—Nose Inlet/Throat Housing Joint

A cross-sectioned view of the STS-26A nose inlet/throat joint is presented in Figure 94. Photographs of the post-flight joint are shown in Figures 95 through 100.

The RTV backfill extended below the joint char line 360 degrees circumferentially. RTV completely filled the radial ID portion of the joint circumferentially except from 309 to 313 degrees. RTV also extended onto the radial OD from 52 to 70, 146 to 149, 163 to 171, 174 to 190, 195 to 197, and 210 to 220 degrees, but did not reach the primary O-ring. One blow path measuring 0.9 inch wide circumferentially and 1.2 inches deep radially was observed at 136 degrees (Figures 101 and 102). The blow path terminated within the RTV. The primary O-ring did not see pressure.

\*RTV filled radial ID circumferentially except from 309 deg to 313 deg  
\*\*RTV extended onto radial OD intermittently around circumference

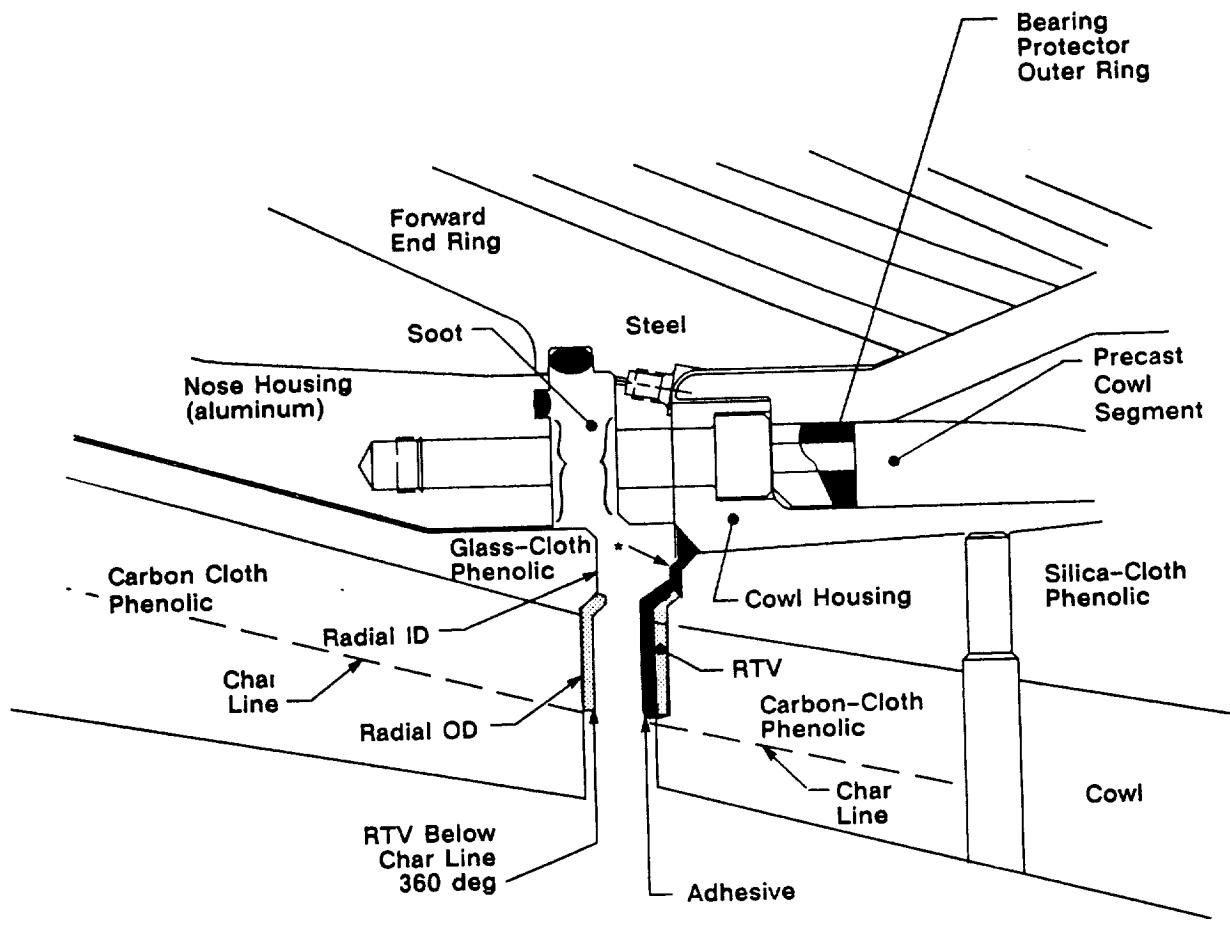
Figure 103 STS-26A Nose Inlet Housing/Flex Bearing Joint

A cross-sectioned view of the STS-26A nose inlet/forward end ring/cowl joint is presented in Figure 103. Photographs of the post-flight joint are shown in Figures 104 through 112.

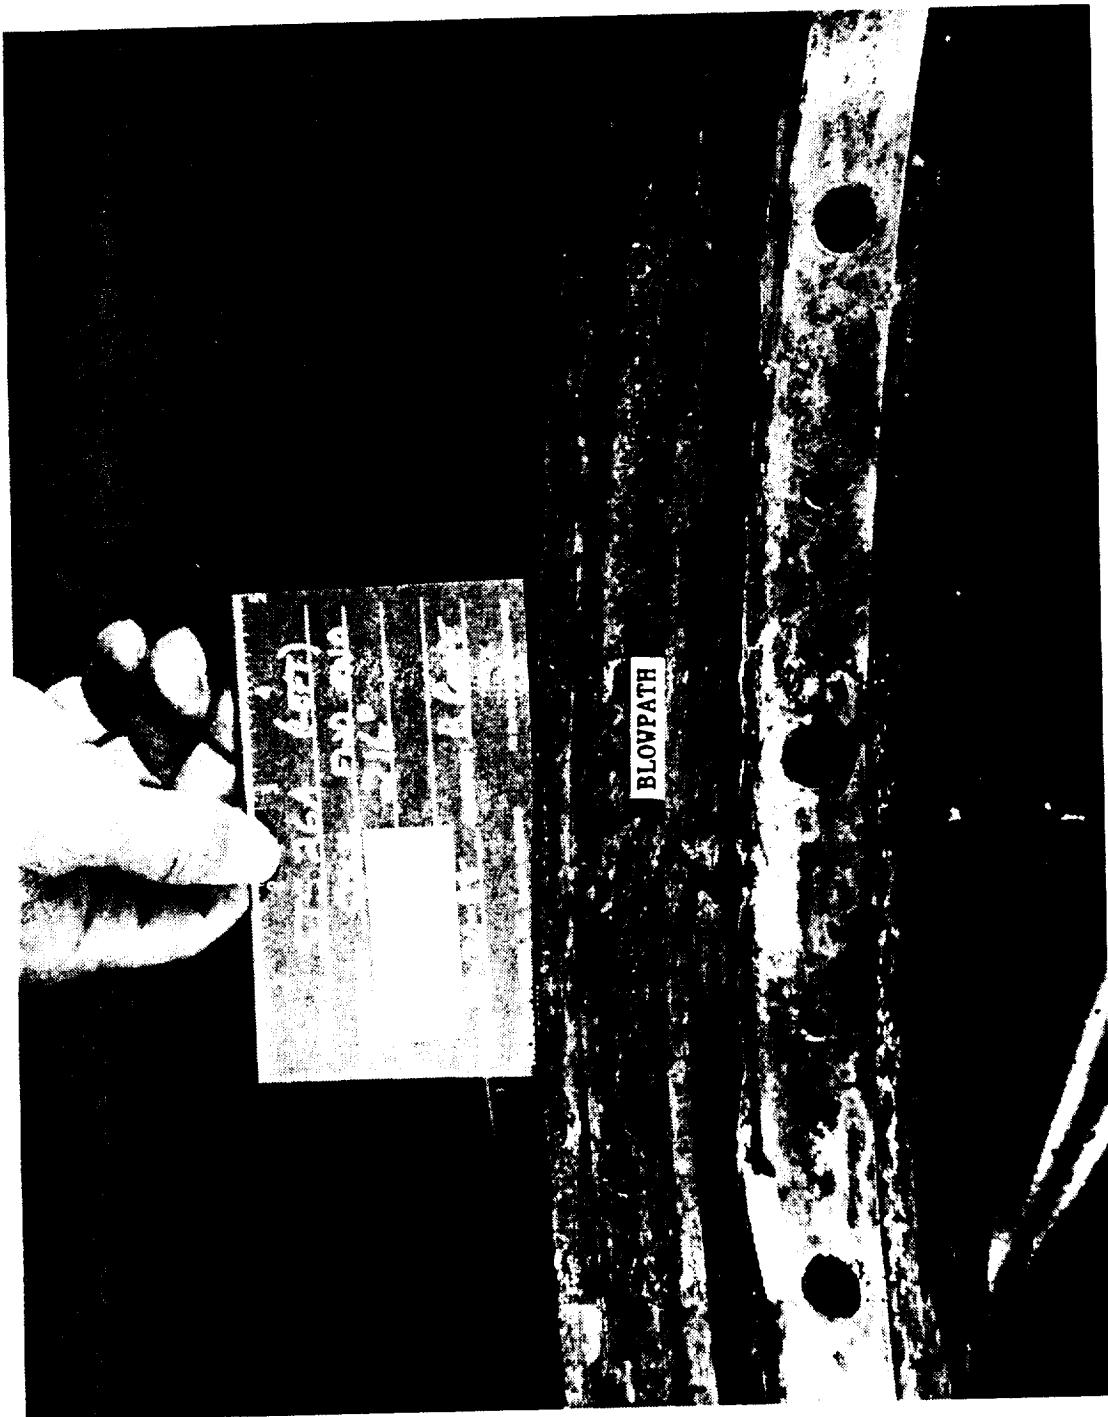
Figure 113 STS-26A Cowl Forward End-Blowpath Location (216 Degrees)

the silica cloth phenolic (SCP) approximately 0.01 inch deep axially (Figure 113). The EA913 NA adhesive on the cowl eroded approximately 0.1 inch deep axially (maximum) by 0.7 inch wide circumferentially at the blow path location. Soot was observed on the nose cap/forward end ring interface surfaces, reaching the primary O-ring from 156 to 162, and 180 to 240 degrees (Figure 112). There was no blowby, erosion, or heat effect to the primary O-ring. Soot also extended to midway between the bolt holes around the remainder of the circumference.

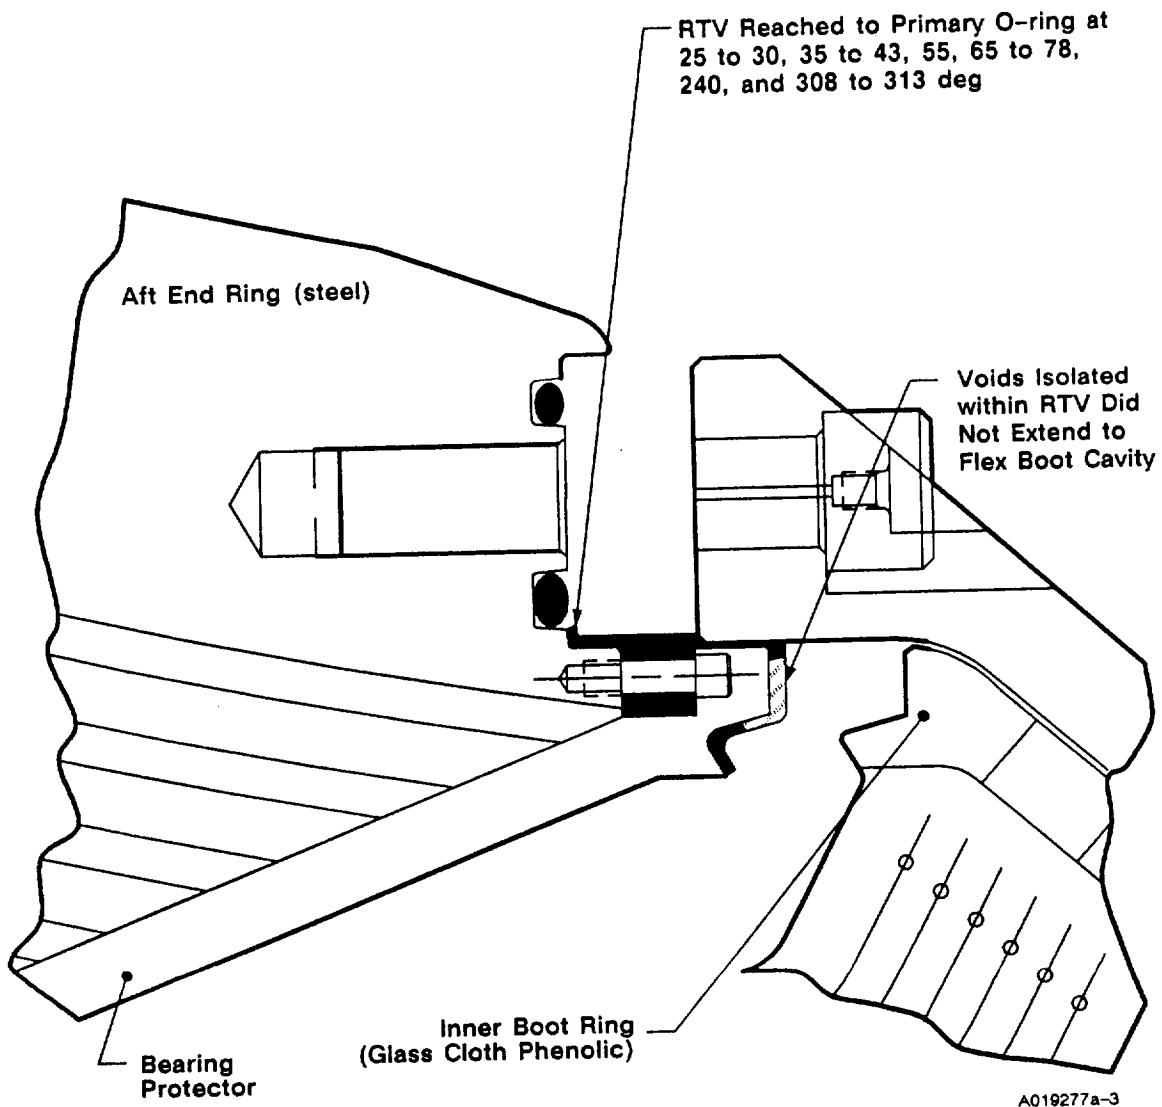
Figure 114 STS-26A—Flex Bearing/Fixed Housing Joint

A cross-sectioned view of the STS-26A aft end ring/fixed housing joint is presented in Figure 114. Photographs of the post-flight joint are shown in Figures 115 through 121.
