# Flight Motor Set 360L001 (STS-26R) Final Report

## Volume V (Nozzle Component)

360L001 (STS-26R)  
Final Report  
Nozzle Component

A review of the performance and post-flight condition of the STS-26 Redesigned Solid Rocket Motor (RSRM) nozzles is presented in this document. Applicable Discrepancy Reports (DRs) and Process Departures (PDs) are presented in Section 5.0. The Nozzle Component Program Team (NCPT) performance evaluation and the Redesign Program Review Board (RPRB) assessment is included in Section 6.0.

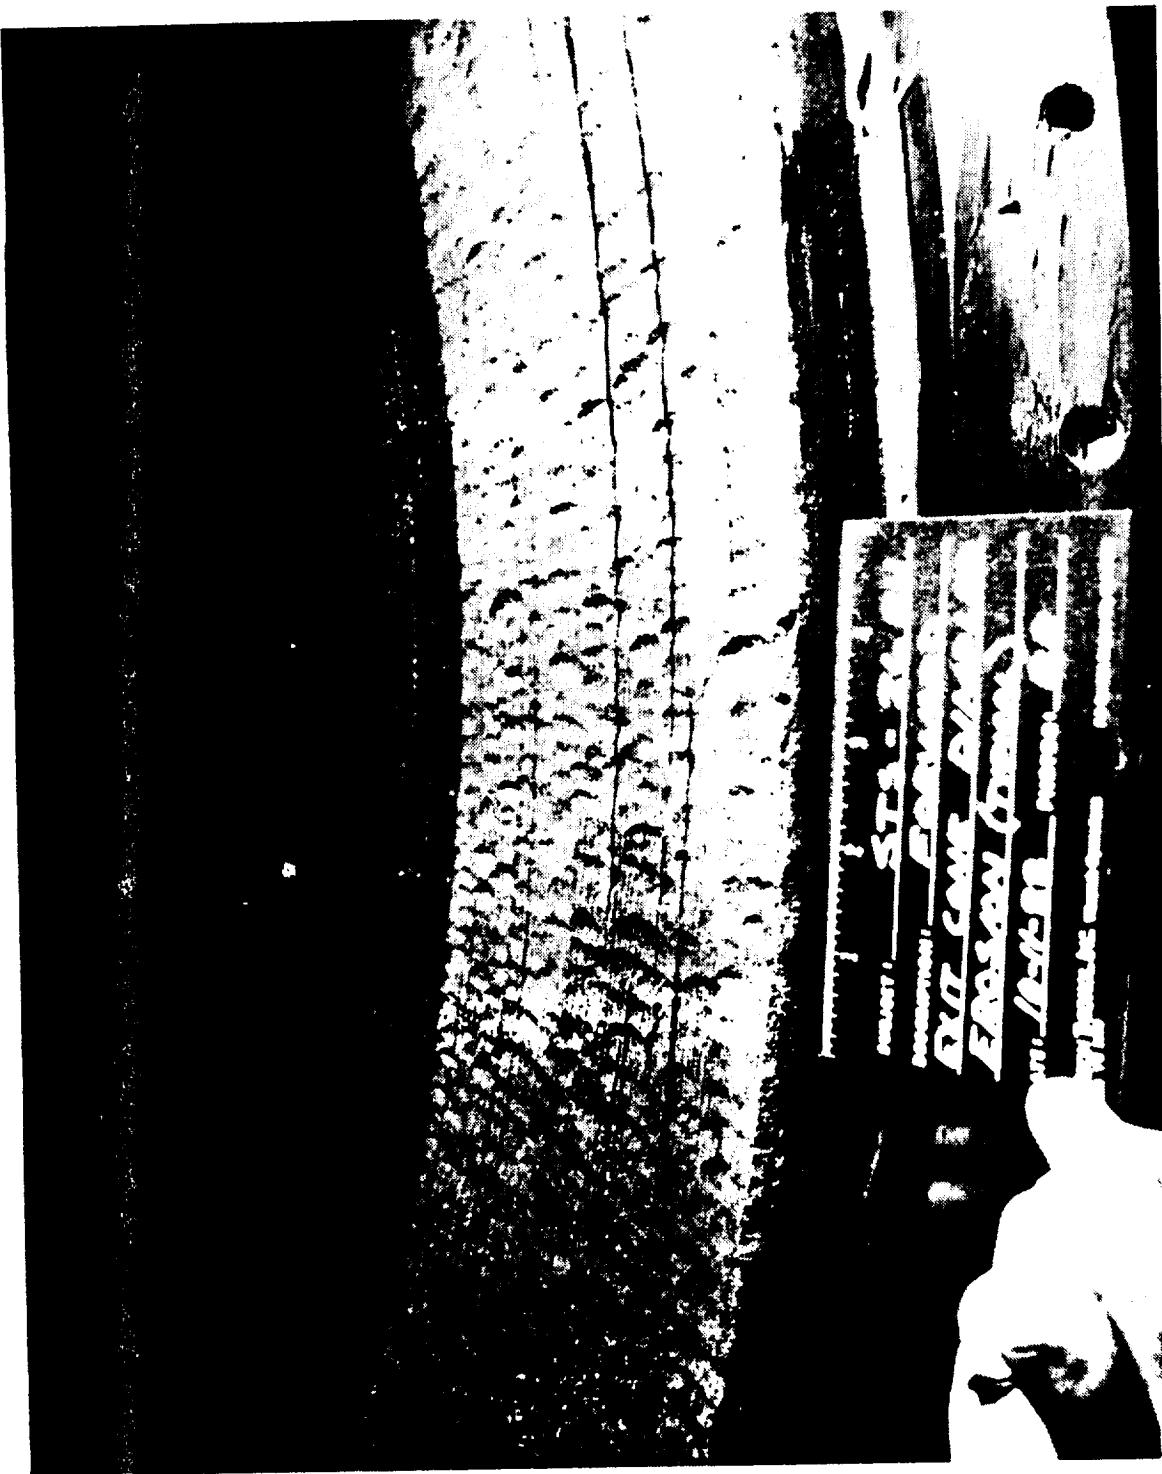
Figure 132 STS-26B Forward Exit Cone Dimpled Erosion

of heat effect. The CCP liner remained bonded on the forward 11 inches and on the aft 9 inches of the cone. These portions showed nominal erosion with no major washing or pocketing. The aft 9 inches of the liner showed the typical dimpled erosion pattern that has occurred on all flight and static test forward exit cones (Figure 132). The maximum radial depth of the dimpled erosion was 0.15 inch.

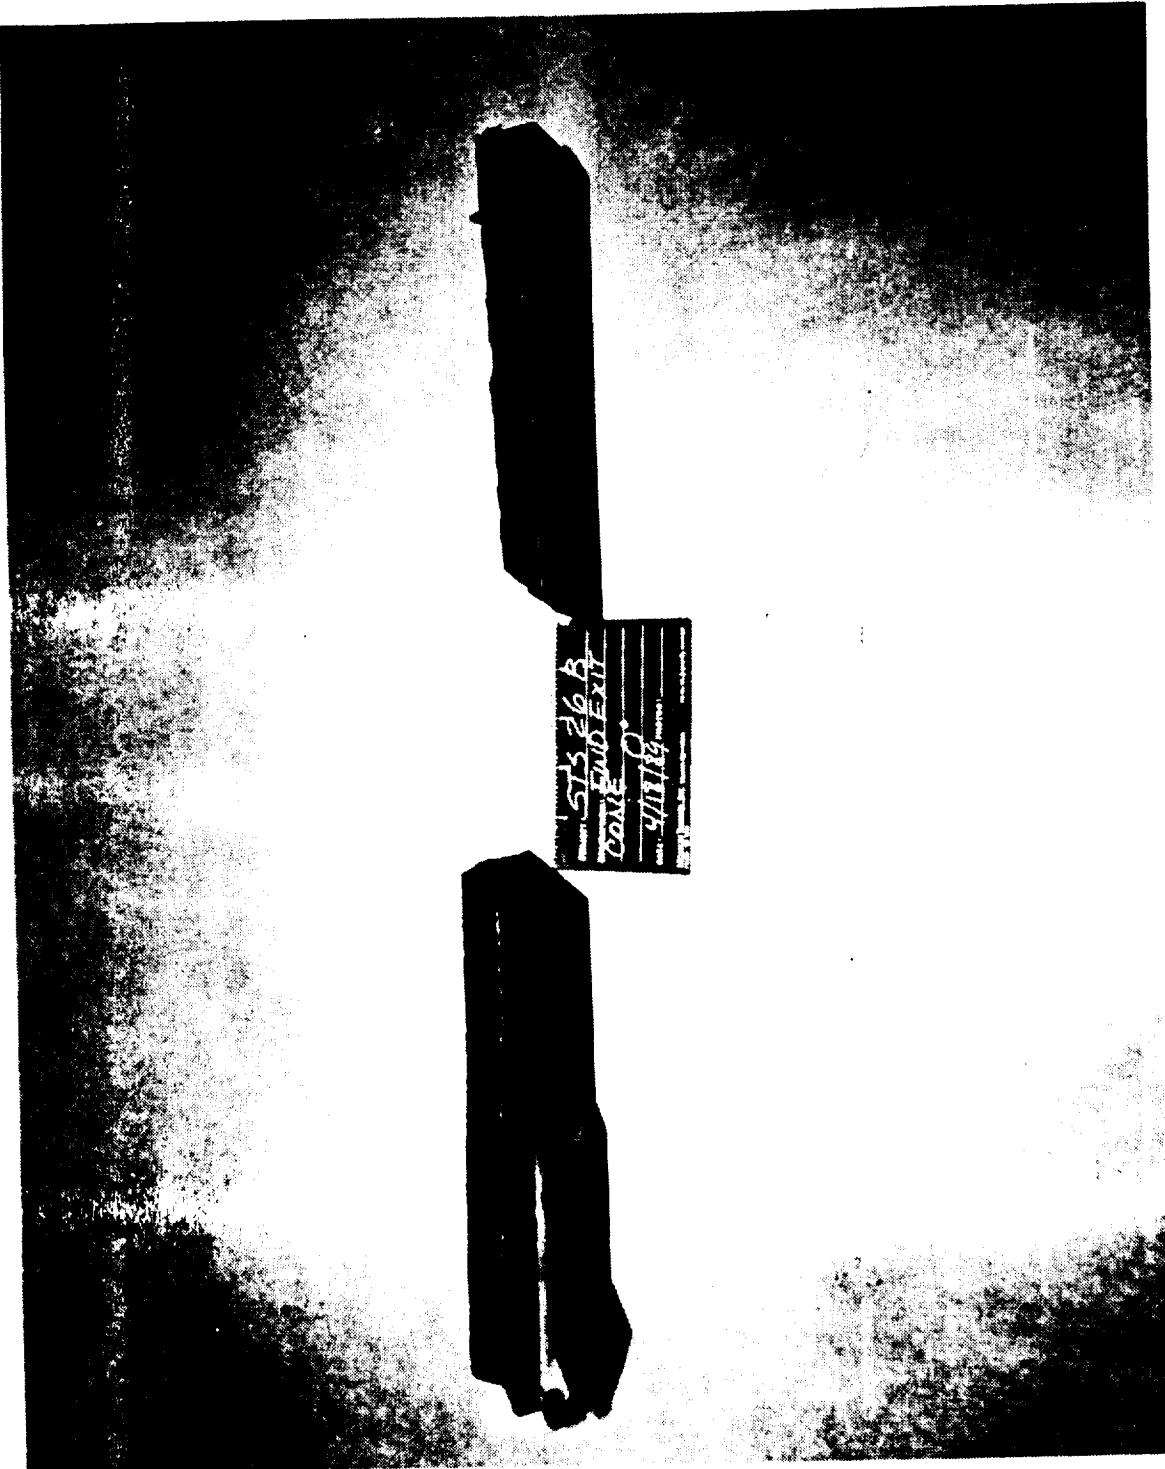
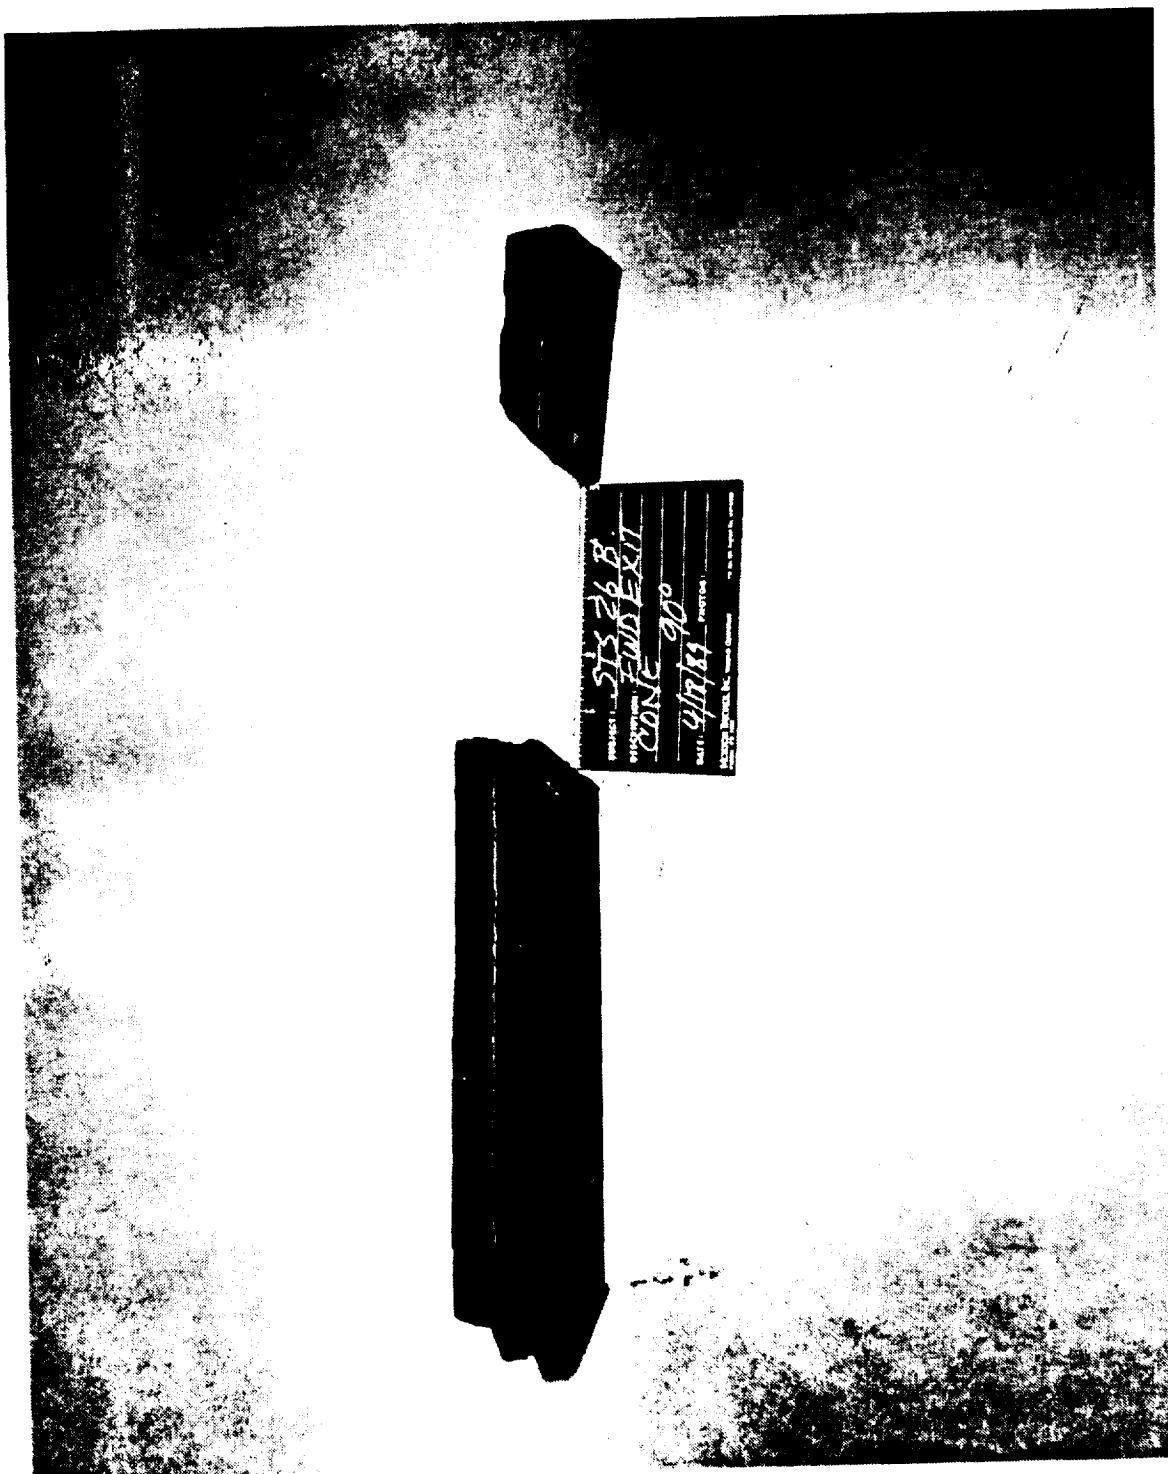
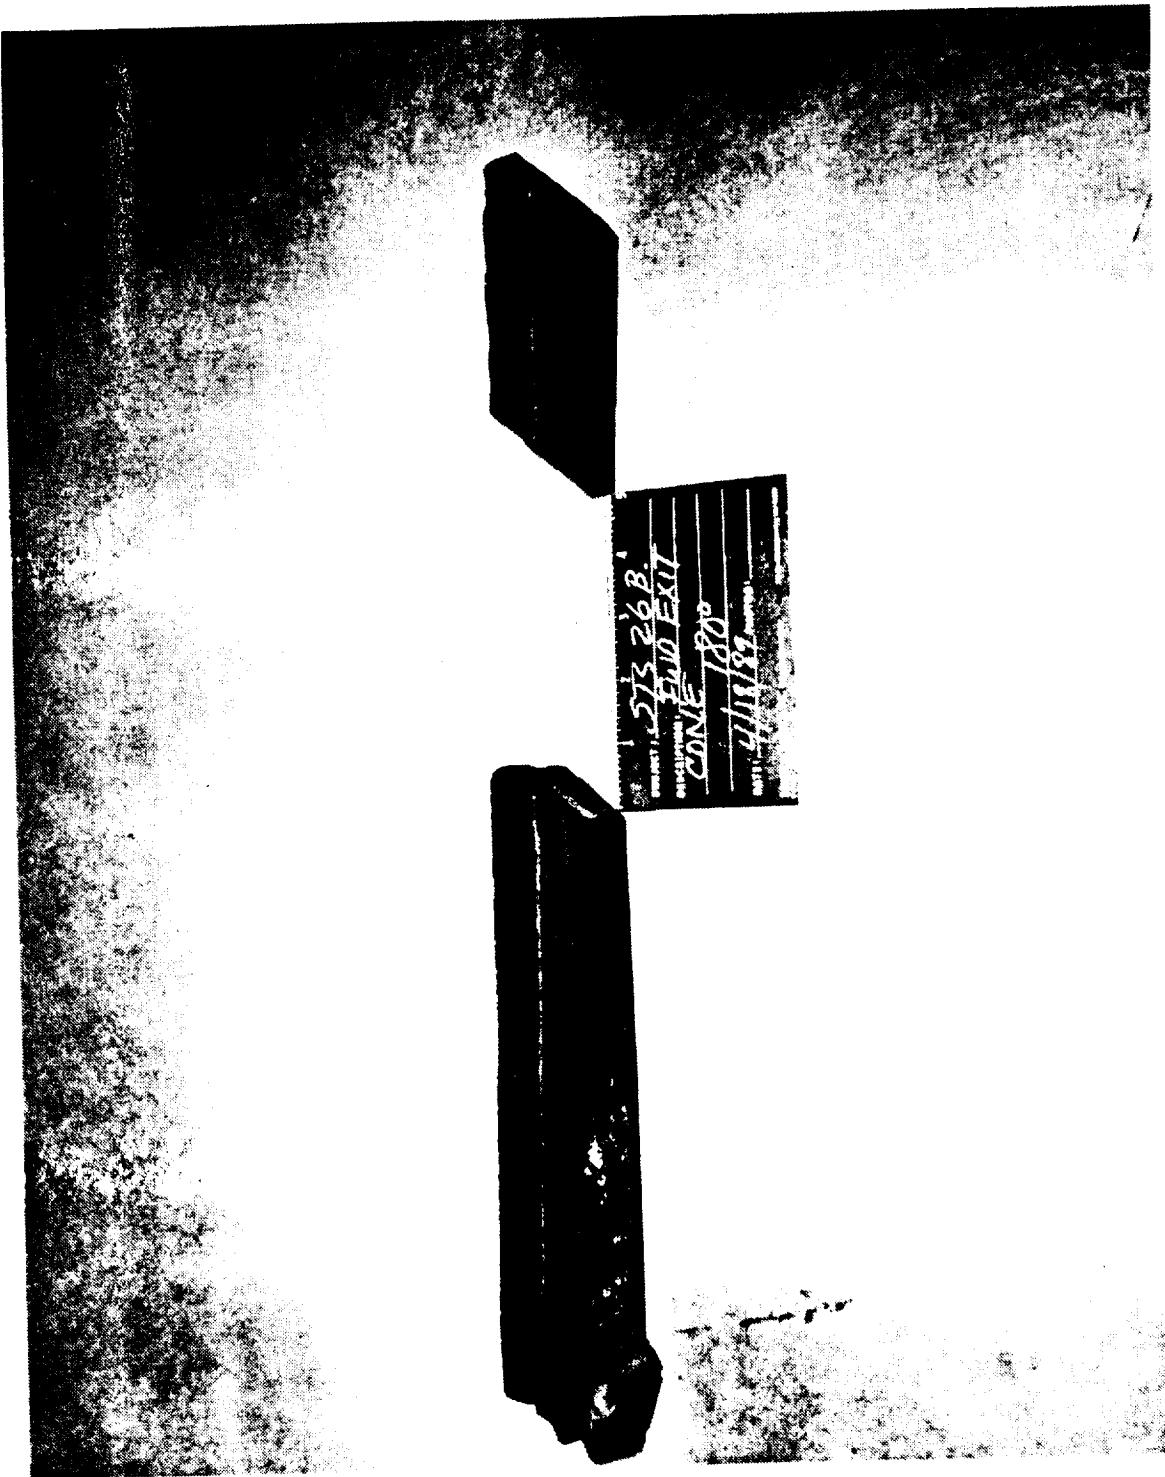
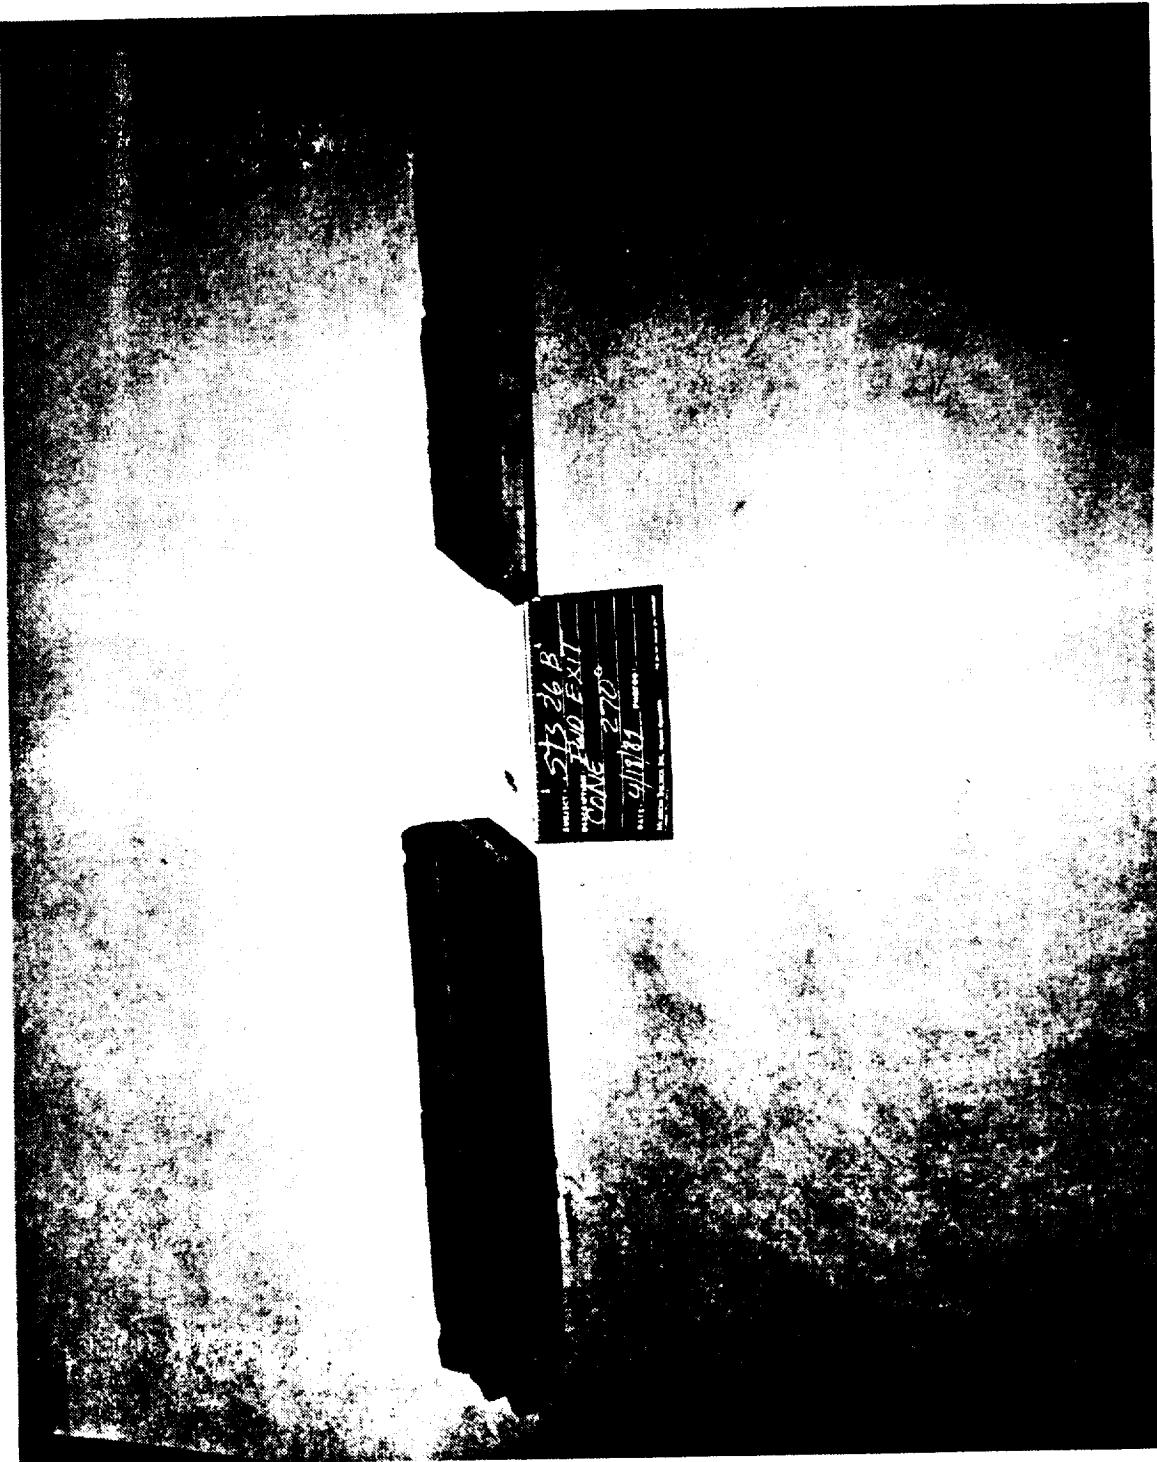
Photographs of the sectioned forward exit cone liner are presented in Figures 134 through 137. Char and erosion analysis of the sections is presented in Table 10. Figure 18 shows the location of the measurement stations. All margins of safety were positive, with a minimum of 0.05 occurring at station 1 (0 and 180 degrees), and station 8 (270 degrees).

Figure 134 STS-26B Forward Exit Cone Liner Section (0 Degrees)

Figure 135 STS-26B Forward Cone Liner Section (90 Degrees)

Figure 136 STS-26B Forward Exit Cone Liner Section (180 Degrees)

Figure 137 STS-26B Forward Exit Cone Liner Section (270 Degrees)

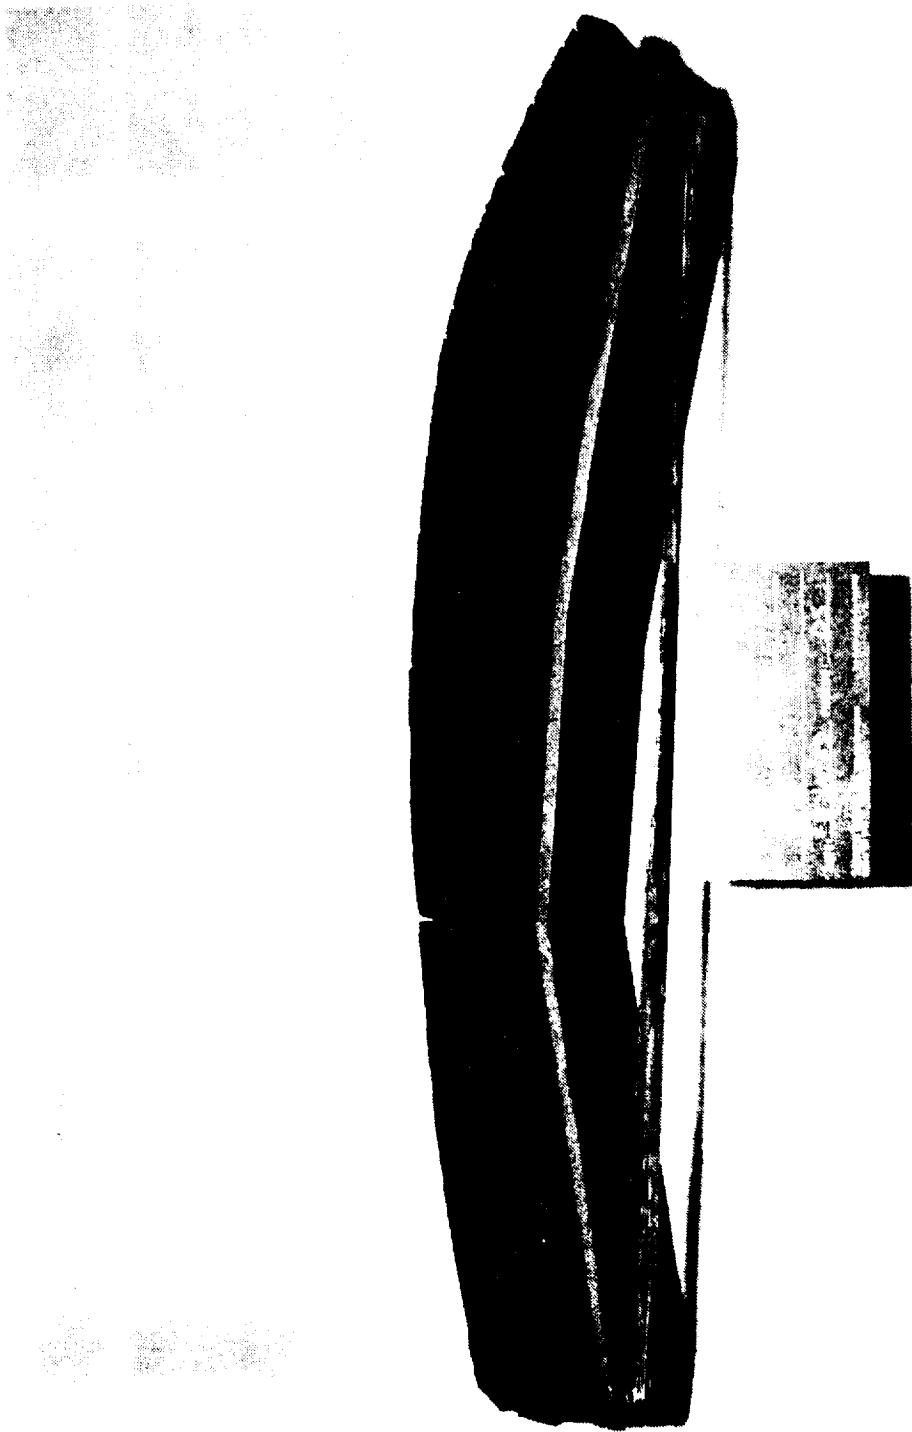
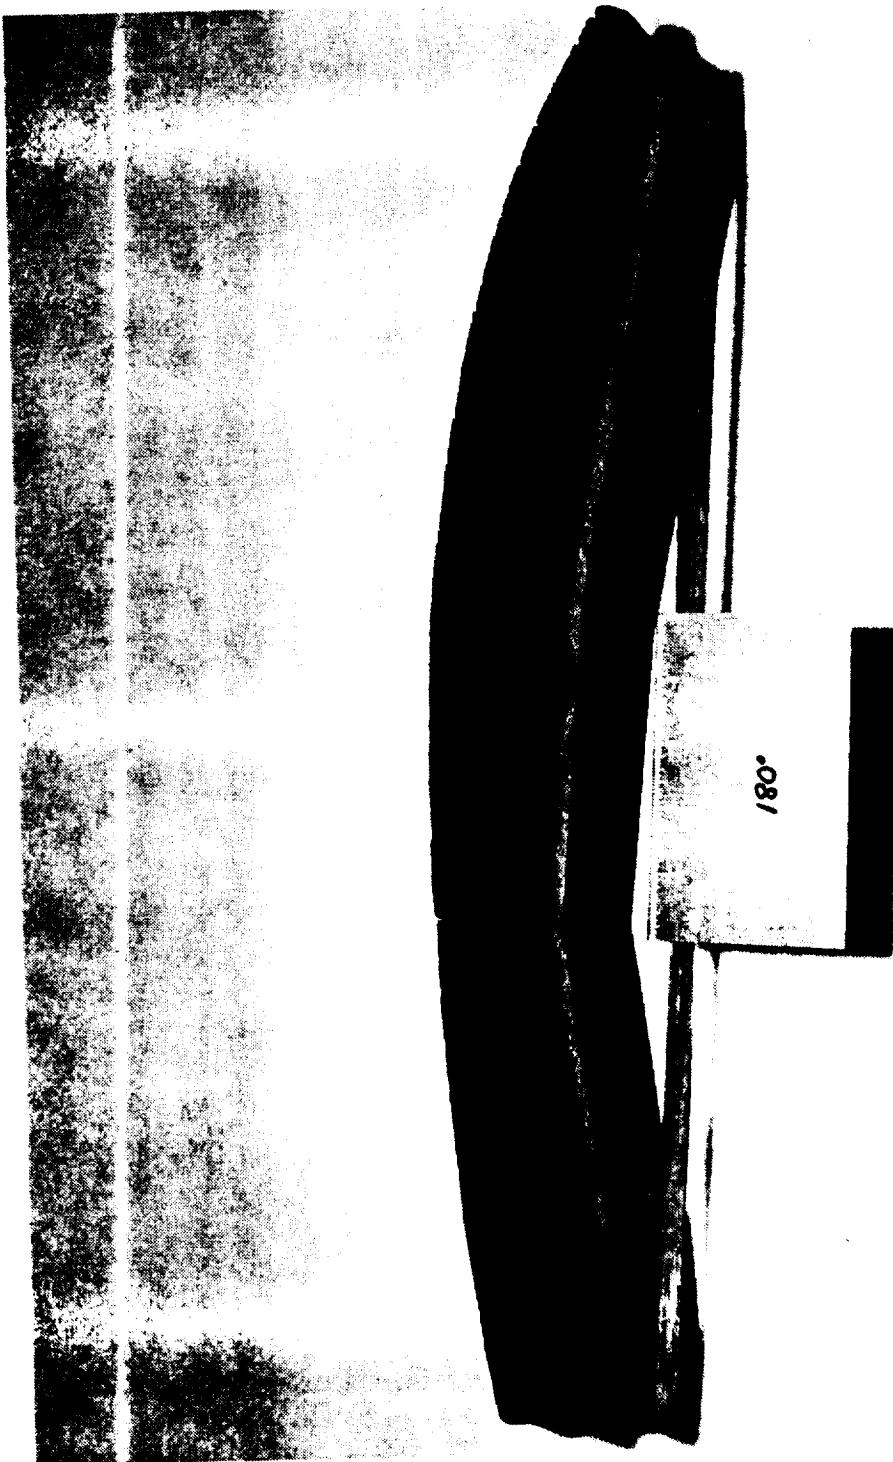
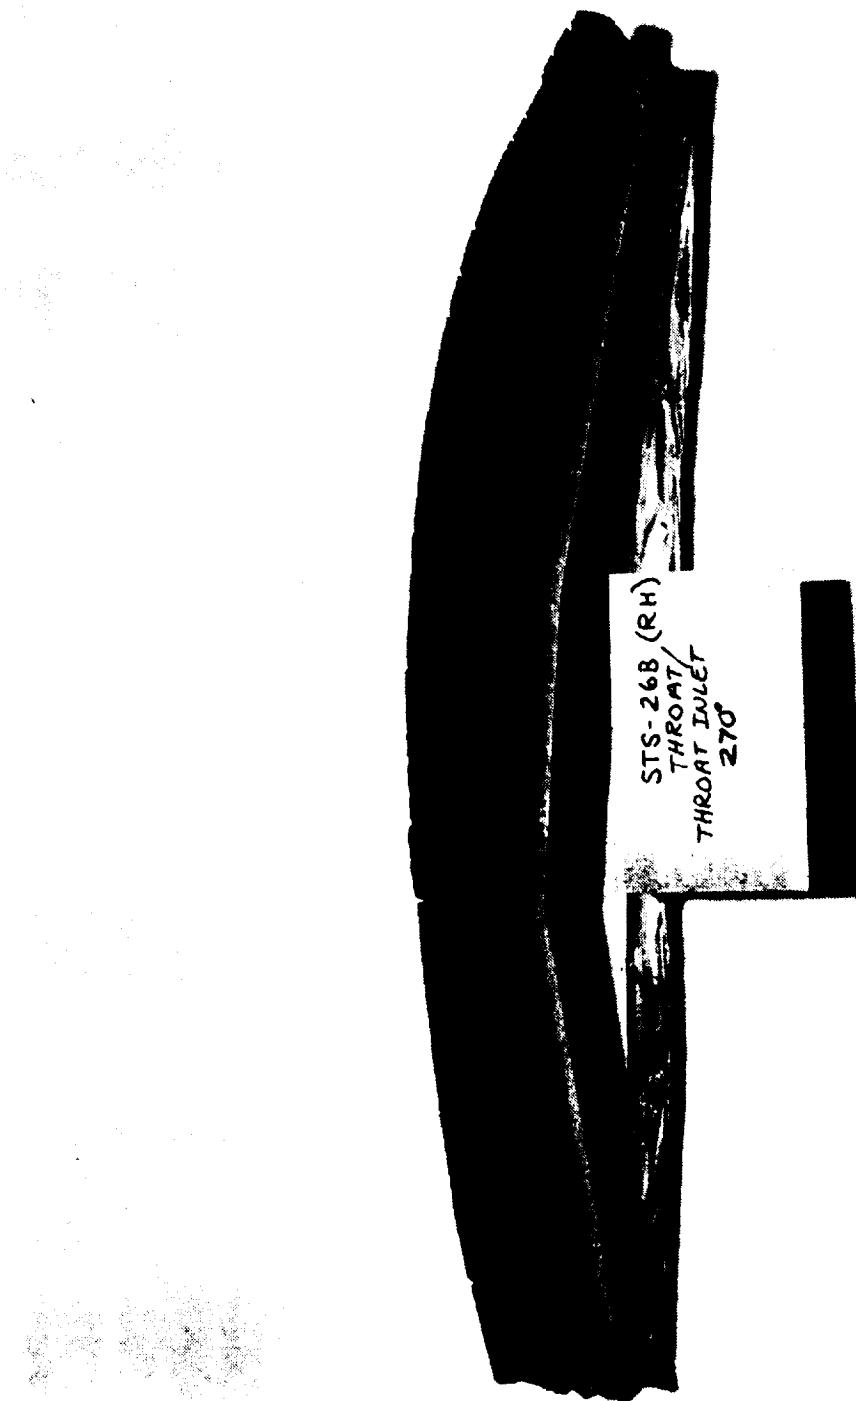
Photographs of the sectioned throat assembly liner are presented in Figures 147 through 149. Char and erosion analysis of the sections is presented in Table 11. Figure 25 shows the location of the measurement stations. All margins of safety were positive, with a minimum of 0.07 occurring at station 8 (180 degrees).

Figure 147 STS-26B Throat/Throat Inlet Section (0 Degrees)

Figure 148 STS-26B Throat/Throat Inlet Section (180 Degrees)

Figure 149 STS-26B Throat/Throat Inlet Section (270 Degrees)

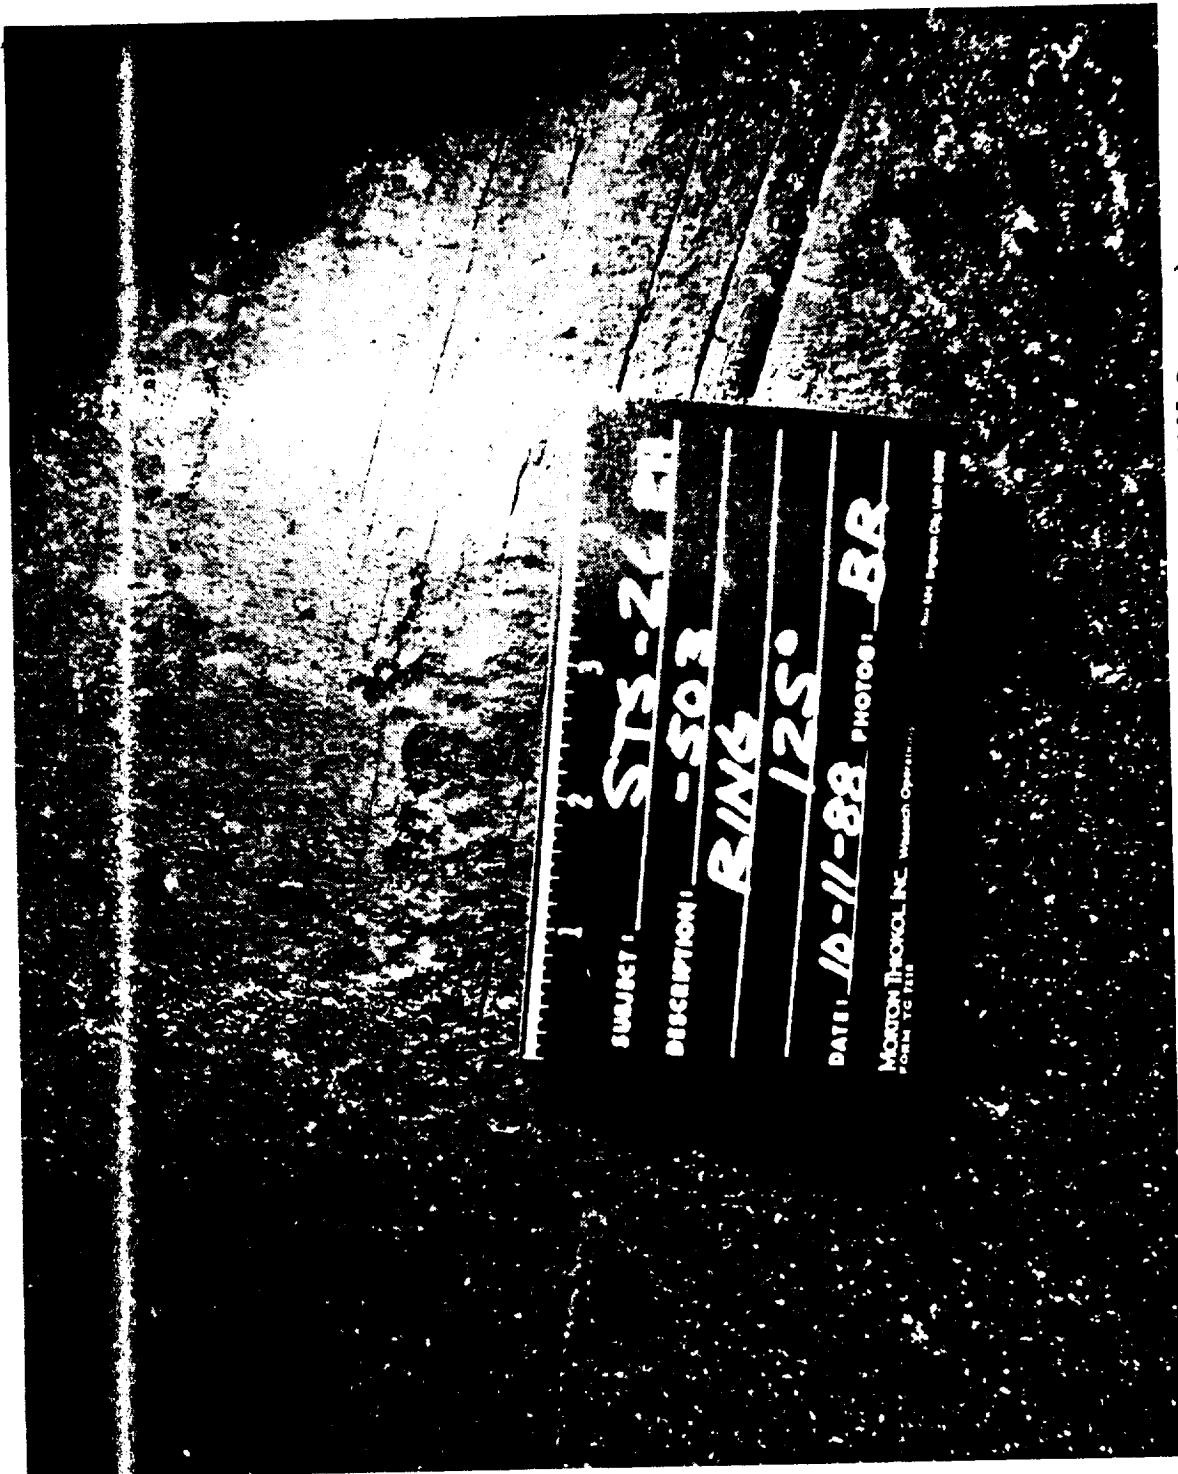
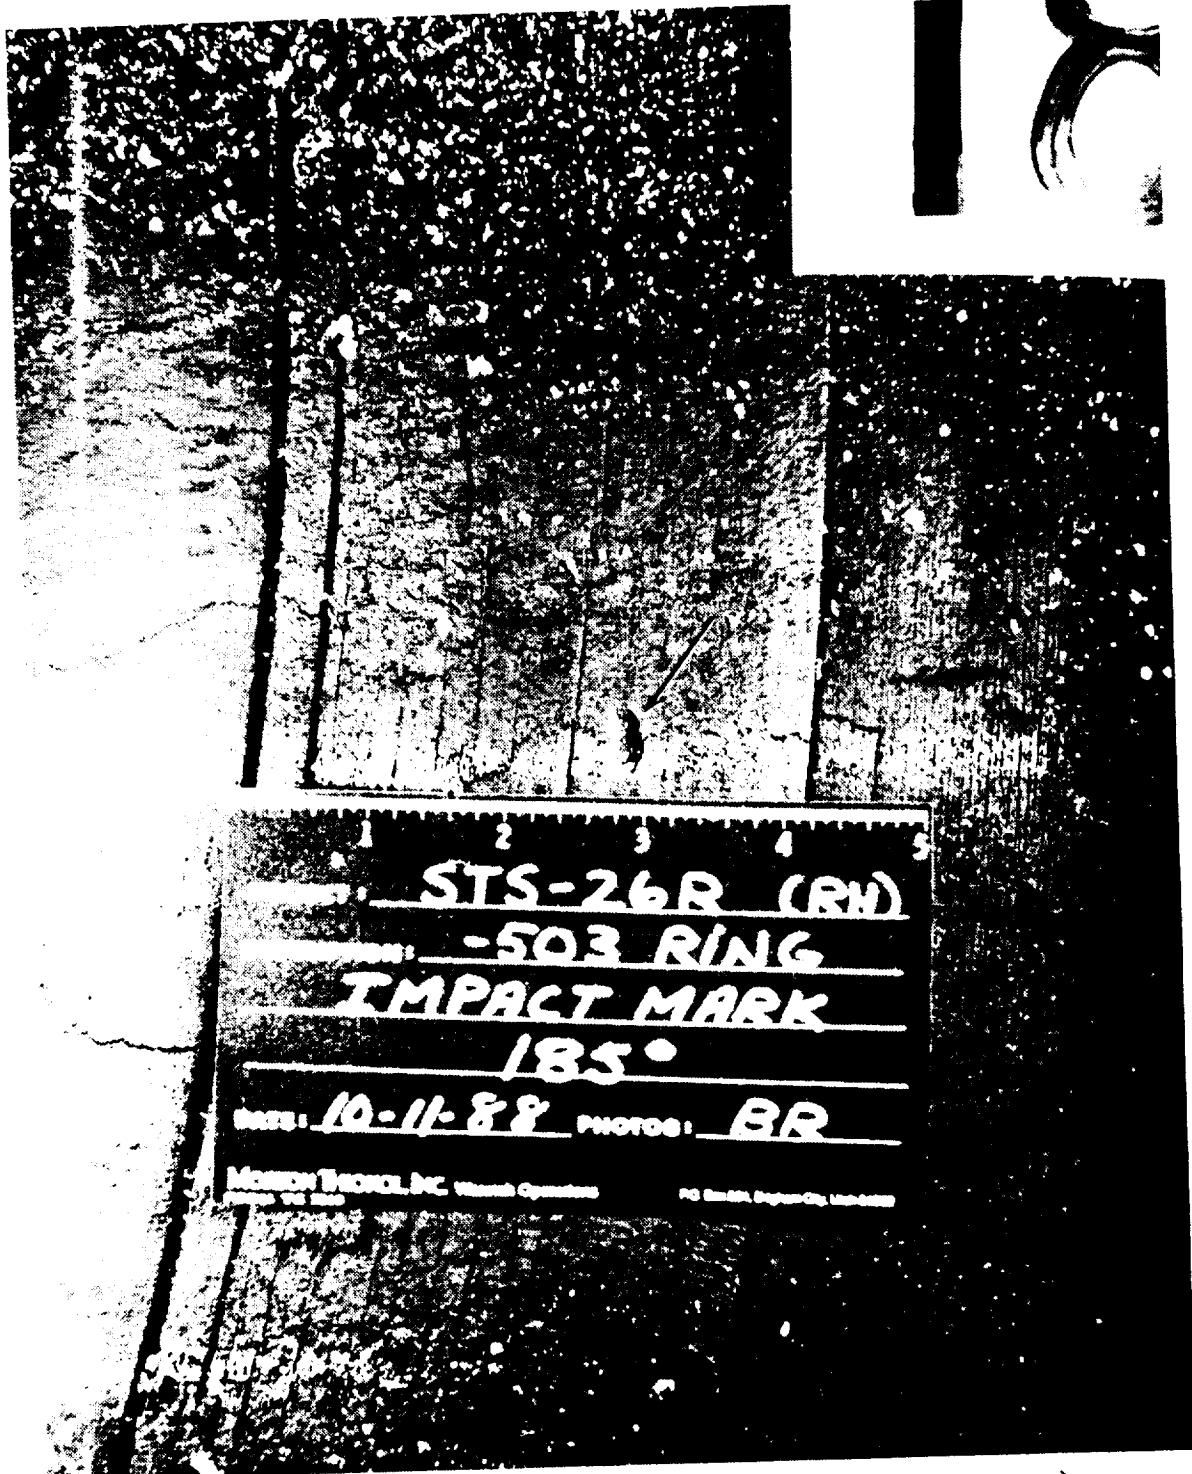
occurring after motor operation were observed on both rings intermittently around the circumference (Figures 150 and 151). The marks most likely resulted from the loose aft and forward exit cone CCP material in the motor at splashdown.

Figure 150 STS-26B (-503) Ring Impact Marks (125 Degrees)

Figure 151 STS-26B (-503) Ring Impact Marks (185 Degrees)

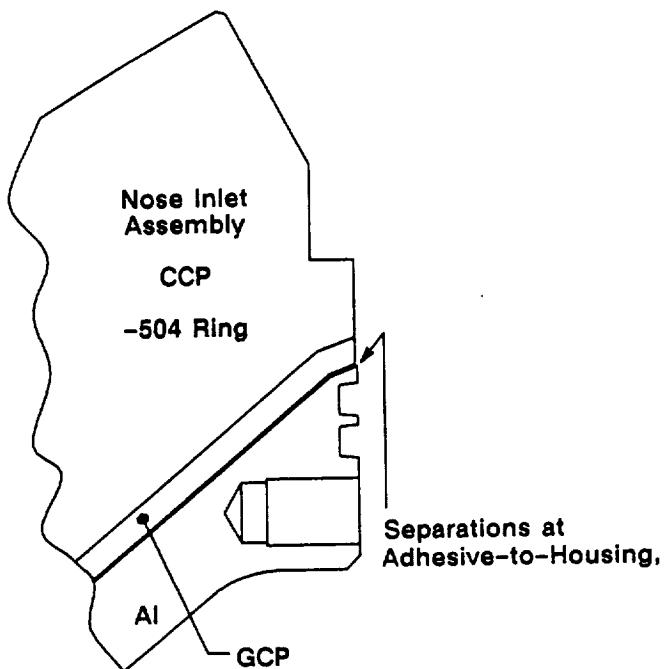
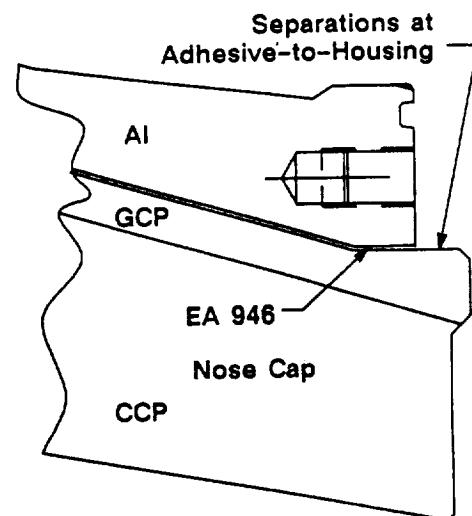
Figure 153 STS-26B Nose Inlet Assembly Bondline Separations

The aft end of the nose inlet assembly (-504 ring aft end) showed metal to adhesive bondline separations measuring 0.02 inch wide radially from 238 to 245 degrees, and at 250 degrees. There were no cohesive separations or separations at the adhesive/GCP and GCP/CCP interfaces. Bondline separations were observed on the aft end of the nose cap between the metal and EA946 adhesive at 105, 135 to 255, 285 to 315, and 345 degrees. These separations were typically 0.005 inch wide radially. There were no cohesive separations or separations at the adhesive/GCP and GCP/CCP interfaces. Figure 153 lists the location and radial width measurements of all separations on the nose inlet assembly. These separations are typical observations seen on previous static test and flight nozzles, and have been shown to occur post-burn.
