# Flight Motor Set 360L001 (STS-26R) Final Report

## Volume V (Nozzle Component)

360L001 (STS-26R)  
Final Report  
Nozzle Component

A review of the performance and post-flight condition of the STS-26 Redesigned Solid Rocket Motor (RSRM) nozzles is presented in this document. Applicable Discrepancy Reports (DRs) and Process Departures (PDs) are presented in Section 5.0. The Nozzle Component Program Team (NCPT) performance evaluation and the Redesign Program Review Board (RPRB) assessment is included in Section 6.0.

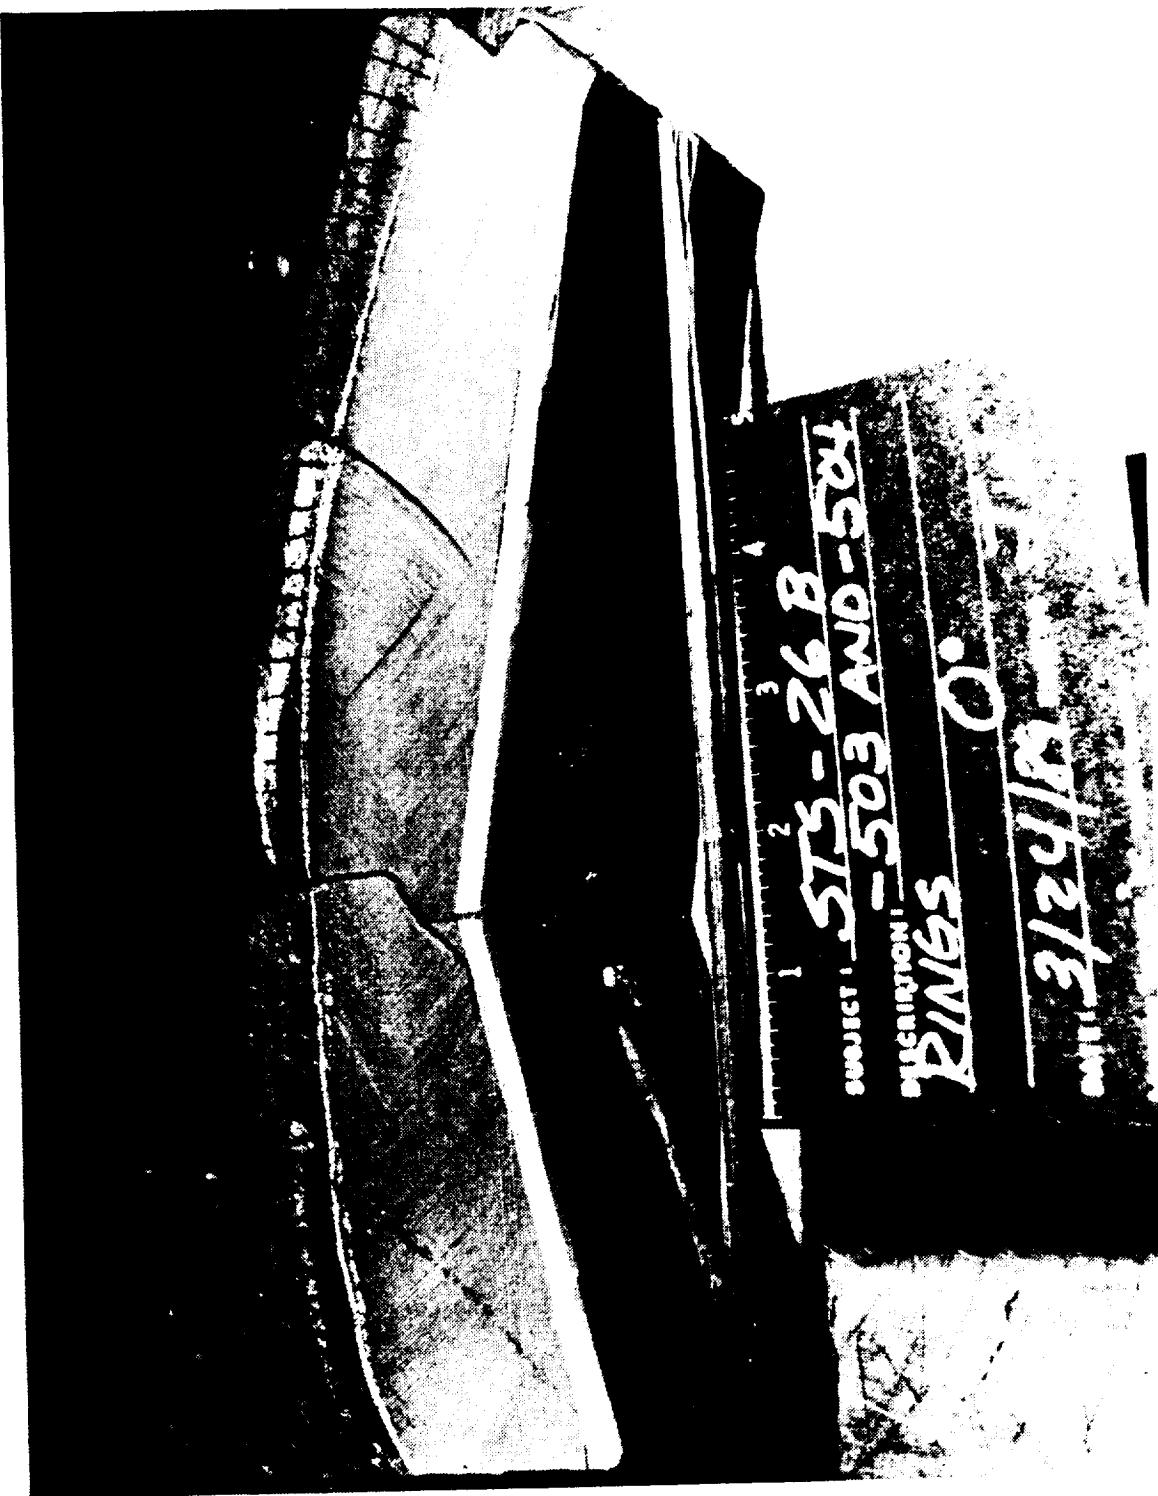
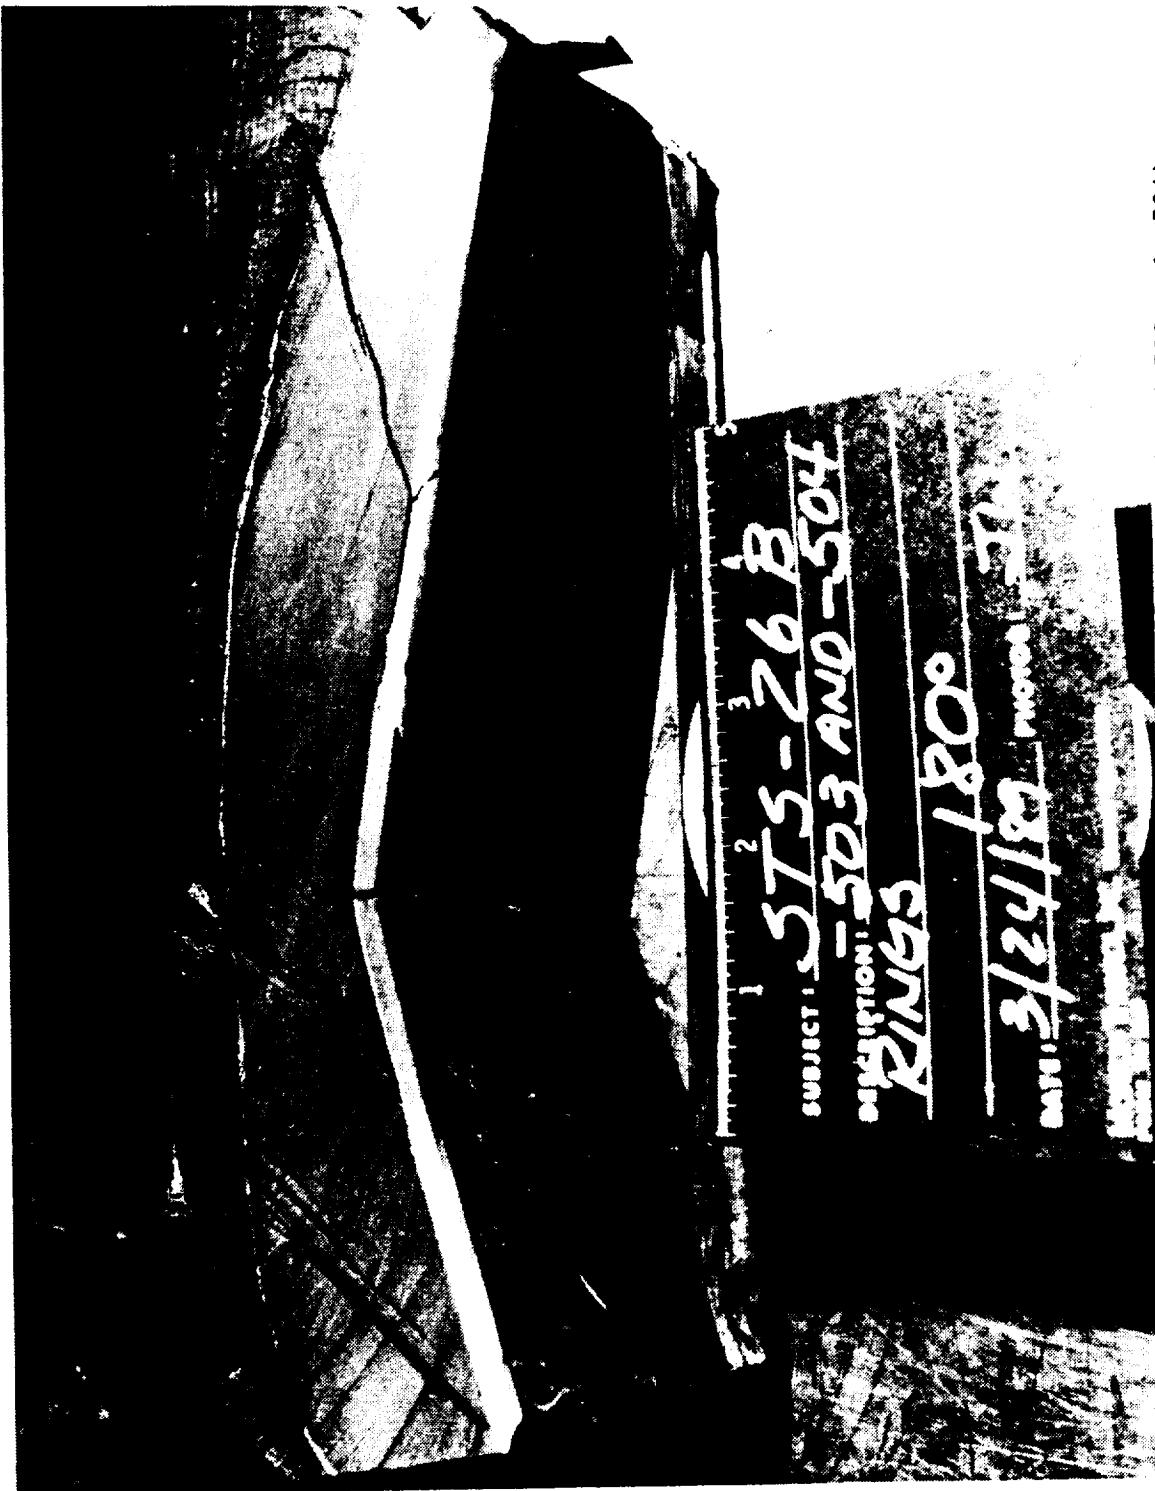
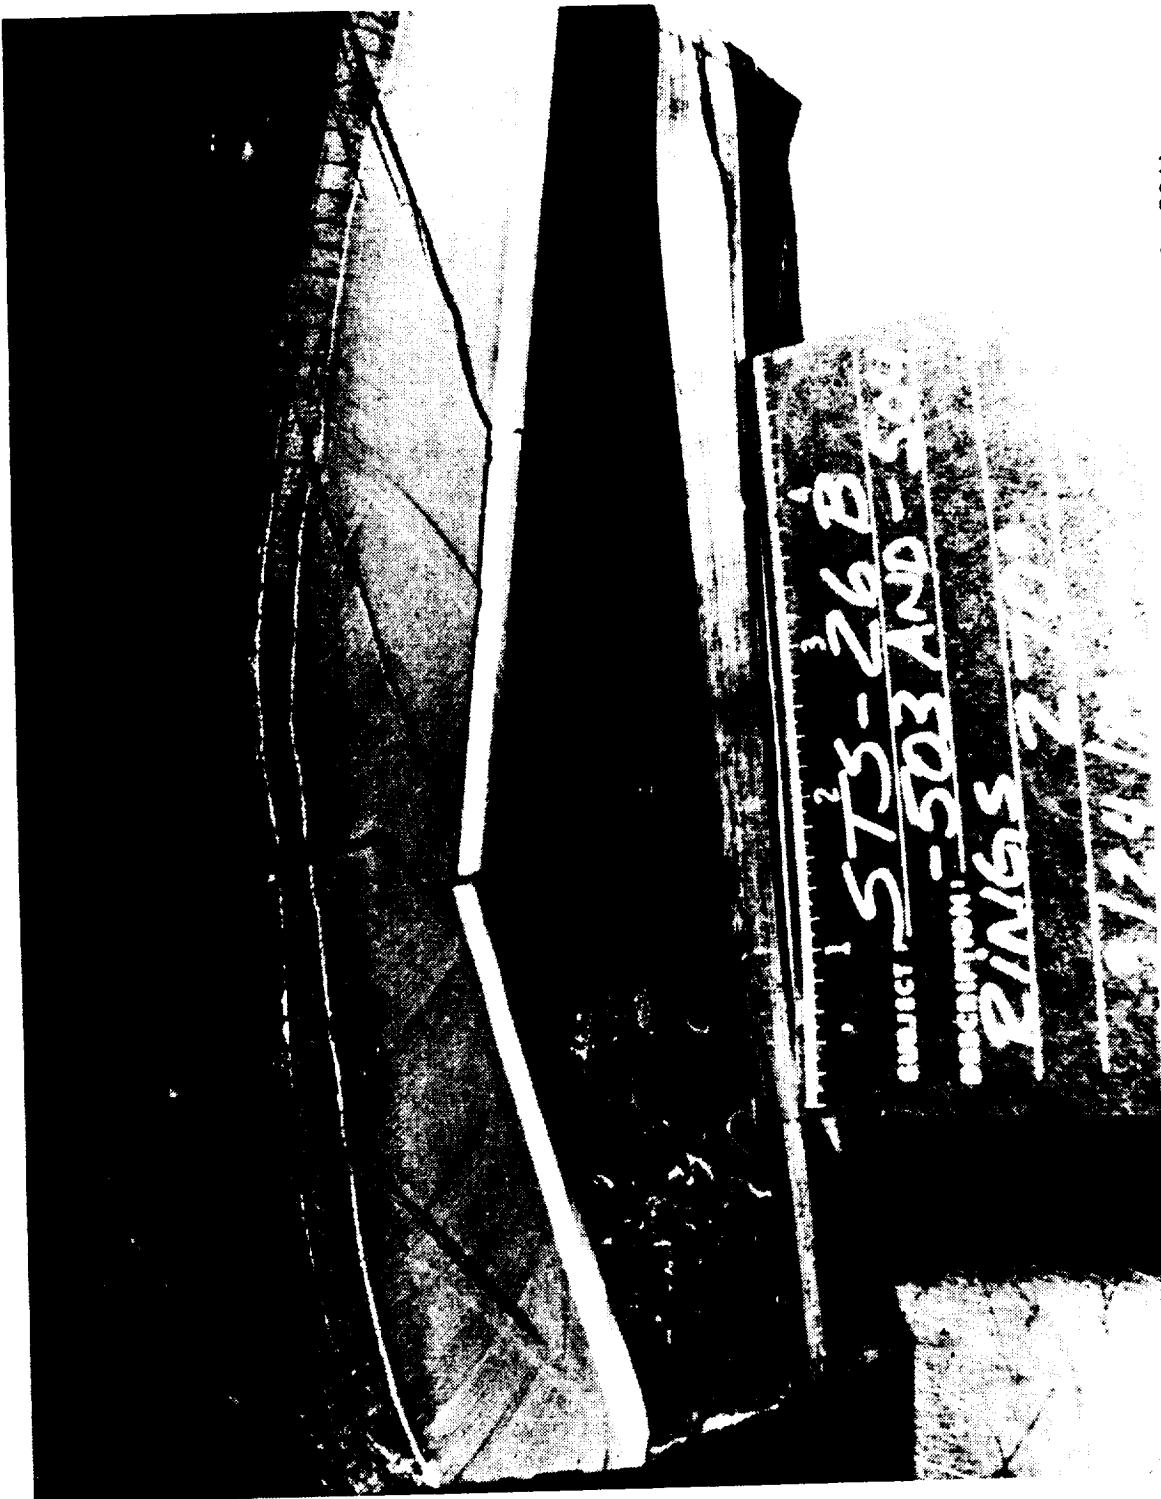
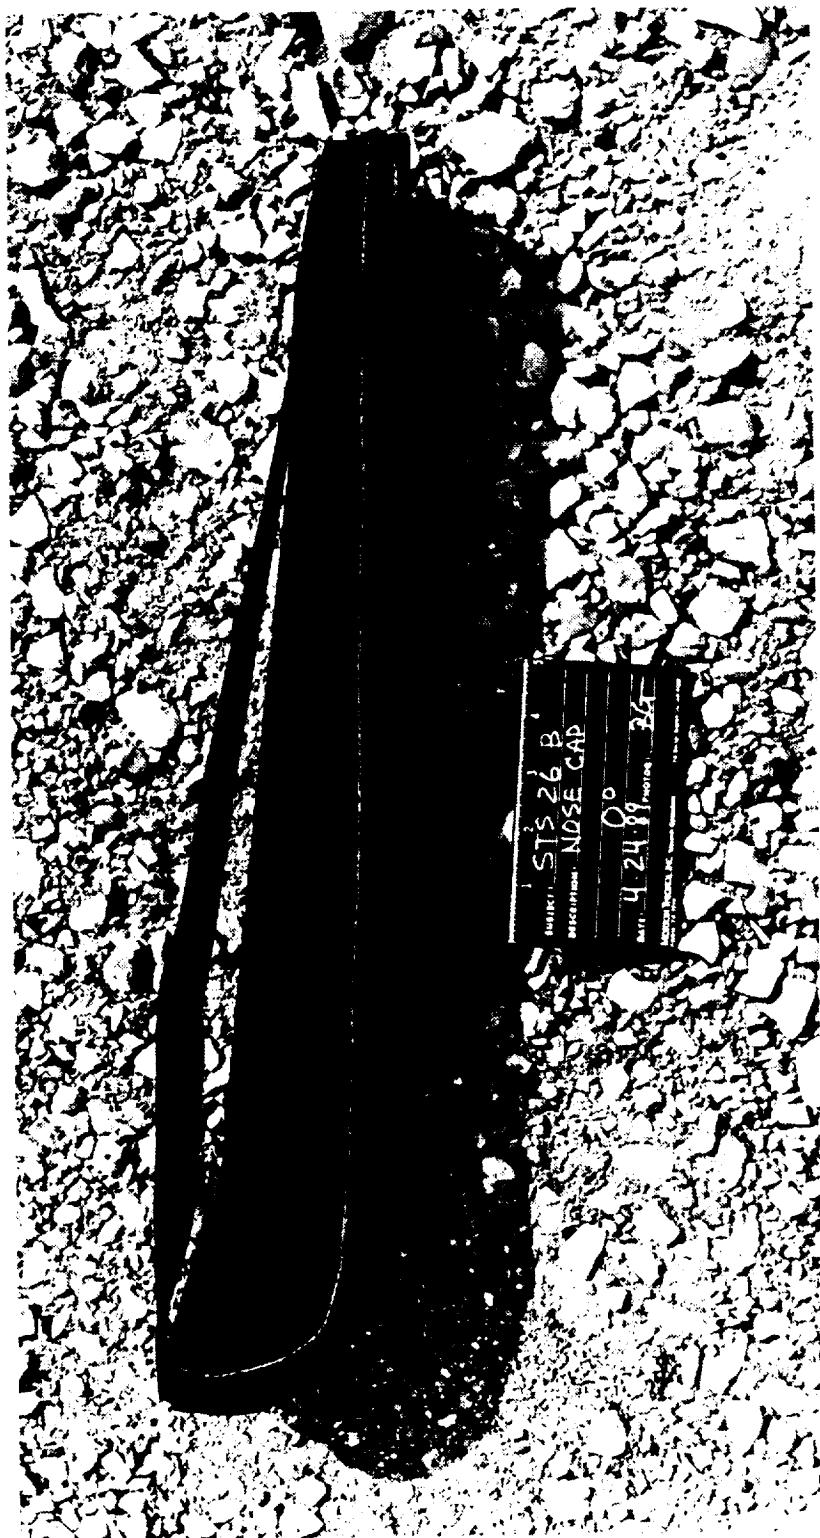
Photographs of the sectioned nose inlet assembly rings are presented in Figures 154 through 161. Char and erosion analysis of the sections is presented in Tables 12 and 13. Figure 38 shows the location of the measurement stations. All margins of safety were positive, with a minimum of 0.01 occurring at station 32 (180 degrees) for the -503/-504 rings, and 0.01 occurring at station 24 (225 degrees) for the nose cap.

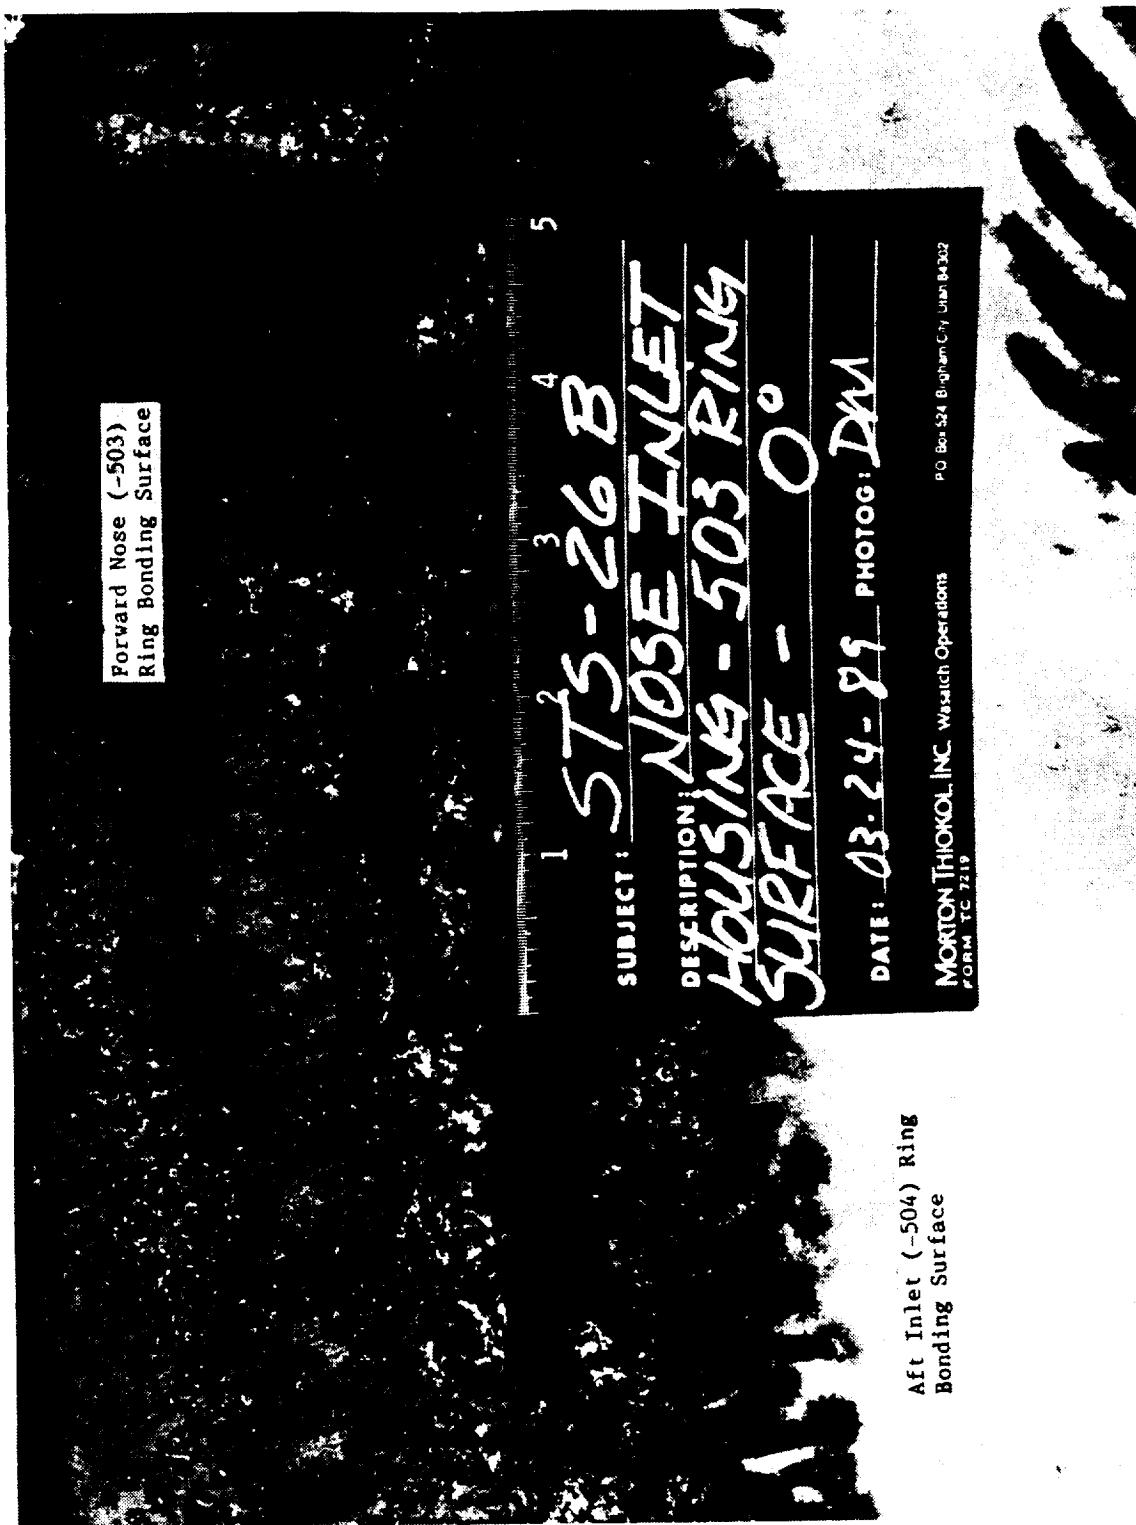
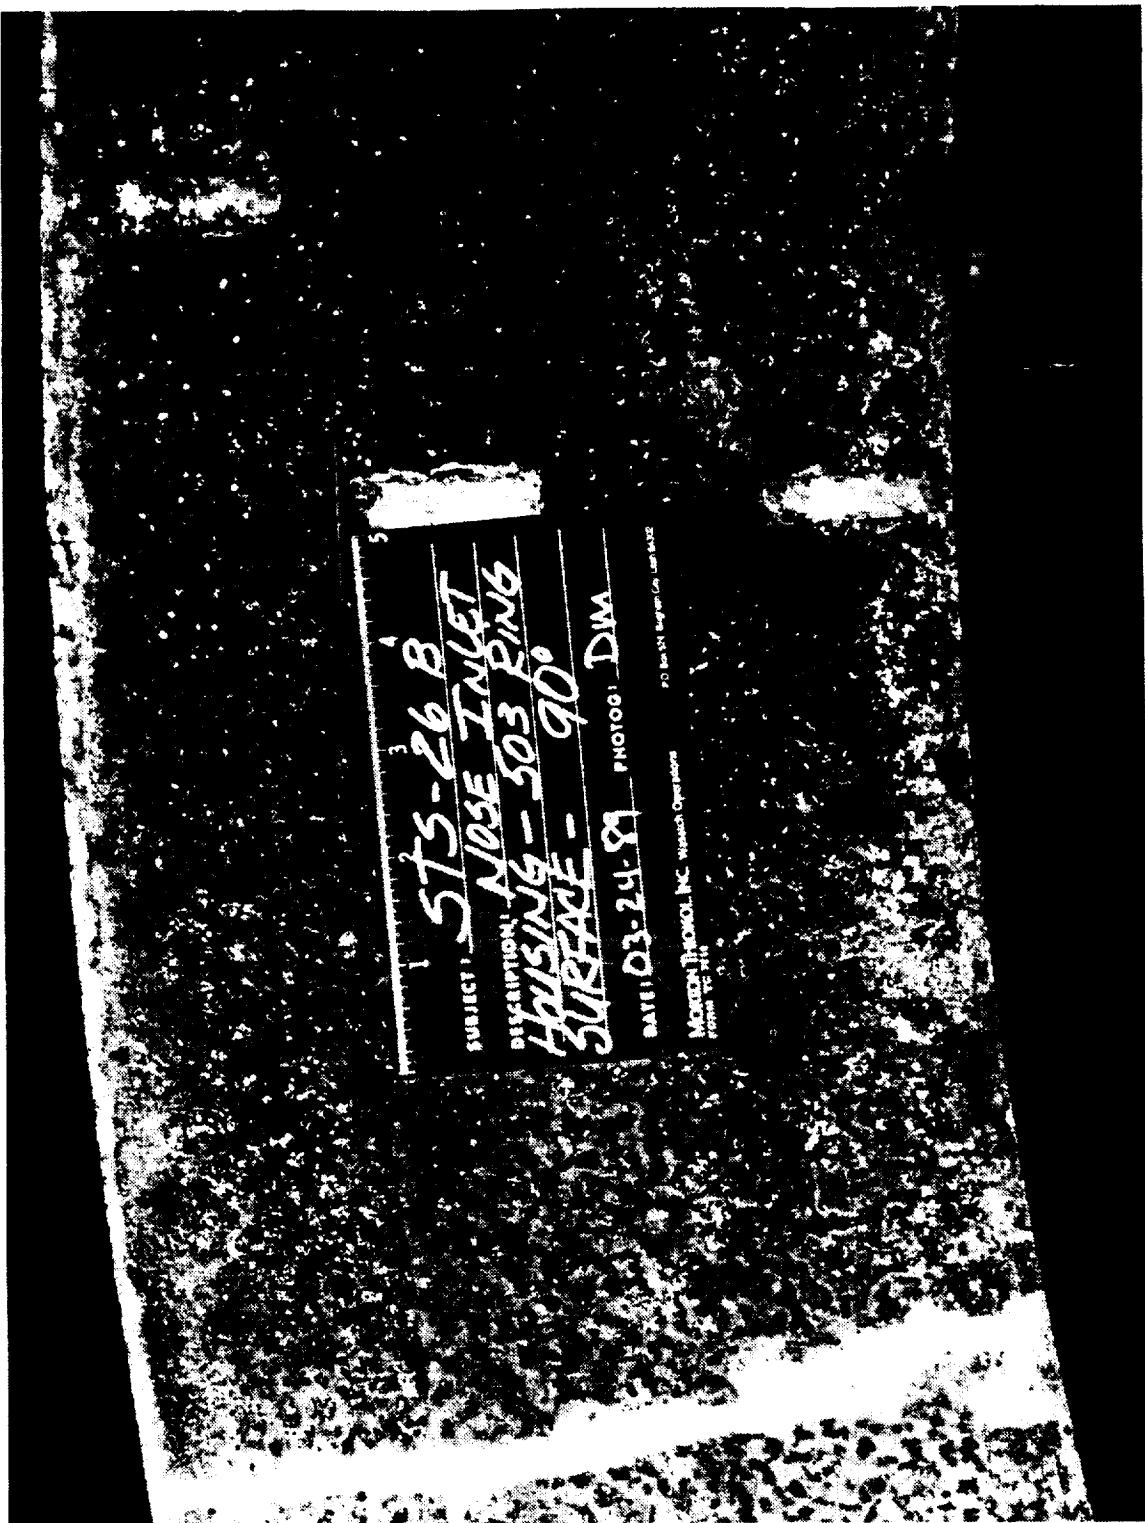
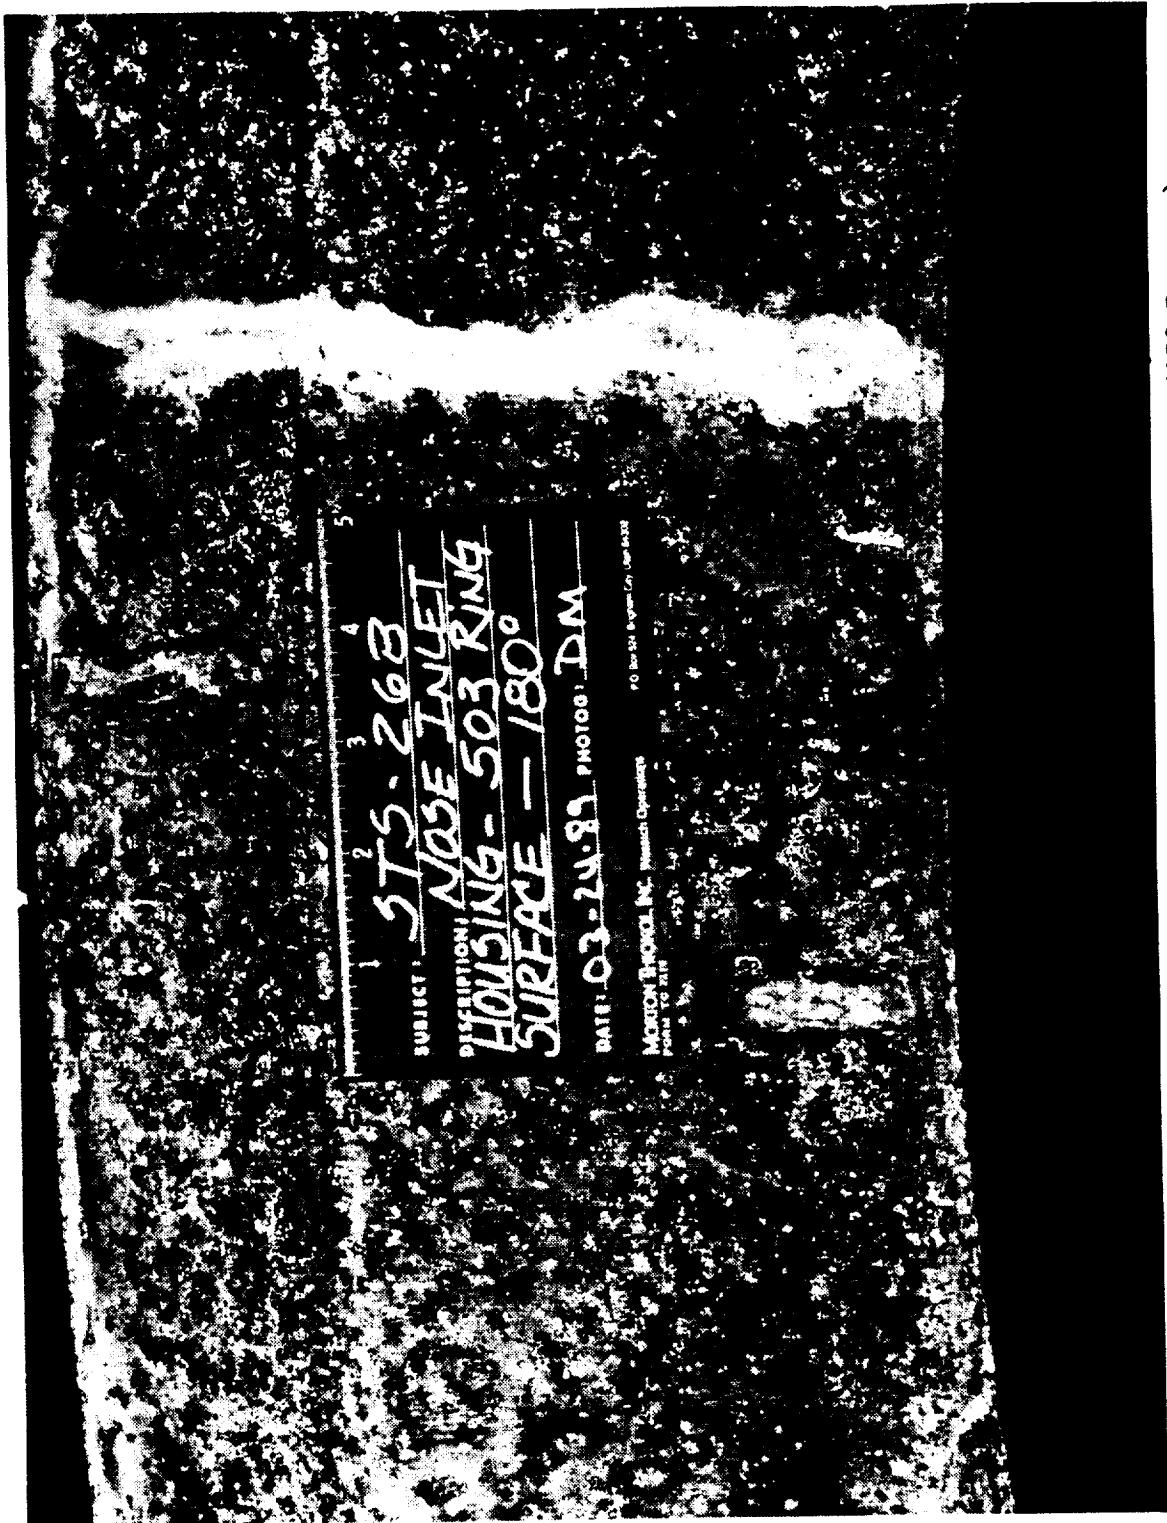
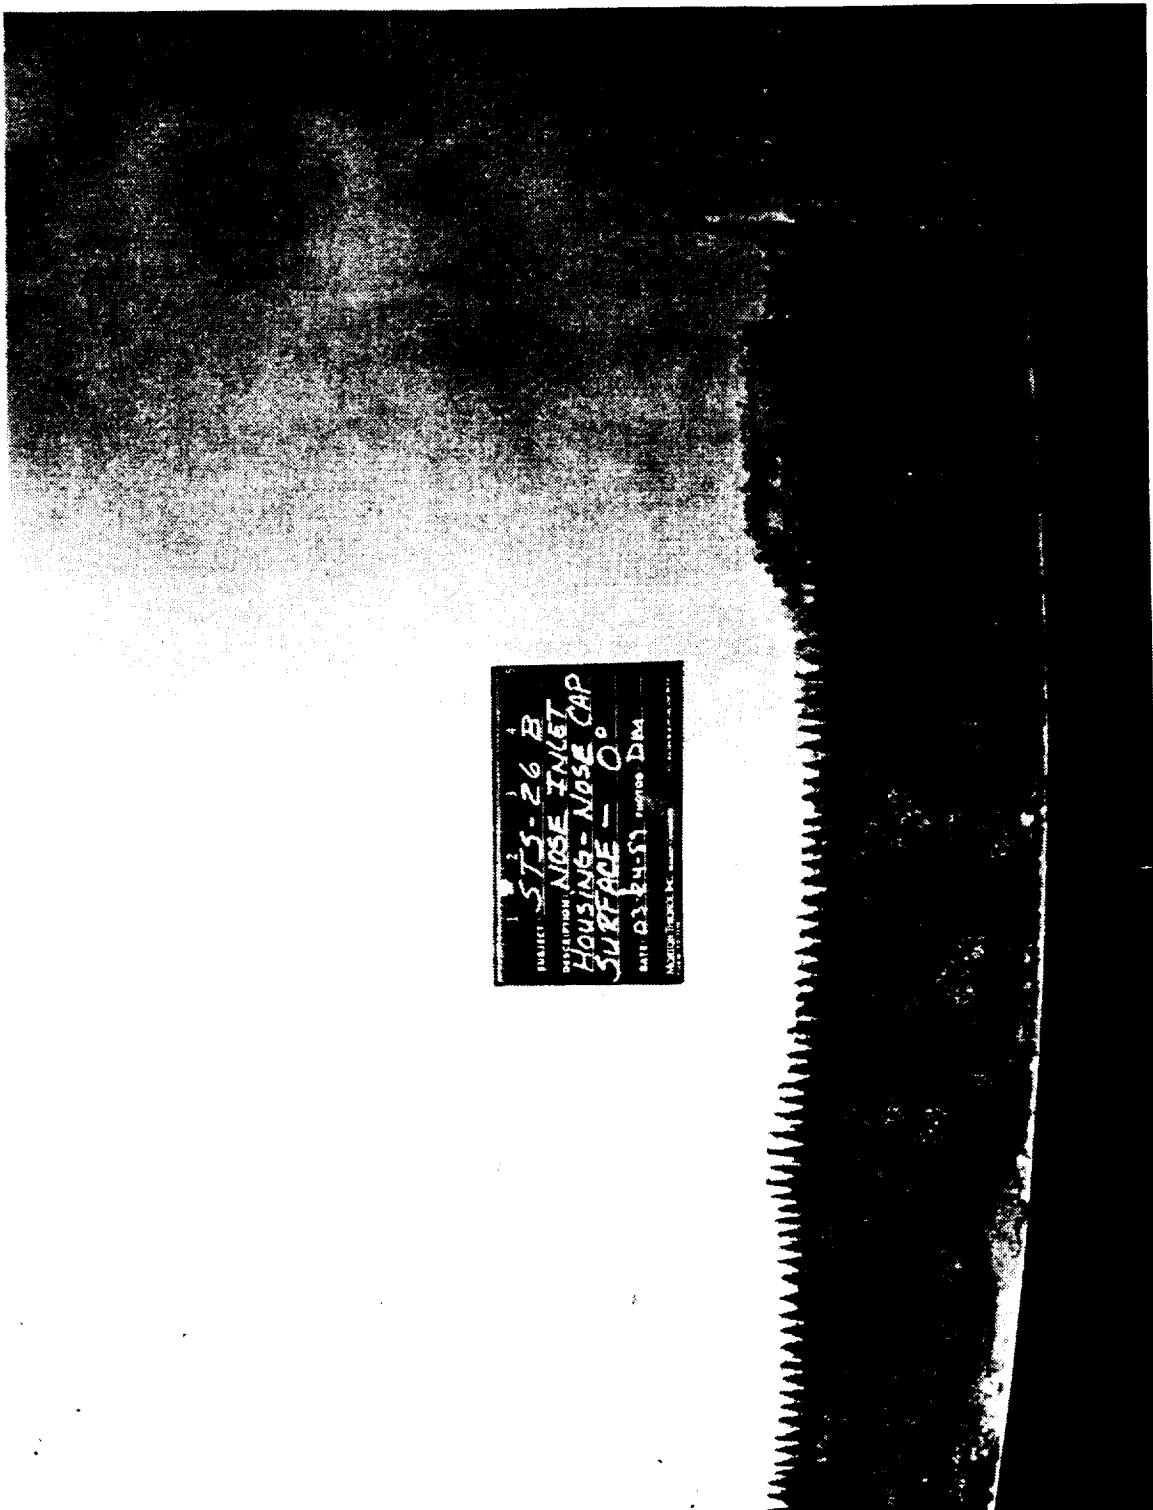
Following the washout of the phenolics, it was found that the aluminum nose inlet housing had extensive corrosion and pitting on all bonding surfaces 360 degrees circumferentially (Figures 162 through 167). Most of the corrosion on the nose cap bonding surface was found on the aft 5 inches 360 degrees circumferentially. The forward edge of this corrosion was shaped in a "saw tooth" pattern (Figure 166). The leading edge of the nose inlet housing showed areas of pitting approximately 0.04 to 0.05 inch deep (Figure 168). The entire -503 ring bonding surface was heavily corroded and pitted 360 degrees circumferentially, and approximately 90 percent of the -504 ring bonding surface showed various stages of corrosion and pitting. This corrosion has been attributed to seawater which enters bondline separations during splashdown and retrieval (Ref. Memo L231-FY89-M130). The metal bonding surfaces were not accessible until phenolic washout at Clearfield Operations. Therefore, corrosion protection was not applied to these surfaces until approximately 4 months after flight. This hardware will be inspected during refurbishment for compliance to STW7-3434 (Refurbishment Of And Acceptance Criteria For Space Shuttle SRM Nozzle Metal Hardware).

Figure 162 STS-26B Nose Inlet Housing Bonding Surfaces (0 Degrees)

Figure 163 STS-26B Nose Inlet Housing Bonding Surfaces (90 Degrees)

Figure 164 STS-26B Nose Inlet Housing Bonding Surfaces (180 Degrees)

Figure 165 STS-26B Nose Inlet Housing Bonding Surfaces (270 Degrees)

Figure 166 STS-26B Nose Cap Bonding Surface (0 Degrees)

Figure 167 STS-26B Nose Cap Bonding Surface (180 Degrees)

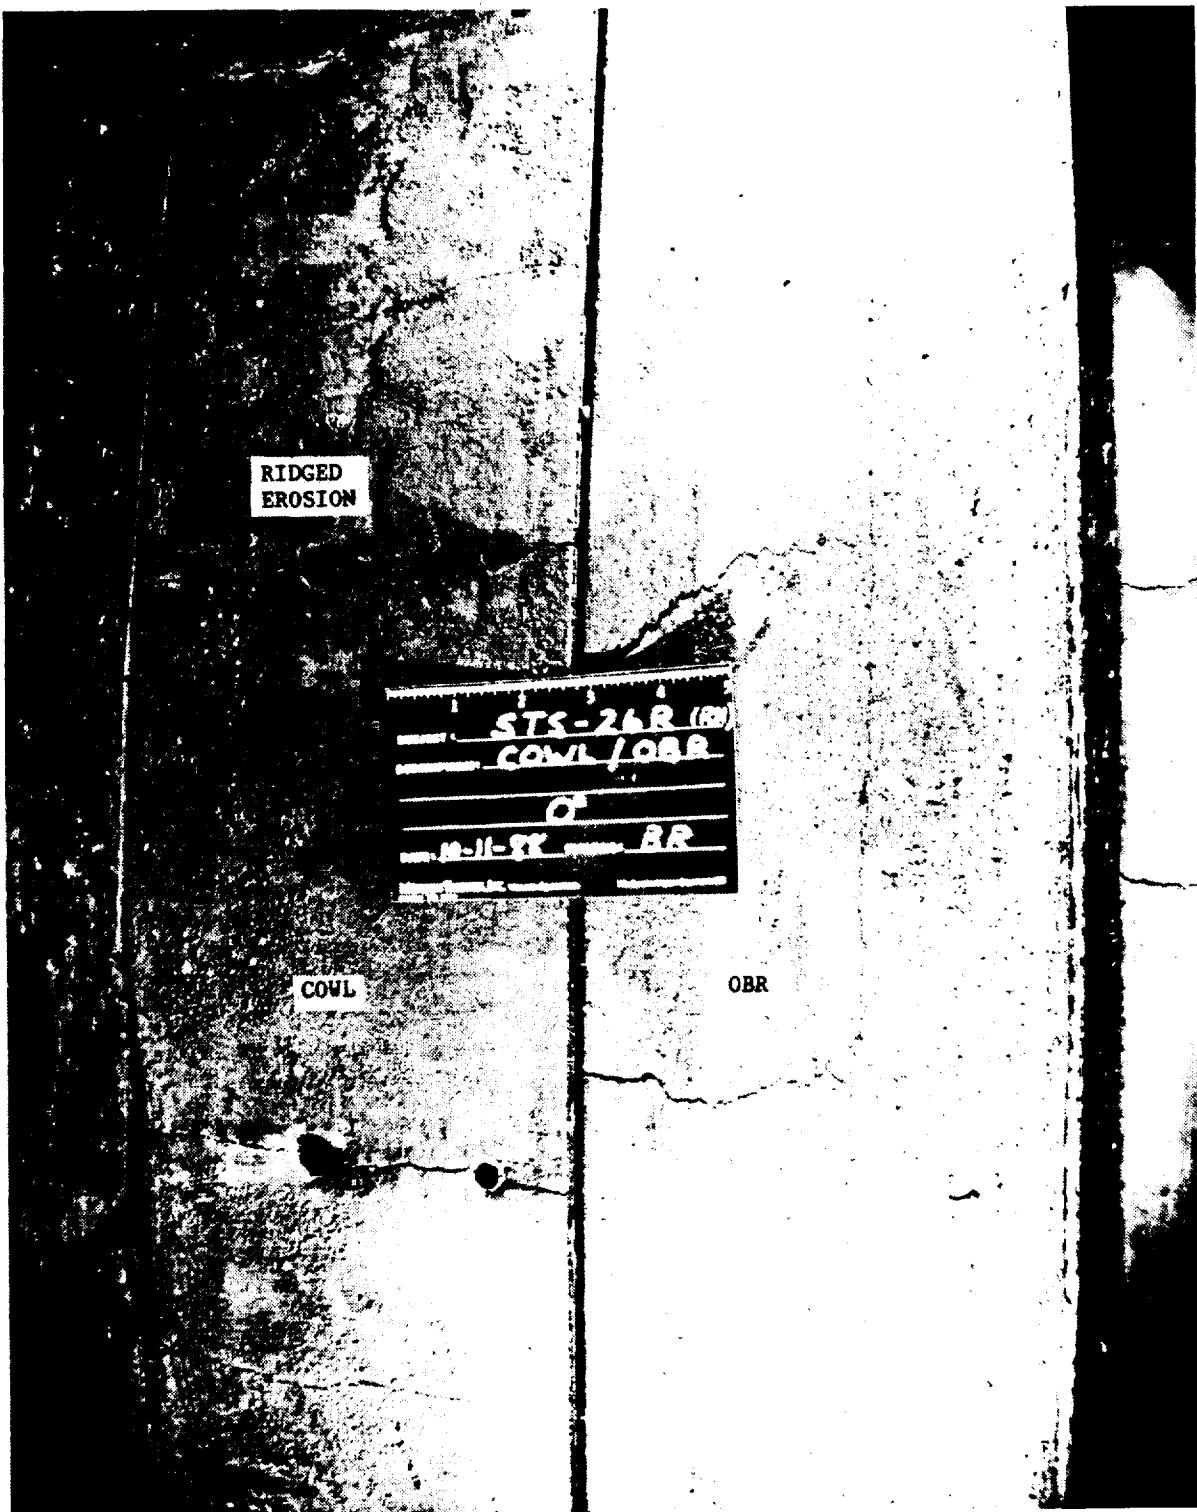
Figure 169 STS-26B Cowl/OBR Closeup (0 Degrees)

Overall views of the STS-26B cowl ring are shown in Figures 127 and 128. Close-up views are shown in Figures 169 through 171. All cowl vent holes appeared plugged with slag on the OD of the ring (Figure 172).

The cowl ring showed typical ridged erosion intermittently around the part circumference. The forward portion of the ring eroded a maximum of 0.15 inch greater than the aft portion (Figure 169). This is a result of the low ply angle of the cowl ring and has been observed on the majority of flight and static test nozzles. One wedgeout was observed on the aft 3.5 inches of the cowl ring from 120 to 137 degrees (Figure 173). The maximum radial depth of the wedgeout was 0.6 inch at the outer boot ring interface. Slag coated the exposed CCP material at the wedgeout location. Sectioning of the liner determined that this wedgeout occurred post-burn.

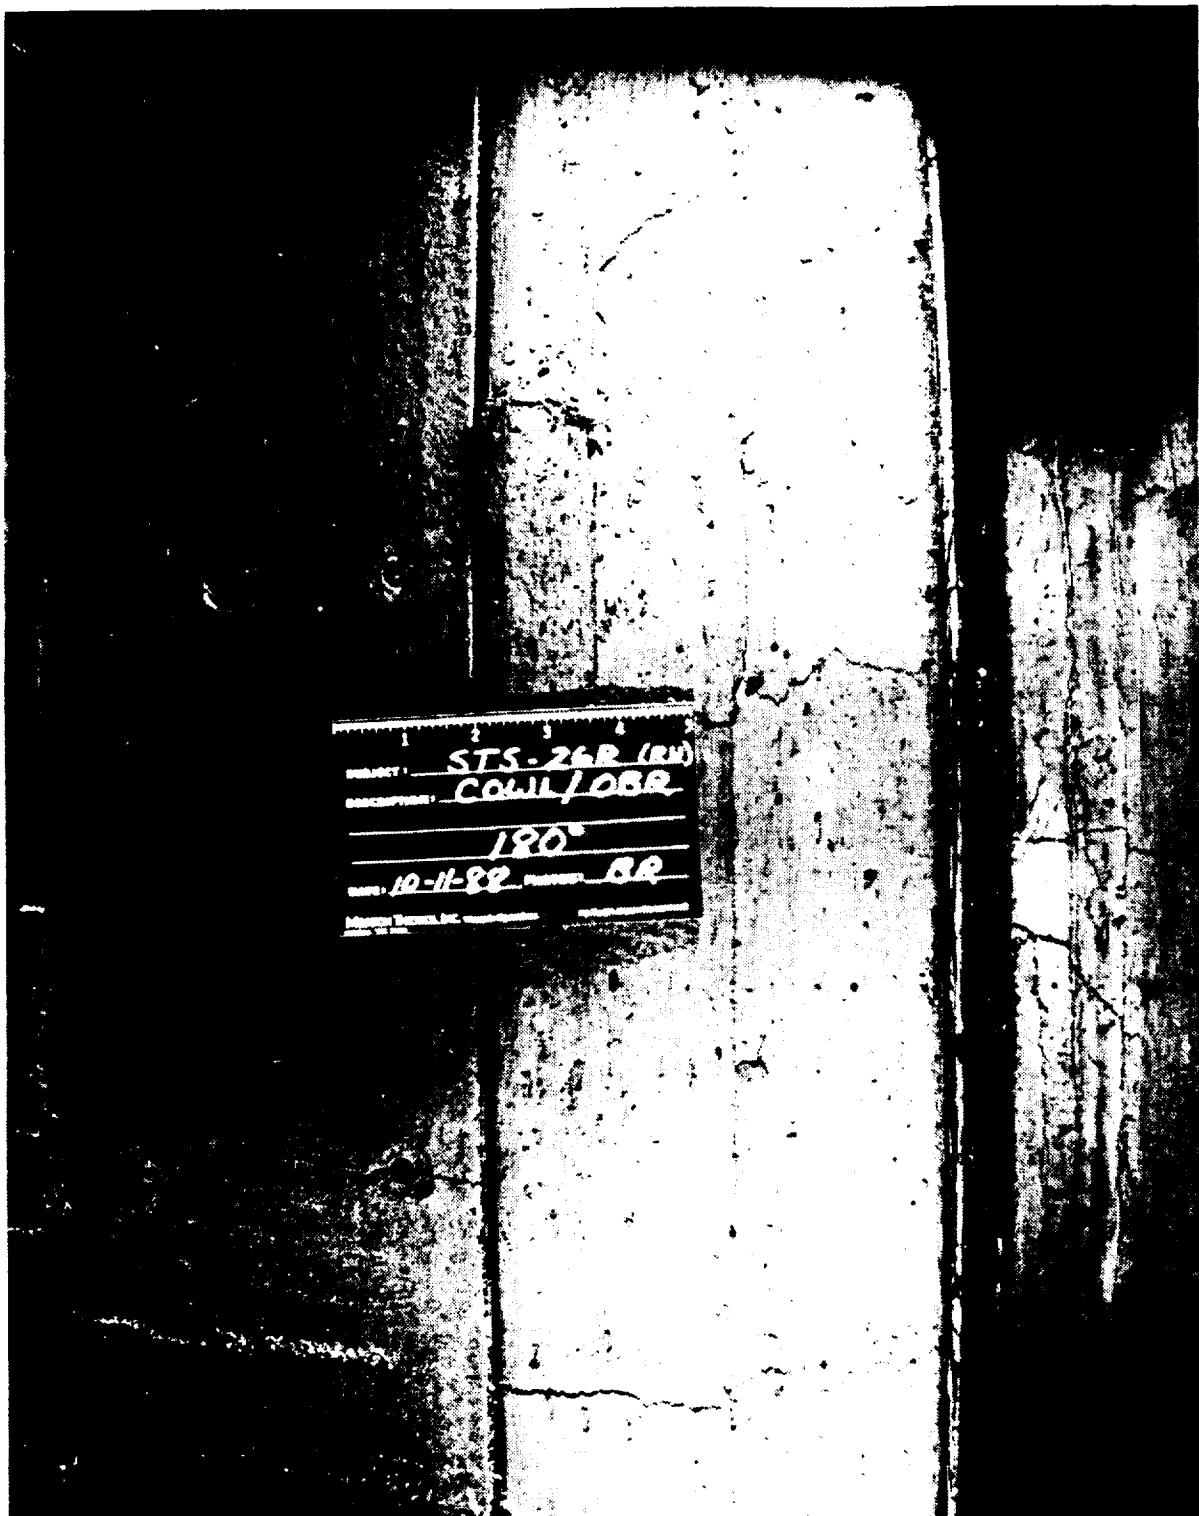
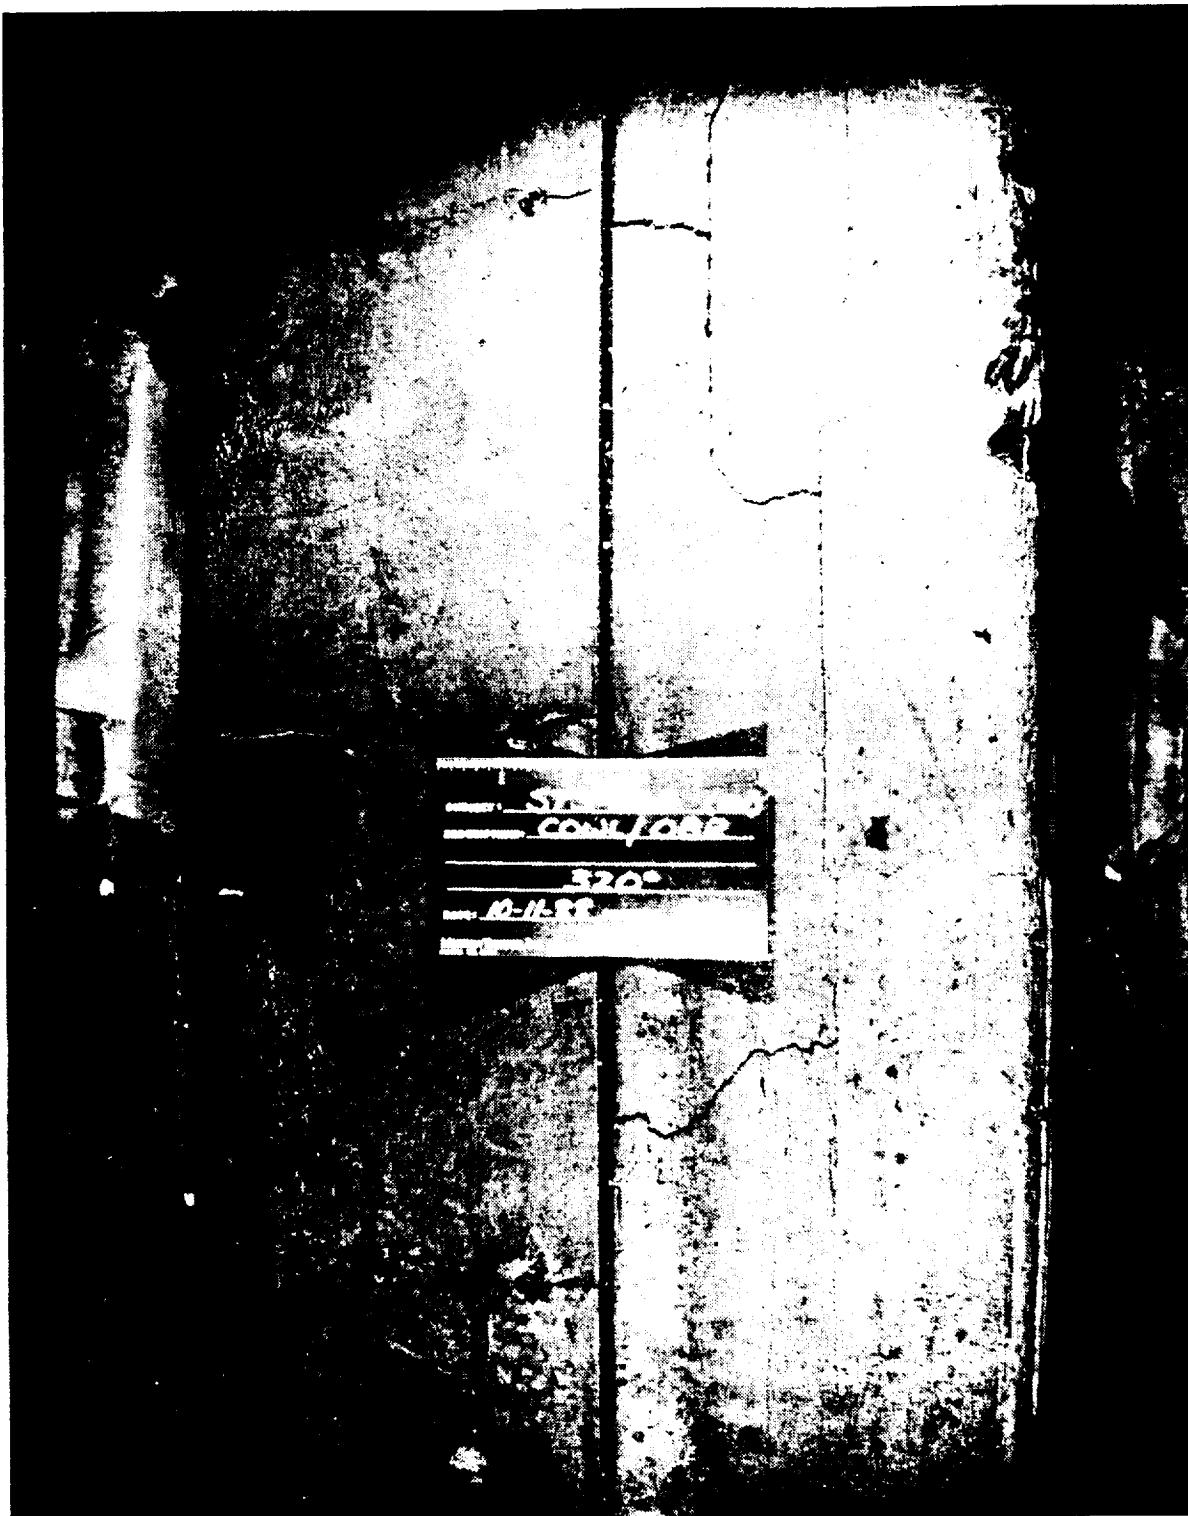
Overall views of the STS-26B outer boot ring are shown in Figures 127 and 128. Close-up views are shown in Figures 169 through 171. The bondline between the outer boot ring and cowl ring remained intact with no indications of flow. The flow surface bondline gap was 0.20 inch and is typical of past static test and flight nozzles.

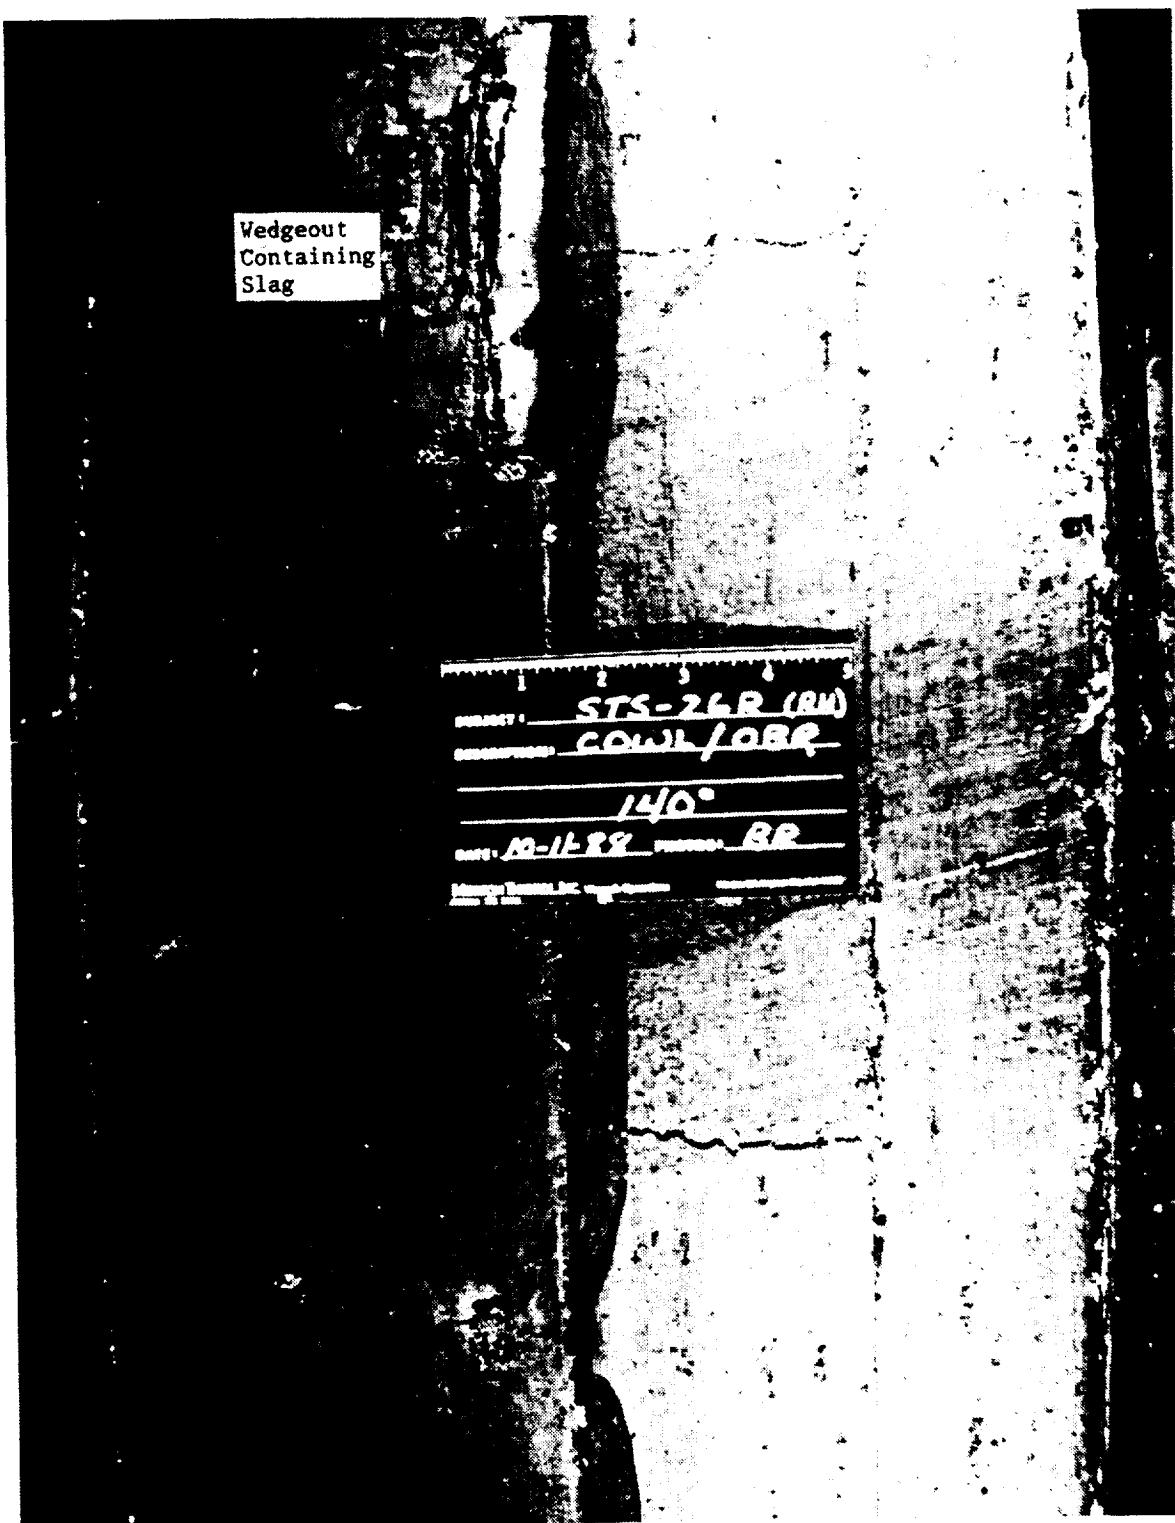
Figure 173 STS-26B Cowl Ring Wedgeout Containing Slag (120 - 137 Degrees)
