# Flight Motor Set 360L001 (STS-26R) Final Report

## Volume V (Nozzle Component)

360L001 (STS-26R)  
Final Report  
Nozzle Component

A review of the performance and post-flight condition of the STS-26 Redesigned Solid Rocket Motor (RSRM) nozzles is presented in this document. Applicable Discrepancy Reports (DRs) and Process Departures (PDs) are presented in Section 5.0. The Nozzle Component Program Team (NCPT) performance evaluation and the Redesign Program Review Board (RPRB) assessment is included in Section 6.0.

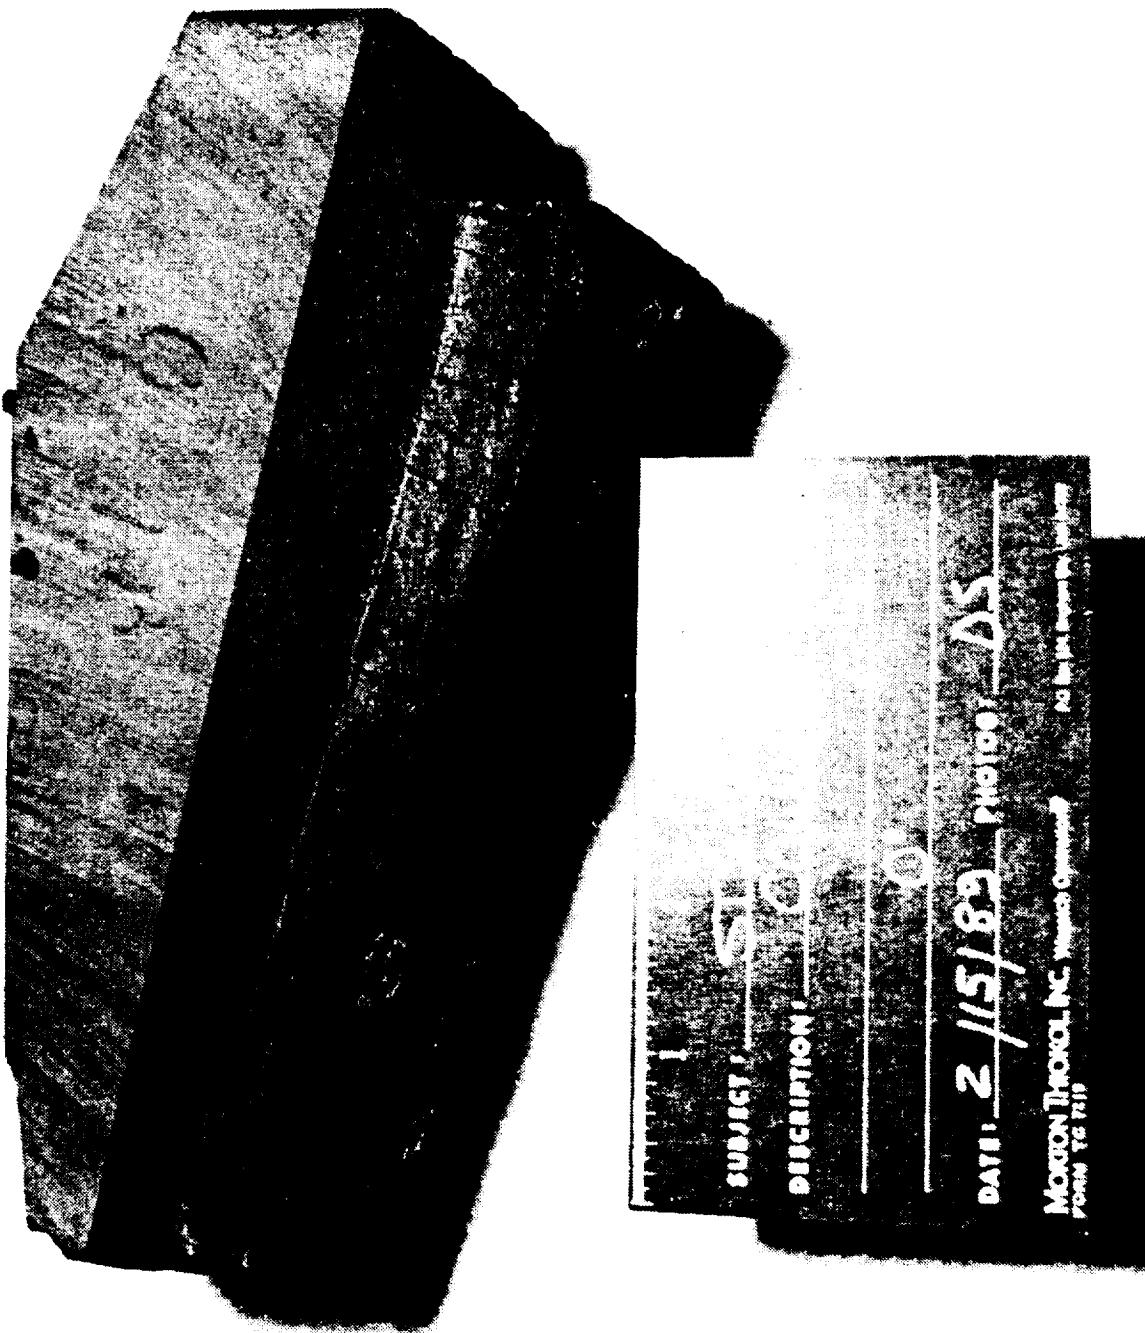
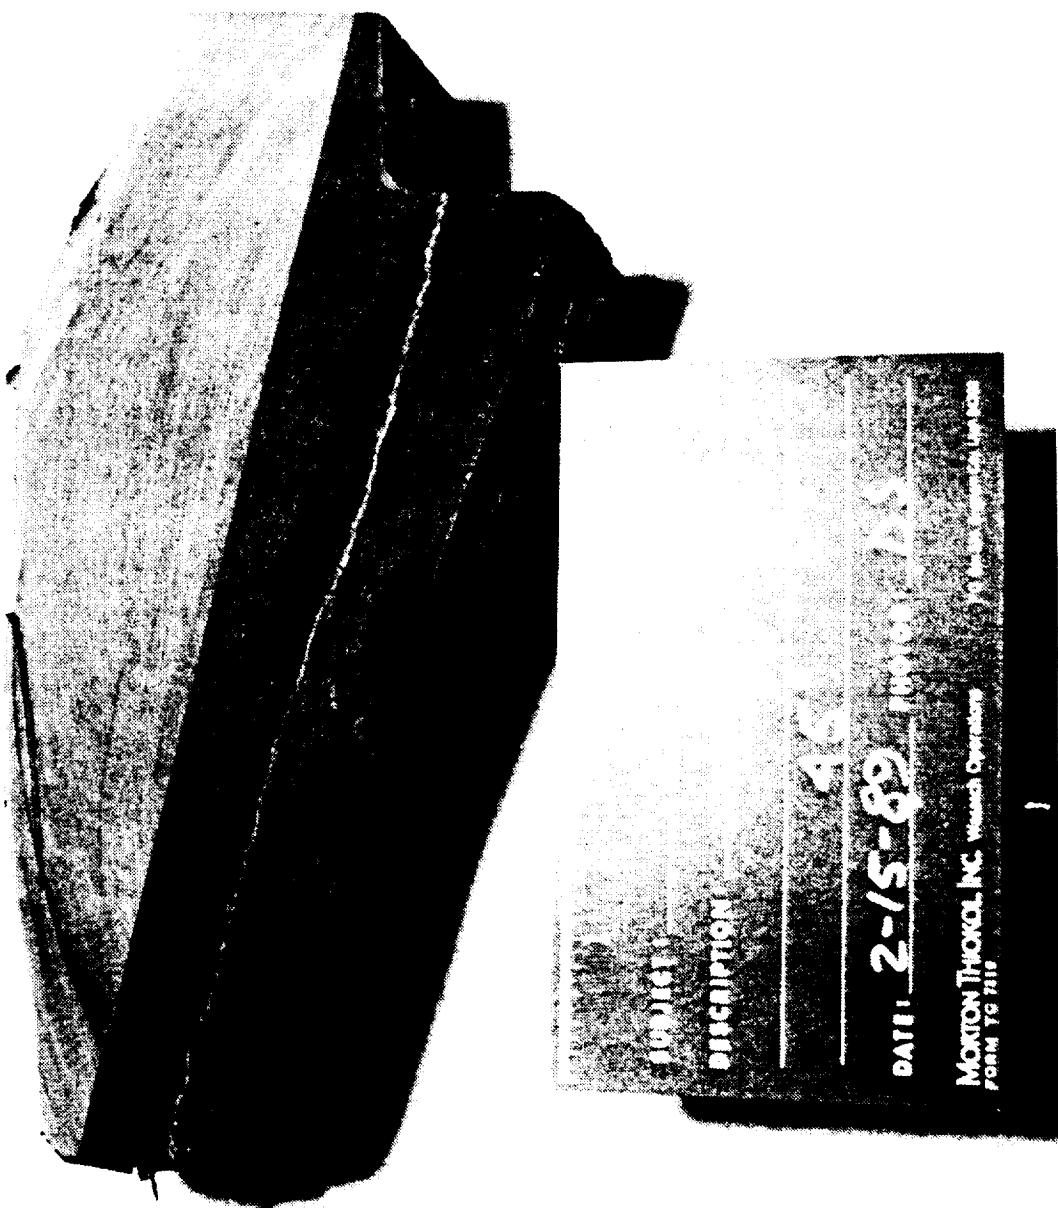
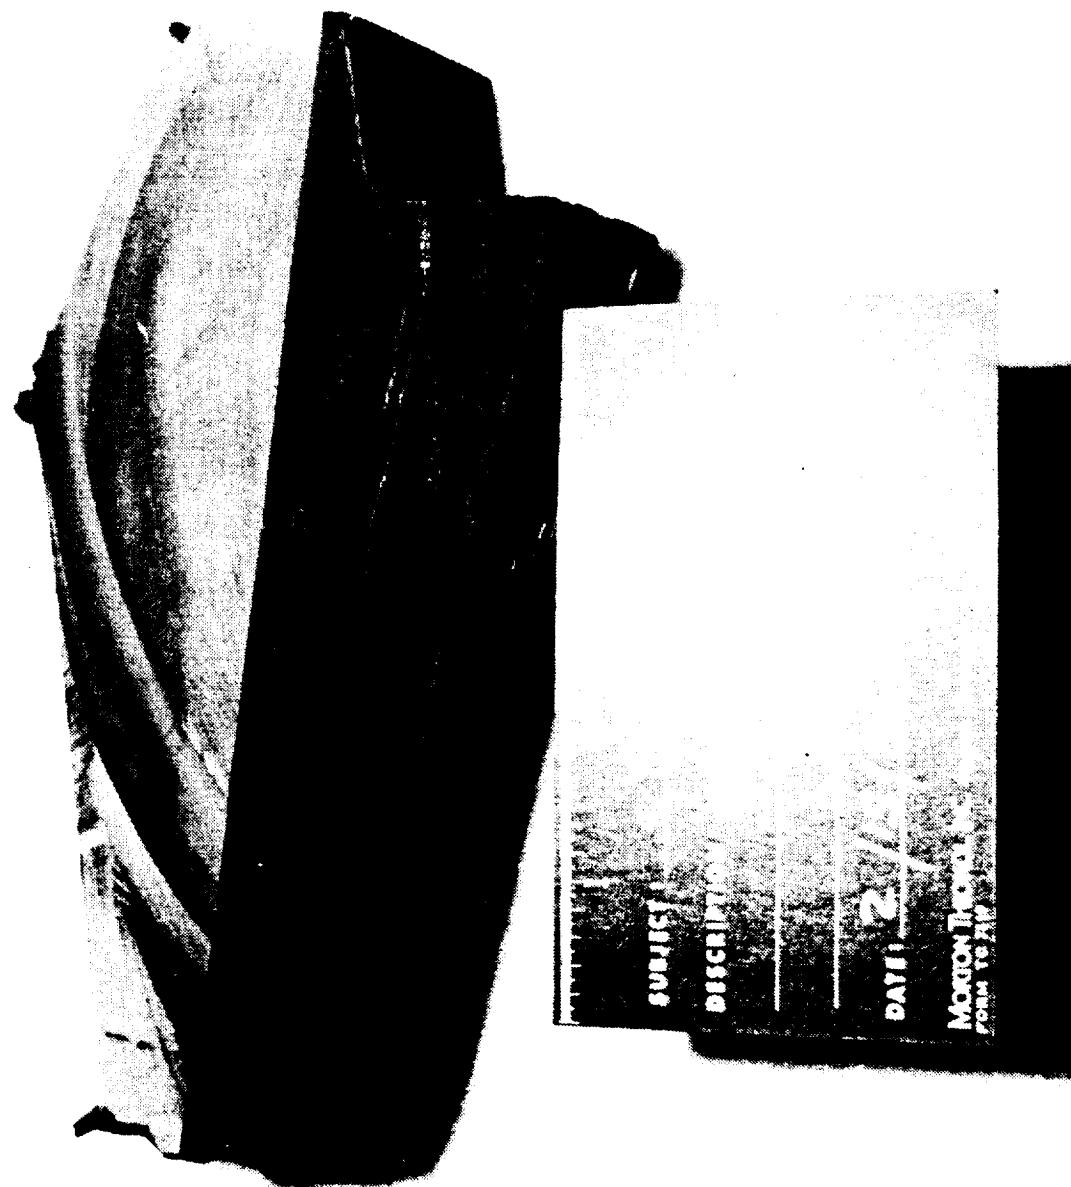
Photographs of the sectioned cowl ring are presented in Figures 174 through 177. Typical subsurface ply lifting was observed intermittently around the circumference along the length of the cowl. The largest ply lift separation was 0.20 inch at 270 degrees (Figure 177). There was no evidence of flow or erosion within the delaminations. Char and erosion analysis of the sections is presented in Table 14 (Stations 0 through 7).

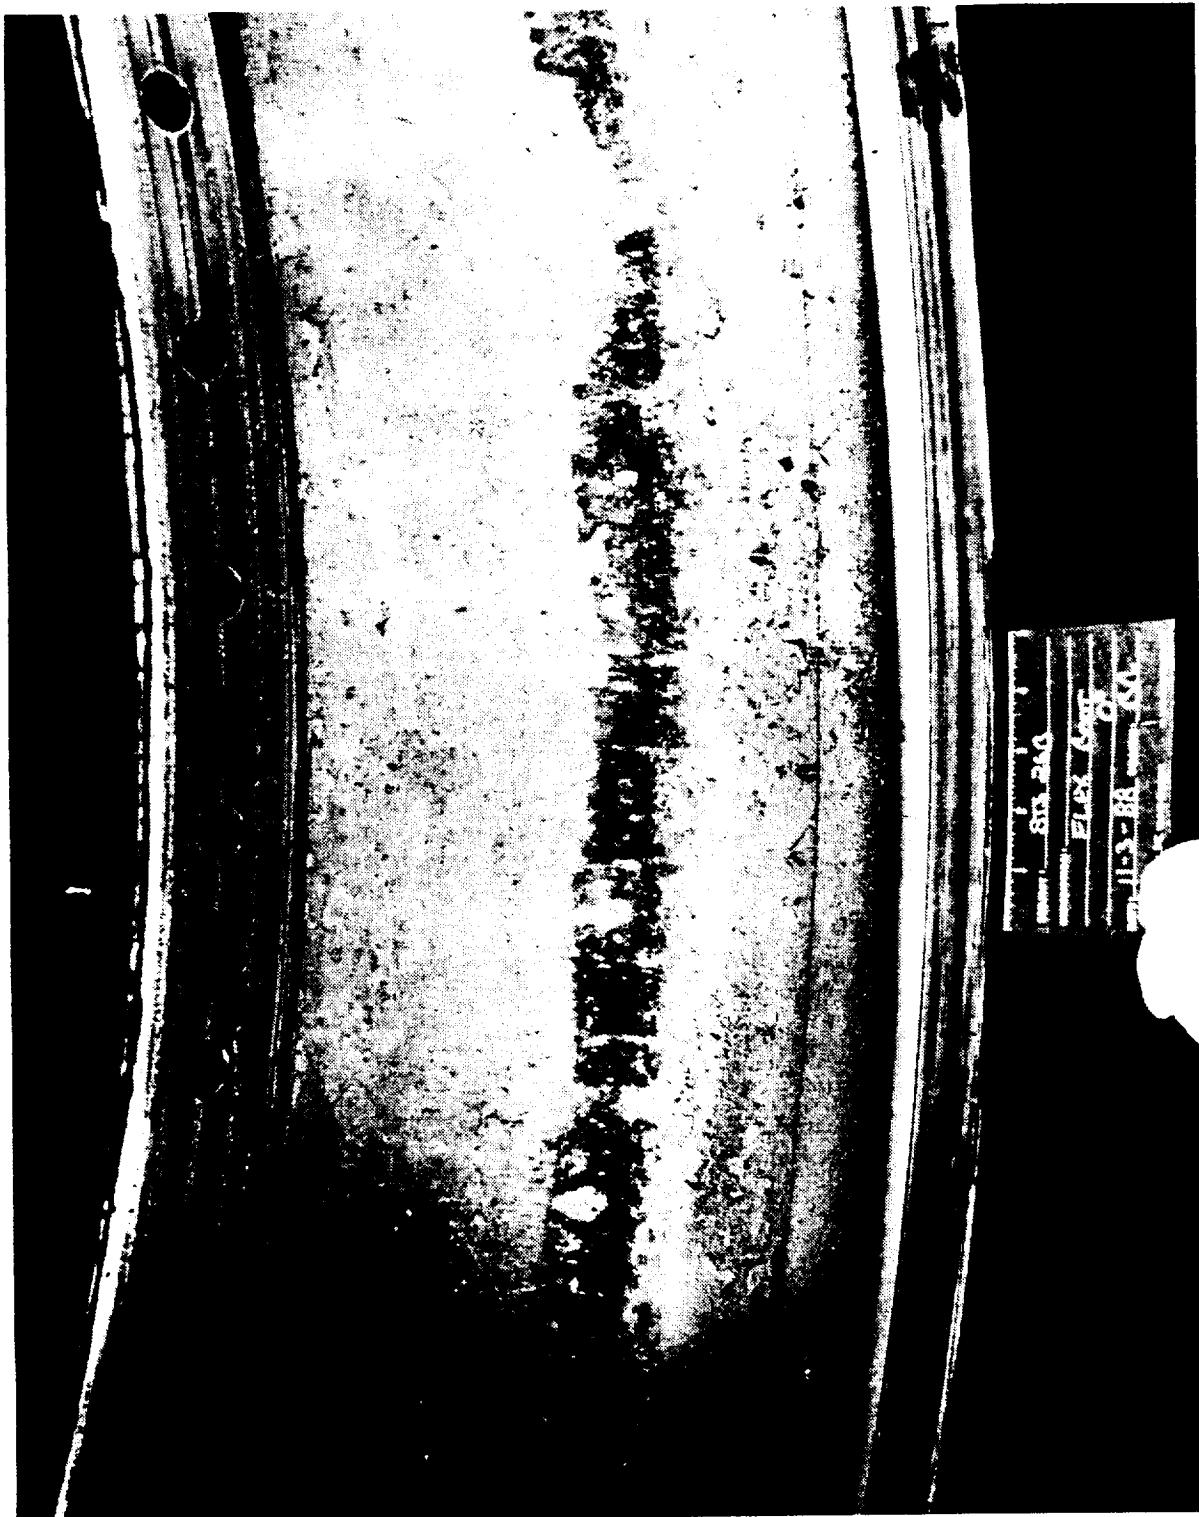
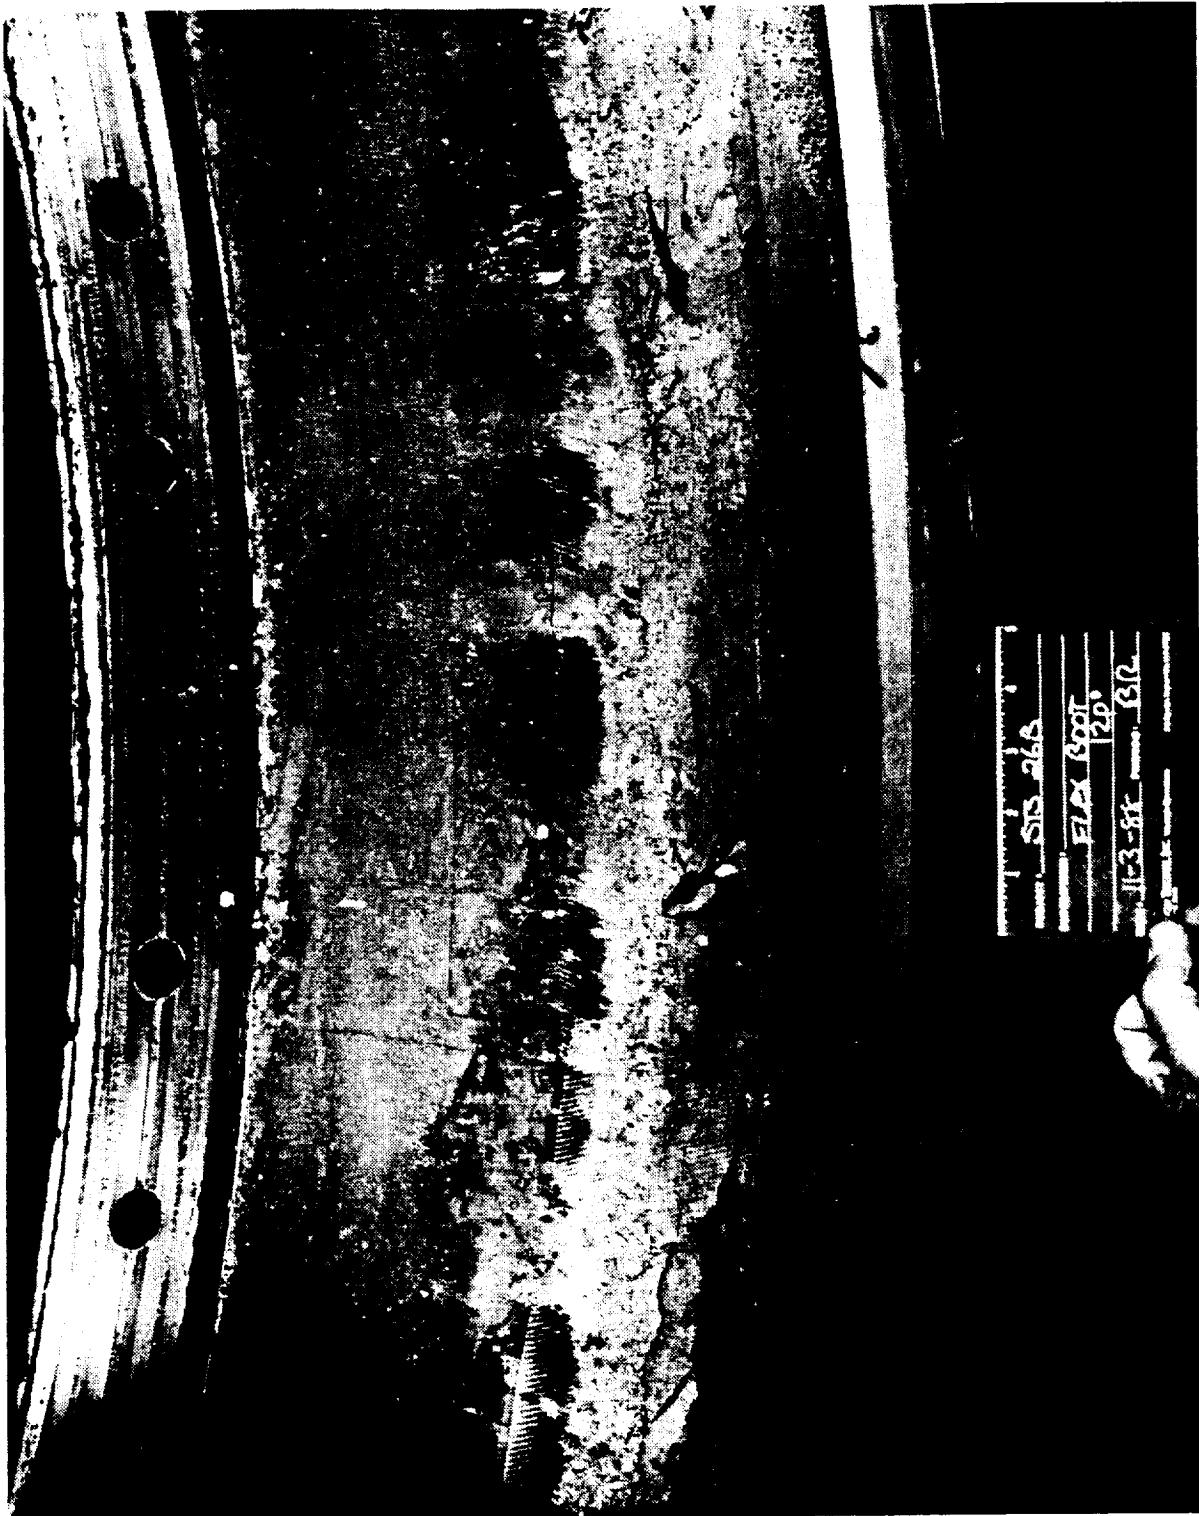
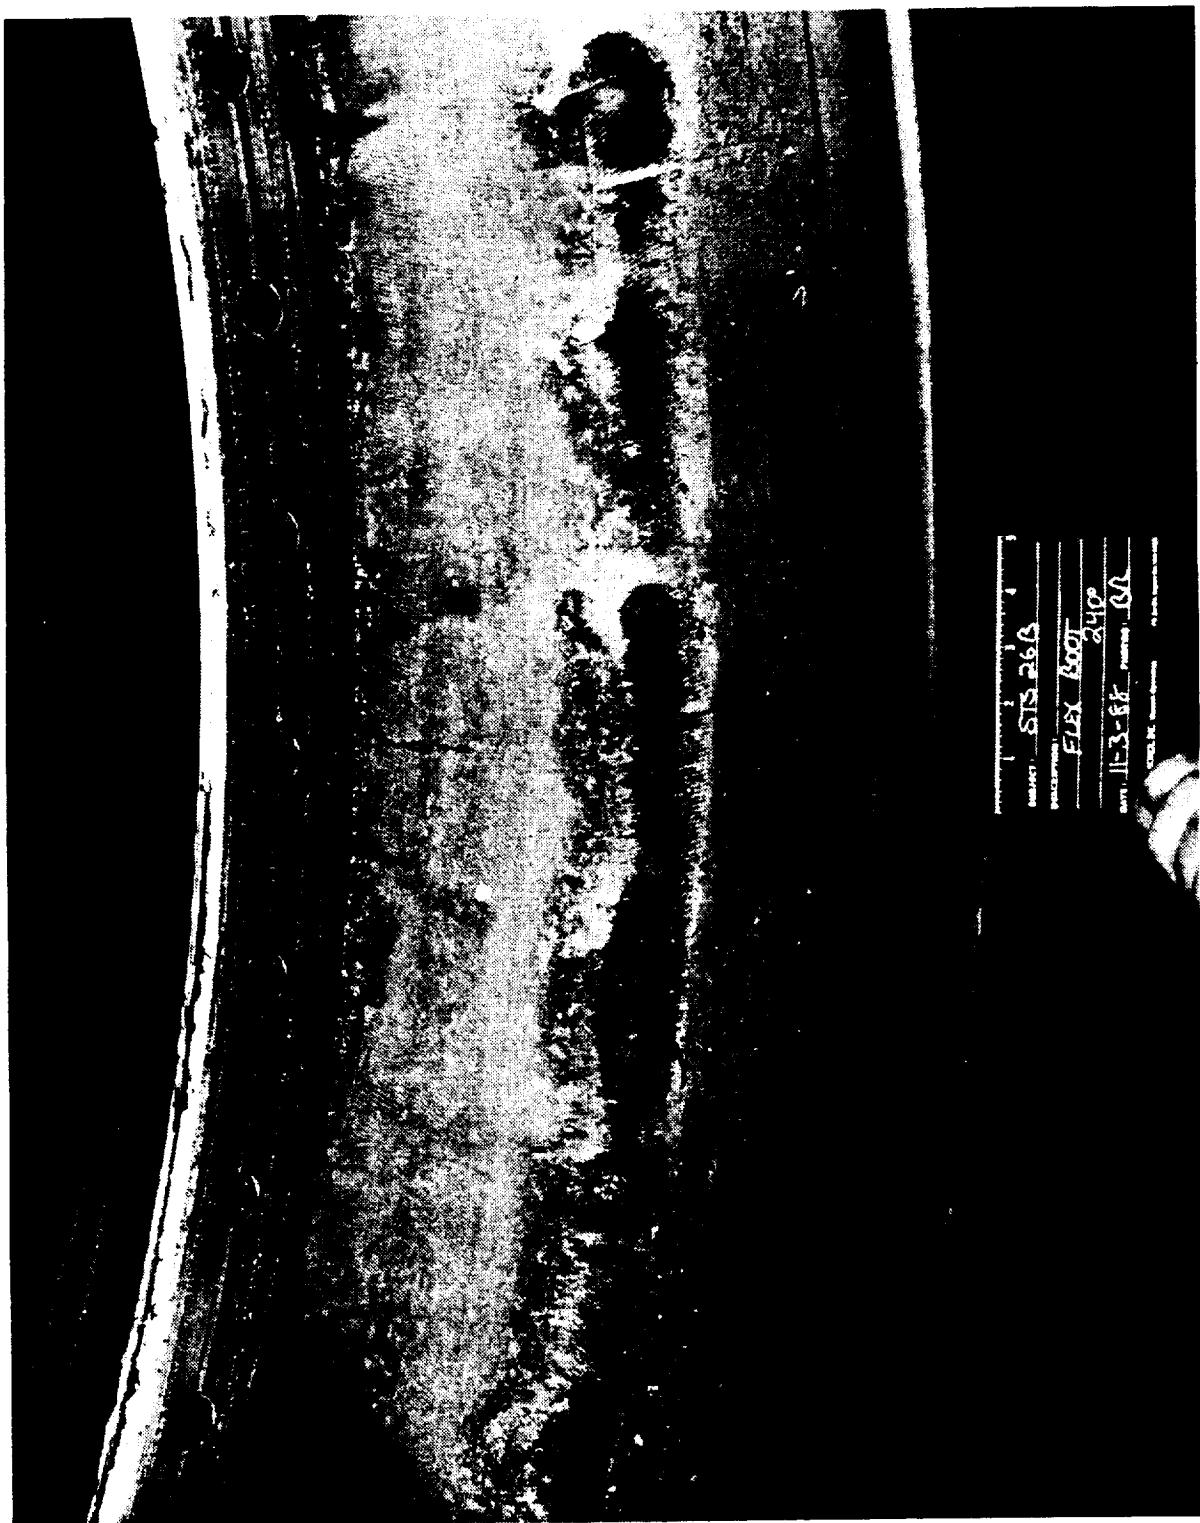
The cavity side of the flex boot was evenly sooted and showed no evidence of flow or erosion (Figures 183 through 185). It appeared typical of previous flight and static test motor flex boots. A minimum of 3.0 NBR plies remained around the circumference after motor burn. Table 15 presents the flex boot material affected depths and Performance Margins of Safety. The worst case PMS was 0.19 at 280 degrees.

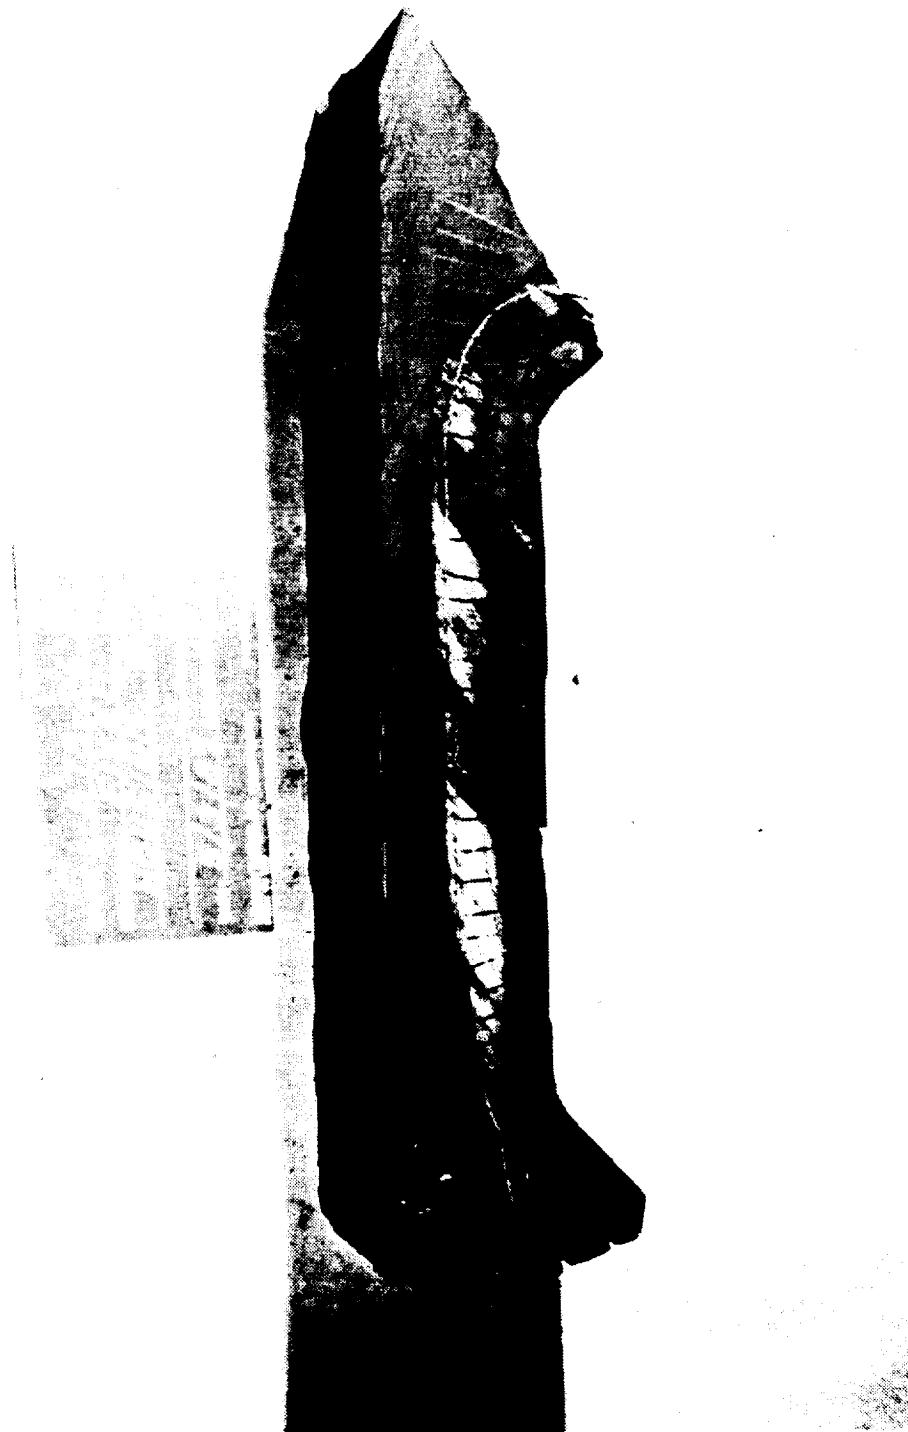
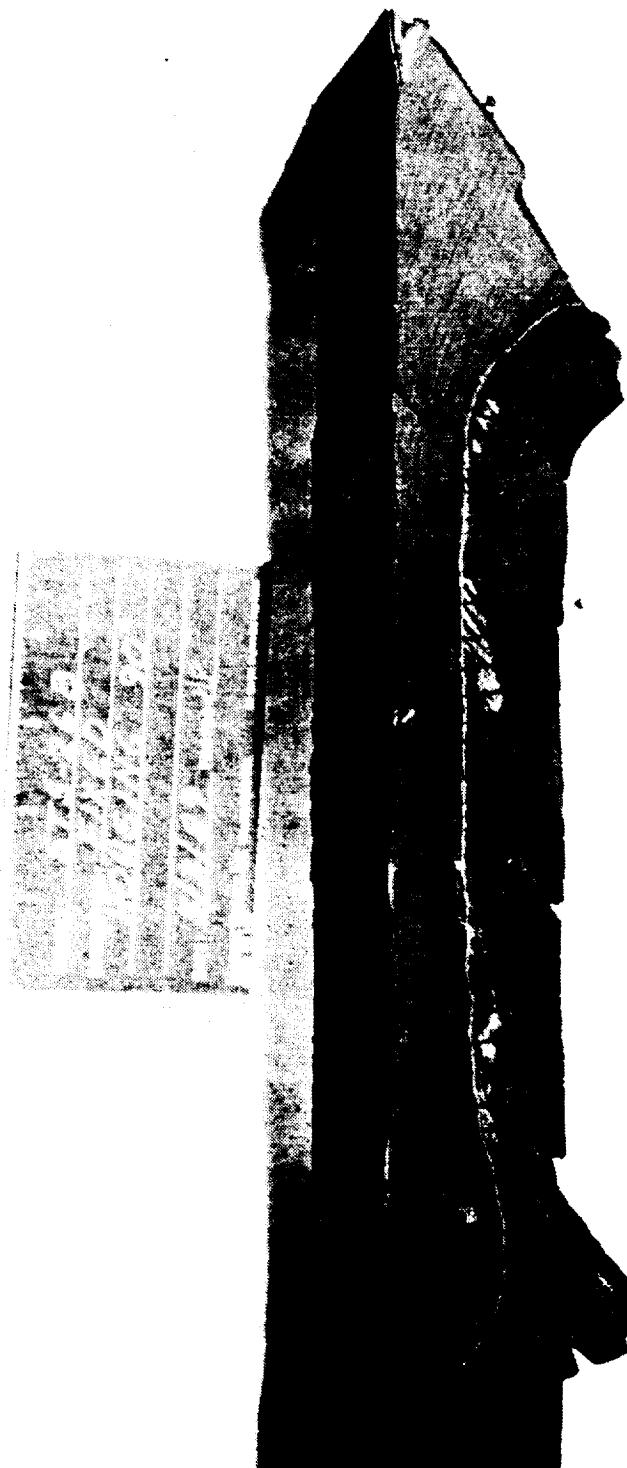
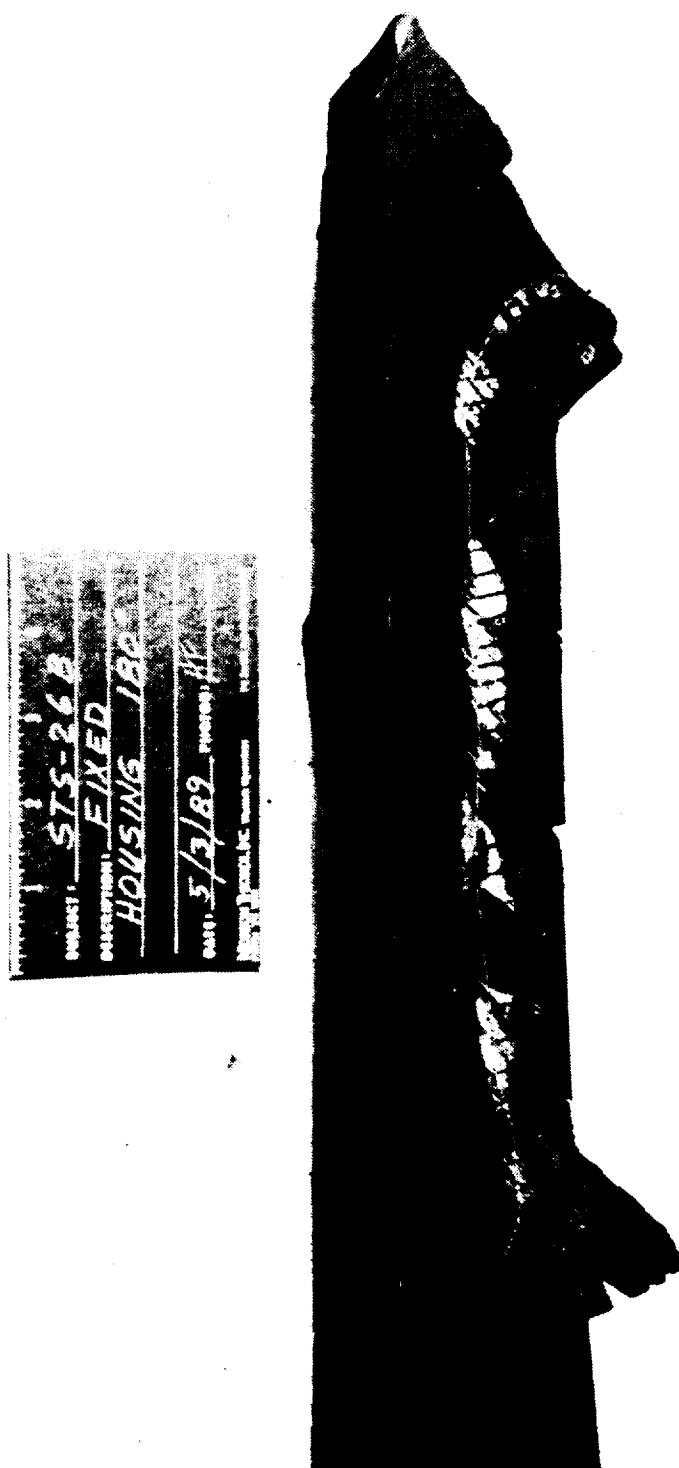
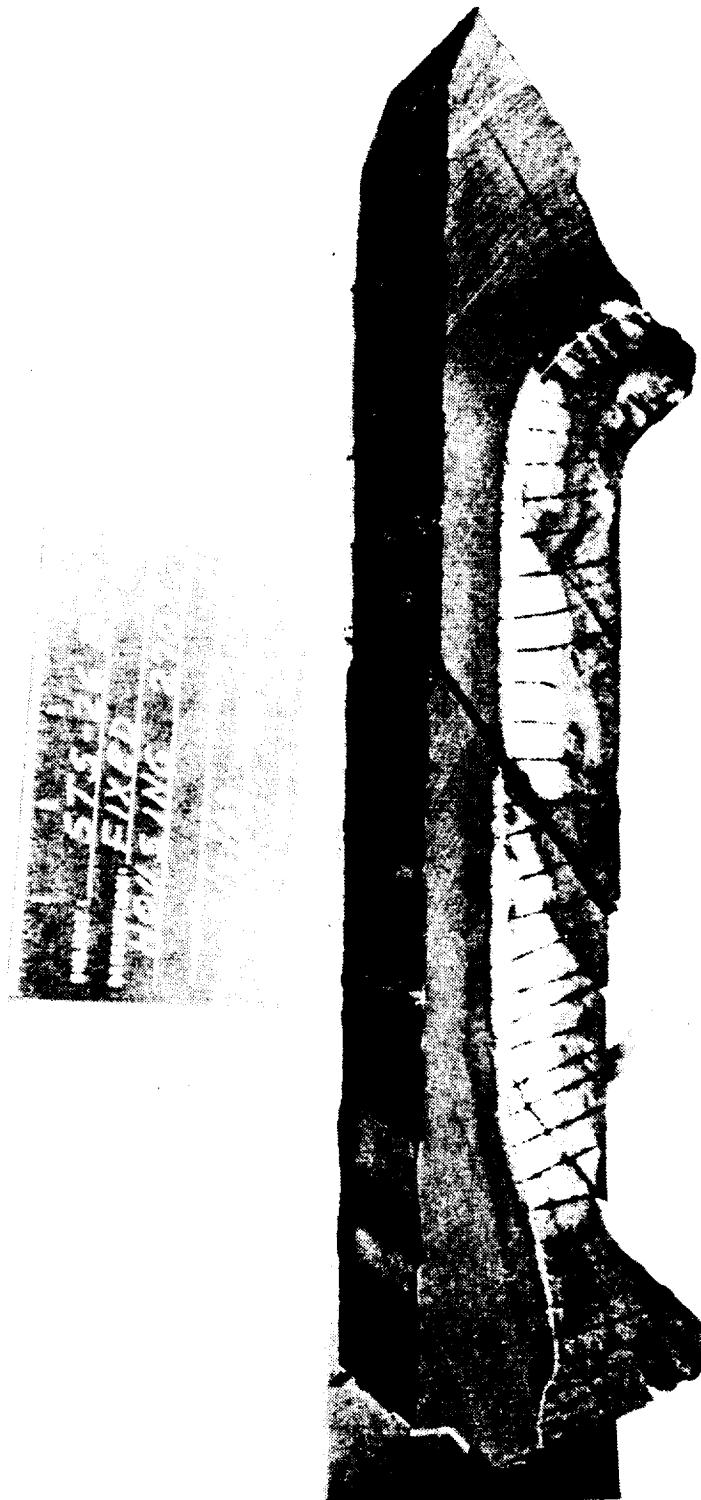
Photographs of the sectioned fixed housing assembly liner are presented in Figures 186 through 189. Char and erosion analysis of the sections is presented in Table 16. Figure 70 shows the location of the measurement stations. All margins of safety were positive, with a minimum of 0.54 occurring at station 3 (270 degrees).

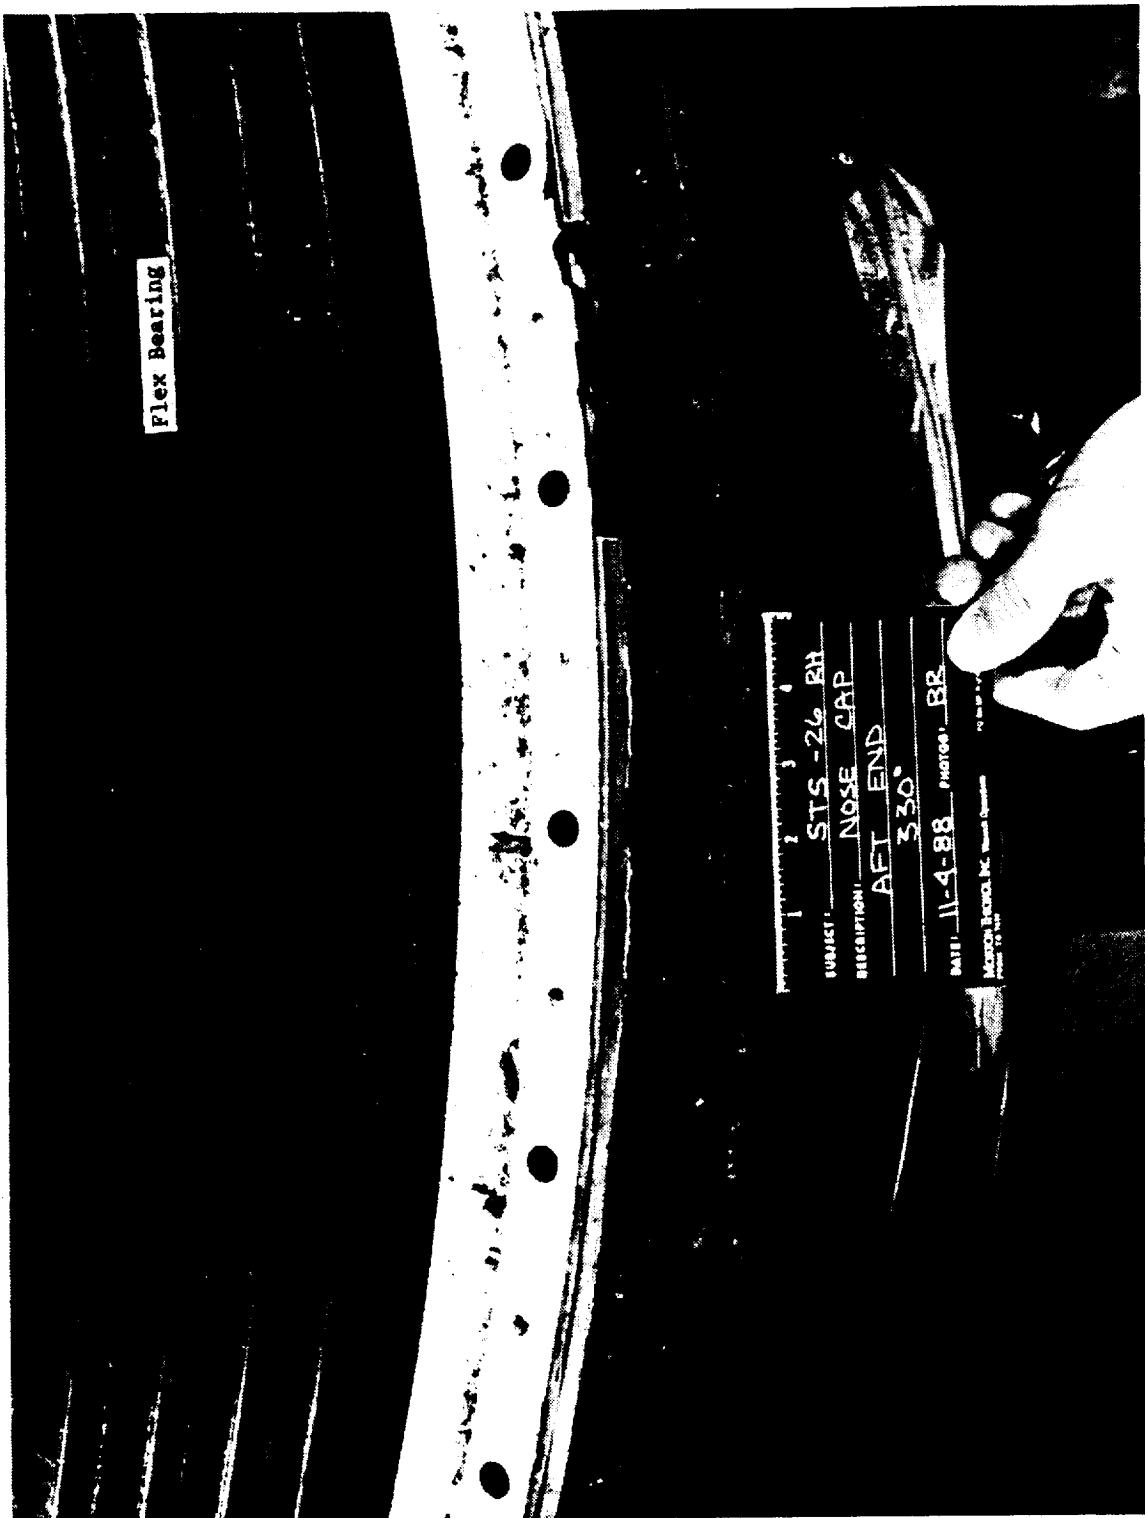
Figure 193 STS-26B Flex Bearing (330 Degrees)

Examination of the flex bearing revealed no damage, soot, heat effect, or flow indications (Figure 193). All rubber pads, metal shims, and end rings appeared to be in nominal condition. Subsequent refurbishment and testing has verified that the flex bearing is acceptable for reuse.

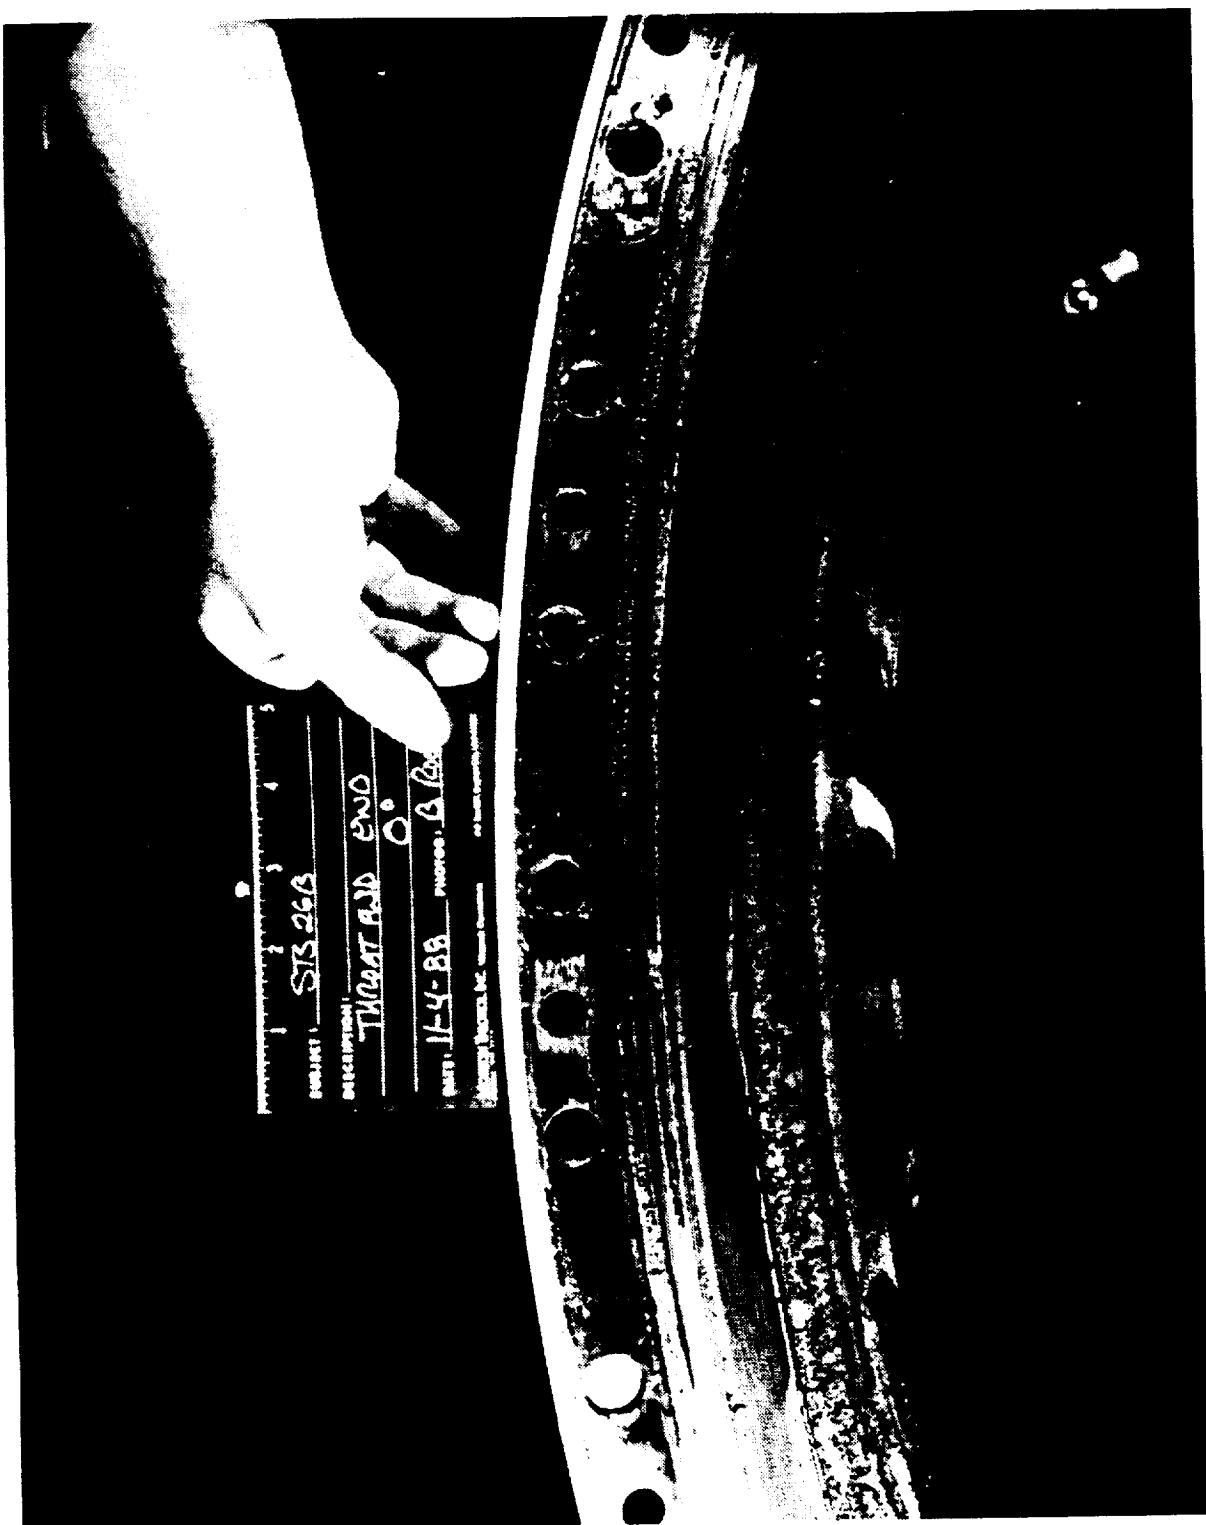
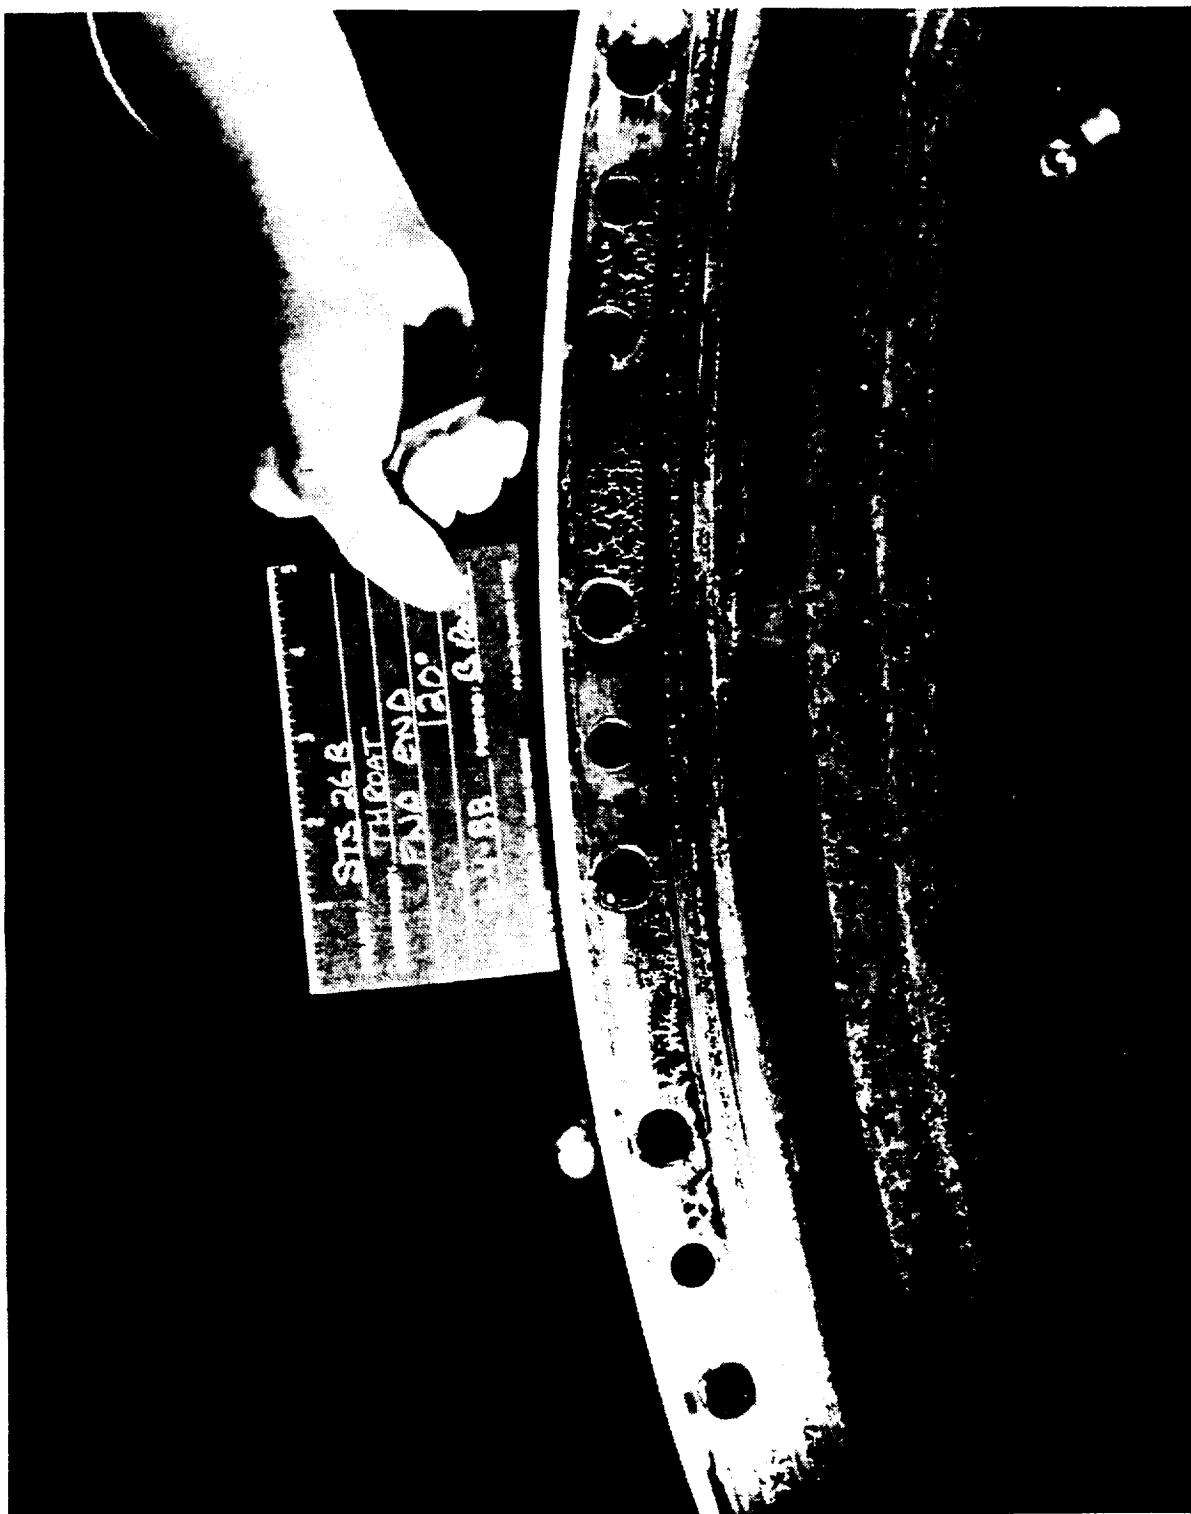
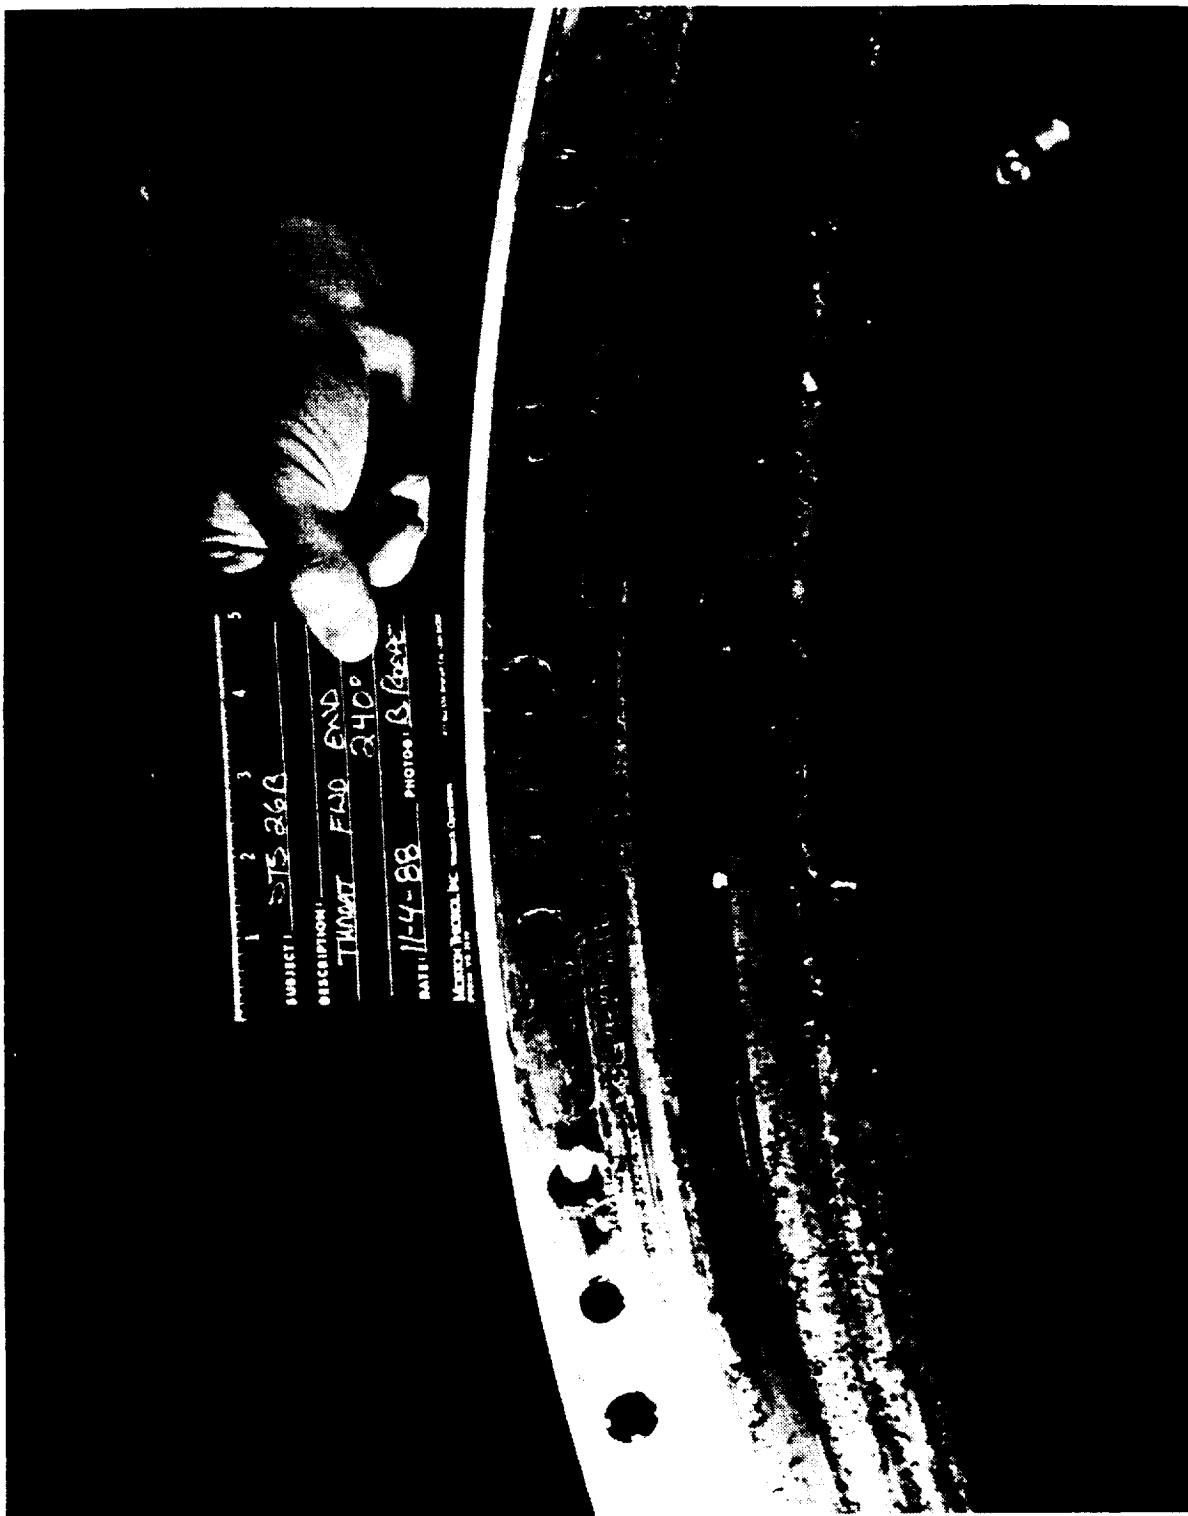
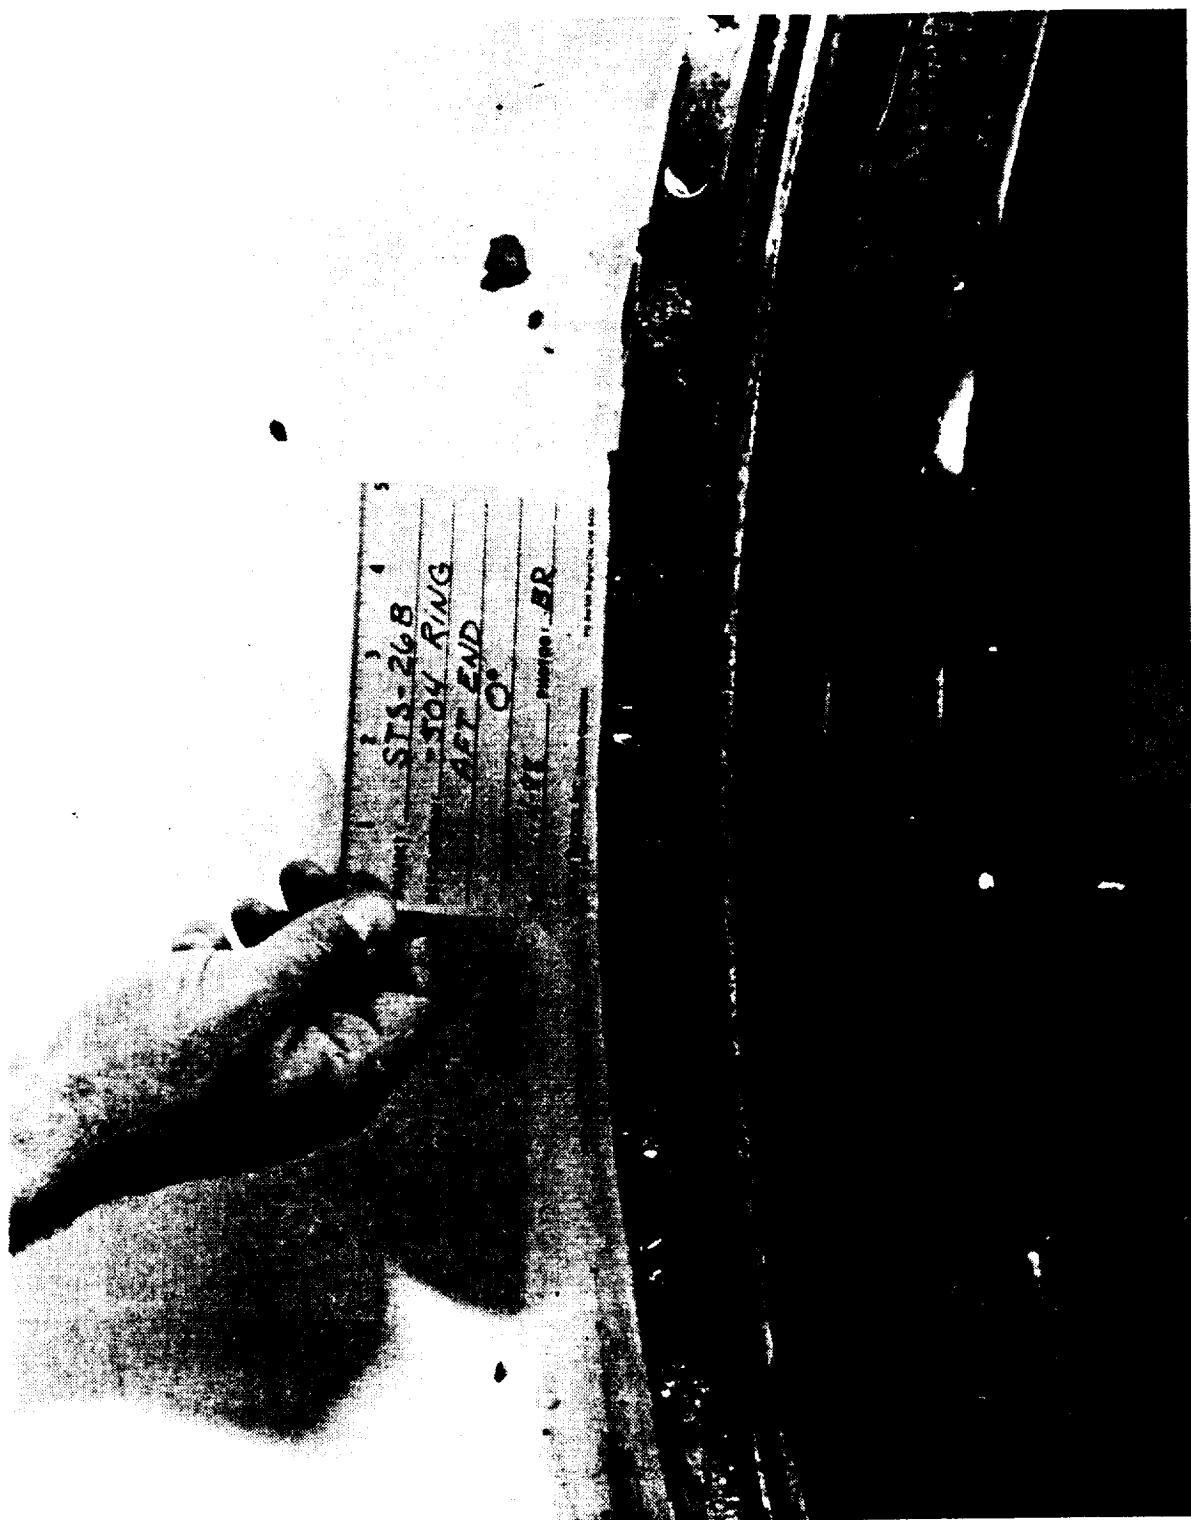
Figure 211 STS-26B Throat-Forward End (0 Degrees)

A cross-sectioned view of the STS-26B nose inlet-to-throat joint is presented in Figure 210. Photographs of the post-flight joint are shown in Figures 211 through 216.
