# Flight Motor Set 360L001 (STS-26R) Final Report

## Volume V (Nozzle Component)

360L001 (STS-26R)  
Final Report  
Nozzle Component

A review of the performance and post-flight condition of the STS-26 Redesigned Solid Rocket Motor (RSRM) nozzles is presented in this document. Applicable Discrepancy Reports (DRs) and Process Departures (PDs) are presented in Section 5.0. The Nozzle Component Program Team (NCPT) performance evaluation and the Redesign Program Review Board (RPRB) assessment is included in Section 6.0.

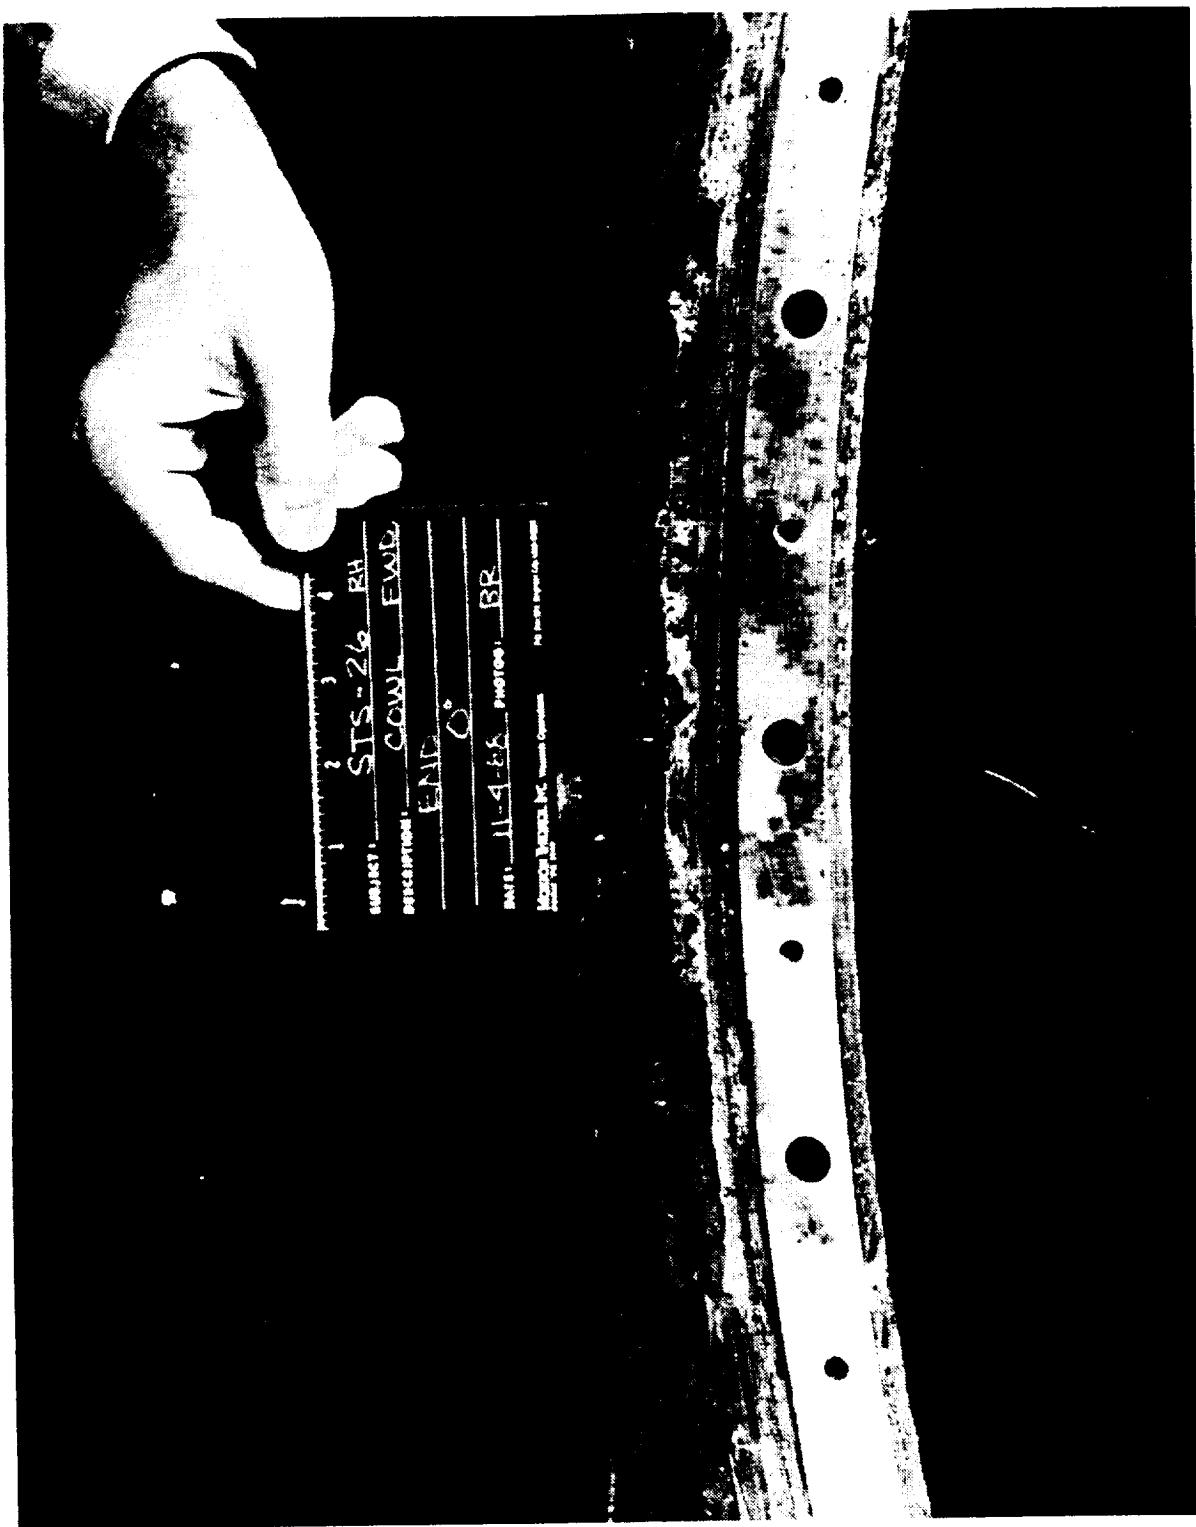
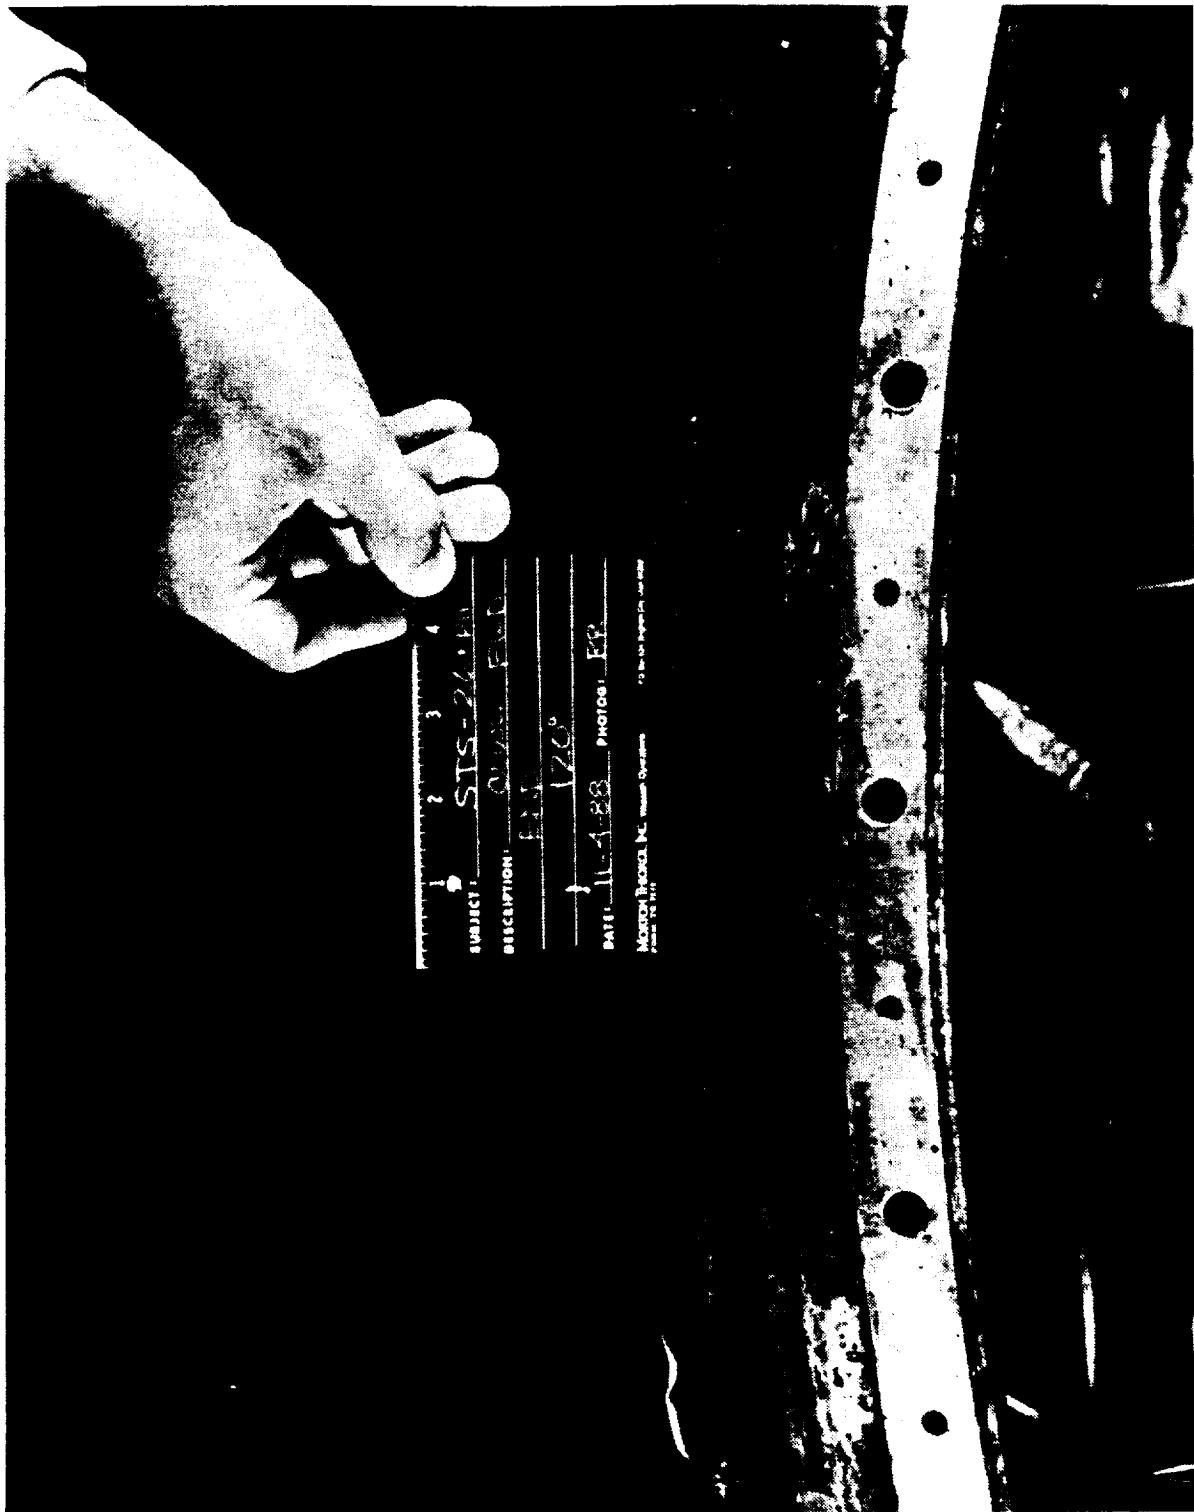
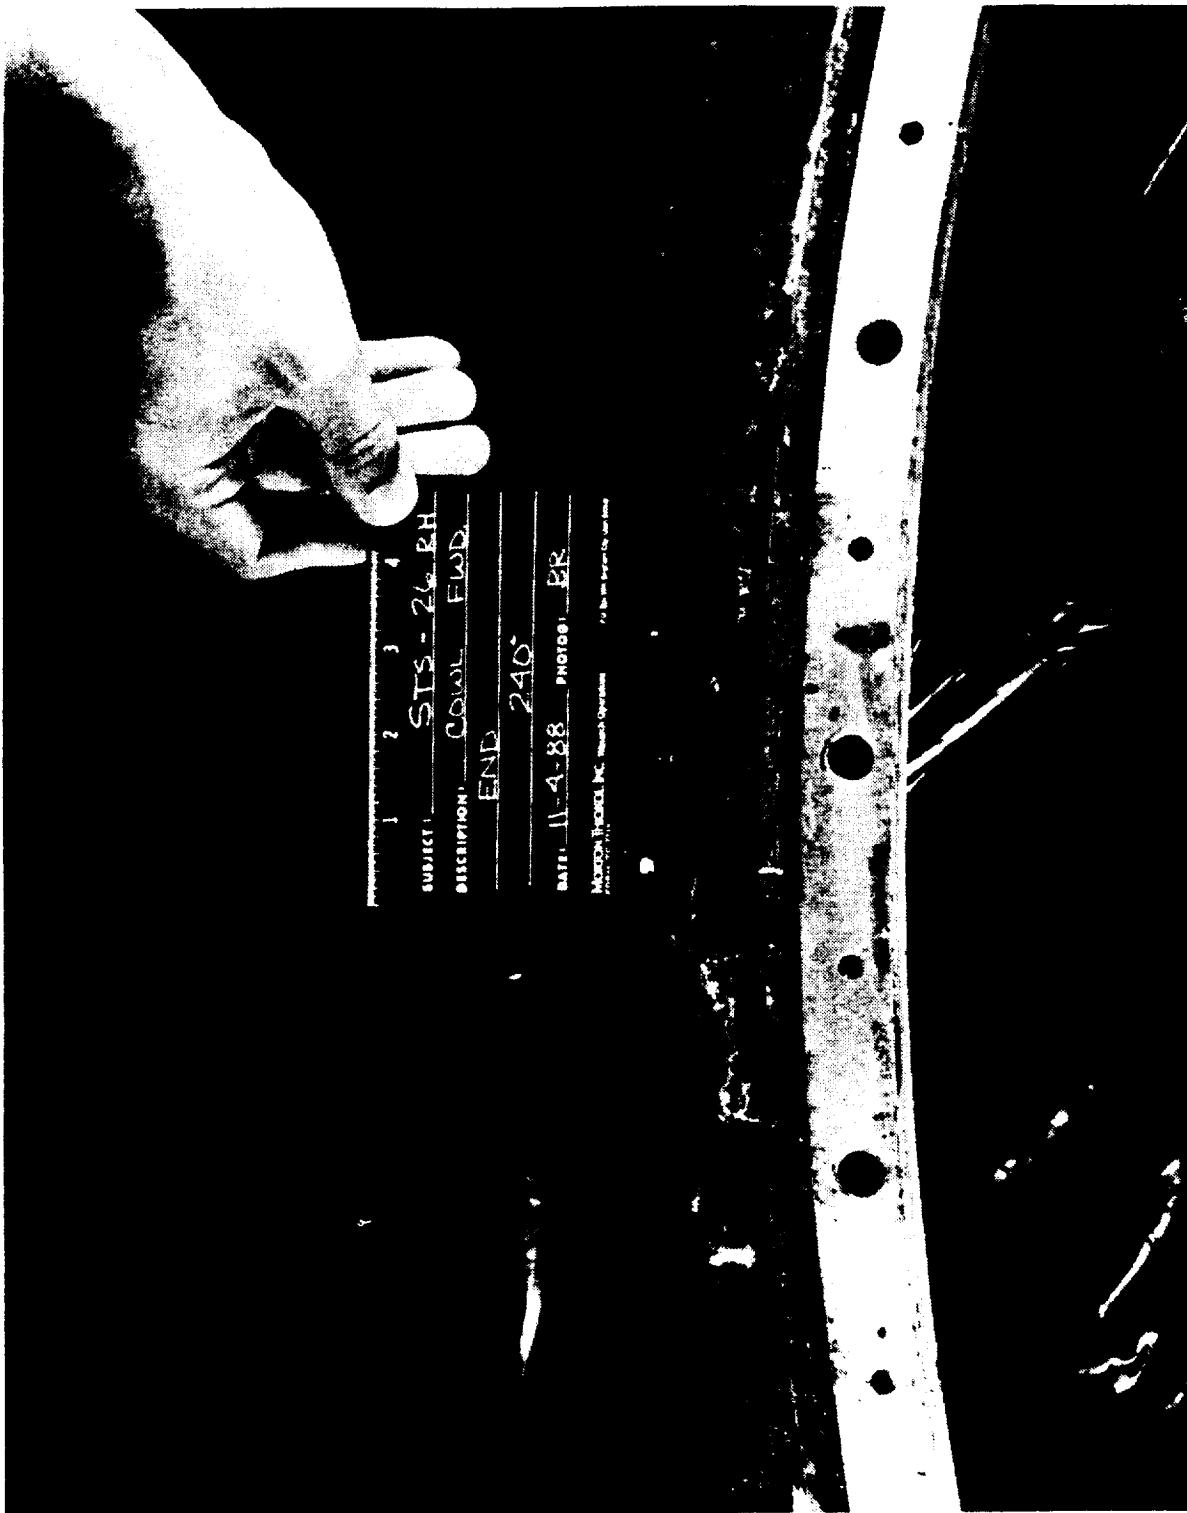
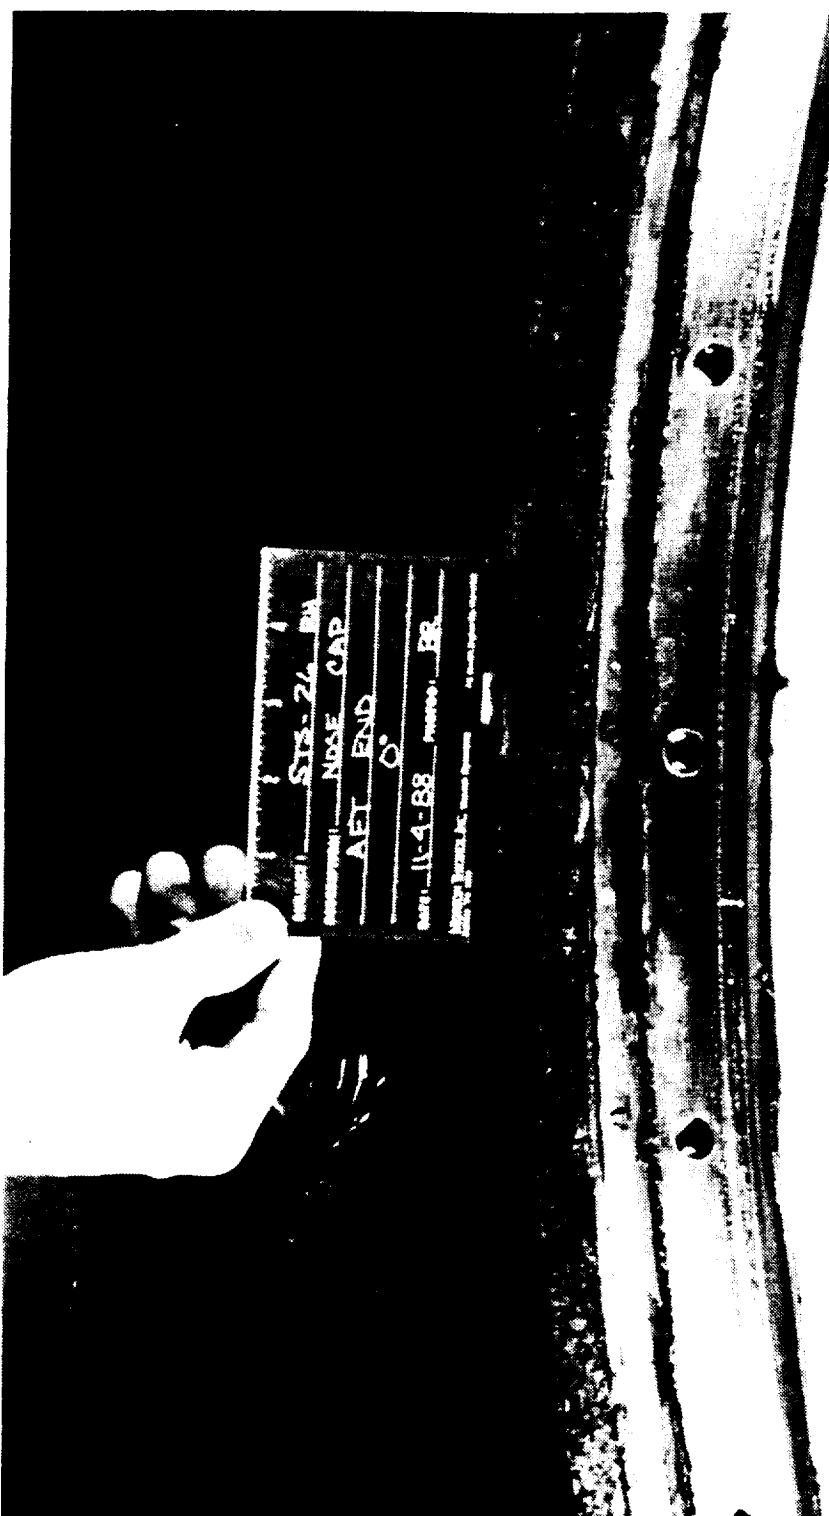
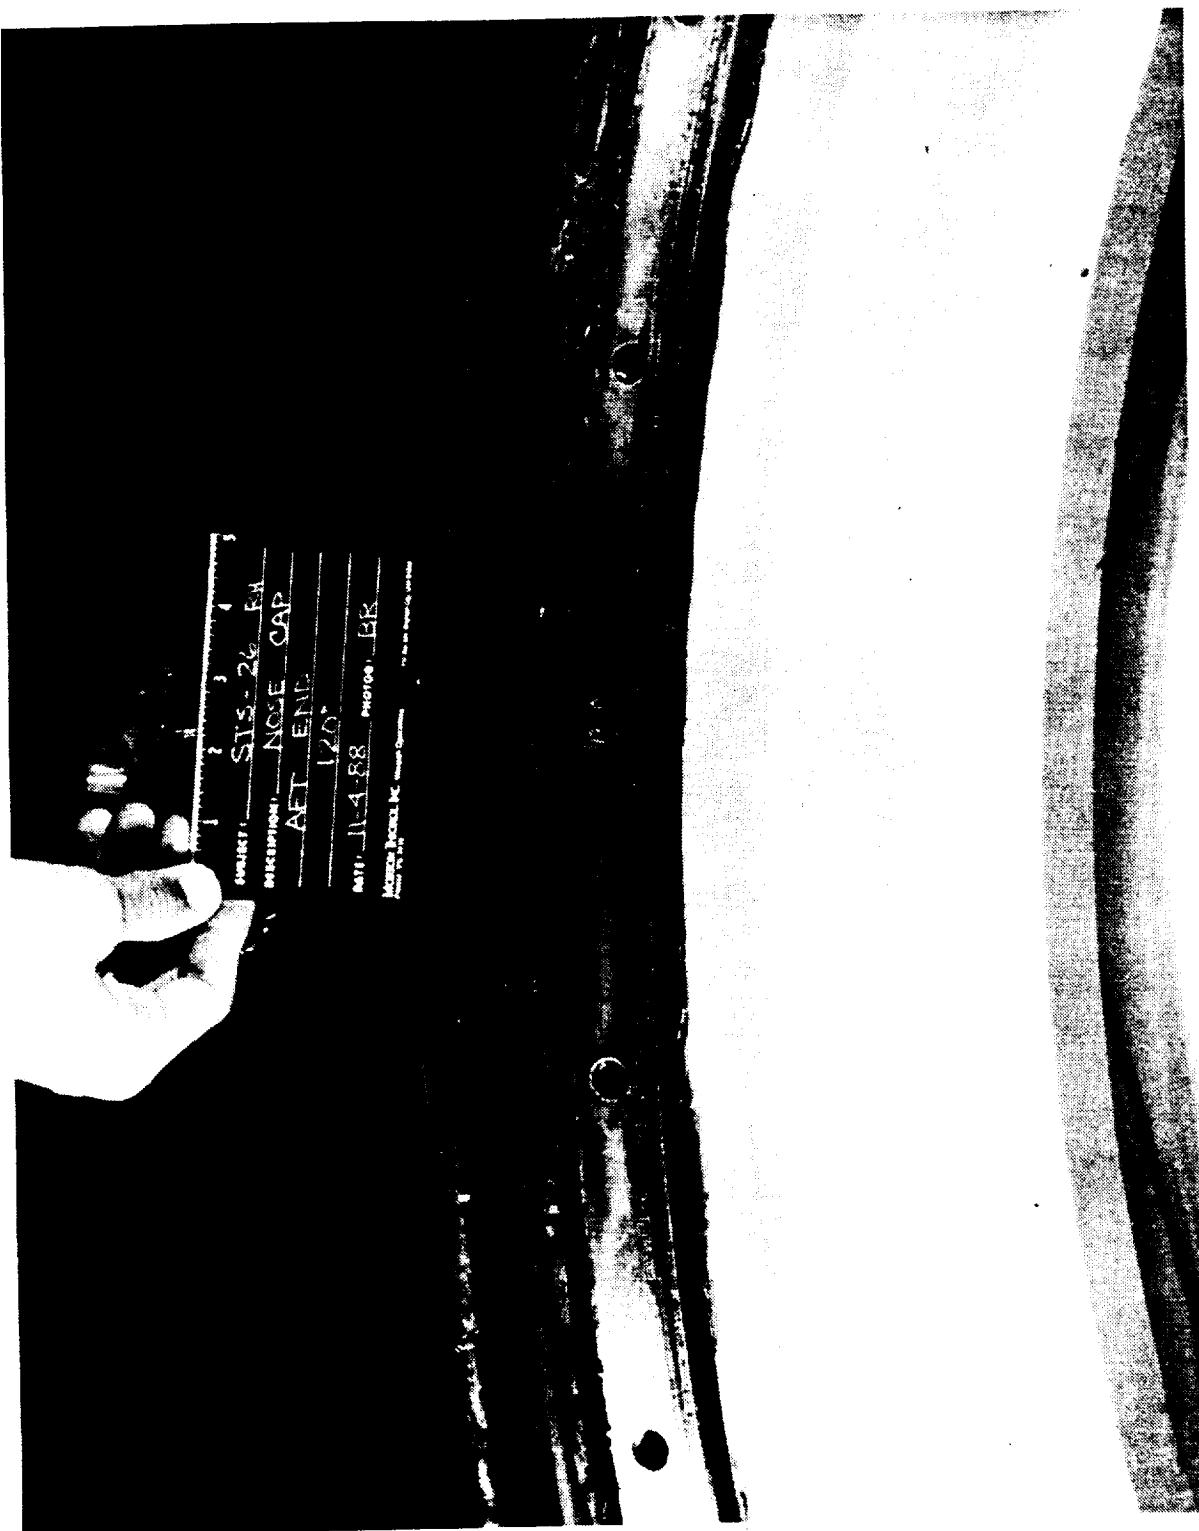
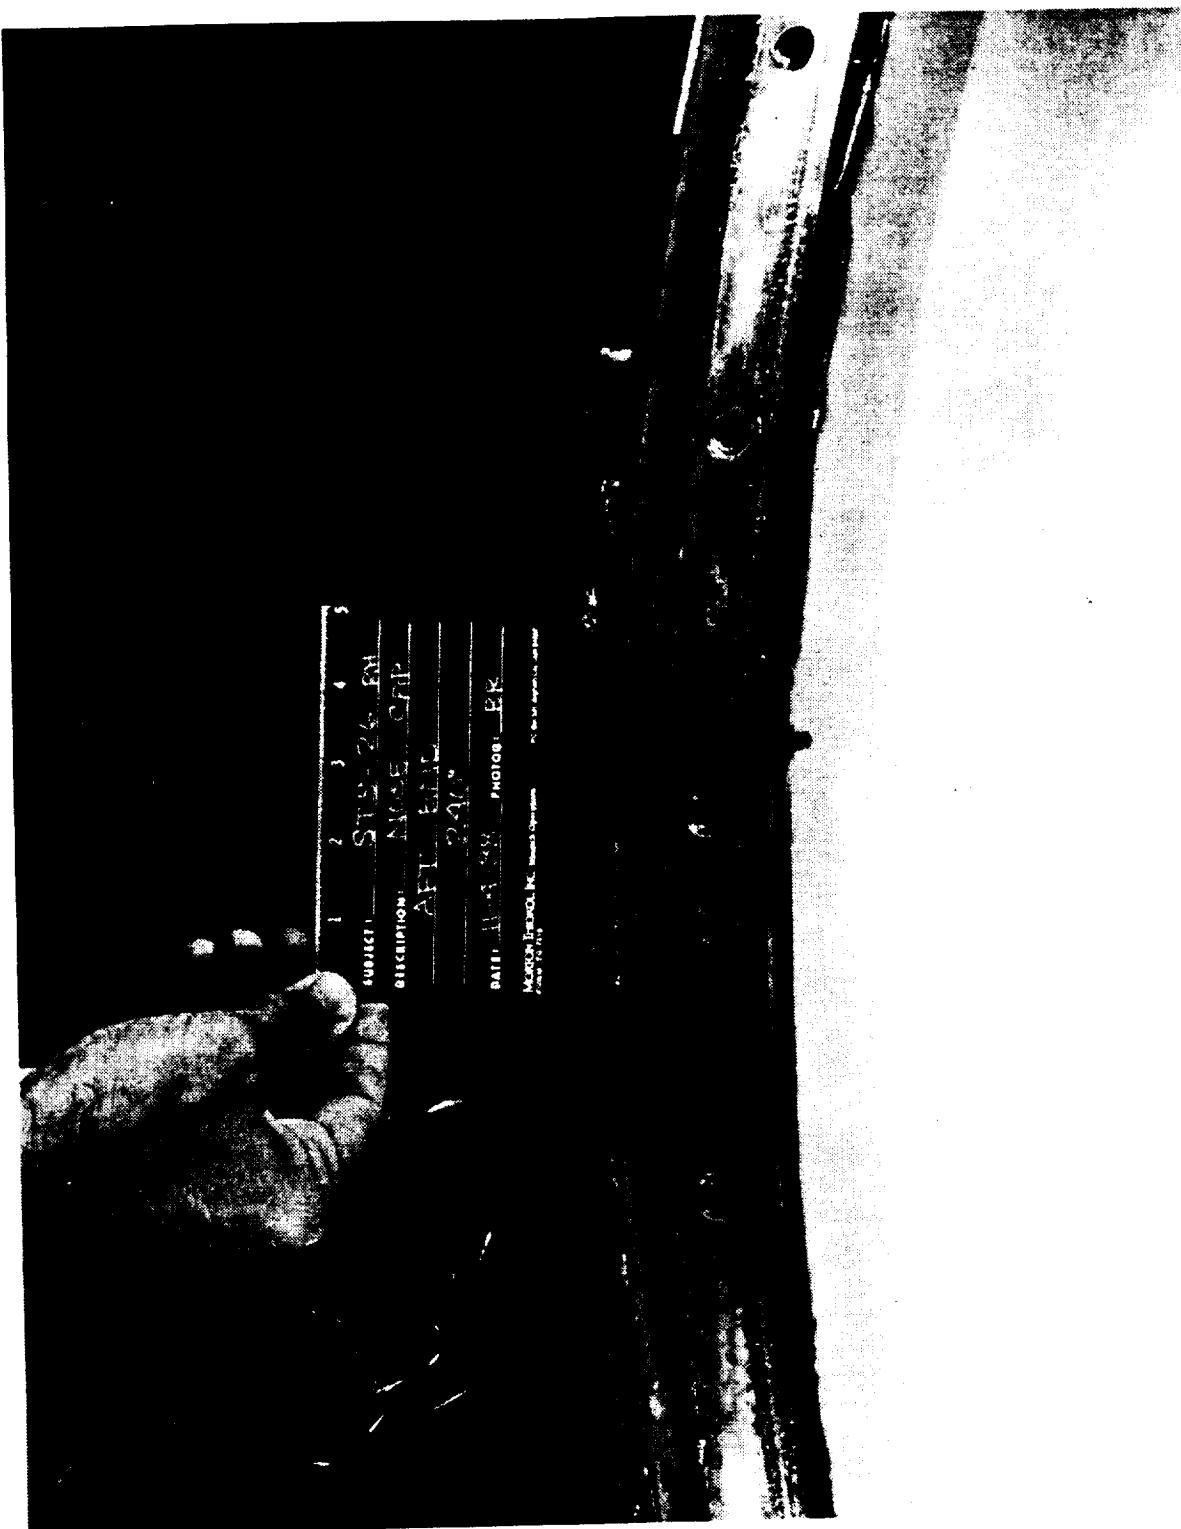
Figure 218 STS-26B Cowl-Forward End (0 Degrees)

A cross-sectioned view of the STS-26B nose inlet-to-bearing forward end ring-to-cowl joint is presented in Figure 217. Photographs of the post-flight joint are shown in Figures 218 through 226.

The RTV extended below the joint char line and filled the axial portion of the joint 360 degrees circumferentially. The radial bondline between the nose cap and cowl showed RTV mixed with the EA913 NA adhesive intermittently around the circumference. The adhesive was typically sandwiched between two layers of RTV. RTV filled approximately 80 percent of the axial bondline between the nose cap and bearing forward end ring. No RTV extended to the primary O-ring. One blow path was observed at 266 degrees and measured 0.5 inch wide circumferentially (Figure 227). The cowl SCP and nose cap GCP insulators showed no heat effect. The primary O-ring saw pressure, but there was no evidence of blowby, erosion, or heat effect. Soot was observed on the radial OD of the joint 360 degrees circumferentially. Soot reached up to the axial bolt holes on the nose inlet housing intermittently around the circumference, but did not reach the primary O-ring. Salt deposits were also noted on the radial OD surfaces.
