Characterization of Failure Processes in Tungsten Copper Composites Under Fatigue Loading Conditions

Yong-Suk Kim, Michael J. Verrilli, and Timothy P. Gabb
Lewis Research Center
Cleveland, Ohio

Prepared for the
International Symposium for Testing and Failure Analysis (ISTFA '89)
sponsored by ASM International
Los Angeles, California, November 6-10, 1989

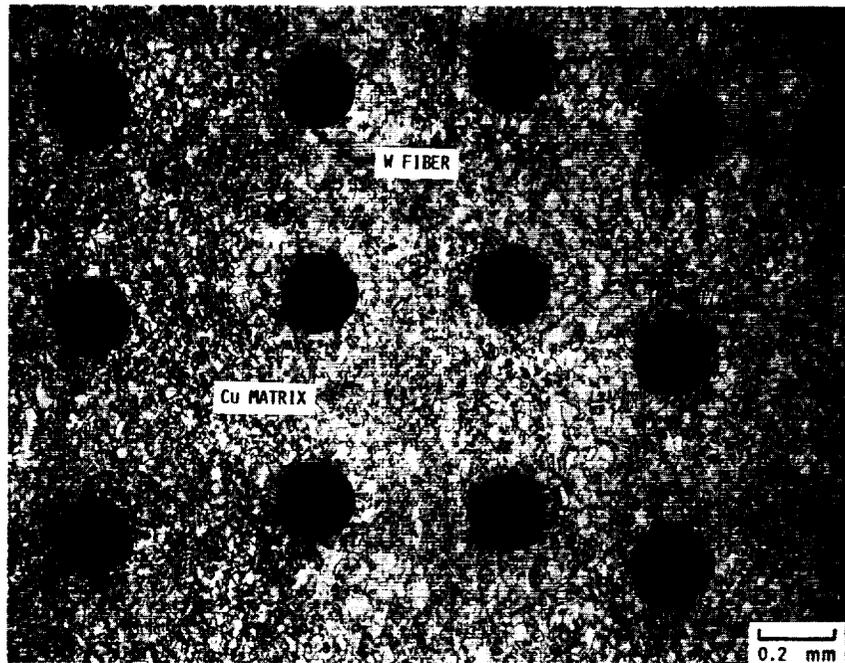
The microstructure of the as-received composite was examined with an optical microscope (fig. 2). Figure 2 shows both the Cu matrix and the periodically arranged W fibers. The interspacing between fibers is not regular, and the matrix grain size varies with locations. Figure 3 is an enlarged micrograph of the as-received composite. The uneven grain size distribution in the Cu matrix is well displayed. The grain sizes are in the range of 8 to 15 μm . Usually, finer grains are observed near the fiber, whereas large grains occur between fibers. No interface reaction products were observed, which is consistent with other studies (refs. 1 to 10).

FIGURE 2. - AS-RECEIVED COMPOSITE SHOWING PERIODICALLY ARRANGED W FIBERS IN THE Cu MATRIX.

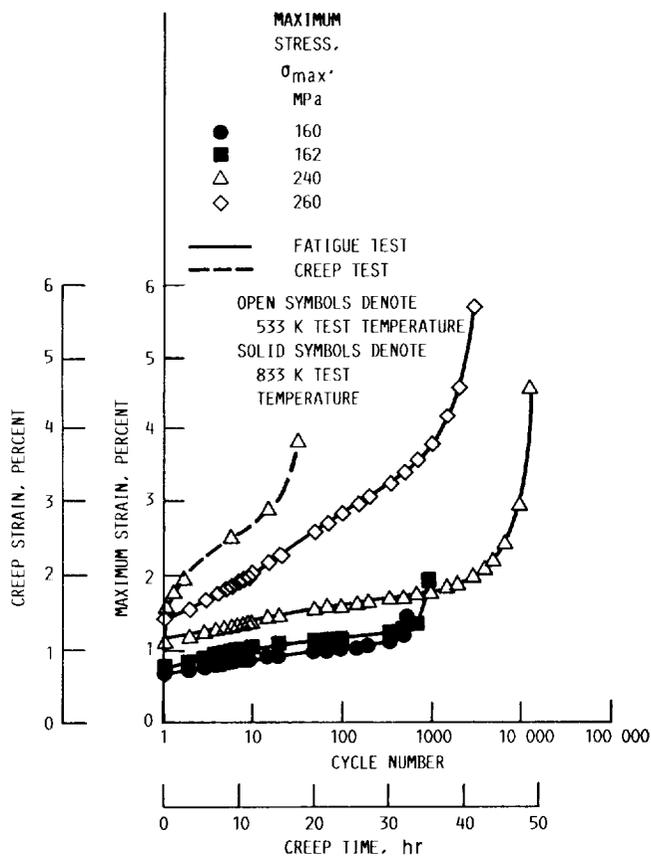
Figure 4 shows some of the fatigue test results as a linear-log plot of the maximum cyclic strain per cycle versus the applied number of cycles. Test results from both 533 and 833 K are plotted together. At both temperatures the maximum strain in each cycle increases (ratchets) continuously until the specimen fails. This behavior is analogous to typical secondary and tertiary strain versus time behavior in the creep of a monolithic material. For comparison, the results of a creep test for the composite at 533 K is also shown in figure 4, as a linear-linear plot of strain versus time. This similarity in behavior will be shown to extend to the matrix failure mechanism as well. The total failure strain increases with increasing maximum cyclic stress at both temperatures. The total failure strain of the specimens tested at 533 K is larger than that tested at 833 K. Additional mechanical test results are reported elsewhere (ref. 11).

FIGURE 4. - MAXIMUM CYCLE STRAIN VERSUS NUMBER OF CYCLES FOR 9 vol % W-REINFORCED Cu TESTED UNDER LOAD-CONTROLLED FATIGUE AT 533 AND 833 K. FOR COMPARISON, A CREEP CURVE OF THE COMPOSITE AT 533 K AND AT 240 MPa IS ALSO SHOWN.
