TWR-17541-5

Flight Motor Set 360L002 (STS-27R) Final Report

Volume V (Nozzle Component)

STS-27 POST-TEST NOZZLE PERFORMANCE EVALUATION REPORT

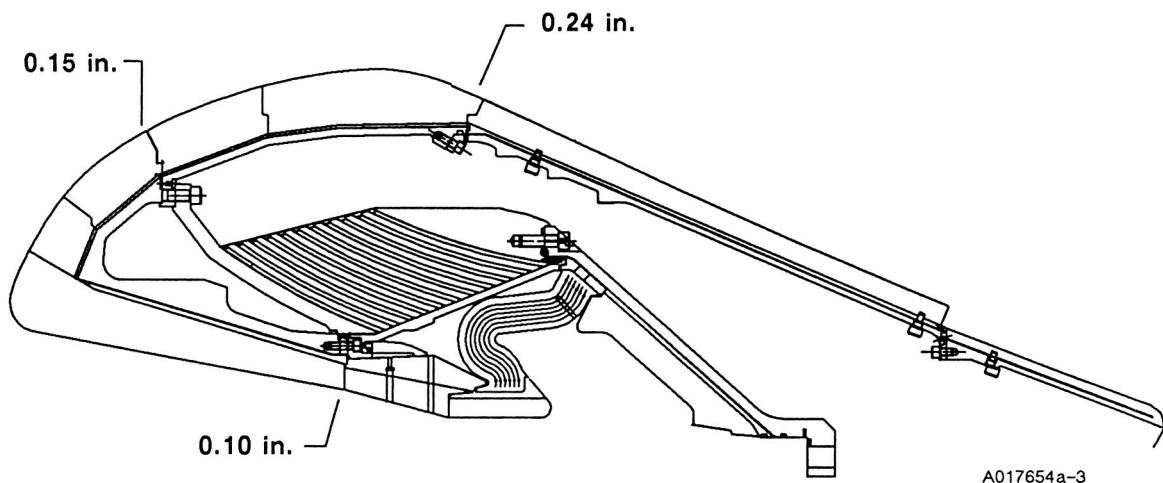
Figure 4.1 STS-27A Joint Flow Surface Gap Openings

Descriptions of the five STS-27A nozzle joints follows. The joint flow surface gap openings between each nozzle subassembly are summarized in Figure 4.1. All gaps were typical of previous static test and flight nozzles.

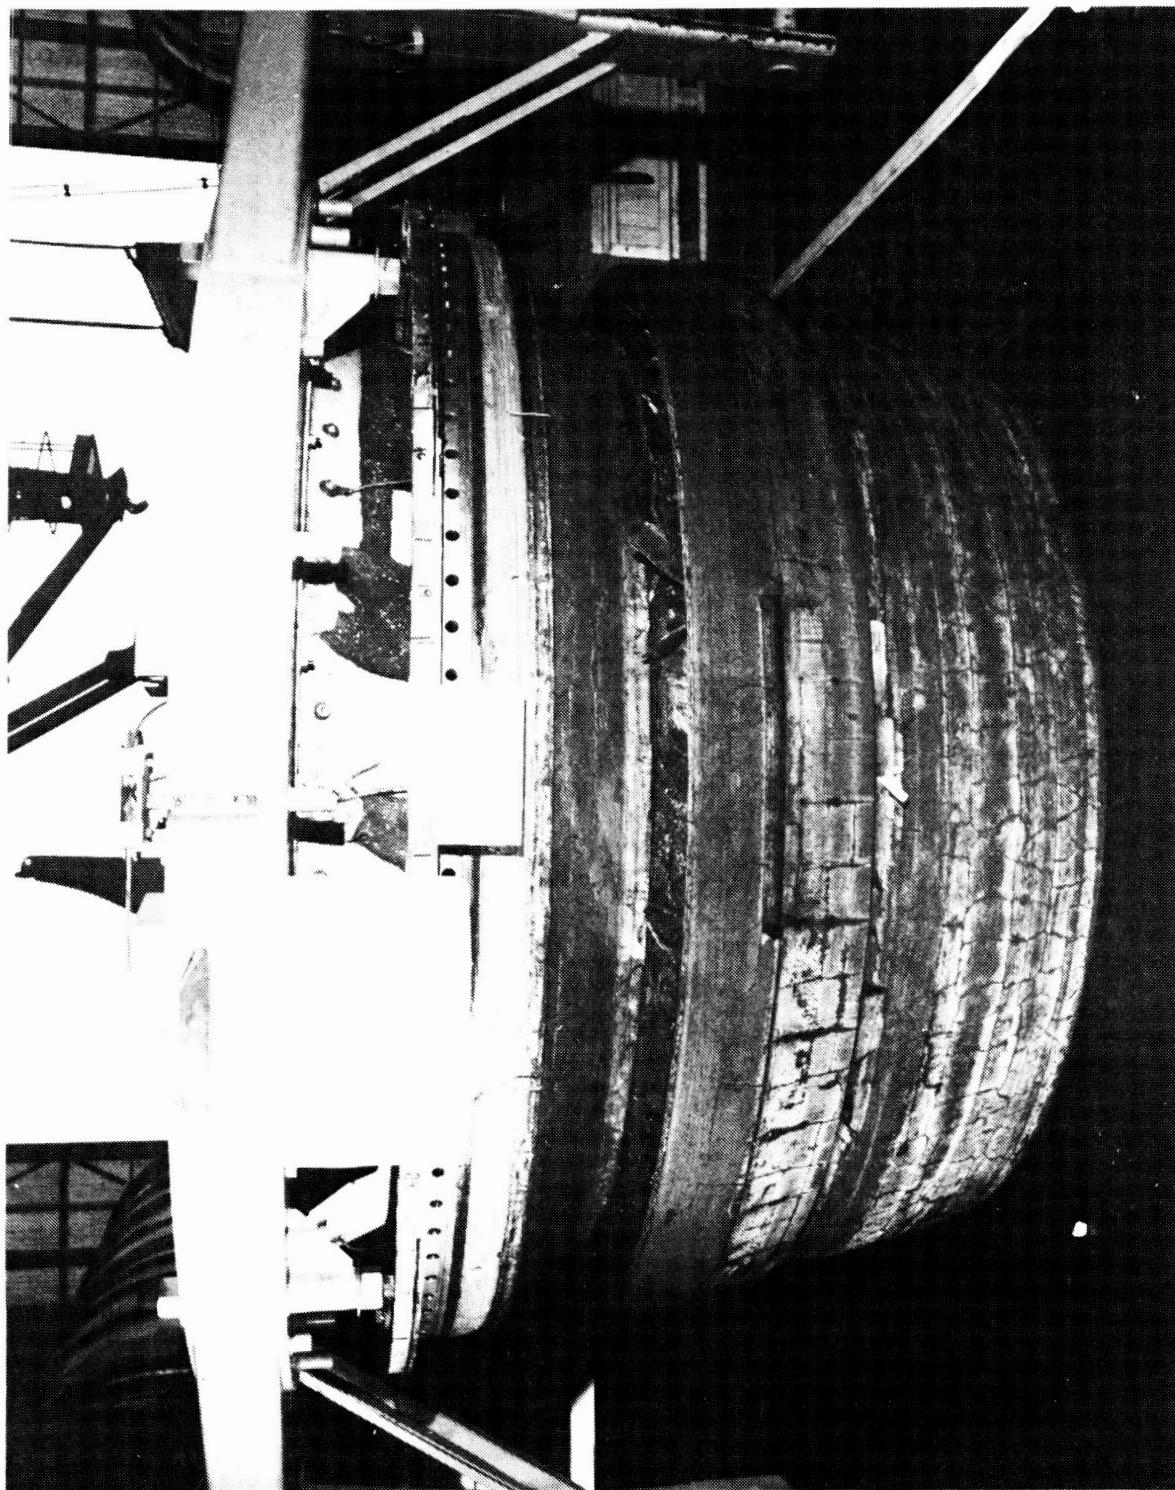
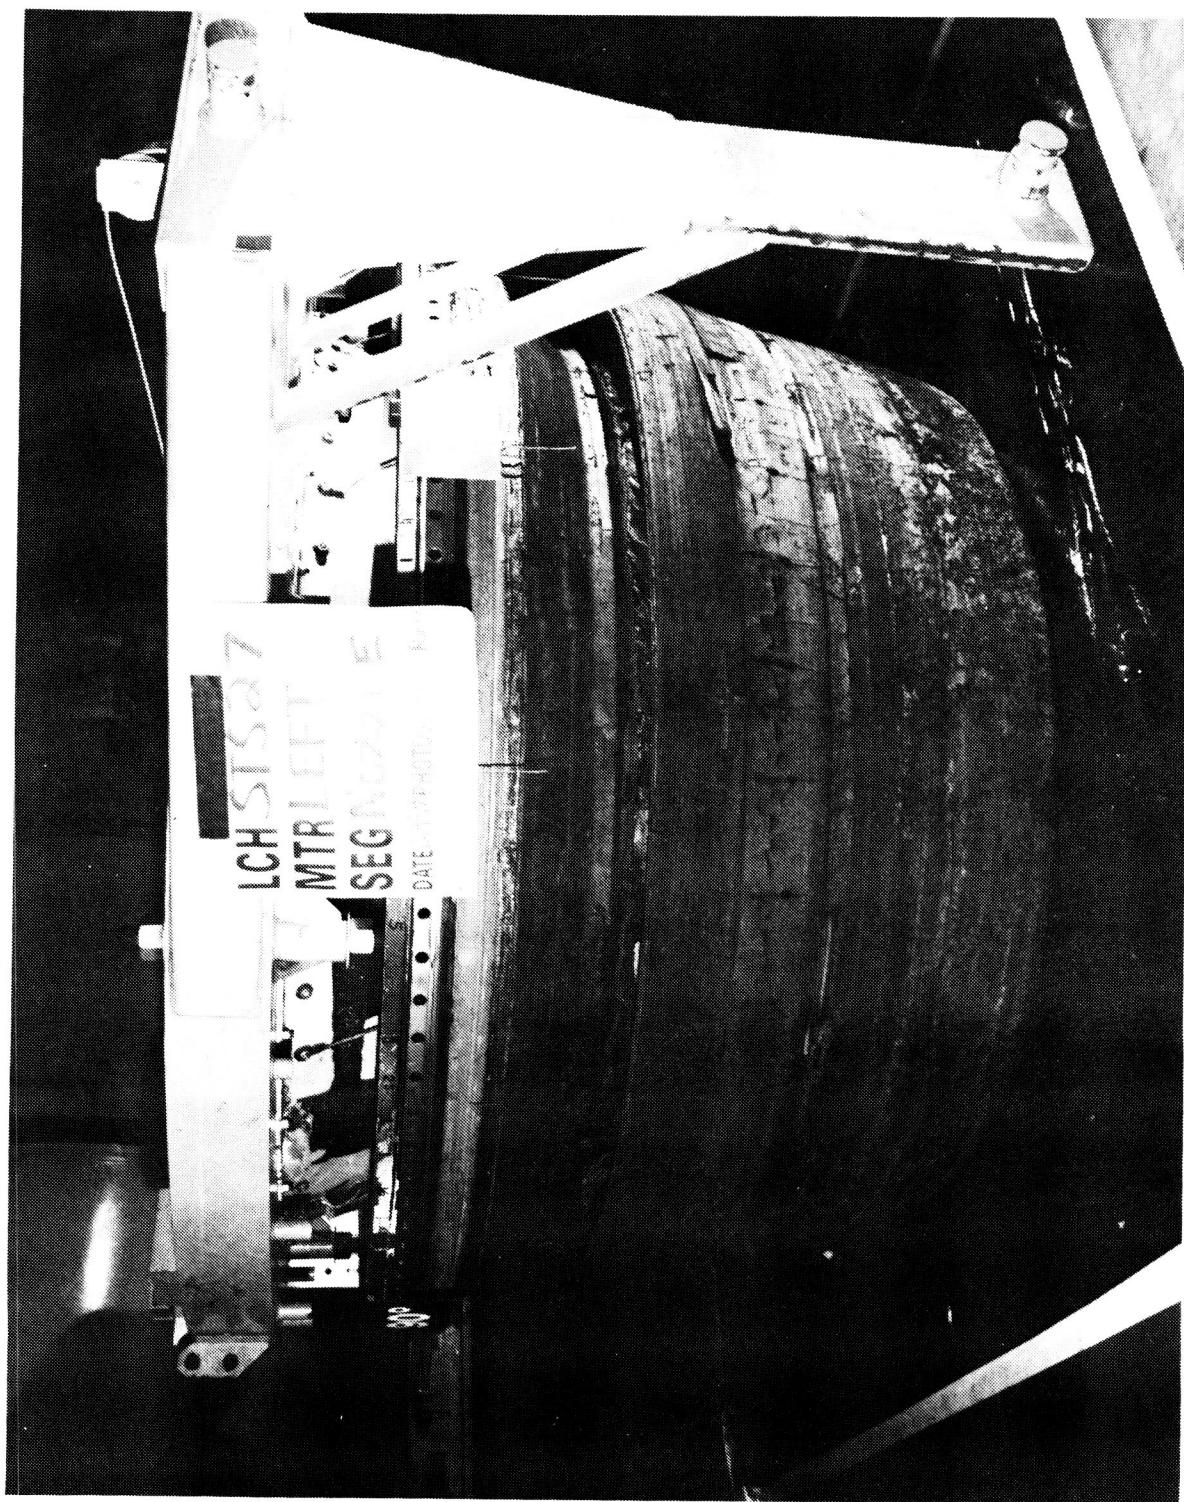
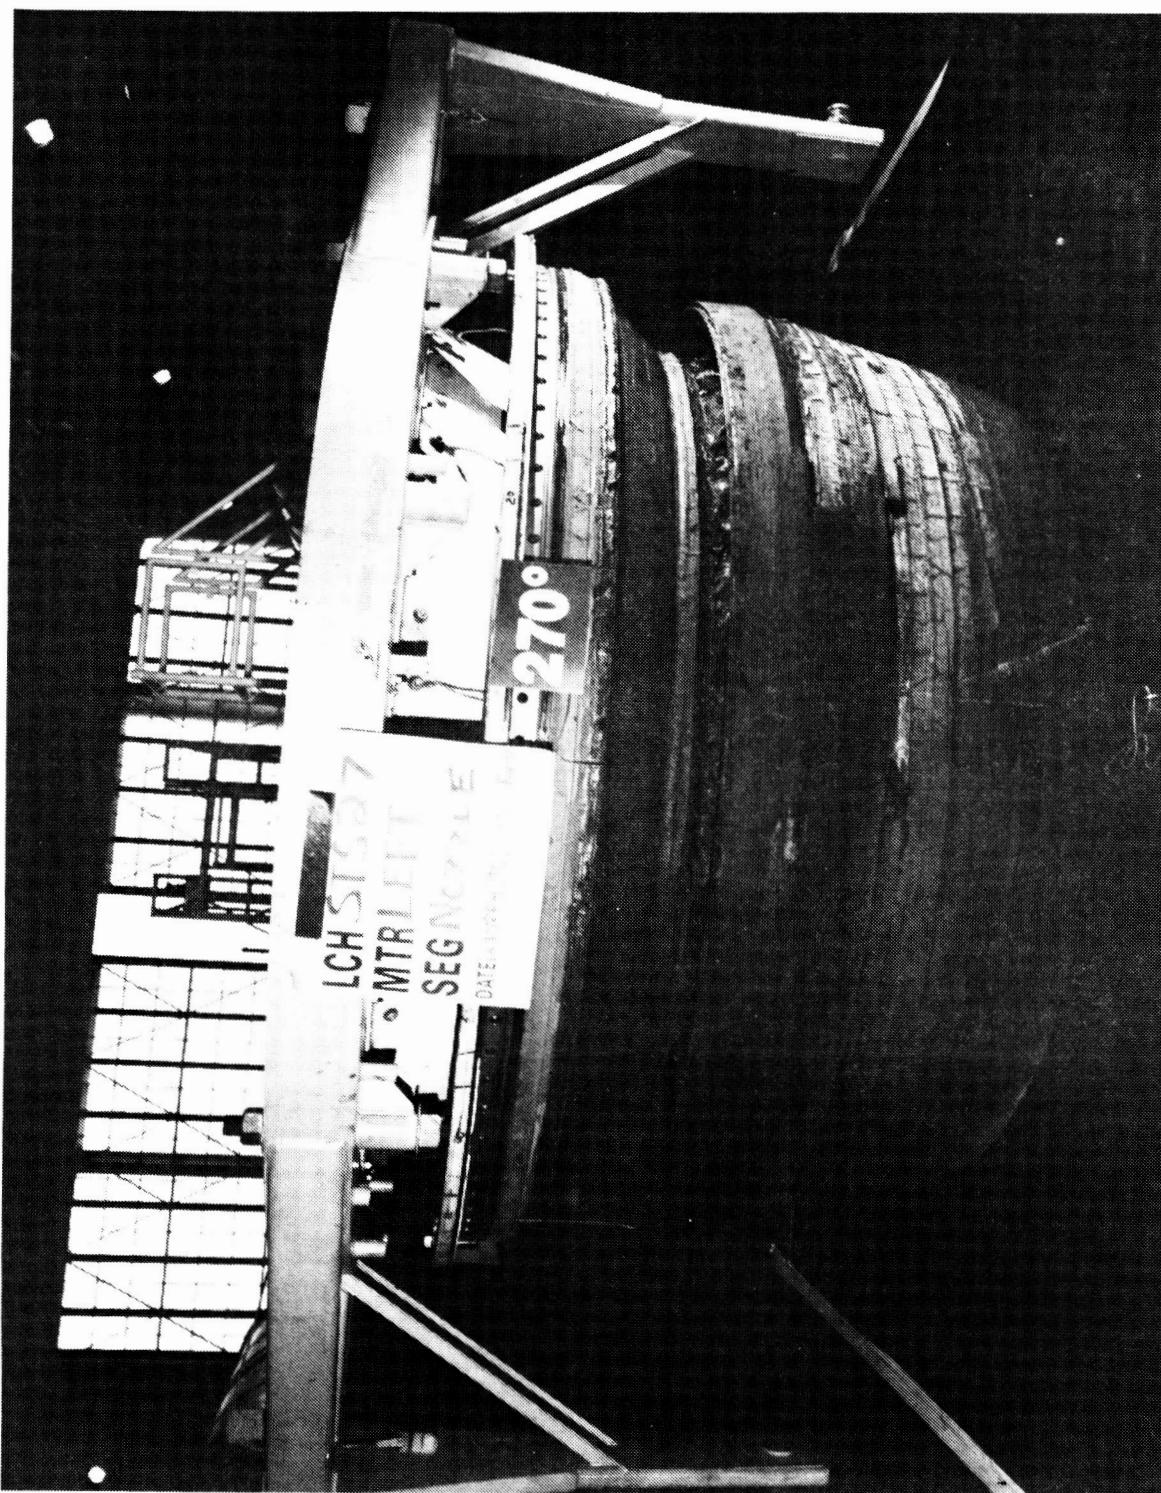
Overall views of the STS-27A fixed housing assembly are shown in Figures 4.2 through 4.4.

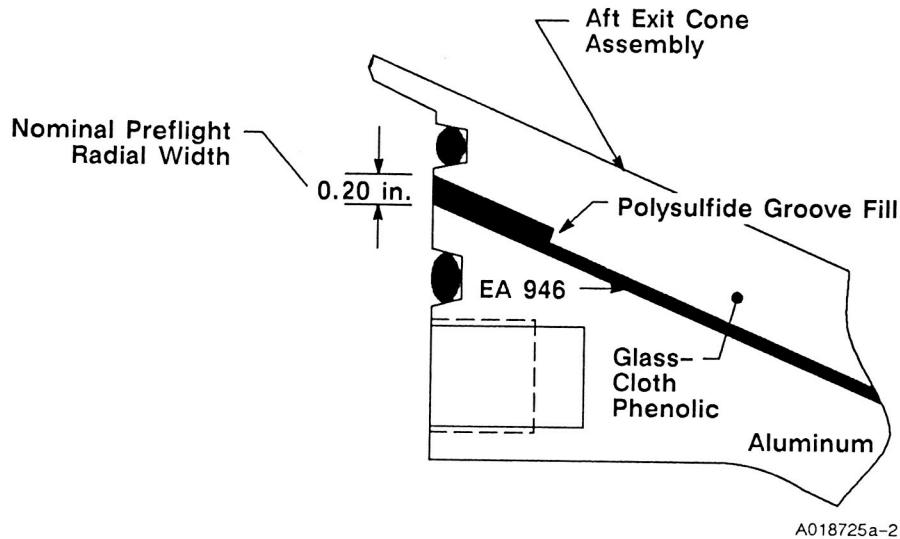
Figure 4.9 STS-27A Polysulfide Groove Fill Post-Flight Radial Width Measurements

Angular Location (deg)	Radial Width (in.)
0	0.18
30	0.17
60	0.18
90	0.18
120	0.18
150	0.18
180	0.17
210	0.18
240	0.18
270	0.17
300	0.18
330	0.18

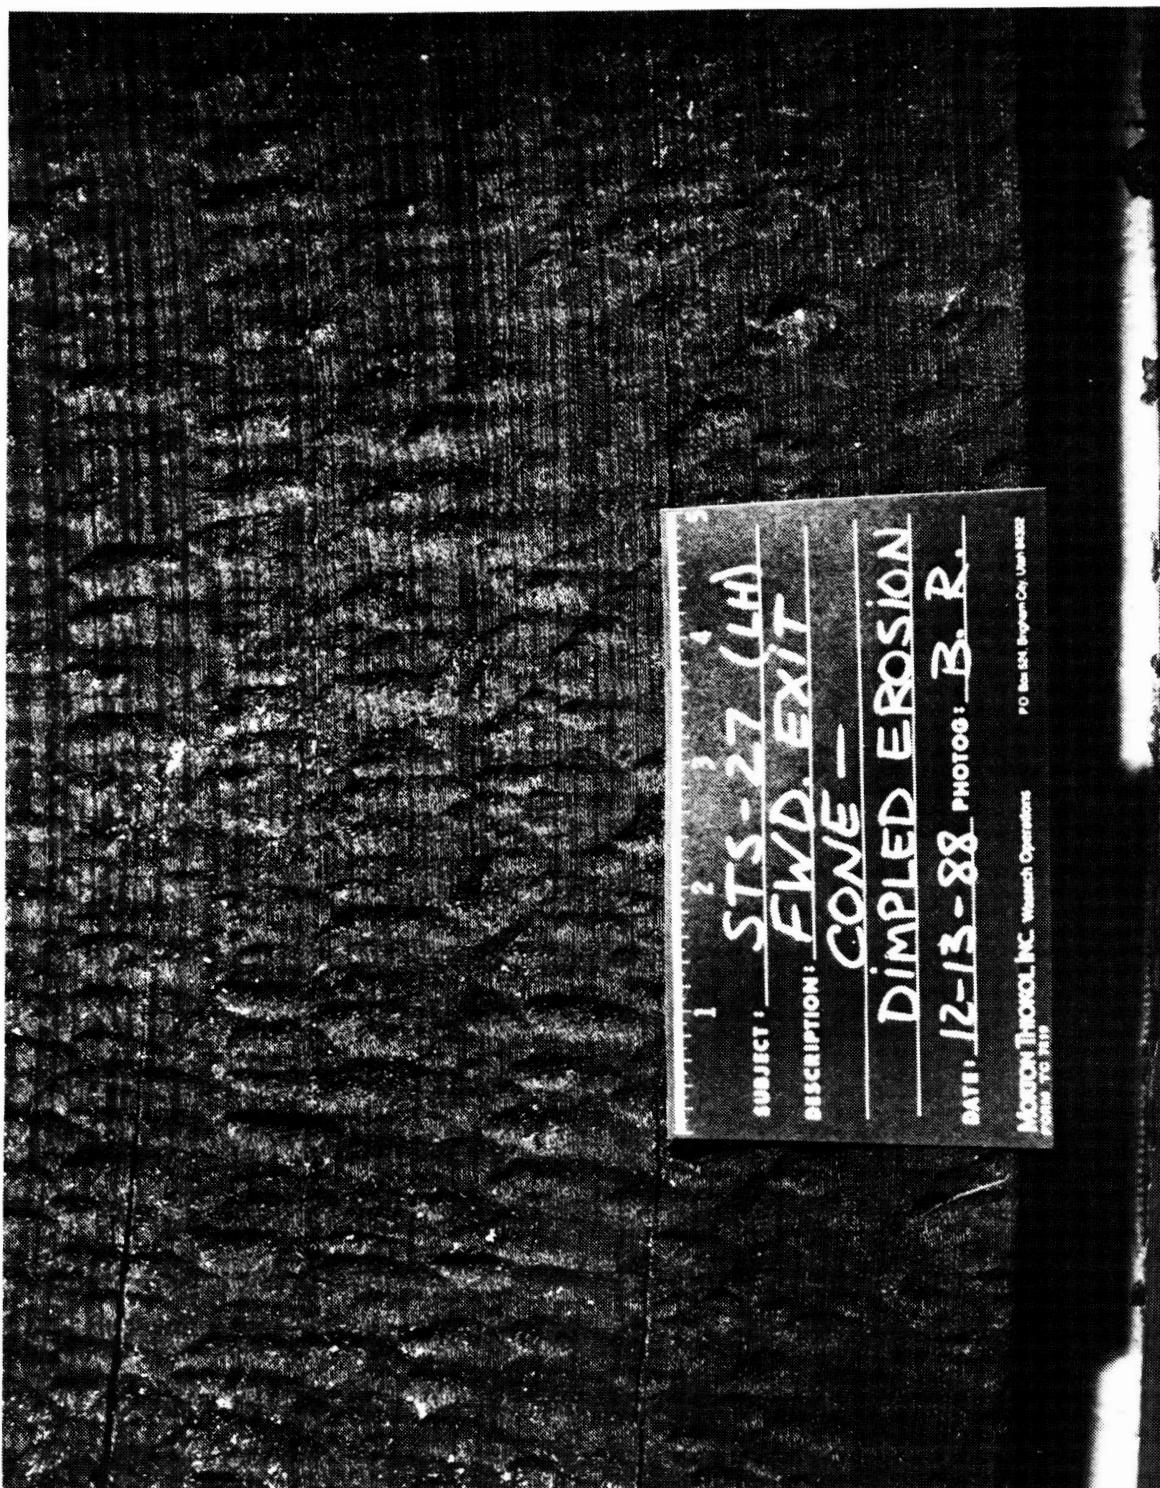
Figure 4.13 STS-27A Forward Exit Cone Dimpled Erosion Pattern

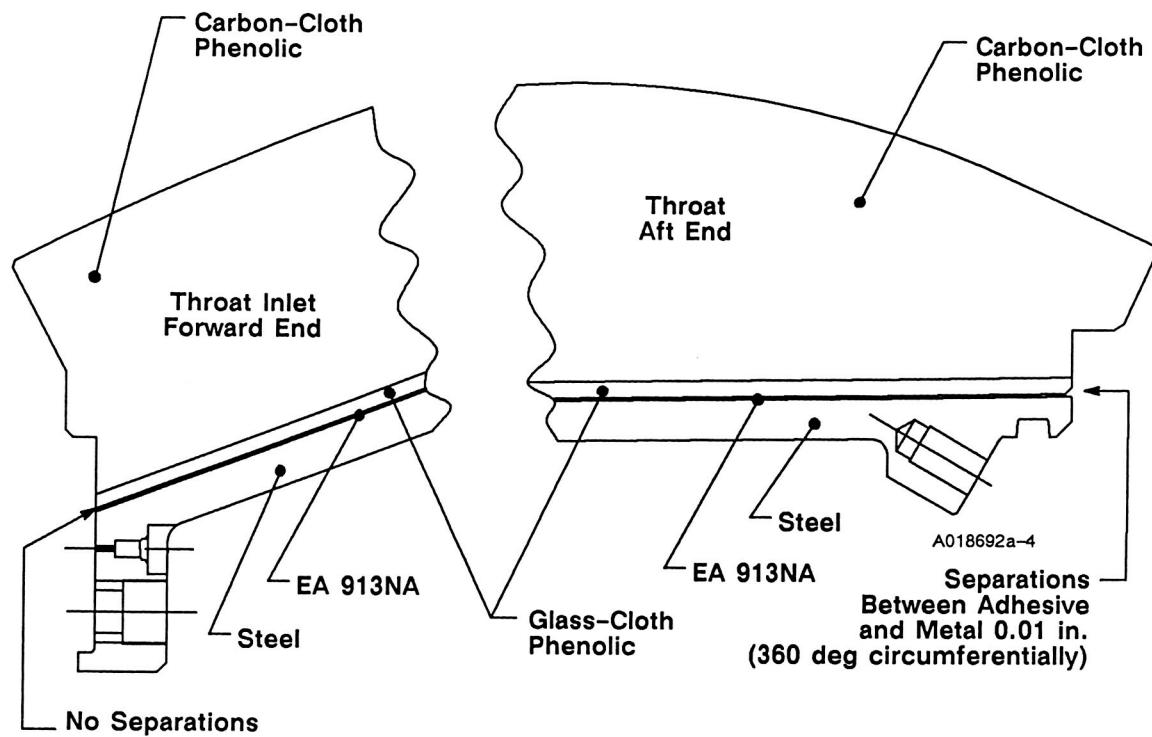
Figure 4.16 STS-27A Throat Assembly Separations

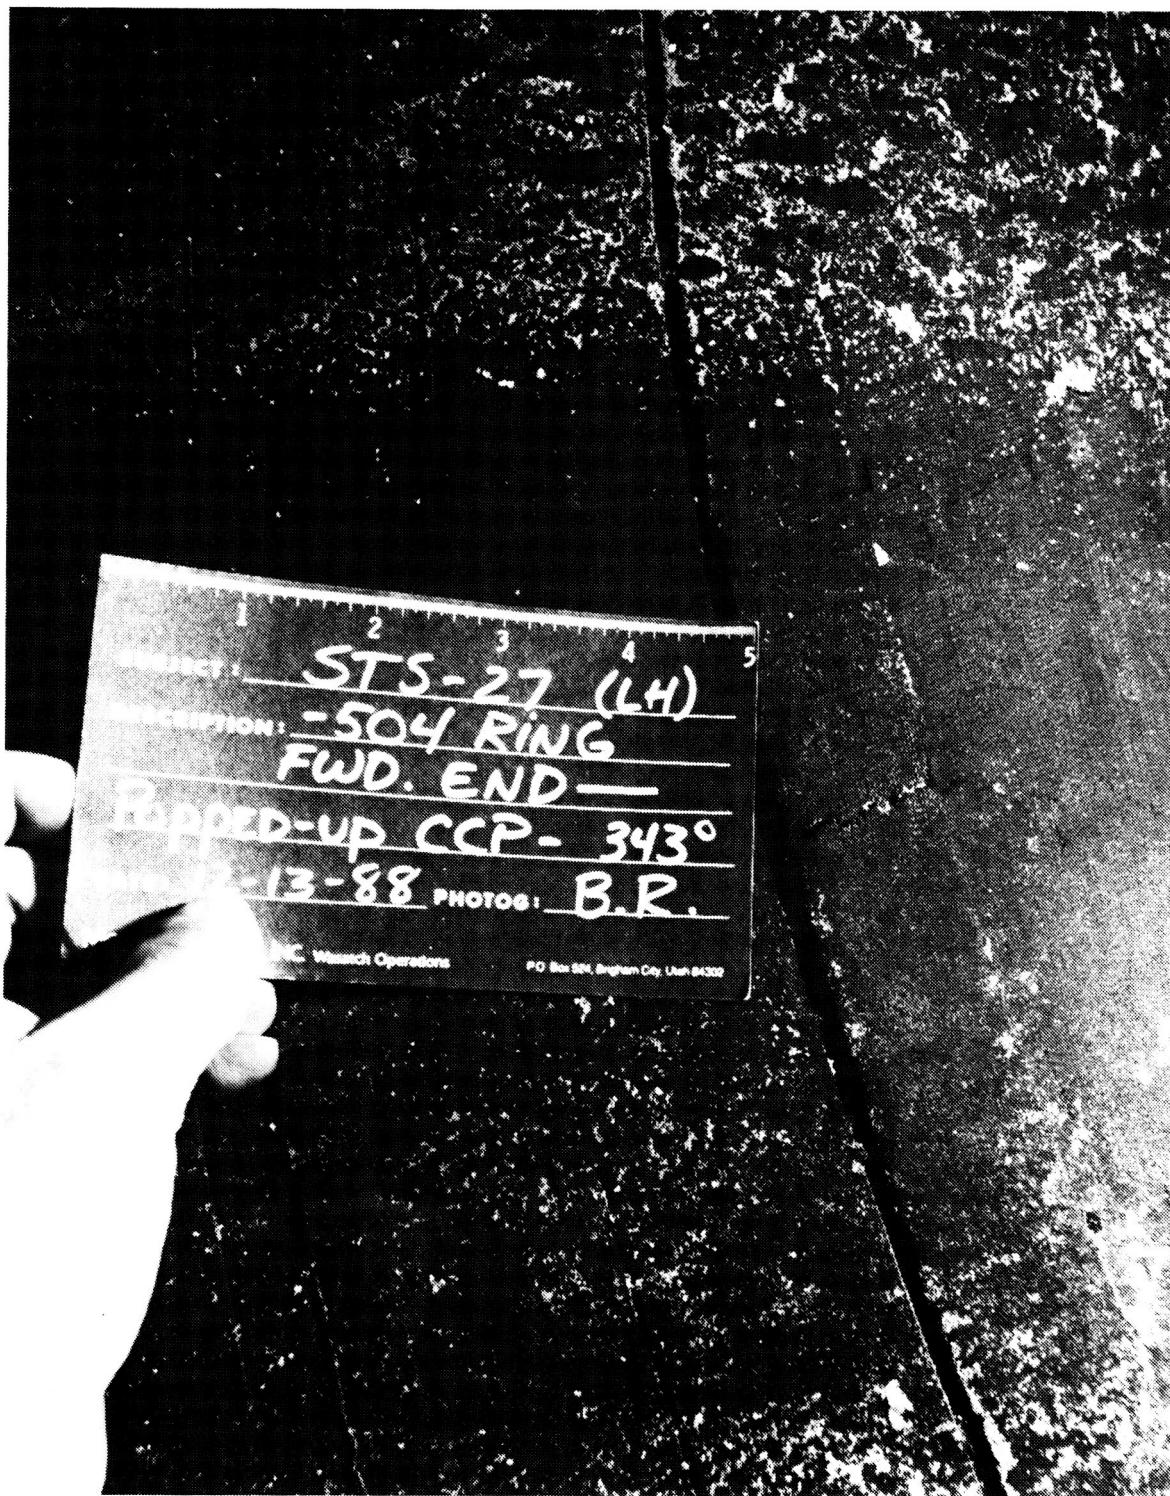
Figure 4.20 STS-27A -504 Ring Forward End Popped-Up Charred CCP
(343 degrees)

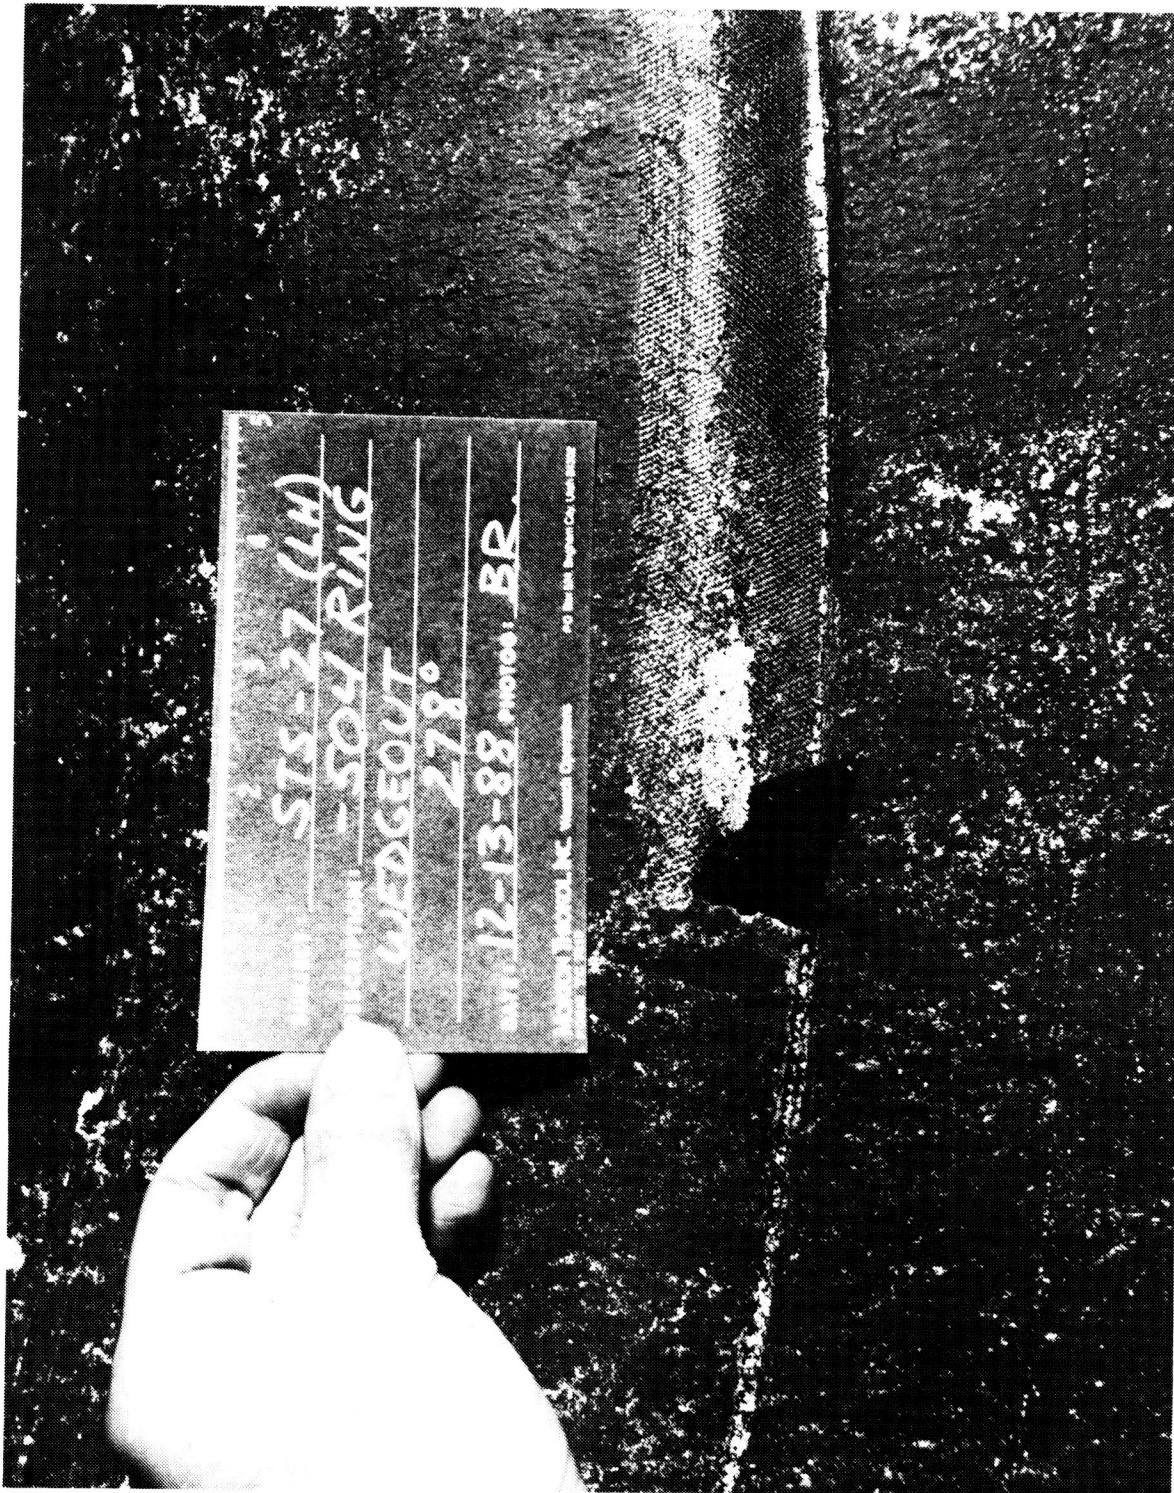
Figure 4.21 STS-27A -504 Ring Forward End Wedged Out Charred CCP
(278 degrees)

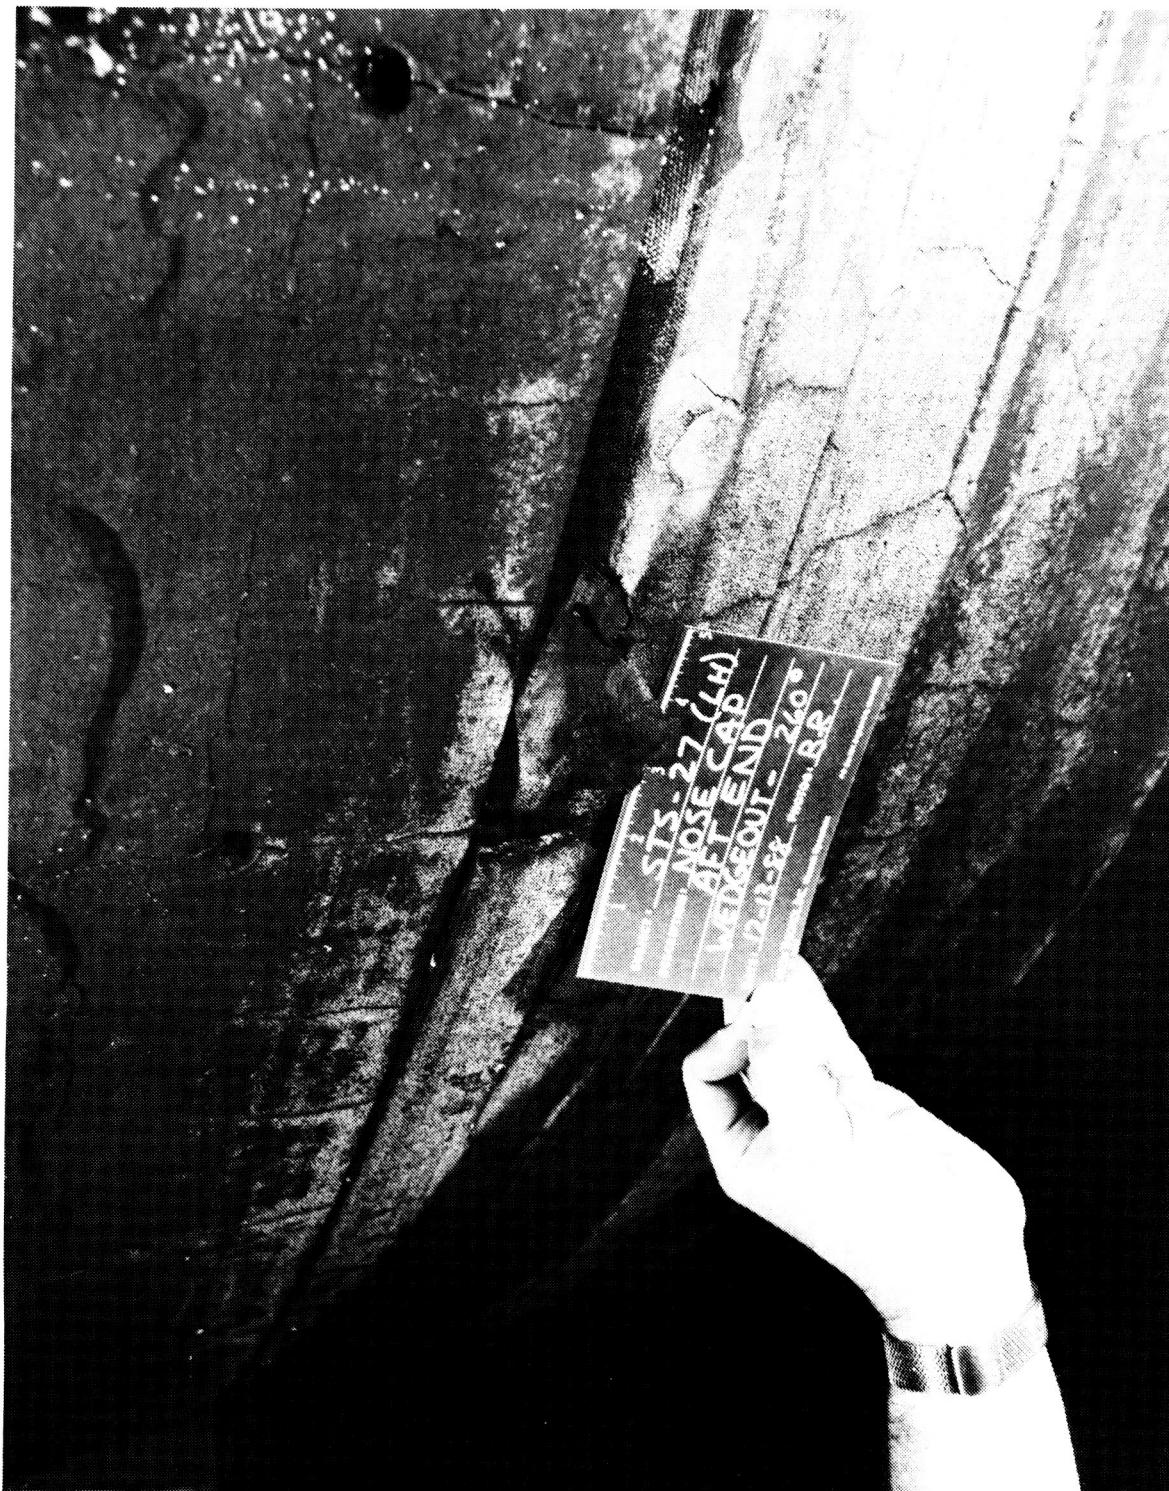
Figure 4.22 STS-27A Nose Cap Aft End Wedgeout (260 degrees)

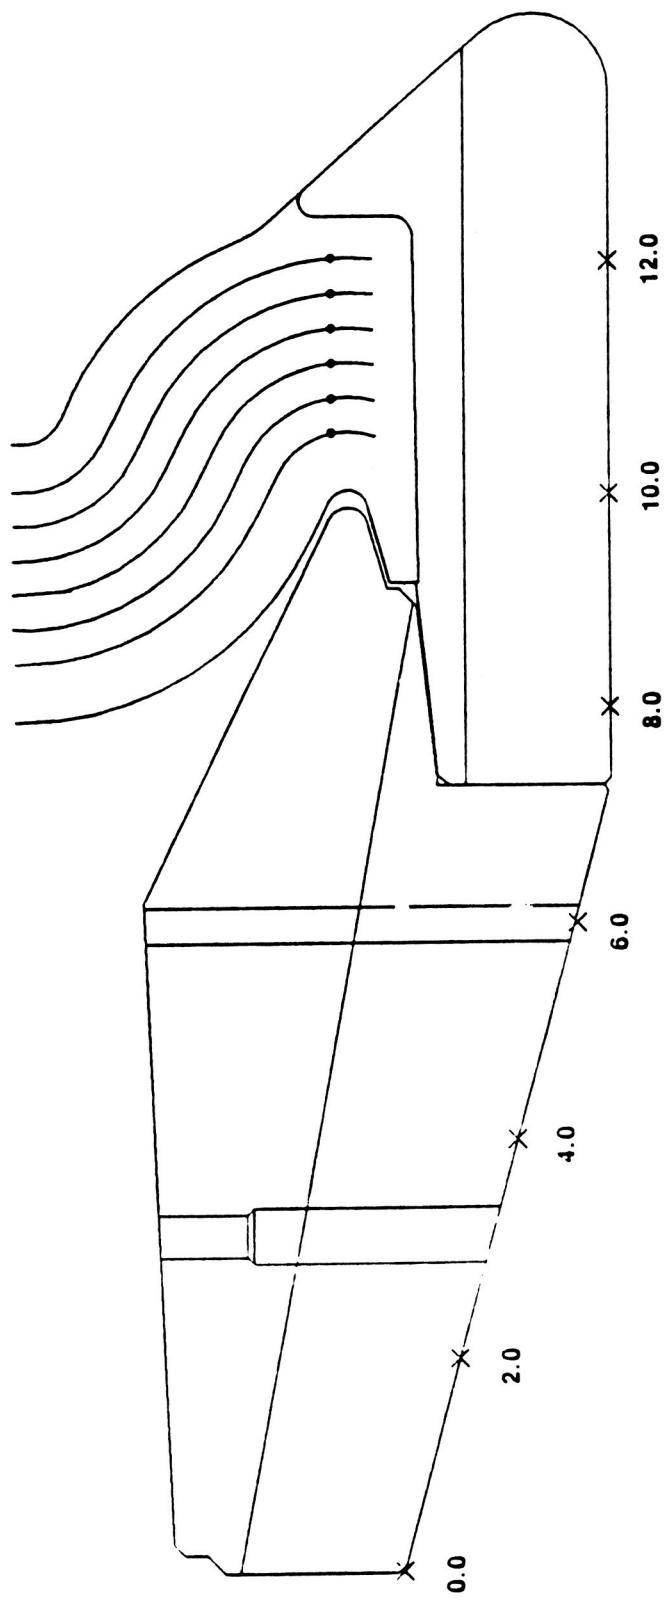
Figure 4.40 Cowl Ring and Outer Boot Ring Erosion Measurement Stations

Table 4.5 presents the STS-27A cowl/outer boot ring char and erosion data and performance margins of safety. The margins of safety in this table were based on measured erosion, corresponding measured char adjusted to the end of action time, and RSRM minimum liner thicknesses. Figure 4.40 shows the locations of the measurement stations on the cowl and outer boot ring. All margins of safety were positive with a worst case of 0.20 at Station 1 (0 degrees).

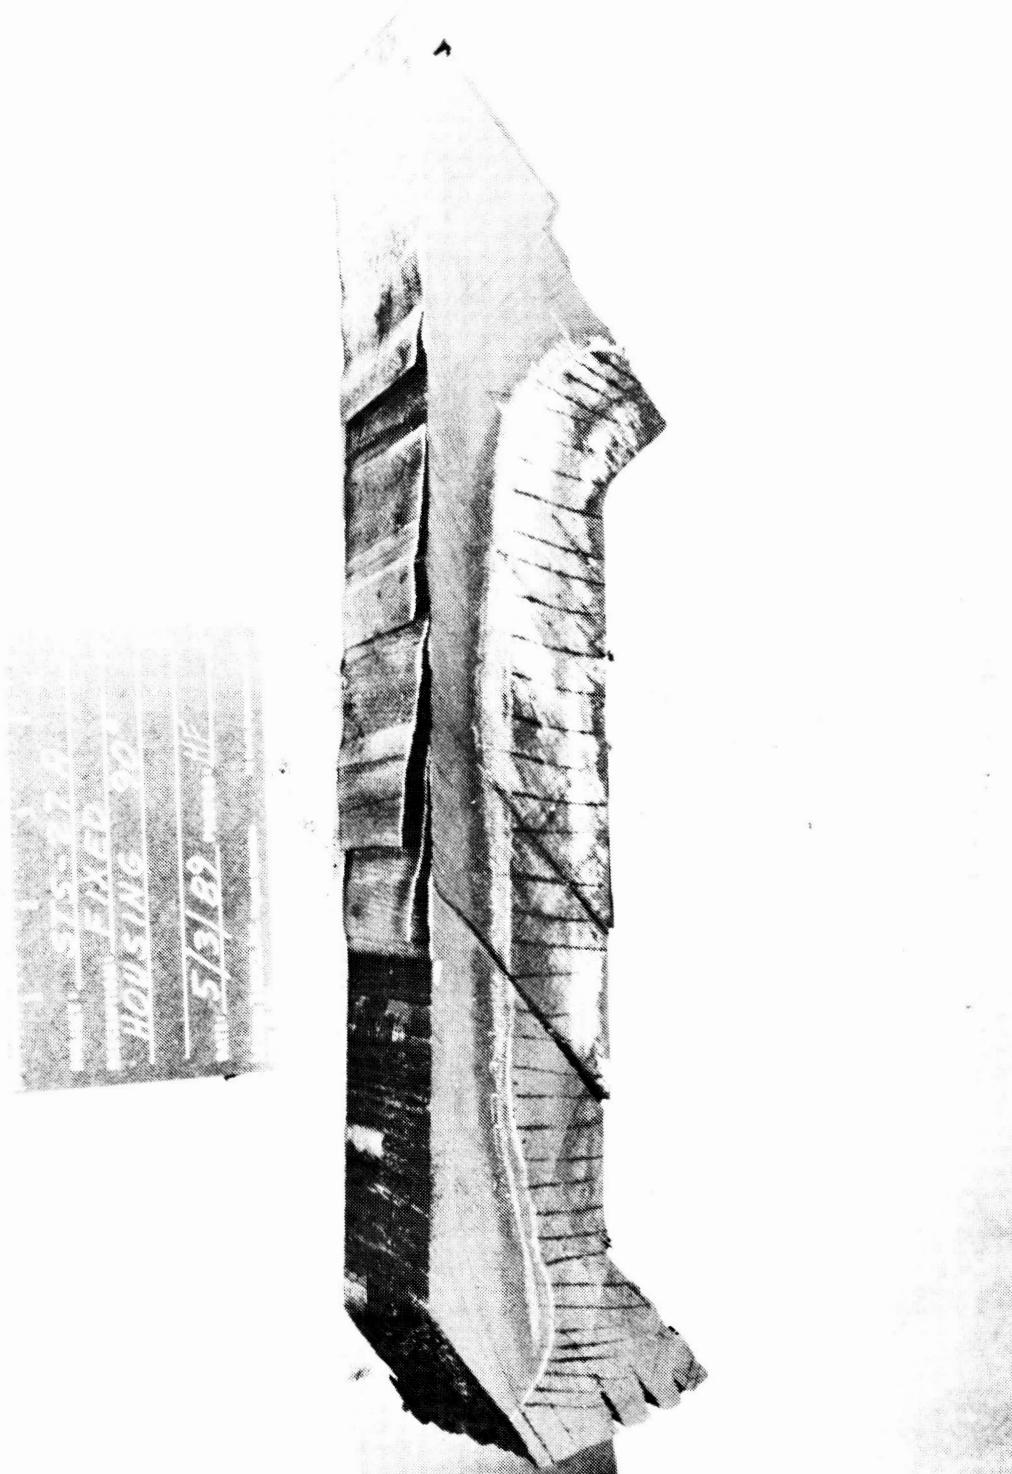
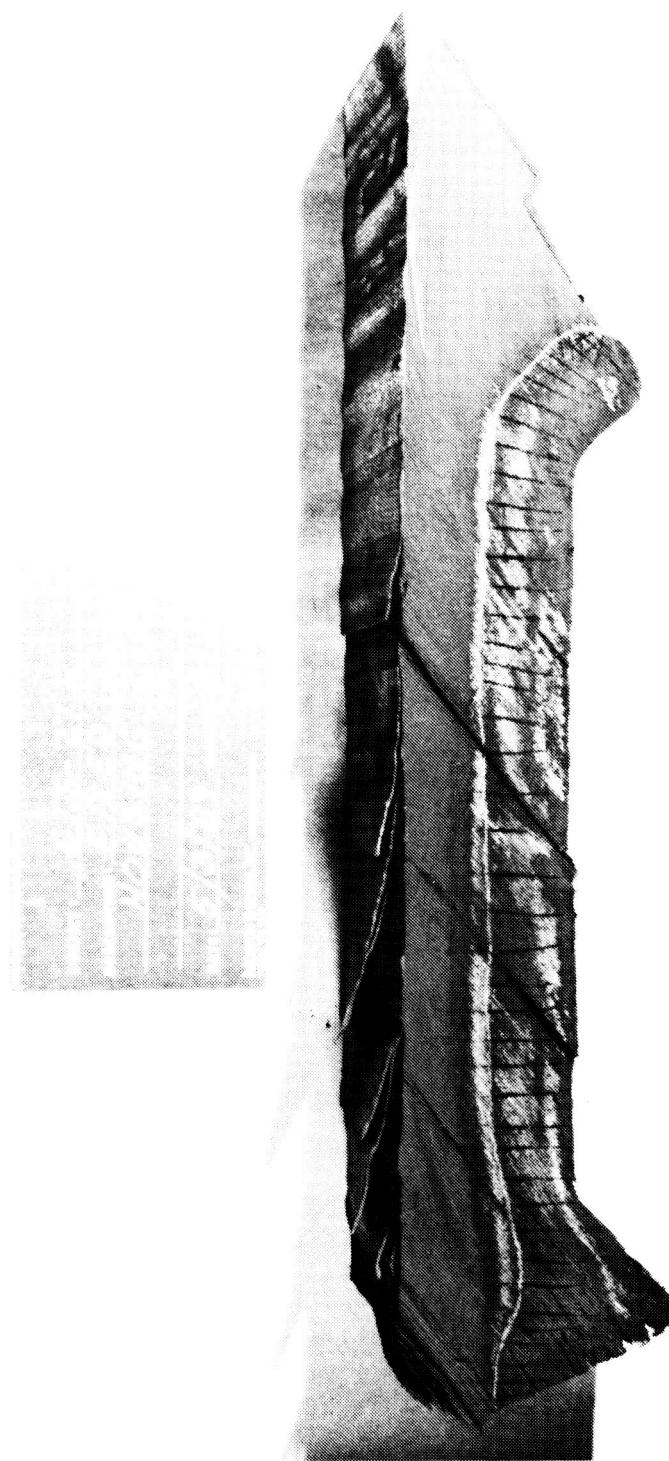
Sectioned views of the fixed housing liner and insulator are shown in Figures 4.43 and 4.44. Sectioning of the liner revealed CCP-to-GCP separations occurring intermittently along the length and around the circumference. Separations within the GCP insulator were also observed. These separations are typical observations and resulted from post-burn heat soak and cooldown liner shrinkage, and/or from washout and sectioning operations. Sectioning also revealed surface delaminations extending into virgin CCP material. There was no evidence of heat effect within the virgin material.

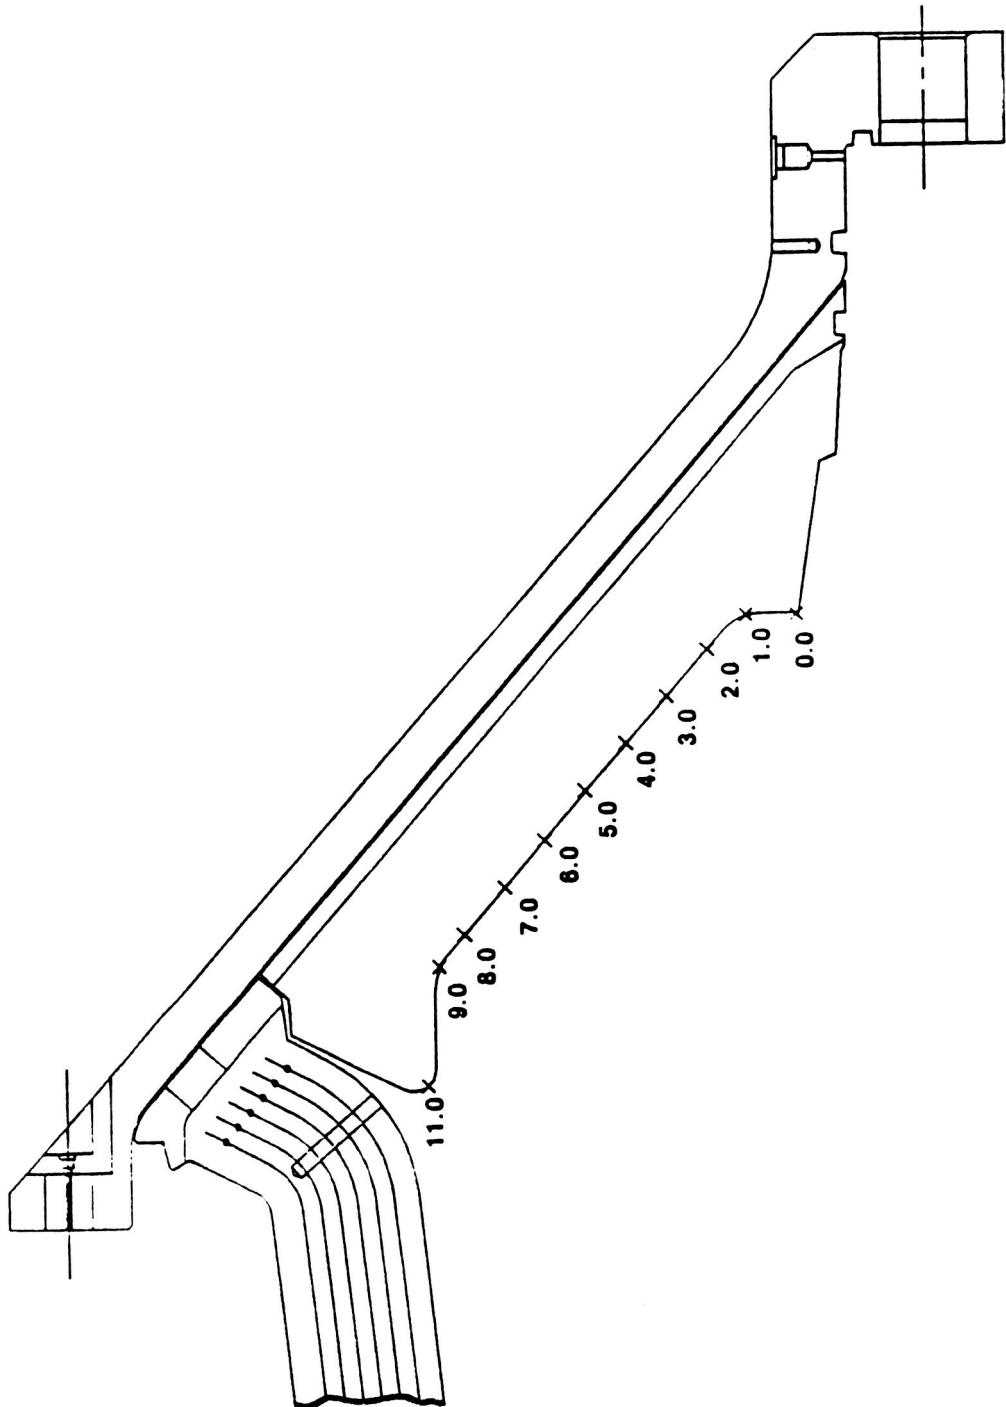
Figure 4.45 Fixed Housing Liner Erosion Measurement Station

to the end of action time, and RSRM minimum liner thicknesses. Figure 4.45 shows the locations of the measurement stations on the fixed housing insulation. All margins of safety were positive with a worst case of 0.66 at Station 3 (180 degrees) and at Station 11 (90 degrees).

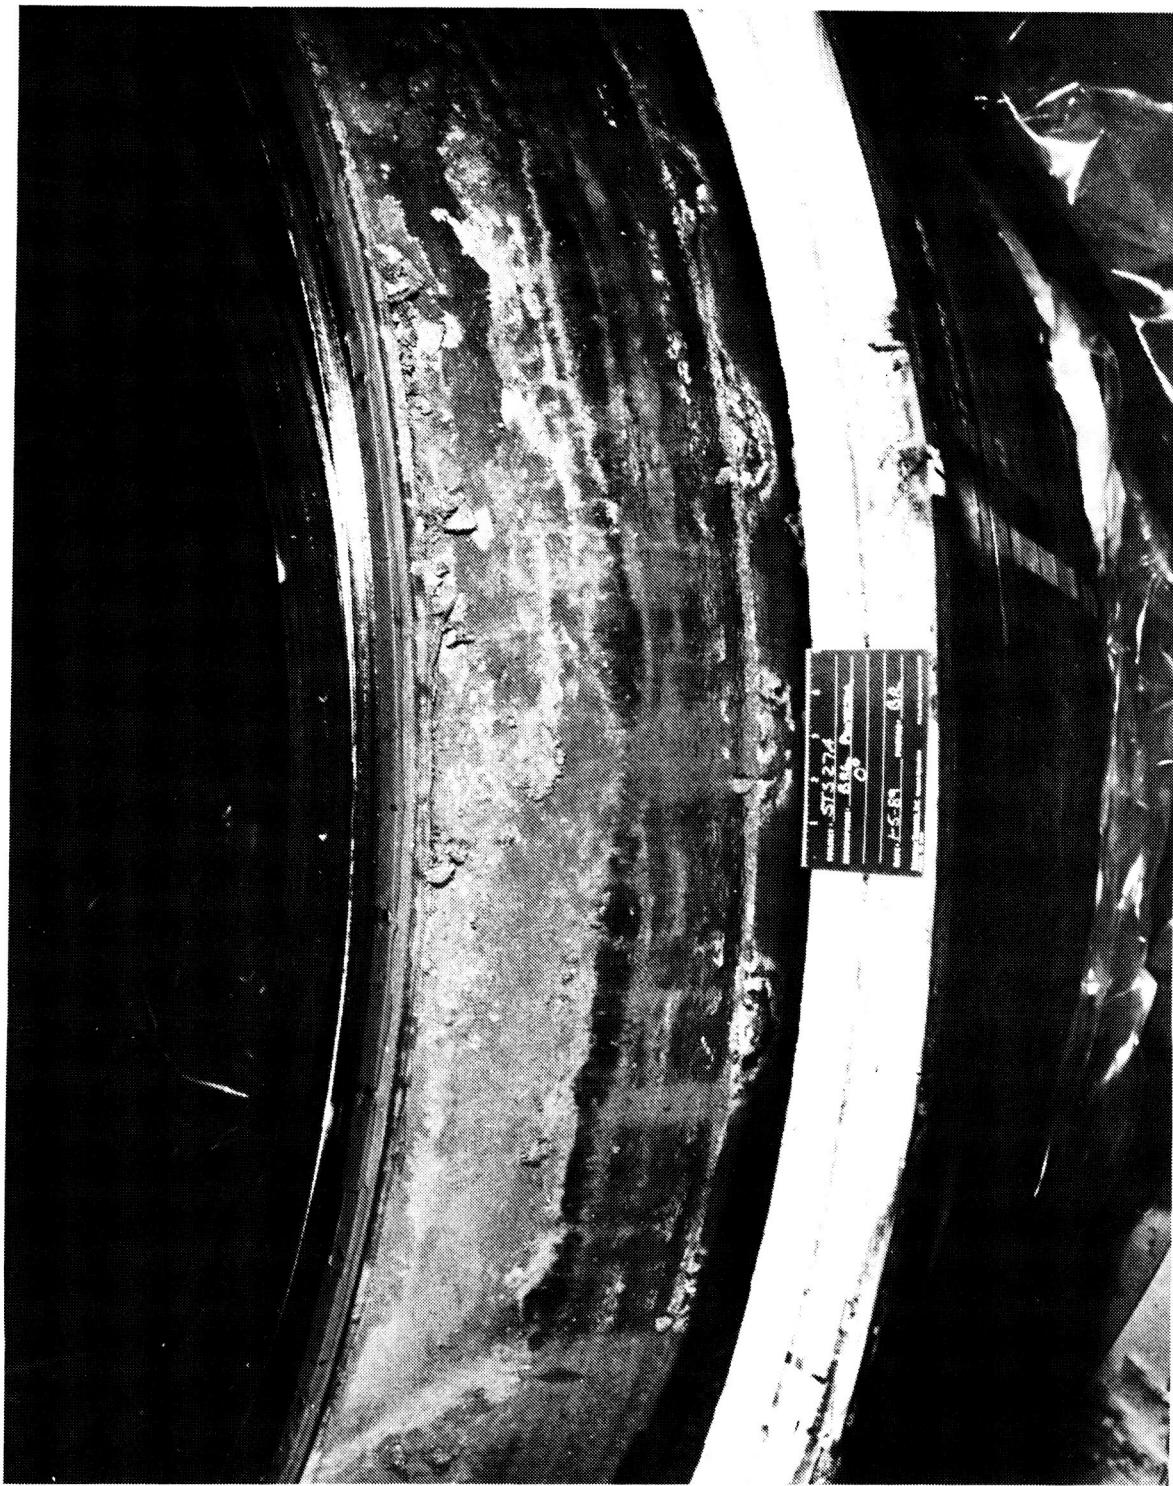
Figure 4.46 STS-27A Bearing Protector (0 degrees)

The bearing protector was sooted along the entire length and circumference (see Figures 4.46 and 4.47). Heavier soot and erosion were observed in line with the cowl ring vent holes at the thickened portion. Erosion depths at these locations are presented in Figure 4.48. There was no evidence of heat effect on the inside diameter (ID) surface of the bearing protector.

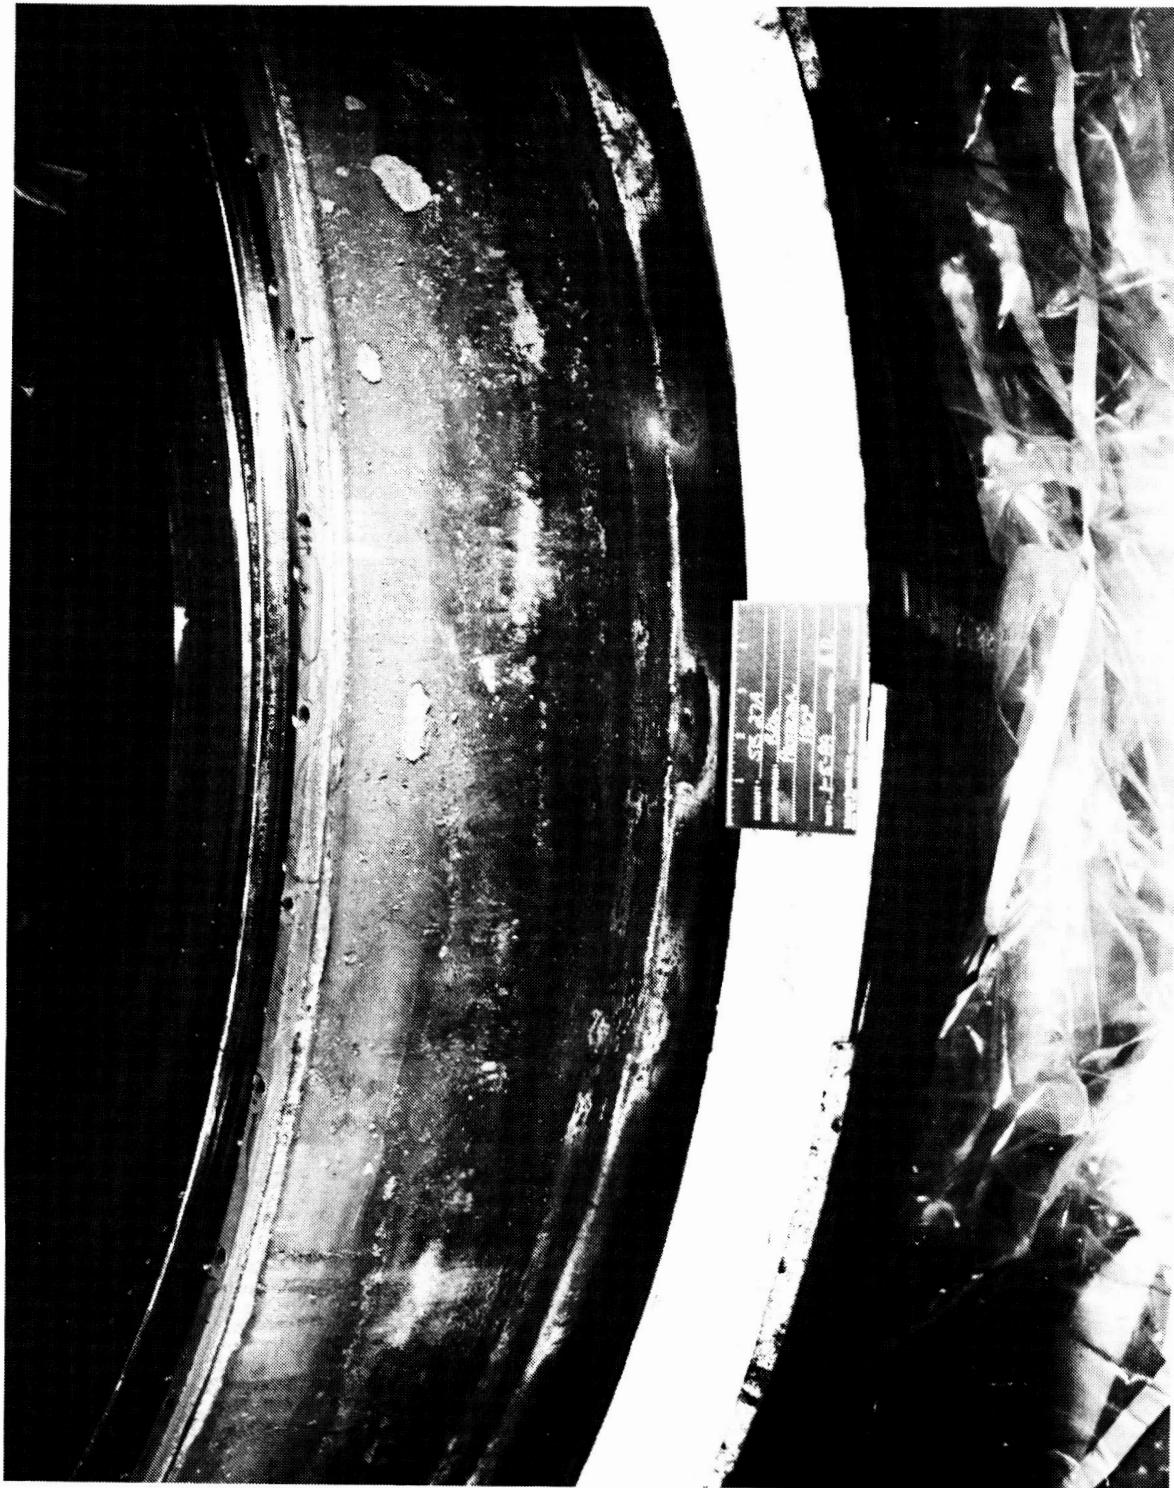
Figure 4.47 STS-27A Bearing Protector (180 degrees)
