TWR-17541-5

Flight Motor Set 360L002 (STS-27R) Final Report

Volume V (Nozzle Component)

STS-27 POST-TEST NOZZLE PERFORMANCE EVALUATION REPORT

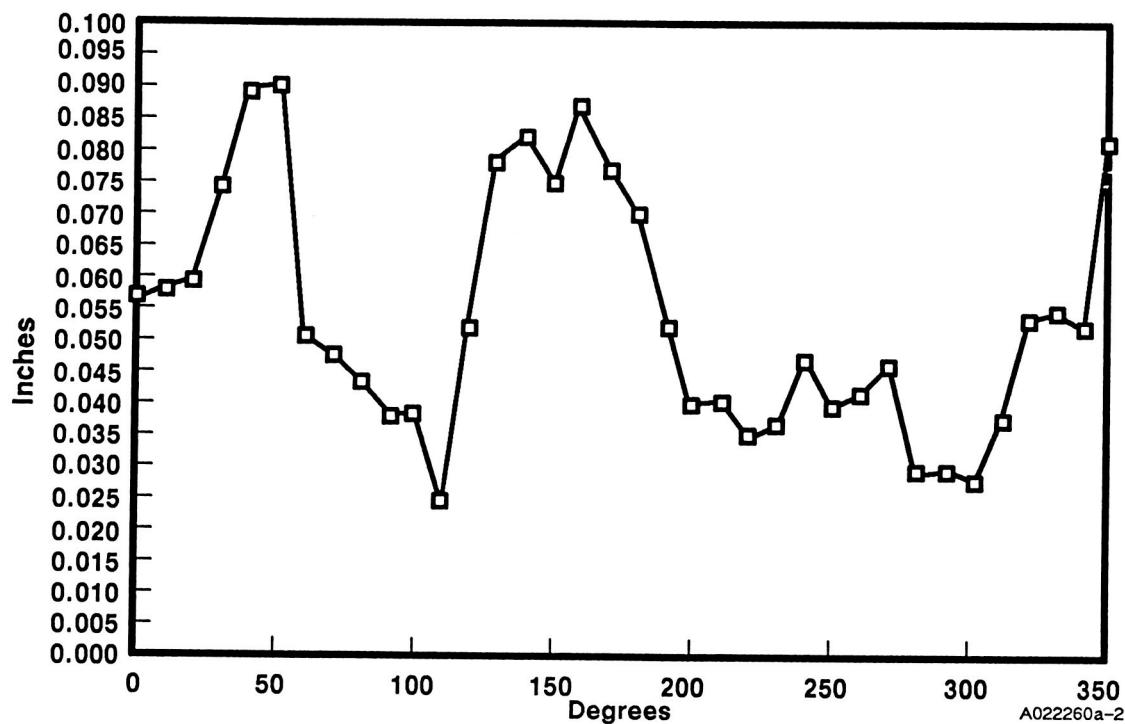
Circumferential Location (deg)	Erosion (in.) [*] <u>In Line With Cowl Vent Holes</u>
0	0.058
10	0.059
20	0.060
30	0.075
40	0.090
50	0.091
60	0.051
70	0.048
80	0.044
90	0.038
100	0.039
110	0.025
120	0.053
130	0.079
140	0.083
150	0.075
160	0.088
170	0.078
180	0.070
190	0.053
200	0.040
210	0.040
220	0.035
230	0.037
240	0.047
250	0.040
260	0.042
270	0.046
280	0.030
290	0.030
300	0.028
310	0.038
320	0.054
330	0.055
340	0.053
350	0.082

Figure 4.48 STS-27A Maximum Bearing Protector Erosion in Line with Cowl Vent Holes

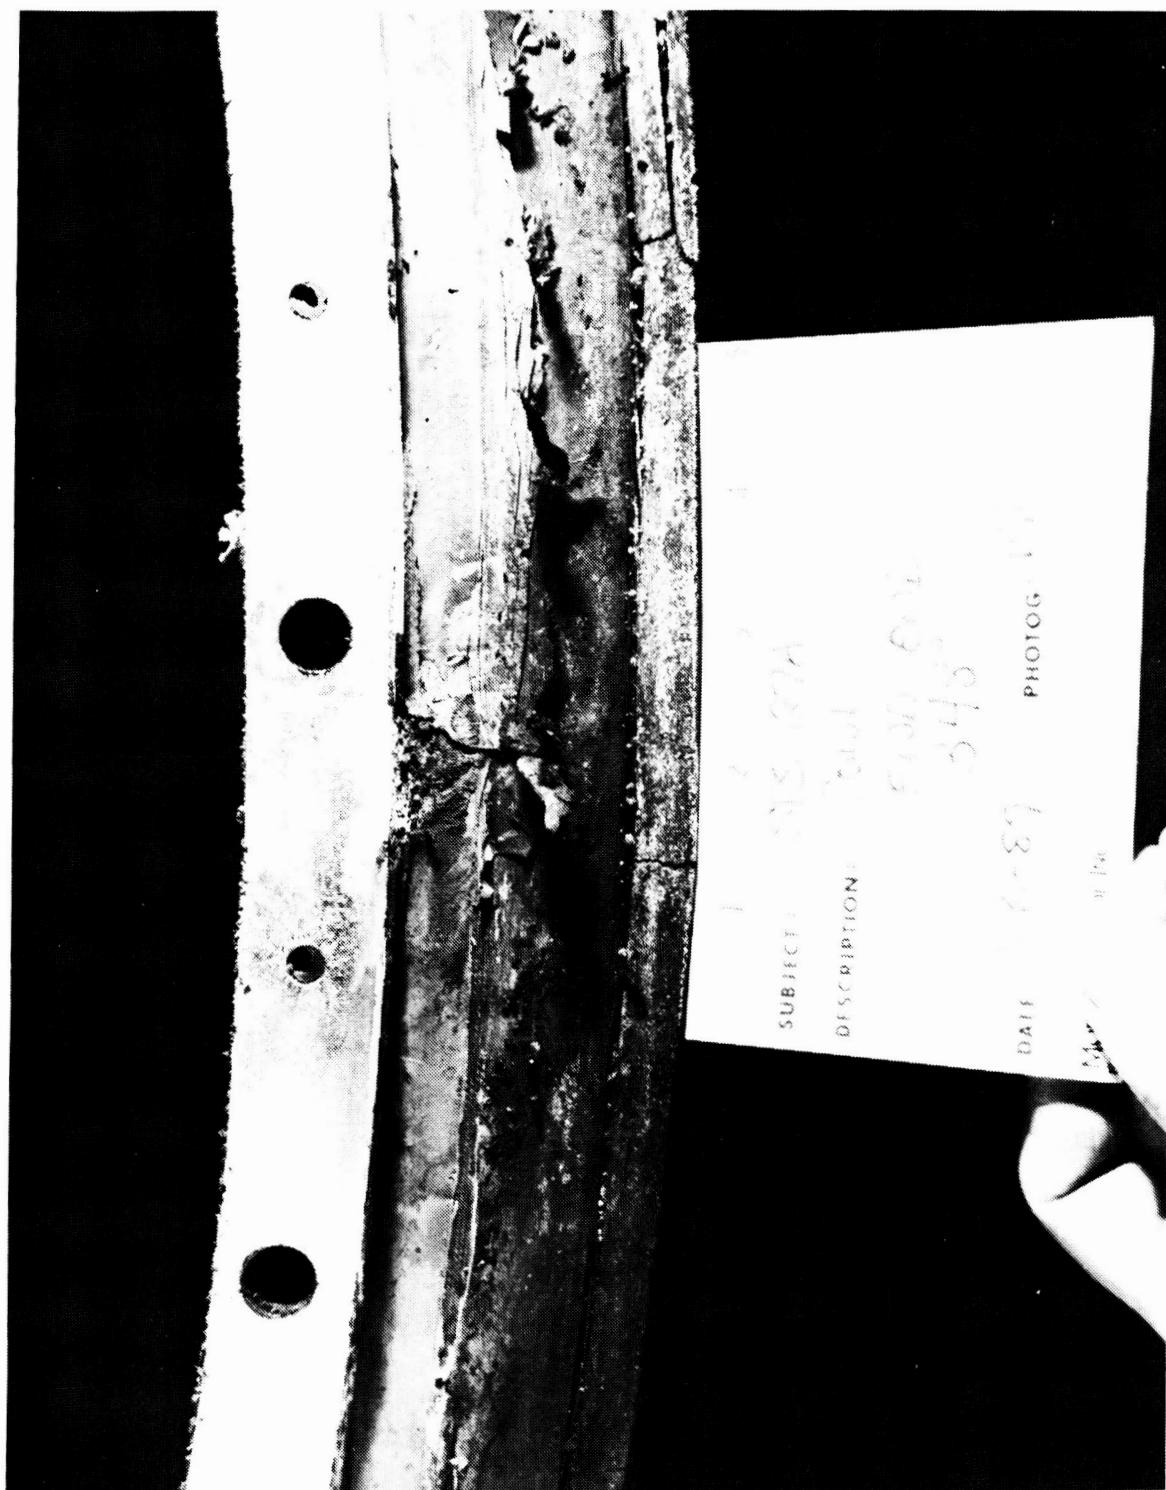
Figure 4.53 STS-27A Joint No. 2 Blowpath at 348 degrees

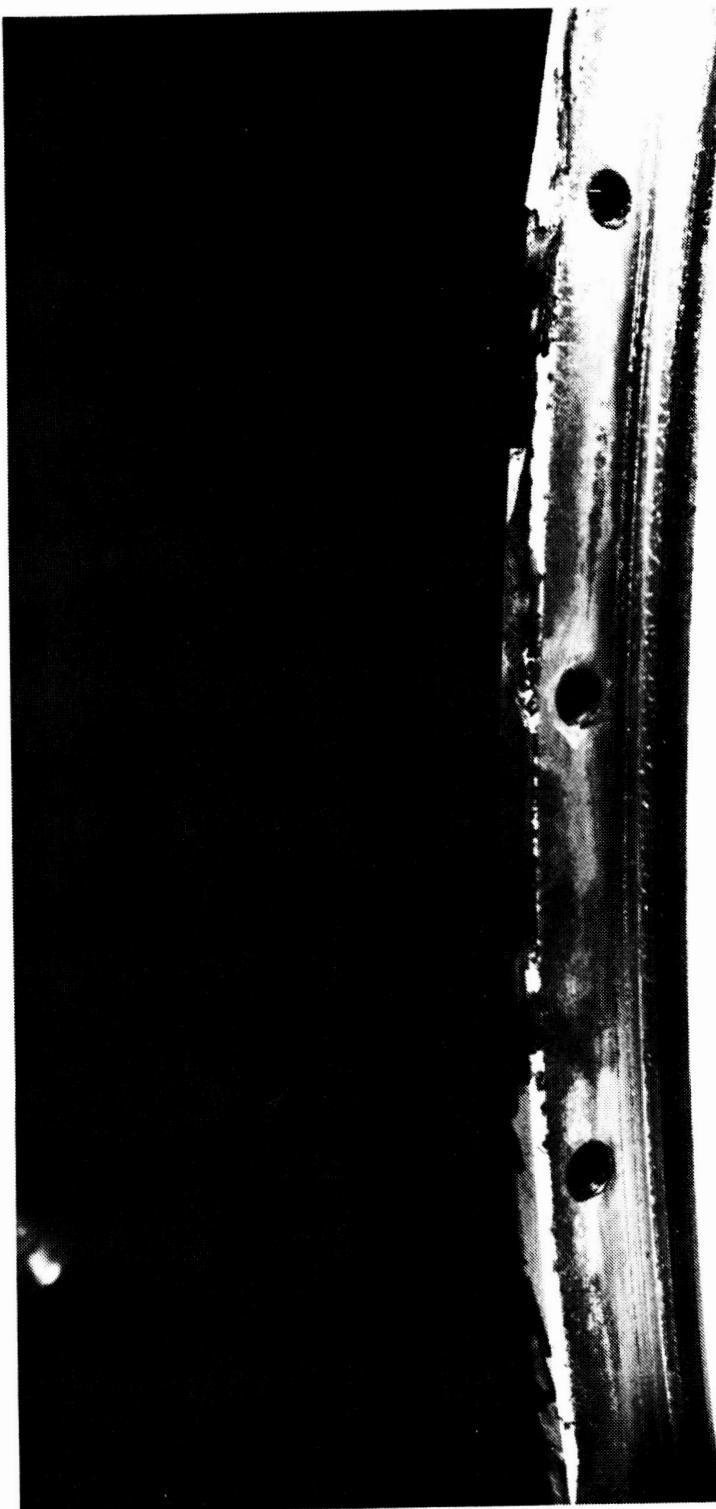
Figure 4.56 STS-27A Joint No. 2 Blowpath at 348 degrees

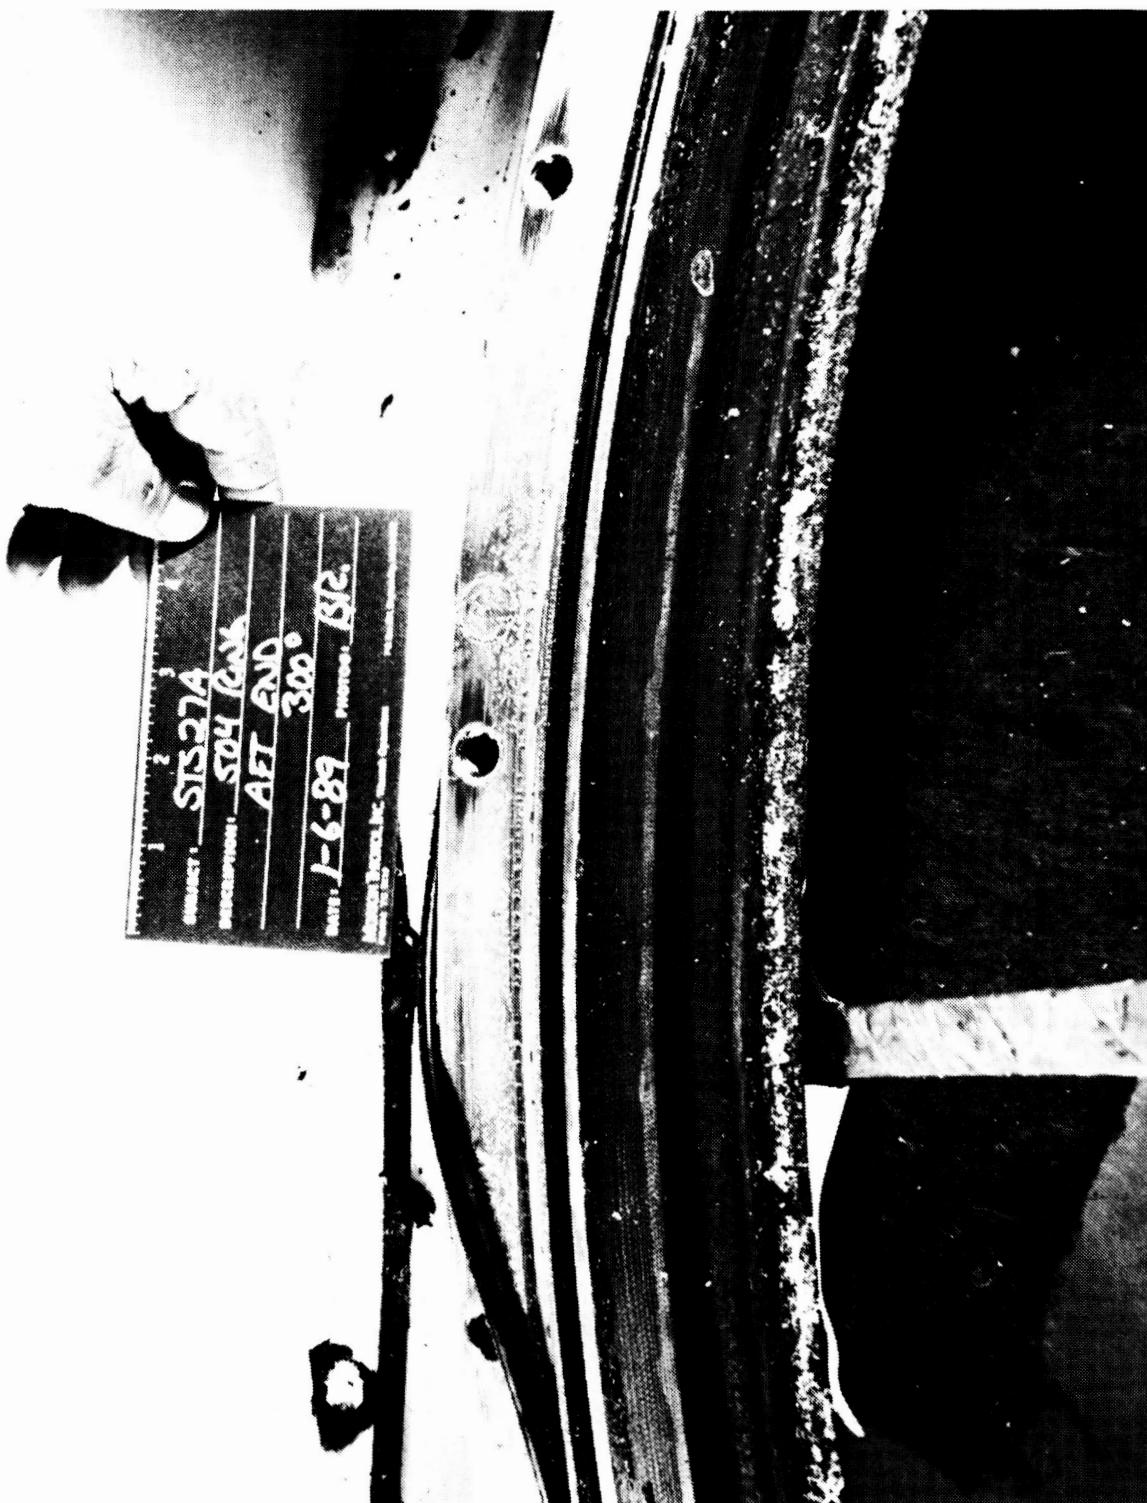
Figure 4.58 STS-27A Joint No. 3 -504 Aft End (300 degrees)

in Figure 4.57. Photographs of the post-flight joint are shown in Figures 4.58 and 4.59.

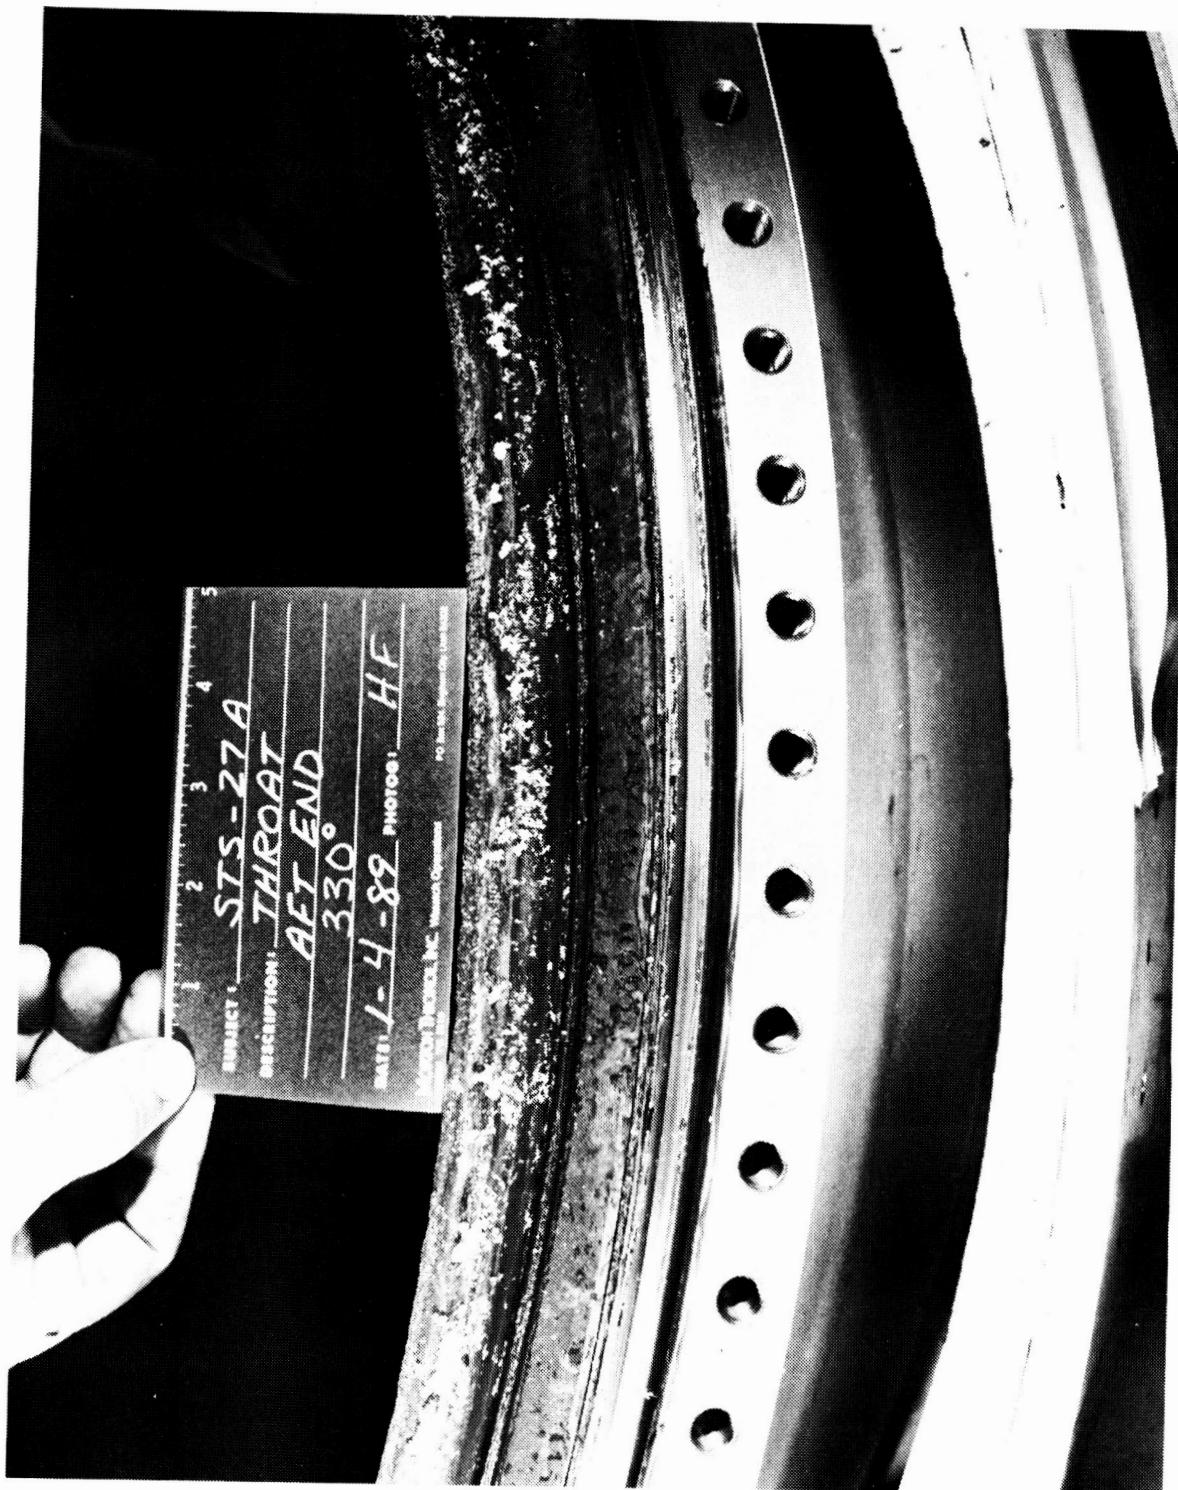
Figure 4.61 STS-27A Joint No. 4 Throat Aft End (330 degrees)

A cross-sectioned view of the STS-27A throat/forward exit cone joint is presented in Figure 4.60. Photographs of the post-flight joint are shown in Figures 4.61 and 4.62.

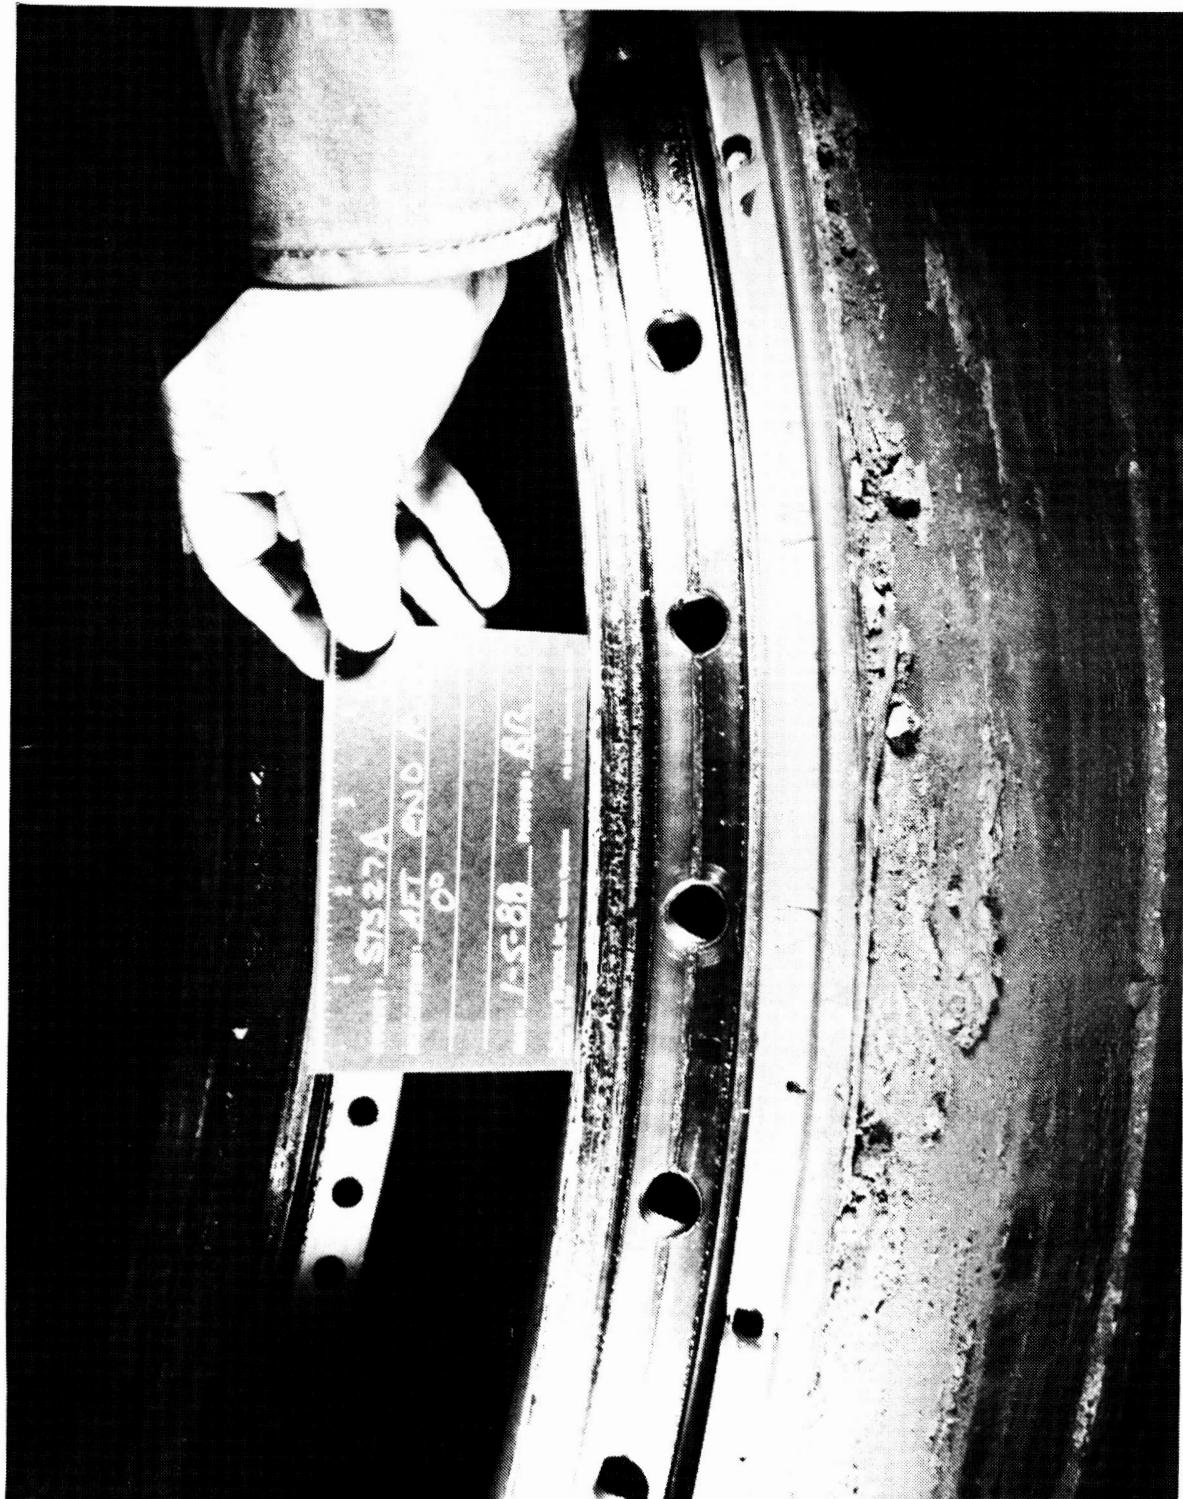
Figure 4.64 STS-27A Joint No. 5 Bearing Aft End Ring Aft End (0 degrees)

A cross-sectioned view of the STS-27A aft end ring/fixed housing joint is presented in Figure 4.63. Photographs of the post-flight joint are shown in Figures 4.64 and 4.65.

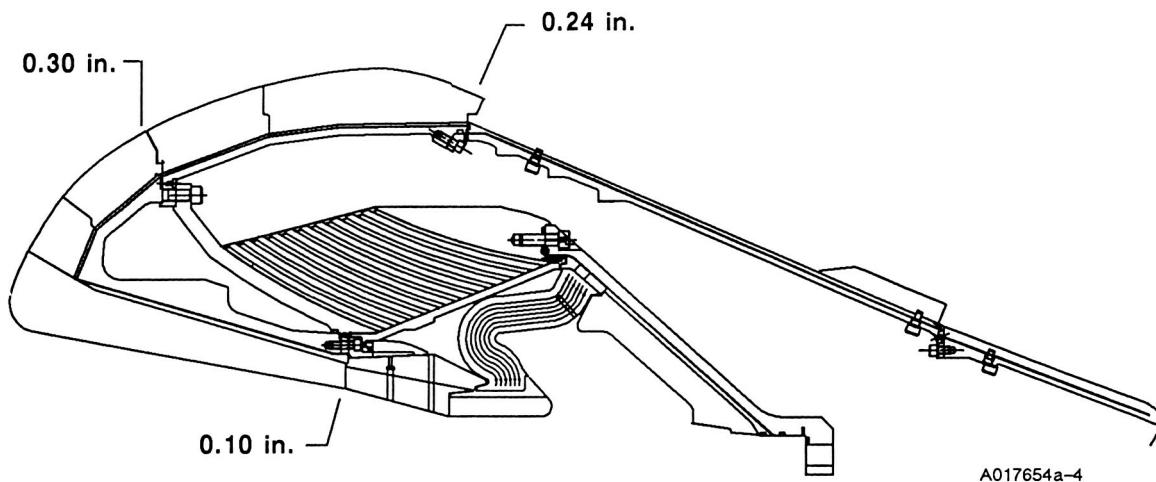
Overall erosion of the STS-27A forward nozzle assembly CCP ablative liner was smooth and uniform. Post-flight subassembly flow surface gaps are shown in Figure 4.66. Eroded chamfer edges were included in the flow surface bond gap measurements. Overall views of the nozzle are shown in Figure 4.67 through 4.74.

Descriptions of the five STS-27B nozzle joints follows. The joint flow surface gap openings between each nozzle subassembly are summarized in Figure 4.66. All gaps were typical of previous static test and flight nozzles.

Figure 4.66 STS-27B Joint Flow Surface Gap Openings

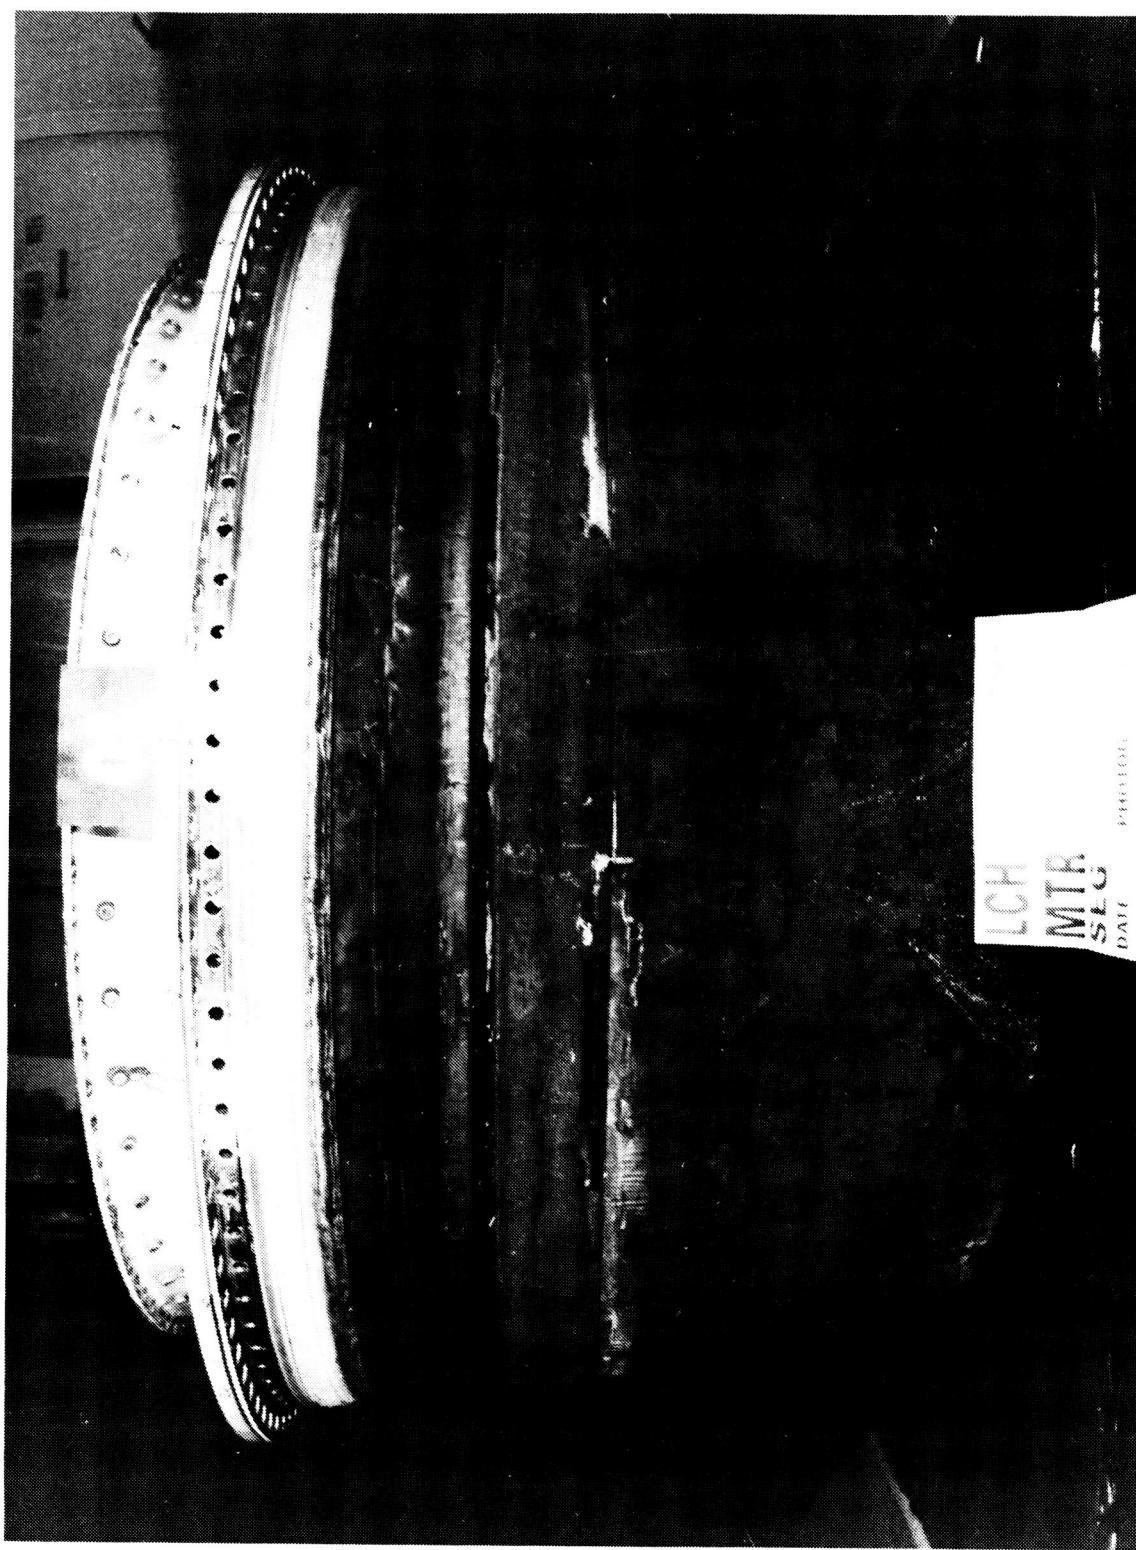
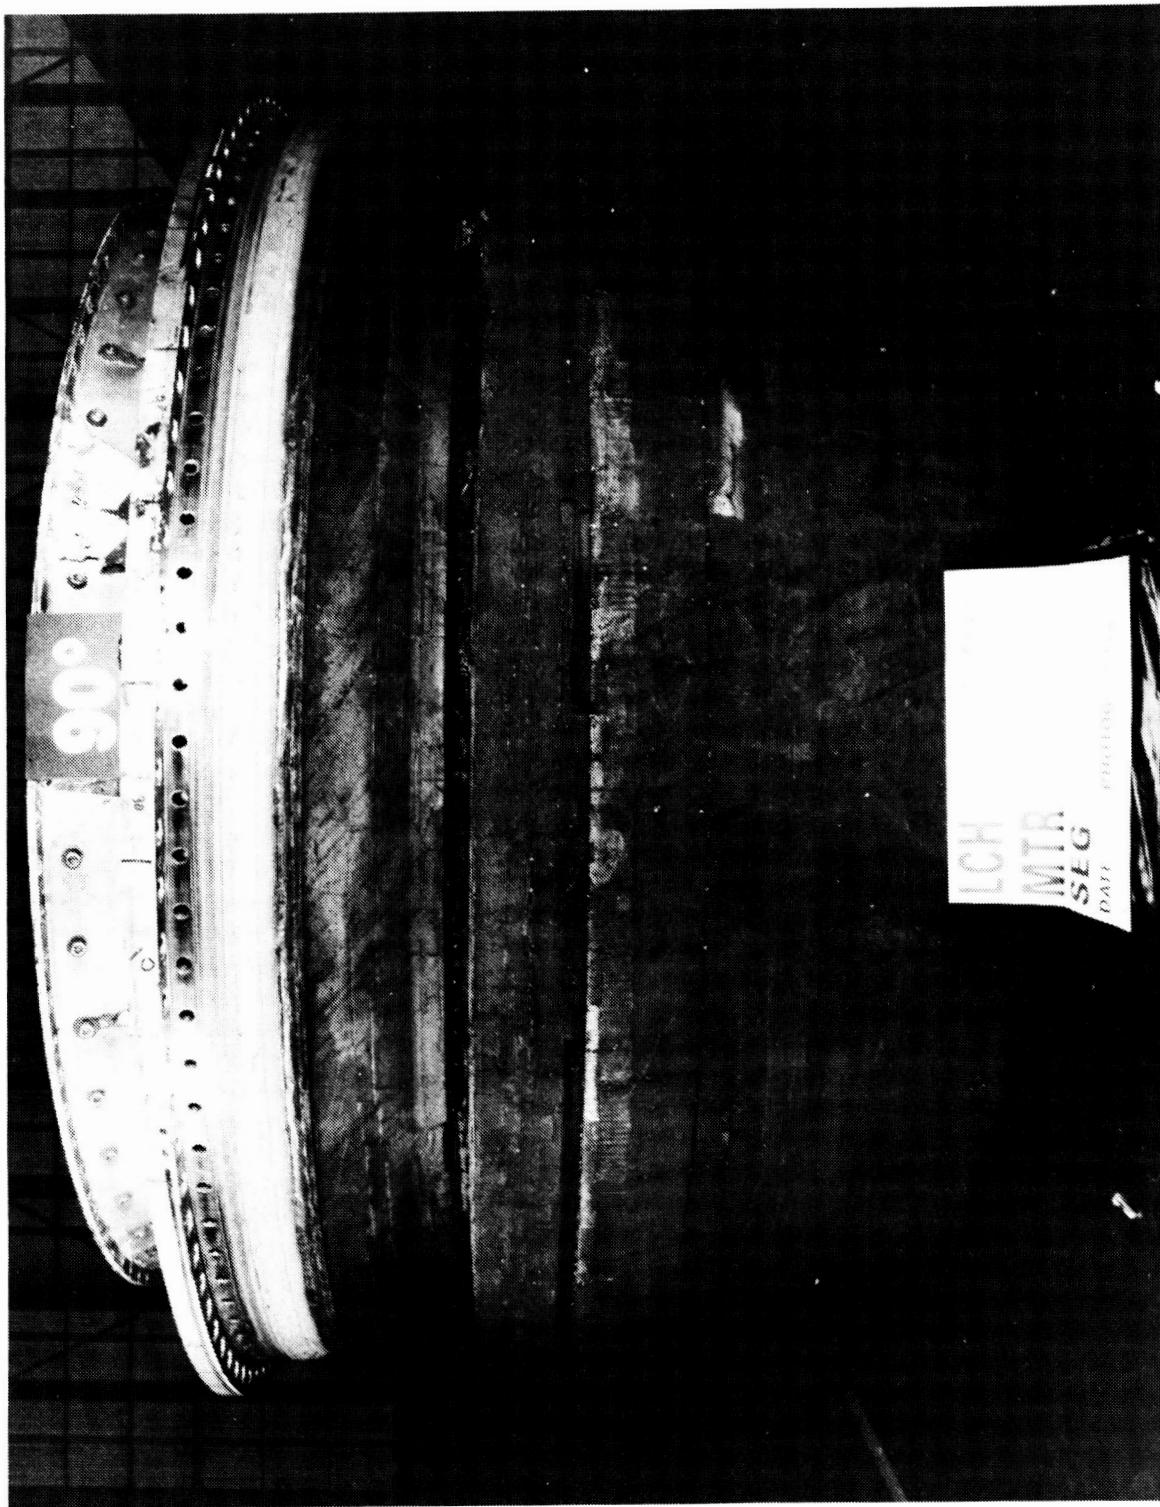
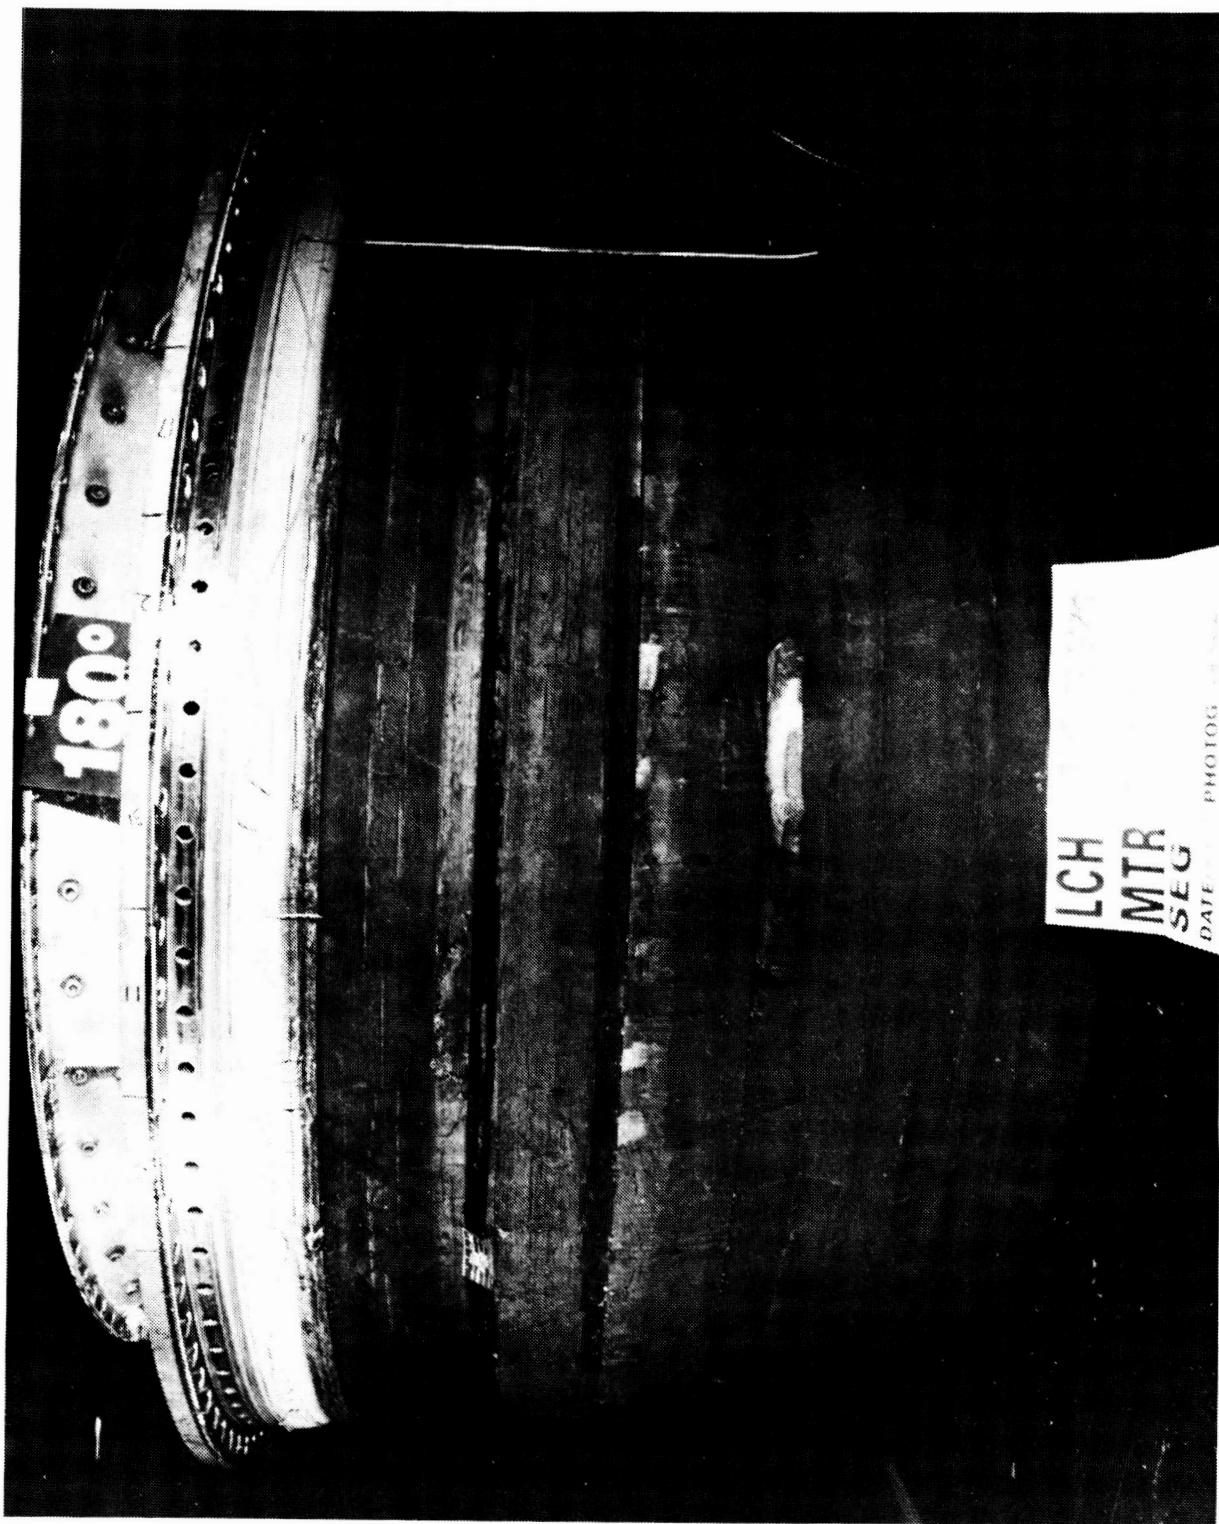
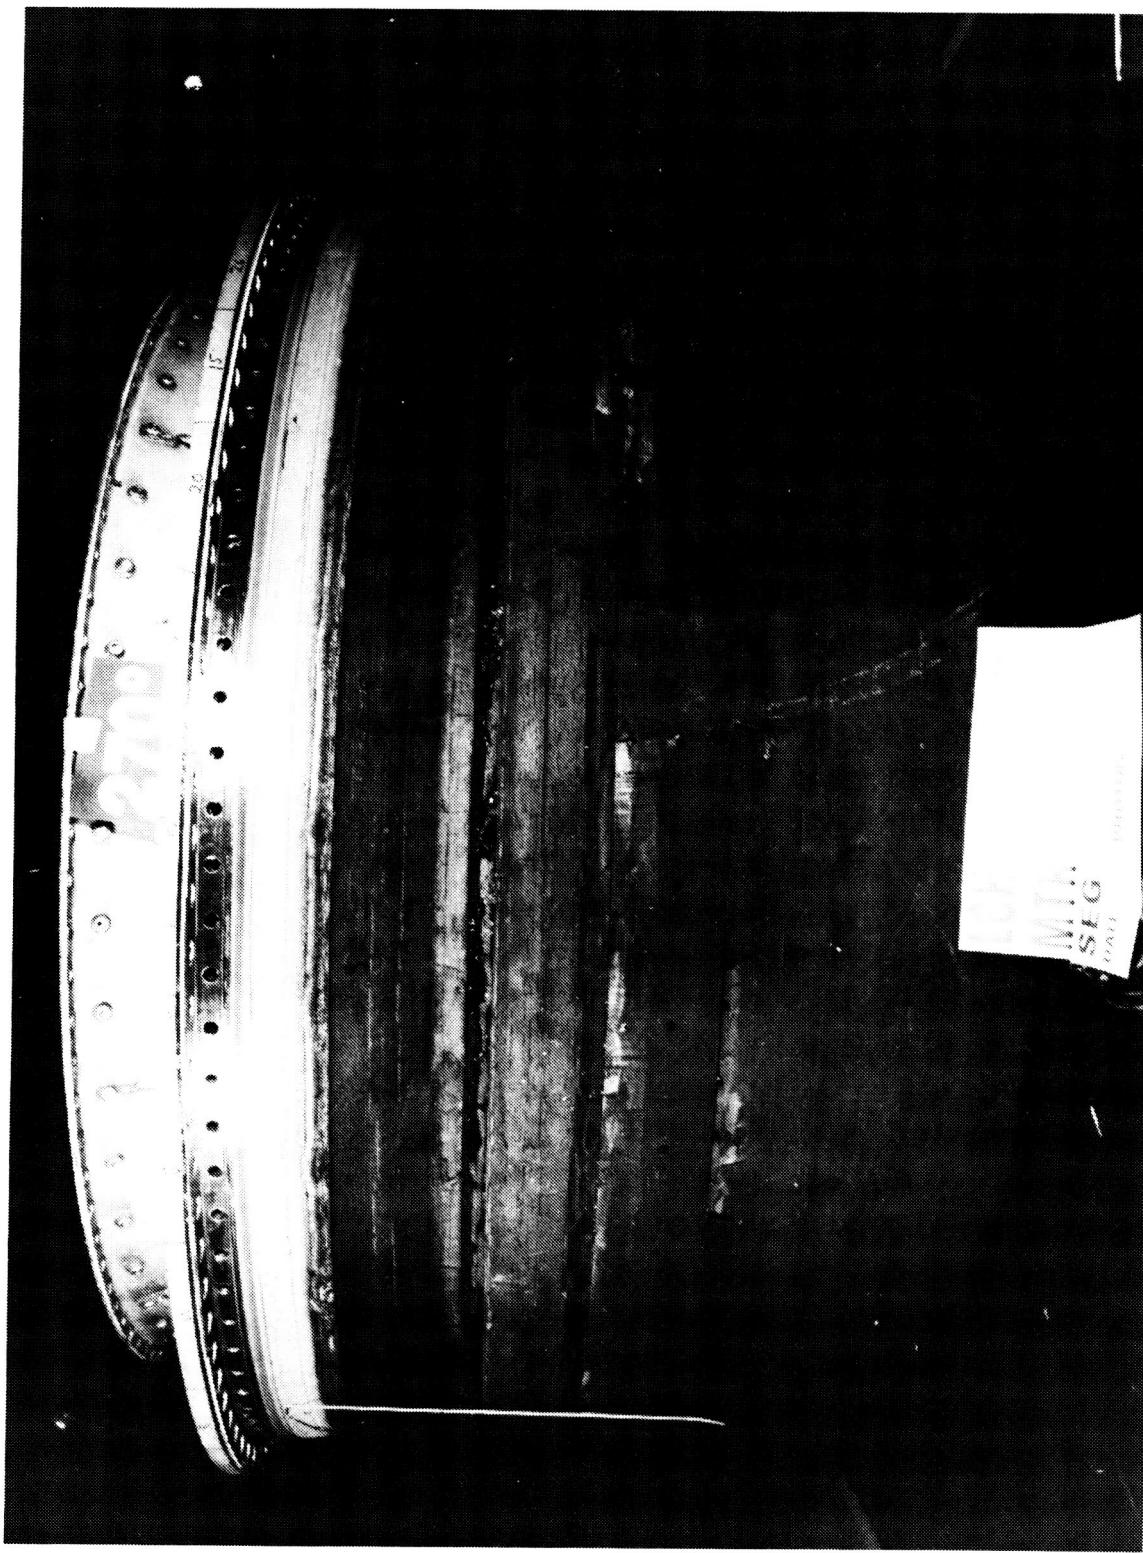
Overall views of the STS-27B cowl and OBR are shown in Figures 4.67 through 4.70. Close-up views are shown in Figures 4.96 and 4.97. The flow surface bondline gap between the cowl and nose cap was 0.10 inch. The flow surface bondline gap between the cowl and OBR was 0.10 inch. These post-burn gaps

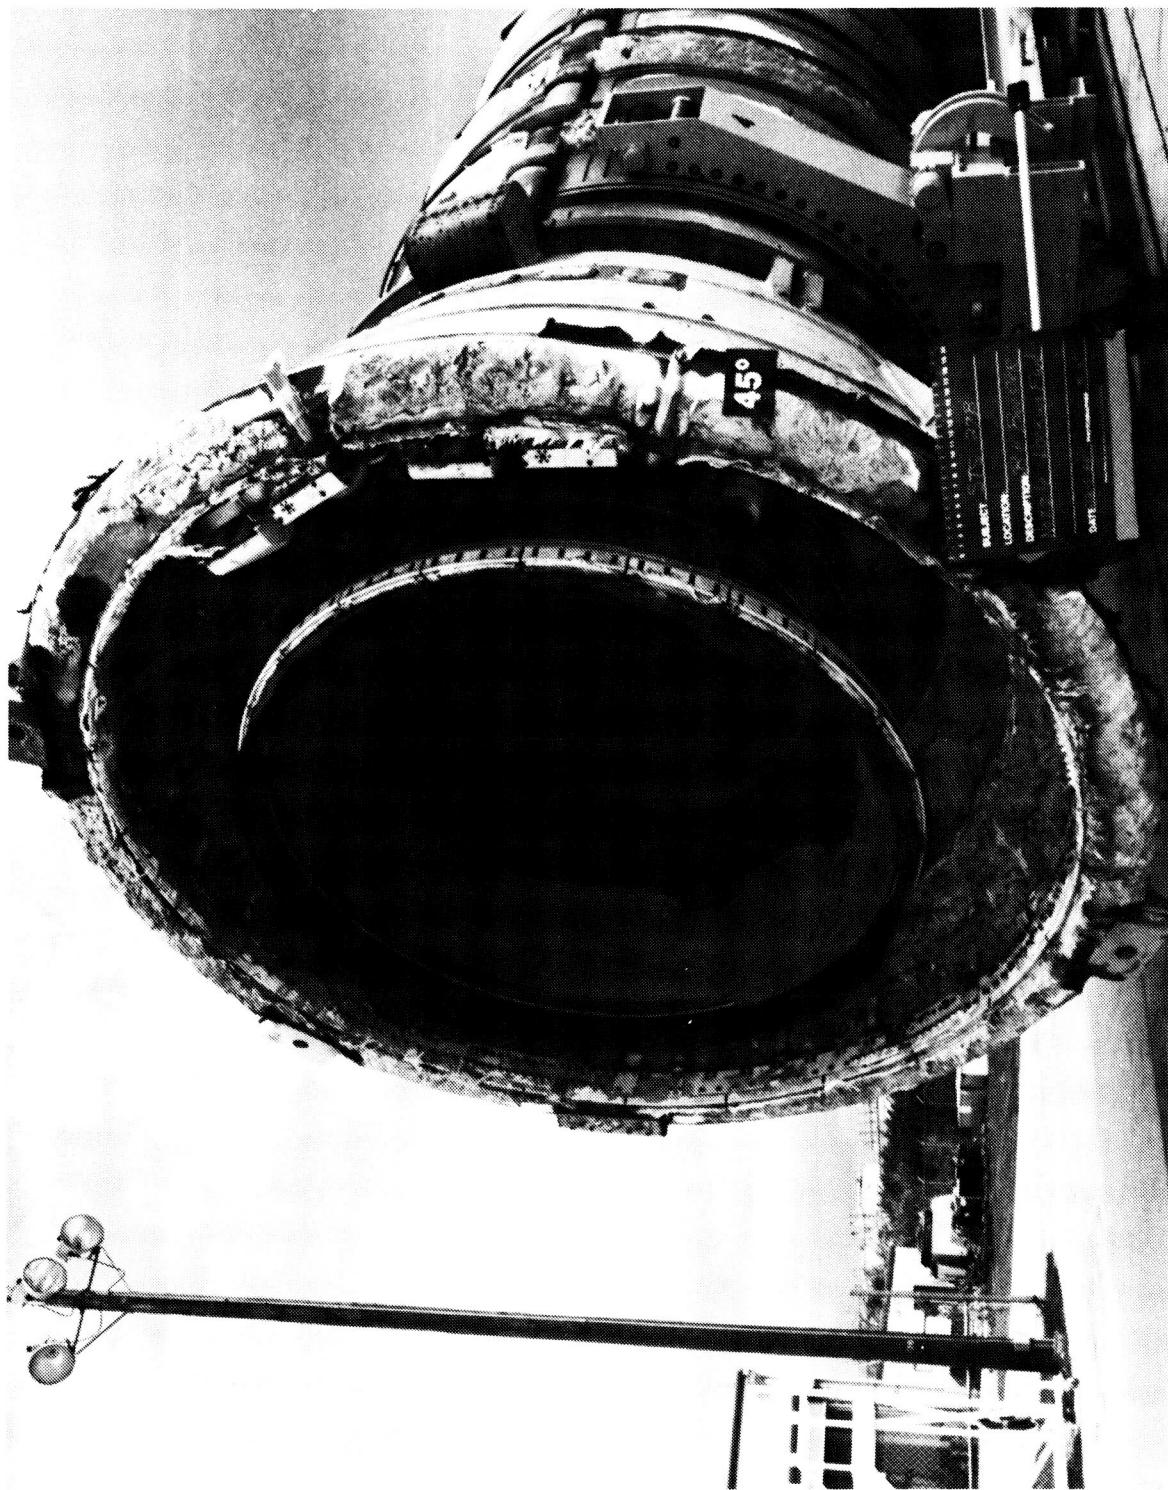
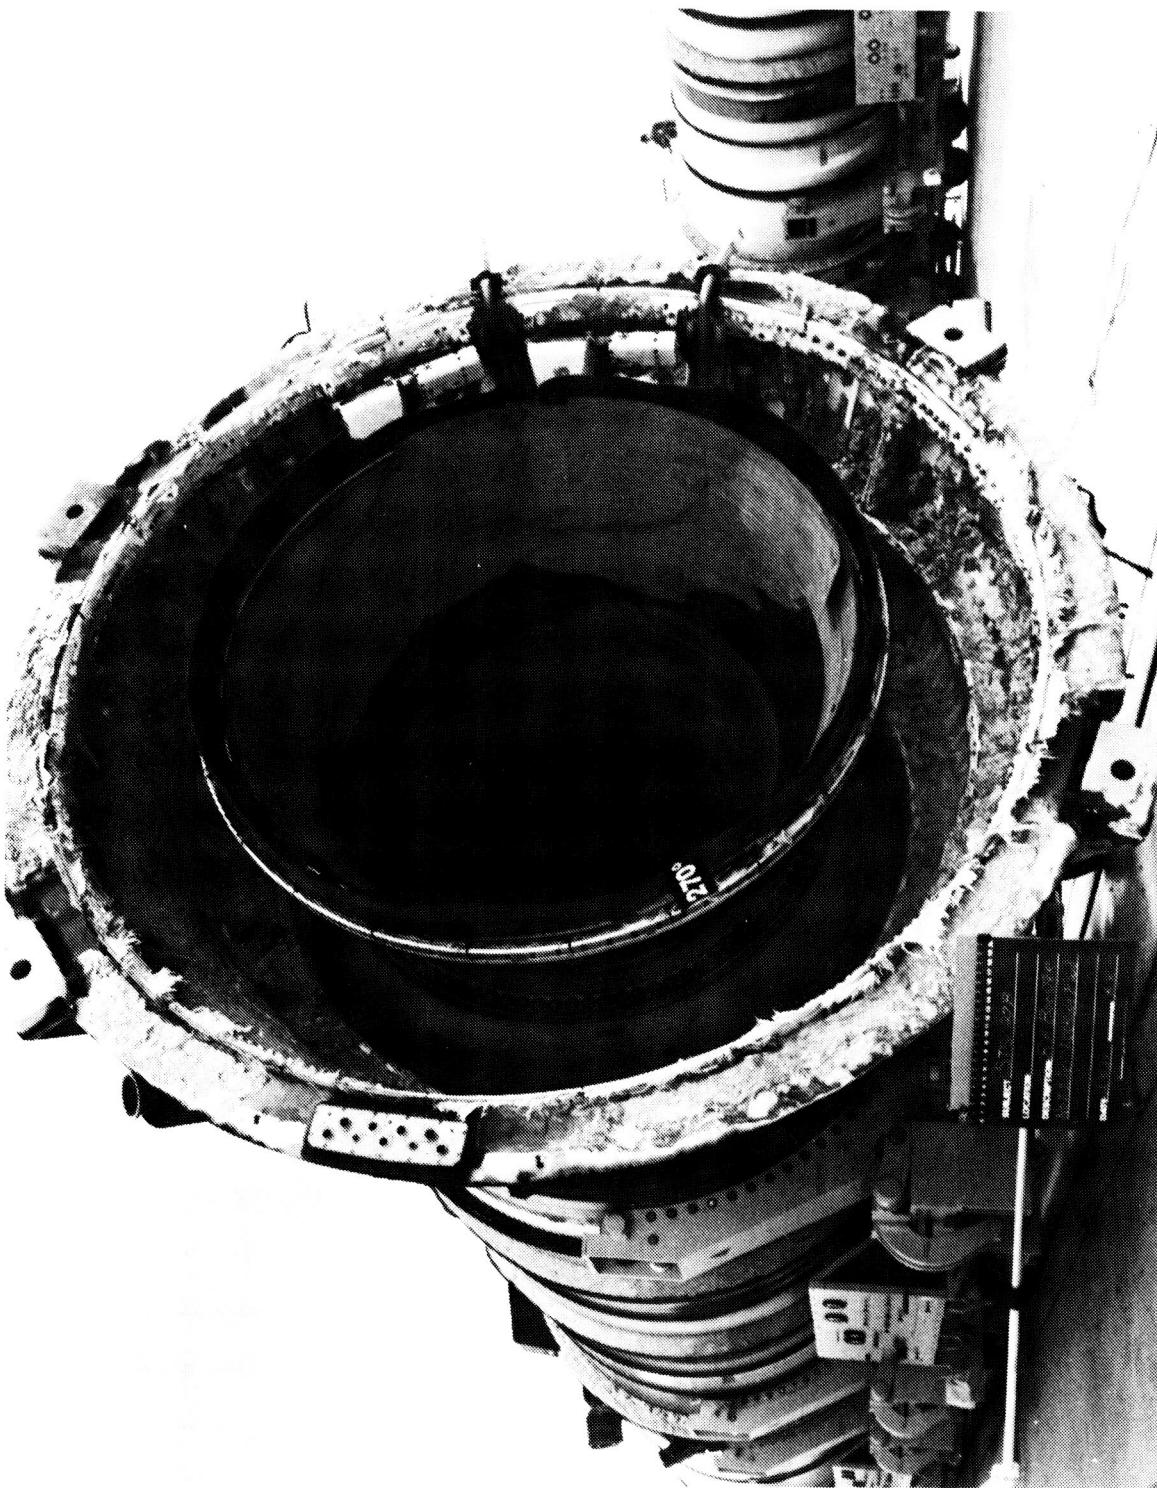
Overall views of the STS-27B aft exit cone fragment are shown in Figures 4.75 and 4.76.

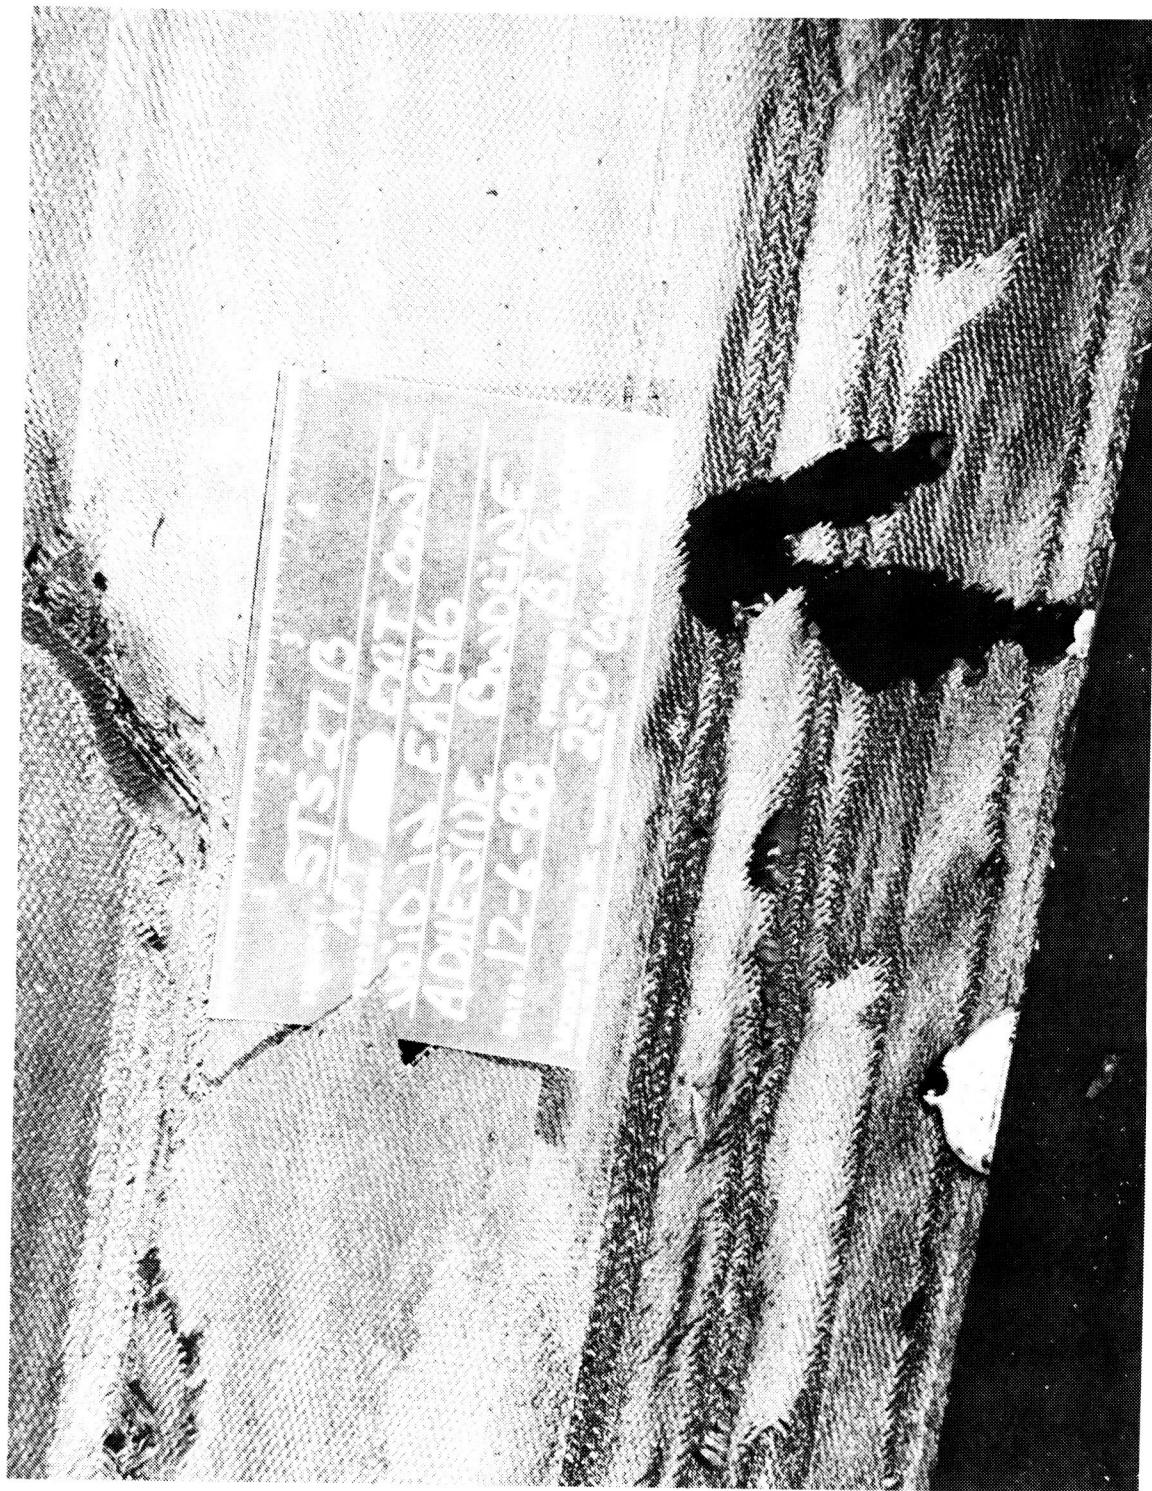
and insulator exposed the aft 4 inches of the aluminum shell from approximately 120 to 290 degrees. There was no corrosion observed on the exposed metal. These are typical post-flight observations which occur during exit cone severance and at splashdown. GCP plies exposed by the missing liner showed no signs of heat effect. The EA946 adhesive bondline was also exposed on the aft 4 inches of the exit cone shell intermittently around the circumference. Voids were observed within the exposed adhesive (see Figure 4.77). The maximum void measured 2 inches circumferentially by 3 inches axially. Adhesive bondline voids are inherent to the aft exit cone bonding process and are an expected condition.

Figure 4.77 STS-27B Aft Exit Cone EA946 Adhesive Void (250 degrees)

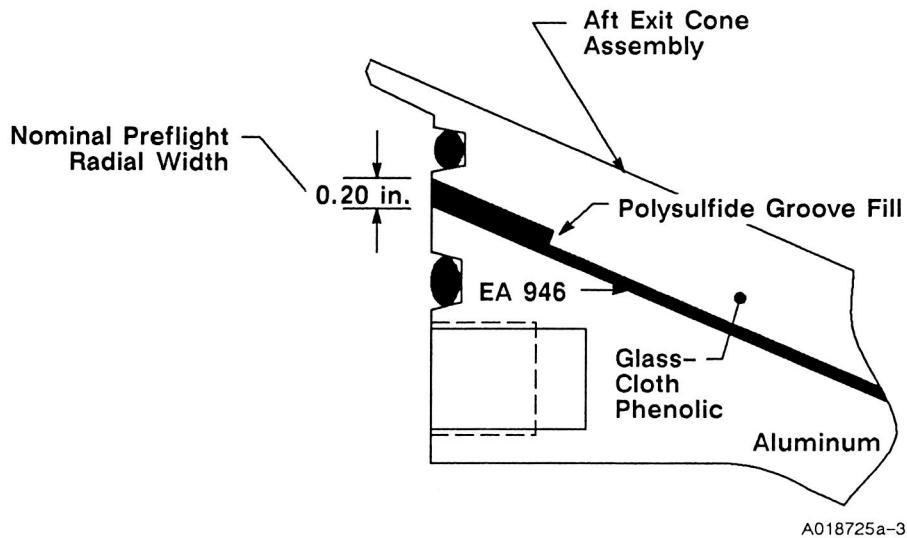
The polysulfide groove fill on the forward end of the aft exit cone showed no separations. Post-flight measurements of the polysulfide groove radial width (see Figure 4.78) show that the GCP insulator did not pull away from the aluminum shell during cooldown. The average post-flight radial width of the groove was 0.17 inch. The polysulfide appeared to shrink axially aft up to 0.09 inch (see Figure 4.79).

Angular Location (deg)	Radial Width (in.)
0	0.16
30	0.17
60	0.17
90	0.16
120	0.16
150	0.17
180	0.17
210	0.17
240	0.20
270	0.16
300	0.17
330	0.17
