TWR-17541-5

Flight Motor Set 360L002 (STS-27R) Final Report

Volume V (Nozzle Component)

STS-27 POST-TEST NOZZLE PERFORMANCE EVALUATION REPORT

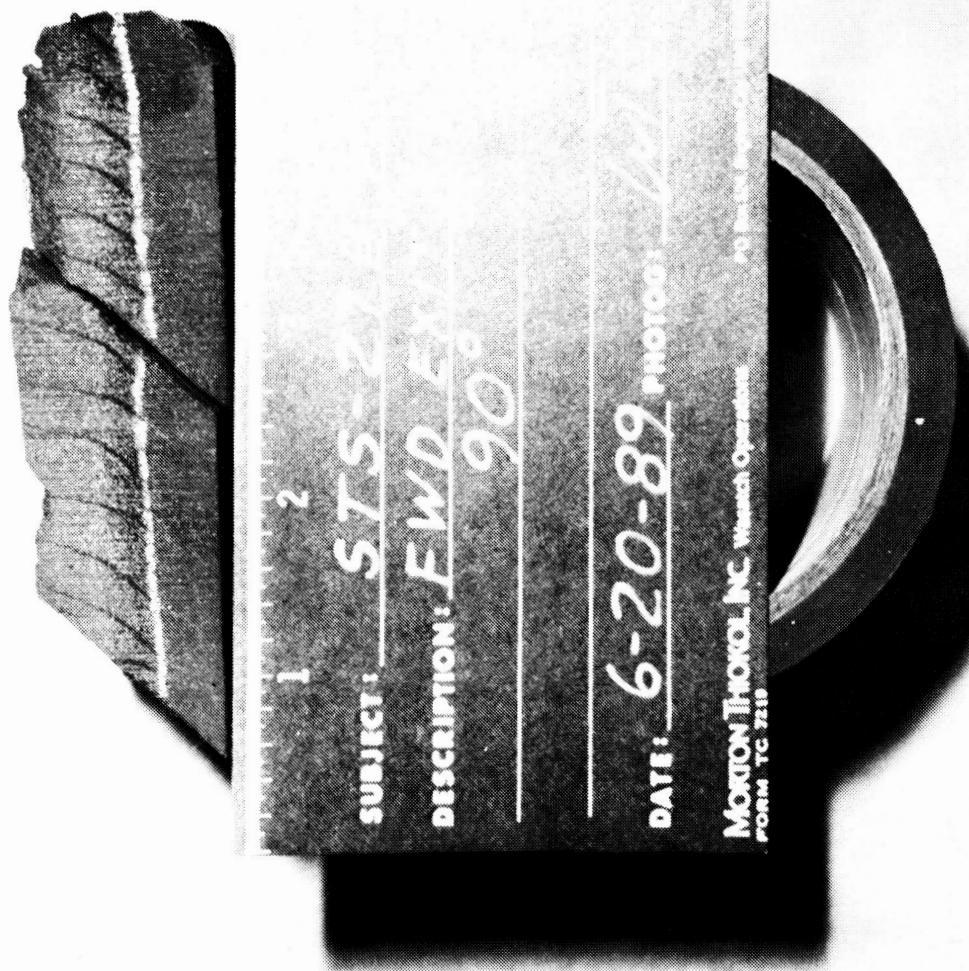
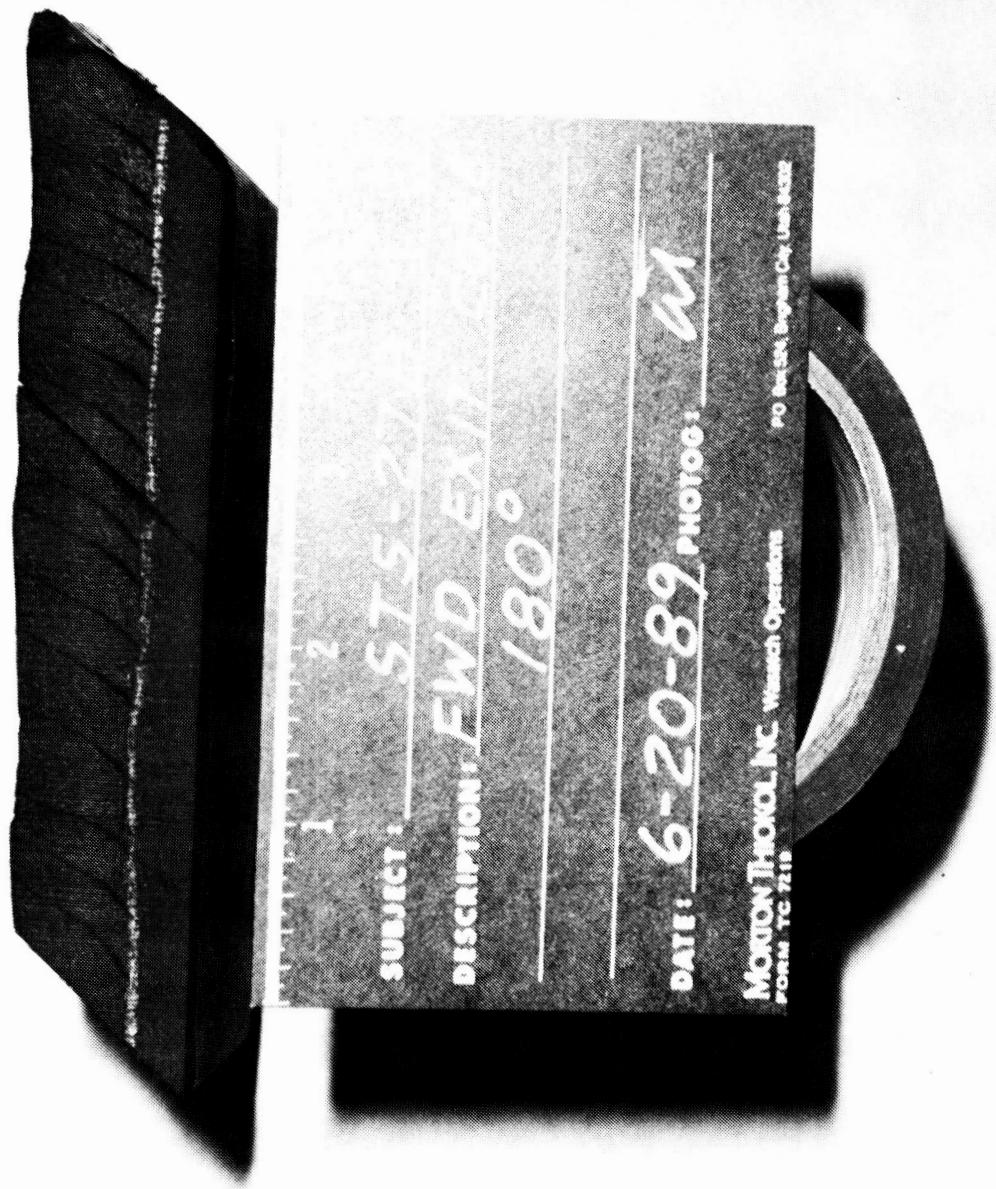
Sectioned views of the remaining forward exit cone liner are shown in Figures 4.81 and 4.82.

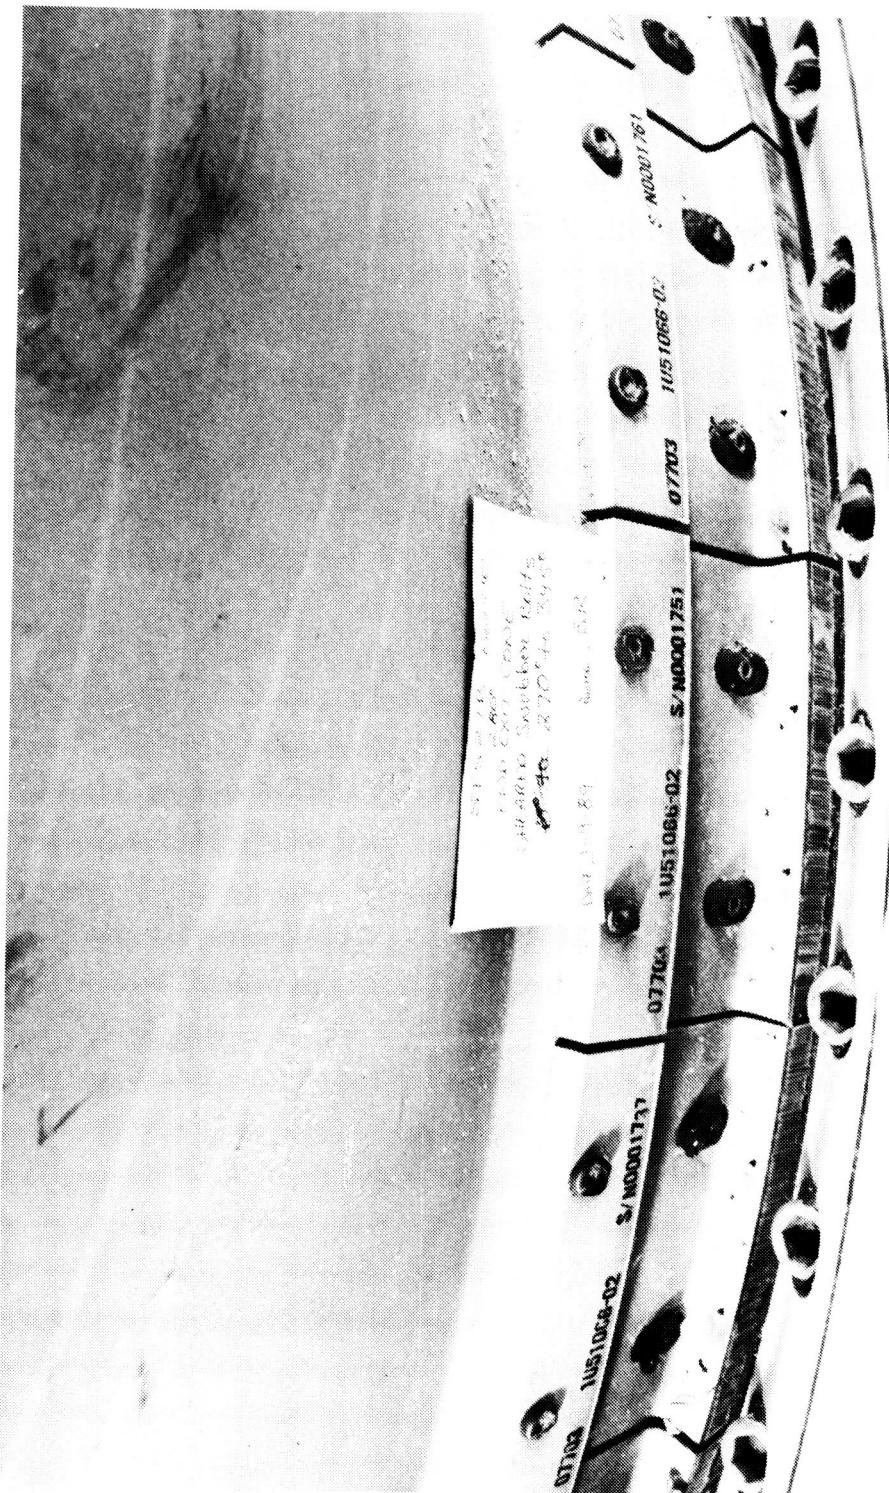
The major splashdown snubber impact on the bearing aft end ring occurred over the 25-to-0-to-235 degree arc. Both the snubbers and aft end ring showed heavy paint scratches in this area (see Figures 4.83 and 4.84). One snubber (S/N 0001731) located at 235 degrees was displaced axially aft approximately 0.5 inch. The snubber segment retainer bolts were either sheared completely off or smashed from 270 to 340 degrees (see Figure 4.83). Impact of these bolts also left paint scratch marks on the aft end ring. The remainder of the bearing aft end ring circumference showed minor paint scratches indicating slight contact with the snubbers.

The fifth minor anomaly was sheared off snubber retainer bolt heads (13 total) on the STS-27B nozzle. The bolts were sheared off during bearing aft end ring impact at splashdown. The bearing aft end ring showed no metal damage, only paint scratches. The forward exit cone housing showed no visible damage following removal of the sheared bolts and snubber retainers. This had not been observed on an RSRM nozzle to date. STS-1 and 2 nozzles showed similar damage occurring at splashdown. The NCPT recommended classifying this as a minor anomaly if there was no bearing damage. The justification used was that the sheared bolts were a departure from our RSRM data base. The NCPT recommended inspecting for future

Figure 4.83 STS-27B Snubber Paint Scratches and Sheared Snubber Segment Retainer Bolts (270-345 degrees)

occurrences and adding accept/reject limits to the Nozzle KSC PEEL Document (TWR-18680 Vol 5) if observations continue. The RPRB accepted the NCPT recommendations. Post-flight bearing acceptance testing showed no damage. This was therefore classified as minor anomaly.

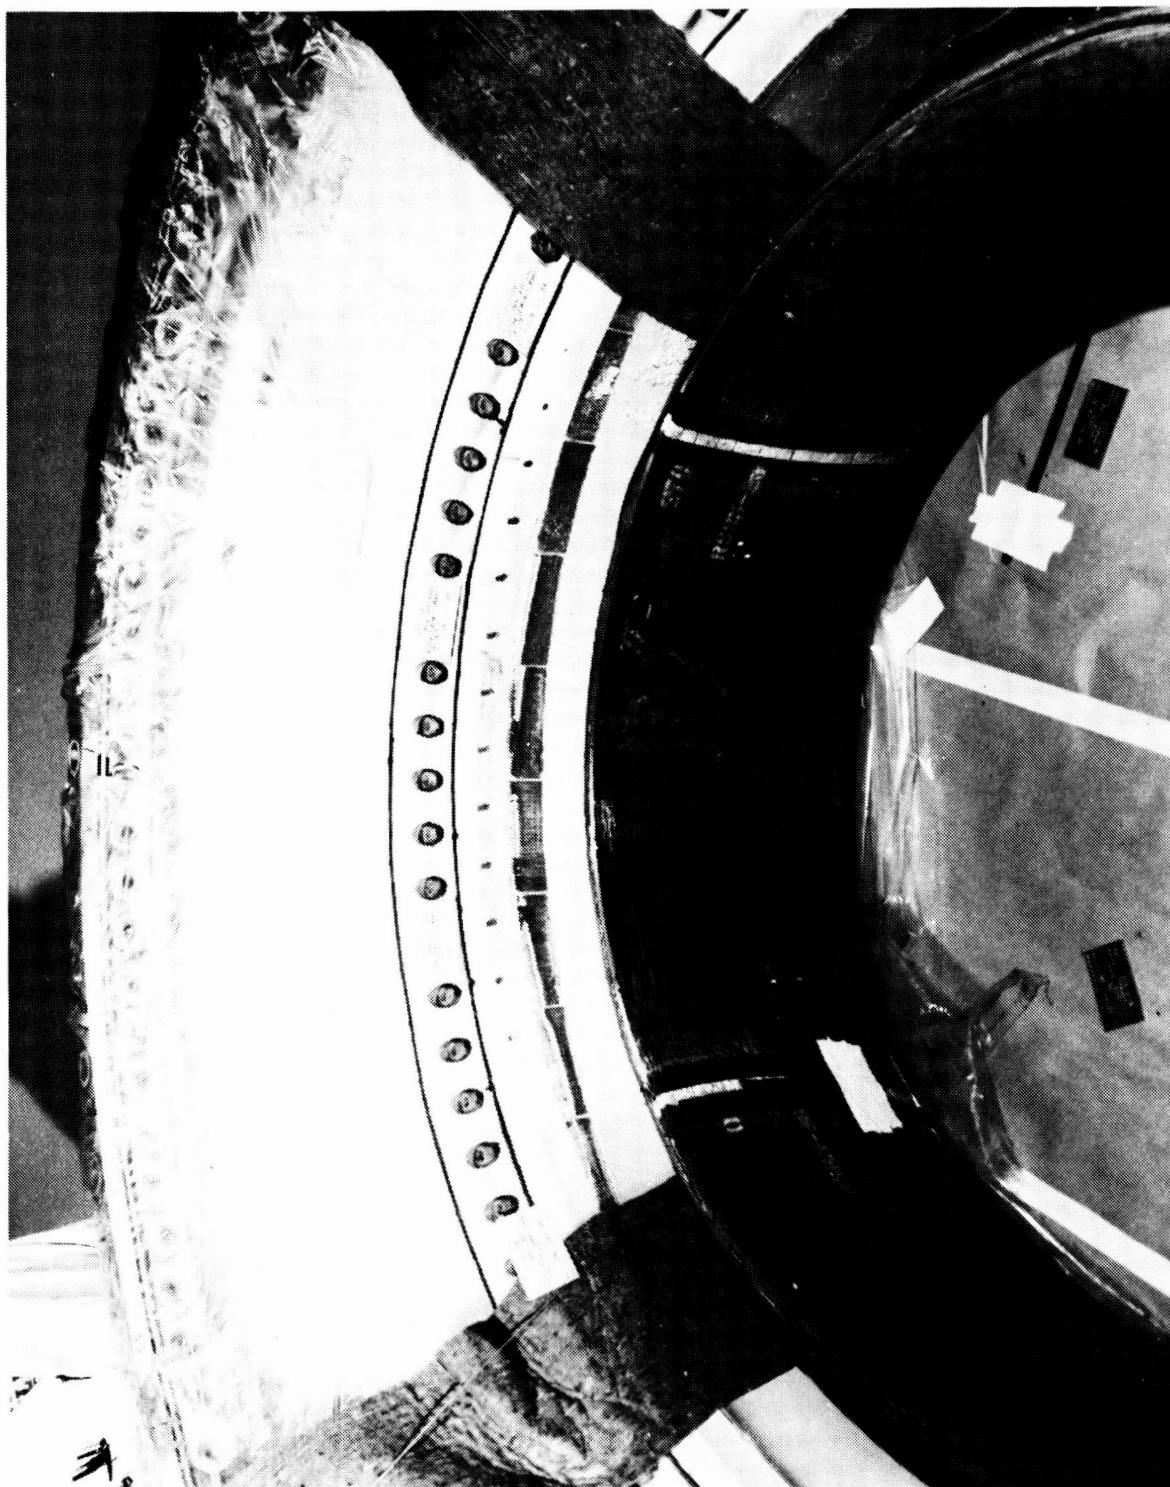
The bearing aft end ring showed major paint scratches occurring from 25 to 0 to 235 degrees, due to snubber impact during splashdown. Impact of the snubber retainer bolts also left paint scratch marks on the aft end ring (see Figure 4.84). The remainder of the bearing aft end ring circumference showed minor paint scratches indicating slight contact with the snubbers.

Figure 4.84 STS-27B Bearing Aft End Ring Snubber Impact Scratches
(270-360 degrees)

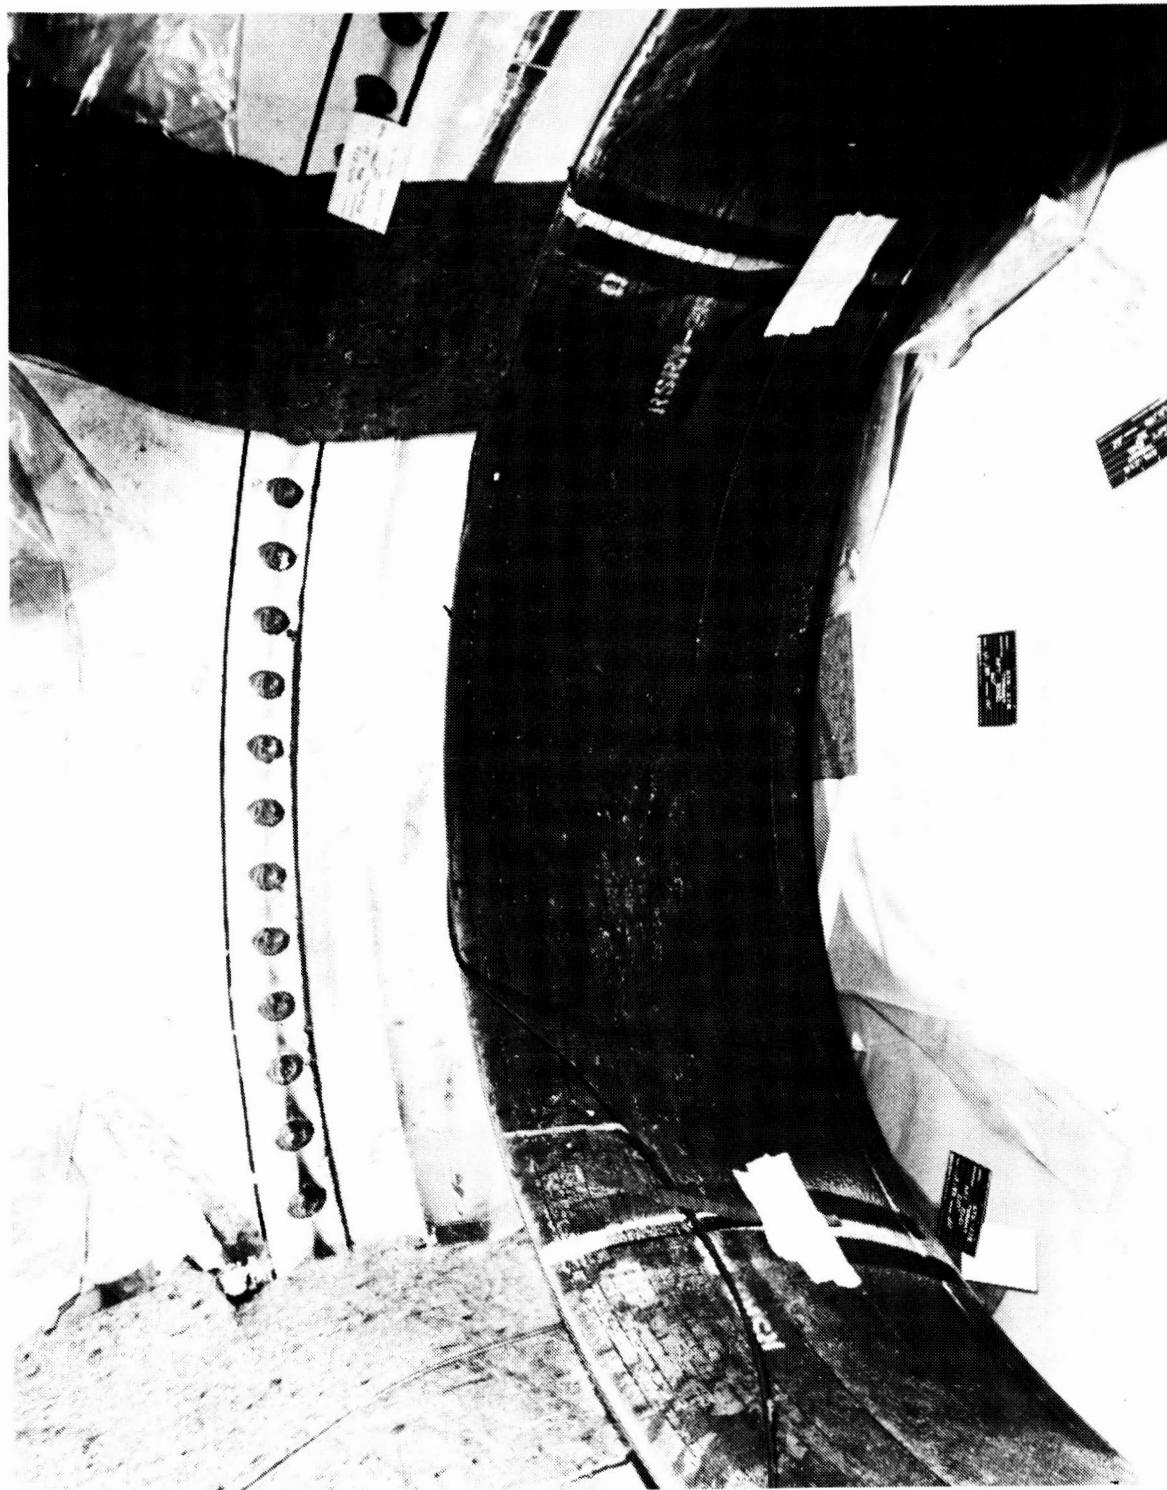
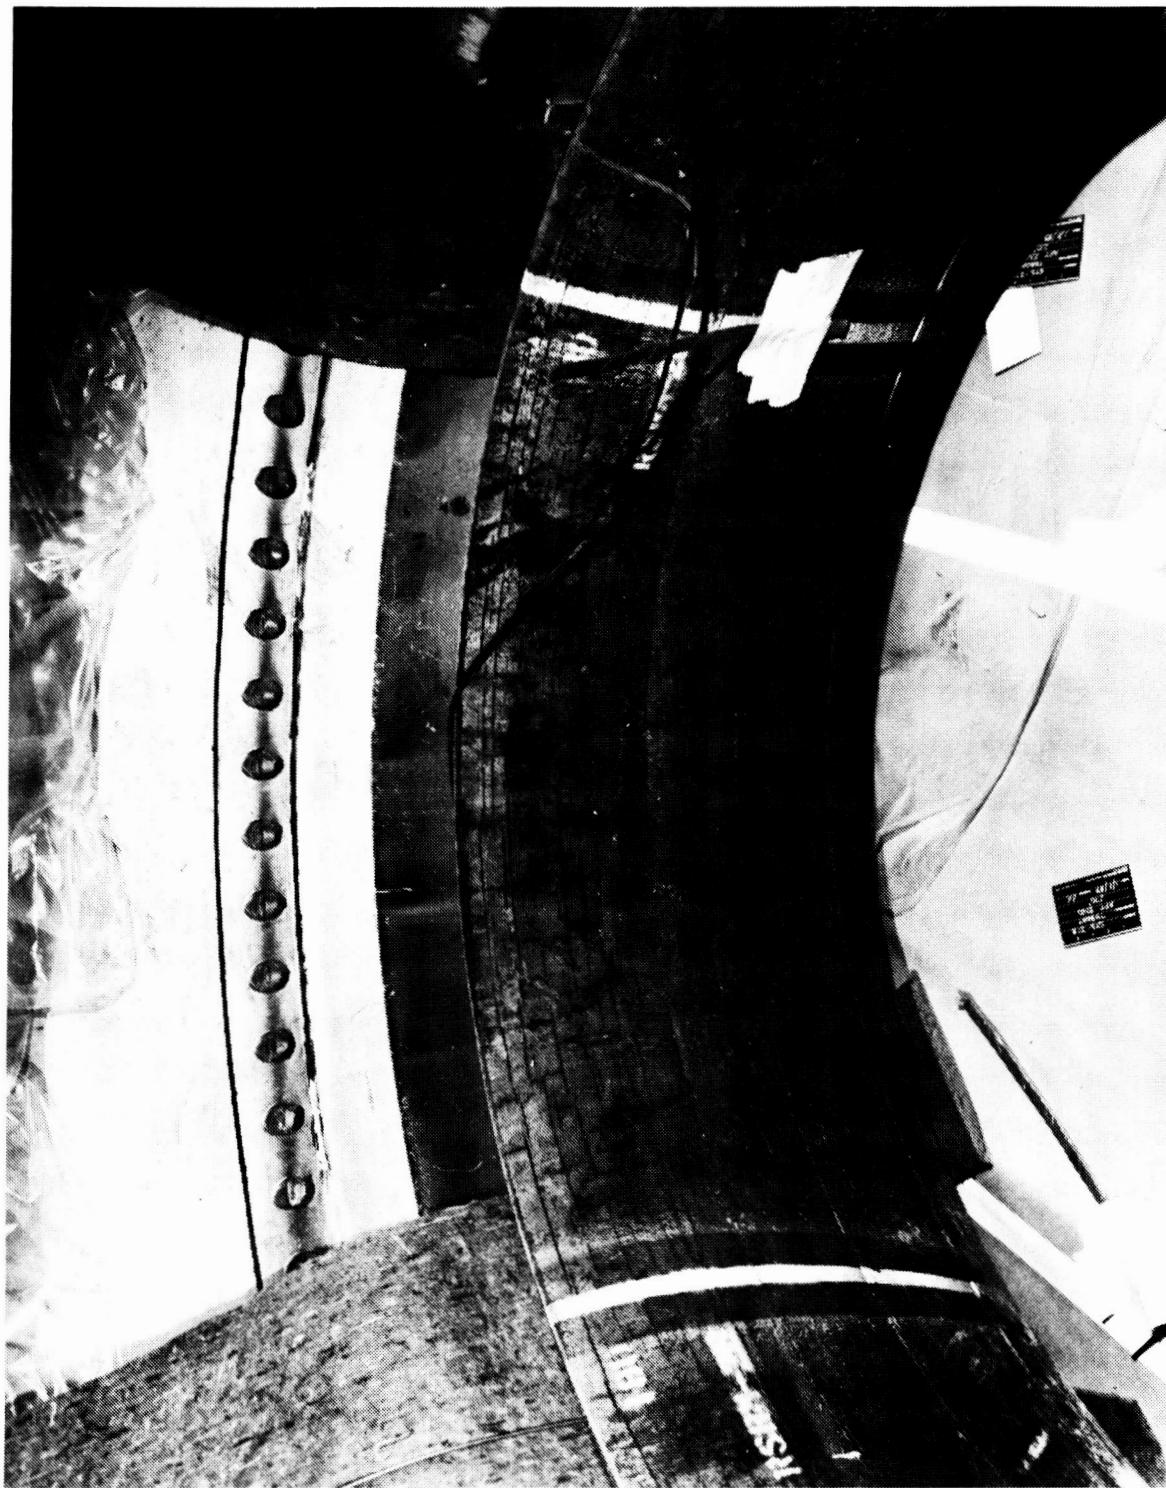
Overall views of the STS-27B throat assembly (throat ring and throat inlet ring) are shown in Figures 4.84 through 4.86.

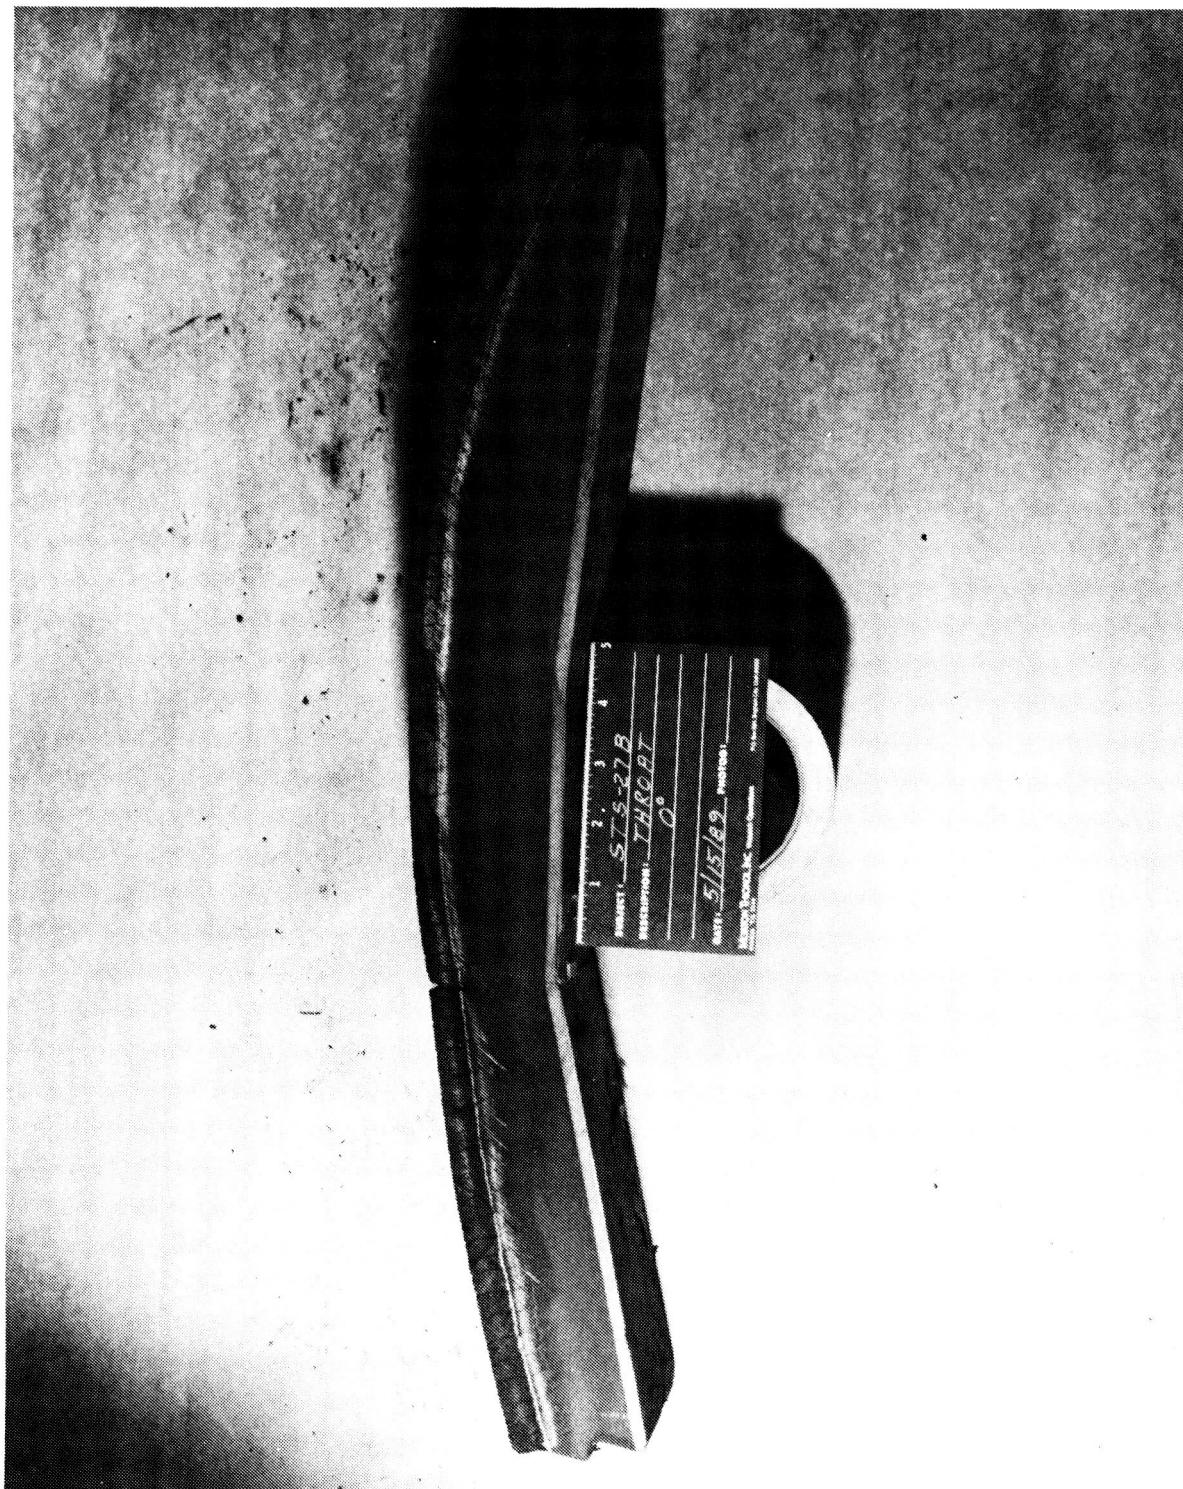
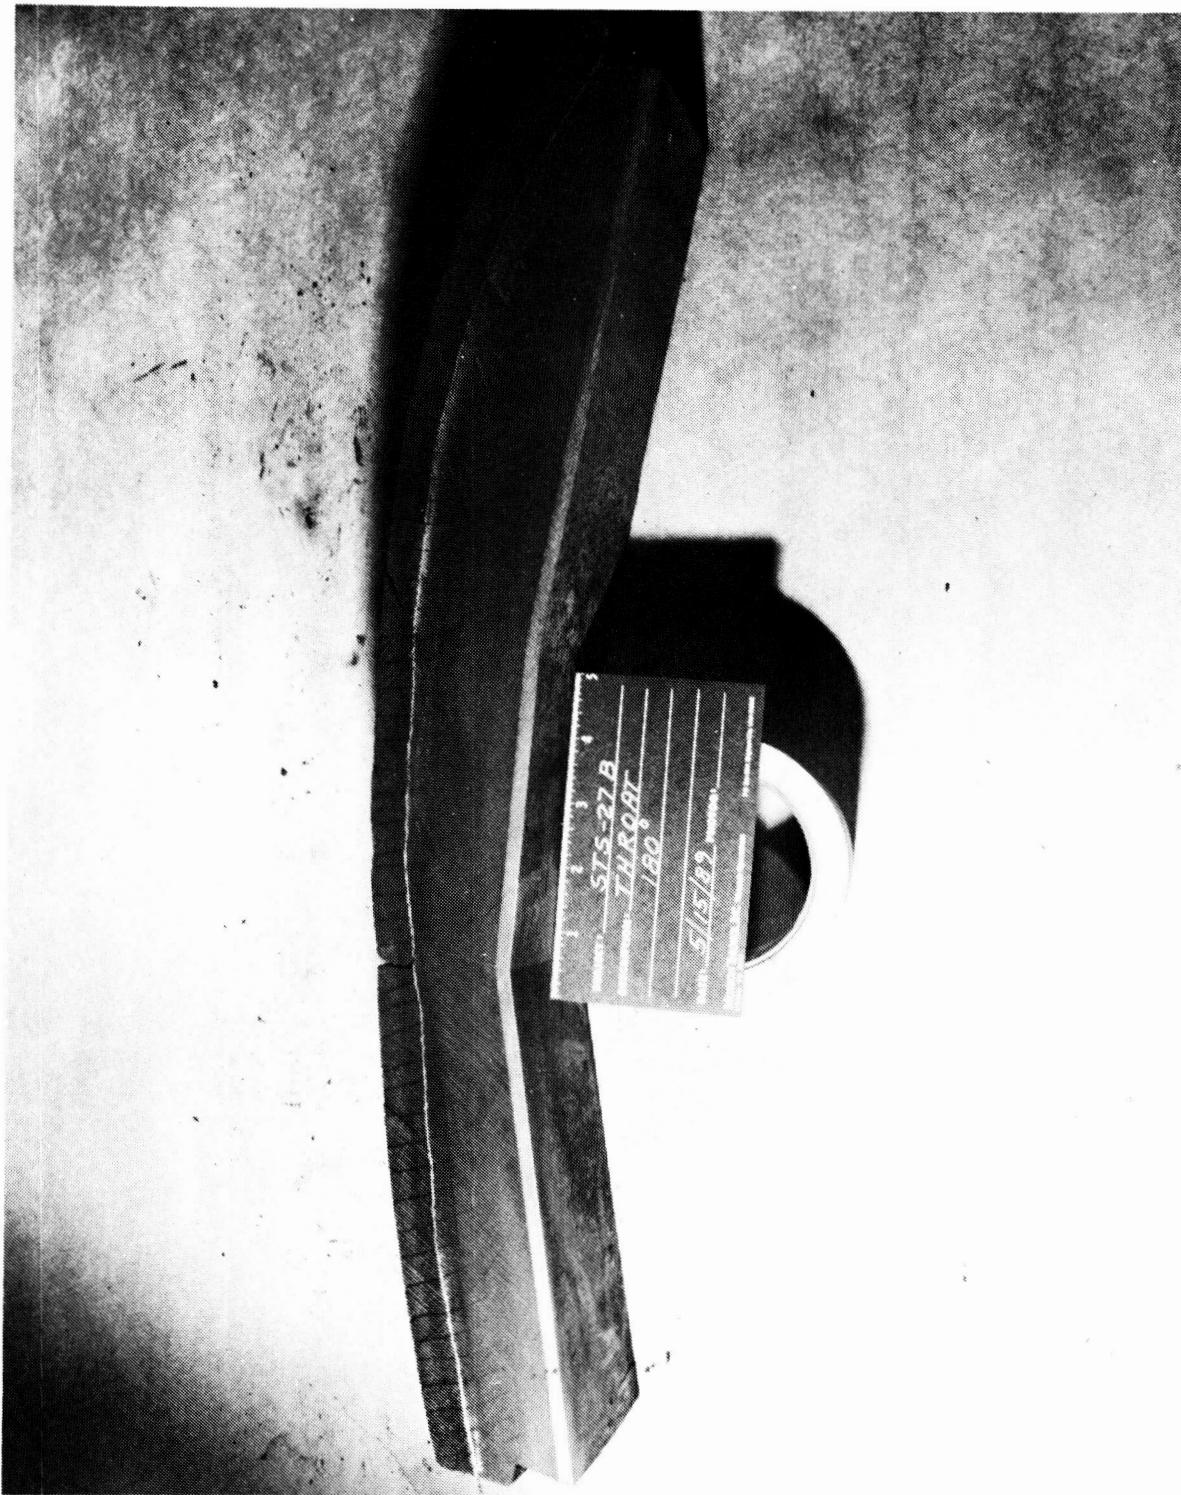
Sectioned views of the throat and throat inlet ring liner and insulator are shown in Figures 4.88 and 4.89. Sectioning of the liner revealed CCP-to-GCP separations occurring intermittently along the throat inlet ring length and around the circumference. Separations were also observed within the GCP insulators of both rings. These separations are typical observations and resulted from post-burn heat soak and cooldown liner shrinkage, and/or from washout and sectioning operations. Sectioning also revealed surface delaminations extending into virgin CCP material. There was no evidence of heat effect within the virgin material.

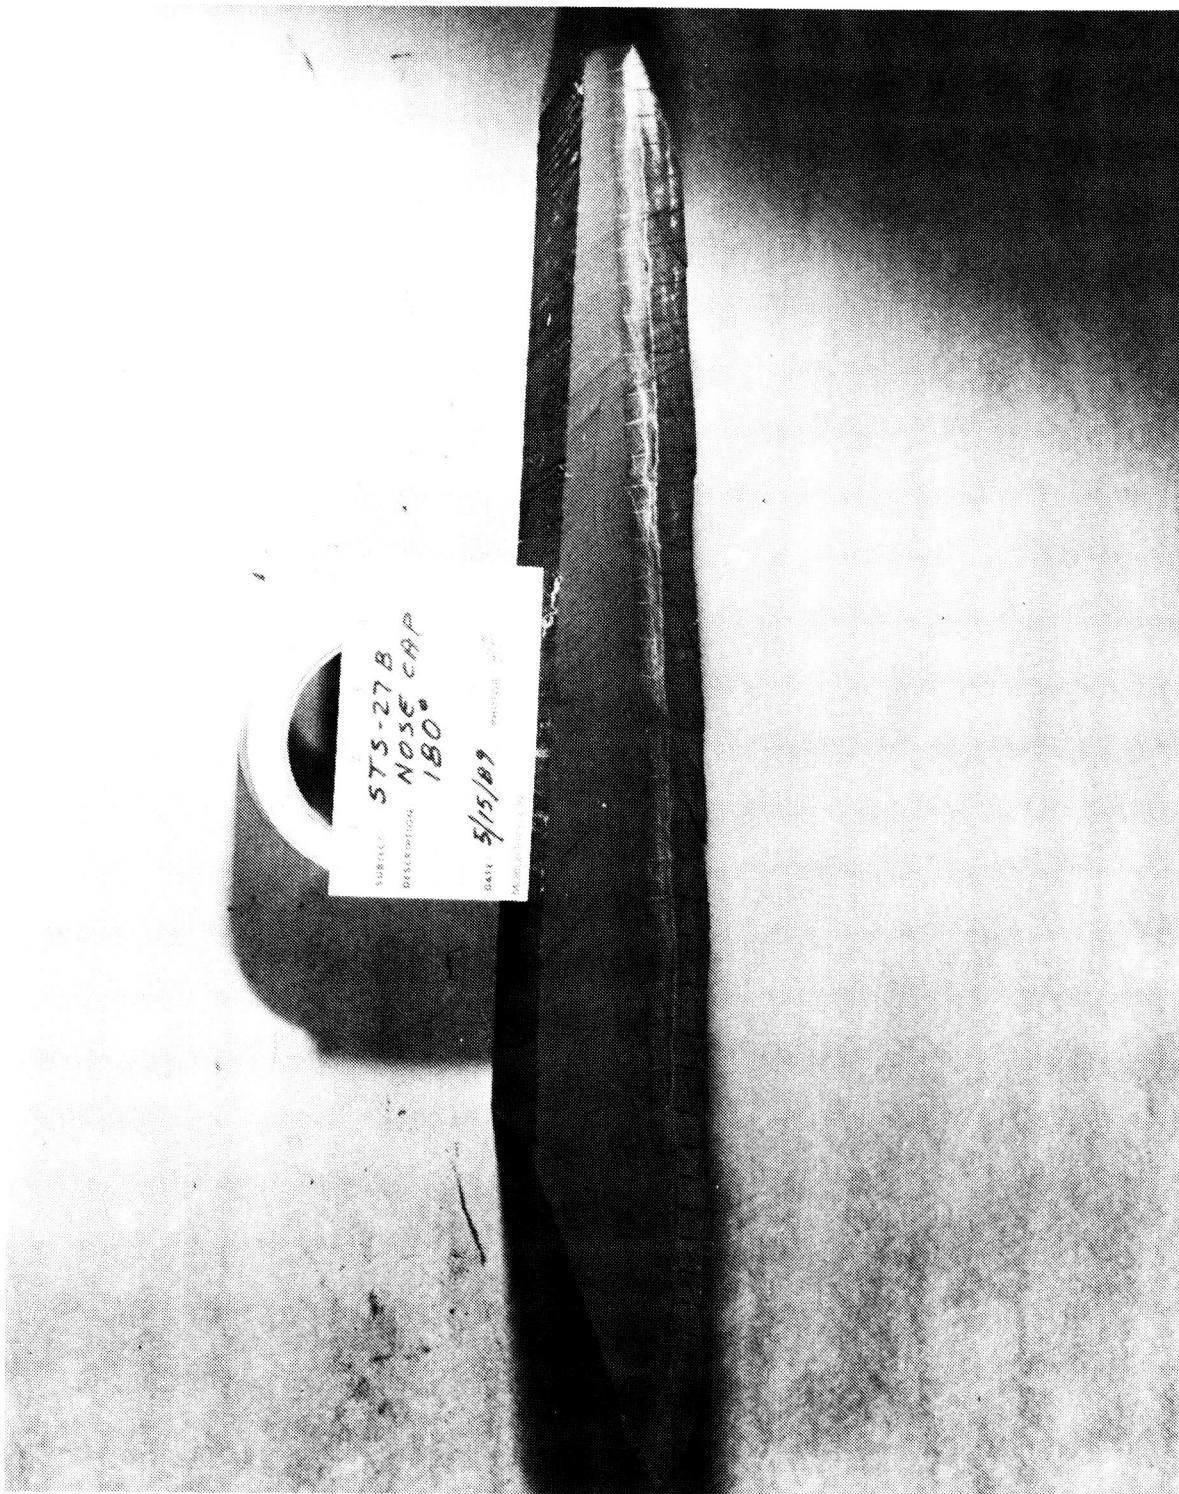
Figure 4.92 STS-27B Nose Cap Sectioned View (180 degrees)

Sectioned views of the nose cap, -503 and 504 rings liner and insulator are shown in Figures 4.92 through 4.95. Sectioning revealed CCP-to-GCP separations occurring intermittently along the lengths and around the circumferences of all three rings. Separations were also observed within the GCP insulators of the -503 and -504 rings. These separations are typical observations and resulted from post-burn heat soak and cooldown liner shrinkage, and/or from washout and sectioning operations. Sectioning

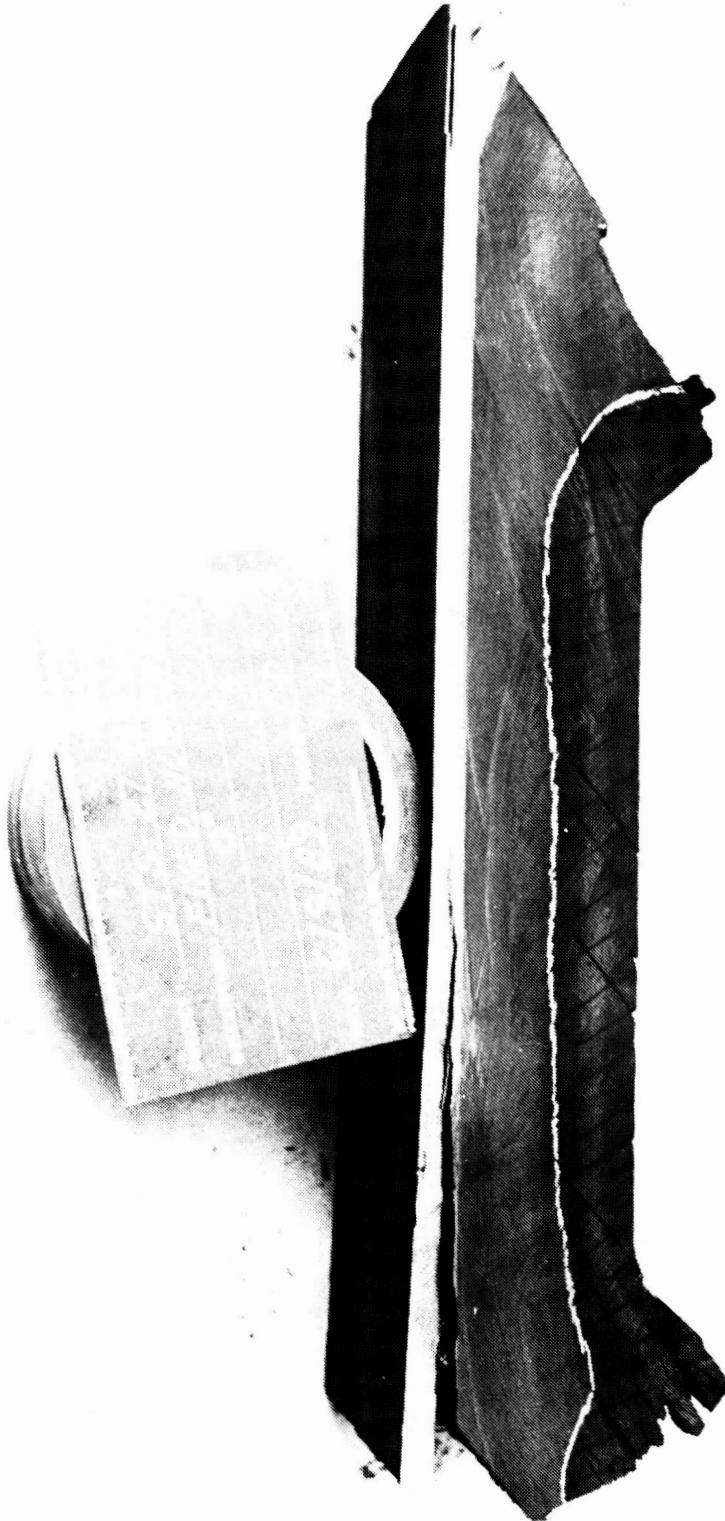
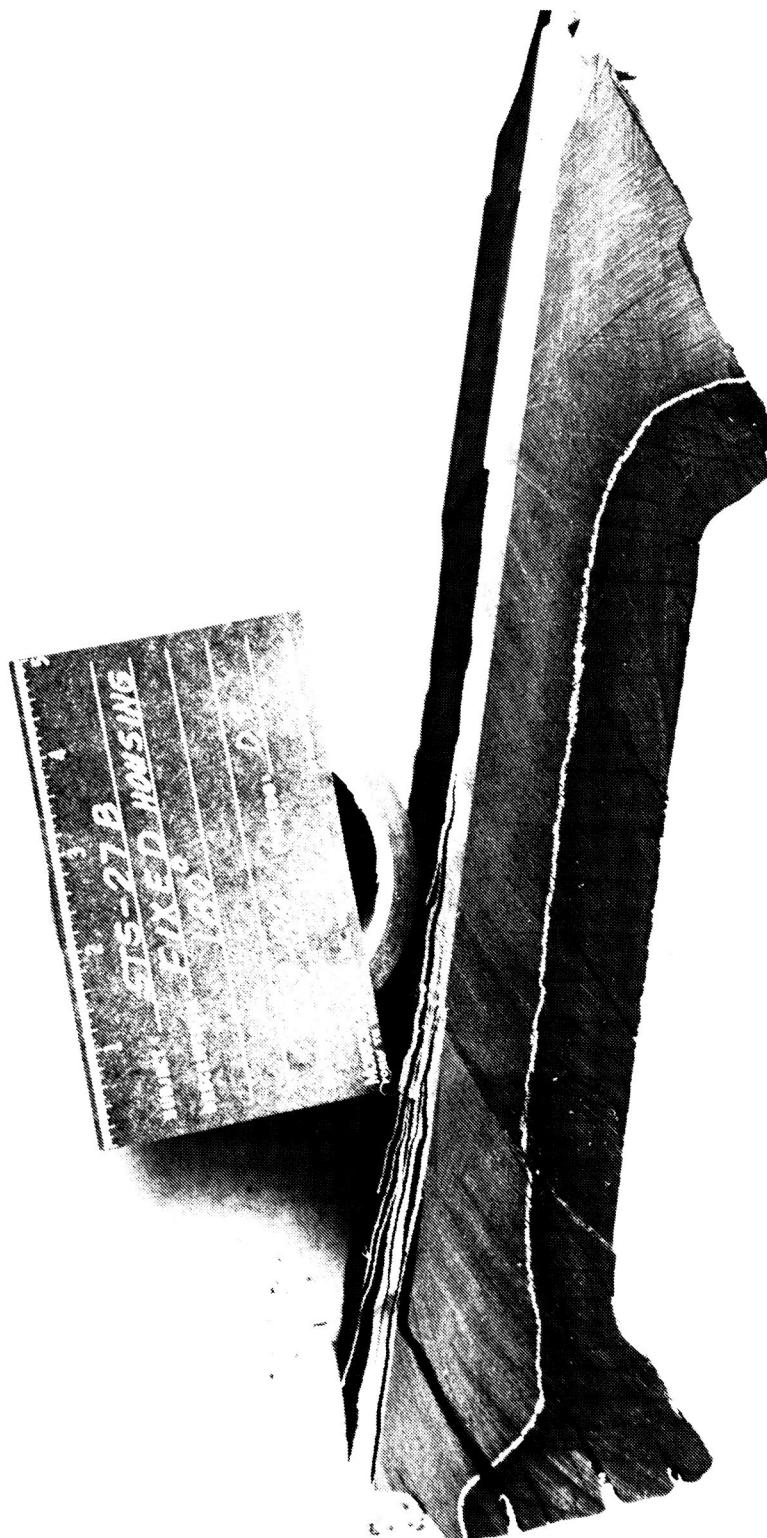
Sectioned views of the fixed housing liner and insulator are shown in Figures 4.108 and 4.109. Sectioning of the liner revealed CCP-to-GCP separations occurring intermittently along the length and around the circumference. Separations within the GCP insulator were also observed. These separations are typical observations and resulted from post-burn heat soak and cooldown liner shrinkage, and/or from washout and sectioning operations. Sectioning also revealed surface delaminations extending into virgin CCP material. There was no evidence of heat effect within the virgin material.

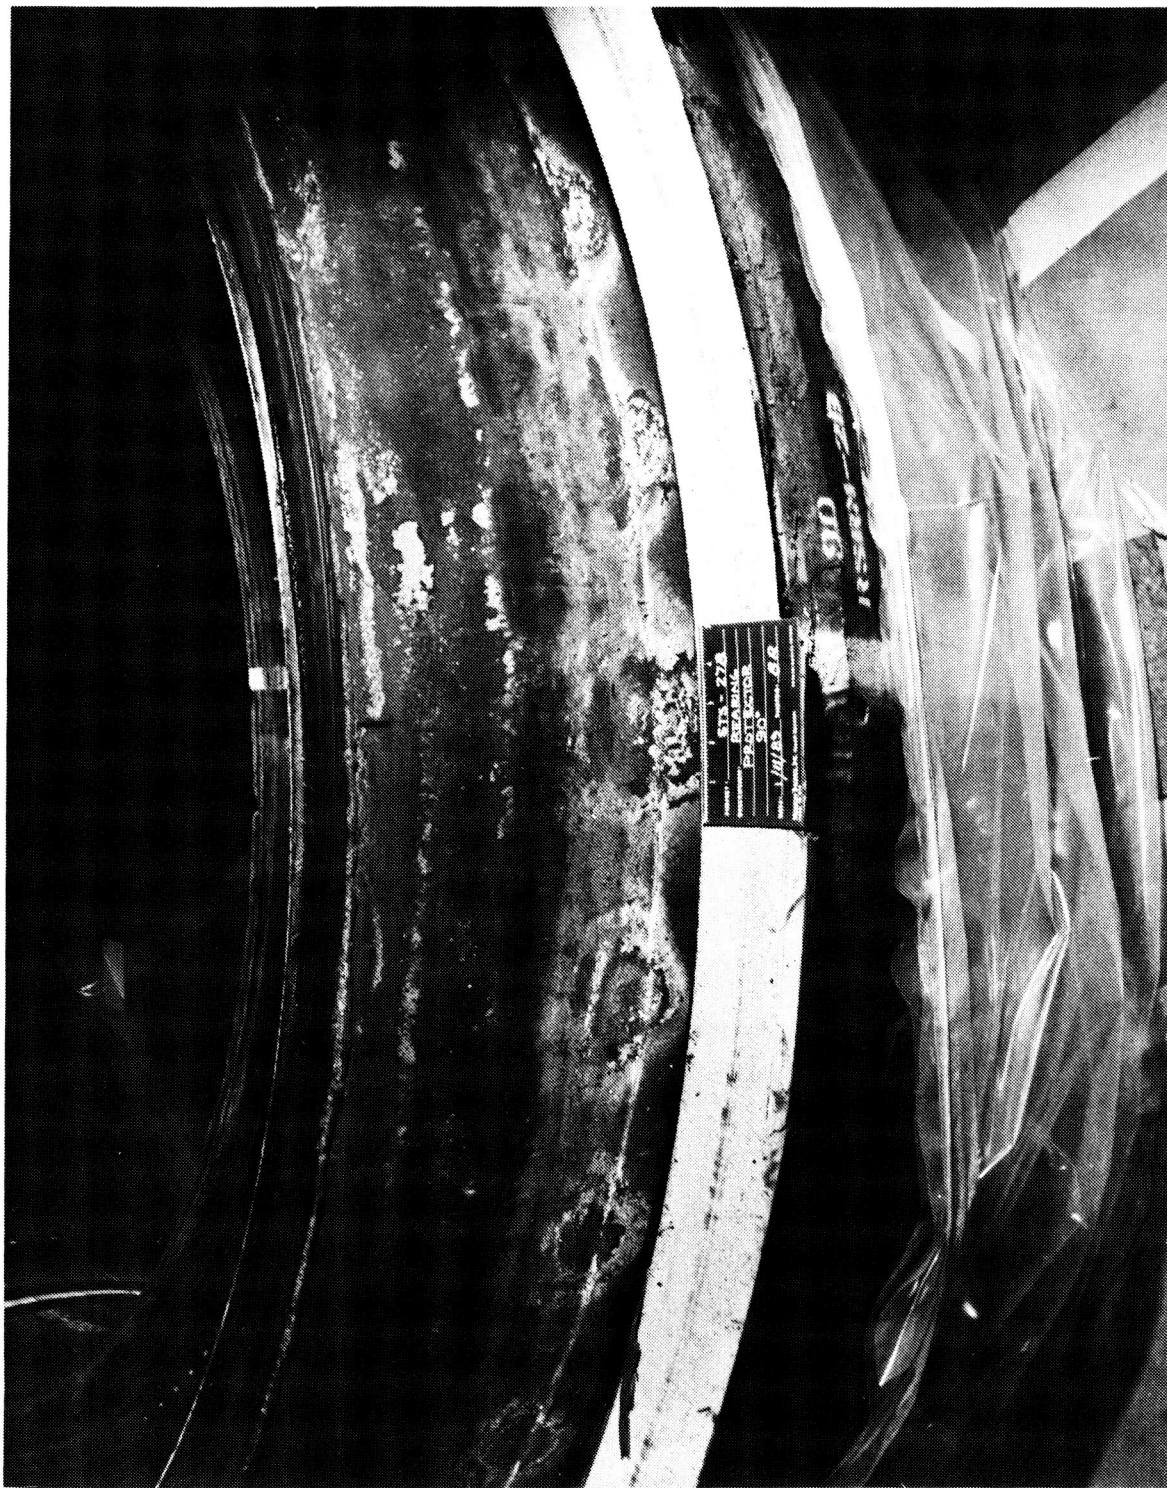
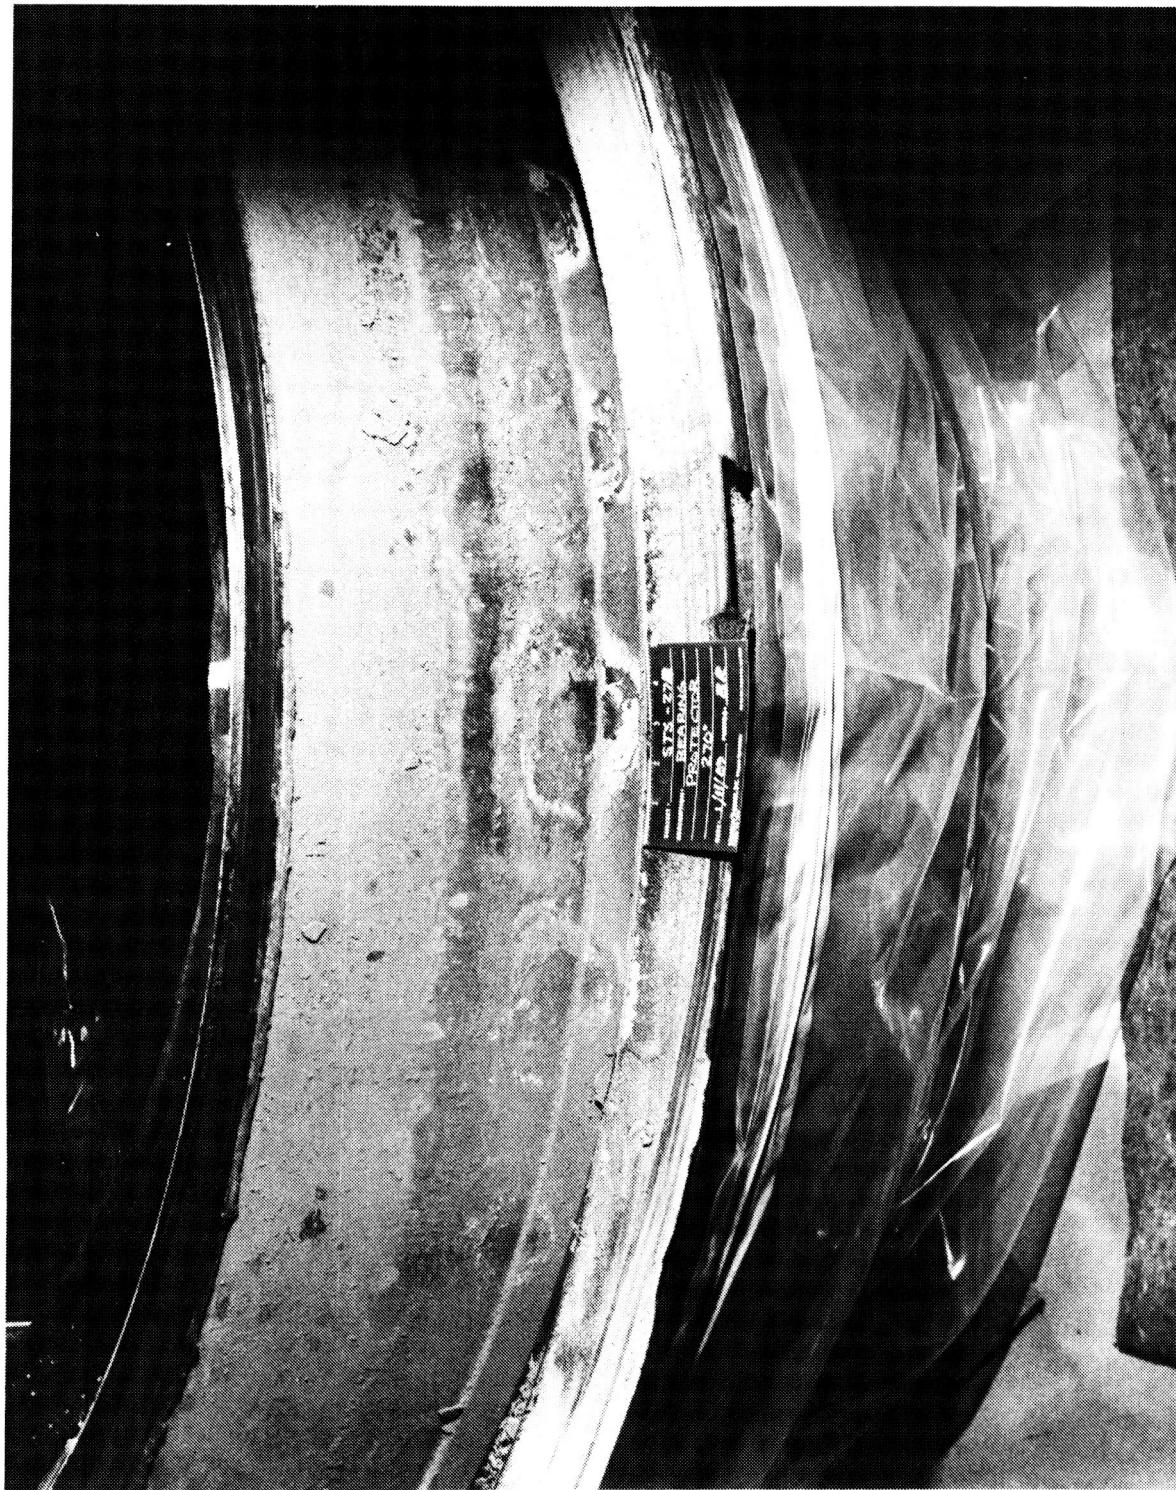
The bearing protector was sooted along the entire length and circumference (see Figures 4.110 and 4.111). Heavier soot and erosion were observed in line with the cowl ring vent holes at the thickened portion of the bearing protector. Erosion depths at these locations are presented in Figure 4.112. There was no evidence of heat effect on the ID surface of the bearing protector.

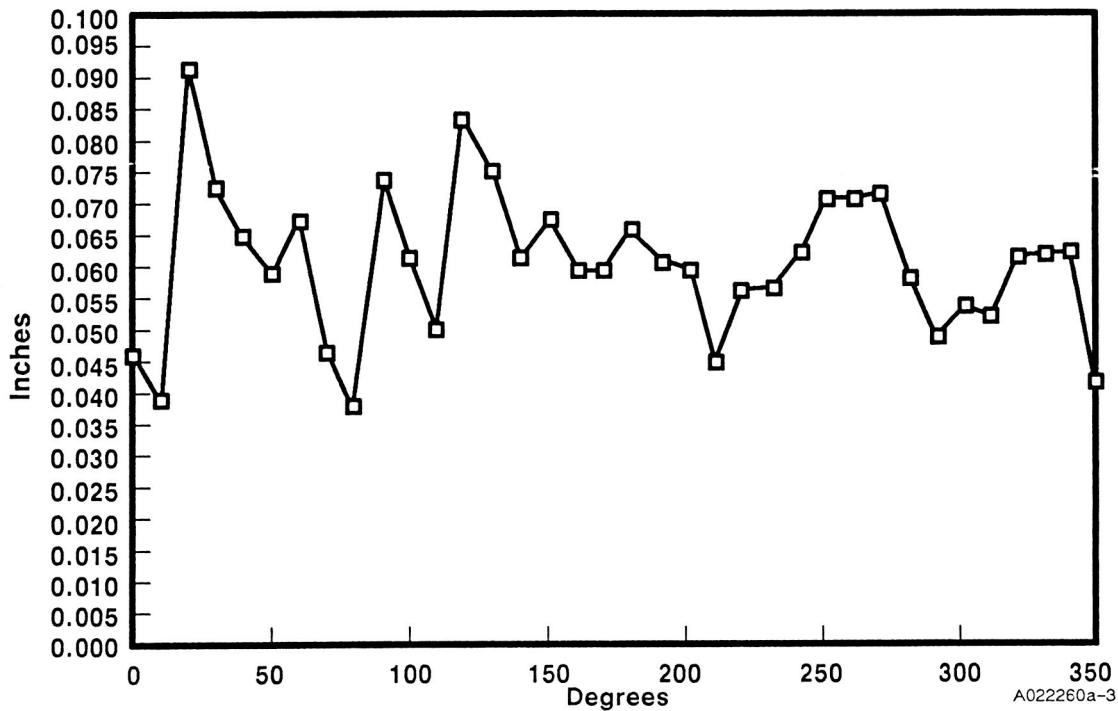
<u>Circumferential Location (deg)</u>	<u>Erosion (in.) in Line With Cowl Vent Holes</u>
0	0.046
10	0.039
20	0.092
30	0.073
40	0.065
50	0.059
60	0.068
70	0.047
80	0.038
90	0.074
100	0.062
110	0.050
120	0.084
130	0.075
140	0.062
150	0.068
160	0.060
170	0.060
180	0.066
190	0.061
200	0.060
210	0.045
220	0.056
230	0.057
240	0.063
250	0.071
260	0.071
270	0.062
280	0.059
290	0.049
300	0.054
310	0.053
320	0.062
330	0.063
340	0.063
350	0.042
