TWR-17541-5

Flight Motor Set 360L002 (STS-27R) Final Report

Volume V (Nozzle Component)

STS-27 POST-TEST NOZZLE PERFORMANCE EVALUATION REPORT

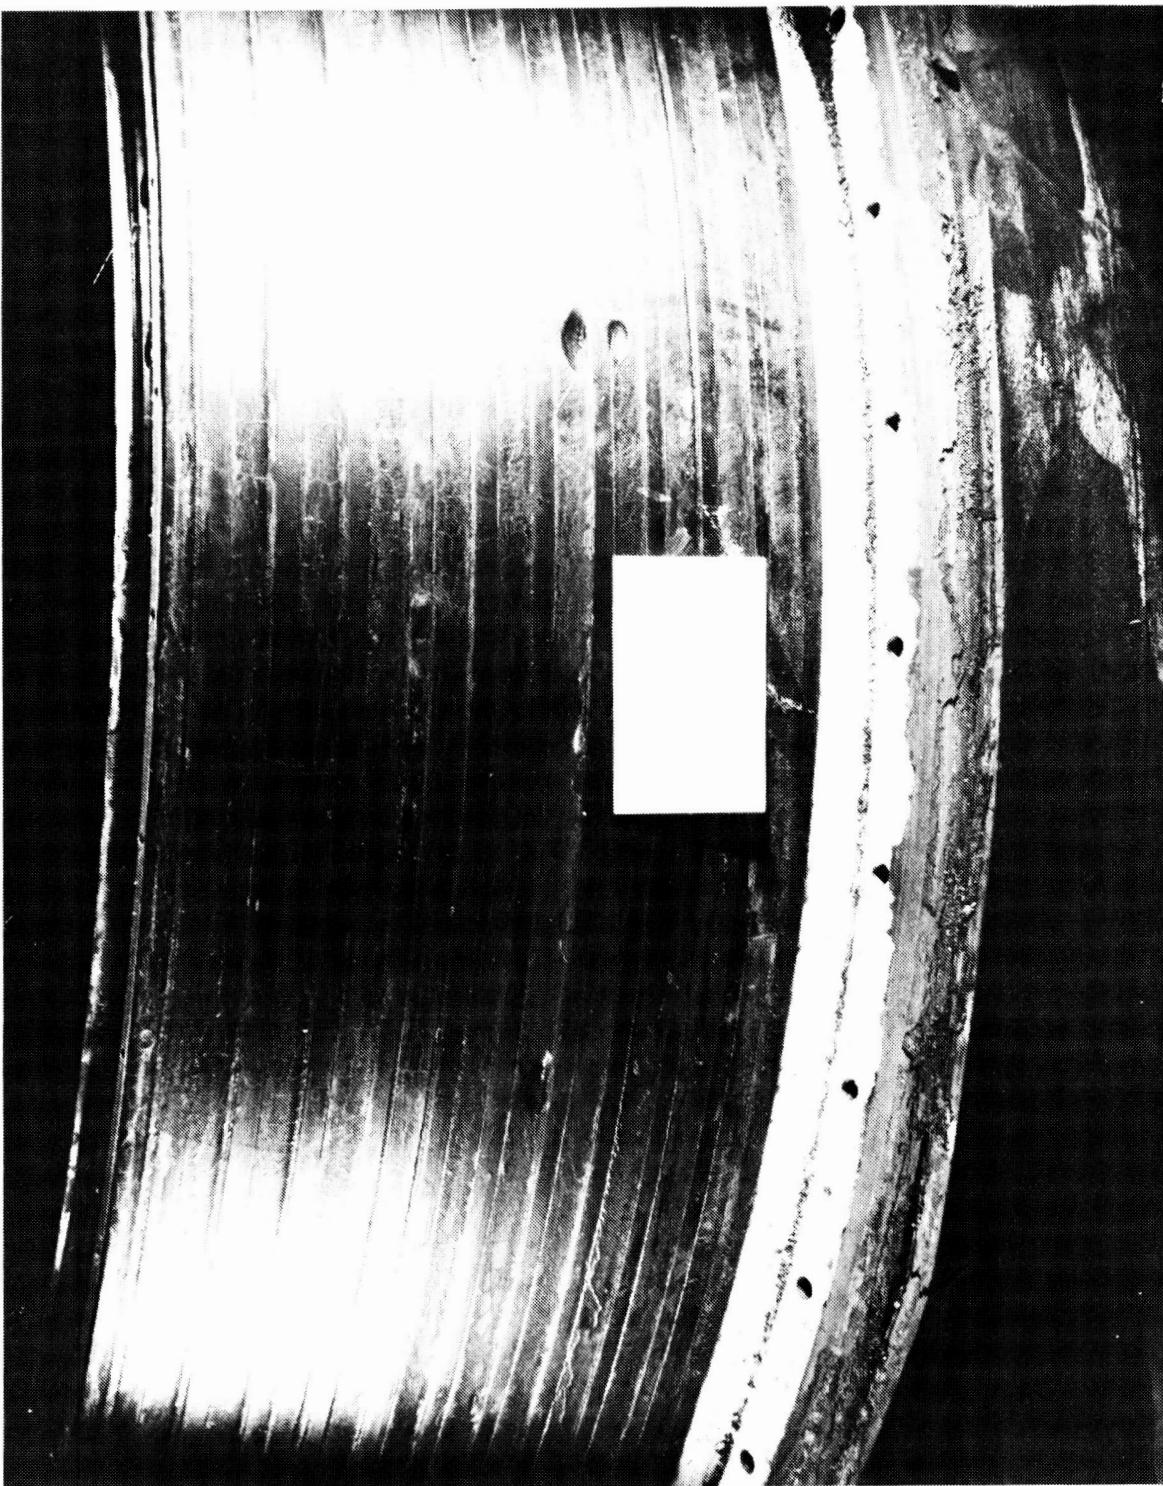
Figure 4.113 STS-27B Flex Bearing Indentations (220 degrees)

During post-flight inspection, six indentations were noticed on the flex bearing pads #7 and #8 (see Figure 4.113). The locations and sizes of the indentations are summarized in Table 4.13. It was initially believed that the indentations might have resulted from hot gas impingement through the cowl vent holes. Closer inspection, however, showed that the Chemlock coating on the rubber had not been heat affected. In addition, the bearing protector did not burn through. The flex bearing rubber pad surfaces were wiped, and an analysis was conducted on the samples taken. No indications of flow were found. The indentations are believed to have resulted from the rubber taking on a permanent set while an object or objects inadvertently rested on the bearing assembly. It should be noted that the indentations do meet the acceptable surface defect criteria specified in STW3-3497A paragraph 3.2.2.6.1, and that the flex bearing assembly is an acceptable part.

CIRCUMFERENTIAL LOCATION (DEGREES)	RUBBER PAD NO.	RADIAL DEPTH (IN.)	CIRC. LENGTH (IN.)	AXIAL WIDTH (IN.)
200	7	0.50	0.65	0.25
210	7	0.20	1.30	0.45
220	8	0.05	0.60	0.40
220	7	0.30	1.70	0.60
230	8	0.10	0.80	0.50
230	7	0.25	1.35	0.50

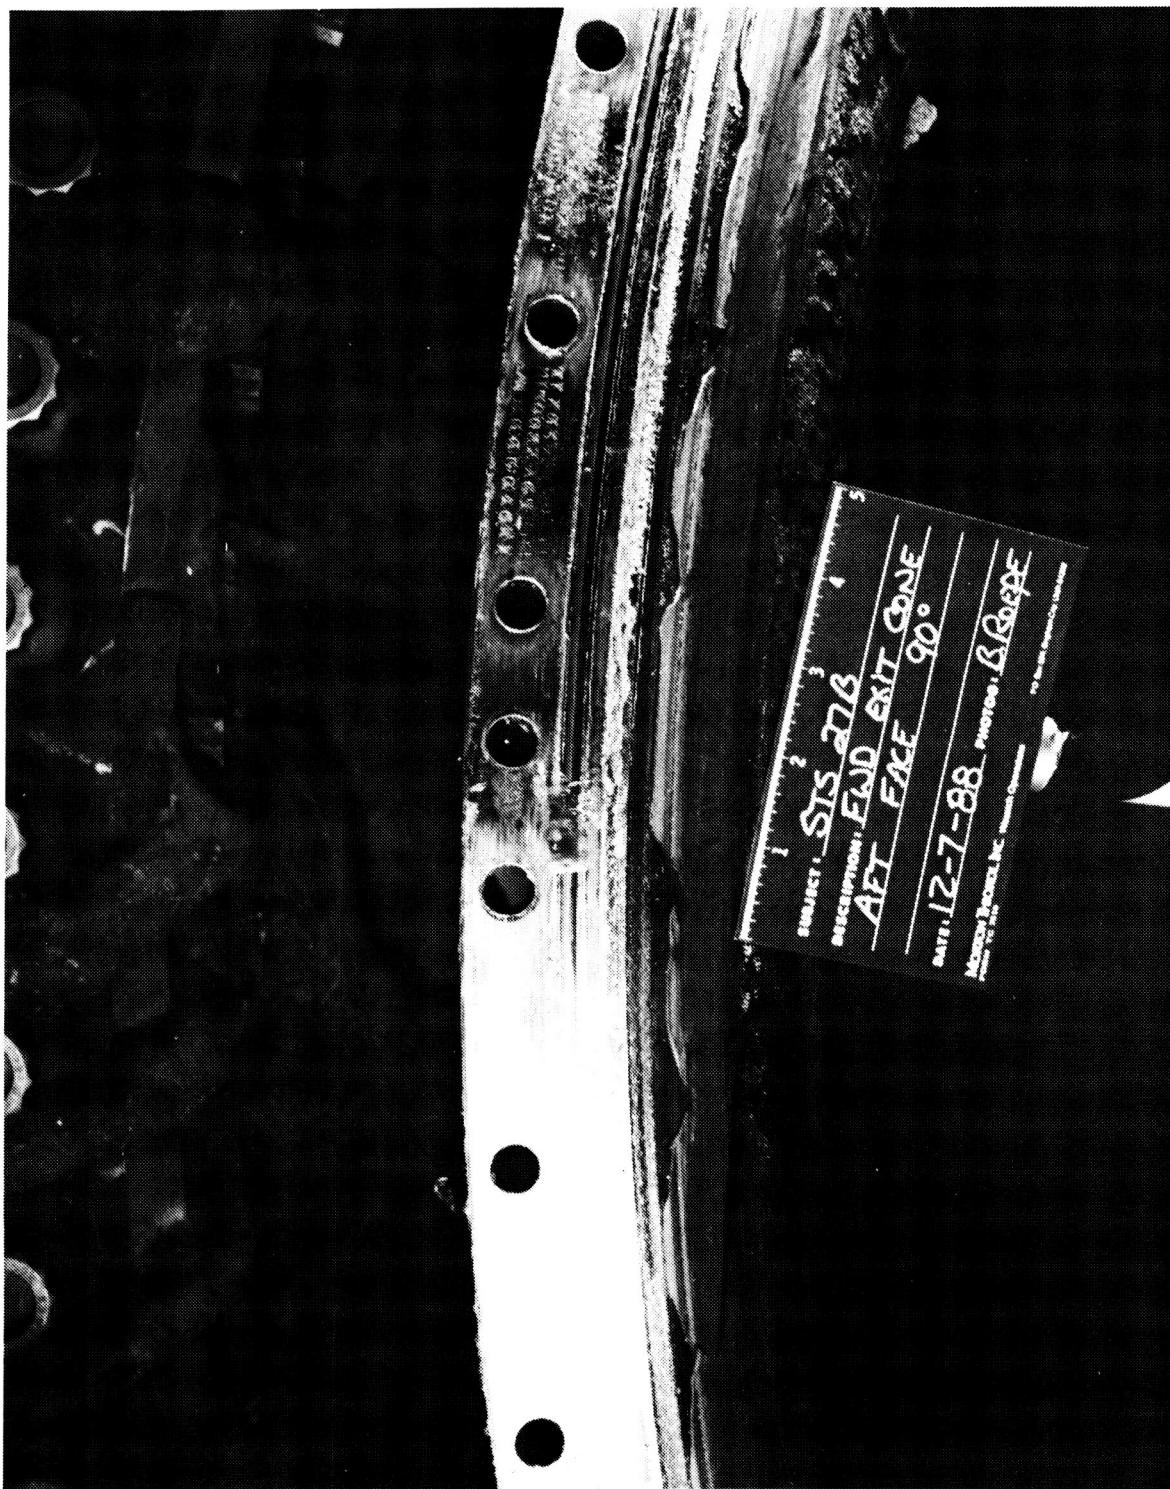
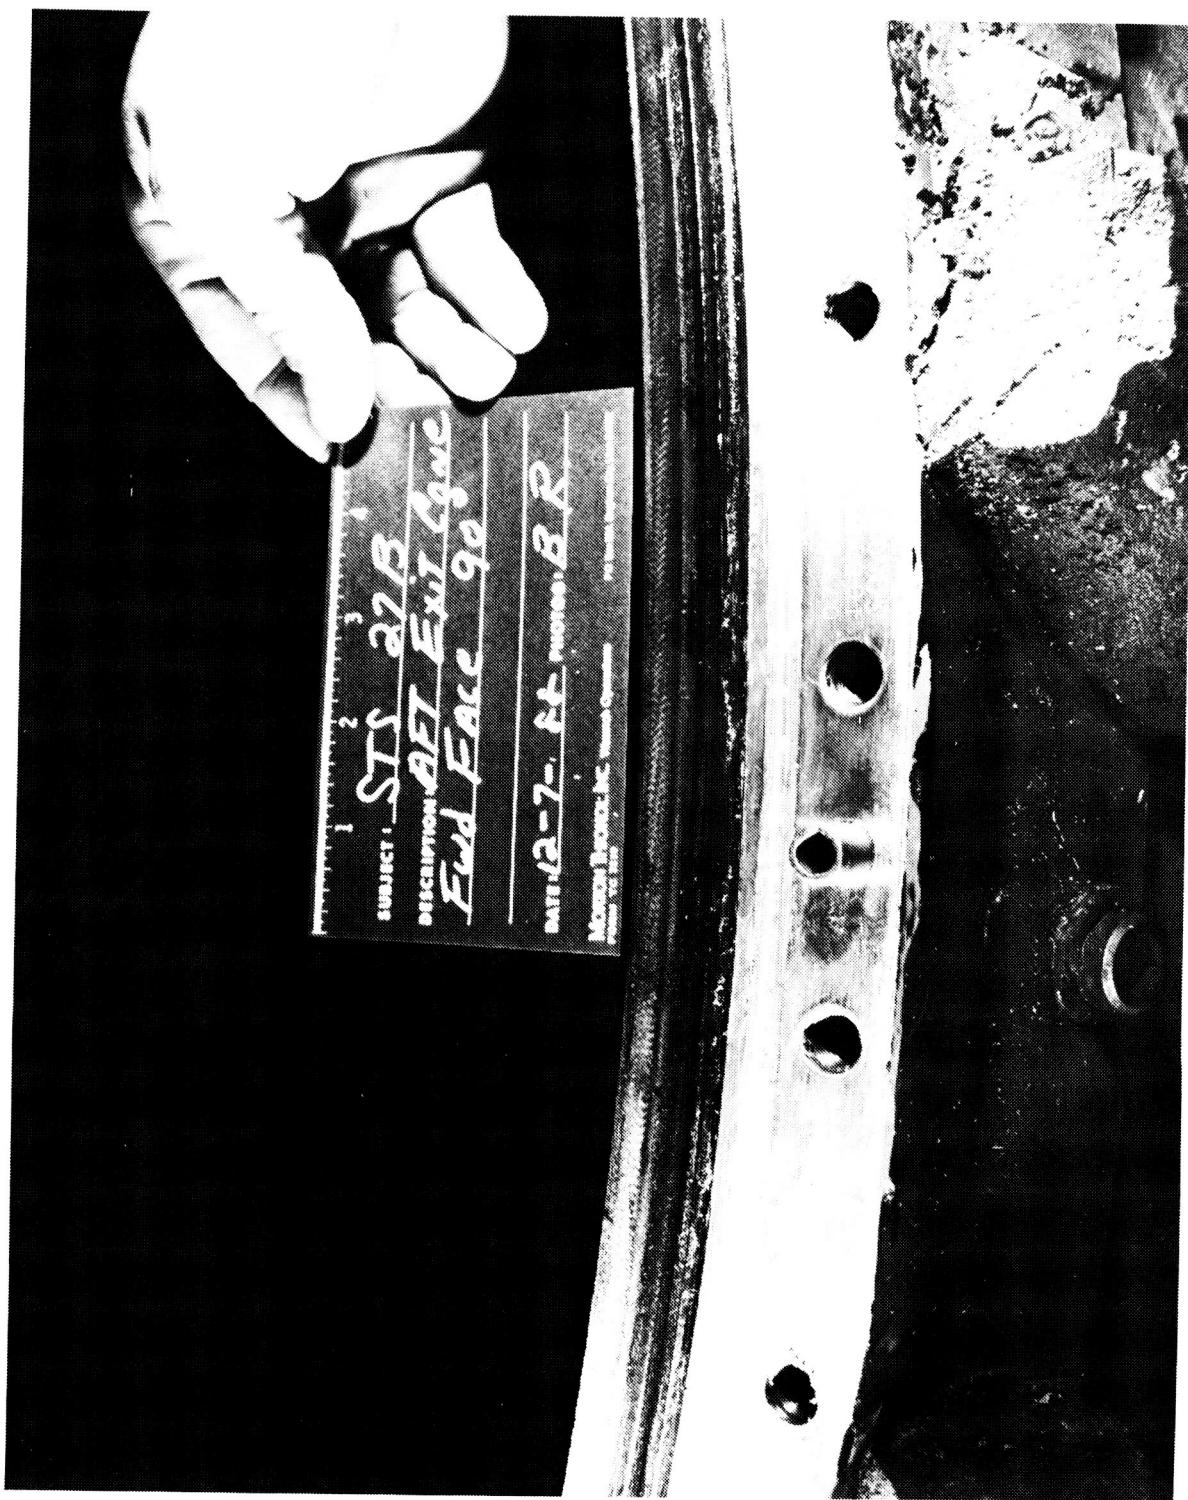
Examination of the joint showed black and white corrosion appearing between the primary and secondary O-rings, and outboard of the secondary O-ring intermittently around the circumference. The black corrosion is the beginning stage of the aluminum oxide. The corrosion was less than that observed on the STS-26 (LH) and (RH) joints. There was no pitting observed. A white colored residue was observed on the high pressure side of the primary O-ring groove intermittently around the circumference (see Figure 4.117). It is believed that the residue is grease mixed with sea water.

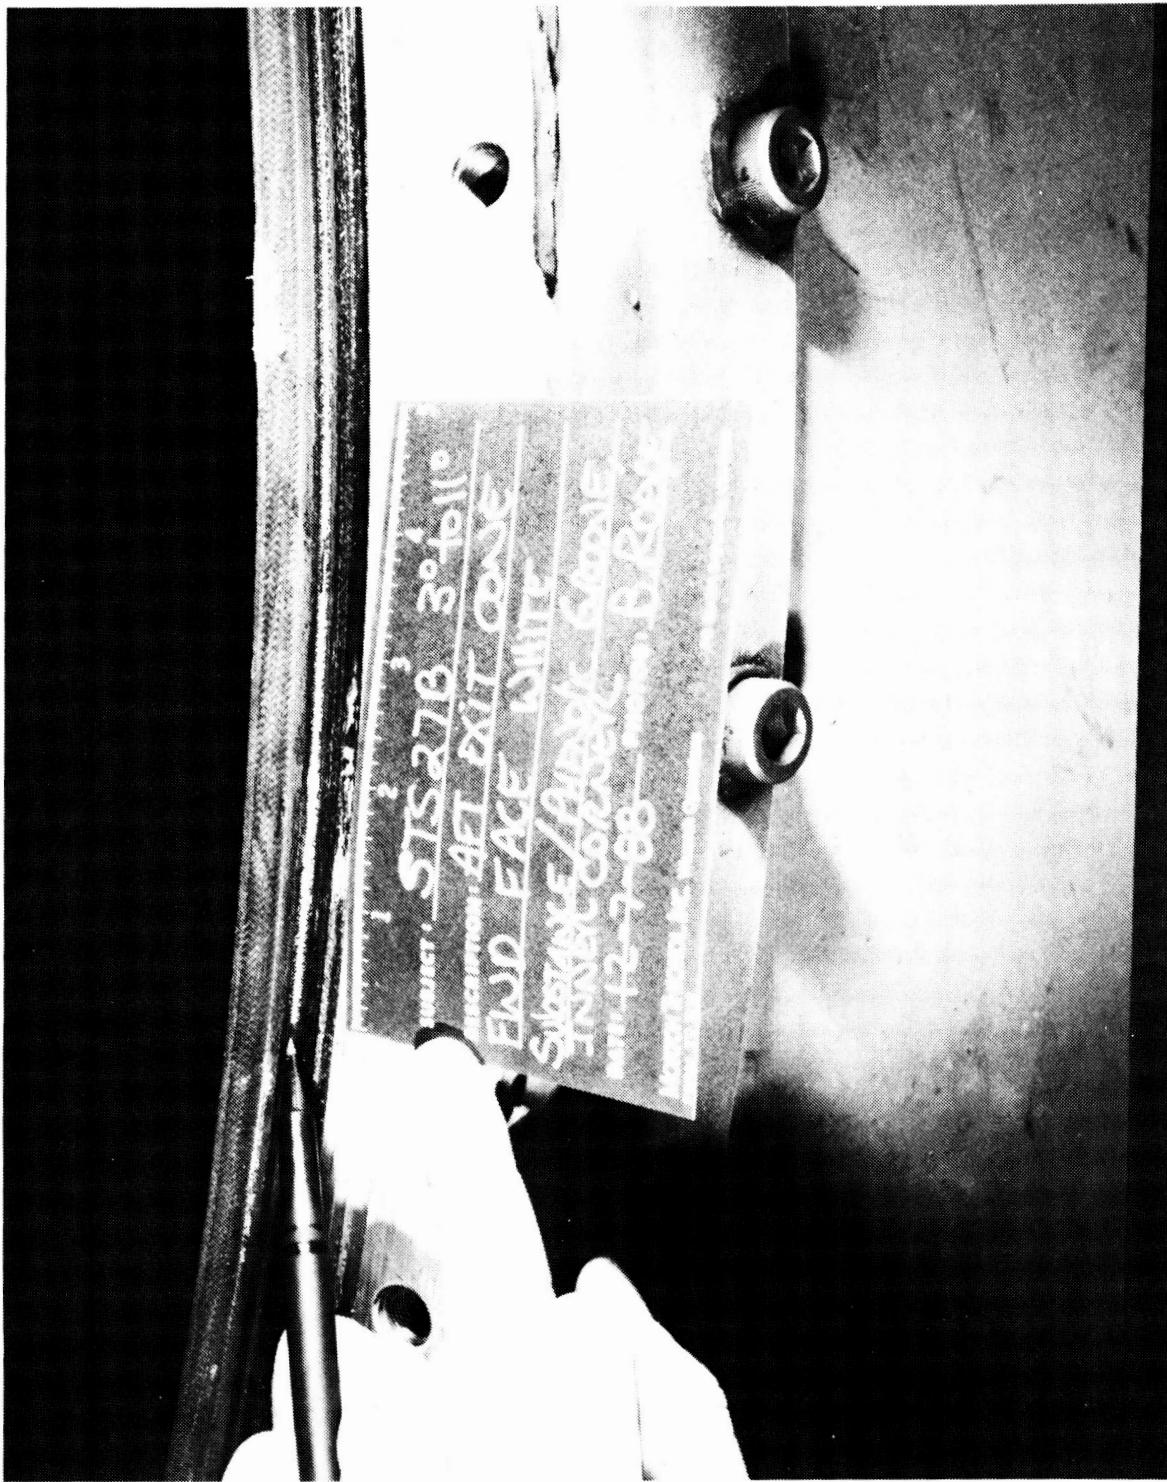
Figure 4.117 STS-27B Joint No. 1 White Substance Believed To Be Salt Mixed with Grease (3 toll degrees)

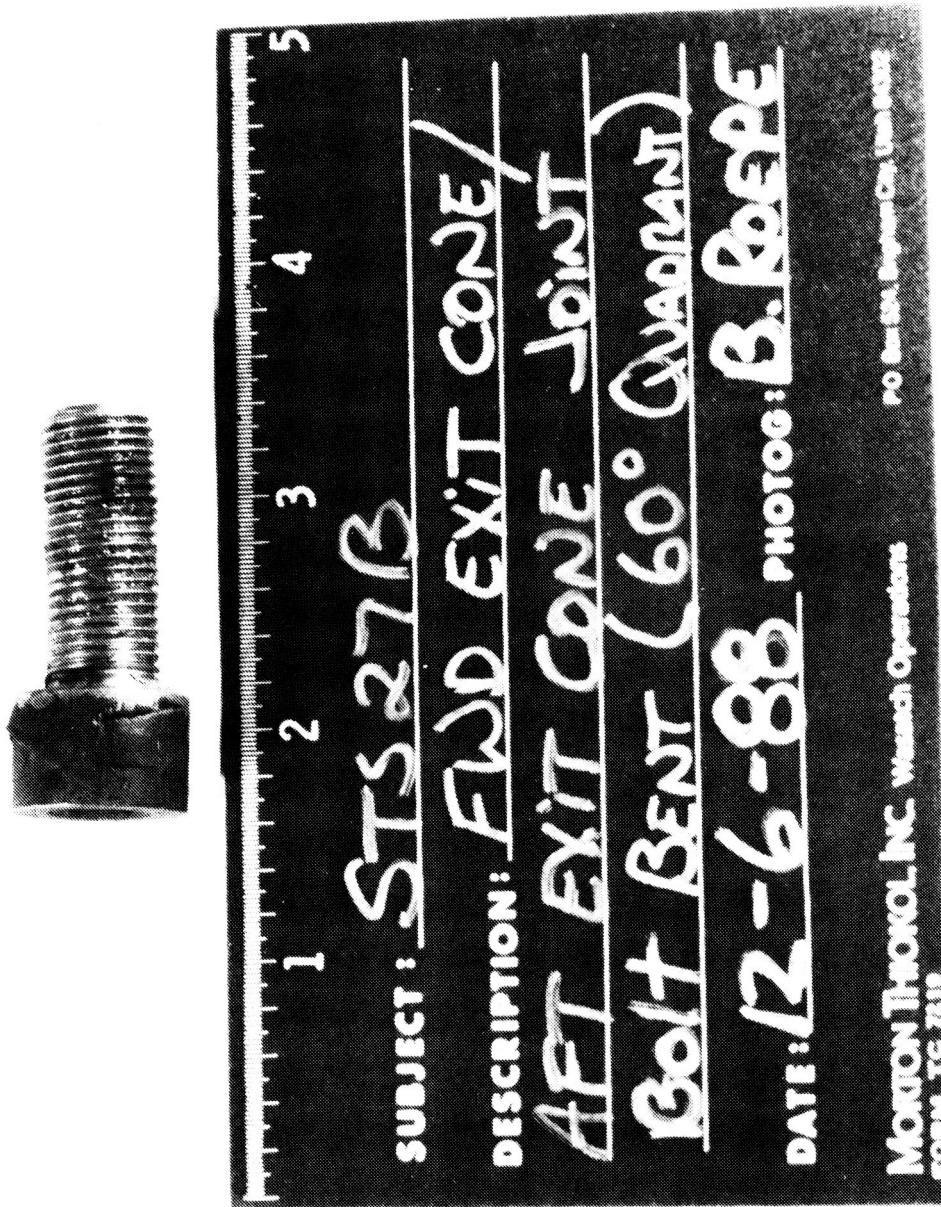
Removal of the aft exit cone field joint bolts showed some bent bolts and damaged bolt threads. Approximately 12 bolts removed from the 0 to 90 degrees quadrant were bent (see Figure 4.118). A preliminary visual examination of the helicoils in the aft exit cone shell forward end revealed no visible damage. There was also no visible damage observed in the forward exit cone housing aft end through holes. Closer inspection information will be gathered during Clearfield H-7 refurbishment.

Figure 4.118 STS-27B Joint No. 1 Bent Bolt

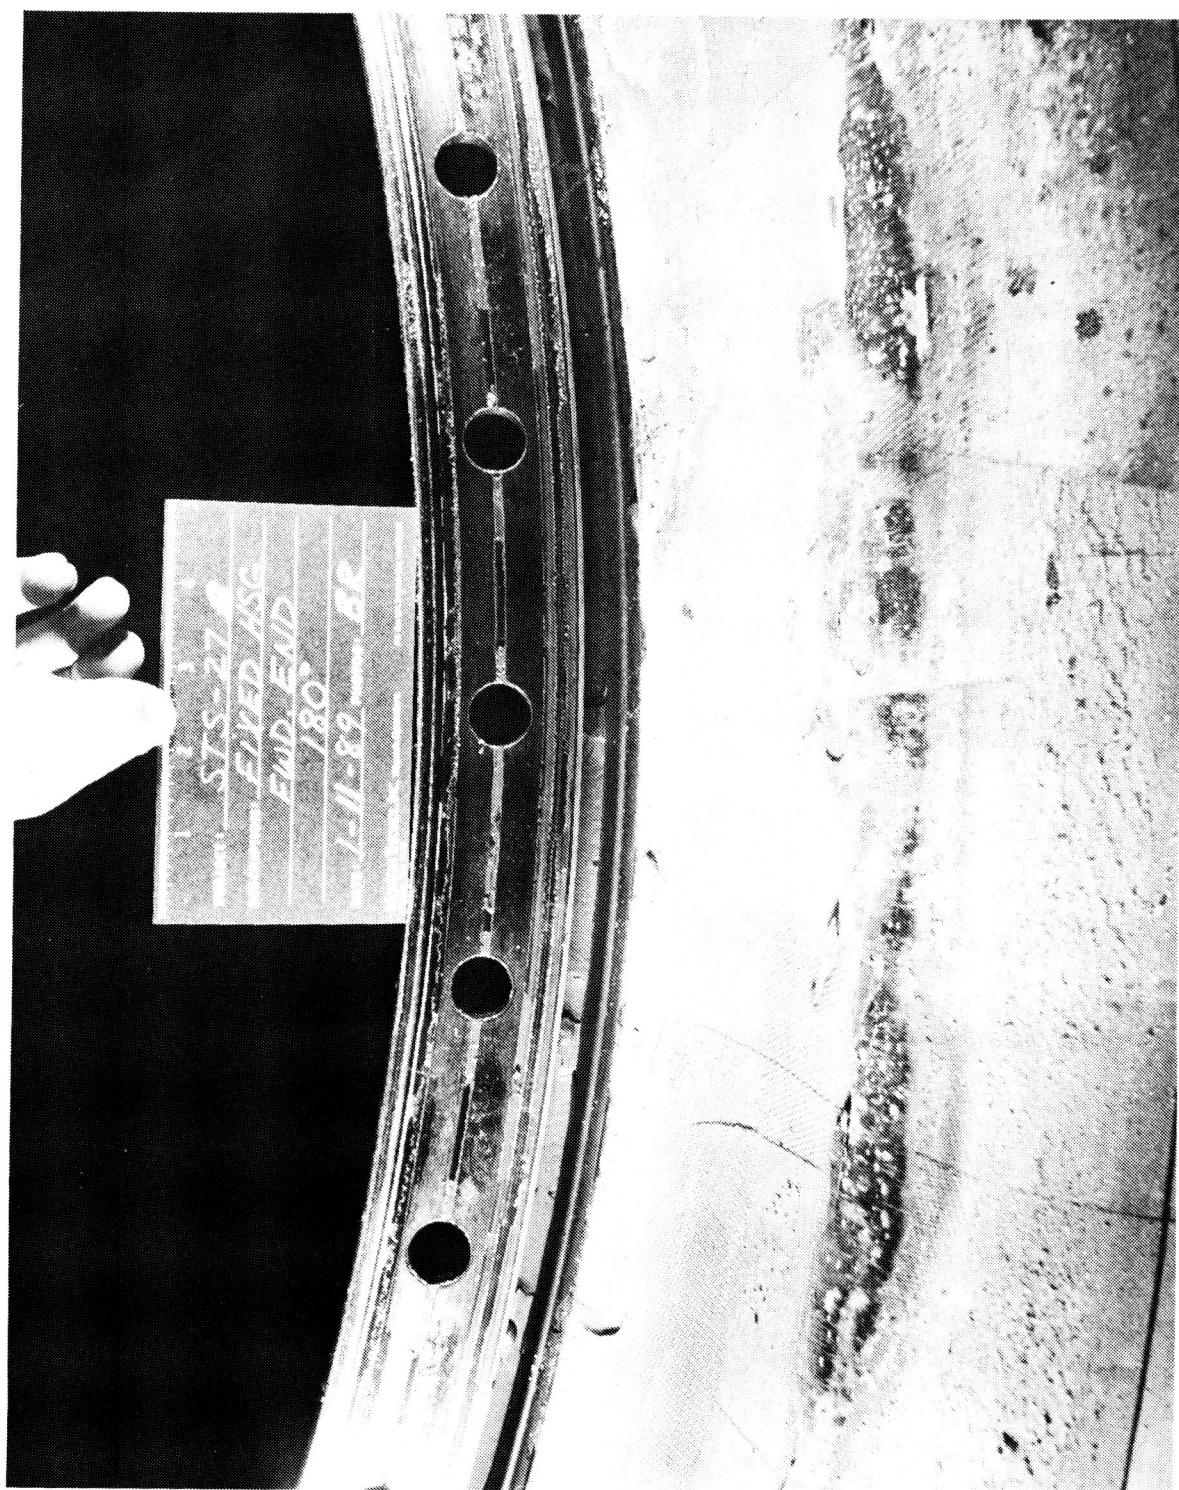
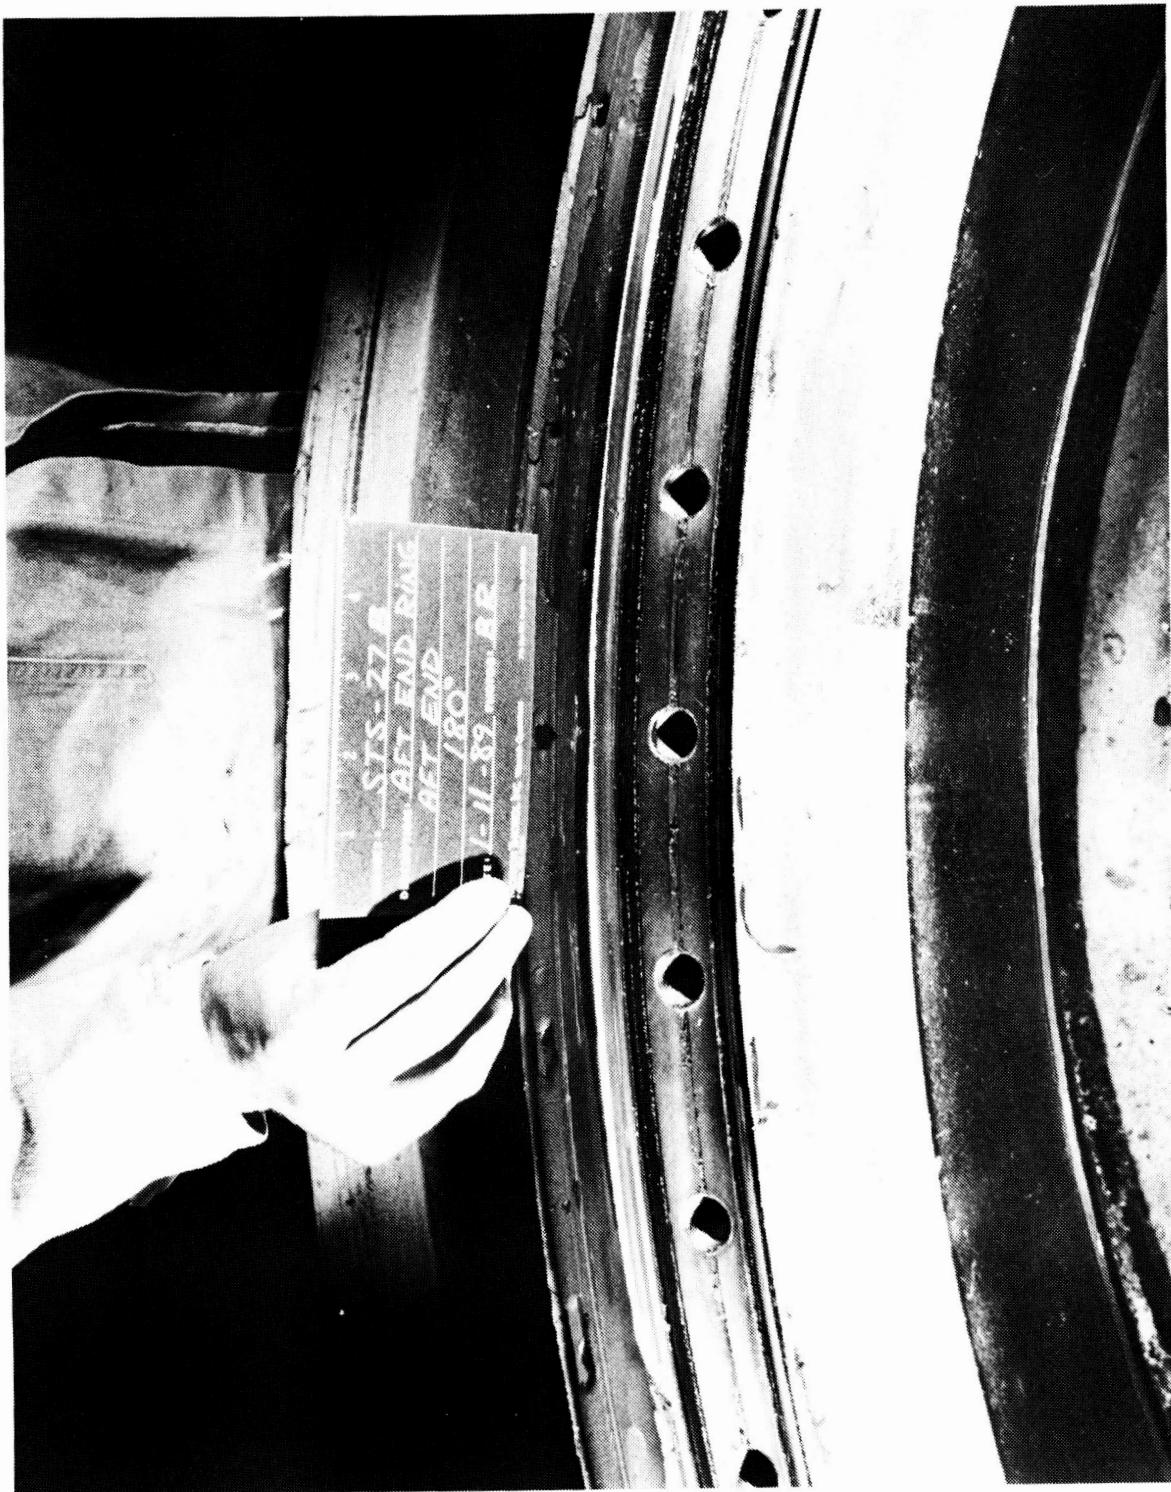
RTV filled all of the radial portion and approximately 12 percent of the axial portion of the joint bondline. RTV did not reach the high pressure side of the primary O-ring groove. There were no blow paths observed in the joint and the primary O-ring did not see pressure. Small voids isolated within the RTV on the radial portion of the joint bondline were observed intermittently around the circumference (see Figure 4.133).

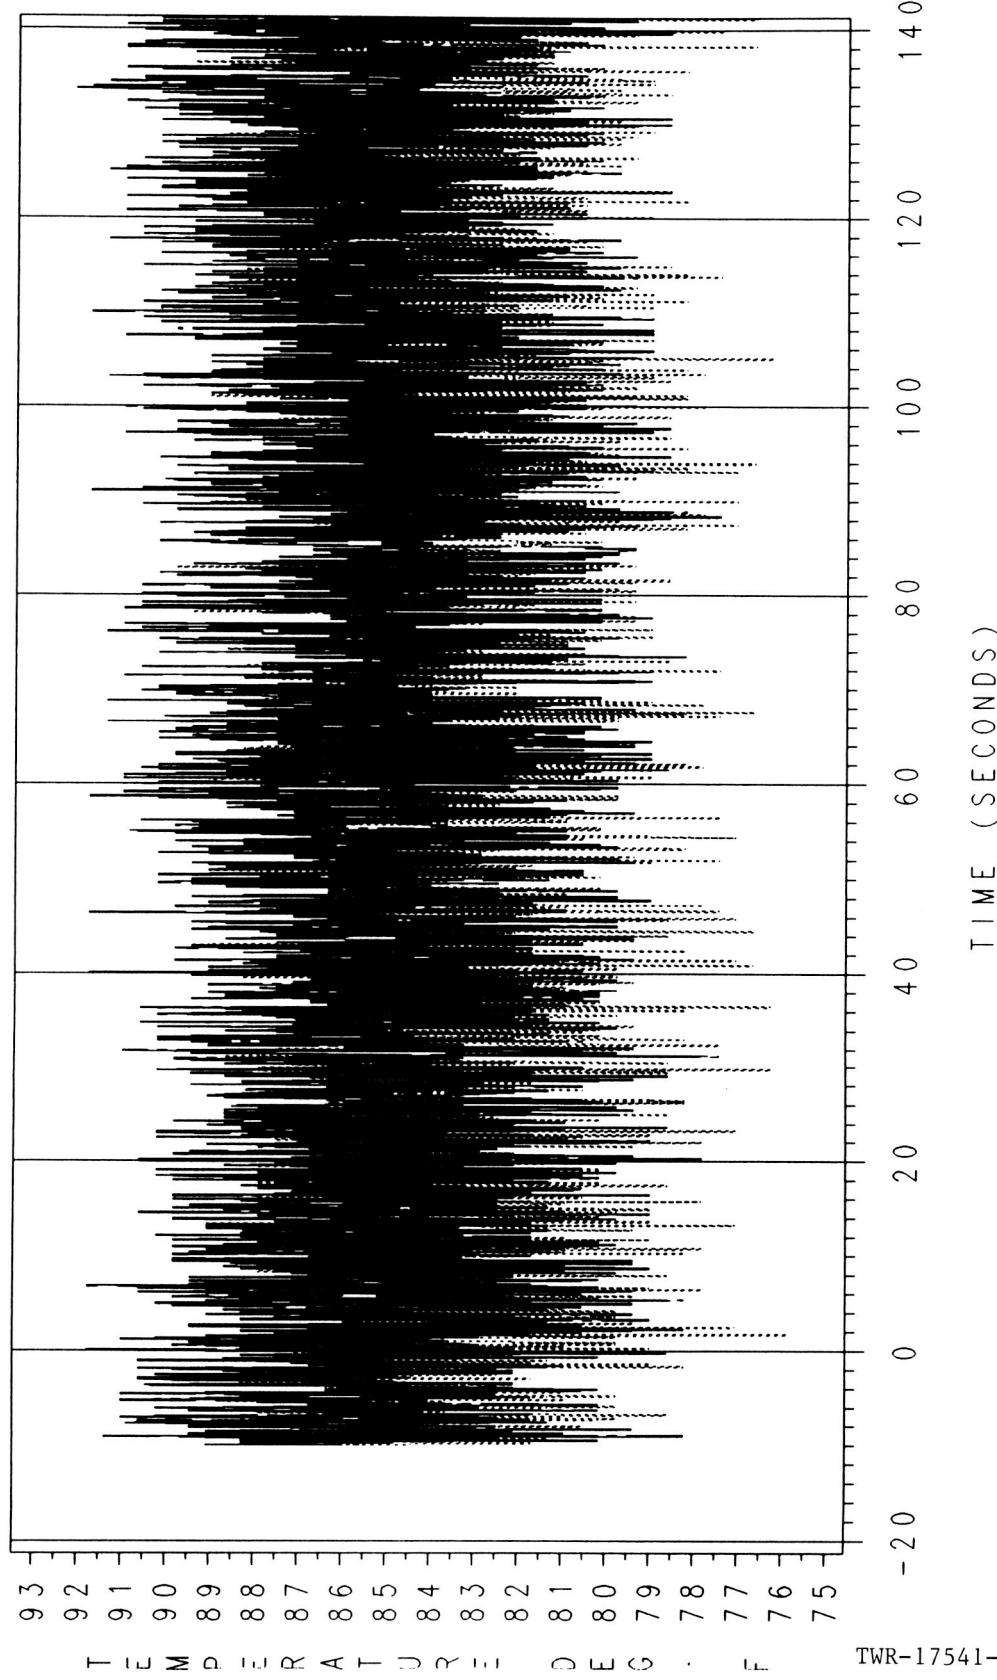
Figure 4.174 STS-27 Nozzle Temperature Gages - Left SRB
 RED SOLID LINE = T7613A • 0 DEG
 BLUE DASHED LINE = T7614A • 90 DEG
 GREEN DOT-DASHED LINE = T7615A • 180 DEG
 LILAC LONG-DASHED LINE = T7616A • 270 DEG

Measured strain results were compared with a course grid TASS Finite Element model. Figures 4.136 through 4.173 show the correlation between each strain gage and the predicted strain at each location. Figures 4.174 through 4.182 show the thermocouple readings for each location. Temperatures tended to be constant throughout the flight and remained in an acceptable range.

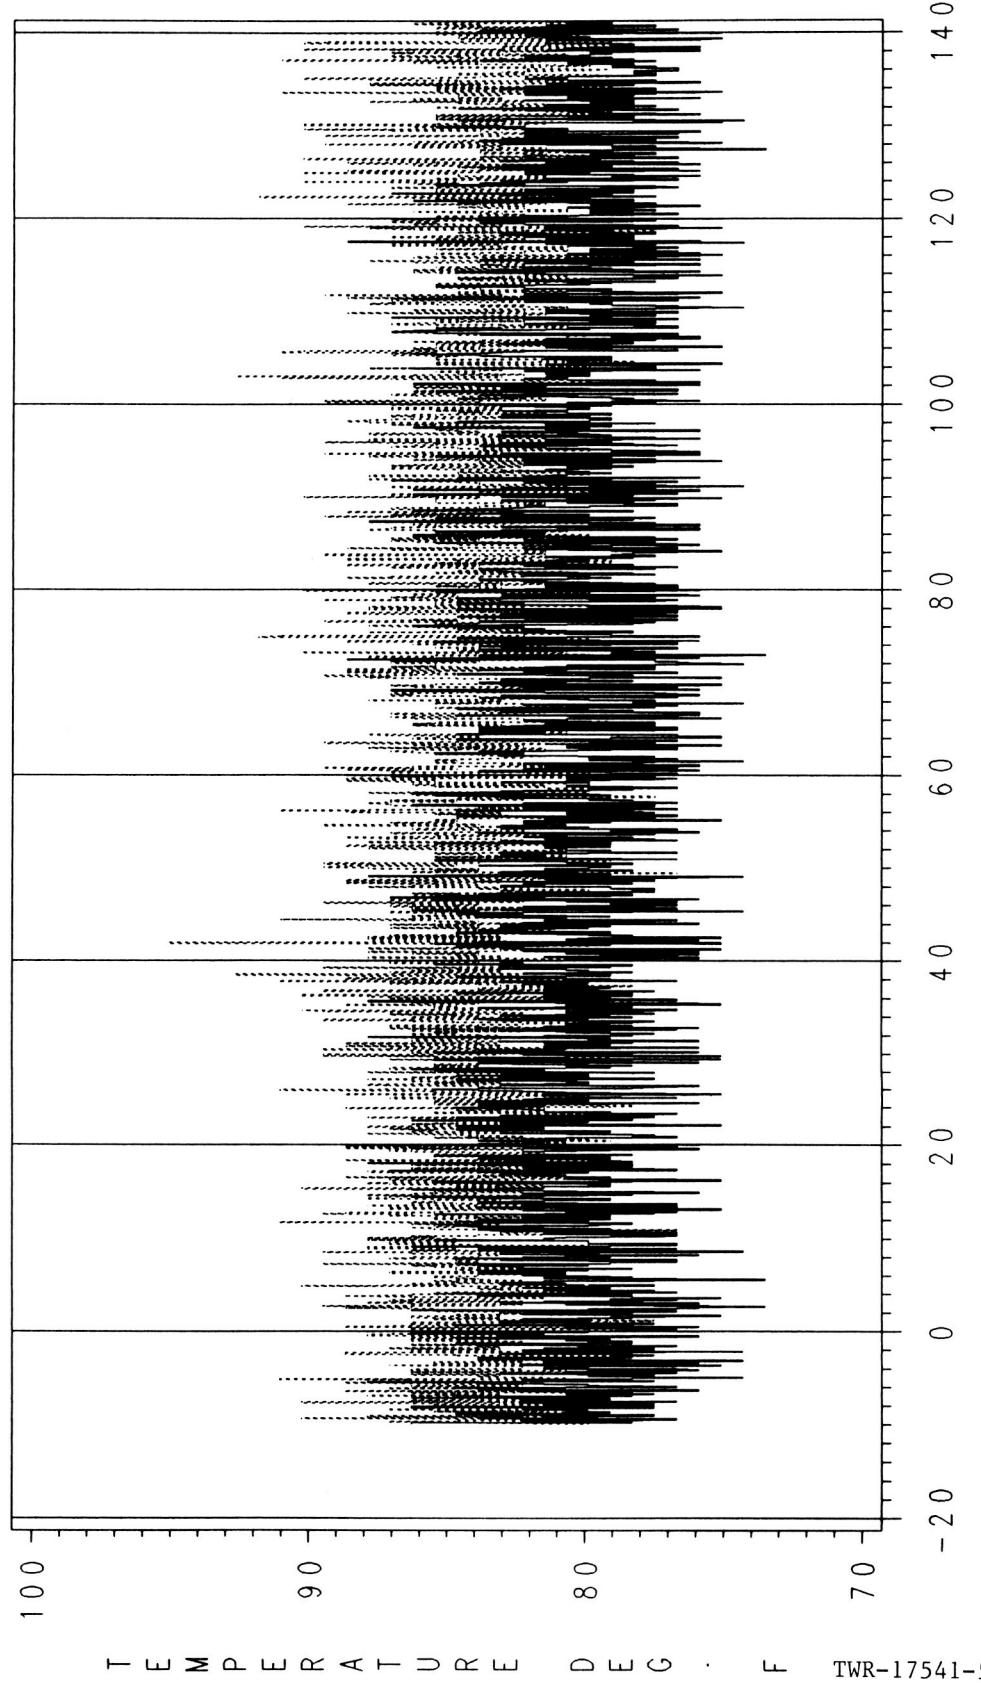
Figure 4.175 STS-27 Nozzle Temperature Gages - Left SRB

NOSE INLET HSG @ LOC. 2T

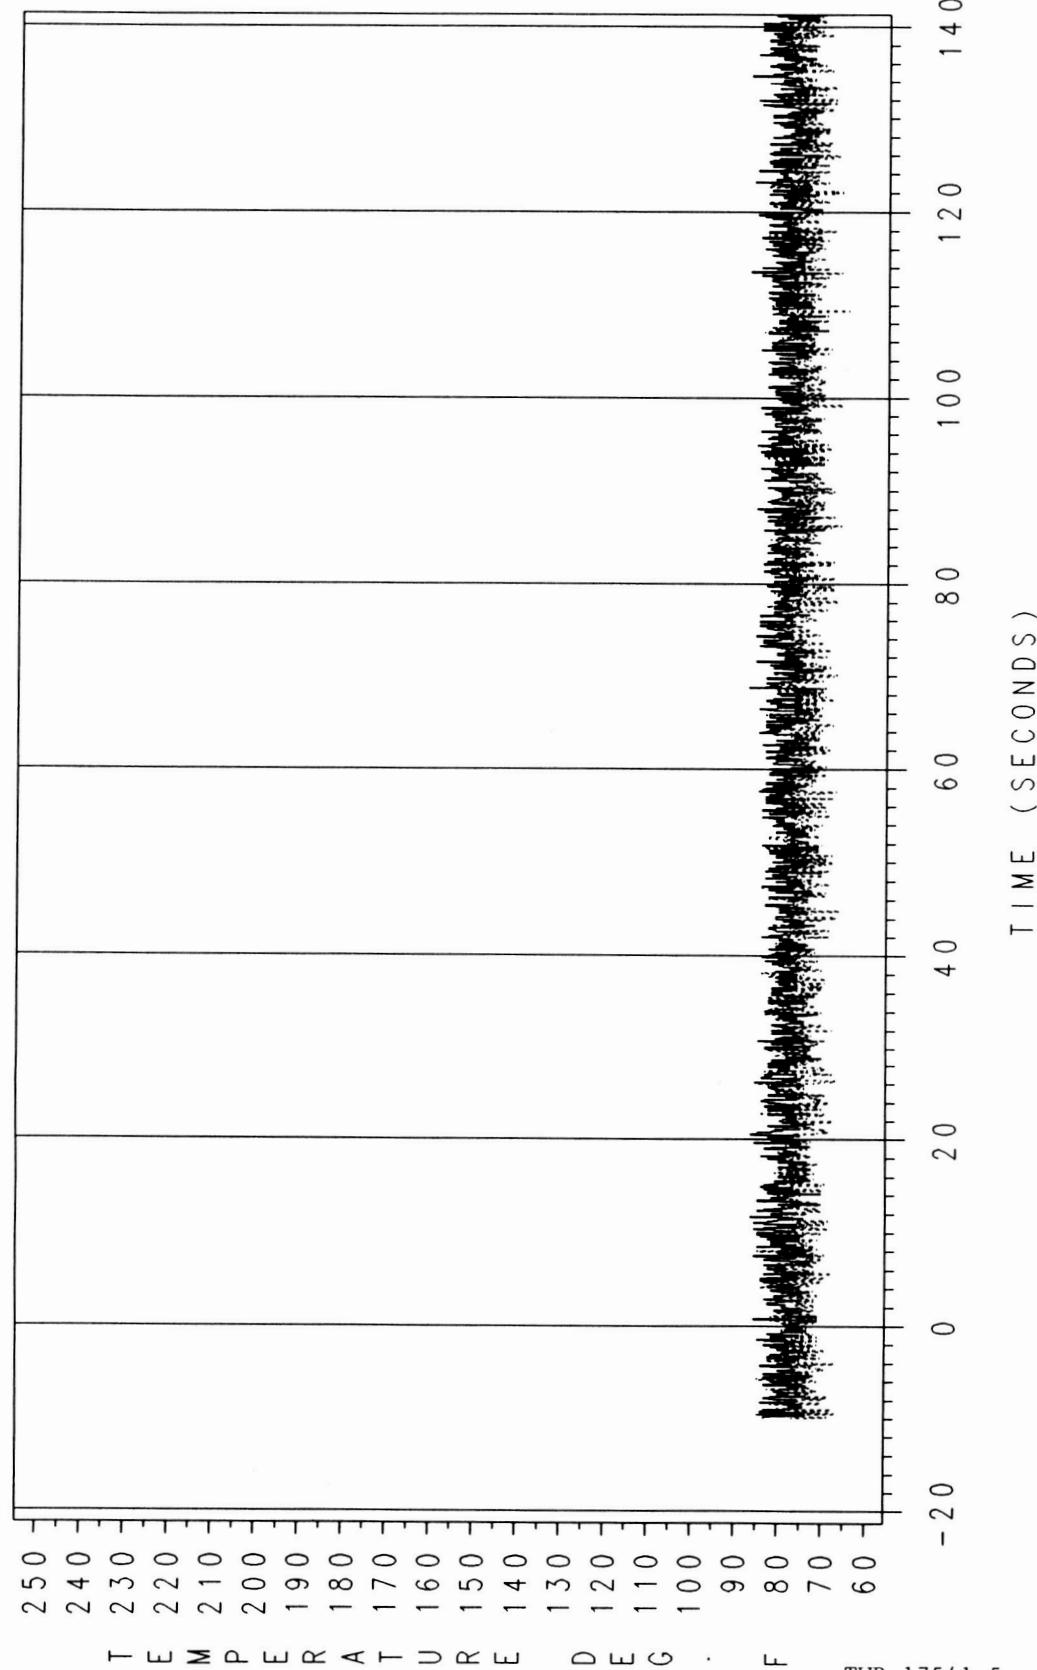
NOSE INLET HSG @ LOC. 2 T

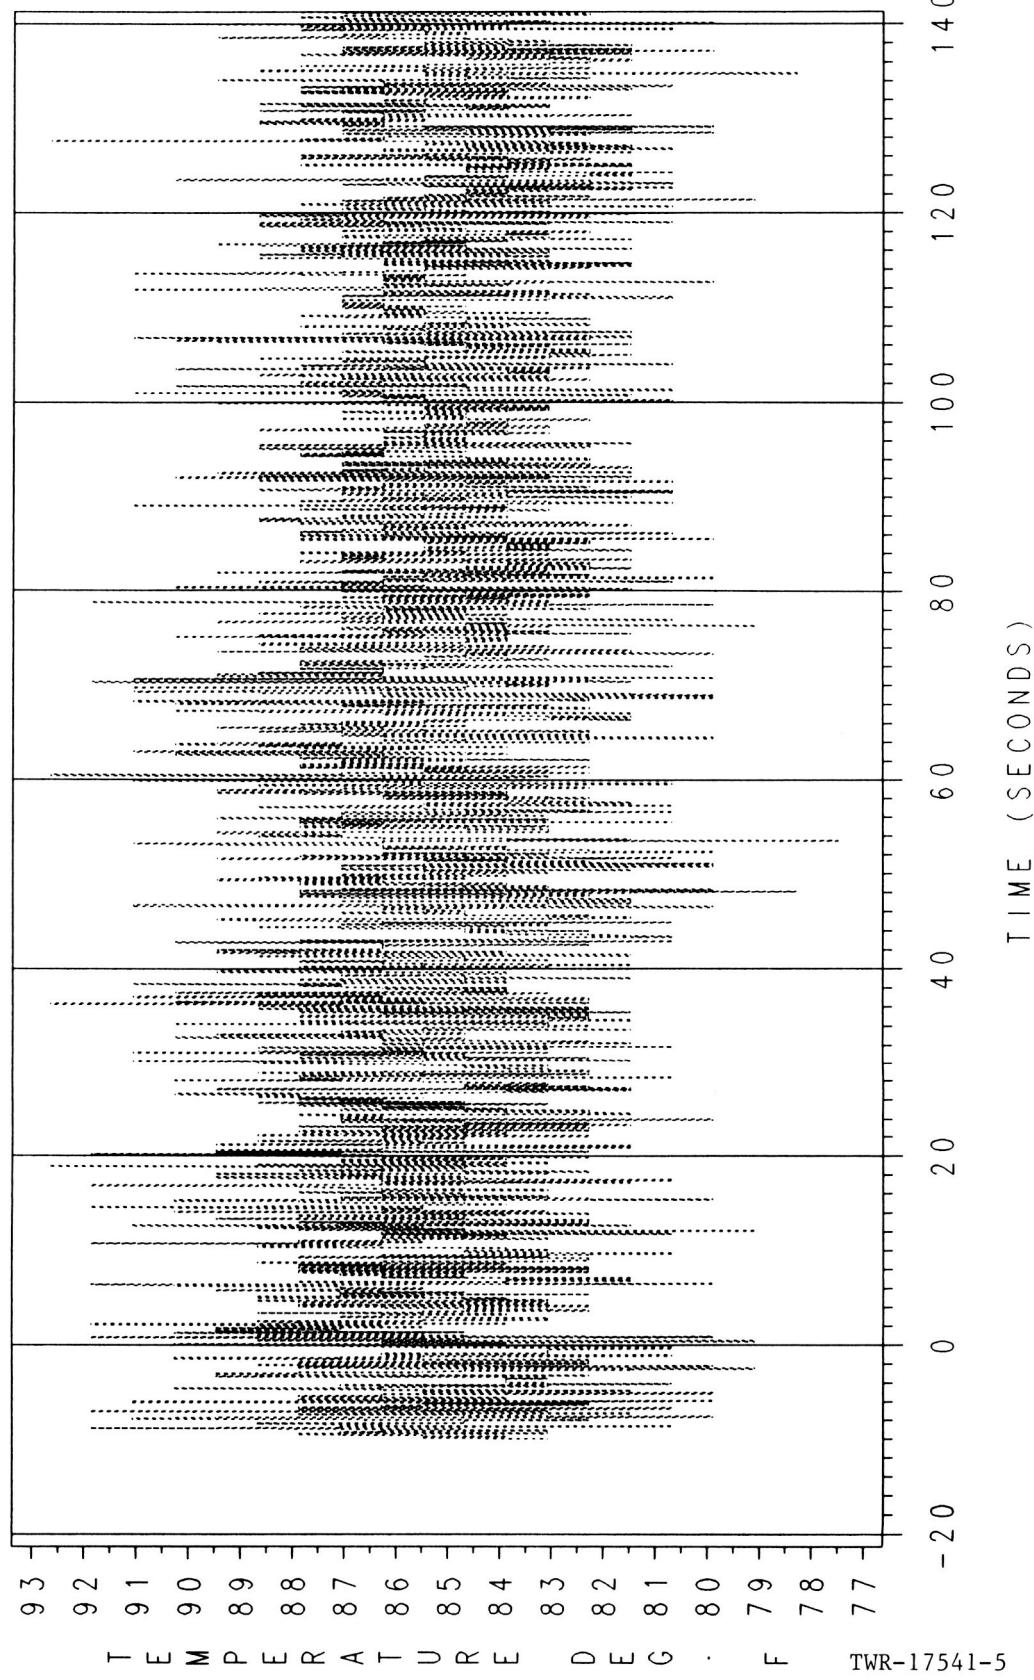
Figure 4.177 STS-27 Nozzle Temperature Gages - Left SRB
RED SOLID LINE = T7620A • 90 DEG.
BLUE DASHED LINE = T7621A • 270 DEG.

STS-27 NOZZLE TEMPERATURE GAGES - LEFT SRB
THROAT ASSY. @ LOC. 3T

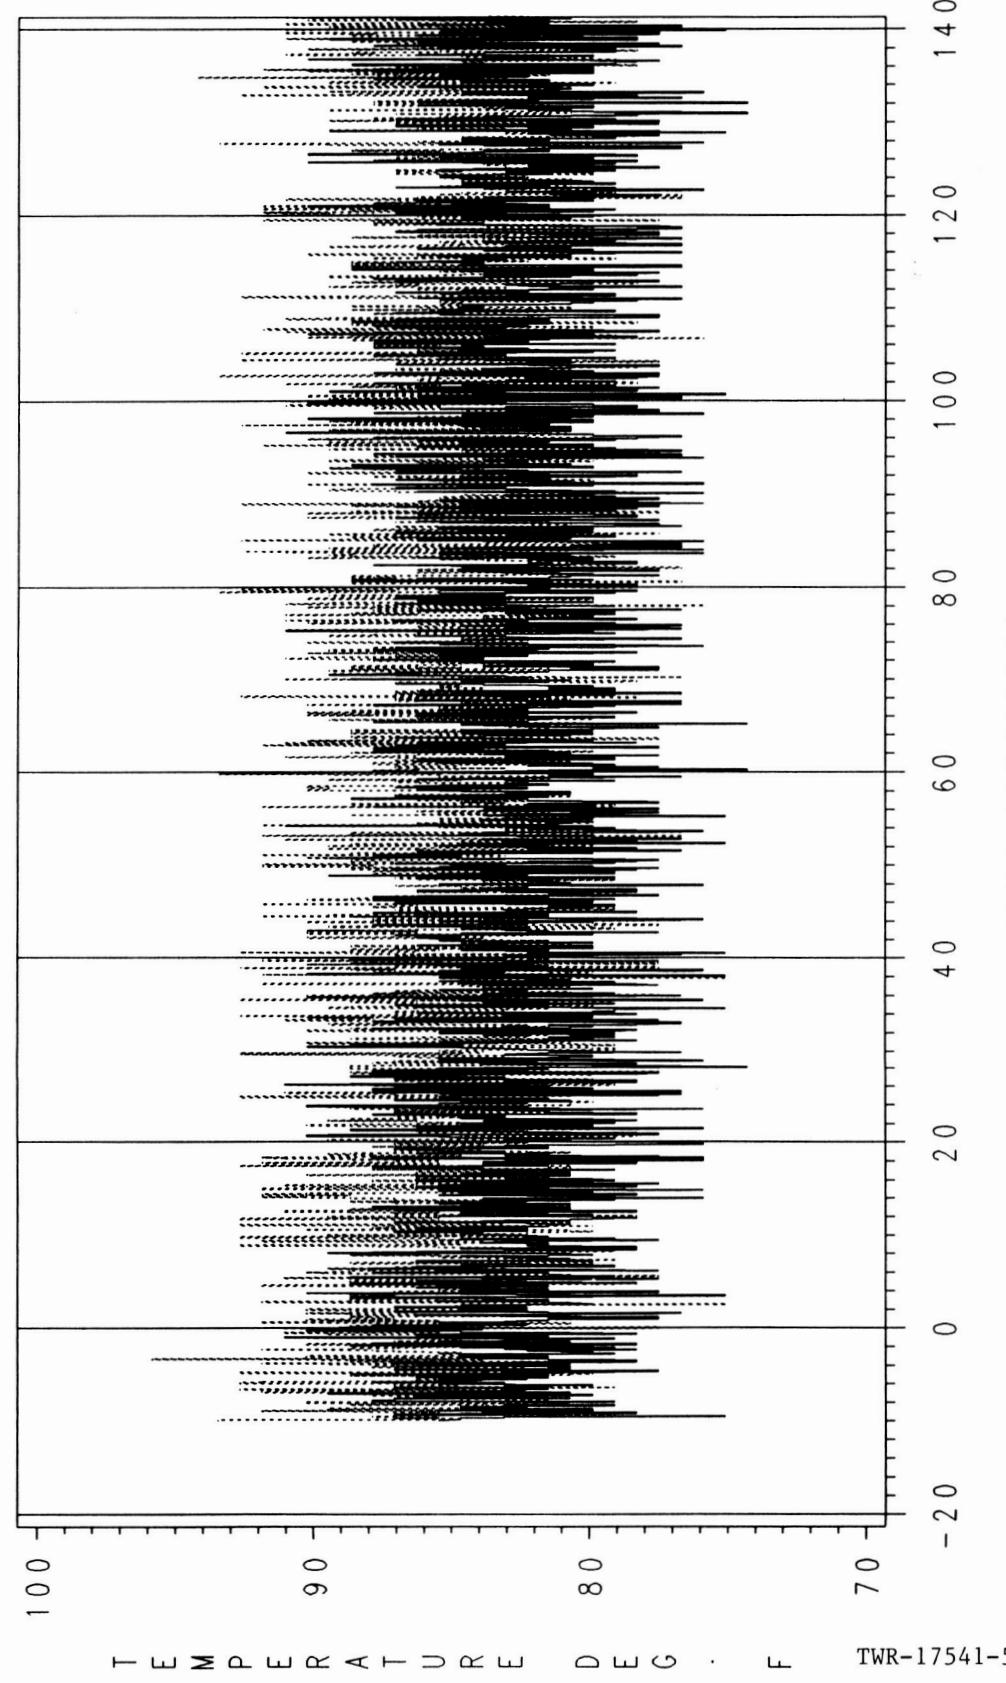
Figure 4.178 STS-27 Nozzle Temperature Gages - Right SRB

THROAT ASSY. @ LOC. 3T

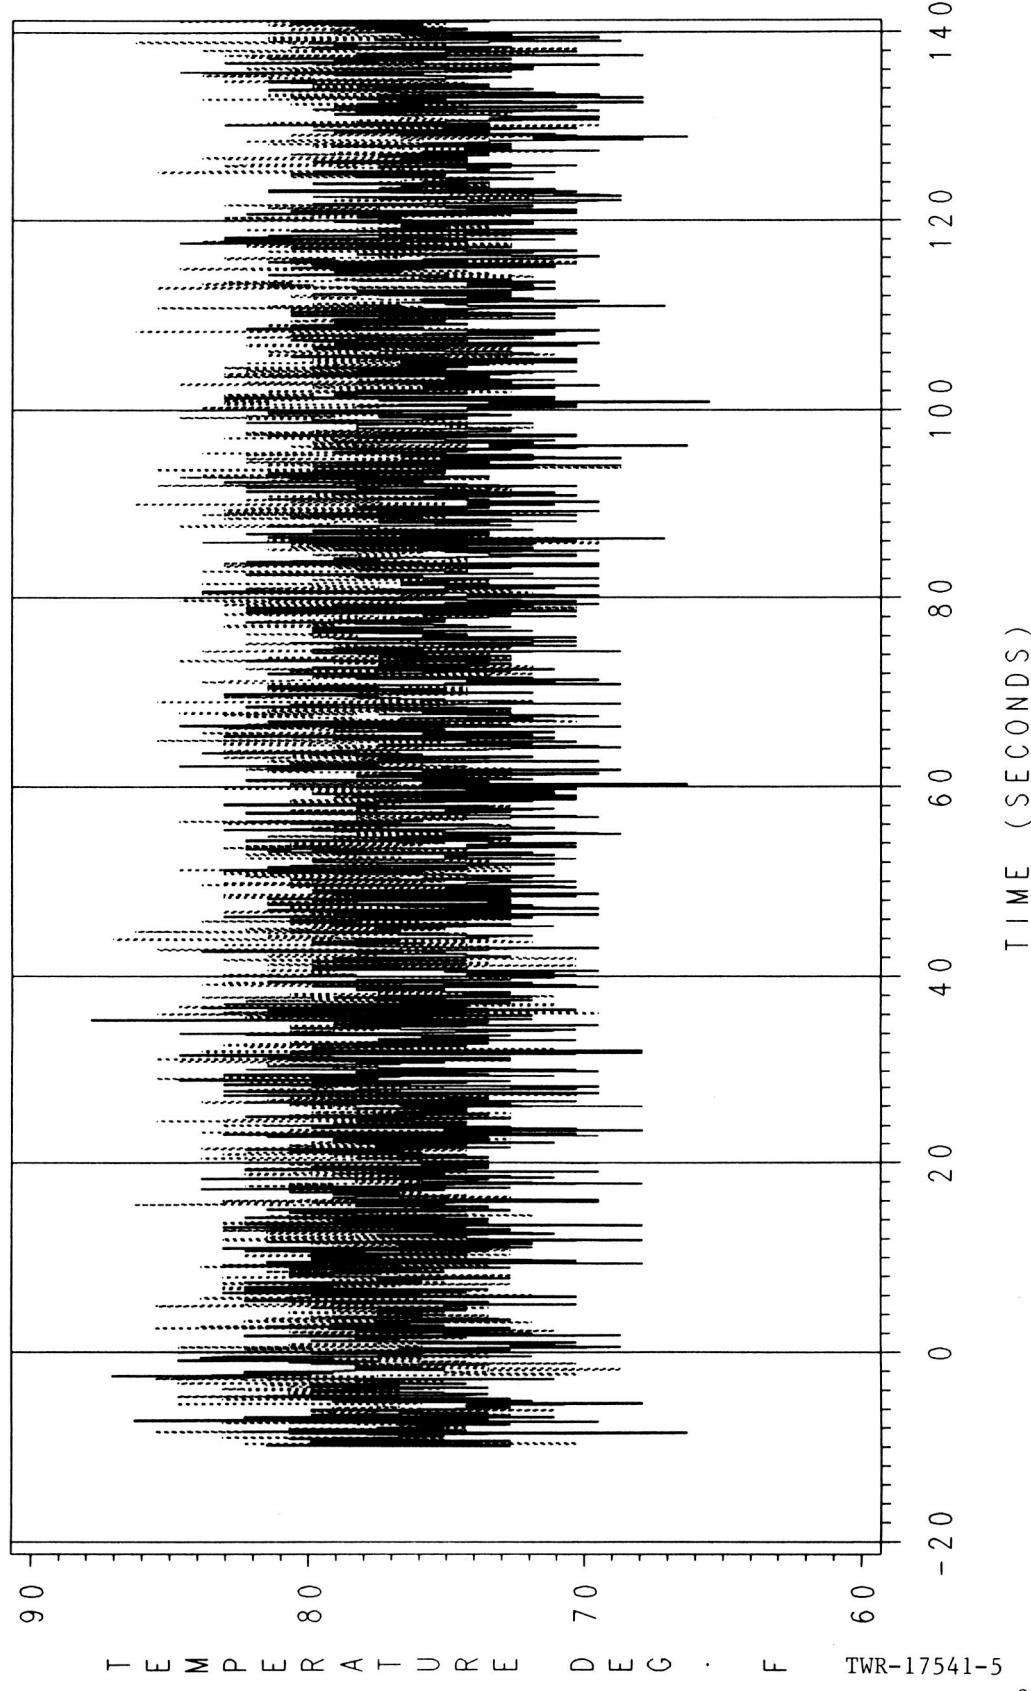
Figure 4.180 STS-27 Nozzle Temperature Gages - Right SRB

AFT EXIT CONE (FWD END) @ LOC. 4 T
