TWR-17541-5

Flight Motor Set 360L002 (STS-27R) Final Report

Volume V (Nozzle Component)

STS-27 POST-TEST NOZZLE PERFORMANCE EVALUATION REPORT

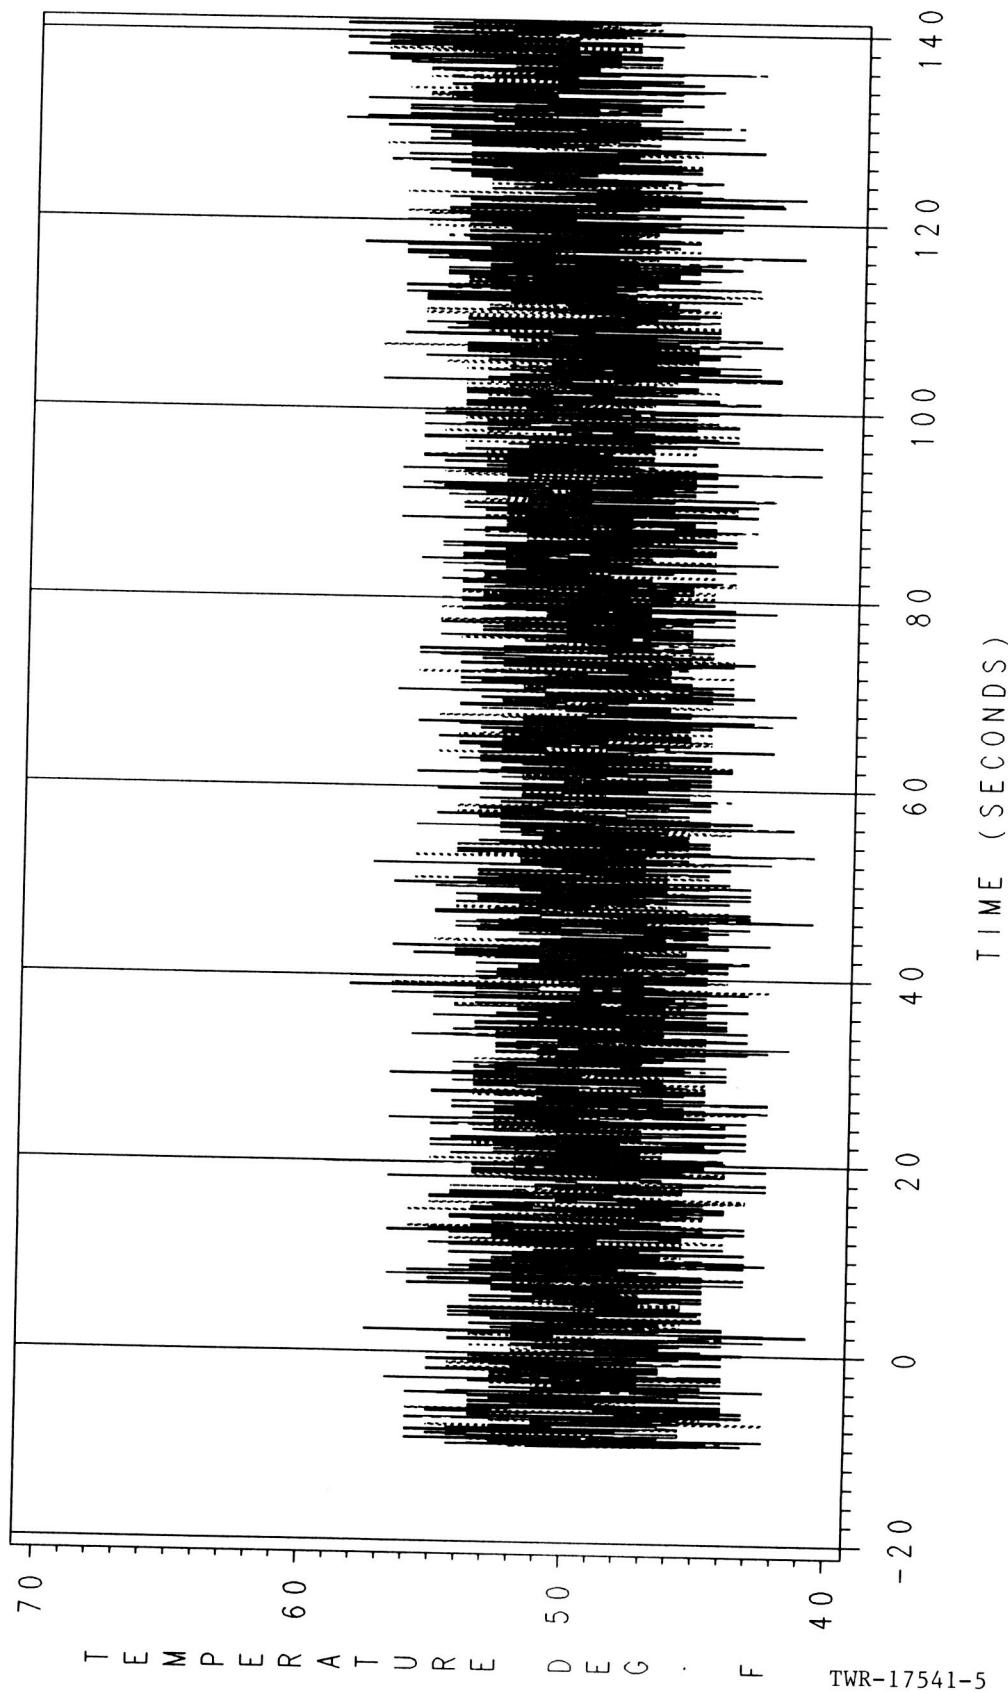
Figure 4.182 STS-27 Nozzle Temperature Gages - Right SRB

STS-27 NOZZLE TEMPERATURE GAGES - RIGHT SRB
 AFT EXIT CONE (AFT END) @ LOC. 5 T

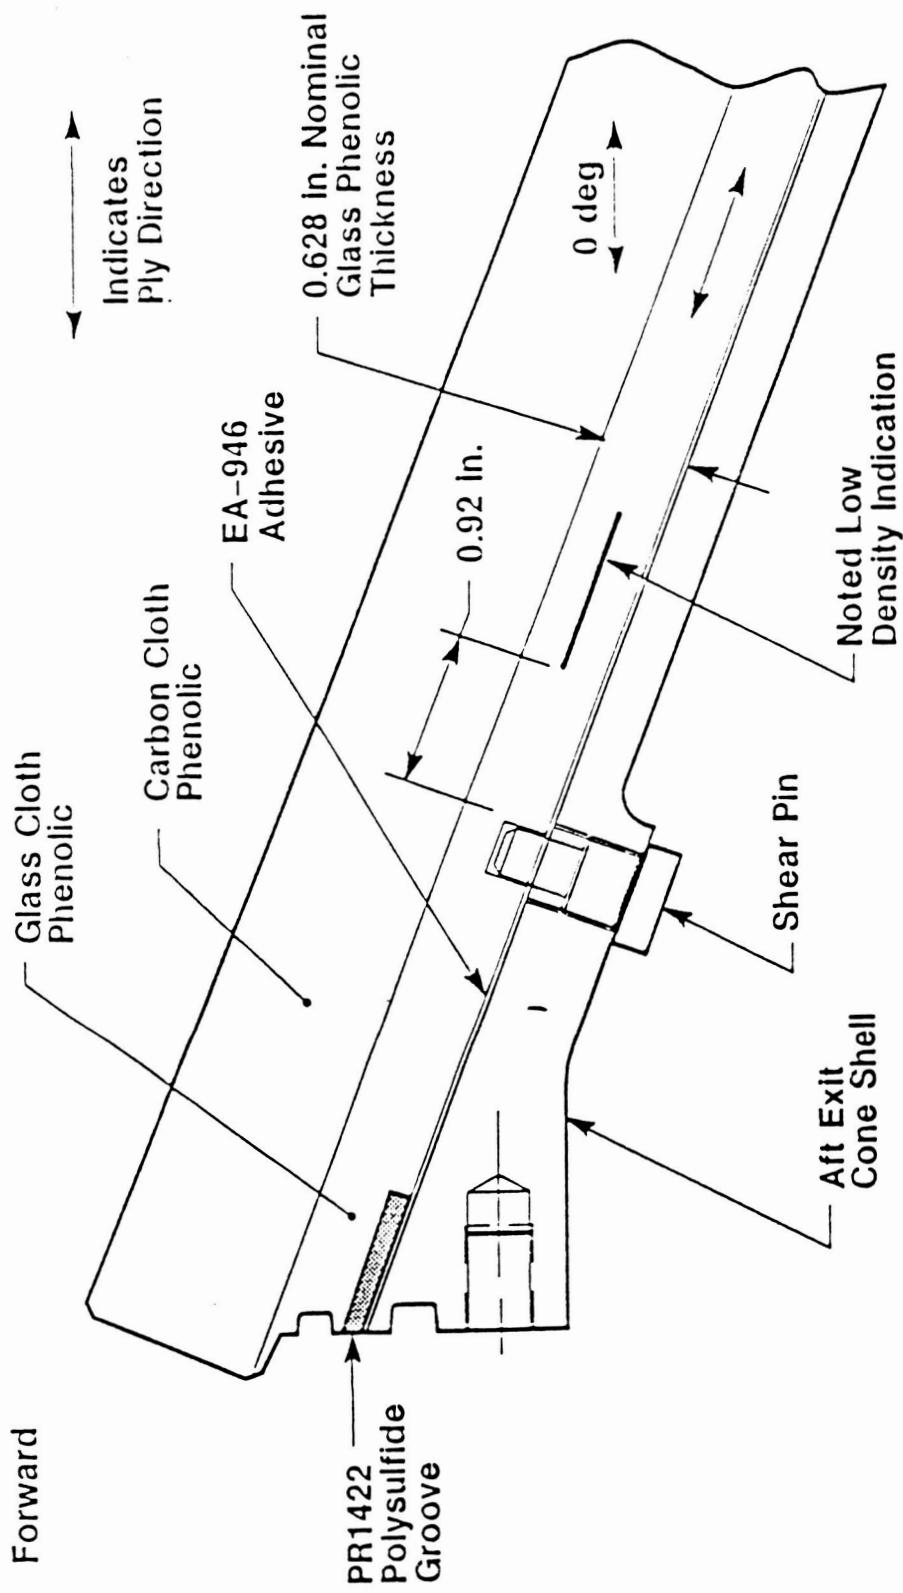
DR 153750-01 Low Density Indication

Worst case condition successfully flown on STS-2B — 4.6 in. circumferential width X 1.90 in. longitudinal length X 0.020 in. radial depth

Minimum margin of safety in GCP^{def} area of defect is 26.35 at T = 100 sec (includes a 1.4 factor of safety)

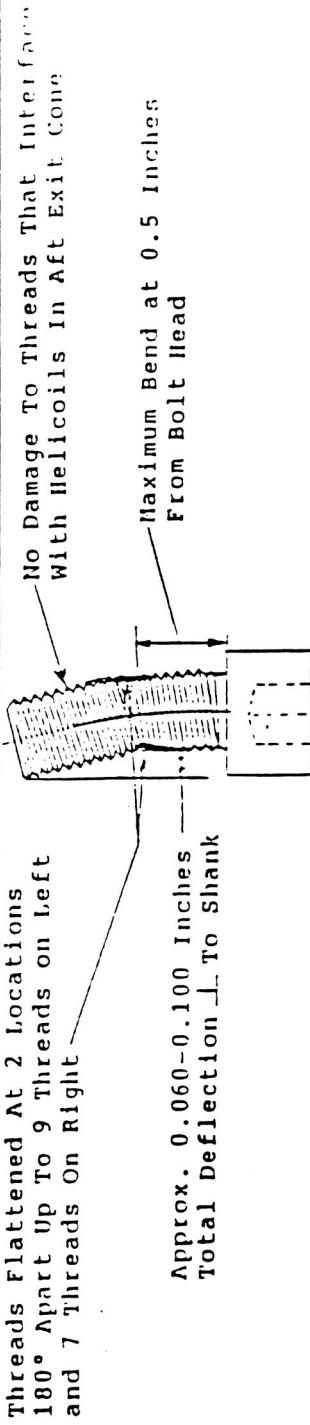
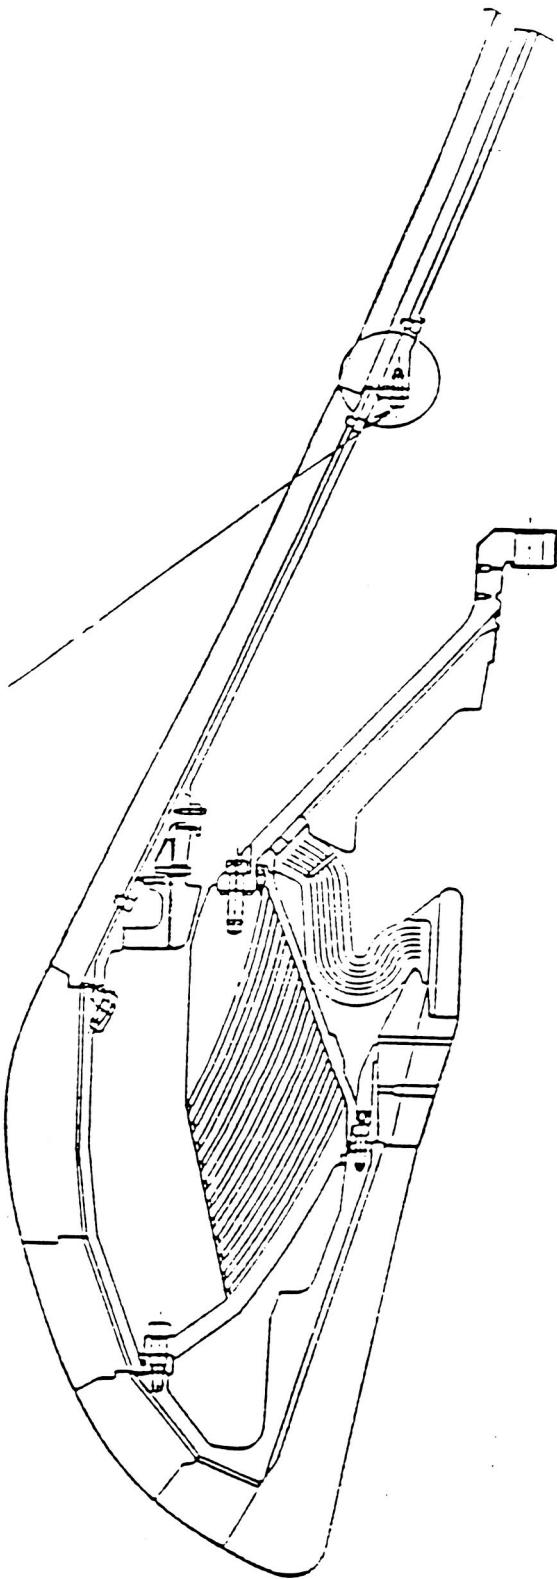
Physical Description of Bent Bolts
in STS-27B Aft Exit Cone Field Joint

DESCRIPTION: DURING (RH) AFT EXIT CONE/FORWARD EXIT CONE BOLT REMOVAL, 12 BOLTS WERE FOUND TO BE VISIBLY BENT FROM THE 0 - 90 DEG QUADRANT. THE BOLT THREADS WERE ALSO FLATTENED.

HISTORY: BENT AFT EXIT CONE FIELD JOINT BOLTS HAVE NOT BEEN OBSERVED ON PAST FLIGHT NOZZLES

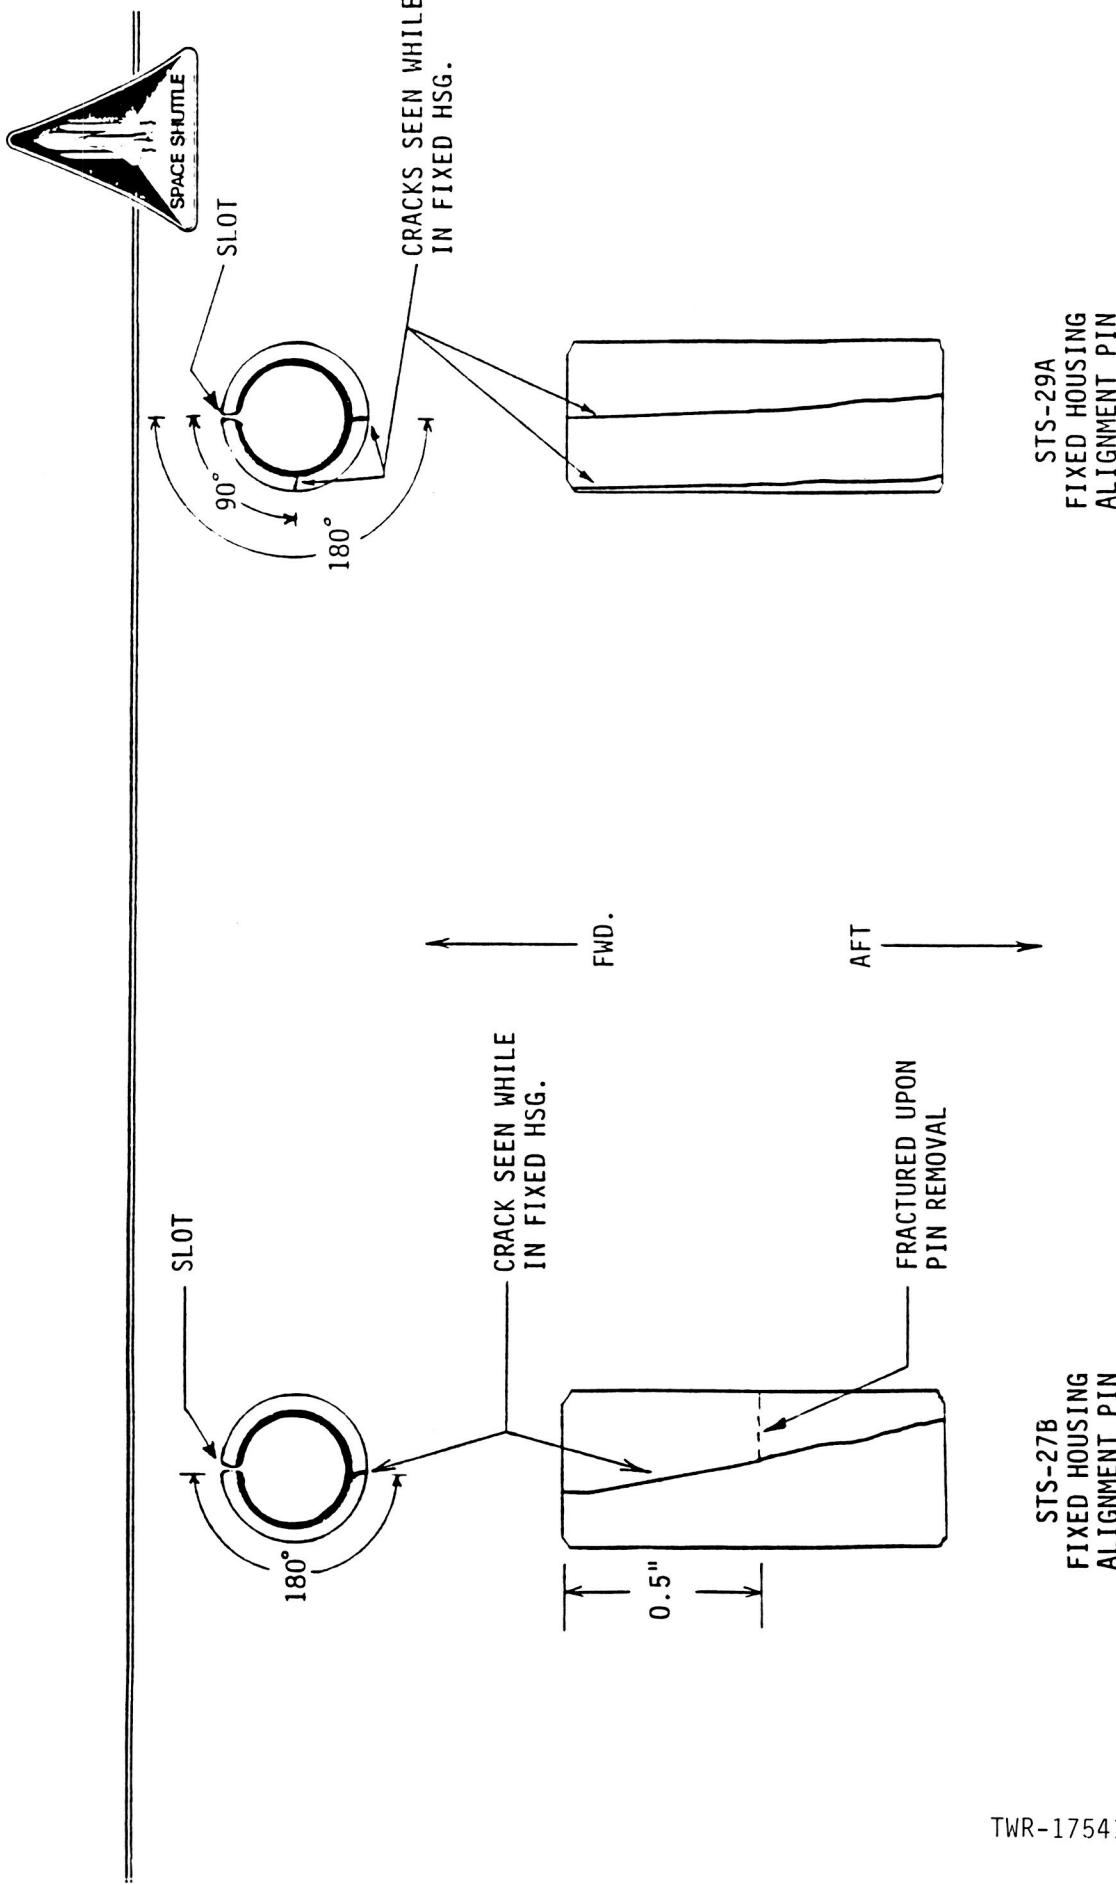
DESCRIPTION: THE ALIGNMENT PIN ON THE (RH) FIXED HOUSING AT 91.8 DEG SHOWED AN AXIAL CRACK EXTENDING ALONG THE LENGTH OF THE PIN

METALLURGY EXAMINED THE CRACK SURFACES AND CONCLUDED THAT THE STS-27B ALIGNMENT PIN CRACK WAS PRESENT PRIOR TO DISASSEMBLY (MEMO 2421-FY89-97).
