# SPACE SHUTTLE CORROSION PROTECTION PERFORMANCE

Session: Corrosion – Space Applications

Cris Curtis

United Space Alliance – Space Systems Engineering

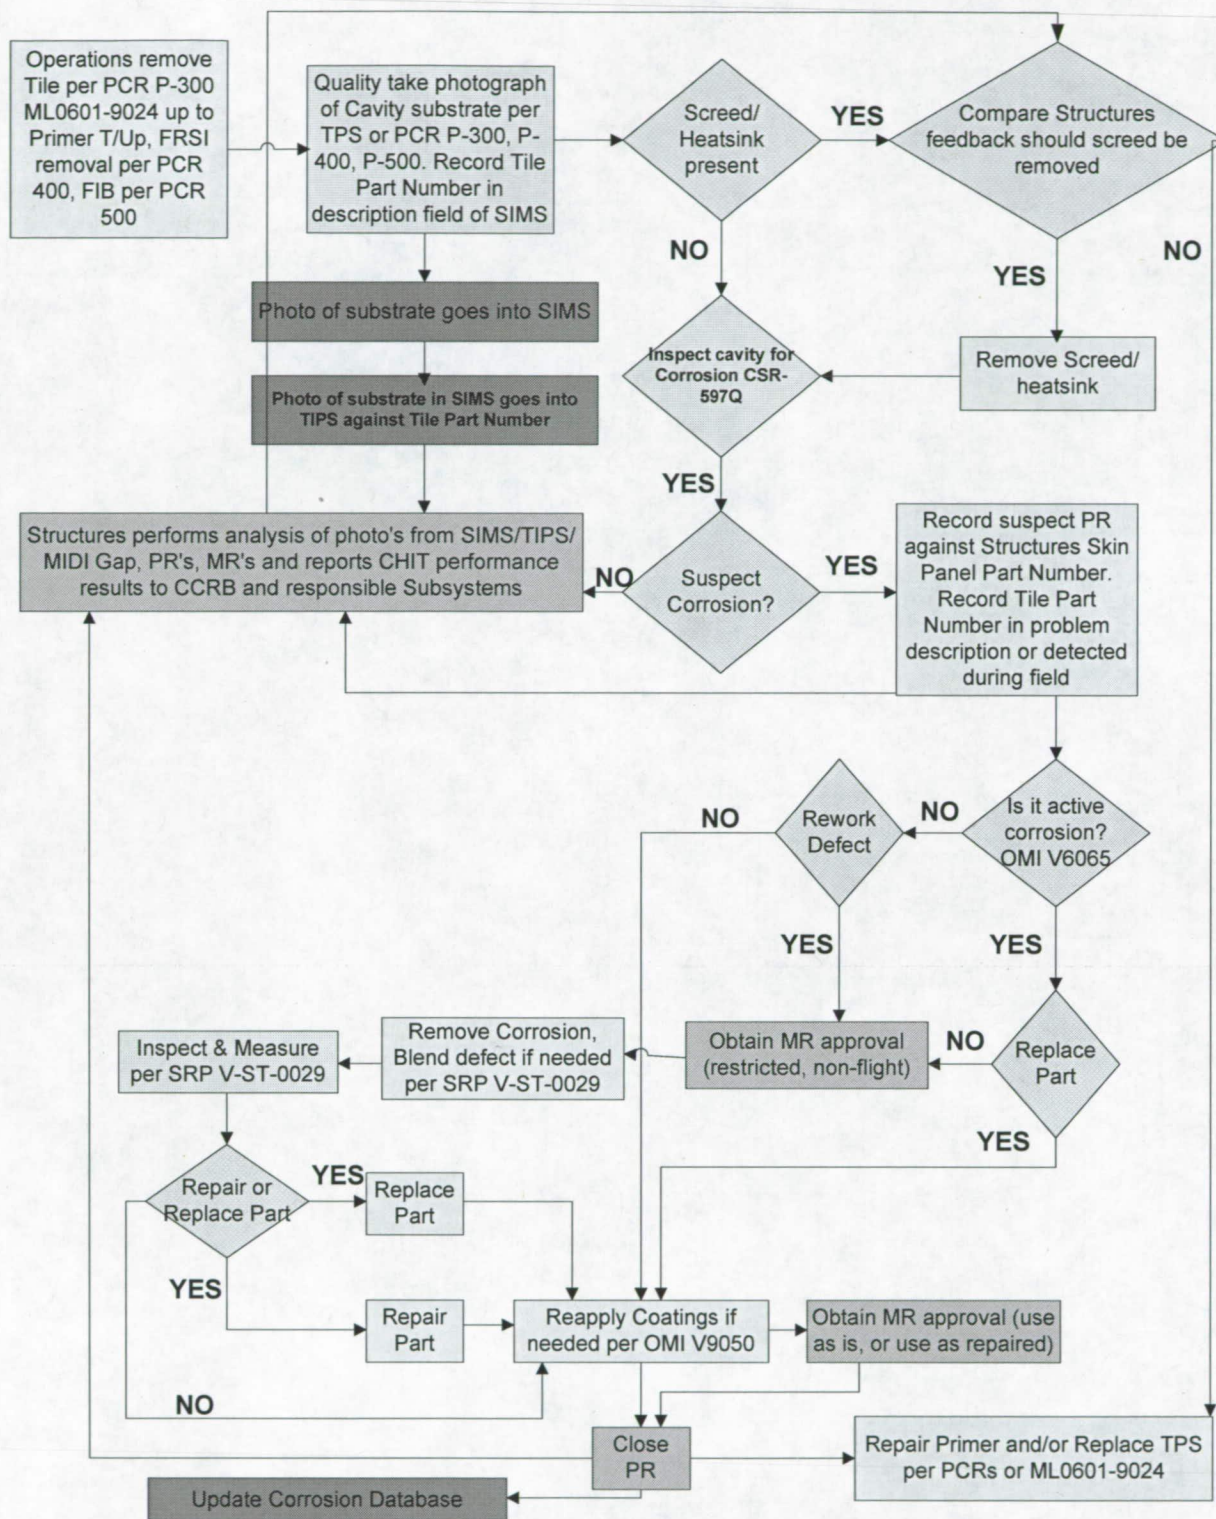
Figure 3: Decision Flow Chart

The decision flow chart aided in identifying the communications, roles and responsibilities. This system allowed any person to view an Orbiter anomaly and immediately know what's going on, who is involved and at what level. Figure 3 is decision flow chart that supported personnel in corrosion assessment and repairs. When an anomaly could not be returned to drawing and required material reviews by additional resources this process was pre-existing. Documenting the activities allowed the team to assess where disconnects might interfere with accomplishing the mission.

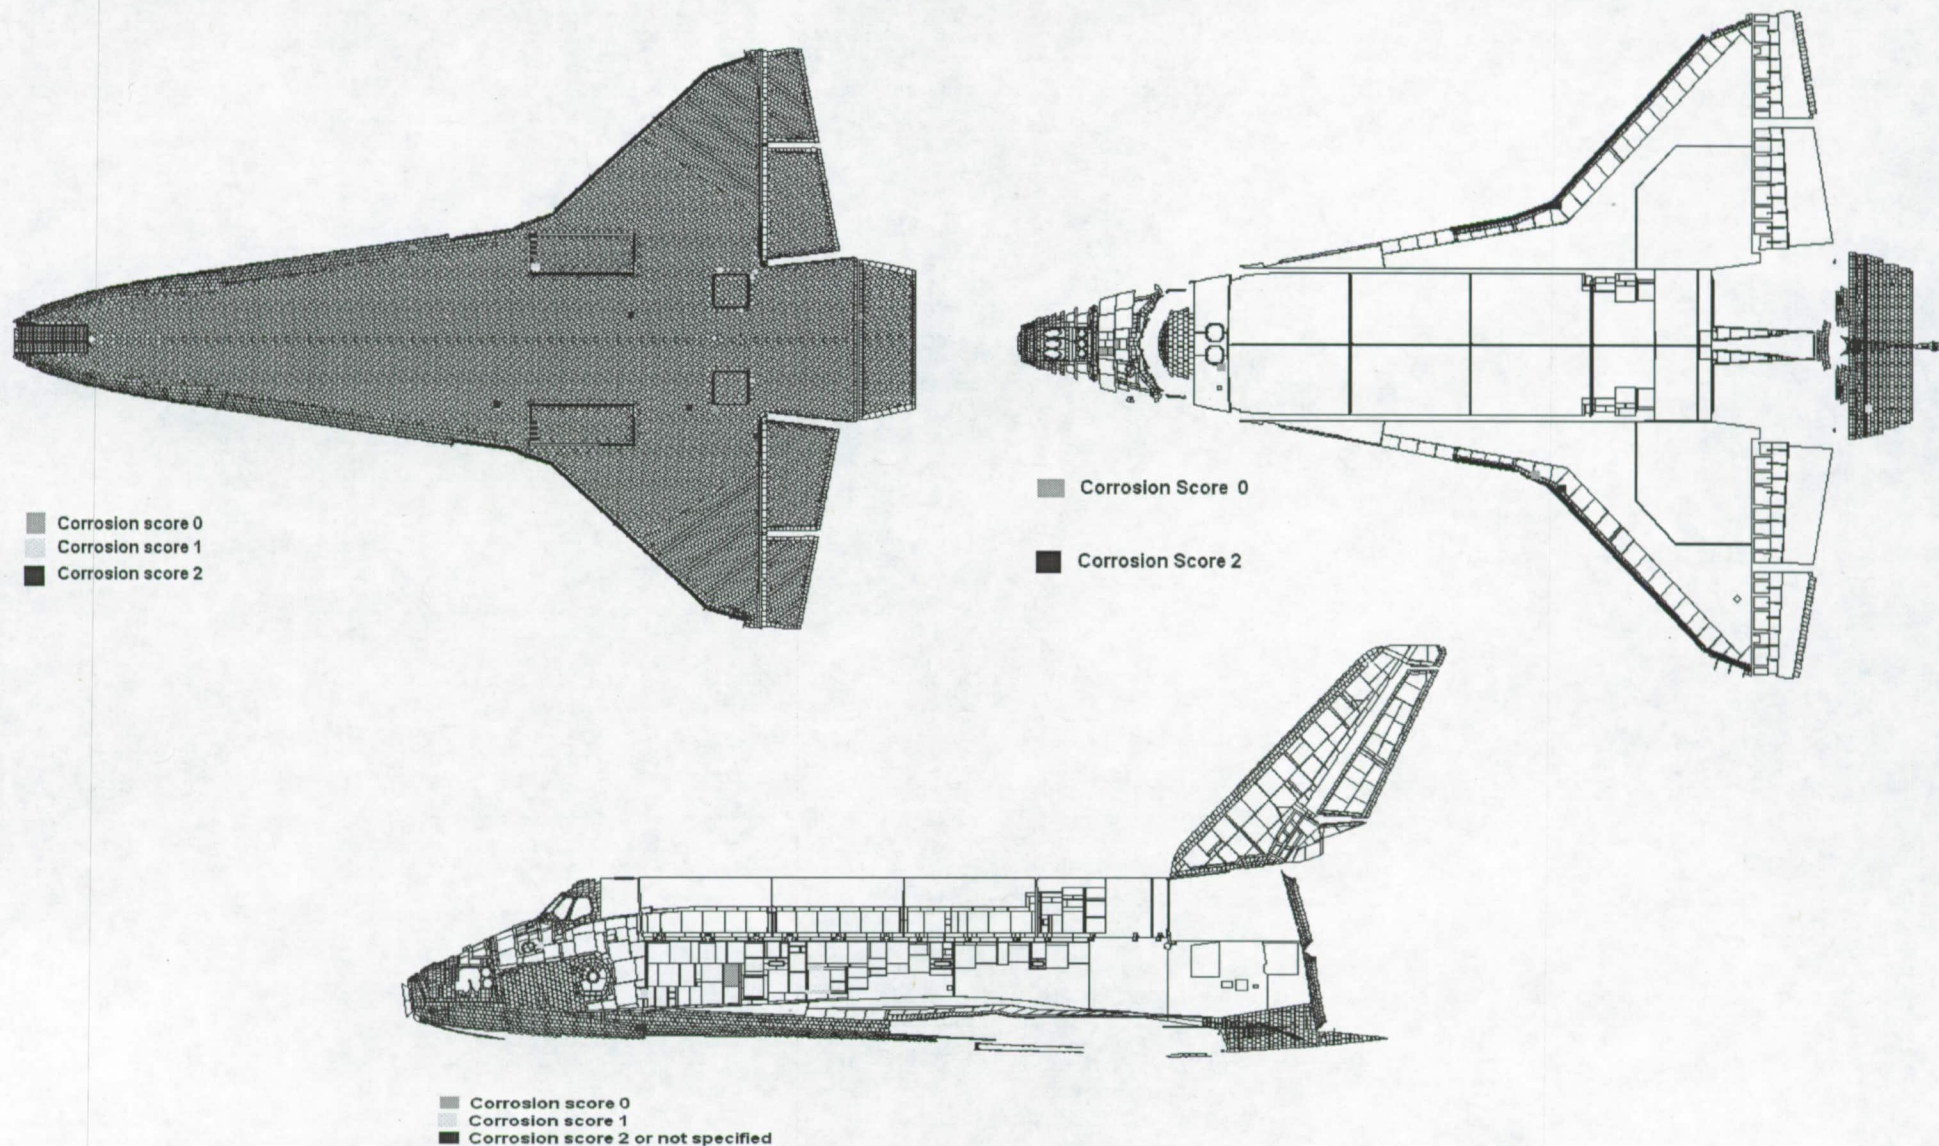
# Results for under "TILE"

Type	Location			Sample Size	% Complete	Total	Wiped Clean	Active, No Material Loss	
Tile	Forward	Fuselage	Lower	6	100	424	0	0	0
			Sides and Upper Surfaces	7	100	401	3	2	1
	MID		Lower	21	100	212	1	1	11
	AFT		Lower	7	100	124	1	6	2
			Sides	2		2	0	0	0
			Base and Dome Heat Shields	6	100	697	0	0	1
			RSB		4	100	122	0	0
		Bodyflap	Lower Surface	3	100	39	1	0	0
			Sides and Upper Surface	3	100	59	0	1	0
				Left	Hand	Wing	14	100	202
	In Board Elevon	3	100			15	0	0	0
	Out Board Elevon	2	50			20	0	0	0
	Right	Hand	Wing			14	86	154	0
			In Board Elevon	3	100	15	0	0	0
			Out Board Elevon	2	50	8	0	0	0
			TOTAL			97		2494	6

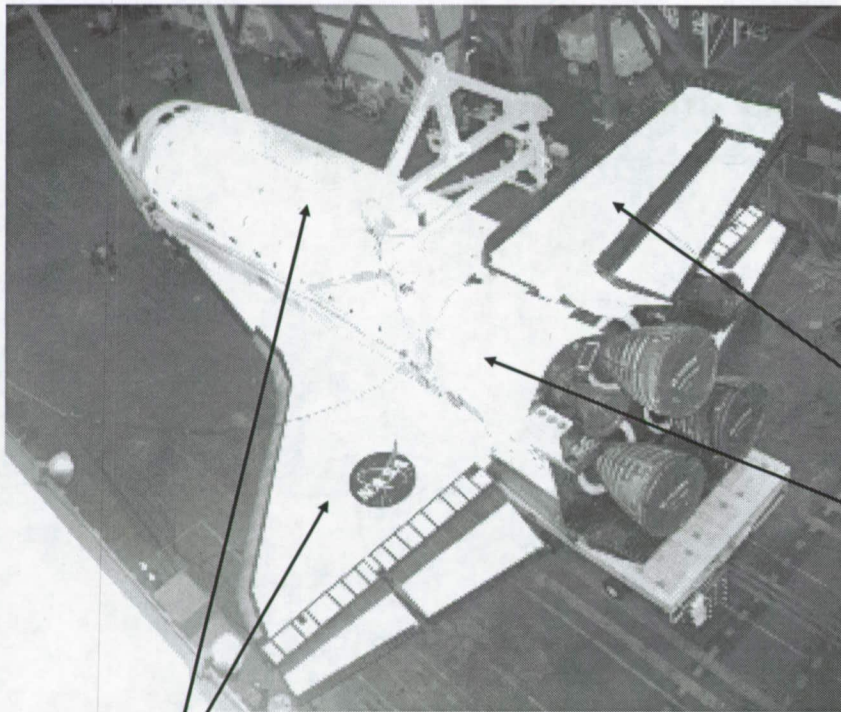
FRSI

The other TPS sampling activity of concern is under Fibrous Insulation Blankets (FIB) and Felt Reusable Surface Insulation (FRSI). There have been several hundred removals to date and several locations with material loss from corrosion. Planning has recently been implemented to direct removals to satisfy requirements in the coming months. The surface locations sampled were
