The Command System Malfunction of the Telstar Satellite

By ~~J. S. MAYO, H. MANN, E. L. WITT, D. S. PECK,~~
H. K. GUMMEL, and W. L. BROWN

(Manuscript received March 22, 1963)

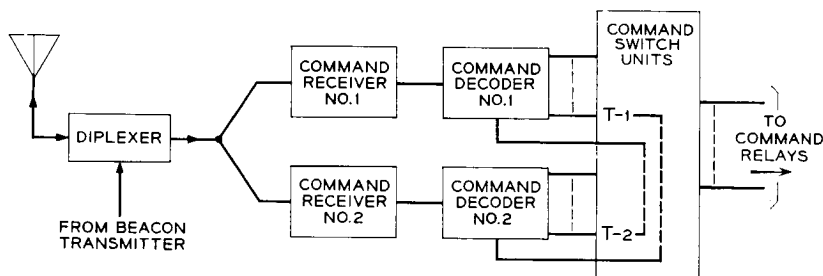
Fig. 1 — Block diagram of command system.

There are two virtually identical command decoders in the command system. Each is driven by one of the two command receivers and each drives a command switch unit, as shown in Fig. 1. Each command relay is normally driven by both command switch units in parallel; the design is such that a pulse from either or both command switch units is sufficient to operate a relay. Thus, redundancy exists between the input to the command receivers and the output of the command switch units.

Failure to respond to the T-2 command is not conclusive evidence that decoder 2 has failed. The same symptom could result from failure of command receiver 2, T-2 relay, or T-2 relay-state telemetry channel

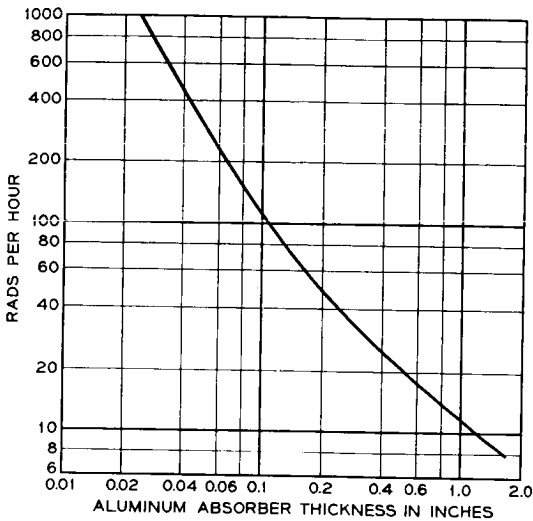
Fig. 2 — The radiation due to high-energy protons in the peak of the inner Van Allen belt.

The estimated upper limit of the radiation dose contributed by energetic protons in the region of highest intensity is illustrated in Fig. 2 as a function of aluminum absorber thickness. The radiation dose rate is shown under the assumption of uniform shielding and exposure to a uniform omnidirectional proton flux. For the decoders which are very close to the surface of the electronics canister, the minimum shield thickness is only about 0.1 inch of aluminum, but the solid angle for acceptance of particles through this thickness is between $\frac{1}{4}$ and $\frac{1}{2}$ of the total 4π solid angle. The curve applied to this case gives an orbital average of between 5 and 10 rads per hour. The proton exposure of the satellite has been quite close to the pre-flight estimate.

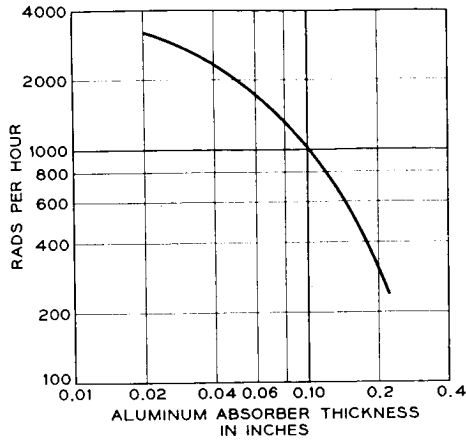
Fig. 3 — The average radiation due to high-energy electrons in the Telstar orbit.

The omnidirectional electron flux averaged over the first four months of the Telstar satellite's orbit is about 10^8 electrons/cm² sec. The radiation dose rate for electrons with this flux and the above spectrum is shown as a function of shield thickness in Fig. 3. The curve represents the radiation in the Telstar canister for shielding thicknesses small compared to that in the middle of the canister.* For transistors in the

decoder the dose rate due to electrons is approximately 10^3 rads/hour. The estimated dose rate due to protons is only 5 to 10 rads/hour. Hence the components in the Telstar command decoder have been exposed to approximately 100 times the anticipated radiation intensity, and the major contribution is not from protons but from high-energy electrons. It is believed that the peak radiation intensity could be as high as 10^4 rads/hour. The bremsstrahlung is insignificant in comparison with the direct electron effects.

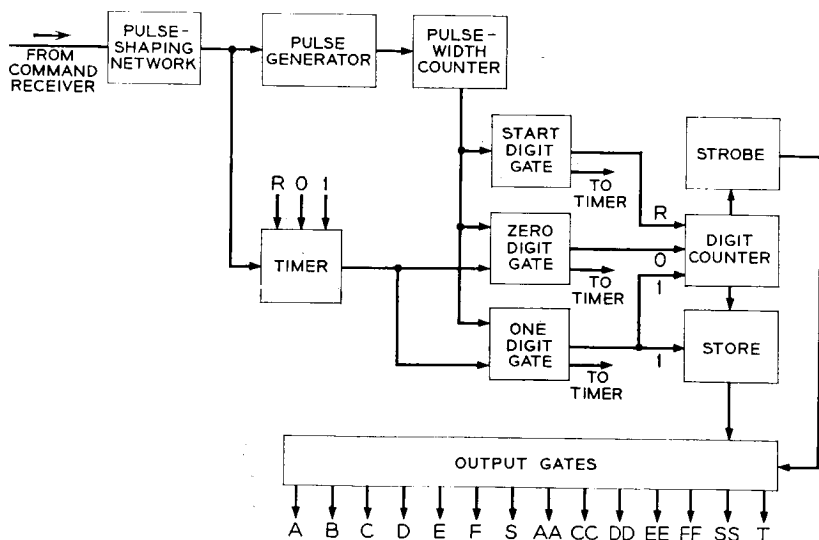
Fig. 6 — Command decoder block diagram.

The five most vulnerable transistor stages, selected in the manner described in Section 5.1.4, require the use of different modified command signal structures to accomplish proper decoding in failed units. The relative location of each of these stages can be determined from the block diagram of the command decoder shown in Fig. 6. A detailed description of the operation of the decoder circuit is given in Ref. 1.

If the gain of the zero digit gate transistor becomes sufficiently low in value, that stage will not be capable of driving the digit counter. As one sees from Fig. 6, the zero digit gate drives the digit counter and the timer; the one digit gate drives the digit counter, and, after a small amount of delay, drives the store. The scheme for circumventing the failed zero digit gate is to send in place of a "zero" a modified "one" code in such a way that the one digit gate is turned on and almost immediately turned off again. By use of the notched and shortened pulse in Fig. 9(c), it is possible to advance the digit counter but not to build up sufficient voltage to set a "one" into the store. Thus this notched "one" causes the same response in the digit counter and store as a "zero." Unfortunately, the notched "one" does not fully enable the timer circuit, and it is difficult to handle codes containing three sequential "zeros," unless these "zeros" are at the end of the code.*
