P&WA CNLM-6028  
QUARTERLY PROGRESS REPORT NO. 1  
December 7, 1964 to February 28, 1965

INVESTIGATION OF CAVITATION DAMAGE OF A MECHANICAL  
PUMP IMPELLER IN HIGH TEMPERATURE POTASSIUM

CONTRACT NAS3-6468

PRATT & WHITNEY AIRCRAFT DIVISION, UAC  
CANEL - Middletown, Connecticut

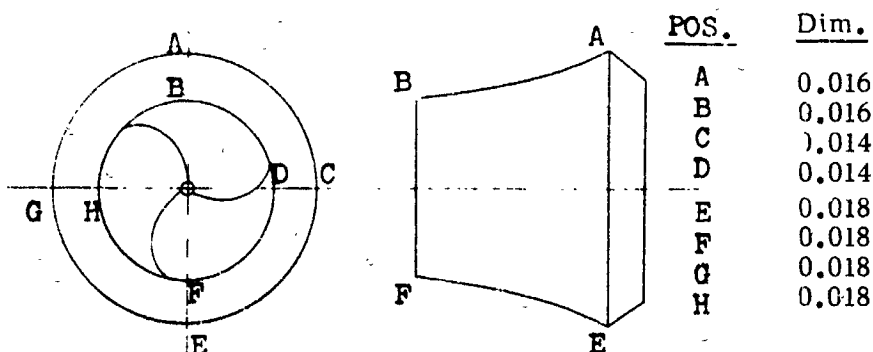
INSTALLED VANE TIP CLEARANCE

The RI-7A3 impeller was initially installed with a nominal vane tip clearance of 0.014 inch that was essentially constant throughout the tip arc. A variation of approximately 0.004 inch was present due to tip contour eccentricity with the impeller centerline. Installation accuracy was held within  $\pm 0.001$  inch. Actual measured values of the installed clearance are given in the following sketch:

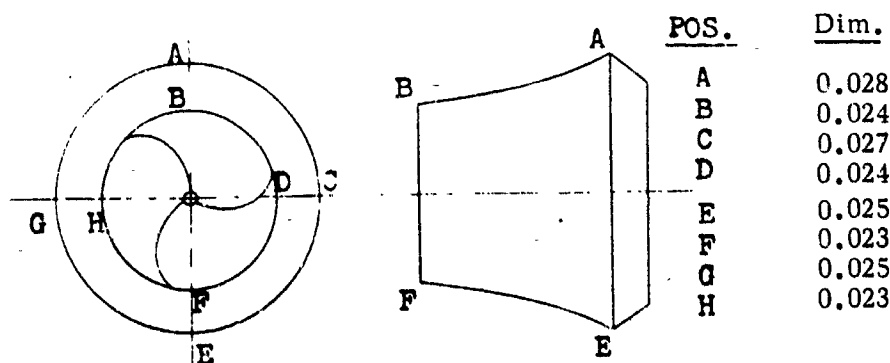
INSTALLED VANE TIP CLEARANCE

At the completion of the 0.015 inch clearance runs the impeller was removed and 0.010 inch was machined from the vane tip arc. This provided a vane clearance of approximately 0.025 inch on reinstallation. The machining operation removed most of the 0.004 inch eccentricity between vane tips and impeller centerline present in the 0.015 inch tests. The actual installed clearance values are given in the following sketch:

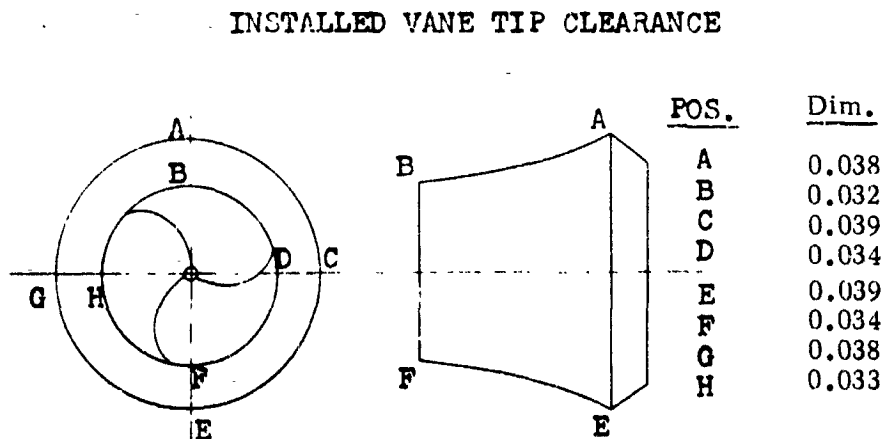
The impeller vane tip arc was again machined removing 0.010 inch to provide a constant vane tip clearance of 0.035 inch after completion of testing at the 0.025 inch clearance. The impeller vane tip radius was not machined correctly because of misalignment of the machining template used to cut the arc. The template was located with the center of the radius too far forward in relation to the impeller. This caused too little material to be removed from the vane tips at the rear of the impeller. Corrective machining was done; but, apparently, the same error was repeated in the opposite direction, causing an overcut by approximately 0.005 inch at the rear of the impeller. This resulted in a variable clearance from inlet to discharge of about 0.006 inch. Measured vane tip clearances at installation are given in the following sketch:

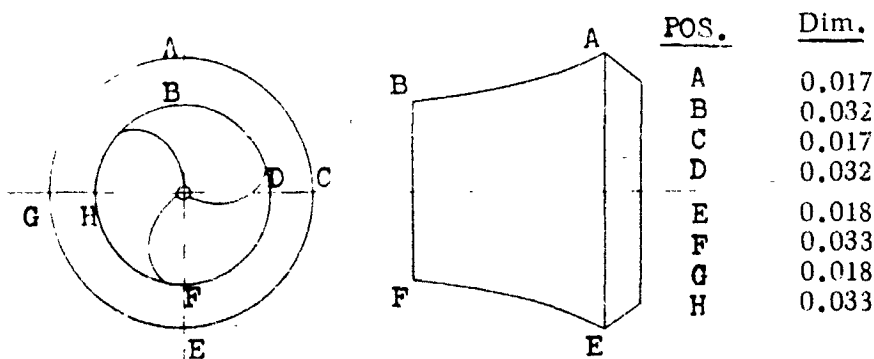
#### INSTALLED VANE TIP CLEARANCE

Actual installed clearances, as measured, are given in the following sketch for the impeller inlet and discharge only:

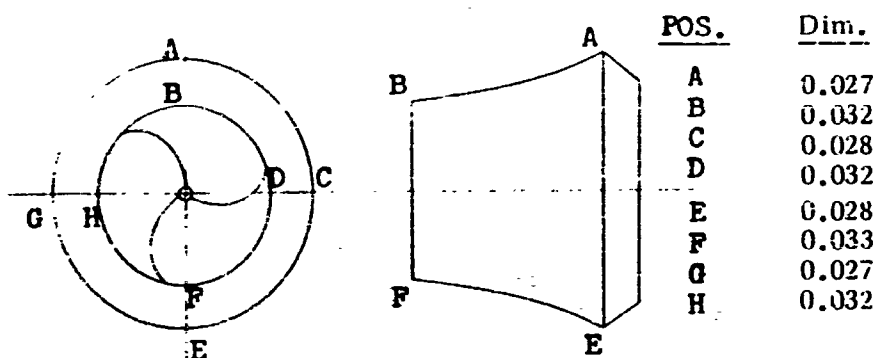
INSTALLED VANE TIP CLEARANCE

The back channel vane tip clearance was increased to approximately 0.027 inch after the tests at 0.017 inch. The increase of back channel clearance was made an even 0.010 inch to correspond to all previous clearance increments. Actual installed vane tip clearance is given in the following sketch:
