SATURN STAGE S-1-8
FINAL STATIC TEST REPORT

August 5, 1964

Chrysler Corporation Space Division
Huntsville, Alabama

This report describes the acceptance test firing of the Saturn flight stage S-1-8 conducted at the Static Test Tower East, Marshall Space Flight Center (MSFC), Huntsville, Alabama.

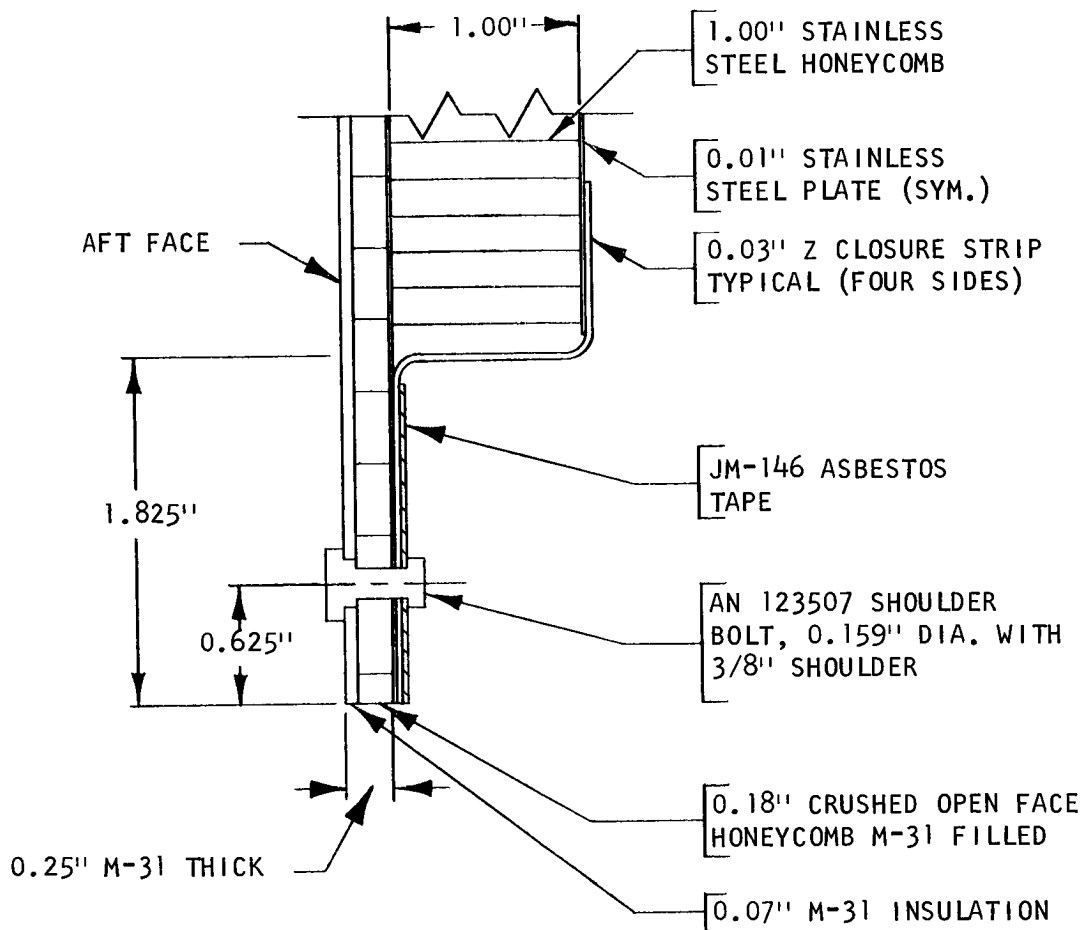
Post-test inspection, following test SA-21, revealed moderate damage to the heat shield. Approximately 900 square inches of M-31 insulating material separated from the stage panels. Insulation material which remained was cracked in many places. The post-test status of the individual panels is shown in FIGURE 5-2 and TABLE 5-1.

The stainless steel honeycomb heat shield panel used in test SA-20 was reinstalled adjacent to engine 8 on fin line IV for test SA-21. This location is subjected to the most vibration and heating during a static firing. Damage to this panel consisted of one hairline crack in the insulation material, 15 inches long, and parallel to the inboard bolt line (see FIGURE 5-3 and FIGURE 5-4).
