# SATURN S-IB STAGE FINAL STATIC TEST REPORT

SATURN S-1B STAGE  
FINAL STATIC TEST REPORT  
STAGE S-1B-4

FEBRUARY 25, 1966

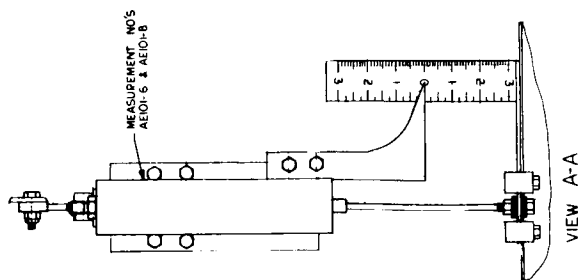
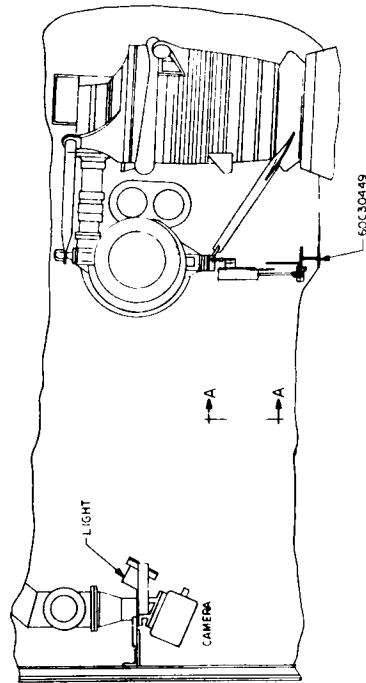
FIGURE 5-1

Following, test SA-33, an inspection of the boattail section revealed that these four heat shield support beam assemblies were distorted. The top flanges were deformed as shown in FIGURE 5-1. It is recommended that the study of heat shield beam assembly damage during static firings be continued.

BEAM 60C3Q459-1  
MAXIMUM DISTORTION NOTED

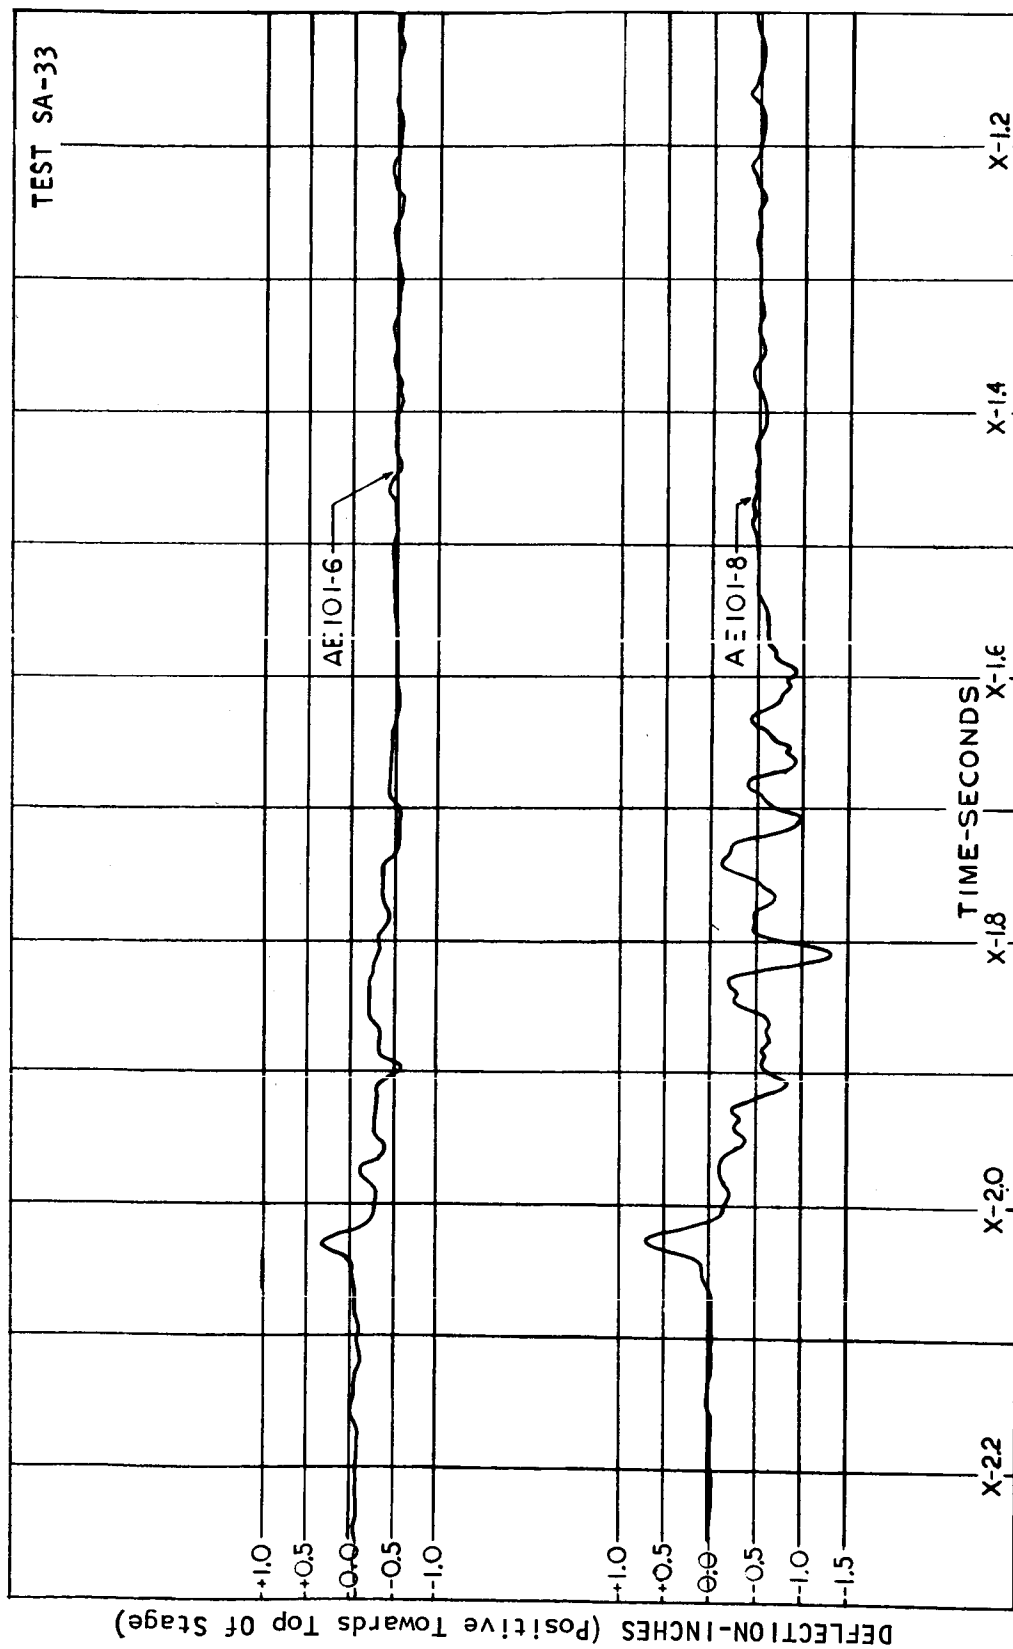
GRAPH 5-1  
HEAT SHIELD BEAM DEFLECTION  
IGNITION TRANSITION

The deflections of the heat shield support beam assemblies during the ignition and cutoff sequences are presented in GRAPH 5-1 and 5-2, respectively. Measurement AE101-6 is not shown in the cutoff sequence graph as this measurement malfunctioned at approximately X+19 seconds. The deflection of these beams during engine start reached a maximum positive displacement of 0.75 inch at X-2.03 seconds and a maximum negative displacement of 1.35 inches at X-1.81 seconds. The deflections of the beams during the cutoff transition were not as severe as during ignition. The configurations of the cameras and deflection indicator assemblies utilized to obtain motion pictures of beam movement during test SA-33 are shown in FIGURES 5-1 and 5-2. The maximum values of heat shield support beam strain during test SA-33 are shown in TABLE 5-2.

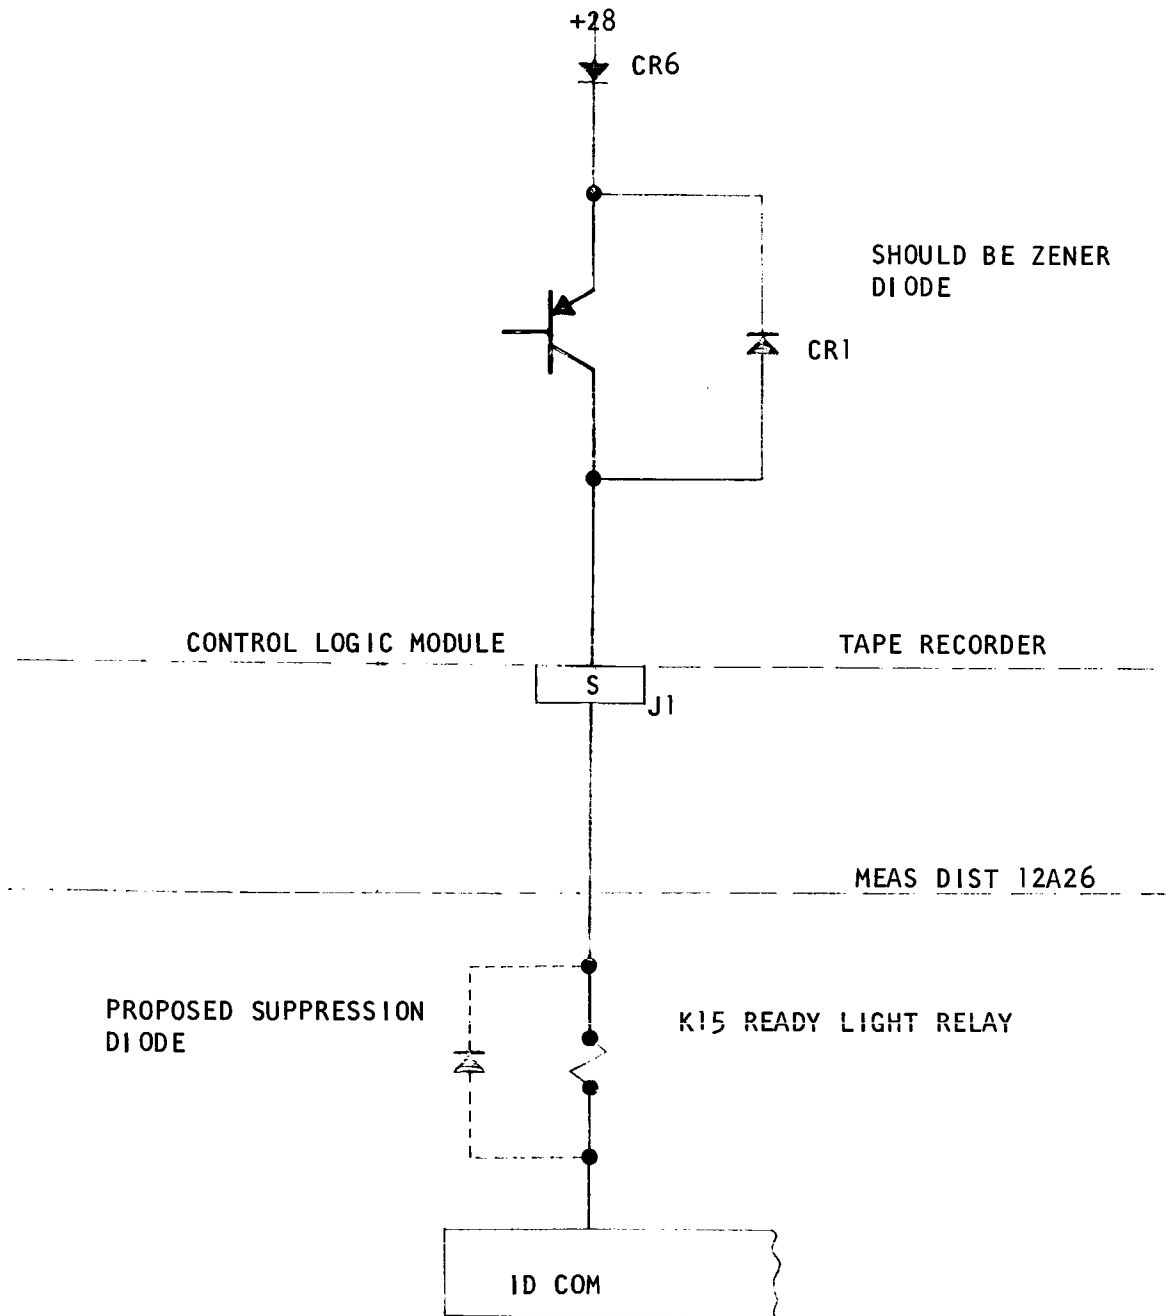
FIGURE 8-2  
TAPE RECORDER-RECORD COMMAND  
CIRCUITRY

An intensive investigation revealed that a negative spike in excess of 100 volts occurred at record command on pin S, plug J1, on the tape recorder. The circuit involved is shown in FIGURE 8-2. Relay K15,

- a. Install a suppression diode across the coil of K15 inside the distributor 12A26 as shown in FIGURE 8-2.
- b. Require the tape recorder vendor to change diode CRI to a zener diode of about 30 volts.
- c. Remove the relay K15 and reconnect pins of J1 on the tape recorder directly to the tape recorder ready indication in the telemetry system.
