## SNAP-8 MATERIALS REPORT FOR JULY - DECEMBER 1965

SEMIANNUAL MATERIALS REPORT

By H. Derow and B. E. Farwell

February 1966

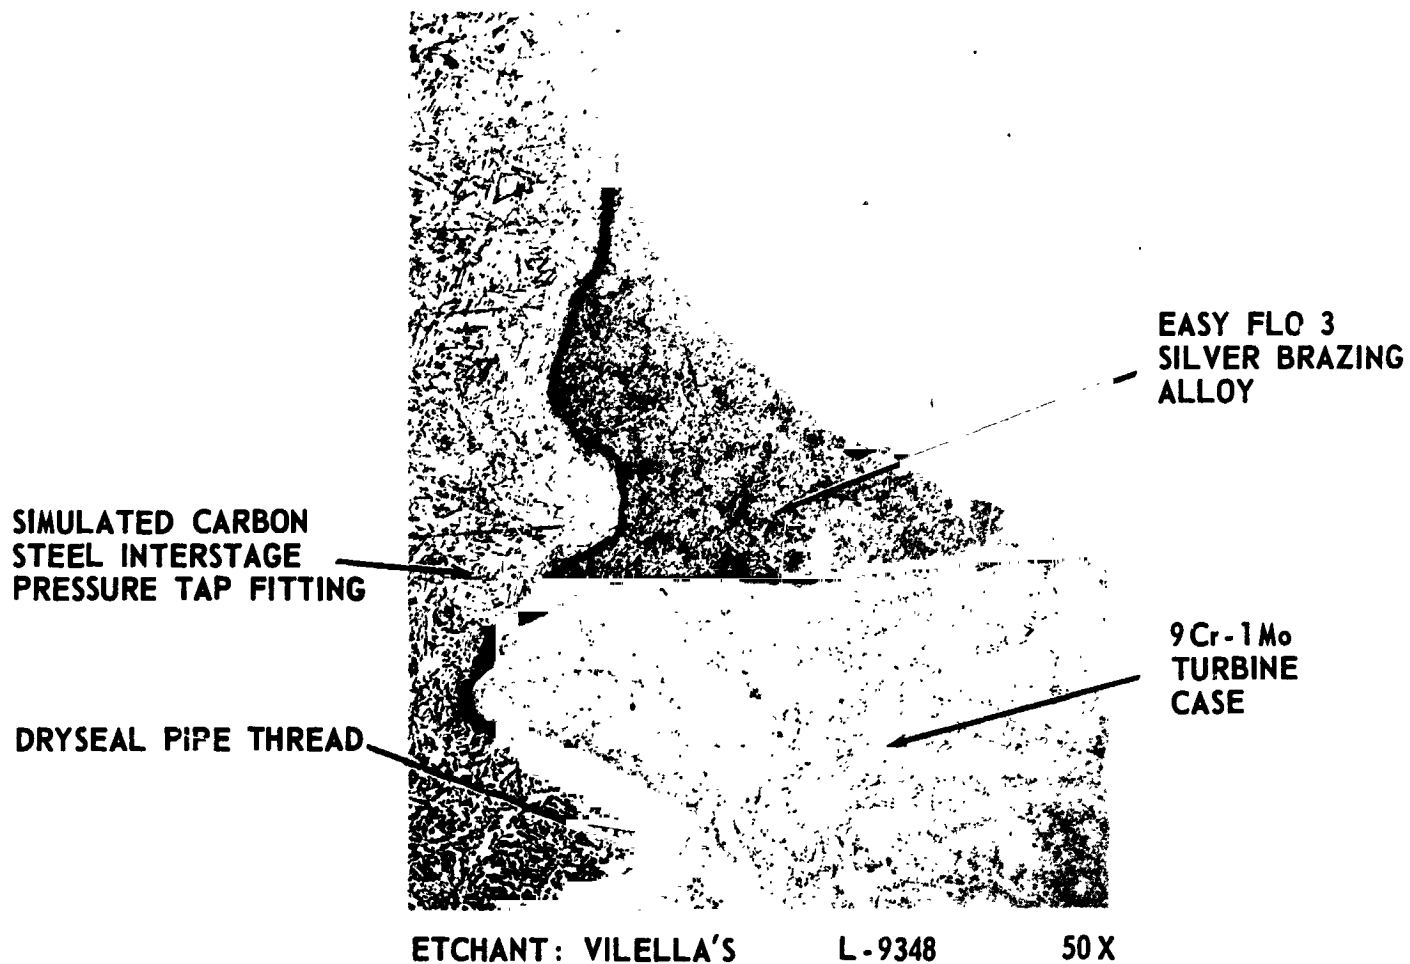
Simulated Turbine Assembly (S/N A-1) Brazed Joint Between Carbon Steel Interstage Pressure-Tap Fitting and 9Cr-1Mo Steel Turbine Case. Joint Produced by Torch Brazing Using Easy Flo 3 Braze Alloy and Flux.

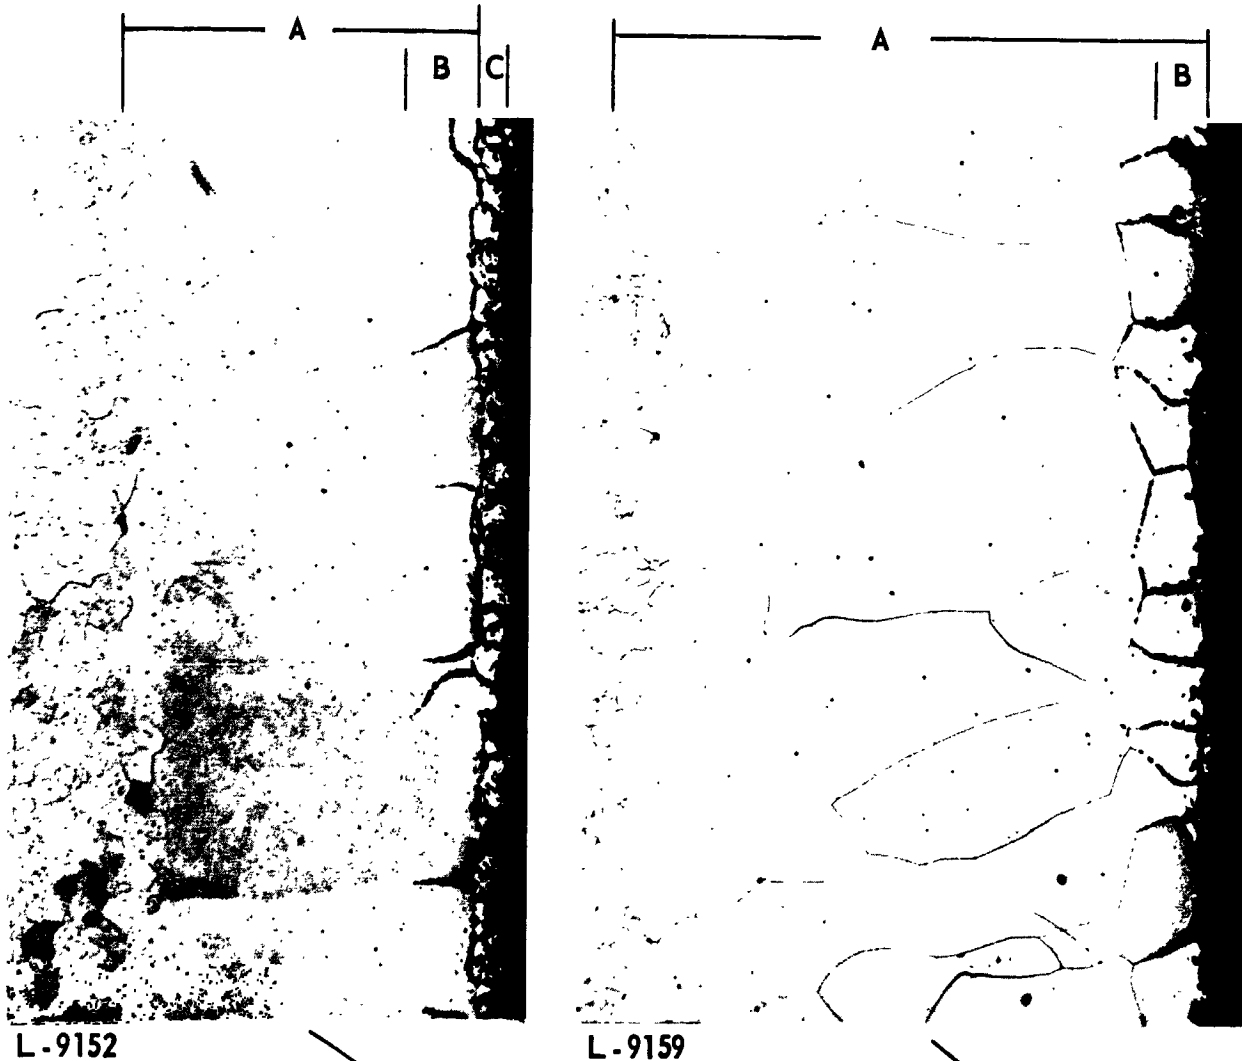
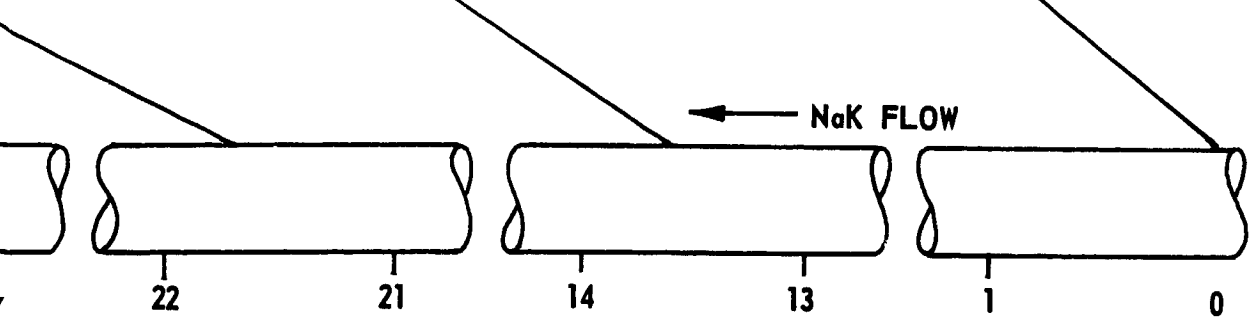
Figure 12-3

NaK-Exposed Surfaces of Hg Containment Coil No. 0-4  
 After 2350 hr of NaK-Side Operation in RPL-2 (Vile:  
 All Areas Show Concomitant Decarburization and Grai  
 The Former is Delineated at Higher Magnification.  
 Corrosion (Area B) and Mass-Transfer Deposits (Area  
 Present.

THIS END CONNECTS TO 5-1/2 IN. RADIUS BEND AT Hg OUTLET MANIFOLD

of -1 Boiler  
lla's Etch).  
n Growth (Area A).  
Intergranular  
C) Are Also

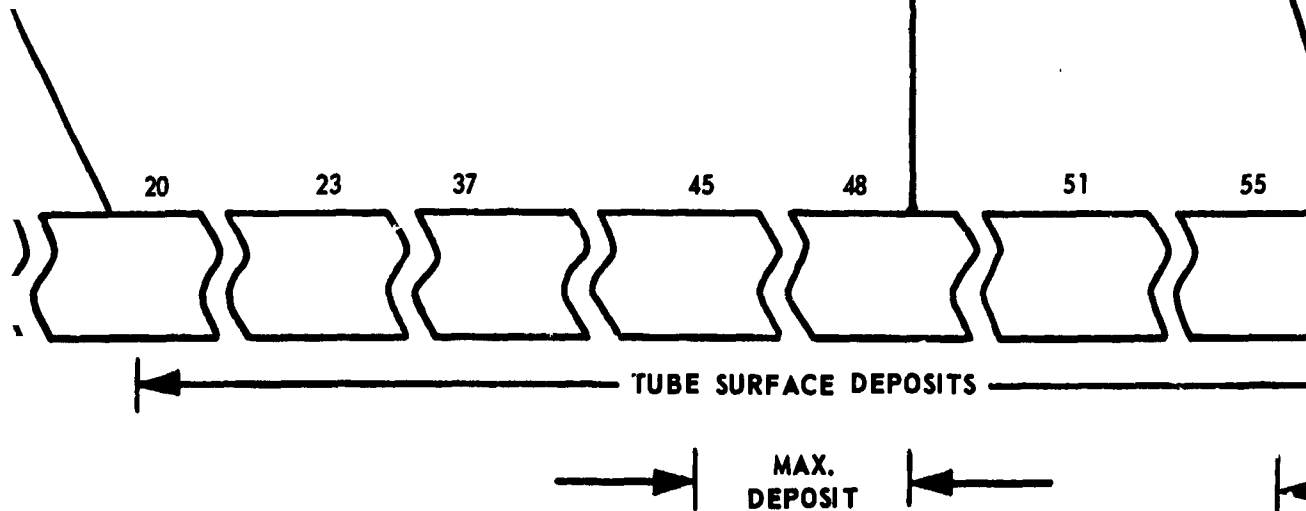
TUBE PITTING

UNIFORM MASS TRANSFER  
DEPOSIT

Mercury Side of Tube Coil No. 0-4 of -1 Boiler Removed From RPL-2  
After 1415 hr of Mercury Operation

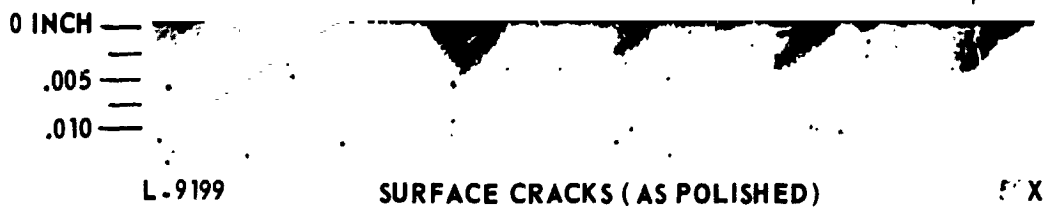
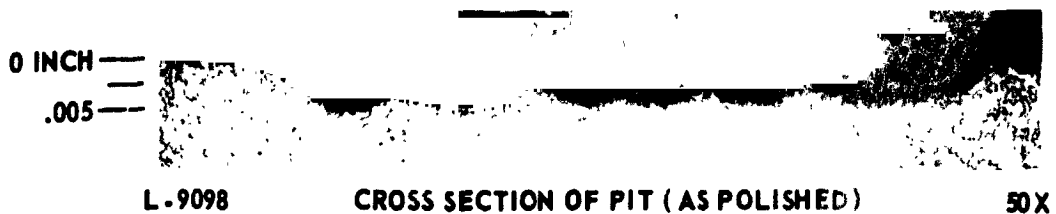
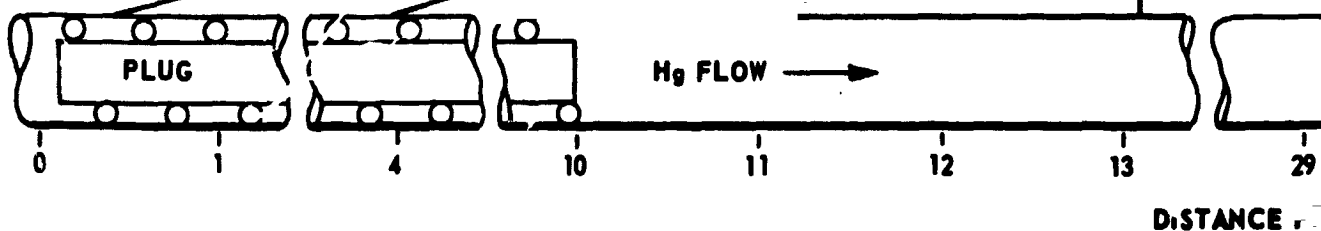
Figure 13.3

TUBE  
SURFACE  
CRACKS

Mercury Exposed Surfaces of Tub  
 Boiler After 1415 hr of Operat

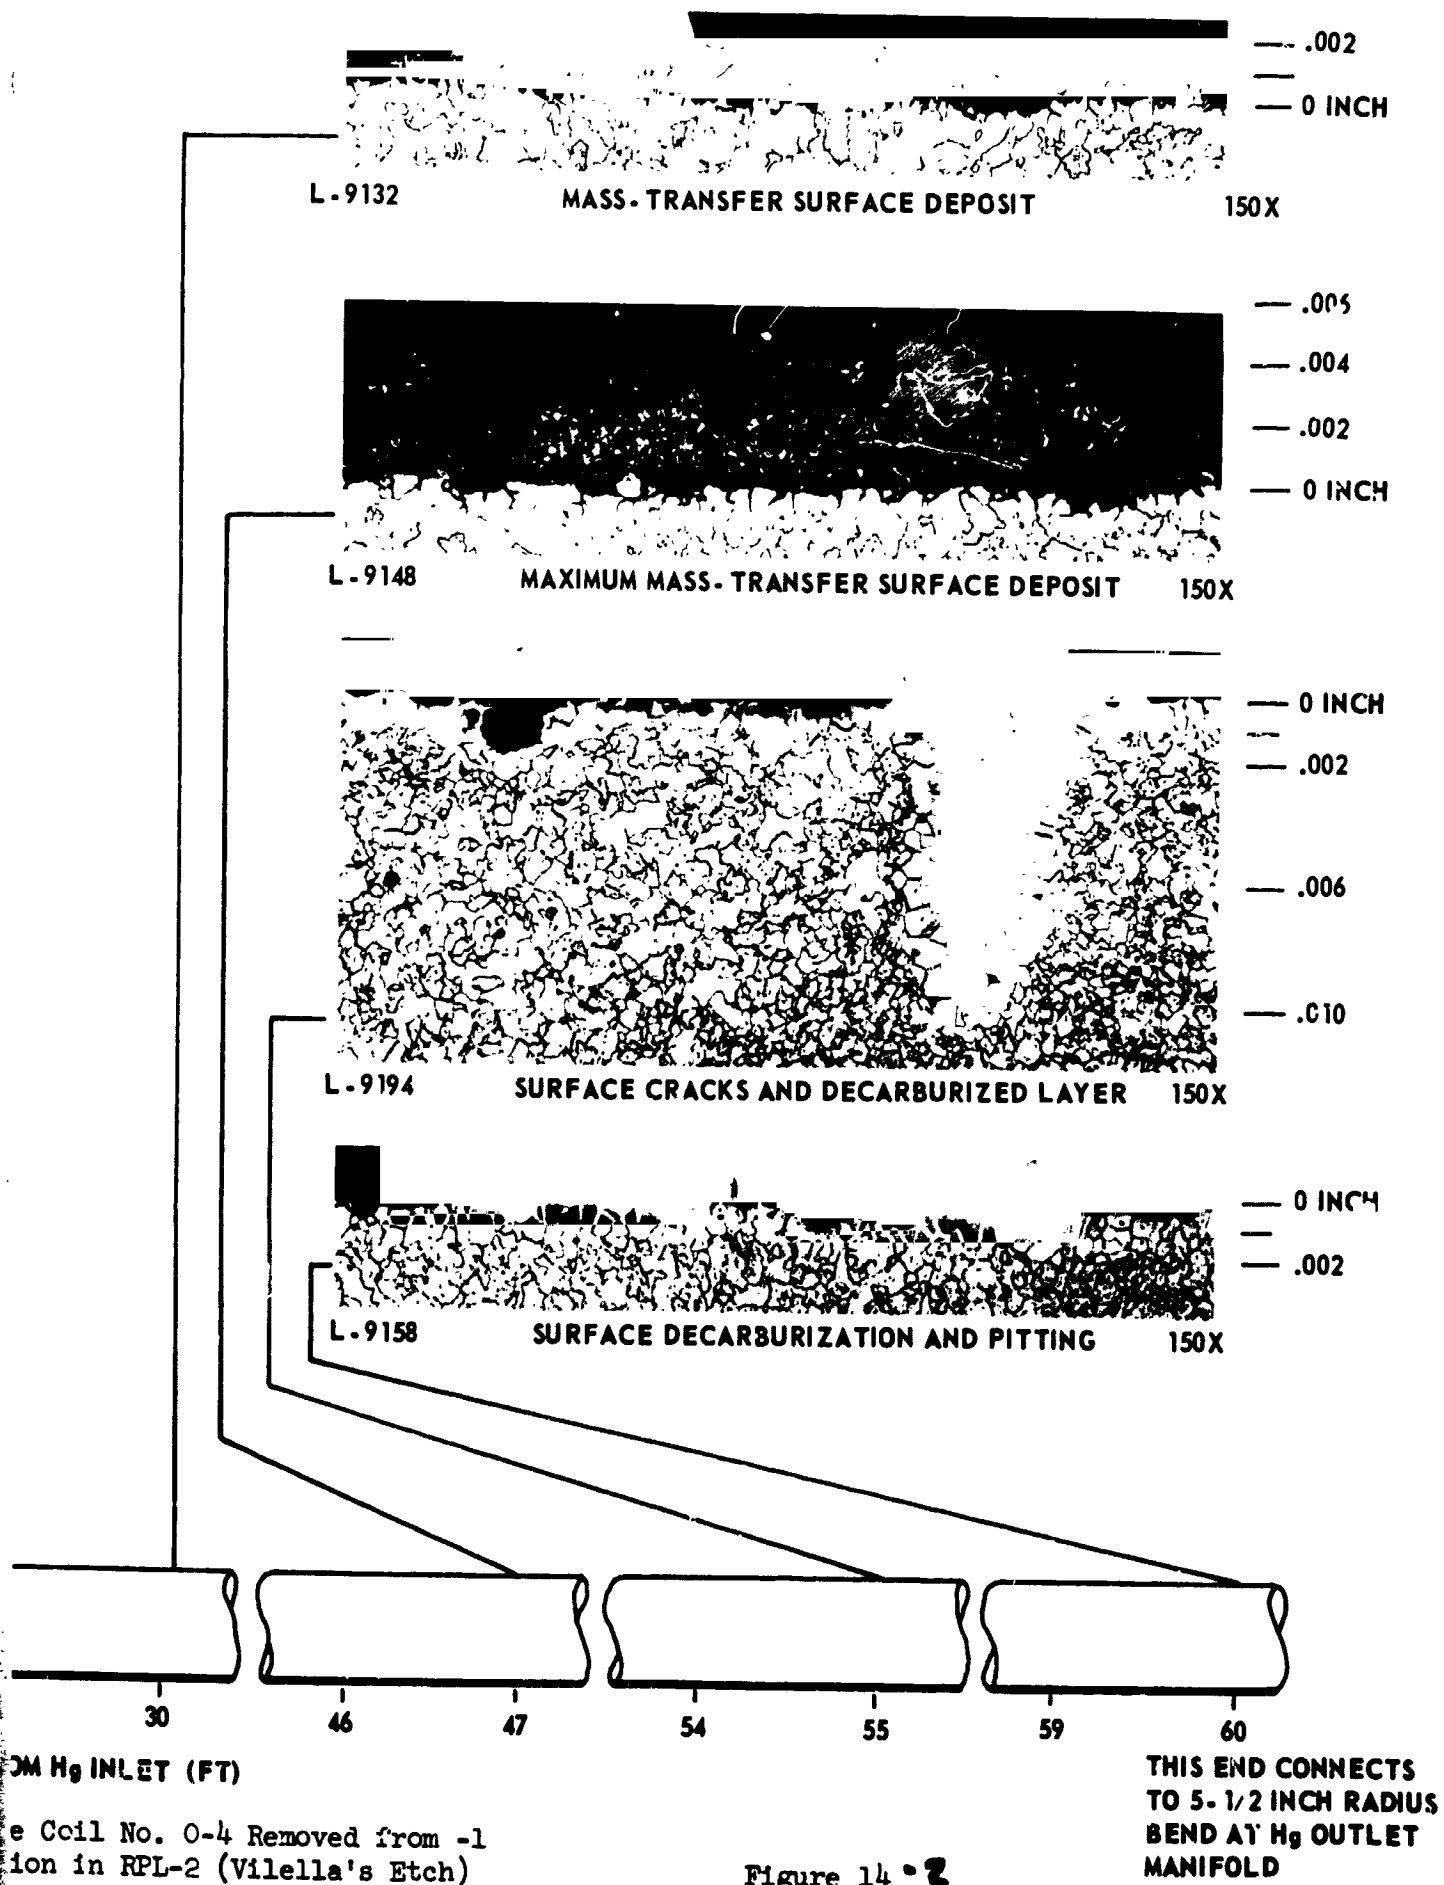
Figure 14 - 2

Pitting was found in the first 23 ft of the No. 0-4 tube (measured from the Hg inlet). Figure 14 shows a micrograph of a section of the tube 11 ft from the inlet. The pits were approximately circular, with a diameter-to-depth ratio between 1 and 10 and a maximum depth of 5.5 mils. Figure 15 describes the maximum pit depth distribution along the tube length. There was no apparent orientation of pitting or maximum pit depth with respect to either gravity or centrifugal forces on the flowing Hg. An analysis of the data with respect to temperature, or vapor quality, or both, will be performed in an effort to correlate pitting with localized Hg conditions.

4 mils (see Figure 14). It is postulated, confirmed by the operating history, Table 2, that the boiler operated for significant time periods with a very short superheat length. This would explain the presence of deposits only 3 to 4 ft from the Hg outlet in this tube coil.

Toward the Hg outlet end, the surface contained a decarburized layer approximately 1 mil thick, shown in the 55-ft located micrograph of Figure 14. Pre-existing decarburization resulting from tube manufacture does not appear probable since all tubes were part of one fabrication lot and other tube sections in this one coil do not exhibit the same phenomena. In order to determine whether Hg corrosion effects could have produced surface decarburization, this same area in two other tube coils removed from the boiler is being examined.

cracks (the 55-ft section shown in Figure 14). A surface decarburization layer follows the contour of the crack and appears to be of uniform thickness throughout. Since the decarburized layer thickness in the crack is not different from that on the tube surface, the decarburizing phenomenon must have been reacting on the crack as long as the surface proper and this would require existence of the crack prior to startup. If the crack had appeared during boiler operation it would be expected that the decarburized layer in the crack would be thinner than on the actual tube surface; a time delay would be required for the Hg and/or internal pressure to cause propagation of the crack from any pre-existing microscopic surface discontinuity. This time delay would have resulted in a difference in decarburization depth.
