NASA TM X-52336

**CENTAUR SOLID STATE INVERTER FAILURE DURING SIMULATED
FLIGHT IN AN ENVIRONMENTAL SPACE CHAMBER**

by Ralph F. Schmiedlin and B. J. Dastoli

Lewis Research Center
Cleveland, Ohio

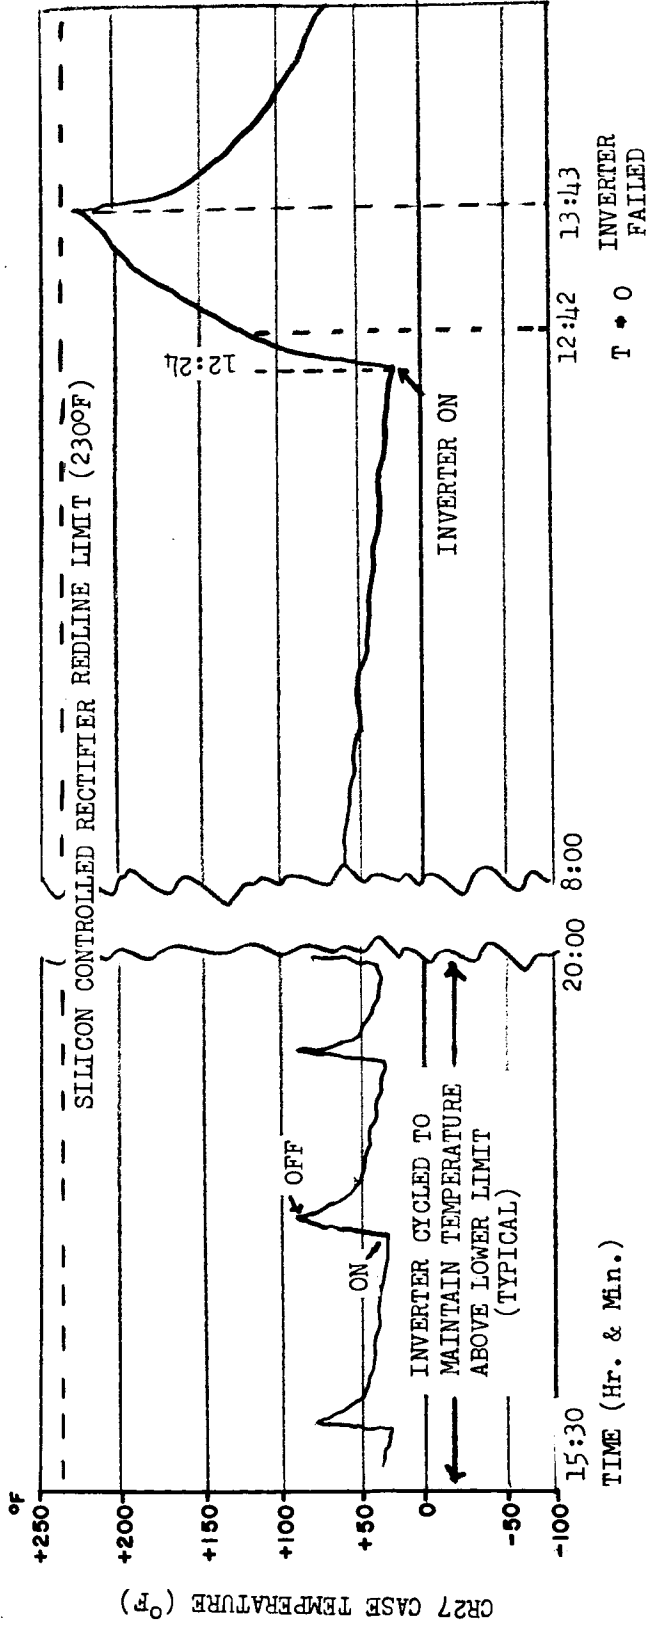
Subsequent inspection revealed that the inverter failure was the result of the overload sensing shunt melting open (fig. 5). Further examination of the inverter also revealed that the overload adjustment potentiometer R54 and resistor R55 (fig. 2) were damaged by excessive current. Replacement of these three components restored the inverter to operational condition.

1. It is believed that the cause of this inverter failure was due to an electrical shorting of the shunt which was probably caused by insufficient electrical insulation provided by the 3-mil-thick mica combined with the burrs and foreign conductive chips on the shunt, some of which worked through the mica. The melting of the R53 shunt was likely caused by arcing rather than operational overheating.

Figure 5. - Inverter failed components.

Special care must be taken in manufacture and inspection to see that the shunt is free of all burrs, chips, dents, cracks, etc. and that other foreign matter does not get imbedded between the mica insulator and the shunt for the heat sink.

After these tests were run, the inverter now used on Centaur vehicles has been redesigned to eliminate the deficiencies as indicated in this report.
