# SNAP-8 ELECTRICAL GENERATING SYSTEM DEVELOPMENT PROGRAM

PROGRESS REPORT FOR JANUARY - JUNE 1966

NASA CR 72-1-03  
Aerojet Report No. 3233

SEMIANNUAL REPORT

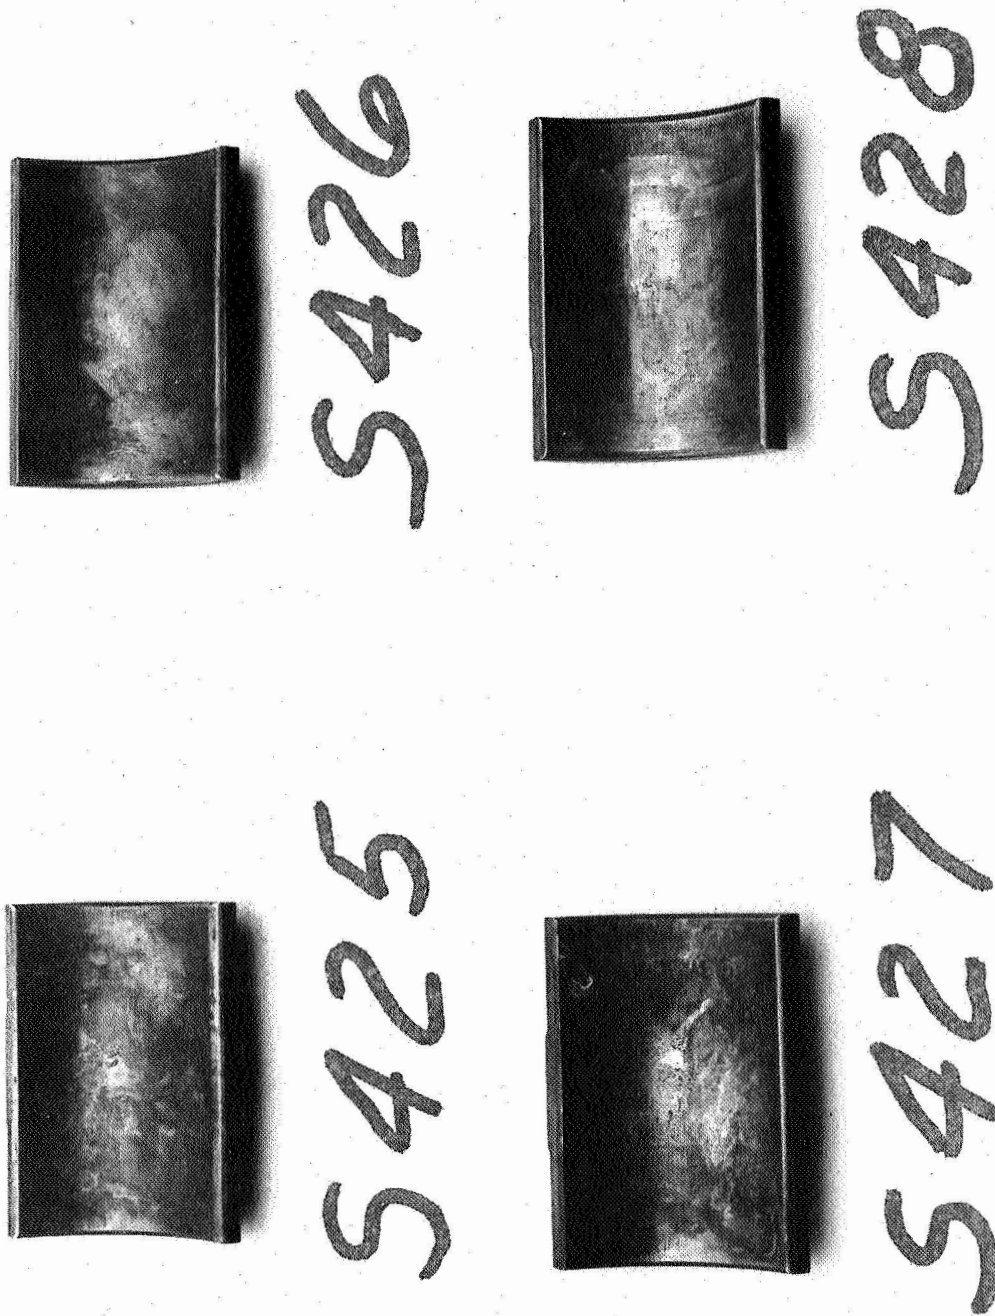
Figure V-34

Pump-End Radial Bearing Pads of NaK Pump-Motor  
Assembly (P/N 093200-13, S/N A-6) From Primary  
Loop of PCS-1 Phase IV Step 2

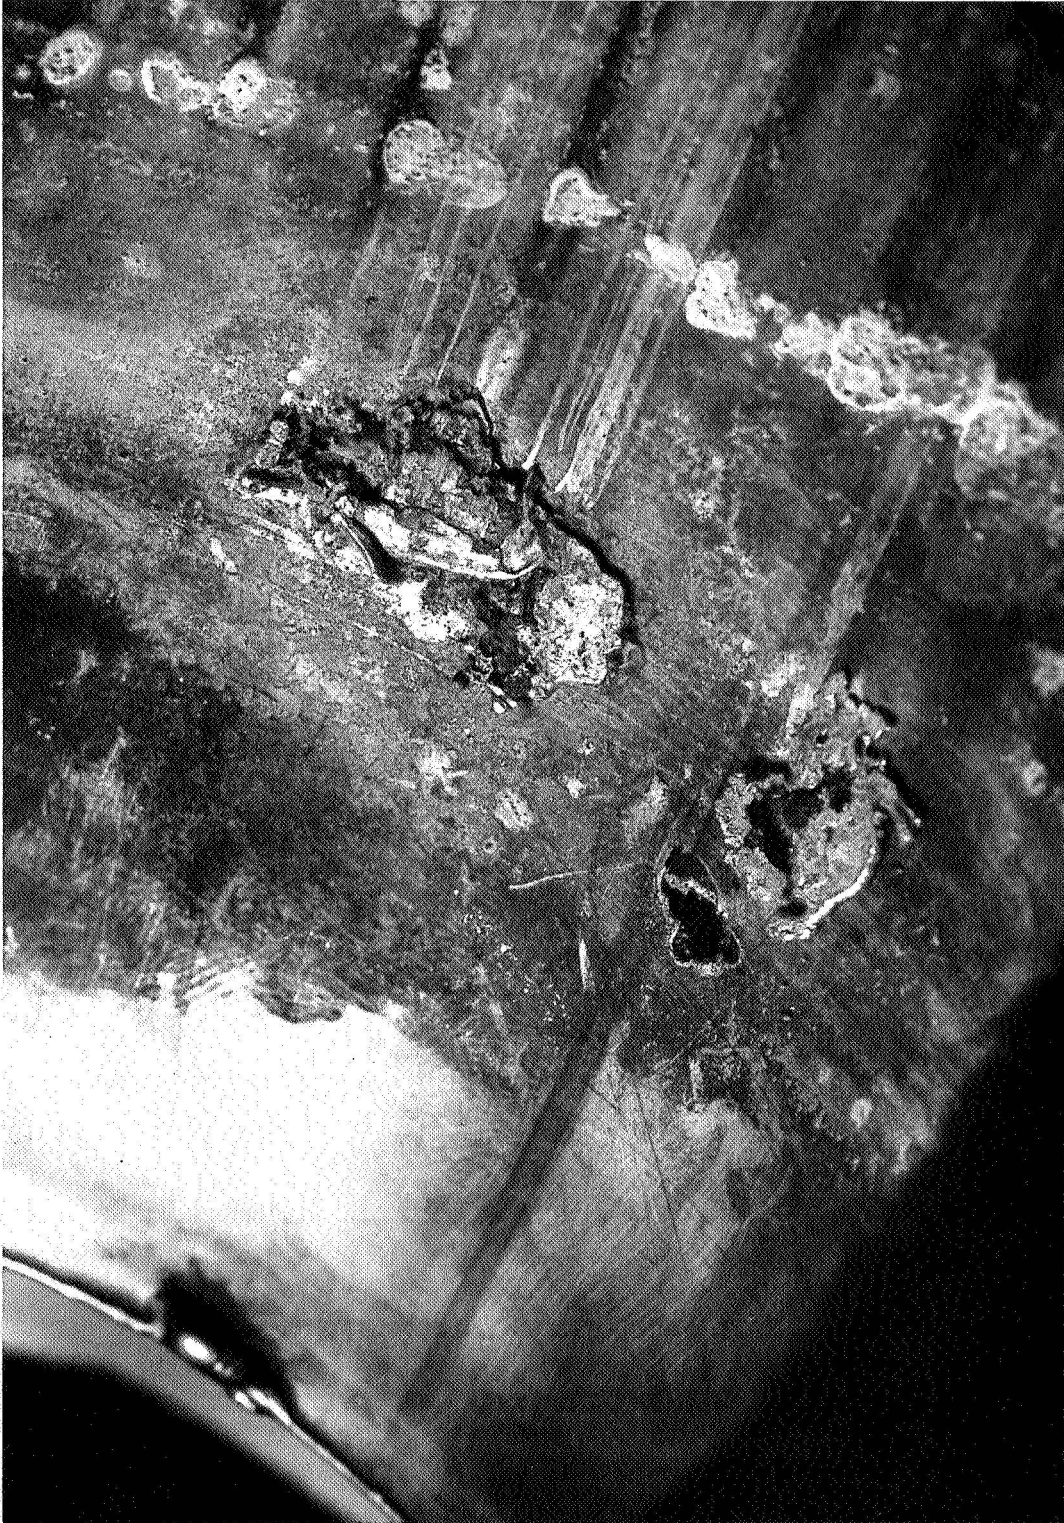
Figure V-42

Inside Bore of Stator Can From NaK PMA Unit 4/1 (P/N 093200-13C,  
S/N A-4), Showing Arc Holes and Copper Splatter at Areas 3 and 4

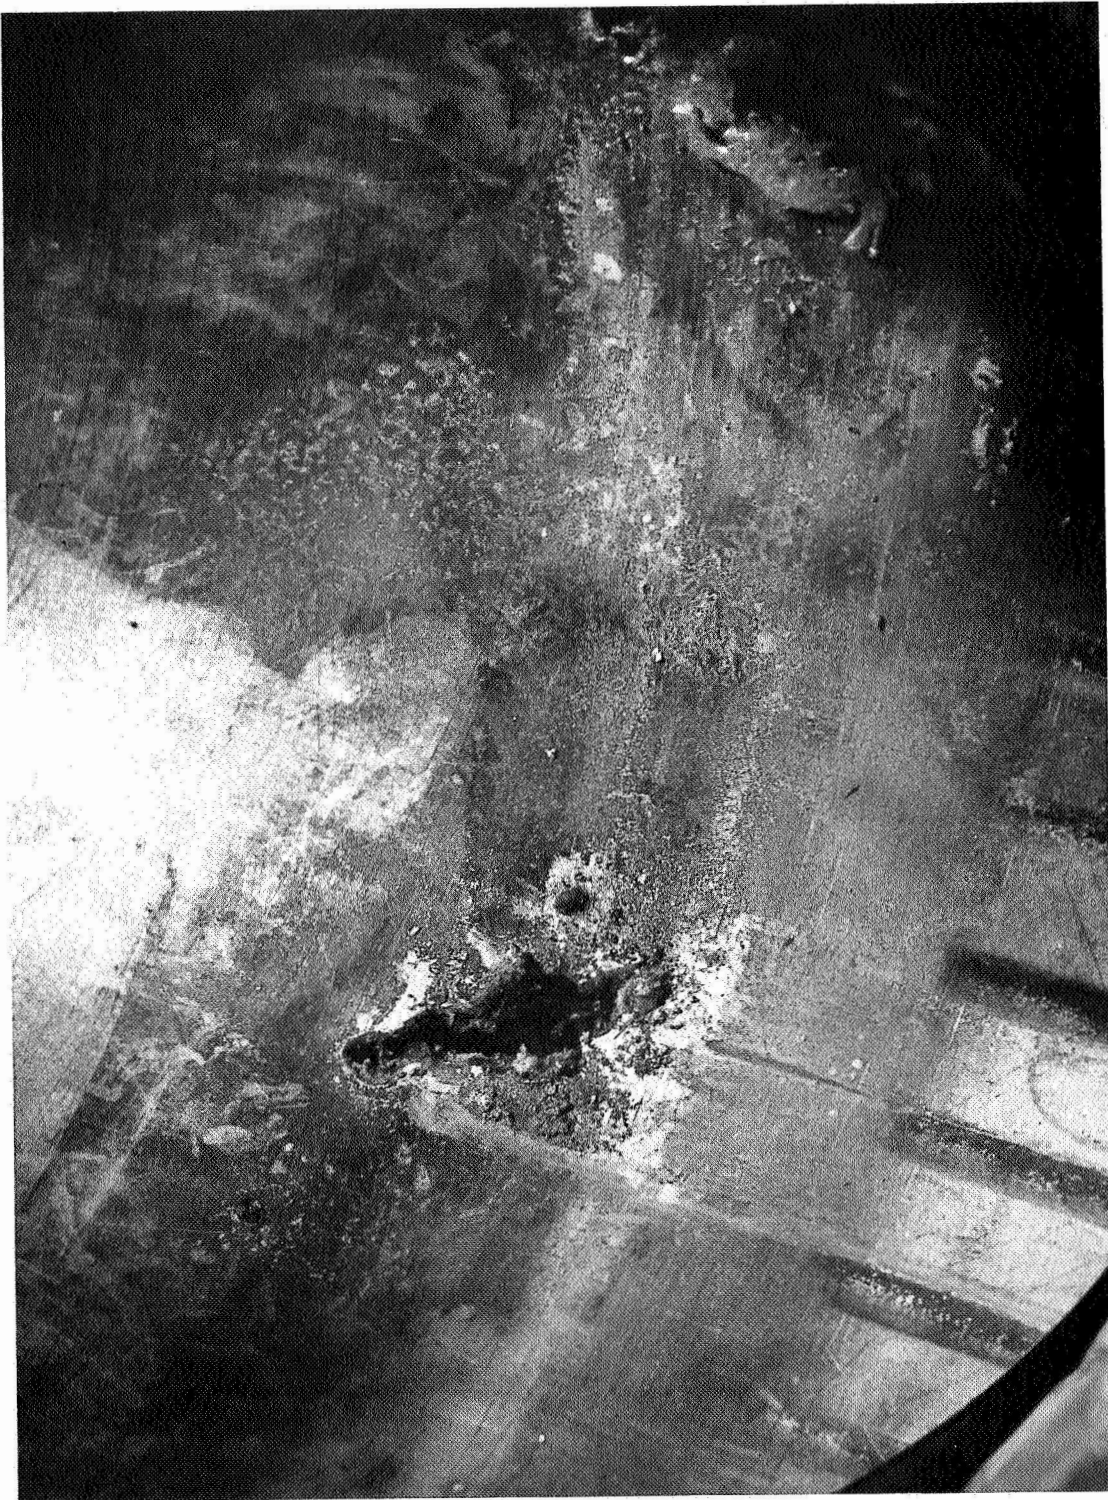
Figure V-43

Inside Bore of Stator Can From NaK PMA Unit 4/1(P/N 093200-13C,  
S/N A-4), Showing Arc Holes at Area 5
