R-7450-2

J-2 ENGINE AS-502 (APOLLO 6)

FLIGHT REPORT

VOLUME 2: S-II STAGE FAILURE ANALYSIS

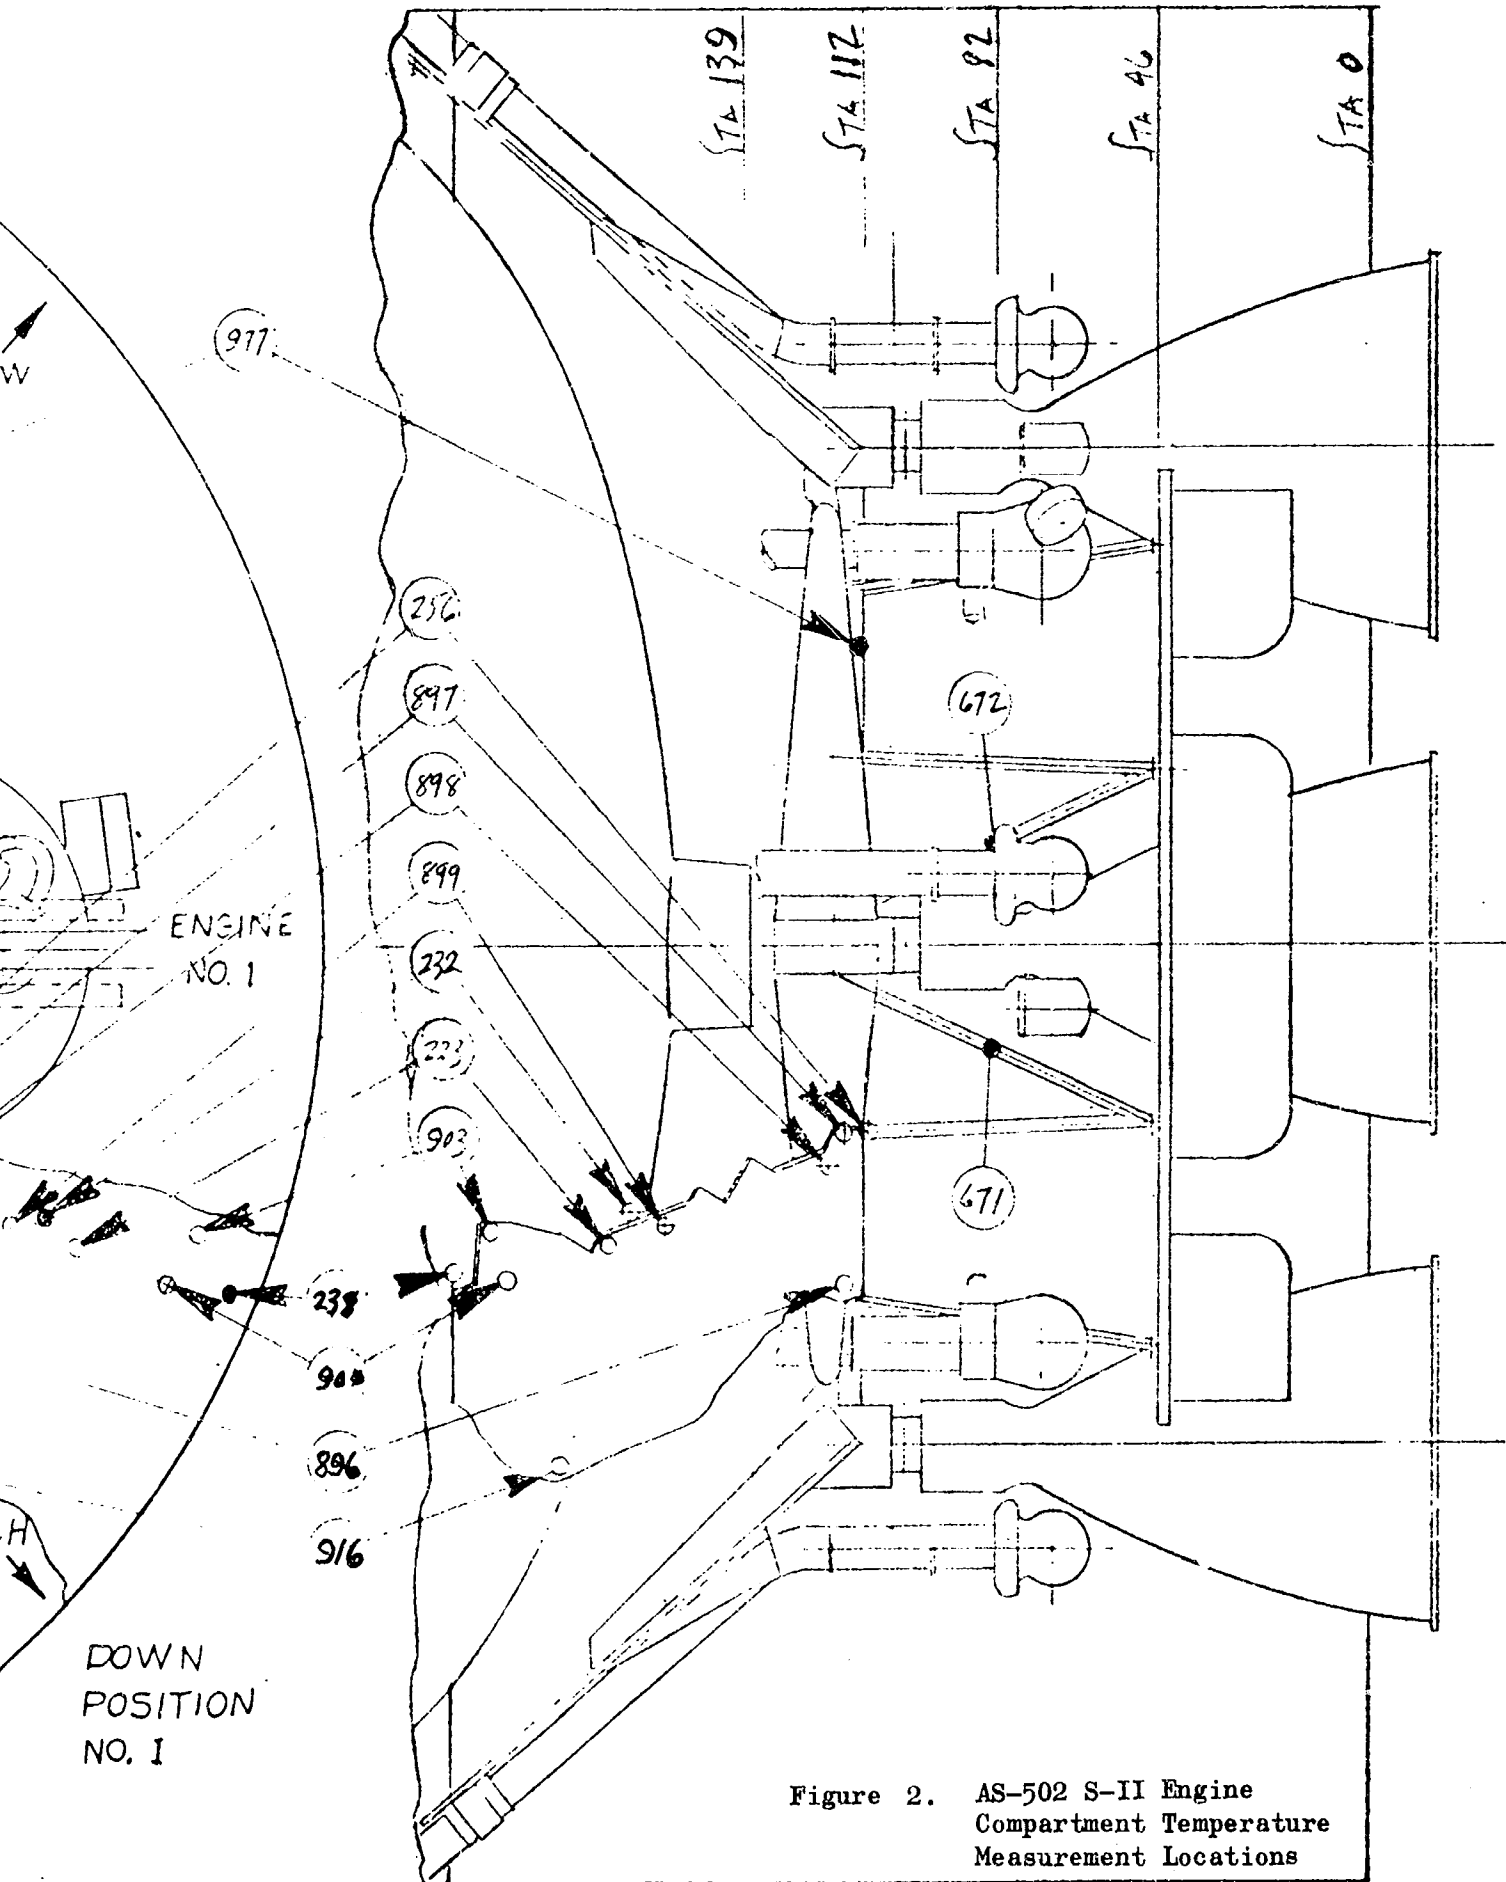
Description of Event. Engine component and stage temperature parameters indicate that portions of the S-II boattail region experienced a cooling trend beginning at approximately 220 seconds range time. Temperature plots (Fig. 2 through 28) illustrate boattail thermal characteristics as a function of time. The engine compartment cooling region generally related to the area occupied by engines 201, 202, and 205, and extended from the heat shield forward to the base of the oxidizer tank. Comparative data from flight AS-501 are included in Fig. 1 through 24 to illustrate that the cooling trend was not encountered during that flight. The chilling trend continued through S-II flight until cutoff of engines 202 and 203 (range times 412.925 and 414.277 seconds, respectively).

Figure 2. AS-502 S-II Engine Compartment Temperature Measurement Locations

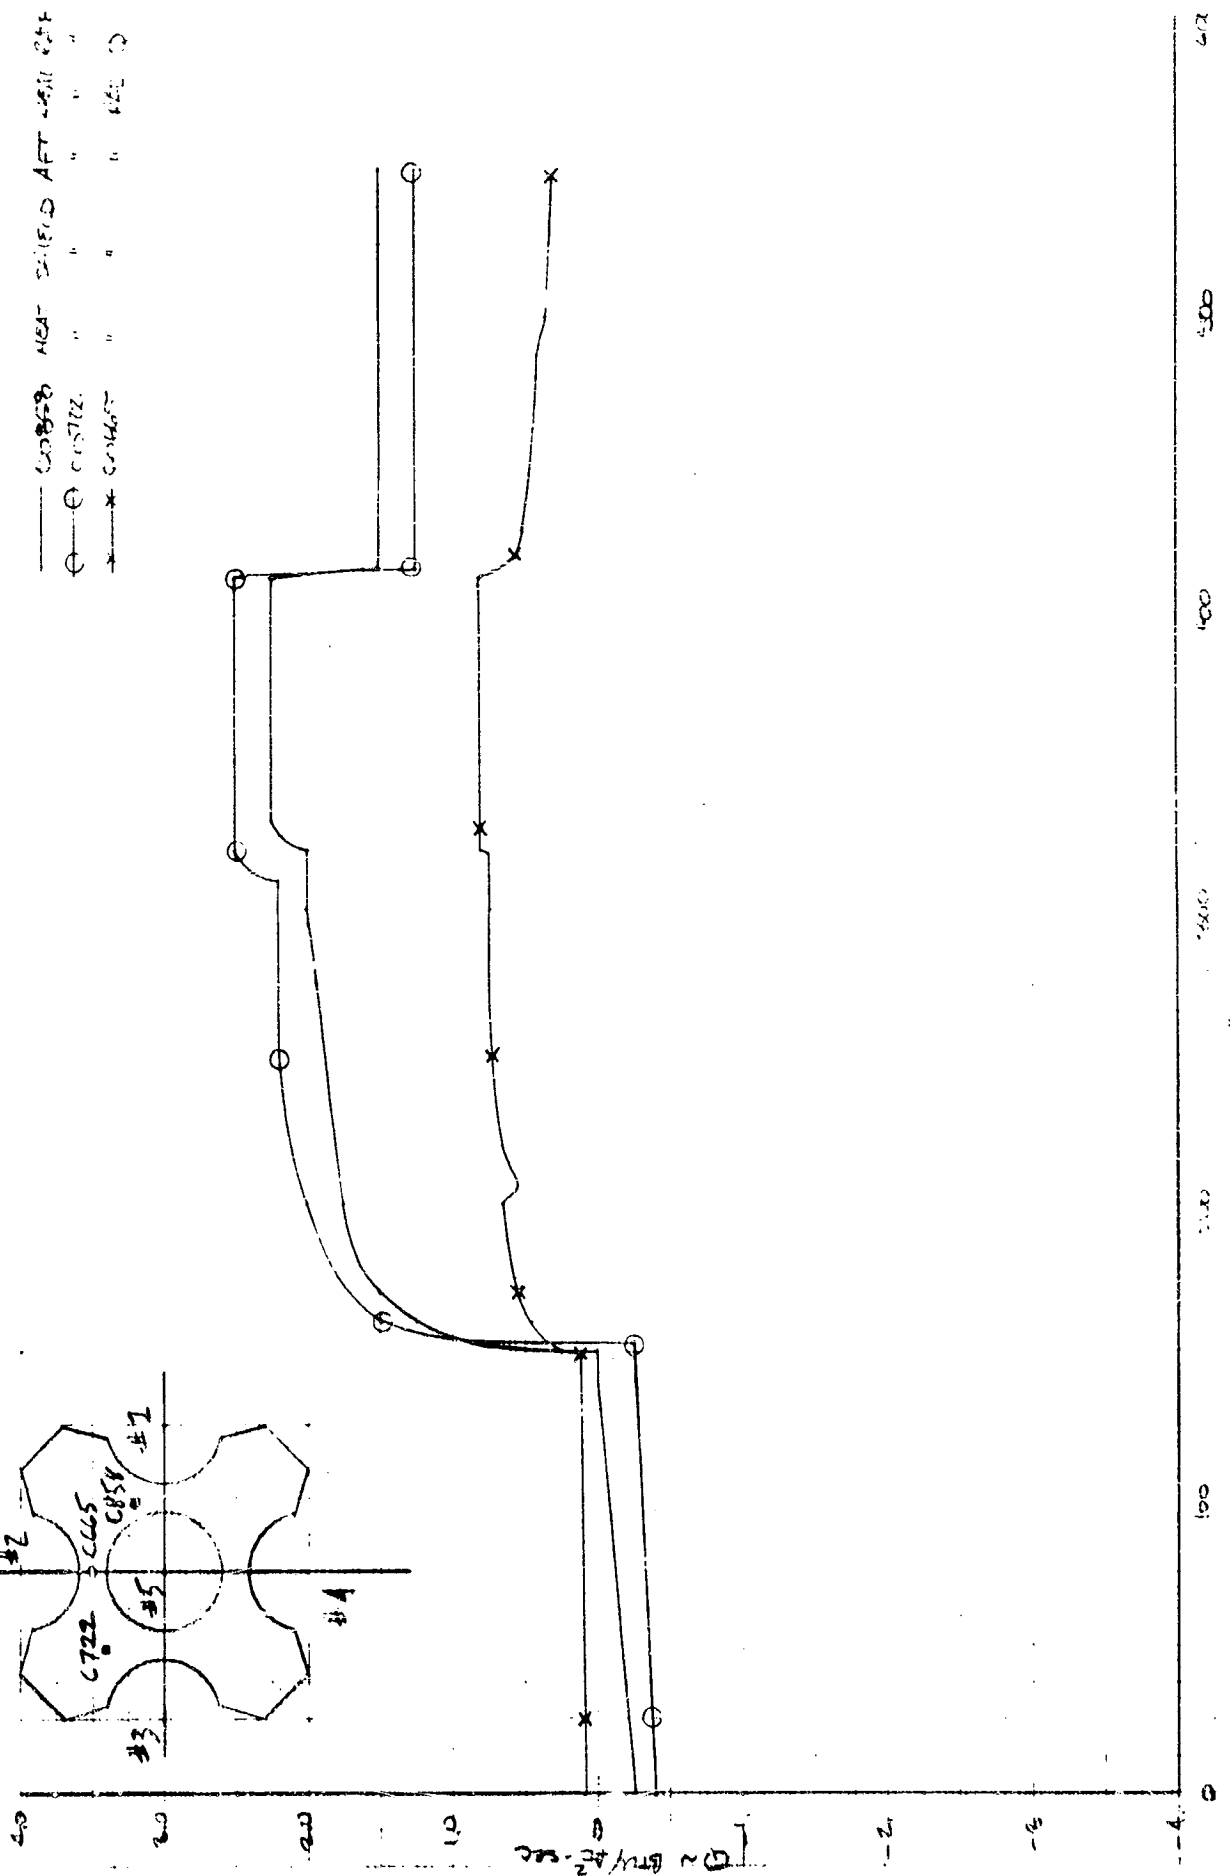
Description of Event. The three heat flux measurements C665, C722 and C858 around engine 202 indicate a step increase of approximately 10 percent at 319 seconds range time (Fig. 2).

Corroboration of Hypothesis. Calculations indicating the 10-percent heat flux increase are based on MSFC-supplied thermal environment data which yield an increase in Q of 25 percent when changing the mixture ratio from 4.7 to 5.5. The indicated change in thrust chamber mixture ratio of +0.4 mixture ratio units was extrapolated from the MSFC data, yielding the approximate increase in heat flux that was noted during flight. The outboard location of the ruptured nozzle tubes is such that minimum effect of the fuel discharging into the exhaust plume is seen by the calorimeters. Thus, the calorimeters can sense the change in injector end combustion accurately.

Figure 28. AS-502 S-II Heat Shield Rate and Flux

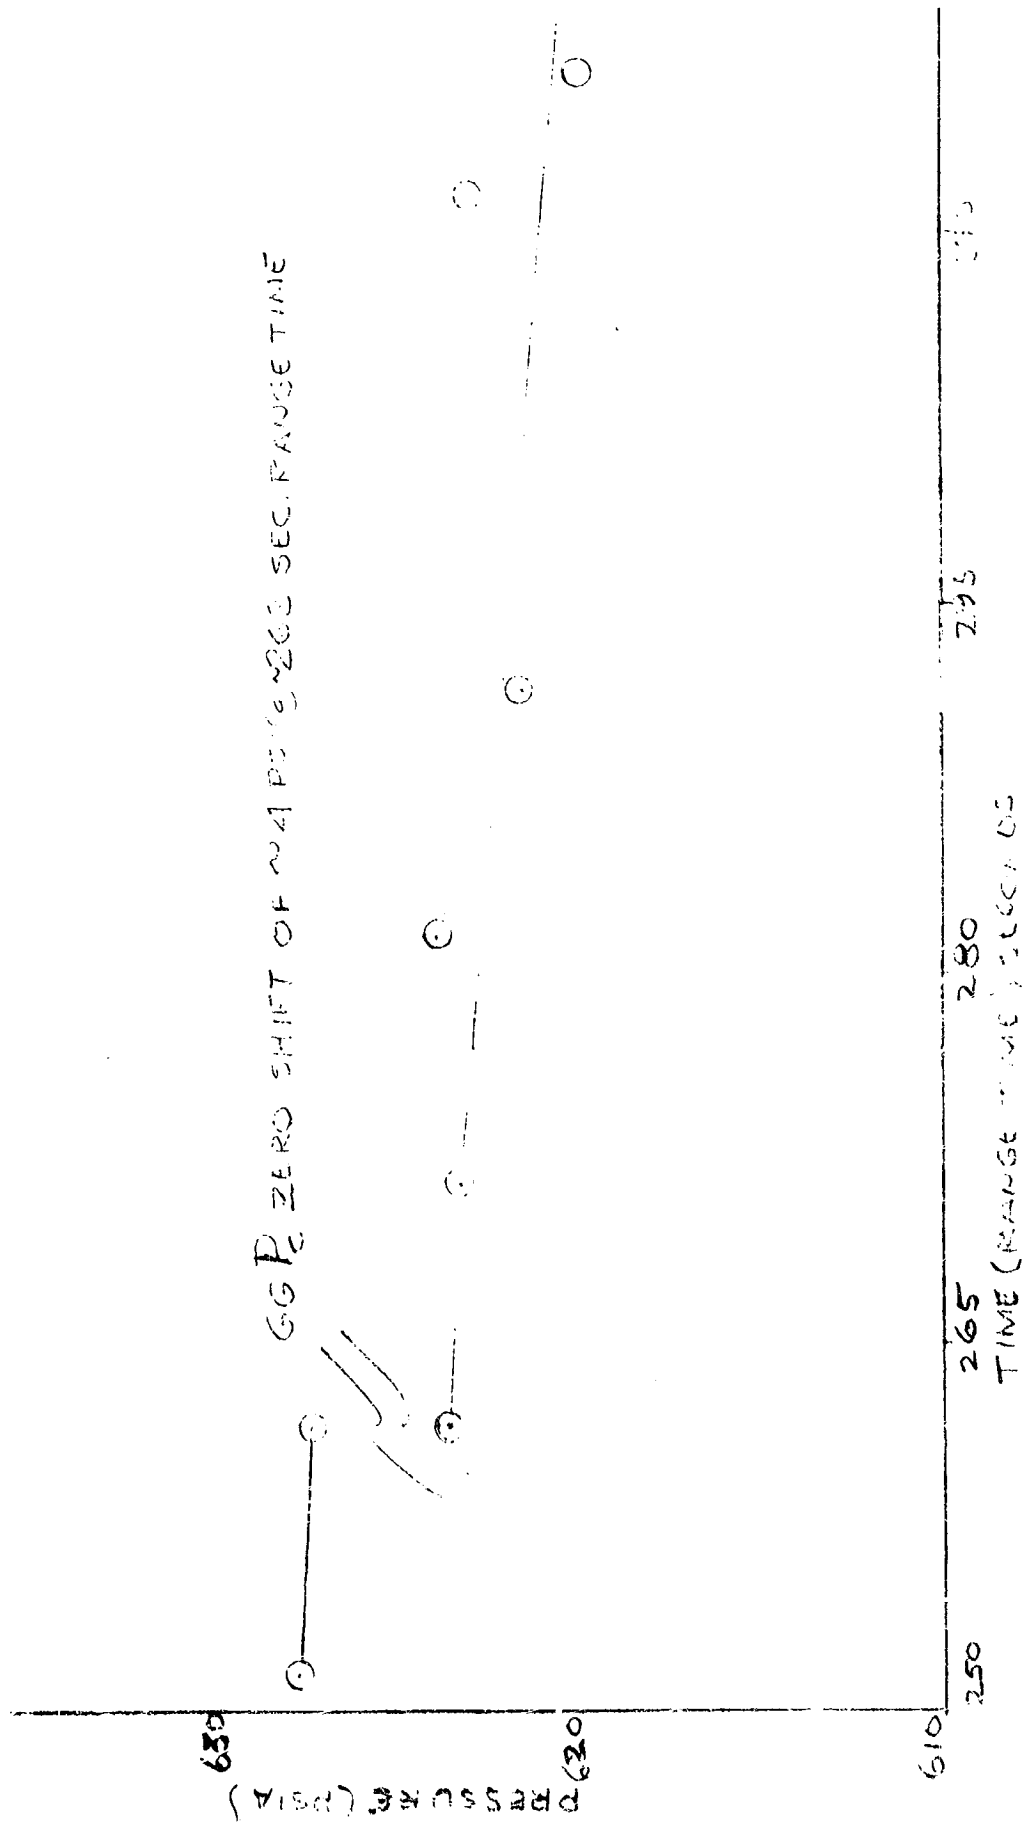
Figure 30. AS-502 S-II Gas Generator Chamber Pressure Performance Decay, 250 to 318 Seconds Range Time (Engine J2044)

Description of Event. The 100-sample/second trace of gas generator chamber pressure indicated an abrupt shift at 262 seconds range time. Data samples taken before (261.5 seconds) and after (266.5 seconds) indicate the gas generator chamber pressure dropped 4 psi (Fig. 30).

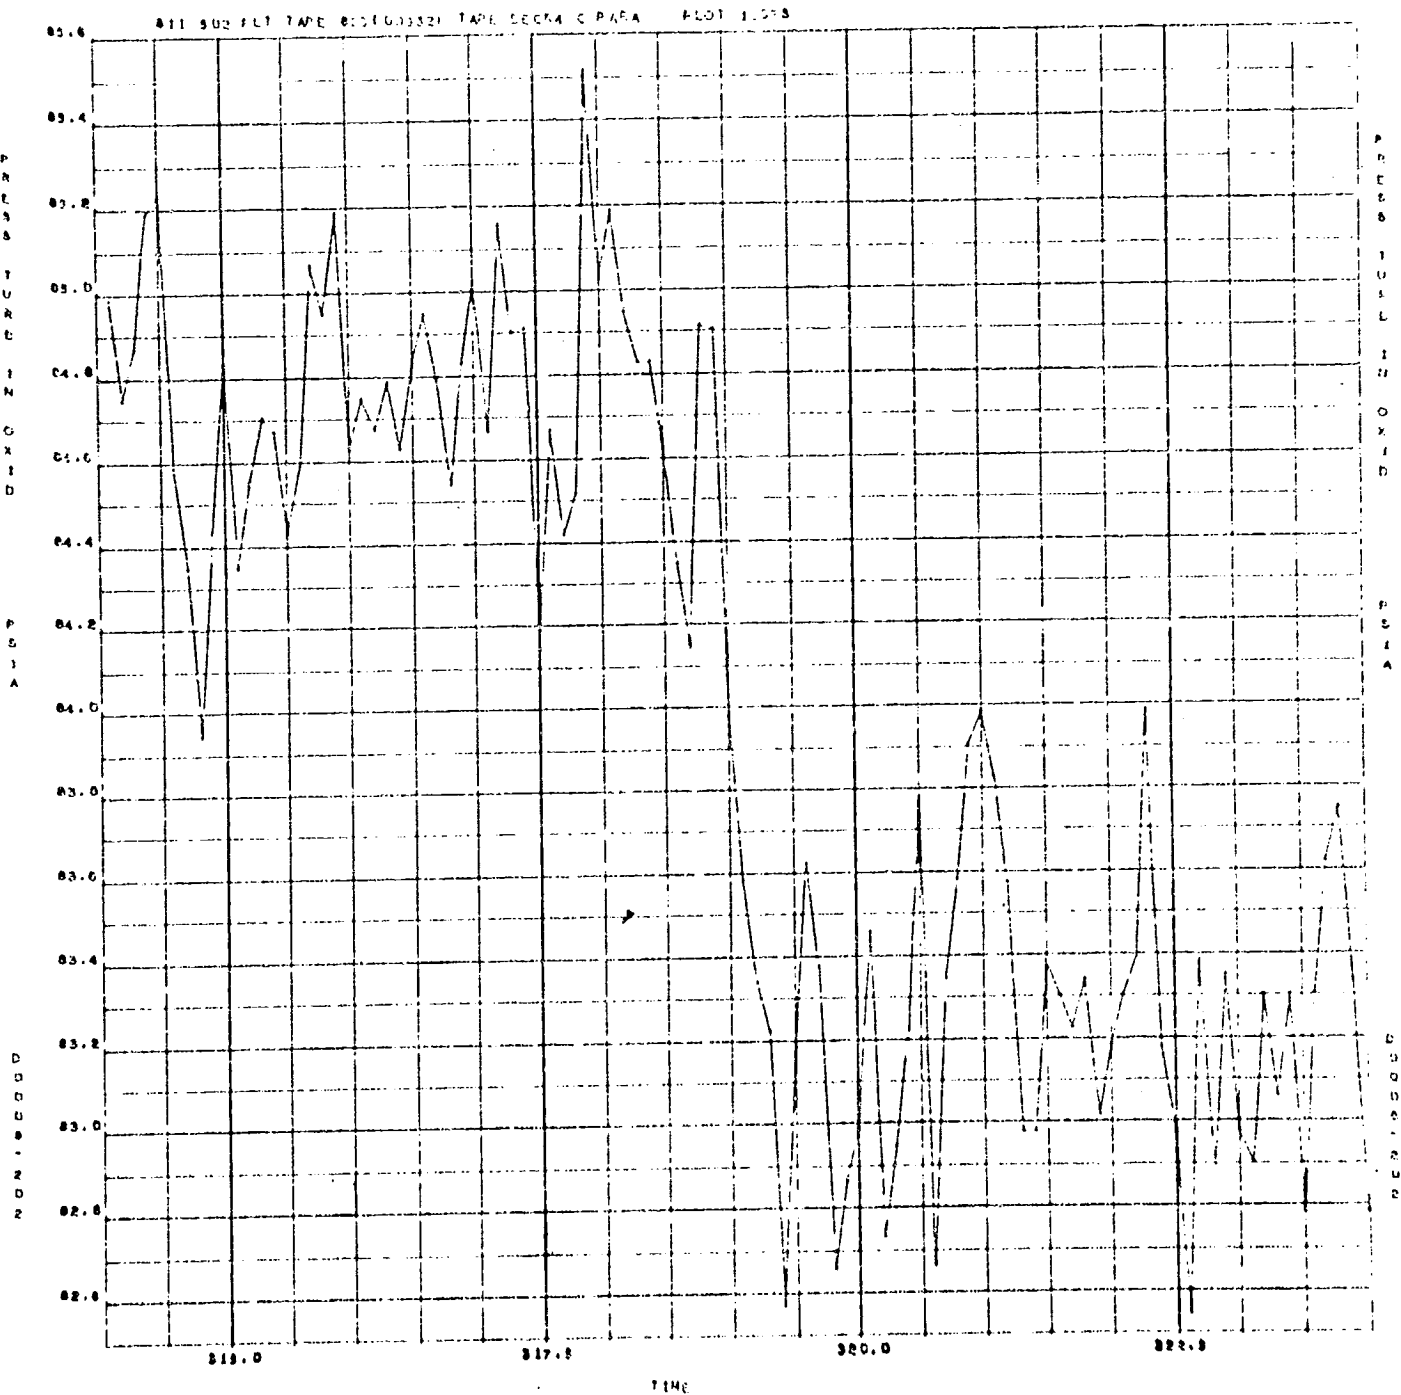
Description of Event. At 319 seconds range time, engine 202 experienced a rapid performance shift. Changes in significant parameters are recorded in Table 5 and shown in Fig. 31 through 47. At the same time as the performance shift, engine environment chilldown rates became greater, indicating cryogenic leakage of increased severity; further, hydraulic ΔP transducers on both of the engine gimbal actuators indicated a compressive loading of approximately 600 psi each.

Figure 31. Turbine Inlet Oxidizer Pressure

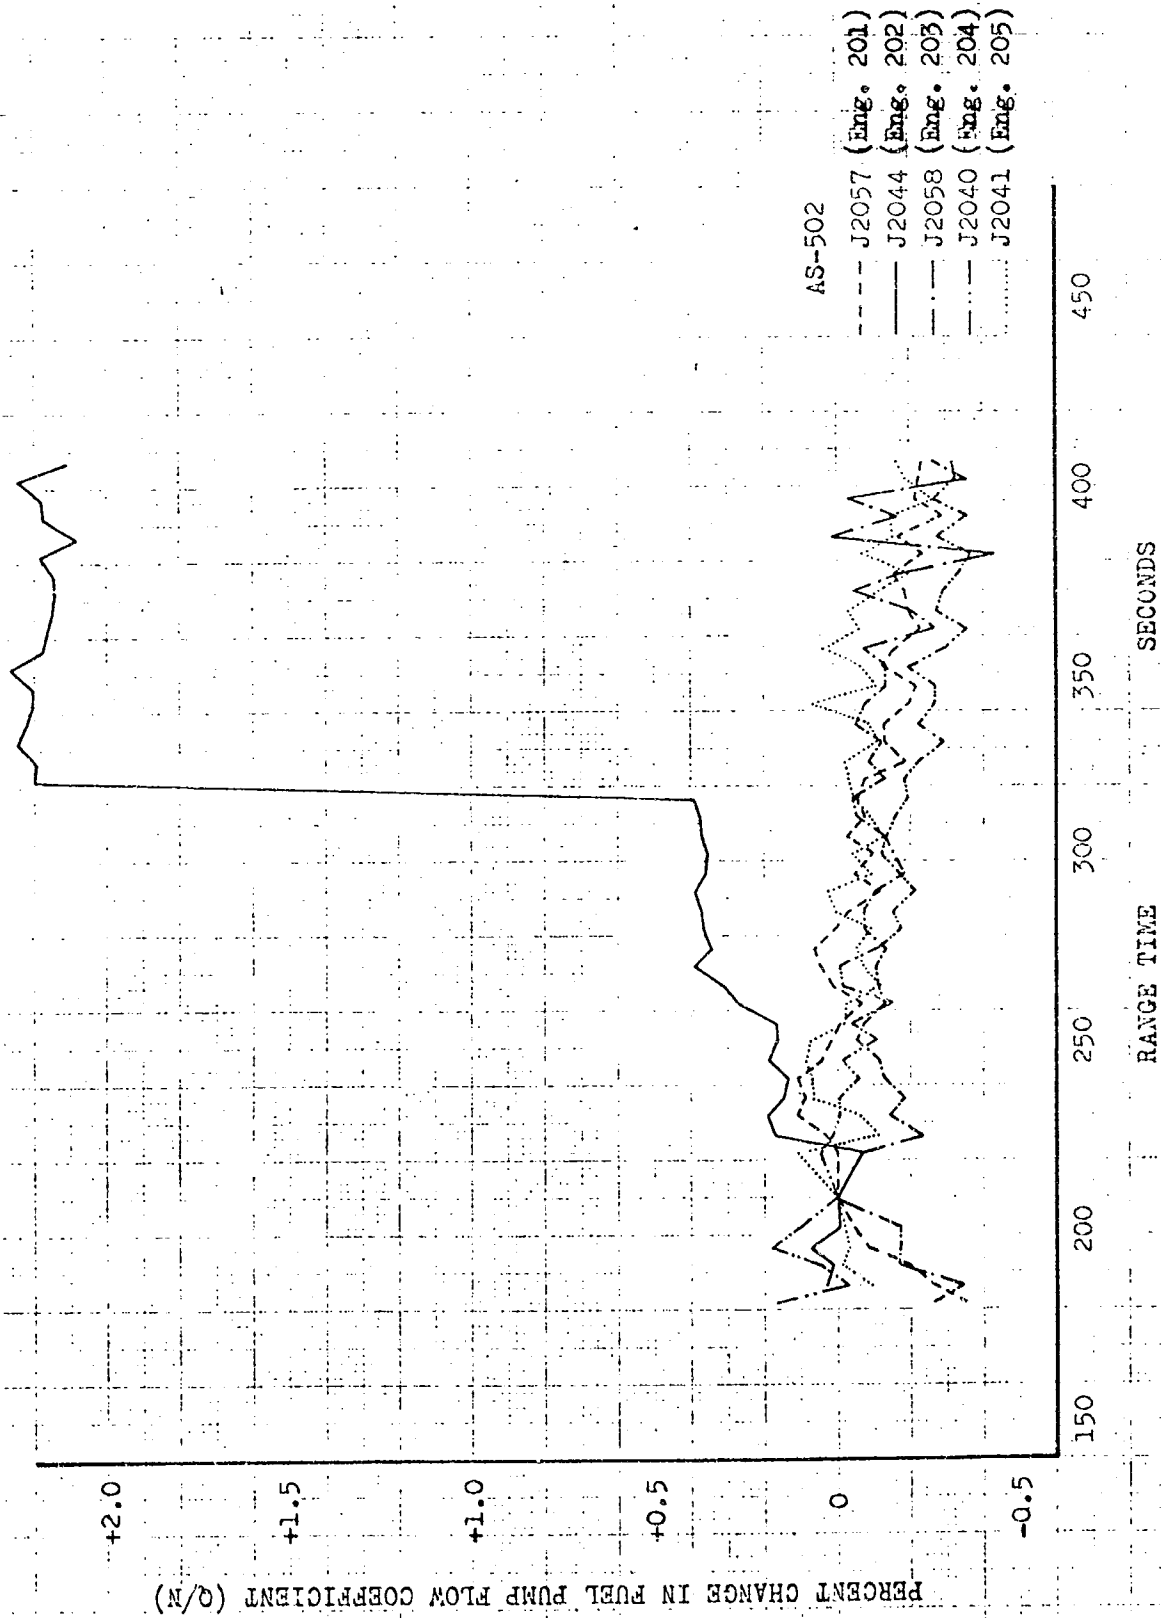
Figure 48. Fuel Flow Coefficient Plot

Comparative analysis of Q/N plots for all five S-II engines during the flight (Fig. 48) indicates that, at 220 seconds range time, a loss in resistance began to appear on the fuel side of engine 202 (J2044). As flight time progressed, the Q/N plot departed further from the Q/N plots of the other four engines until the abrupt engine performance shift of 519 seconds. At that time, an extreme Q/N shift occurred. The Q/N shifts were then related to fuel leakage flow as shown in Fig. 49. From this figure it may be seen that ASI fuel leakage, which began after 220 seconds range time, increased to approximately 2 lb/sec at 290 seconds range time. These data are consistent with compartment chilling data from a time standpoint. S-II stage compartment and engine temperature data do not indicate any source of "heating" until engine 202 cutoff; therefore, it is assumed that no reverse flow of warm ASI gases into the engine compartment took place, such as is indicated for the S-IVB stage.

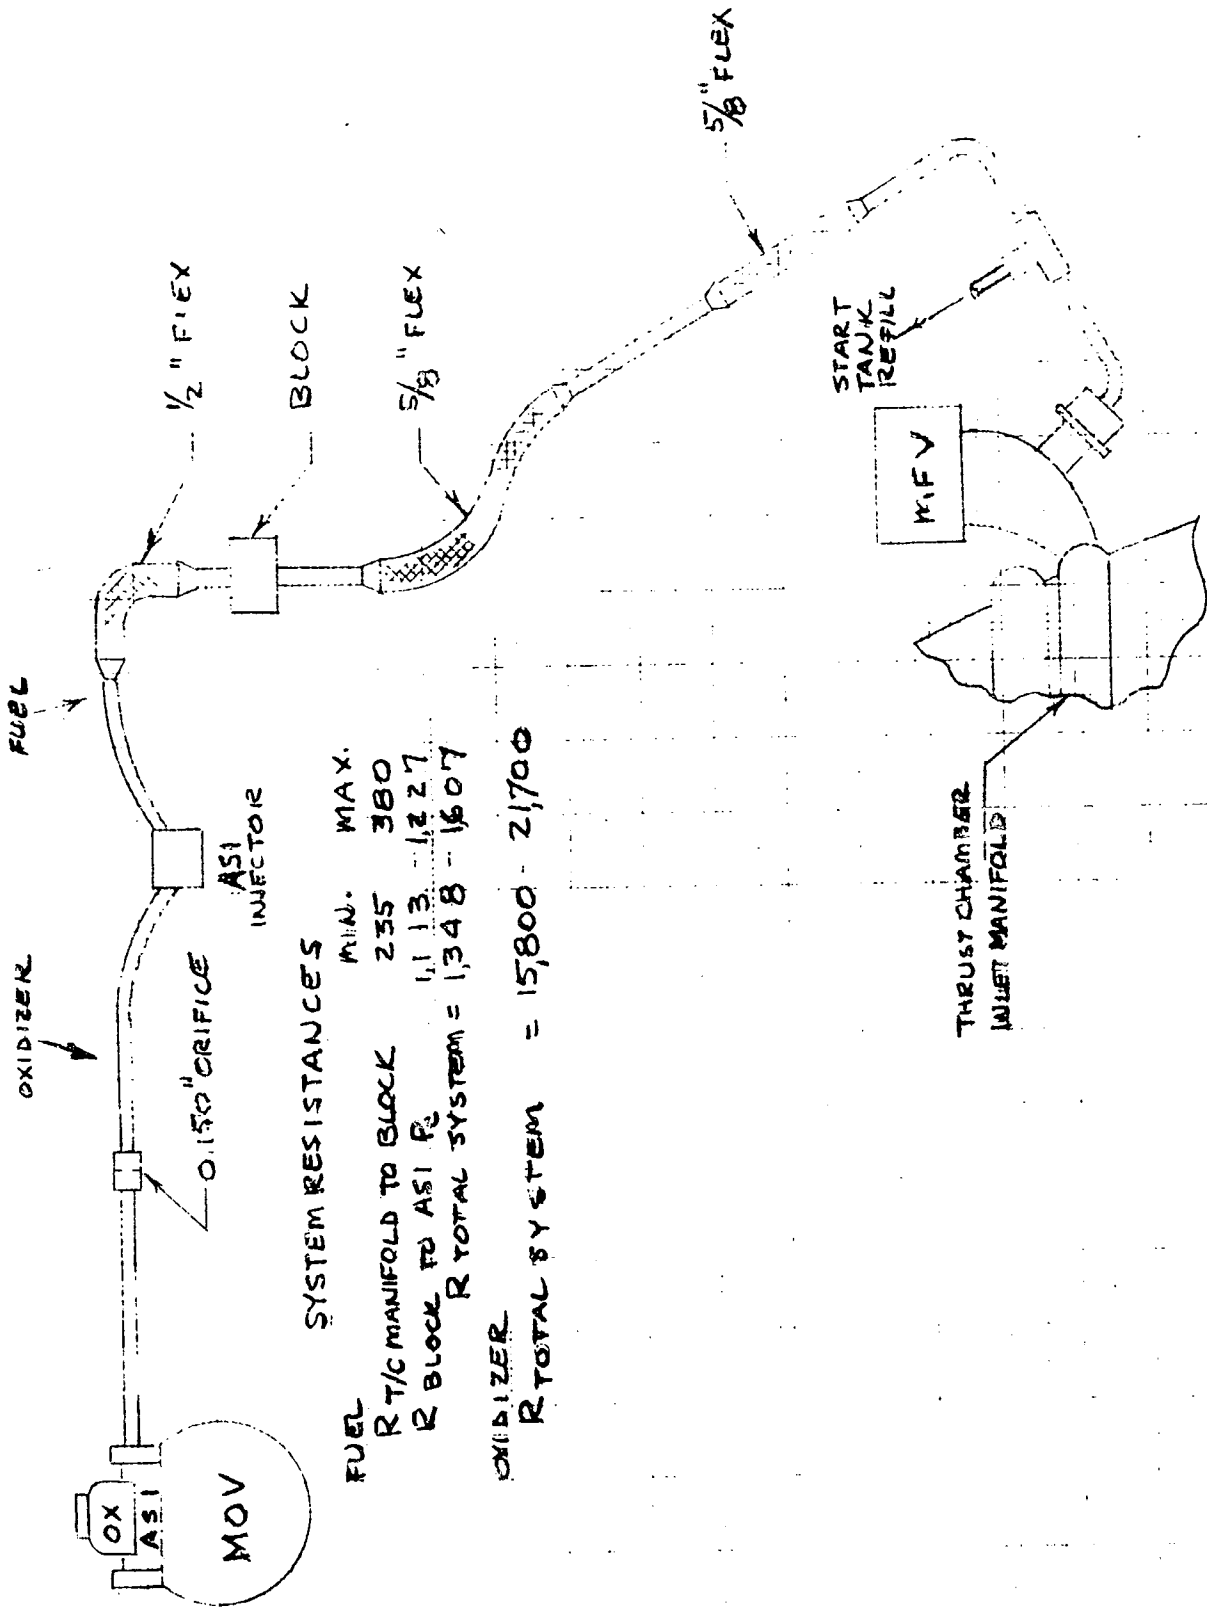
Figure 50. AS-502 S-II ASI System Schematic Diagram

The ASI system is schematically represented in Fig. 50. The range of oxidizer-side resistance and fuel-side resistance from the block to ASI chamber pressure was determined from engine J2044 ASI acceptance data. The range of resistance from the block upstream to the thrust chamber inlet manifold was that which could be expected from hardware variation. Using these data, a 2-lb/sec leak would have to be located between the middle flex section and the downstream 0.5-inch-diameter flex section to permit the 0.13-lb/sec fuel flow to continue to the ASI injector. The most probable location is in the downstream 0.5-inch-diameter flex section. With a 2-pound leak rate at 290 seconds range time, and a leak location within the downstream flex section as the basic assumption, the ASI operation (weight flows and mixture ratio) was reconstructed from 220 seconds range time (normal operation) through to 326 seconds, i.e., after the abrupt performance shift (Fig. 51 and 52). No significant change in ASI operation is visualized from that time on to engine cutoff.

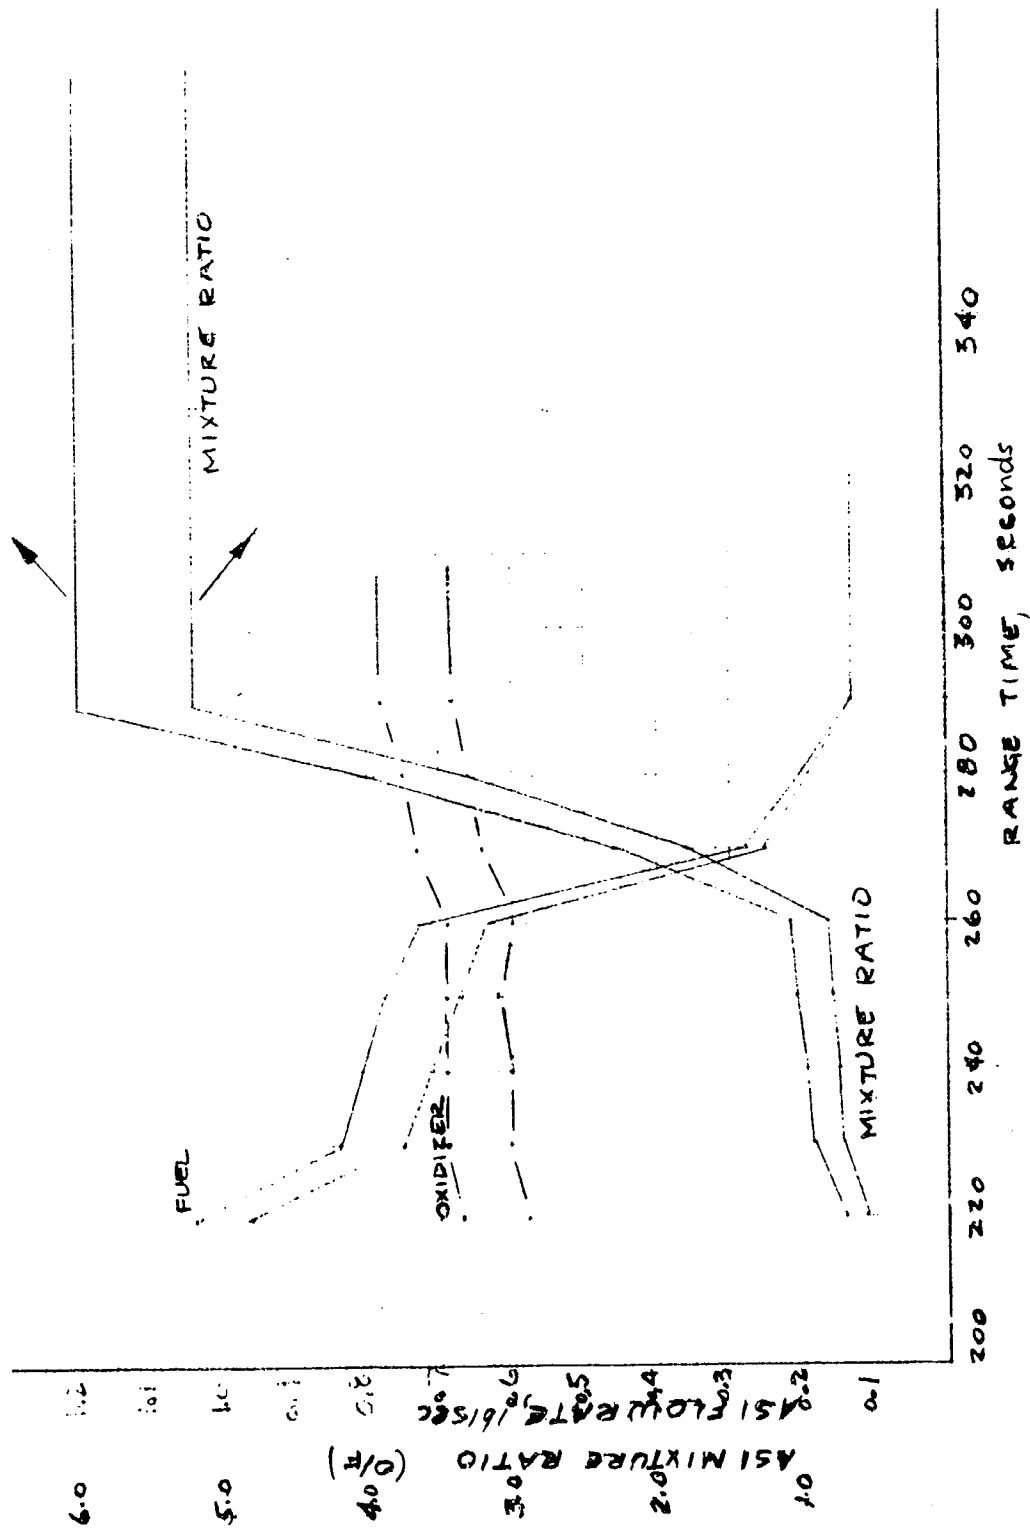
Figure 52. AS-502 S-II ASI Propellant Flowrates and Mixture Ratio vs Range Time (Engine J2044)

When the ASI reaches high mixture ratio conditions, it should be noted that the system ΔP downstream of the leak location is low (approximately 4 psi). A minor upward fluctuation in ASI chamber pressure would therefore have a large effect upon the fuel flow into the ASI. Fuel flow variations, in turn, would have a magnified effect on ASI chamber pressure. The ASI operation after 270 seconds range time is thus characterized by highly oscillatory pressure and flow functions. Burning of parent metal (main injector and ASI) is intermittent, as the ASI mixture ratio tends to swing from infinity (fuel flow stoppage) to 2:1 (as ASI chamber pressure approaches main chamber pressure).

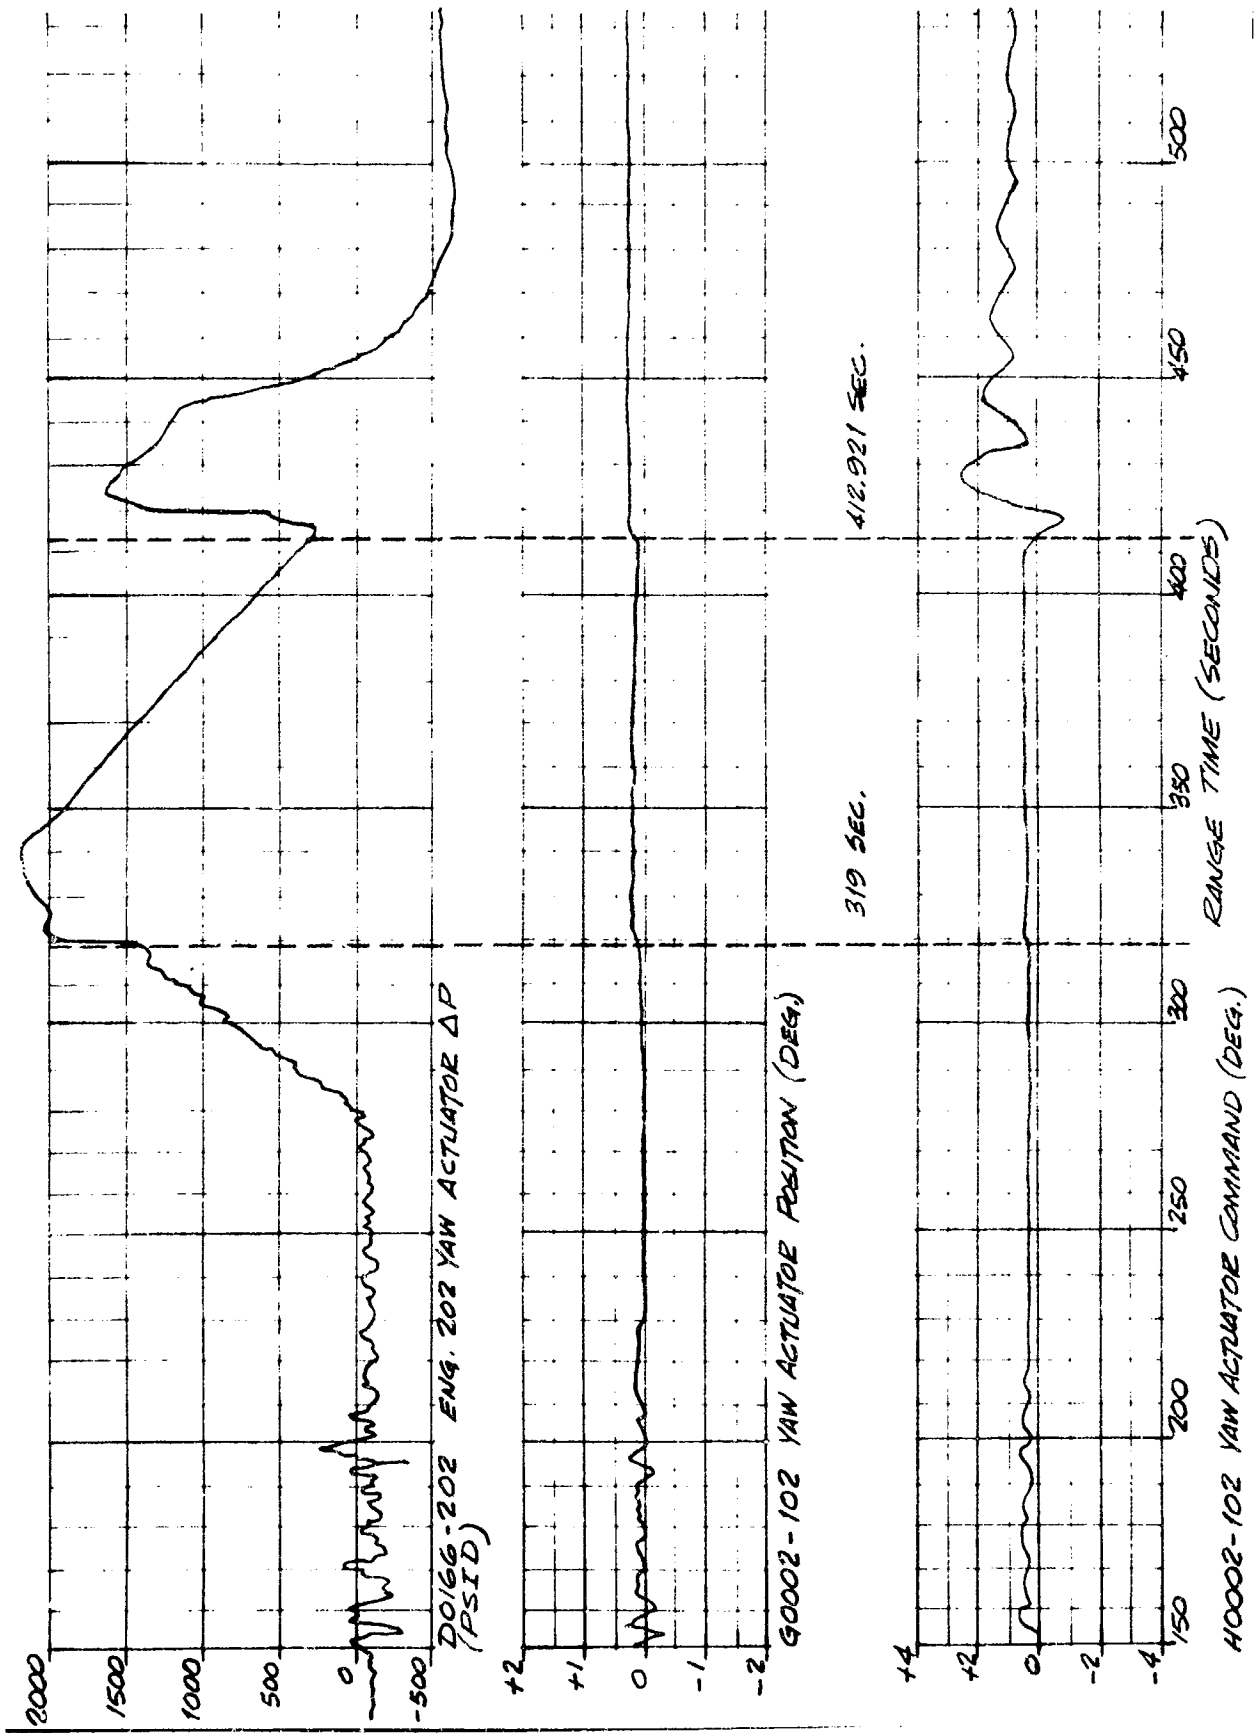
Figure 55. Engine 202 Yaw Hydraulic Actuator Data

Description of Event. At approximately 282 seconds range time, the engine 202 engine actuation system (EAS) yaw actuator ΔP measurement indicated a ΔP rise rate of 35 psid/sec; this indication continued for approximately 37 seconds. At 319 seconds range time, an additional step of +600 psid was indicated; this step also was reflected in the pitch actuator ΔP measurement. Yaw actuator ΔP indicated a further rise to +2200 psid following the 319-second shift. At 340 seconds range time, the yaw actuator ΔP measurement indicated a decay rate of 25 psid/sec which persisted until engine 202 cutoff at 412.9 seconds; the indicated ΔP at cutoff was +250 psid. Following engine 202 cutoff, yaw actuator ΔP exhibited a step rise to +1700 psid at 442 seconds range time and then a decay to -500 psid at 530 seconds range time (Fig. 53); the pitch actuator ΔP indication also was -500 psid at 530 seconds range time.

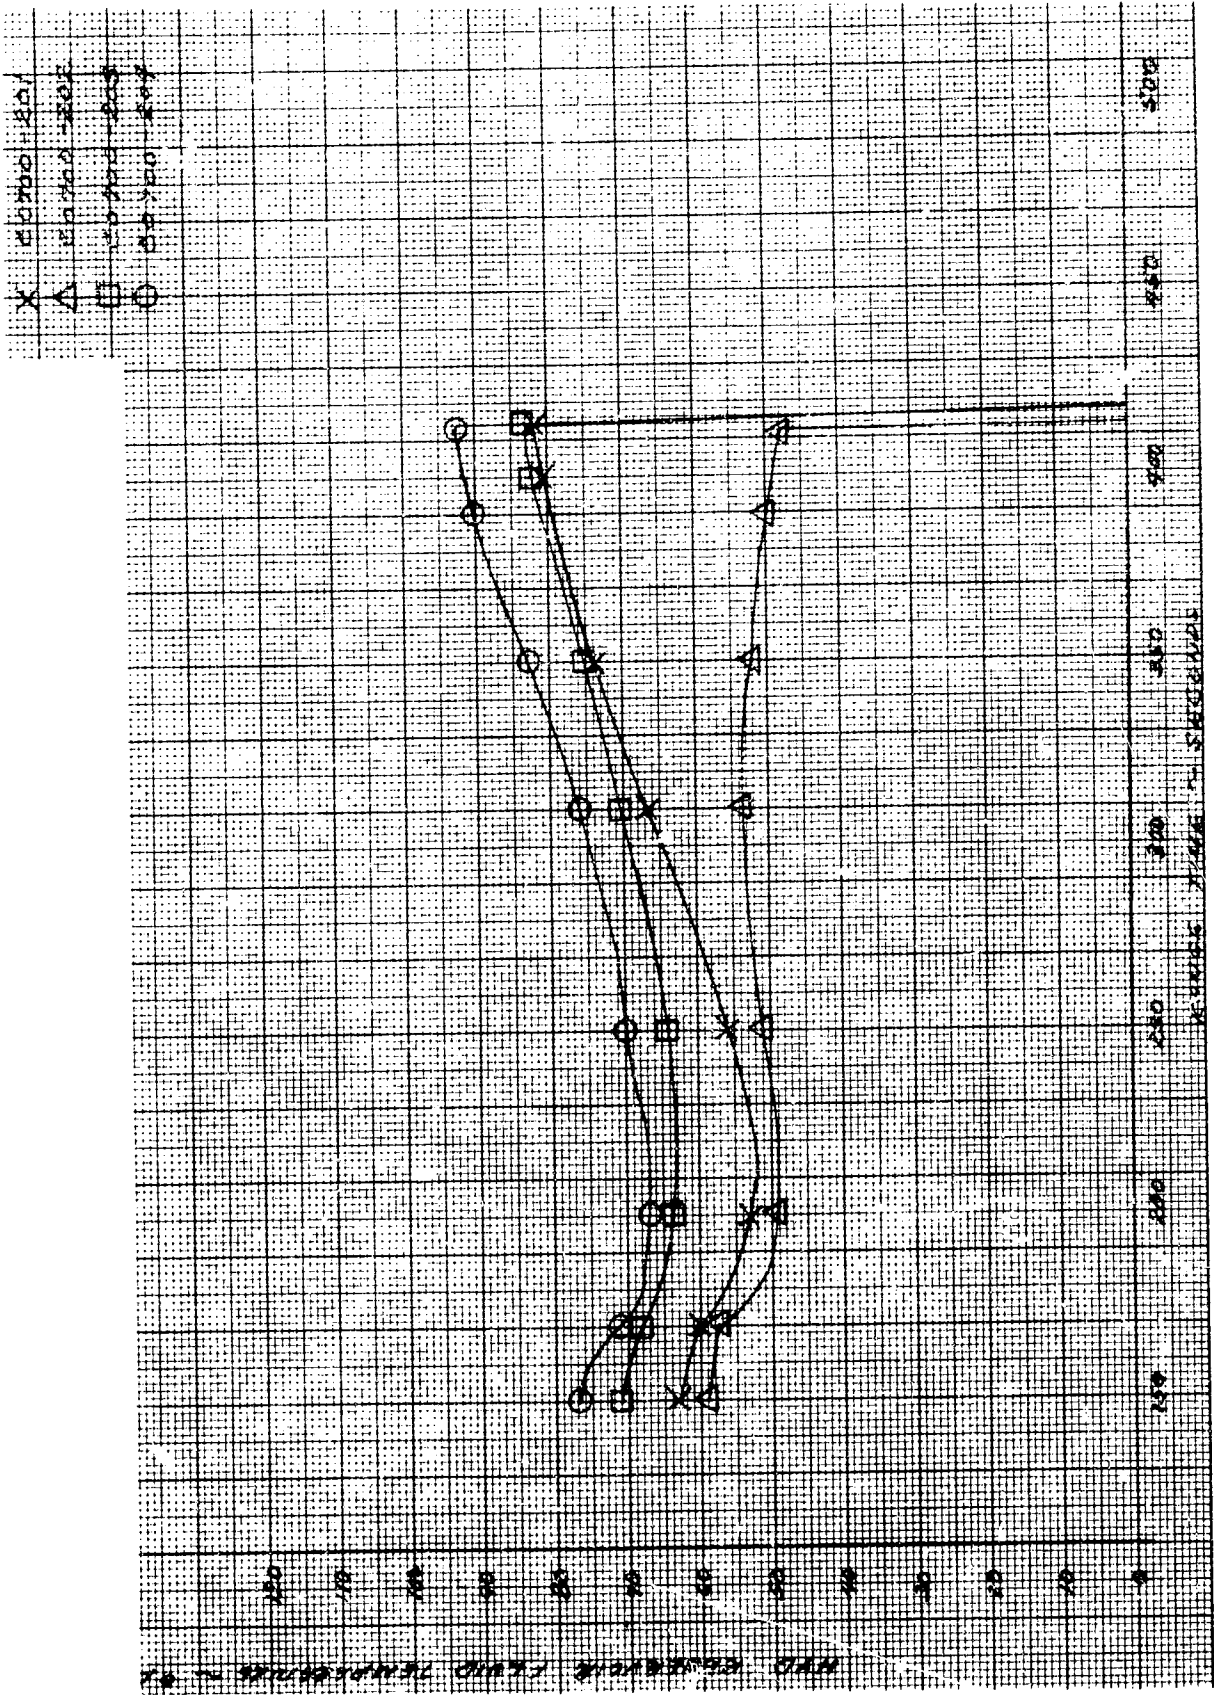
Figure 54. Hydraulic Reservoir Fluid Temperature vs Time

At approximately 250 seconds range time, engine 202 EAS hydraulic fluid reservoir temperature started to decrease (Fig. 54); comparison of this measurement to EAS fluid reservoir temperatures for engines 201, 203, and 204 indicates a decay of 16 F by 319 seconds range time. A stage equipment container located just forward of the engine 202 hydraulic fluid reservoir indicated a cooling trend at 319 seconds range time; this container was insulated and equipped with an internally mounted temperature transducer.

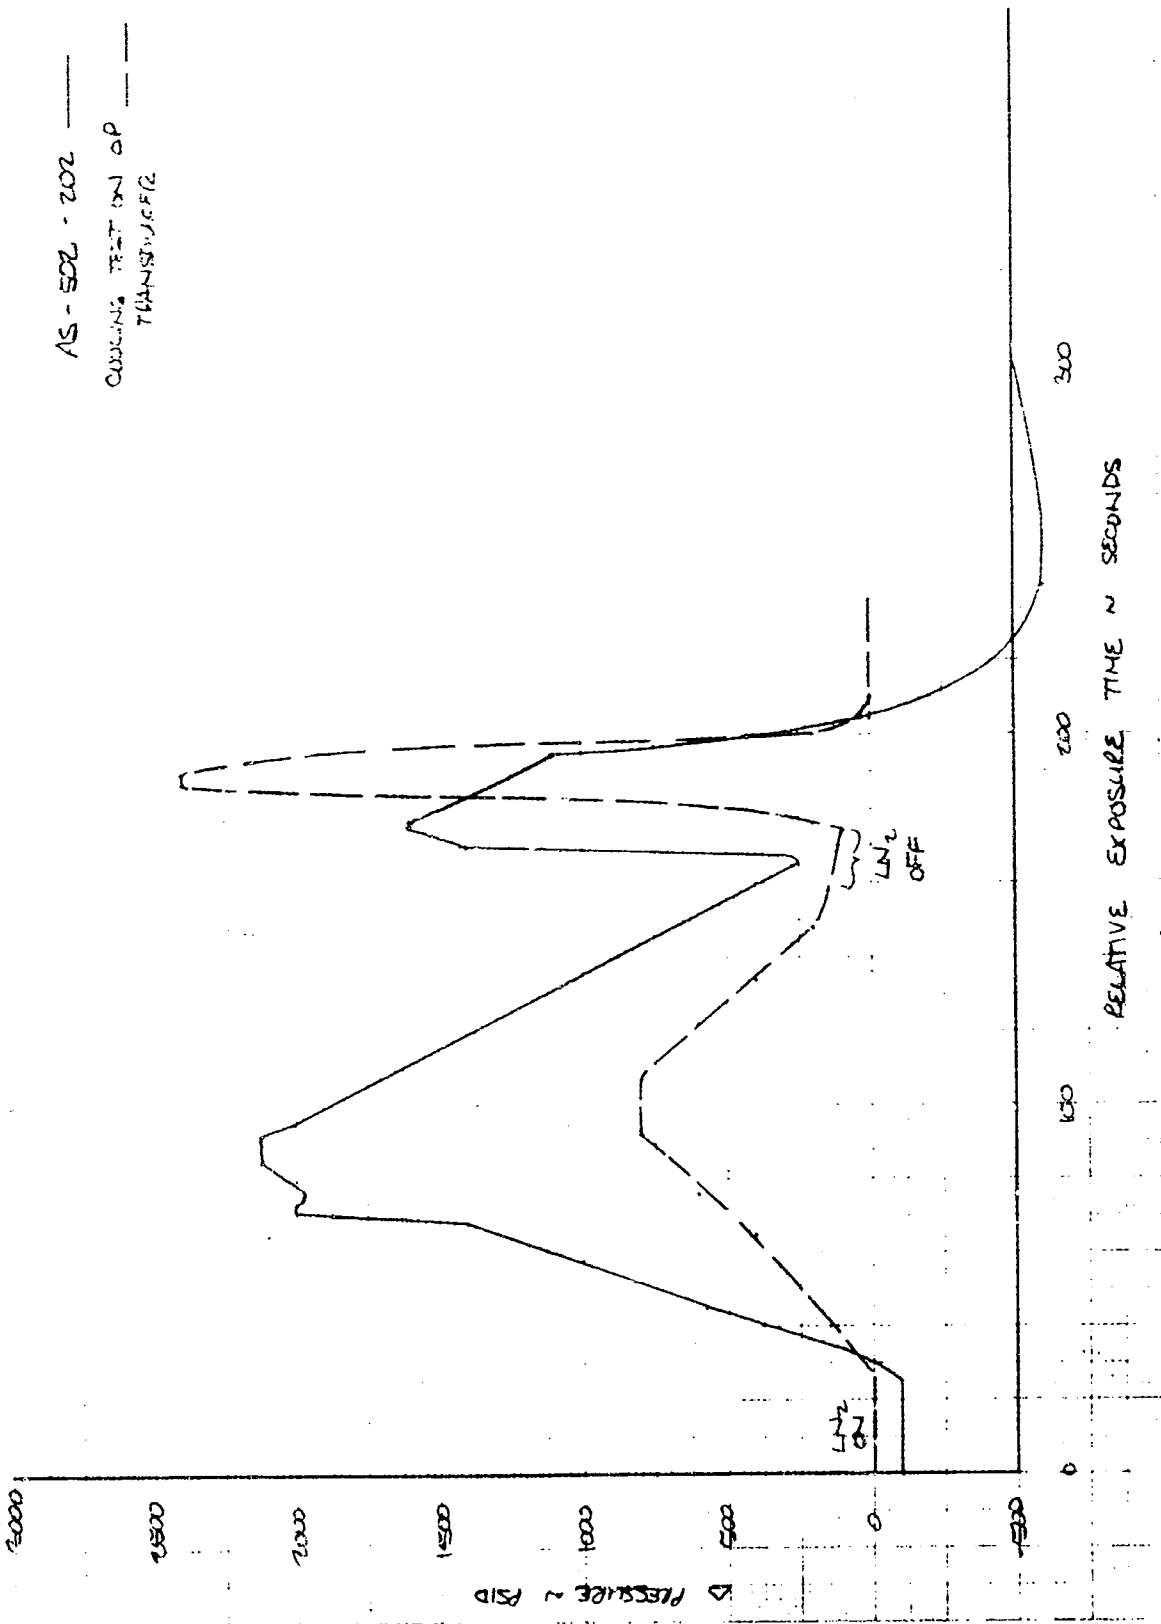
Figure 55. Yaw Actuator Differential Pressure

Chilldown testing of the hydraulic actuator performed at Space Division of North American Rockwell Corporation, Seal Beach, California, indicates that the actuator ΔP transducer is adversely affected by low temperature. The transducer is of the double bourdon tube type, and is located on the outboard side of the actuator (as installed on the engine): a resistance potentiometer modulates a signal in direct proportion to the differential pressure across the actuator low- and high-pressure sides. The testing consisted of monitoring the output of the ΔP transducer while chilling the transducer with a liquid nitrogen spray. As the transducer was chilled, the ΔP output signal ramped upward at the rate of 20 psid/sec to a peak value of 800 psid. As the chilling continued, the ΔP ramped downward to 0 psid at about the same rate as the upward ramp. Chilldown with the LN_2 spray was discontinued and, shortly afterward, the ΔP output rose rapidly to 2370 psid and then decayed to zero (Fig. 55). The test data are in good agreement in the pattern indicated by flight data, i.e., a ΔP rise with initial chilling, ΔP decay with continued chilling, and ΔP surge upon termination of chilling (removal of leakage sources).

Description of Event. At 319 seconds range time, engine 202 yaw and pitch actuator ΔP measurements indicated a shift of -600 psid. The step in pitch actuator ΔP persisted until cutoff of engine 202, at which time the indication changed from -600 to -400 psid. The yaw actuator ΔP measurement, while indicating the -600 psid shift at 319 seconds, failed to respond properly because of cryogenic chilling (Fig. 55 and 56).
