R-7450-2

J-2 ENGINE AS-502 (APOLLO 6)

FLIGHT REPORT

VOLUME 2: S-II STAGE FAILURE ANALYSIS

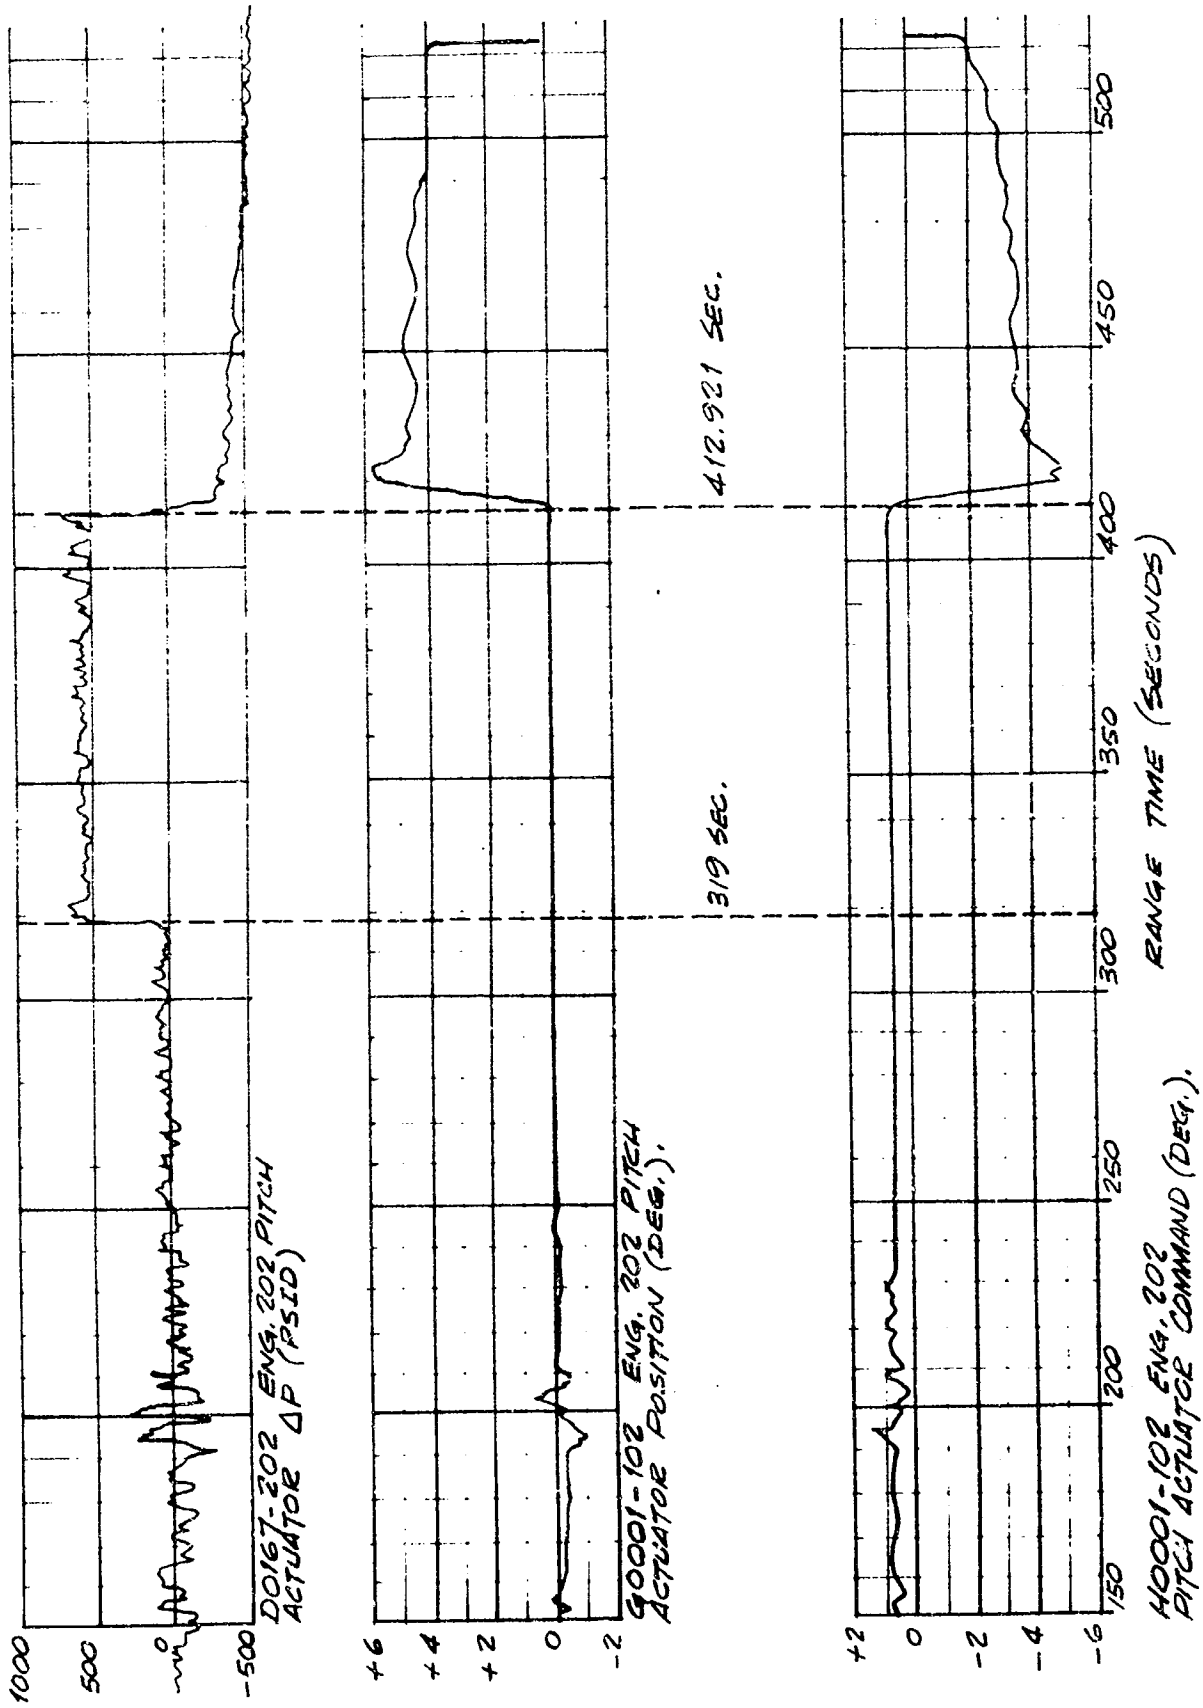
Figure 56. Engine 202 Pitch Hydraulic Actuator Data

Description of Event. At 319 seconds range time, engine 202 yaw and pitch actuator ΔP measurements indicated a shift of -600 psid. The step in pitch actuator ΔP persisted until cutoff of engine 202, at which time the indication changed from -600 to -400 psid. The yaw actuator ΔP measurement, while indicating the -600 psid shift at 319 seconds, failed to respond properly because of cryogenic chilling (Fig. 55 and 56).

8. Analysis of actuator tapes revealed that the engine 202 pitch actuator was in a 0.13-degree retract position at 319 seconds when the loss in engine thrust occurred. The pitch actuator then moved to a 0.20-degree retract position (0.07-degree retract motion) at 319.1 seconds; no command signal was given to cause this motion. The pitch actuator started a corrective extend motion when, at 319.9 seconds, an extend command was ordered by the vehicle instrumentation system. The system actuator stabilized at 322 seconds in the 0.08-degree retract position (extended 0.05 degree from the pre-performance shift position) with a locked-in

indicated ΔP of 600 psi. Because no command signal was given at 319.1 seconds, the actuator compression must have been caused by an external load on engine 202.

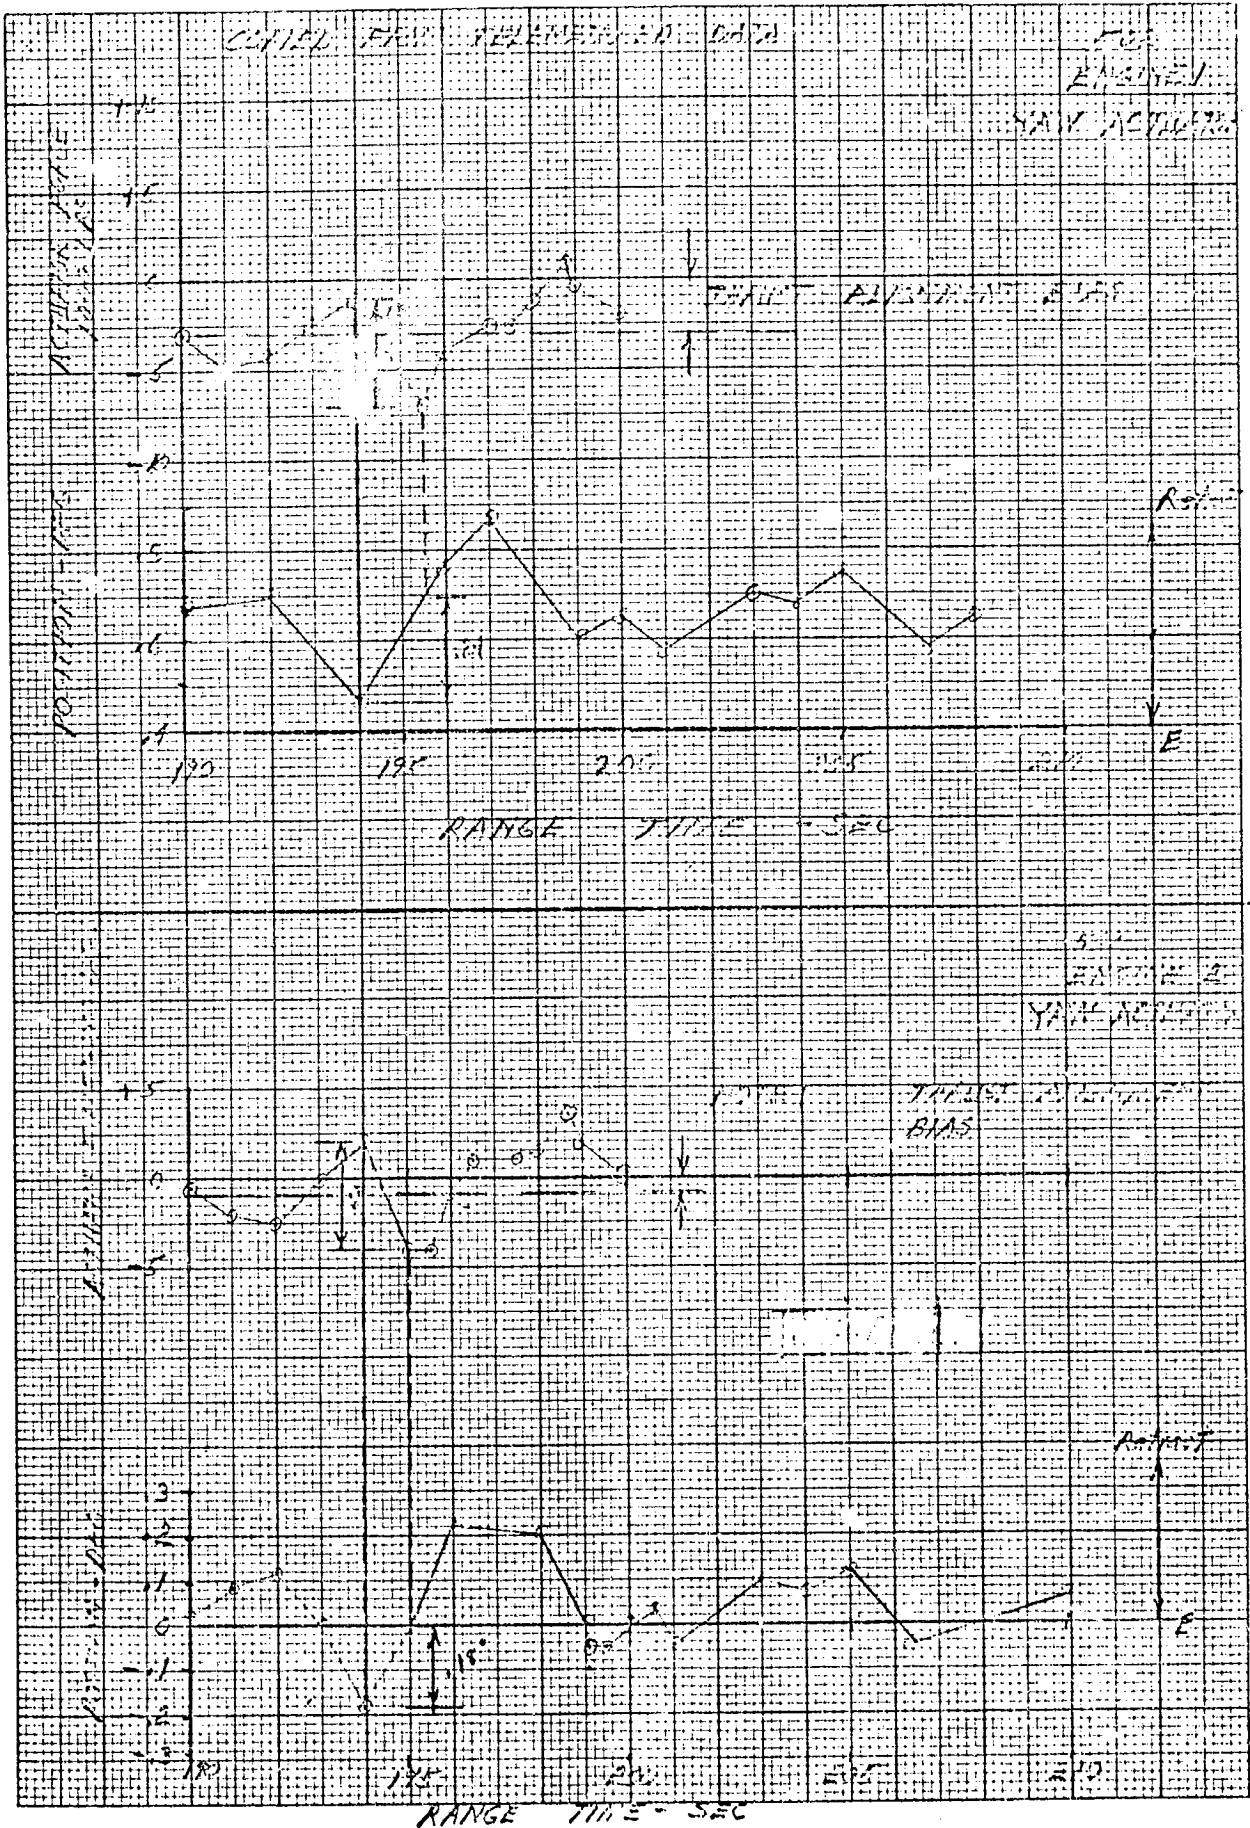
Figure 57. Engines No. 1 and 2 Yaw Actuator Comparison

Actuator force and position data were then compared for the yaw actuators of engines No. 1 and 2, as shown in Fig. 57. (Note the thrust alignment bias of -3000 pounds on engine No. 1.) Calculations on engine No. 1 thrust alignment and inlet loads indicate the yaw actuator should have had a load of 2800 pounds compression for static equilibrium. Data indicate good agreement with calculations. The No. 2 engine yaw actuator indicates a force bias of -1000 pounds and calculations indicate it should have had a -3400-pound bias. This indicates the effective thrust misalignment of No. 2 engine was much less than expected. This is probably the result of changing the gimbal bearing on this engine in the field.

The plots in Fig. 57 also show that a change in force occurs with approximately a 0.2-degree gimbal motion. This indicates the point at which gimbal friction is overcome. (Note for the point shown there is reasonable agreement on the magnitude of the friction force for engines No. 1 and 2.)

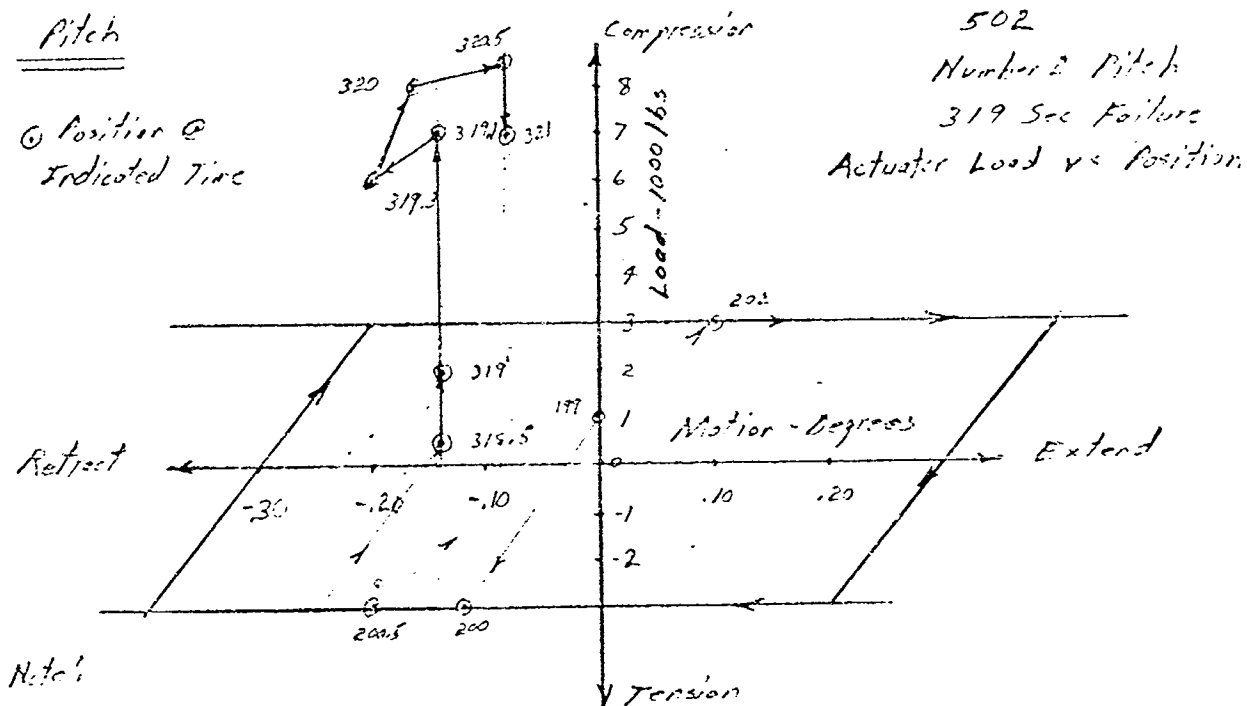
Figure 59. No. 2 Engine Gimbal Friction (Pitch)

Cross plots of the AS-502 engine No. 2 pitch and yaw actuator force and position data were then prepared to determine the magnitude of the friction moment, as shown in Fig. 58 through 60.

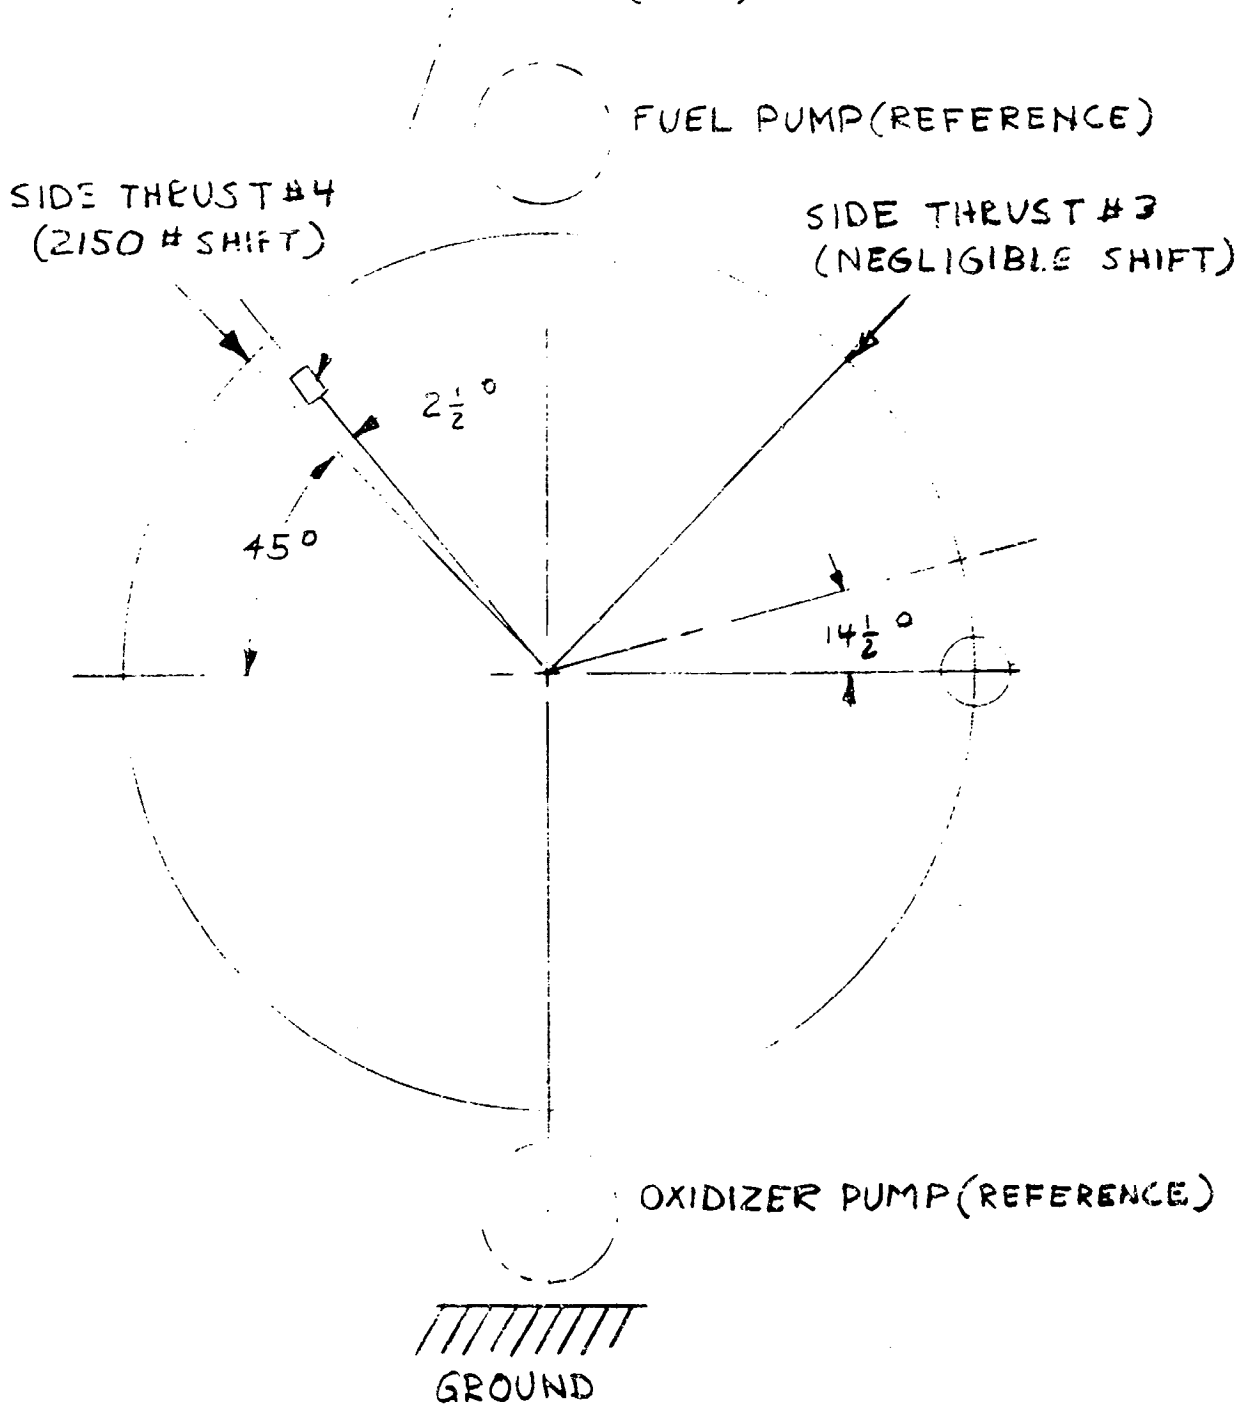
VIEW LOOKING AFT

Further corroboration resulted from flight support testing conducted at the MSFC high-pressure thrust chamber component stand. During the second of two tests conducted with high ASI mixture ratios, and resultant erosion of the ASI and main injector, two adjacent thrust chamber up tubes sustained gate-type splits. The tube damage was located approximately 5 inches from the nozzle exit, at the interior (hot gas) side of the nozzle, and was apparently caused by ejected injector debris. Fuel flow from the tube splits, estimated at 7 to 8 lb sec, produced a 145,000 in.-lb moment load at the gimbal bearing. Analysis of the MSFC thrust chamber component testing included calculations of leakage resulting from the thrust chamber damage and calculations of resultant side loads. These calculations are presented below and on the following pages.

SPLIT TUBES { #362, 5 3/4" U/S OF EXIT 1 1/2" LG
 { #363, 5" U/S OF EXIT 1" LG

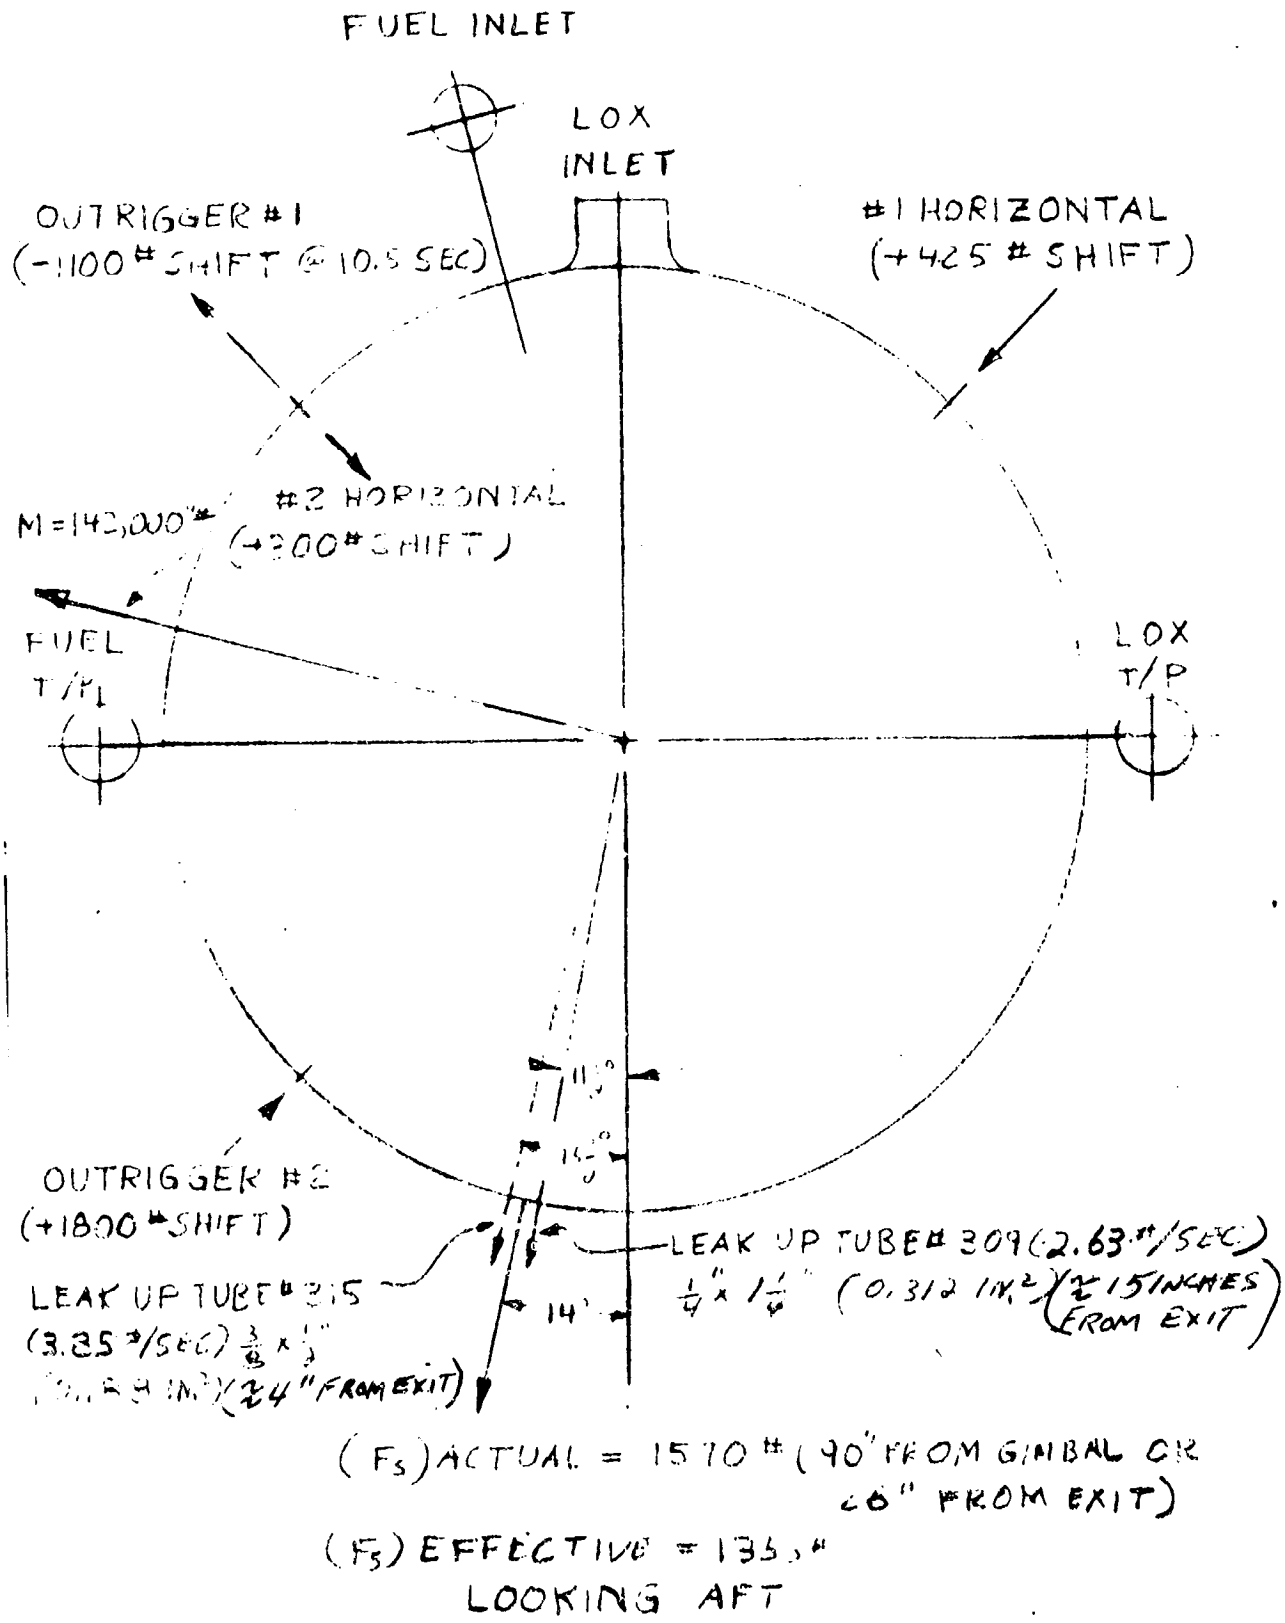
Figure 61. Engine J024-3 Test No. 623005 Load Analysis

1. R&D engine J024-3 incurred thrust chamber damage during an injector combustion stability test (623-005) when a bomb fragment was ejected from the combustion zone and struck the interior of the thrust chamber wall near the exit. Two tube splits resulted (one 1/4 by 1-1/4 inch, located approximately 15 inches from the exit, and one 3/8 by 1/2 inch, located approximately 4 inches from the exit).
2. The following calculations of loads resulting from test 623-005 thrust chamber damage indicates that the lateral force caused by the fuel leak is located approximately 26 inches forward of the chamber exit, approximately 11 inches forward of the most forward damage point; it is believed that the center of pressure of the bow shock set up by the fuel leak is forward of the actual leak location (Fig. 61 and 62).

NOTE: CENTER OF FORCE IS UPSTREAM OF LEAKS, IF TRUE A BOW SHOCK AHEAD OF LEAK MAY ACCOUNT FOR THIS.

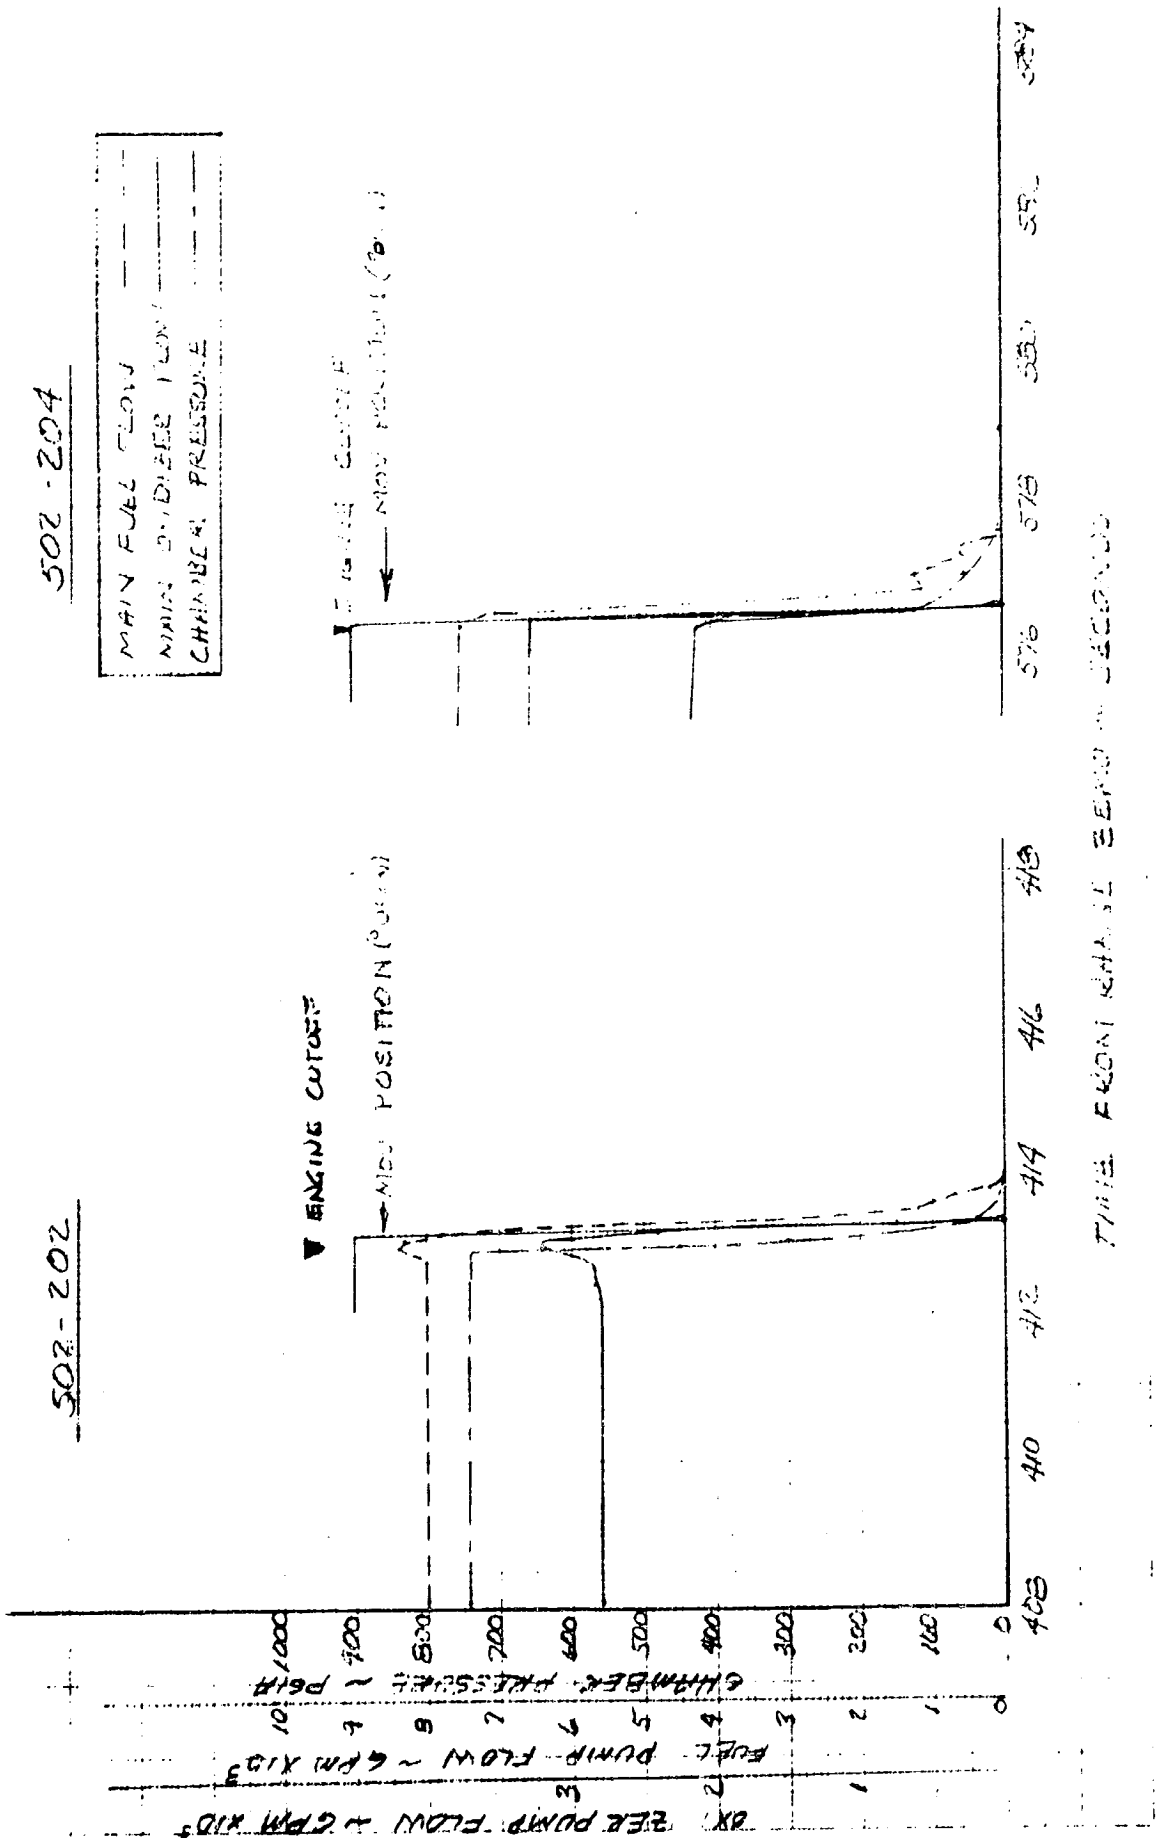
Figure 65. Pump Flows and Chamber Pressures vs Time

Main oxidizer injection pressure decayed very rapidly prior to main oxidizer valve closing; oxidizer pump discharge pressure decayed more slowly, and more closely approximated a normal shutdown (Fig. 64).

Rapid decay of main oxidizer injection pressure, as compared with oxidizer pump discharge pressure and increasing oxidizer flow, is indicative of oxidizer system failure downstream of the main oxidizer valve.

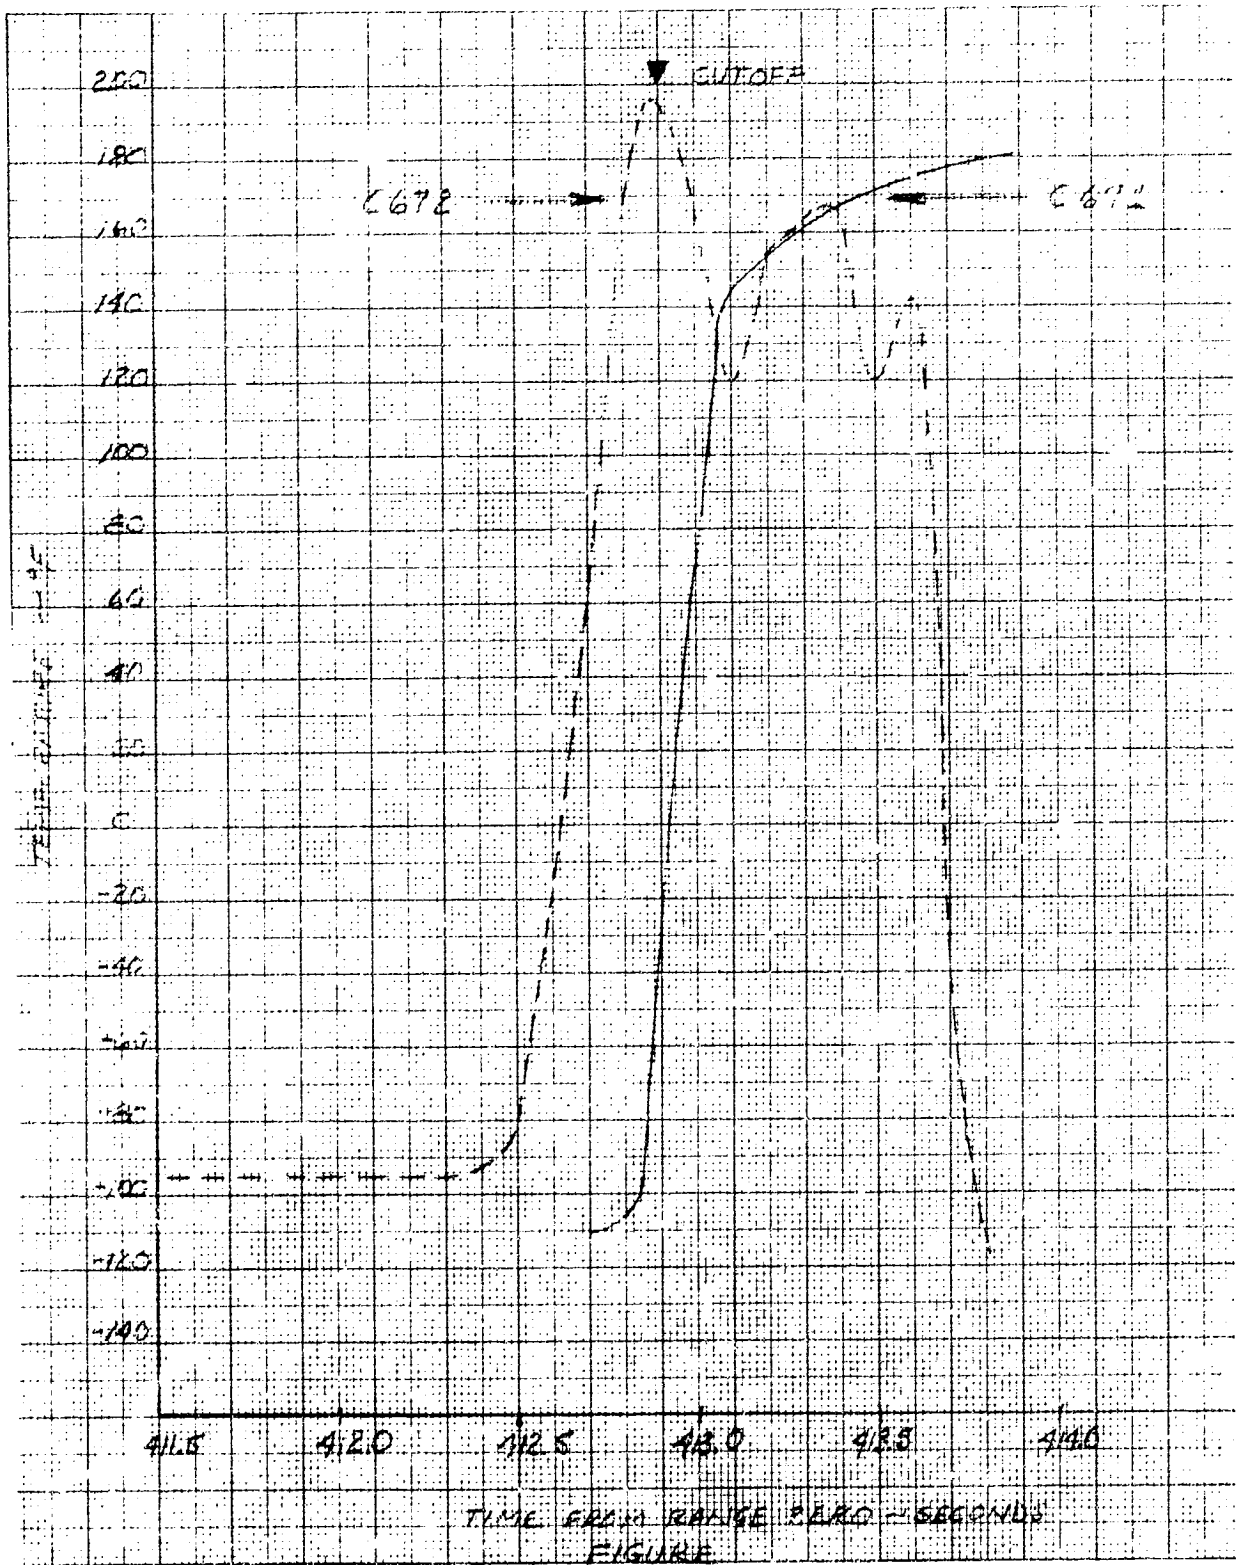
Figure 65. Engine Compartment Gas Temperatures

Engine Compartment Anomalies. Engine compartment gas curtain and heat shield forward temperatures increased starting at 412.3 seconds (Fig. 65 and 66).

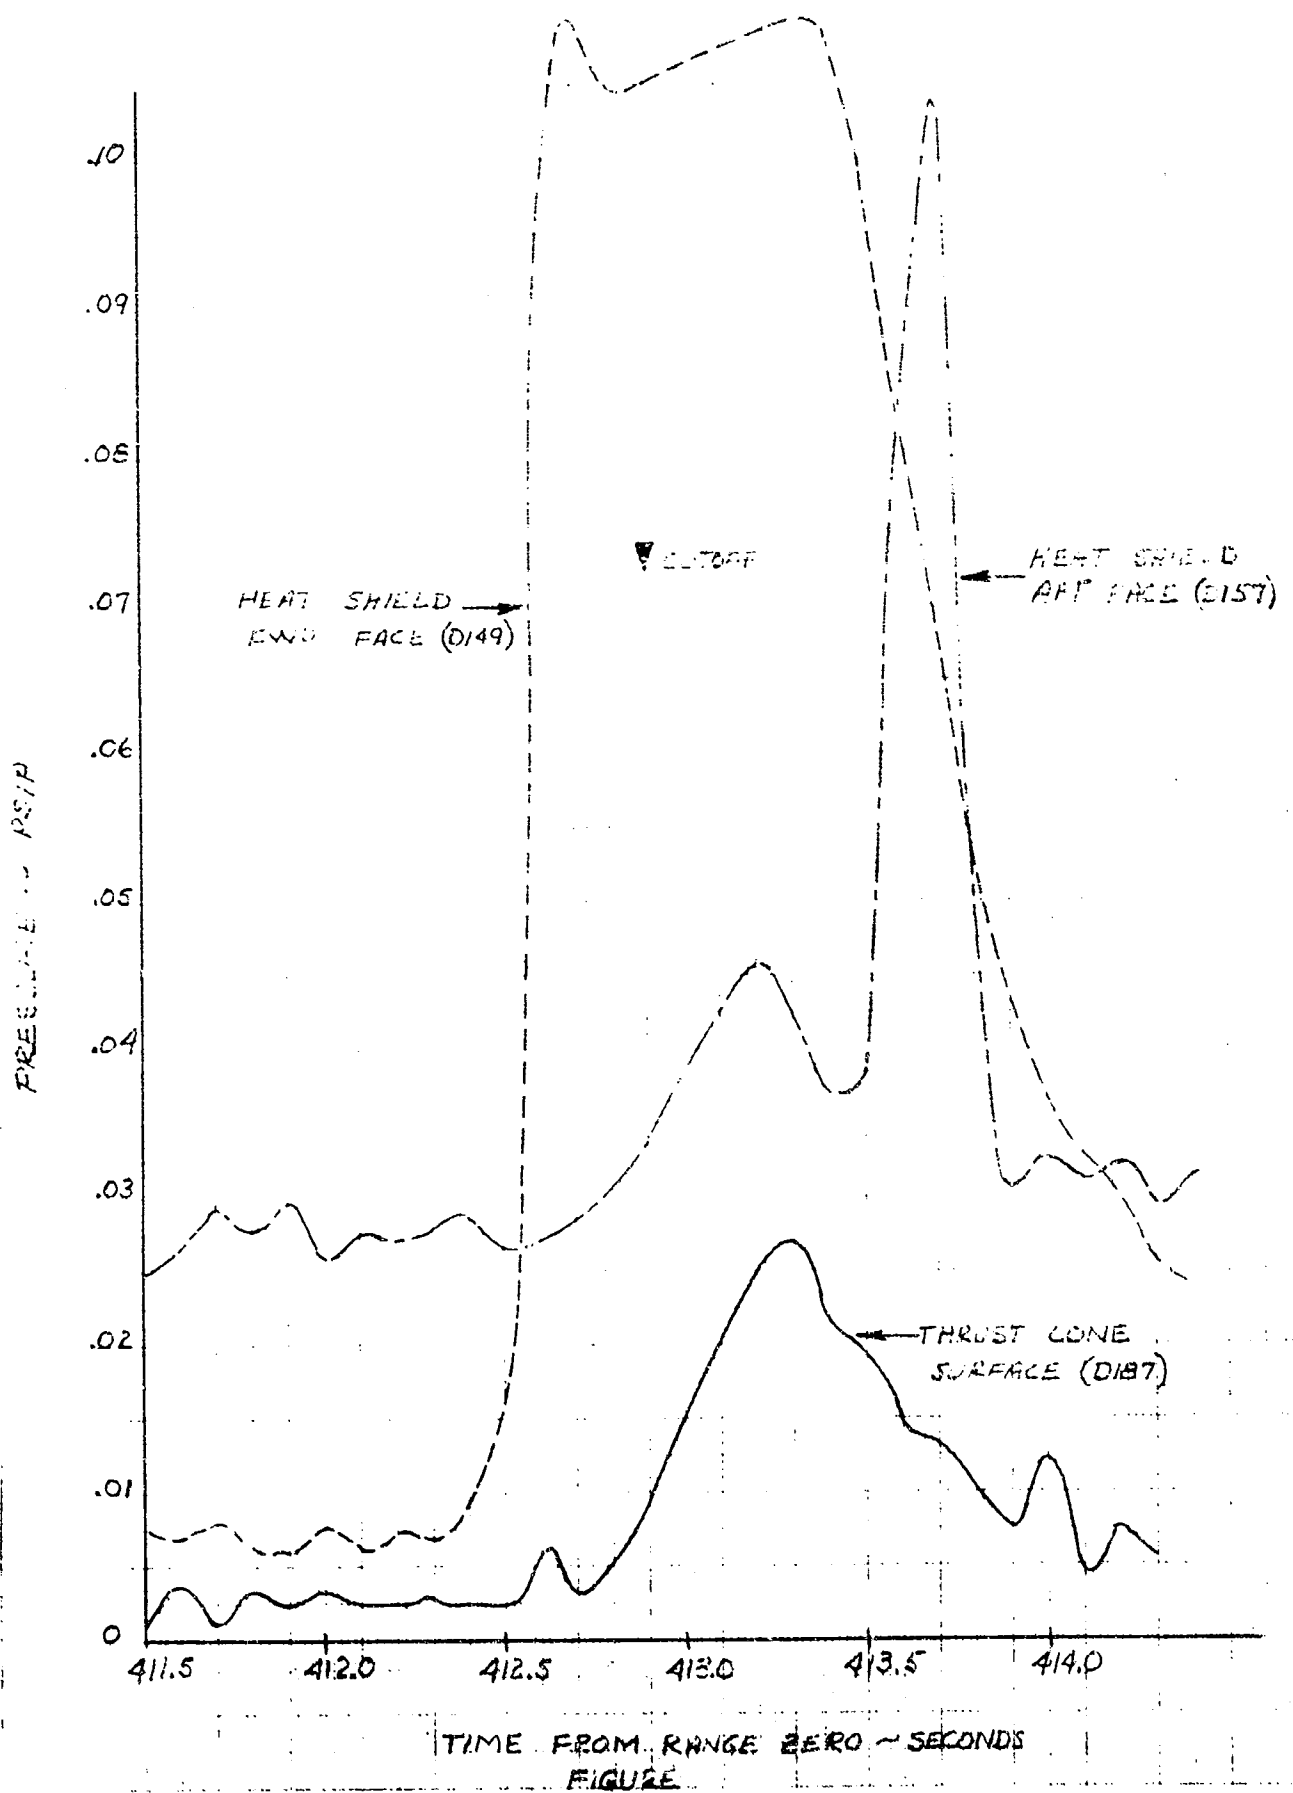
Figure 67. S-II Stage Compartment Pressures

Engine compartment pressures increased starting at 412.5 seconds (Fig. 67).

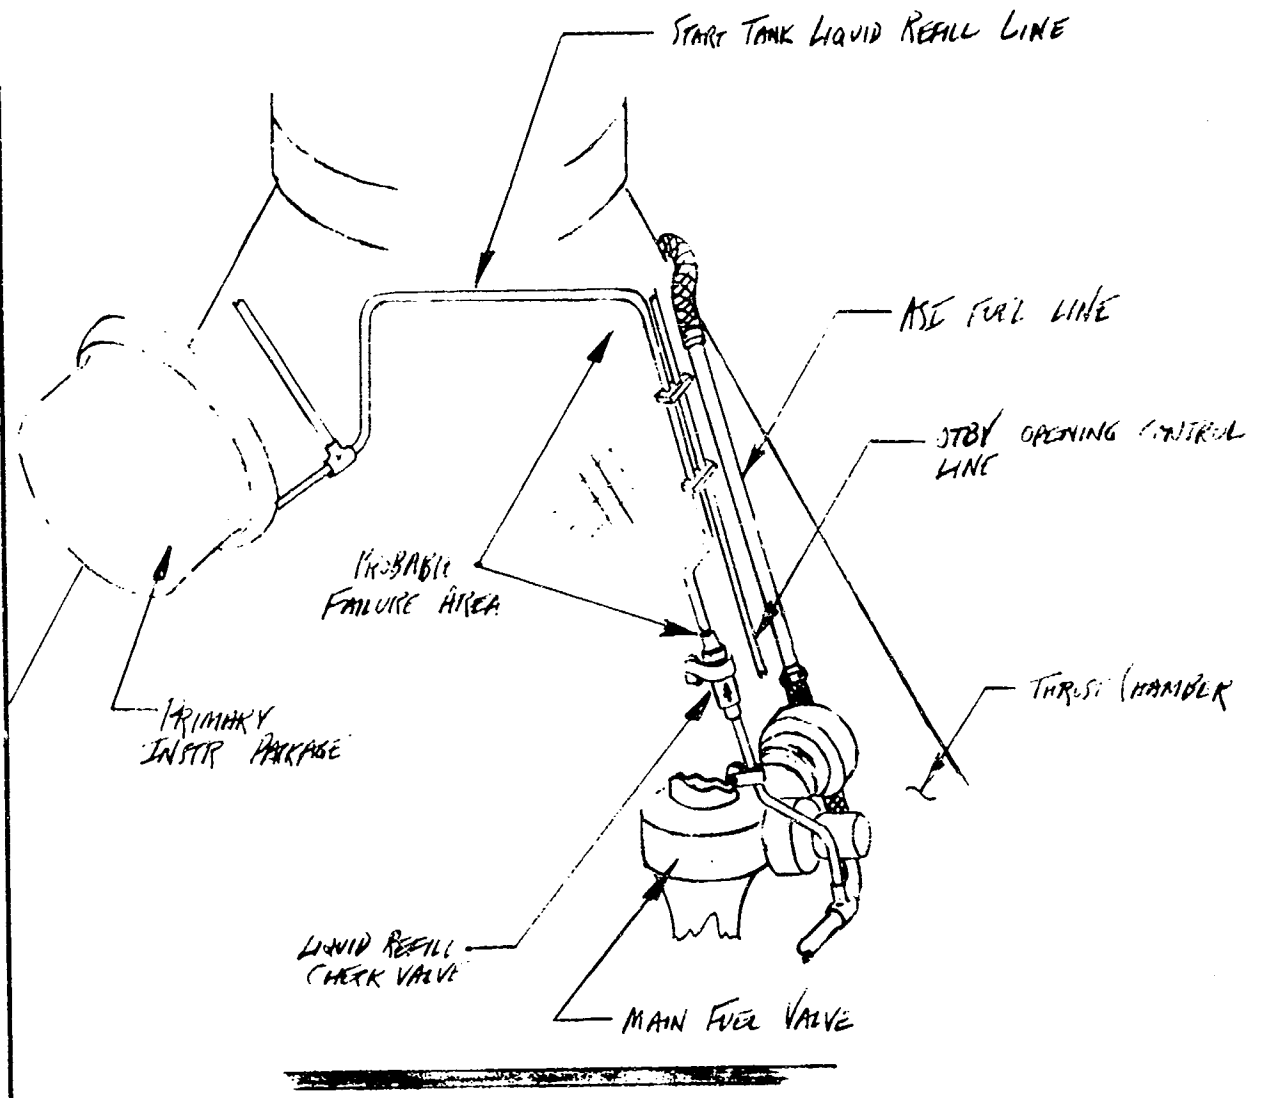
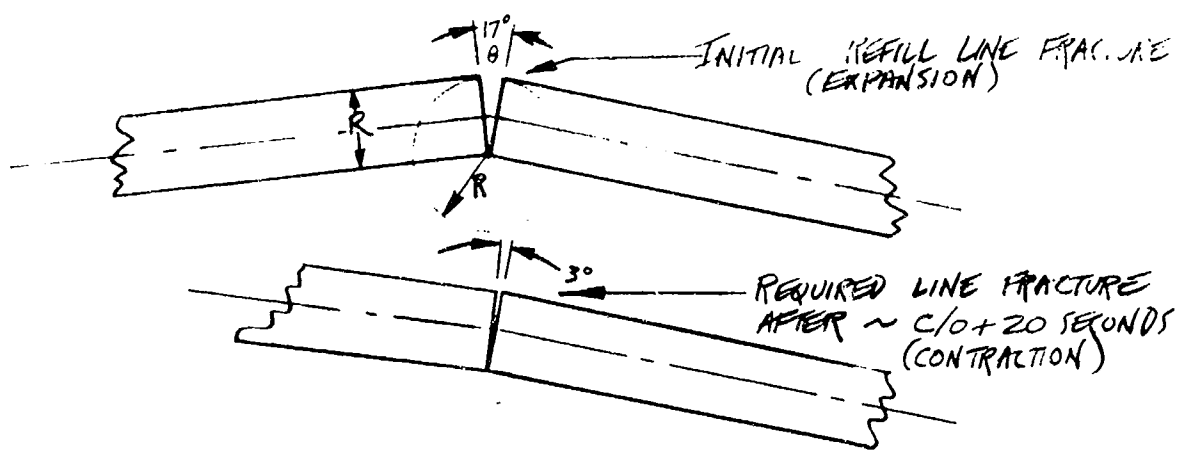
Figure 77. AS-502 Start Tank Blowdown Anomaly, Engine 202

Description of Event. The Engine 202 start system (start tank) exhibited severe leakage/venting characteristics at 413.8 seconds range time. Figure 77 illustrates Engine 202 start tank pressure and temperature profiles from engine cutoff until termination of S-II telemetry transmission (approximately 590 seconds range time). The initial leakage/venting flowrate was approximately 0.2 lb/sec of gaseous hydrogen, decreasing to an approximately constant value of 0.017 lb/sec after 20 seconds.

Hypothesis. Leakage/venting of the Engine 202 start system resulted from rupture of the start tank liquid refill line downstream of the liquid refill check valve. Rupture of the liquid refill line occurred as a result of the engine compartment hot-gas fire, which occurred during cutoff of Engine 202. The decreasing leakage rate characteristic noted from flight data resulted from incomplete burnthrough or rupture of the liquid refill line (complete burnthrough was prevented by the immediate cooling action of the escaping gaseous hydrogen), followed by contraction of the liquid refill line as further cooling of the line by the expanding gas occurred. Figure 78 illustrates the location of the liquid refill line in relation to other engine components and depicts initial and final line rupture conditions.

Analysis indicates that start system leakage, based on the hypothesis stated above, was polytropic in nature, i.e., was initially close to an isentropic process, and later approached the isothermal case, as may be concluded from Fig. 77. Figure 79 is a plot of the calculated isentropic and isothermal processes for flow diameters versus time from engine cutoff.

75 R calculated vs 80 R flight data also indicates a polytropic process, but now more like an isothermal one. (Refer to Fig. 77.)

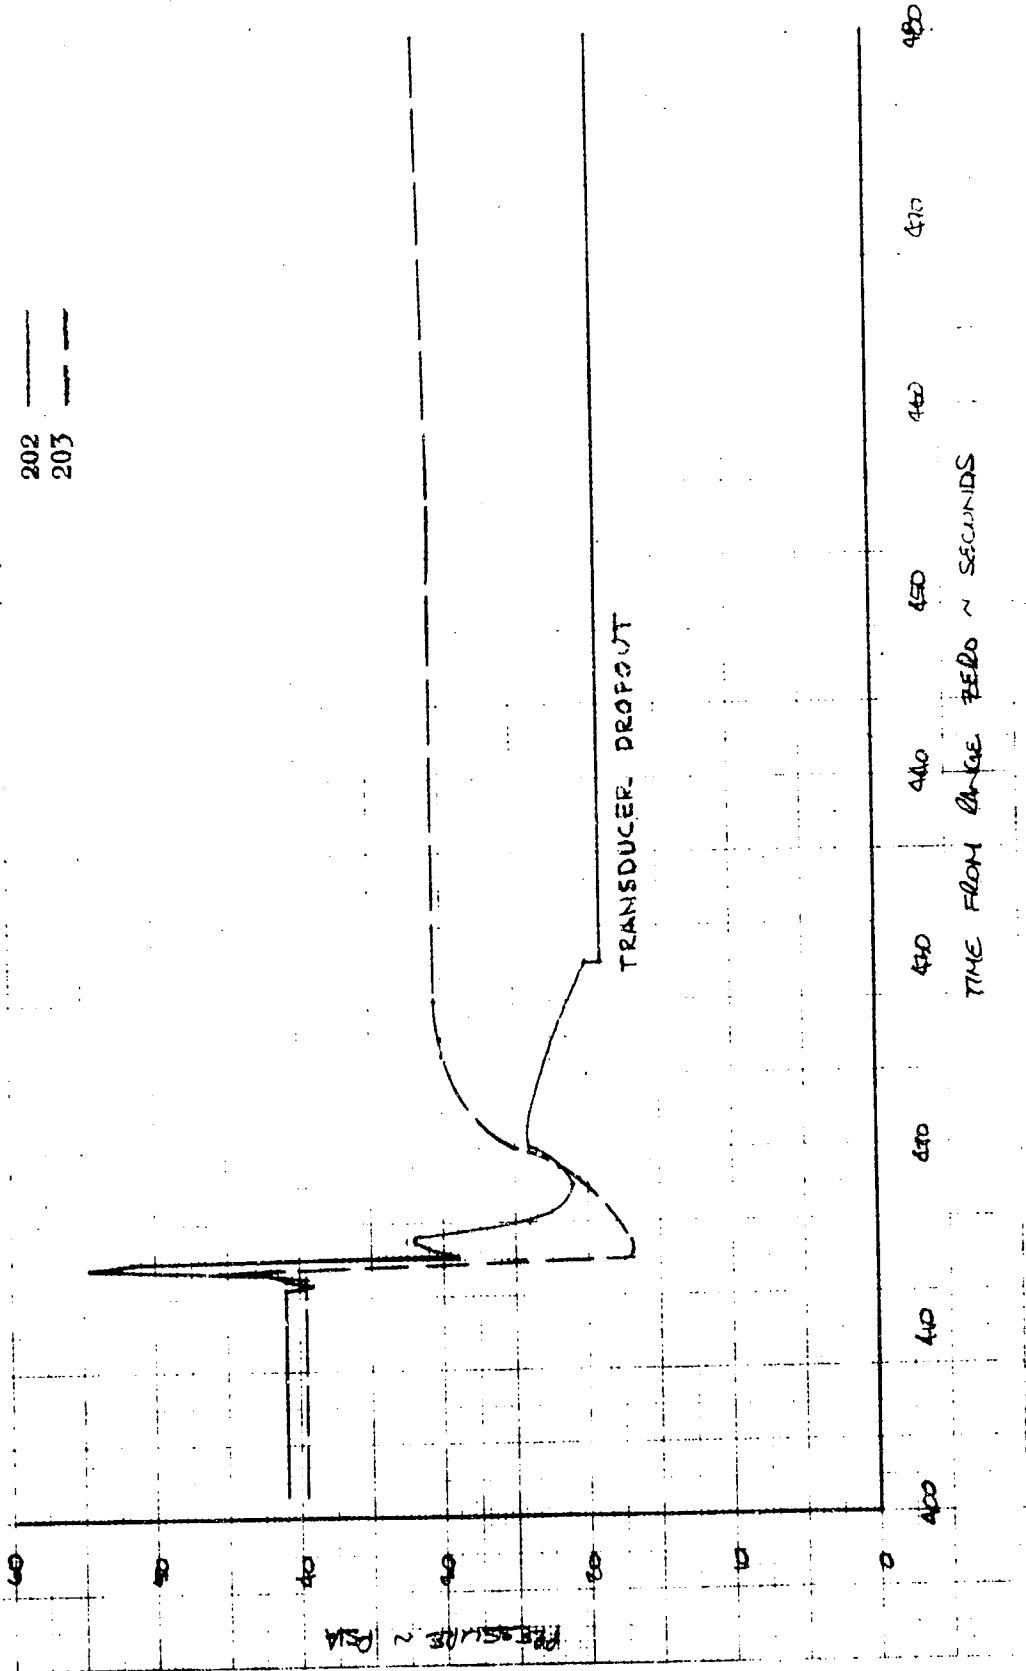
Figure 80. Oxidizer Pump Inlet Pressure

Corroboration of Conclusion. Data plots of engine 202 oxidizer pump inlet pressure (Fig. 80), PU valve outlet pressure (Fig. 81), and oxidizer pump discharge pressure (Fig. 82) indicate abnormal pressure decay following engine cutoff. Engine 203 exhibited no such decays in these parameters following cutoff.
