R-7450-2

J-2 ENGINE AS-502 (APOLLO 6)

FLIGHT REPORT

VOLUME 2: S-II STAGE FAILURE ANALYSIS

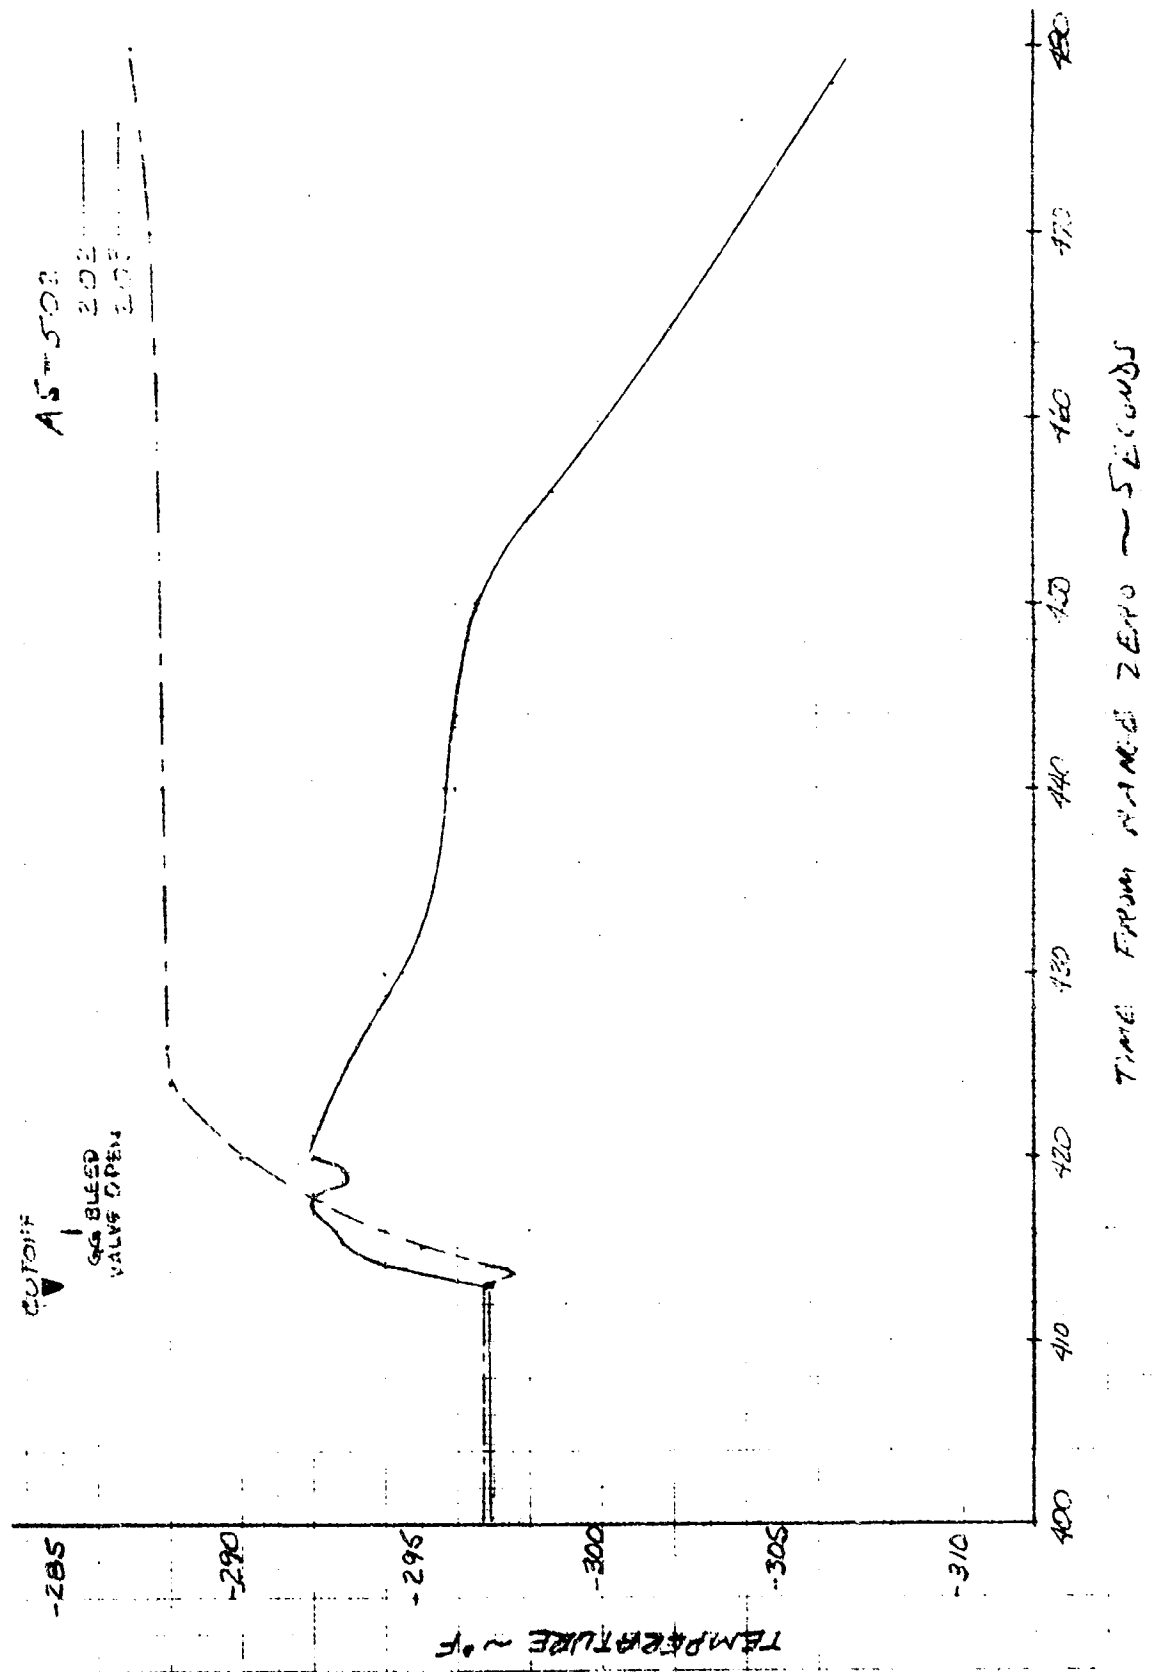
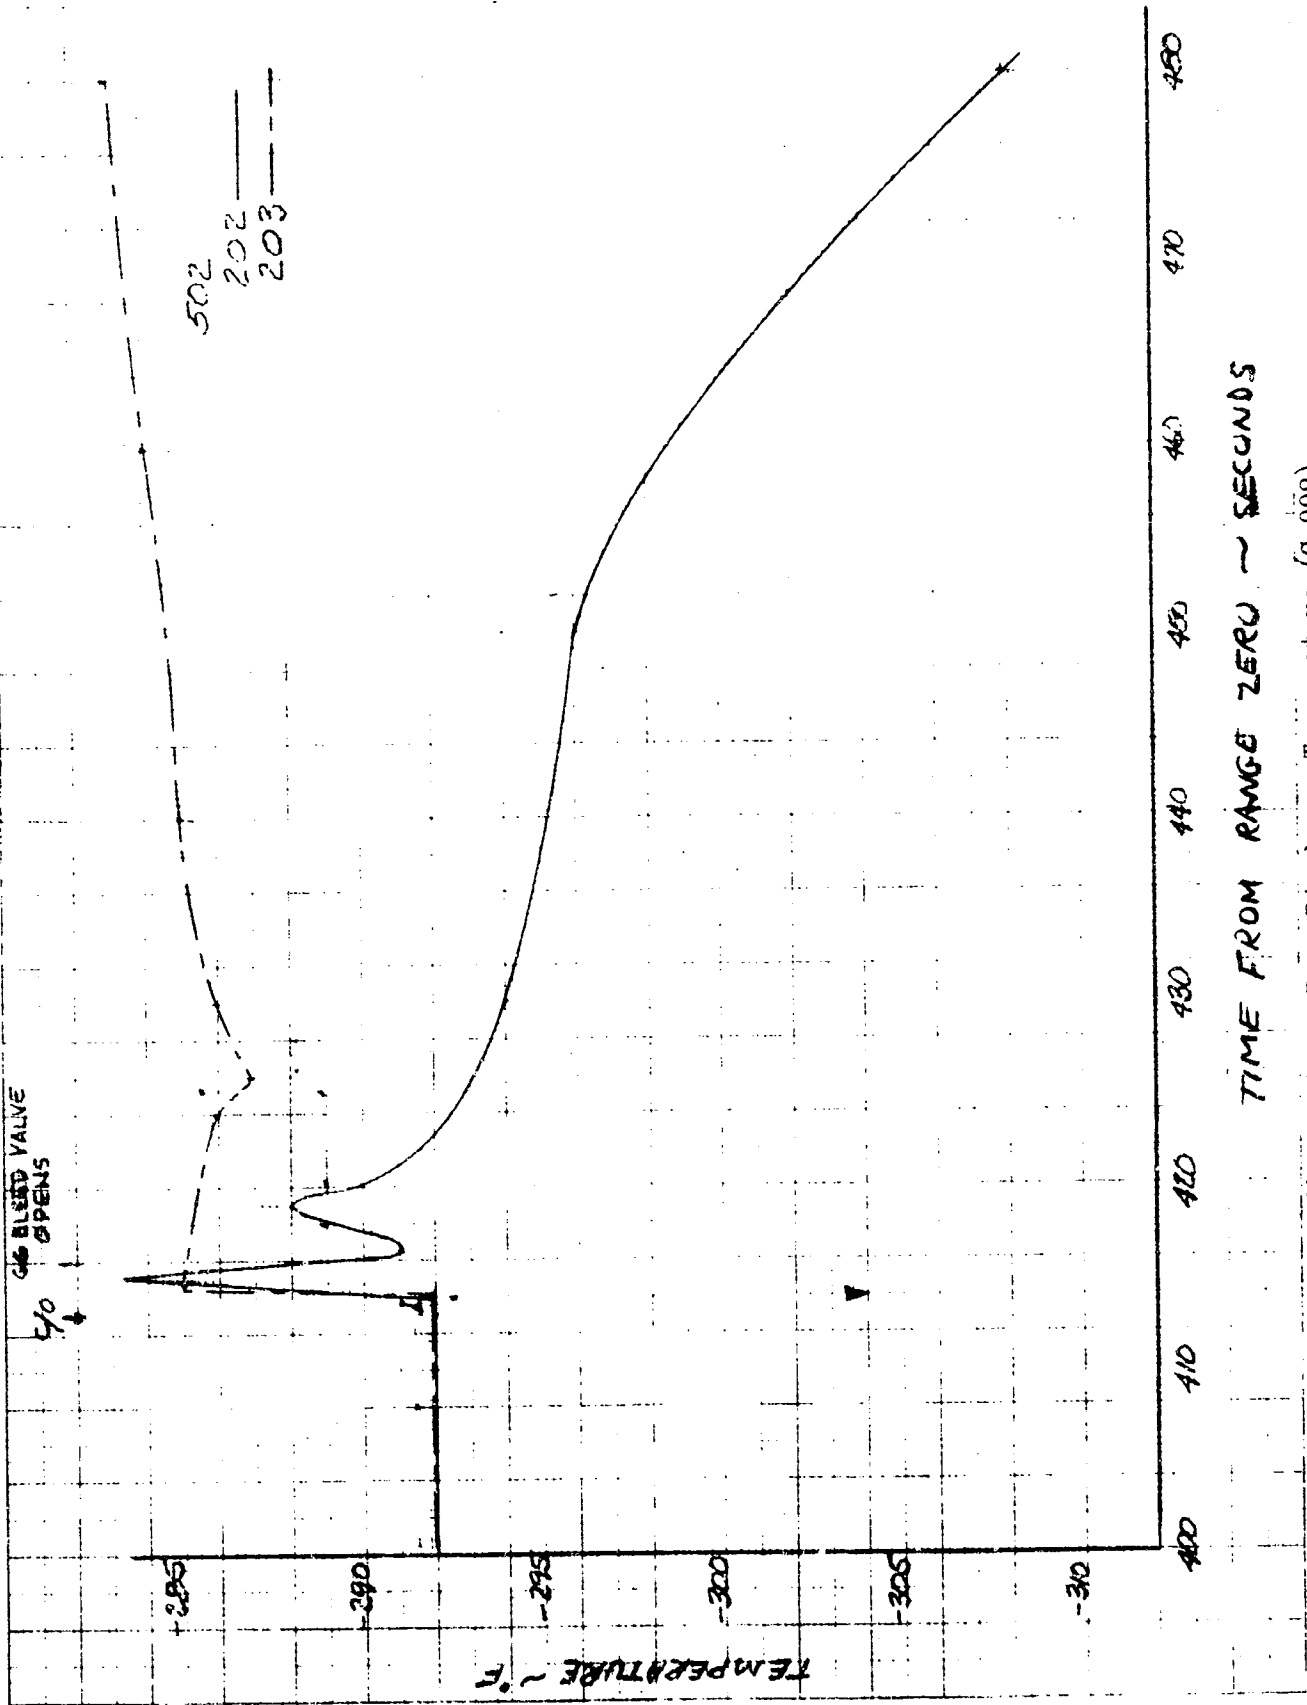
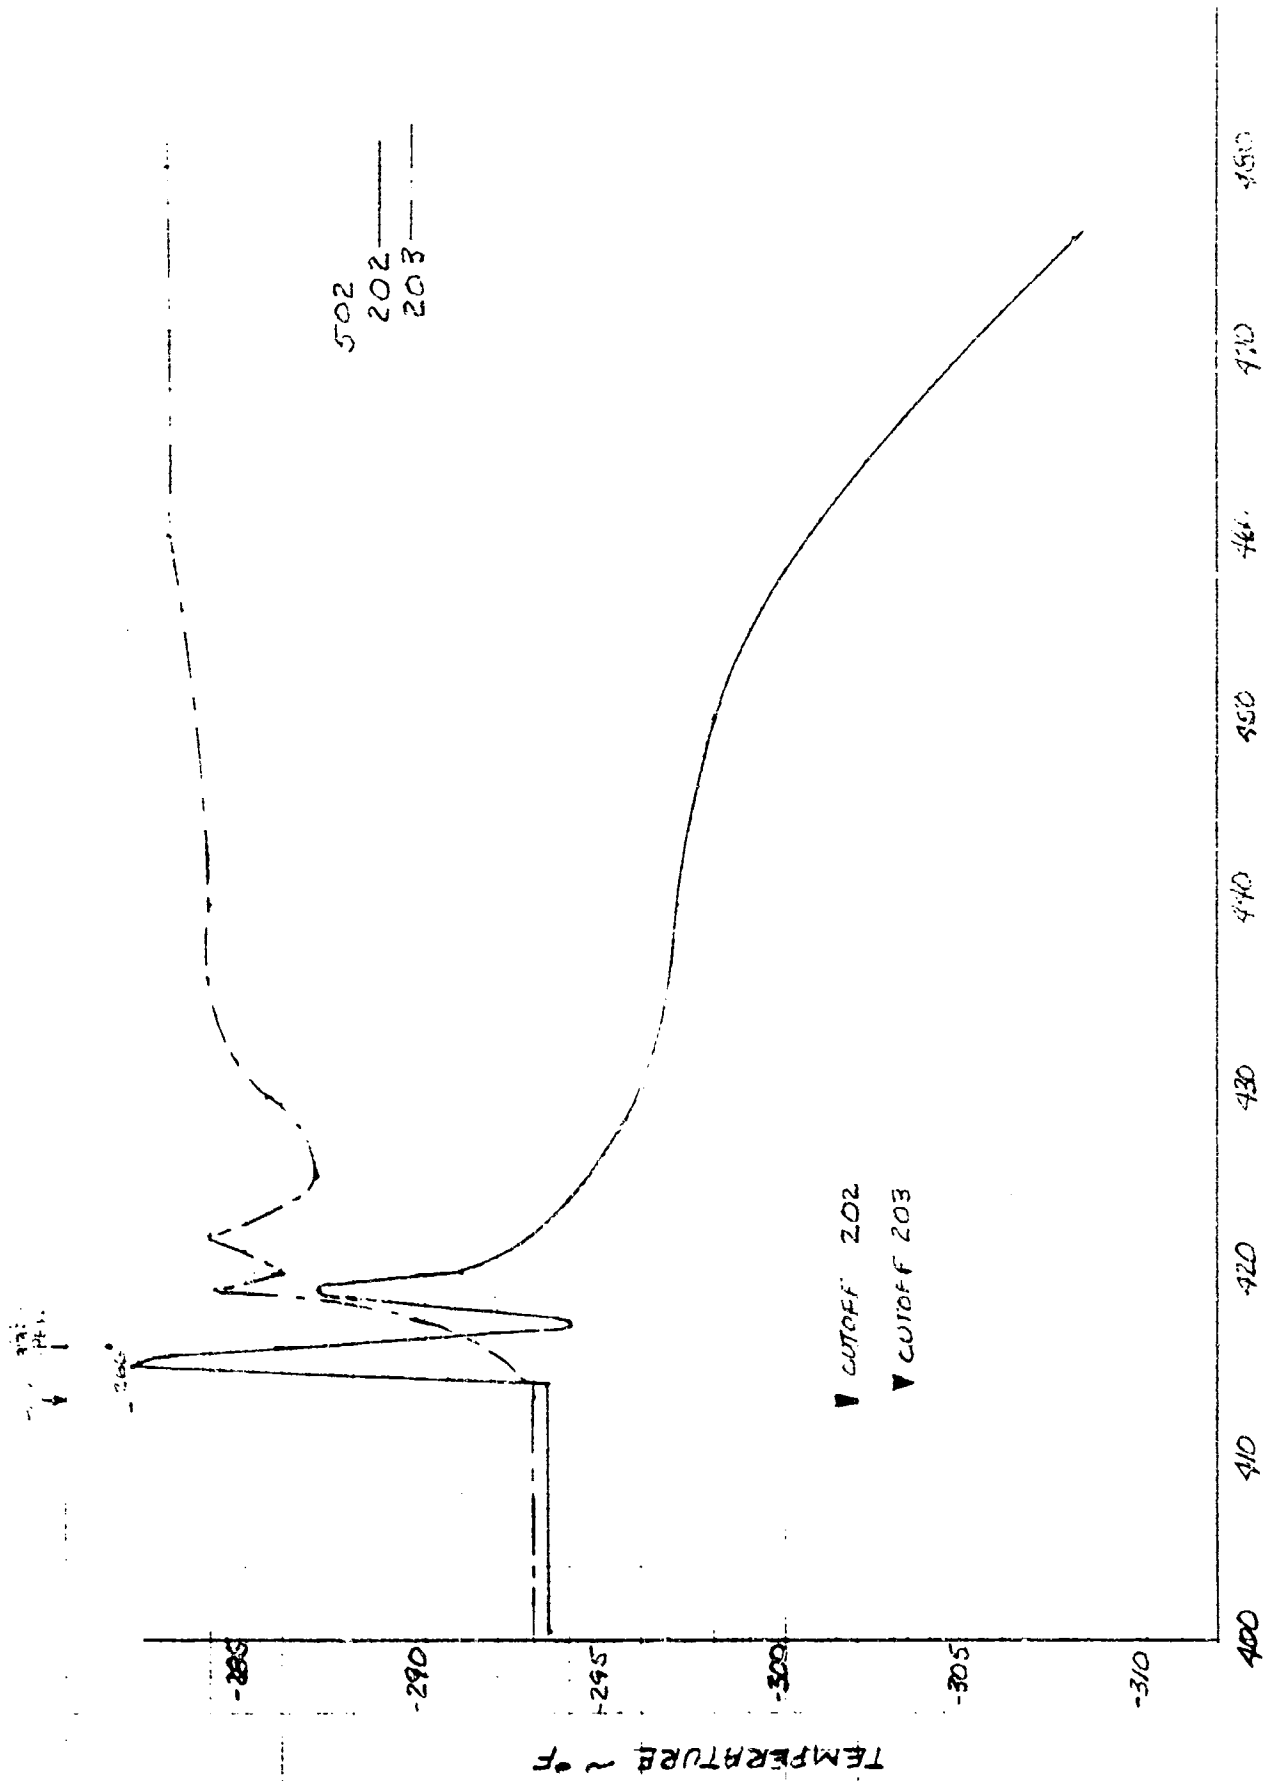
The conclusion that the oxidizer system pressure decays resulted from loss of system integrity is further supported by decreasing oxidizer feed system temperatures (Fig. 83, 84, and 85). Engine 202 oxidizer inlet temperature, oxidizer pump discharge temperature, and gas generator oxidizer inlet temperature (gas generator bleed valve temperature) decreased to

approximately -508 F (transducer limit) by 65 seconds after cutoff; slope of the temperature curves at this point indicated that the temperature decrease would continue.

Because it is concluded that integrity of the Engine 202 fuel feed system was essentially maintained following cutoff, cooling of the oxidizer feed system could only be caused by vaporization of oxidizer within the system, i.e., decay of system pressure to below the oxidizer vapor pressure.

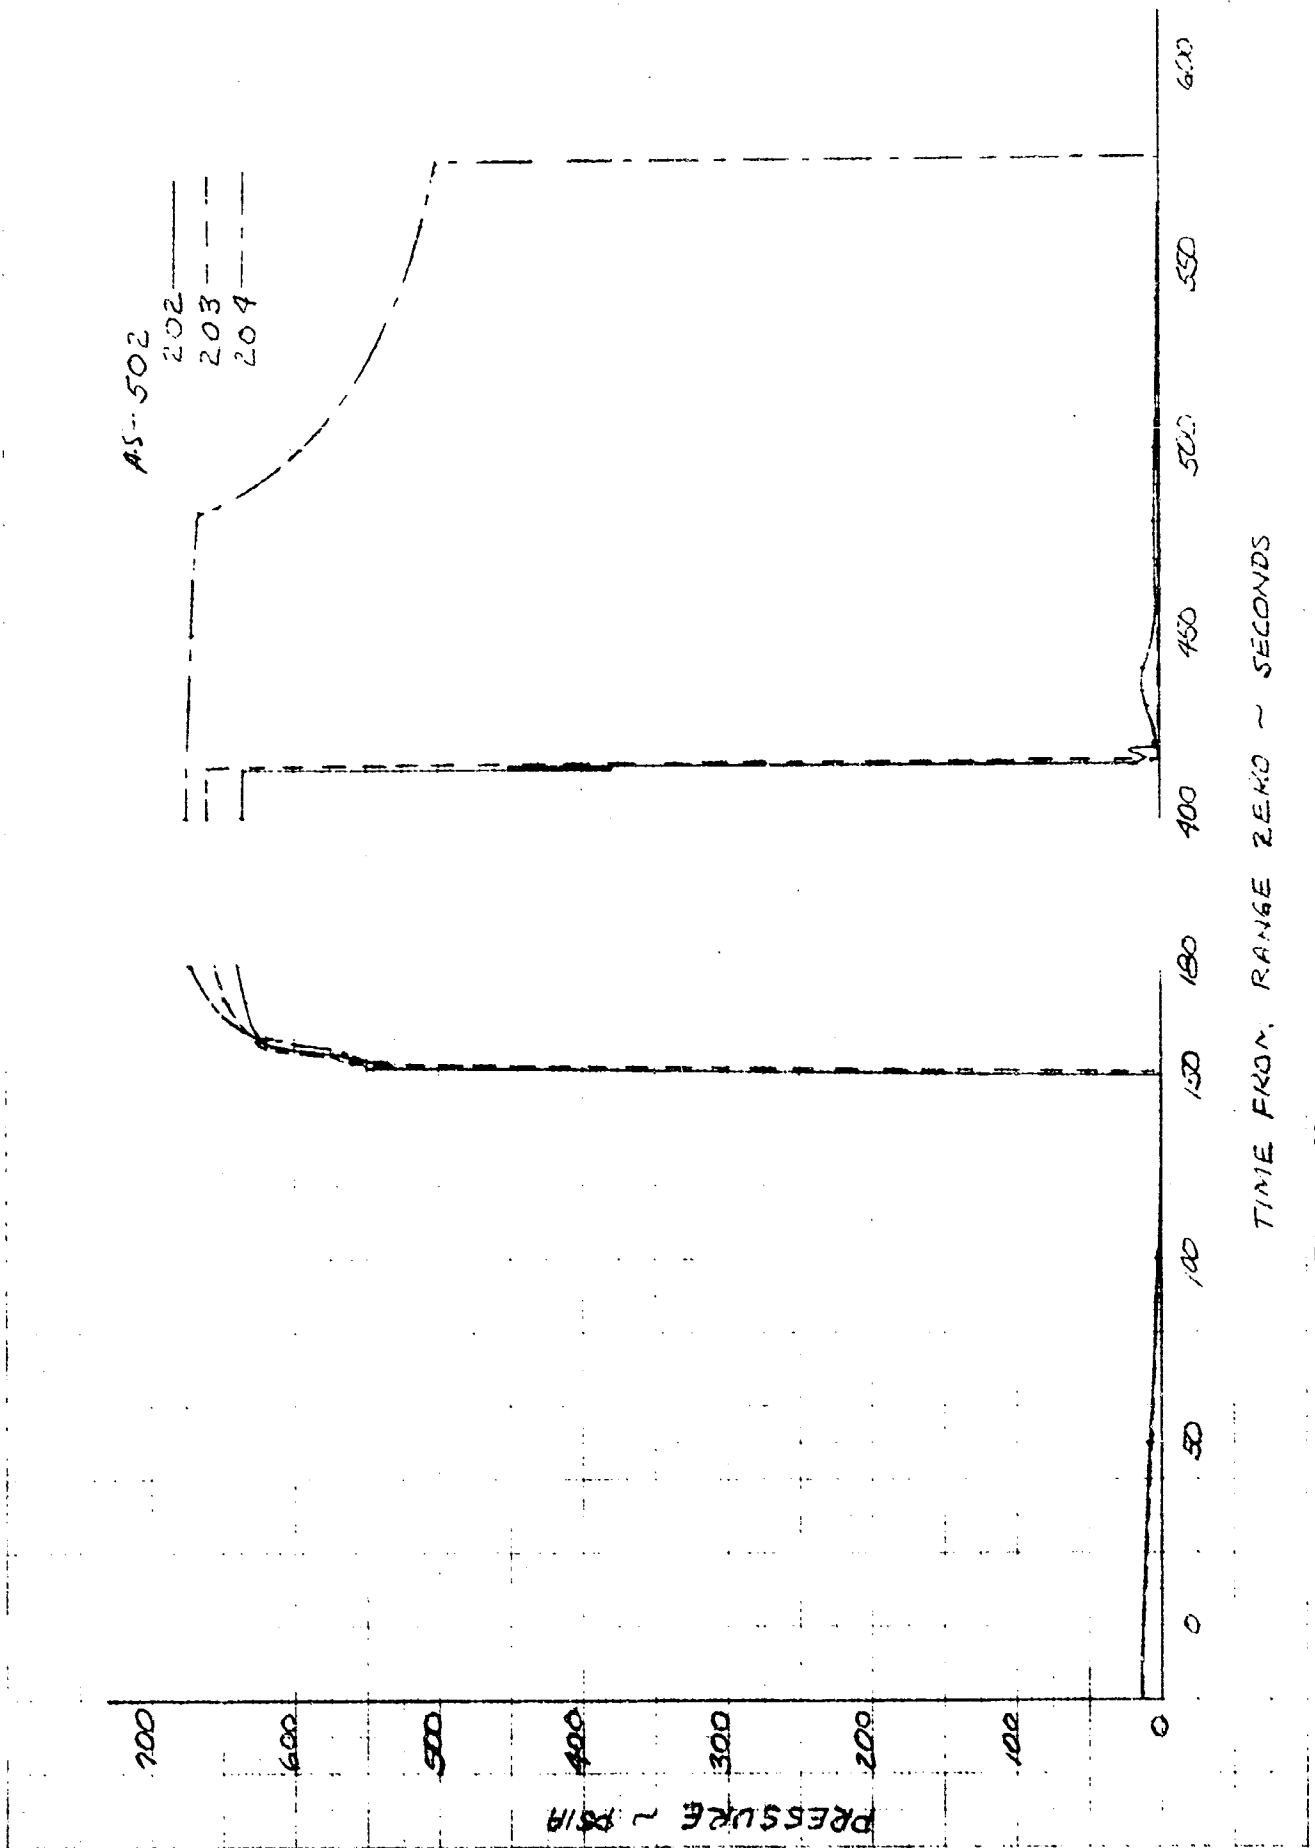
Figure 92. Gas Generator Chamber Pressure

At 415 seconds, the gas generator valve partially opened, and then closed again. Gas generator chamber pressure (Fig. 92) spiked to approximately 20 psia, decays to 5 psia, then rose back to 12 psia for approximately 30 seconds. The latter rise appears to be the result of a leaking gas generator fuel valve. The leaking fuel, picking up heat from the gas generator combustor, entered the turbine at approximately 1000 F and provided sufficient torque to maintain fuel pump rotation for the extended period observed. Table 8 presents gas generator and fuel turbine parameter data versus time; it is assumed that fuel within the turbopump was in a gaseous state and that the pump power load resulted from windage; turbine torques stated are sufficient to result in the extended pump speed decay.

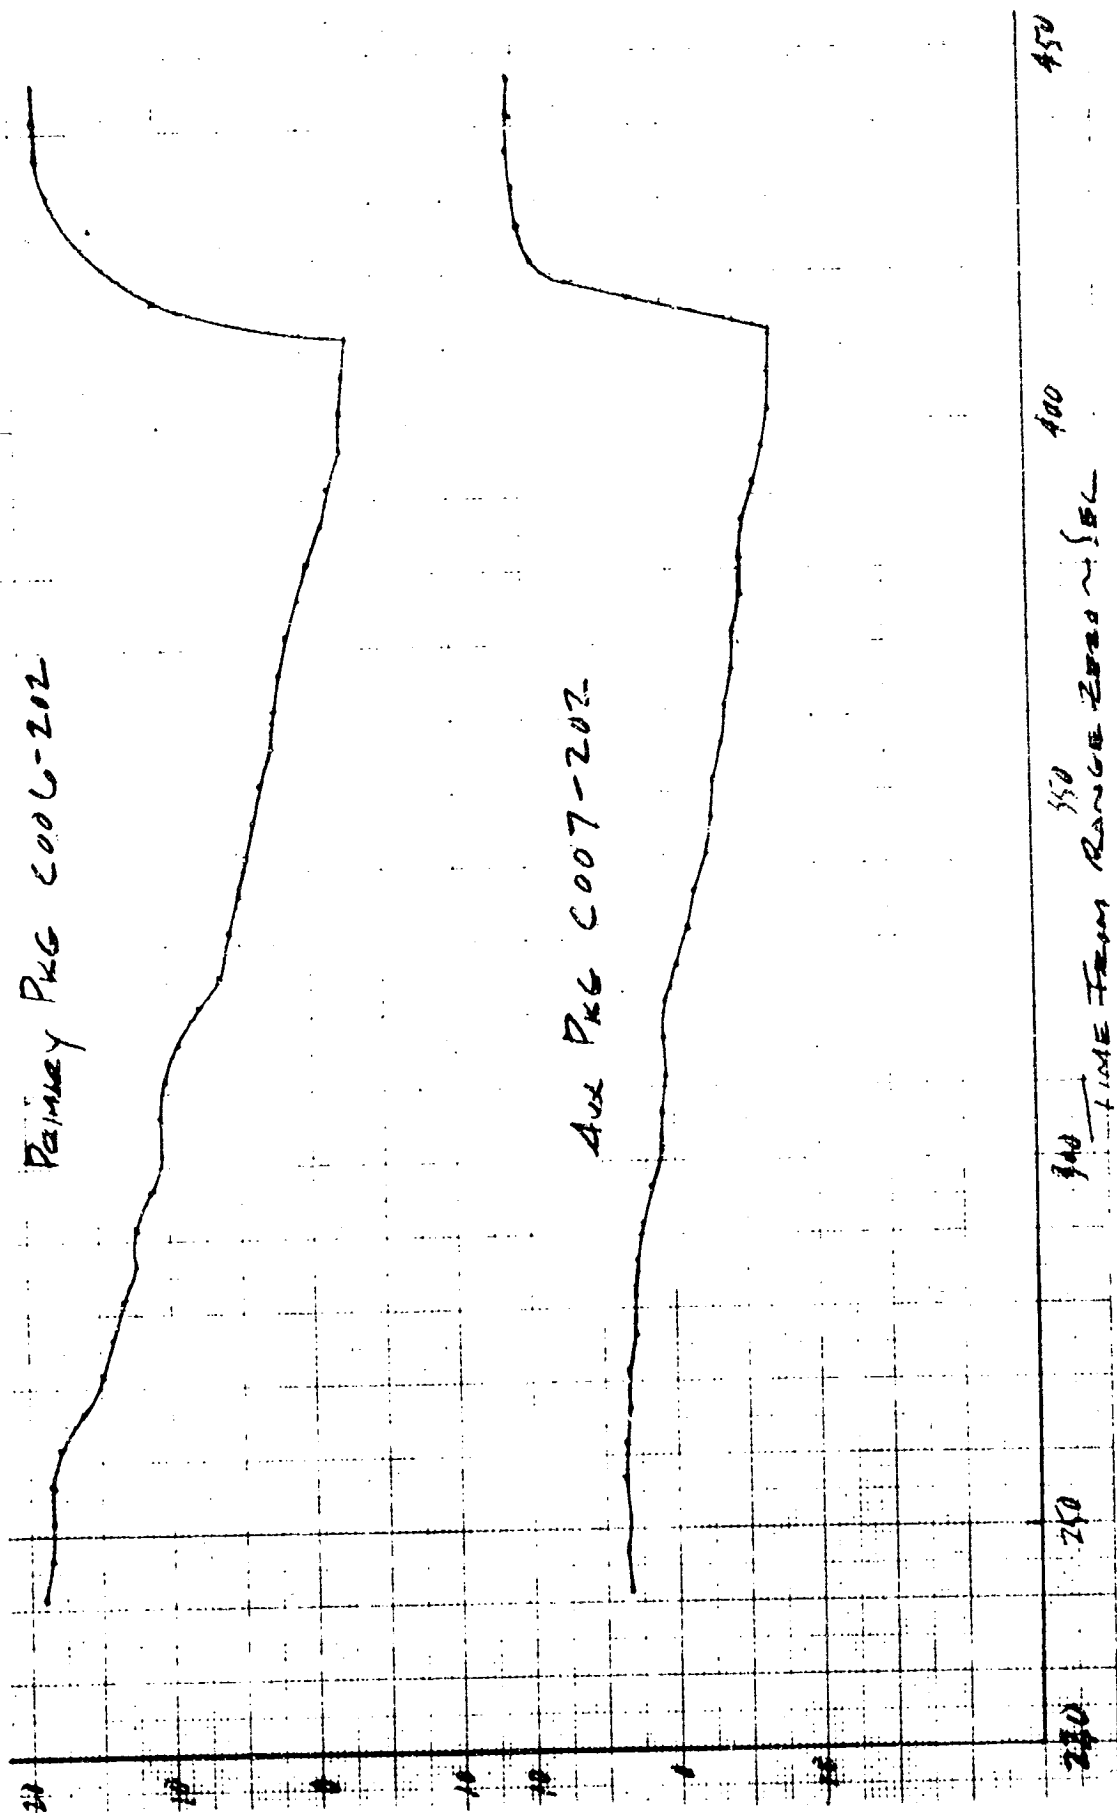
Figure 104. Instrumentation Package Temperatures

Description of Event. Engine 202 primary and auxiliary instrumentation package temperatures changed at cutoff from a slow continuous decrease trend to an abrupt rapid rise, and then leveled off during the remaining 140 seconds preceding cutoff of S-II engines 201, 204, and 205 (Fig. 104).

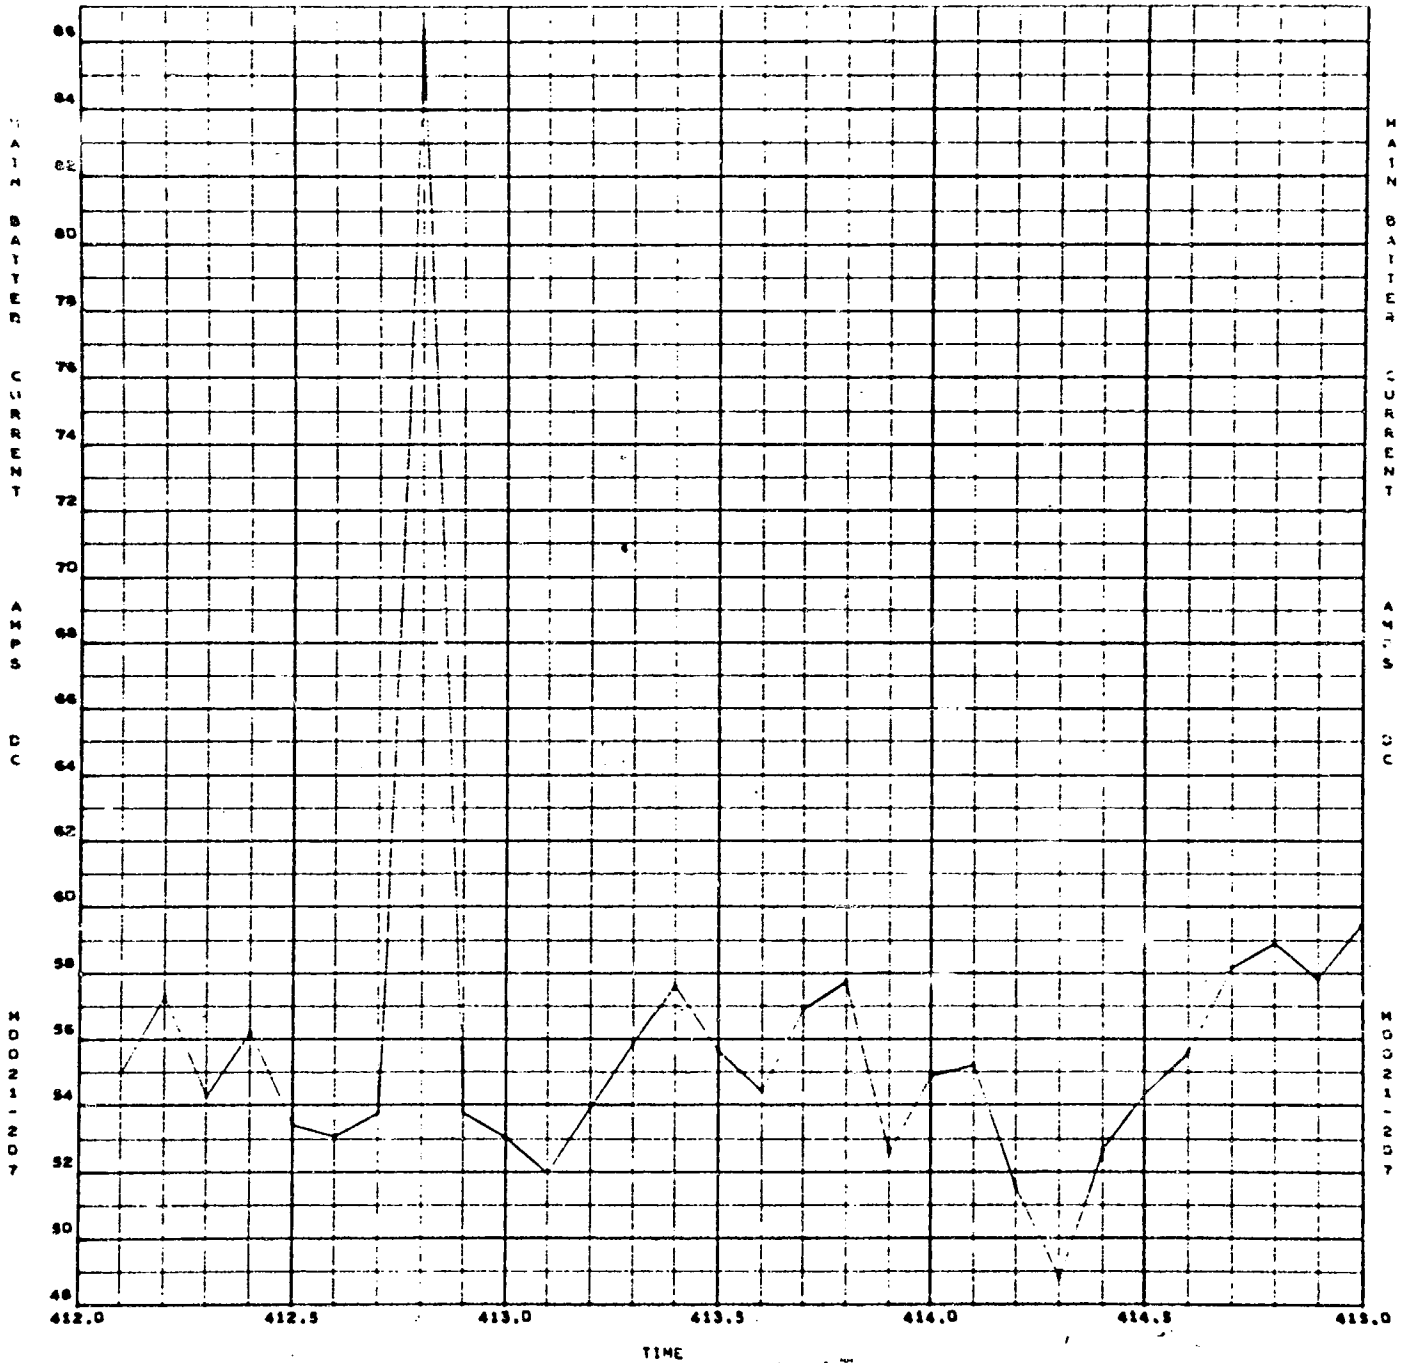
Figure 125. Main D-C Battery Current

Hypothesis. The current/voltage spikes observed in the flight data indicate a momentary short circuit, probably resulting from a fire or insulation breakdown. No evidence can be found to indicate abnormal operation of any electrical equipment operating on the main battery at this time.

Corroboration of Hypothesis. Drawing of excessive amperage from the battery at the 412.8-second time is supported by the associated drop in main d-c bus voltage (Fig. 125 and 126), and is typical of short circuit or insulation breakdown conditions. The possibility of an engine compartment fire as the cause of a momentary short circuit at approximately the same range time as the current/voltage spike anomalies is supported by environmental data.

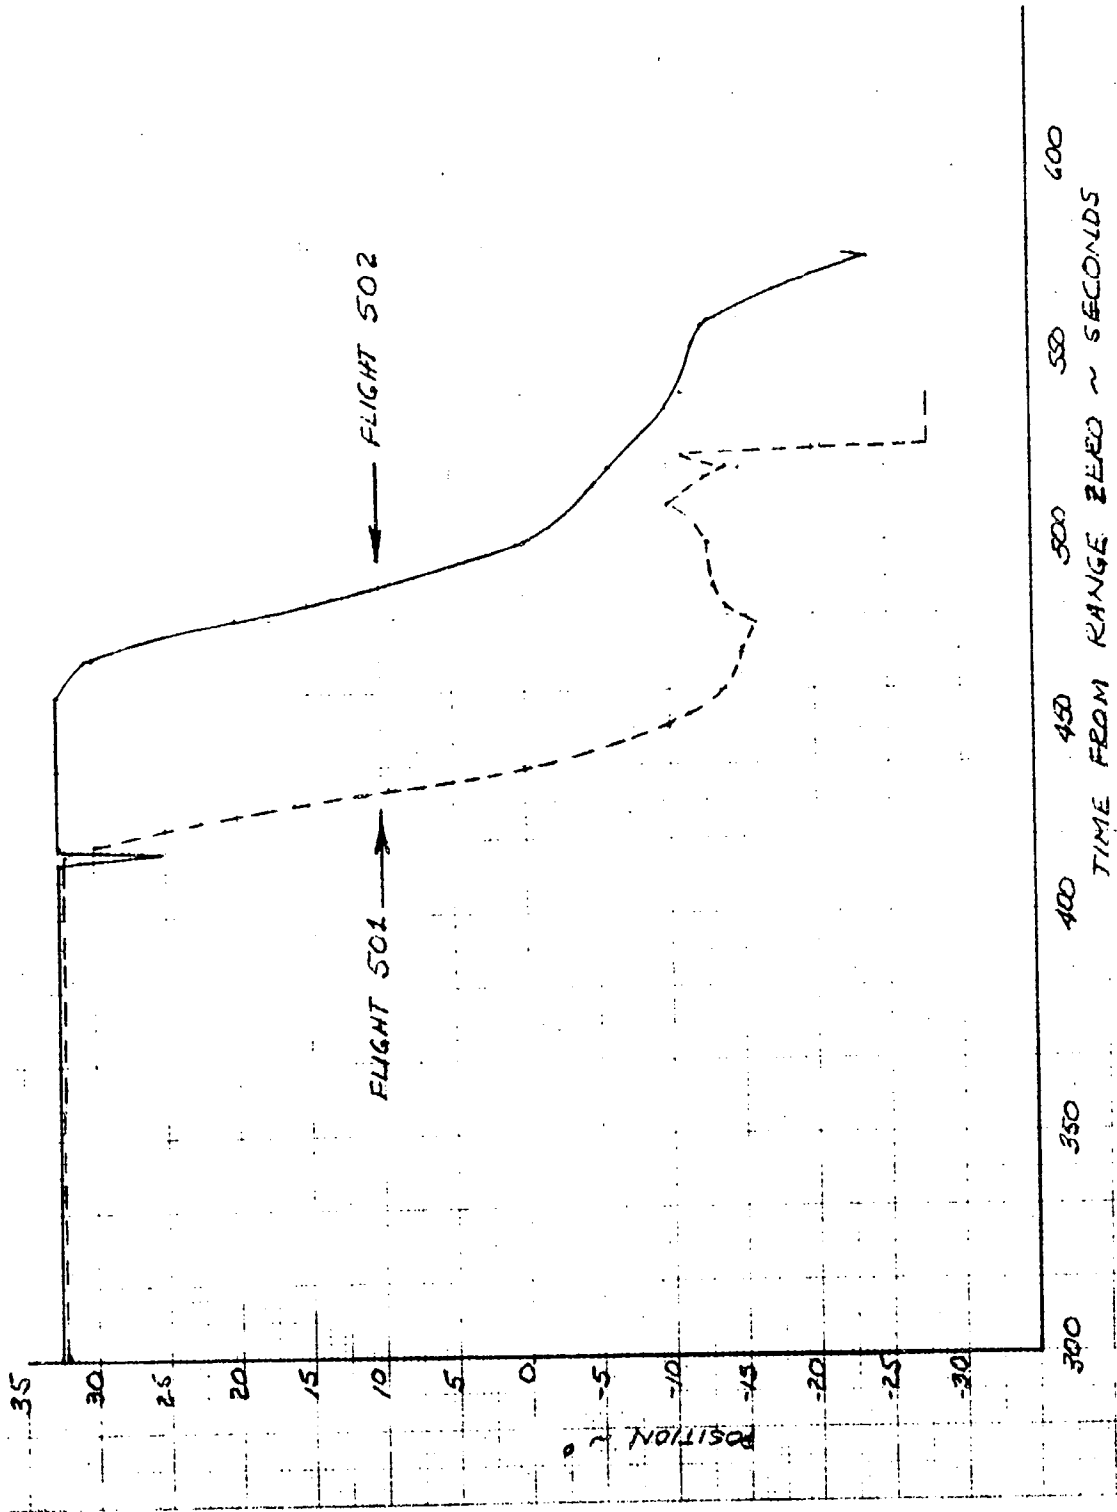
Figure 127. S-II Propellant Utilization Valve Position
(Typical of the Five Engines)

Description of Event. At approximately 418 seconds range time, the engine 202 propellant utilization valve opened 6 degrees and then reclosed. Analysis of flight data revealed that all S-II engine PU valves had exhibited the same anomaly. There were no engine performance changes, engine compartment environmental changes, or supporting system anomalies at this time that would contribute to, or result from, the anomalous PU valve operation. Figure 127 illustrates typical PU valve position traces for S-II engine during AS-501 and AS-502 flights. Burn time for engines 201, 204, and 205 was longer during the AS-502 flight than during AS-501; therefore, the PU valves remained closed for a longer duration.

Conclusions. The sudden change in vehicle velocity/attitude which occurred at cutoff of S-II engines 202 and 203 resulted in sloshing of propellants within the S-II tanks. Propellant tank liquid level sensors signalled the PU computer to open the engine PU valves and, when the sloshing damped out or ceased, signalled the PU computer to reclose the valves.

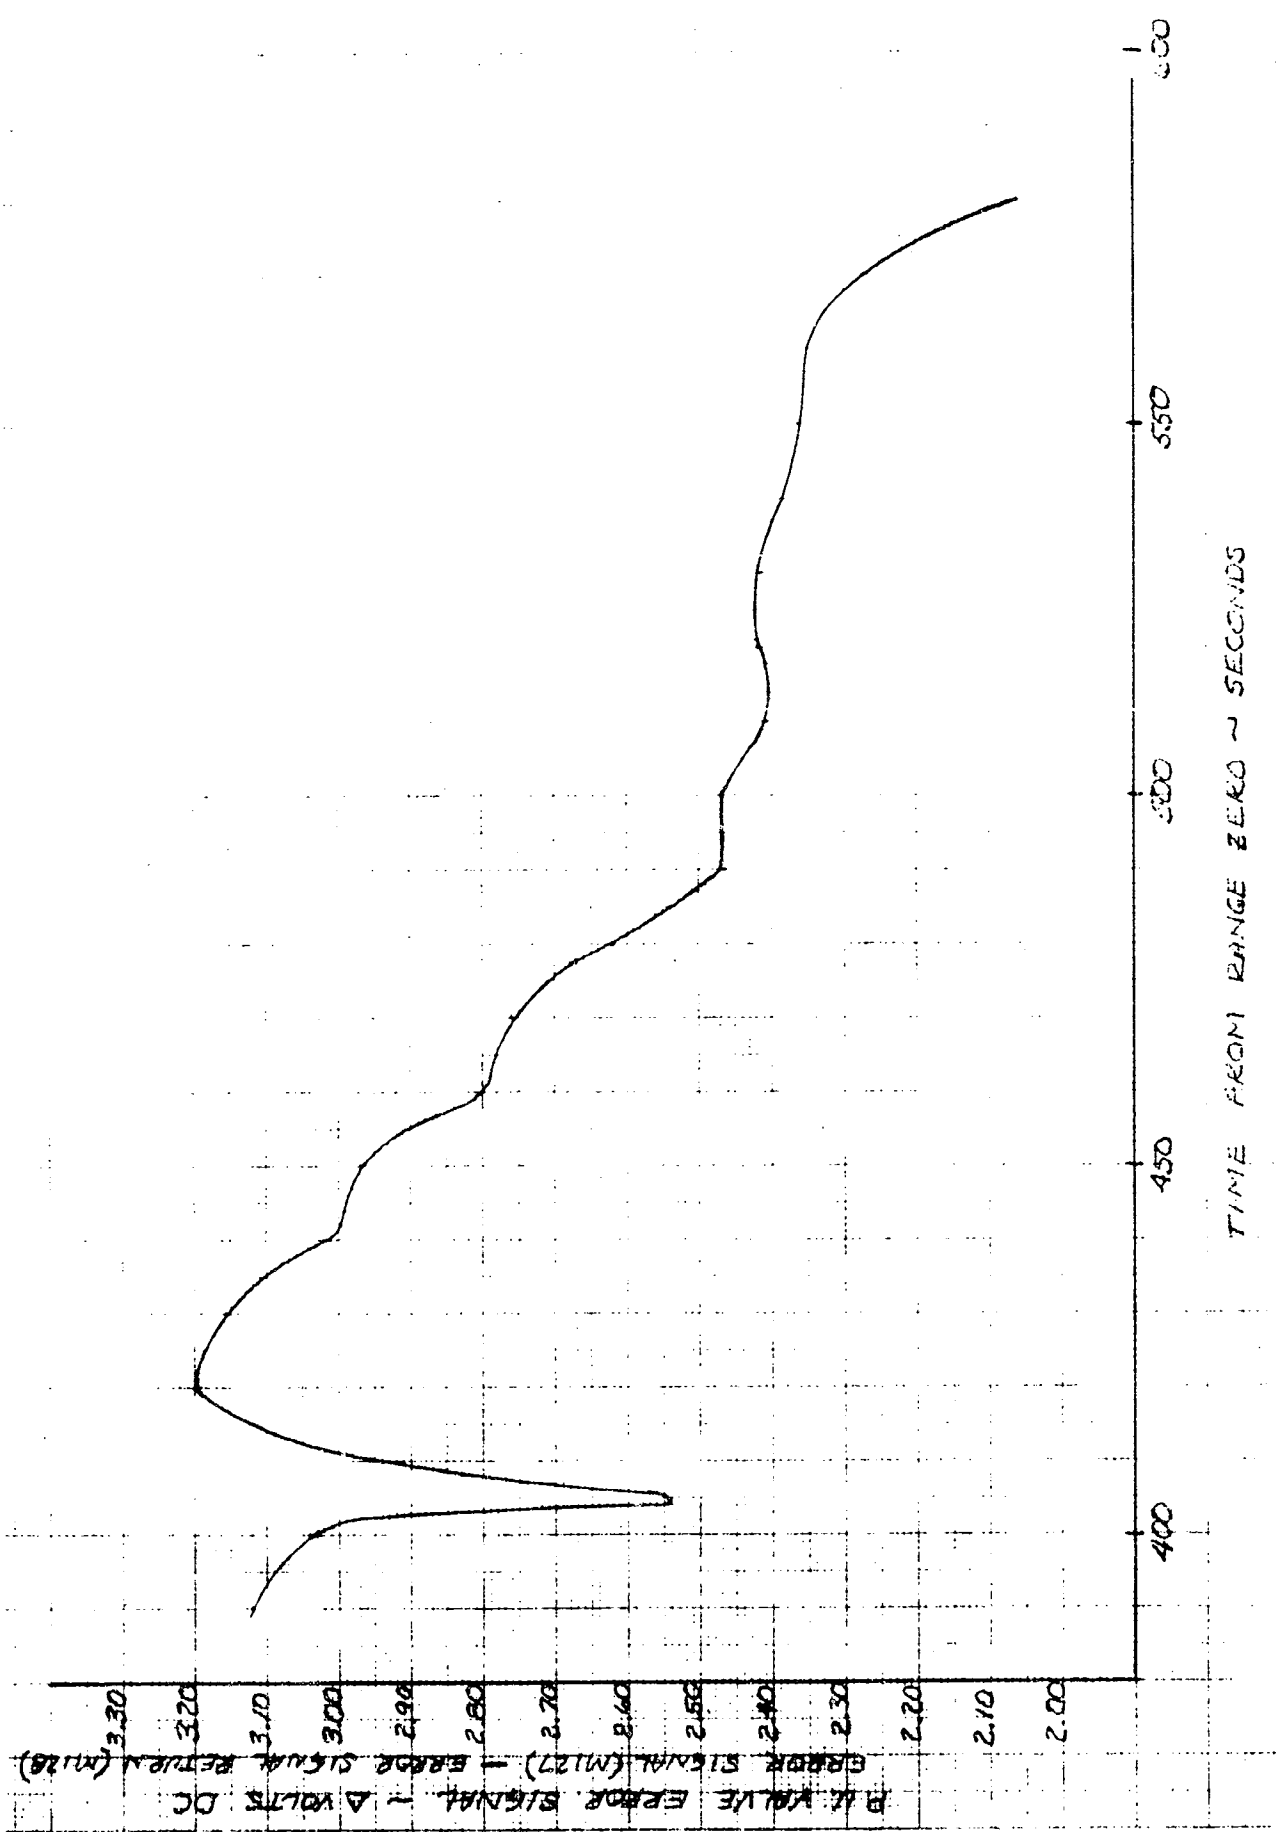
Figure 128. Propellant Utilization Valve Error Signal, Engine 202

Corroboration of Conclusions. The PU computer error signal corroborates excursion of PU valves at 418 seconds. Figure 128 illustrates engine 202 PU valve error signal (net error signal) at 418 seconds. No performance shift was observed for the three S-II engines remaining in operation at this time because the PU valve has a 14-degree overlap in the closed position.

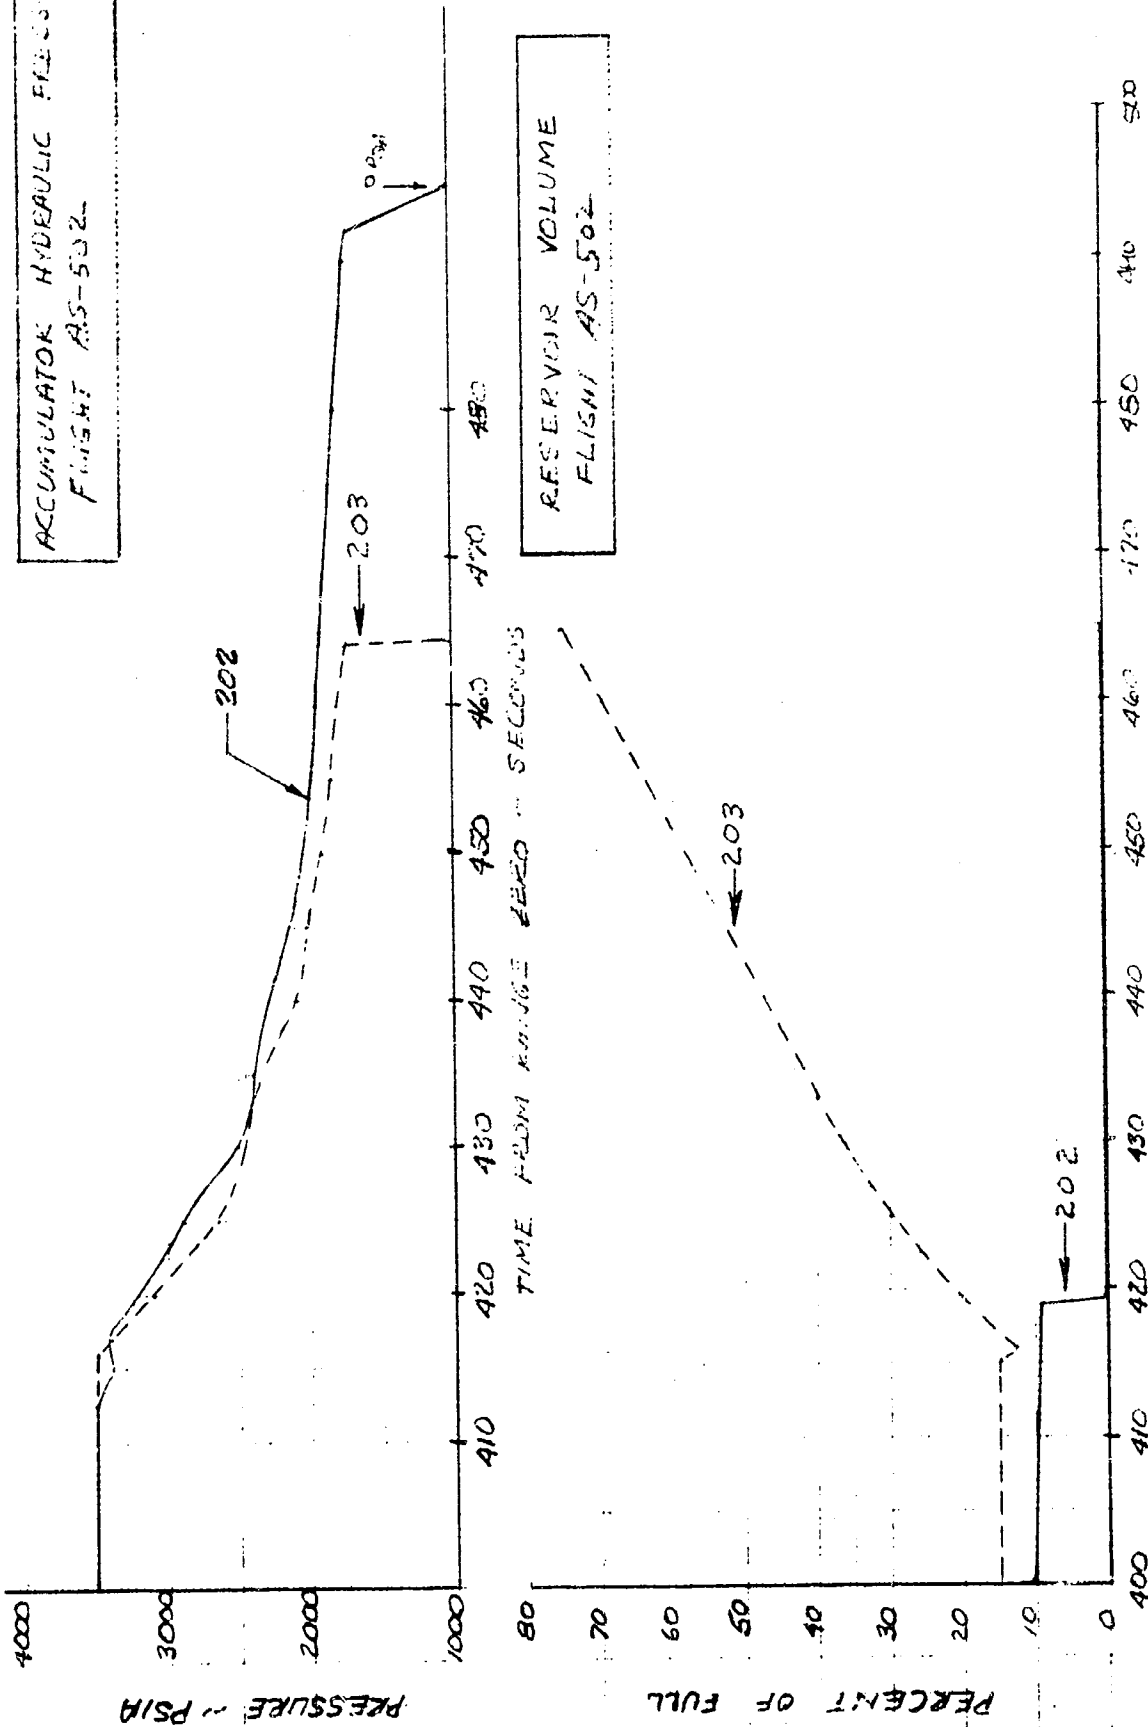
Figure 1-59. Accumulator Hydraulic Pressure and Reservoir Volume, Engines 202 and 203

1. Sudden loss of hydraulic reservoir pressure, i.e., 170 psi/sec as compared to 5 psi/sec normal pressure decay following engine cutoff (Fig. 129).
2. Sudden decrease in reservoir volume (percent of capacity) from 10 to 0 percent in 0.5 second, as opposed to a normal increase to 75 percent approximately 60 seconds after cutoff as a result of reservoir filling from the accumulator (Fig. 130).

Conclusions. Loss of engine 202 engine actuation system hydraulic fluid occurred following engine cutoff; the hydraulic fluid loss resulted from leakage at the low-pressure side of one or both actuators. The cause of the leakage is indeterminate.

Corroboration of Conclusions. The engine 202 accumulator pressure decay rate following engine cutoff was approximately 30 percent slower than anticipated. This reduction in decay rate indicates that fluid was not leaking at the high-pressure line between the accumulator and actuators, but rather at the low-pressure side; the decay rate further indicates that

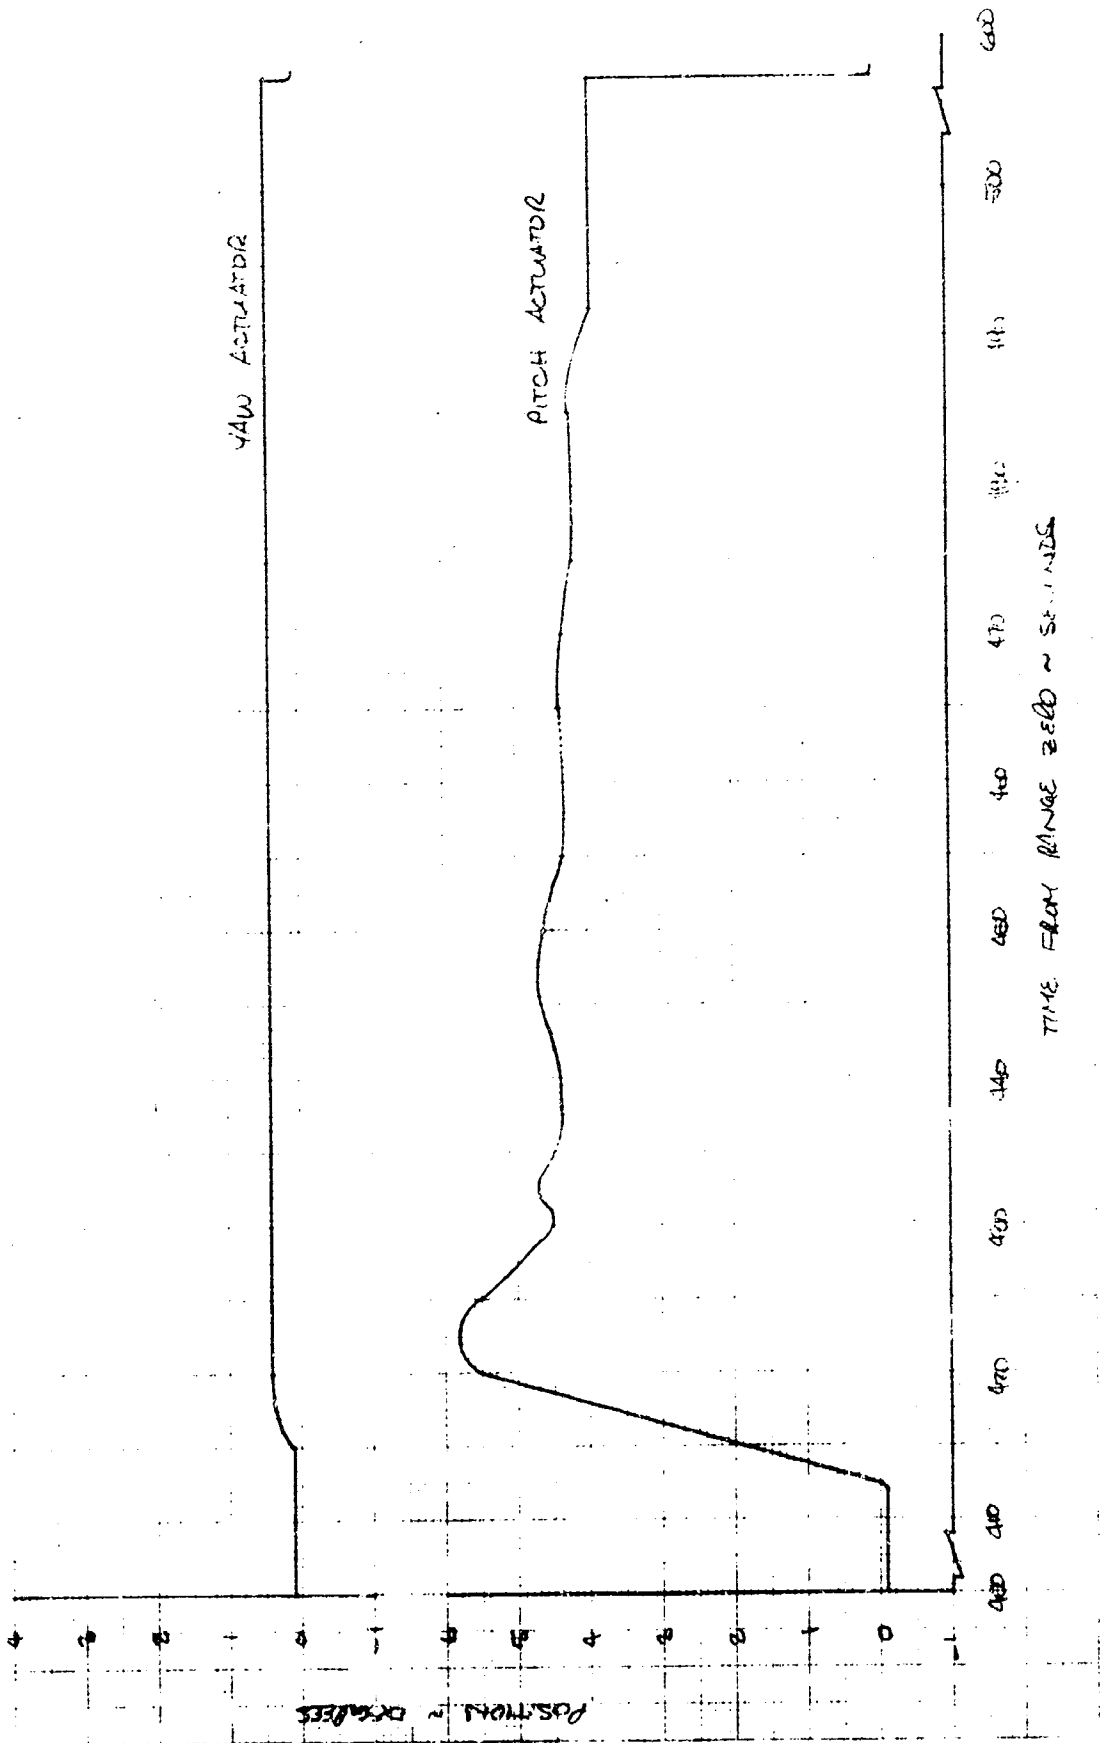
Figure 130. Actuator Position, Engine 202

The severity of hydraulic system chilling is indicated by hydraulic lockup of the engine 202 yaw actuator at approximately 3200-psia accumulator pressure (415 seconds range time). The lockup function is performed by a differential pressure valve, connected across the actuator cylinder volumes, which is actuated whenever the ΔP across the actuator falls between 1300 and 1700 psi. The lockup condition was achieved with 3400 psia at the high-pressure side, thus indicating that the low-pressure side had experienced higher than normal pressure because of increased fluid viscosity.
