R-7450-2

J-2 ENGINE AS-502 (APOLLO 6)

FLIGHT REPORT

VOLUME 2: S-II STAGE FAILURE ANALYSIS

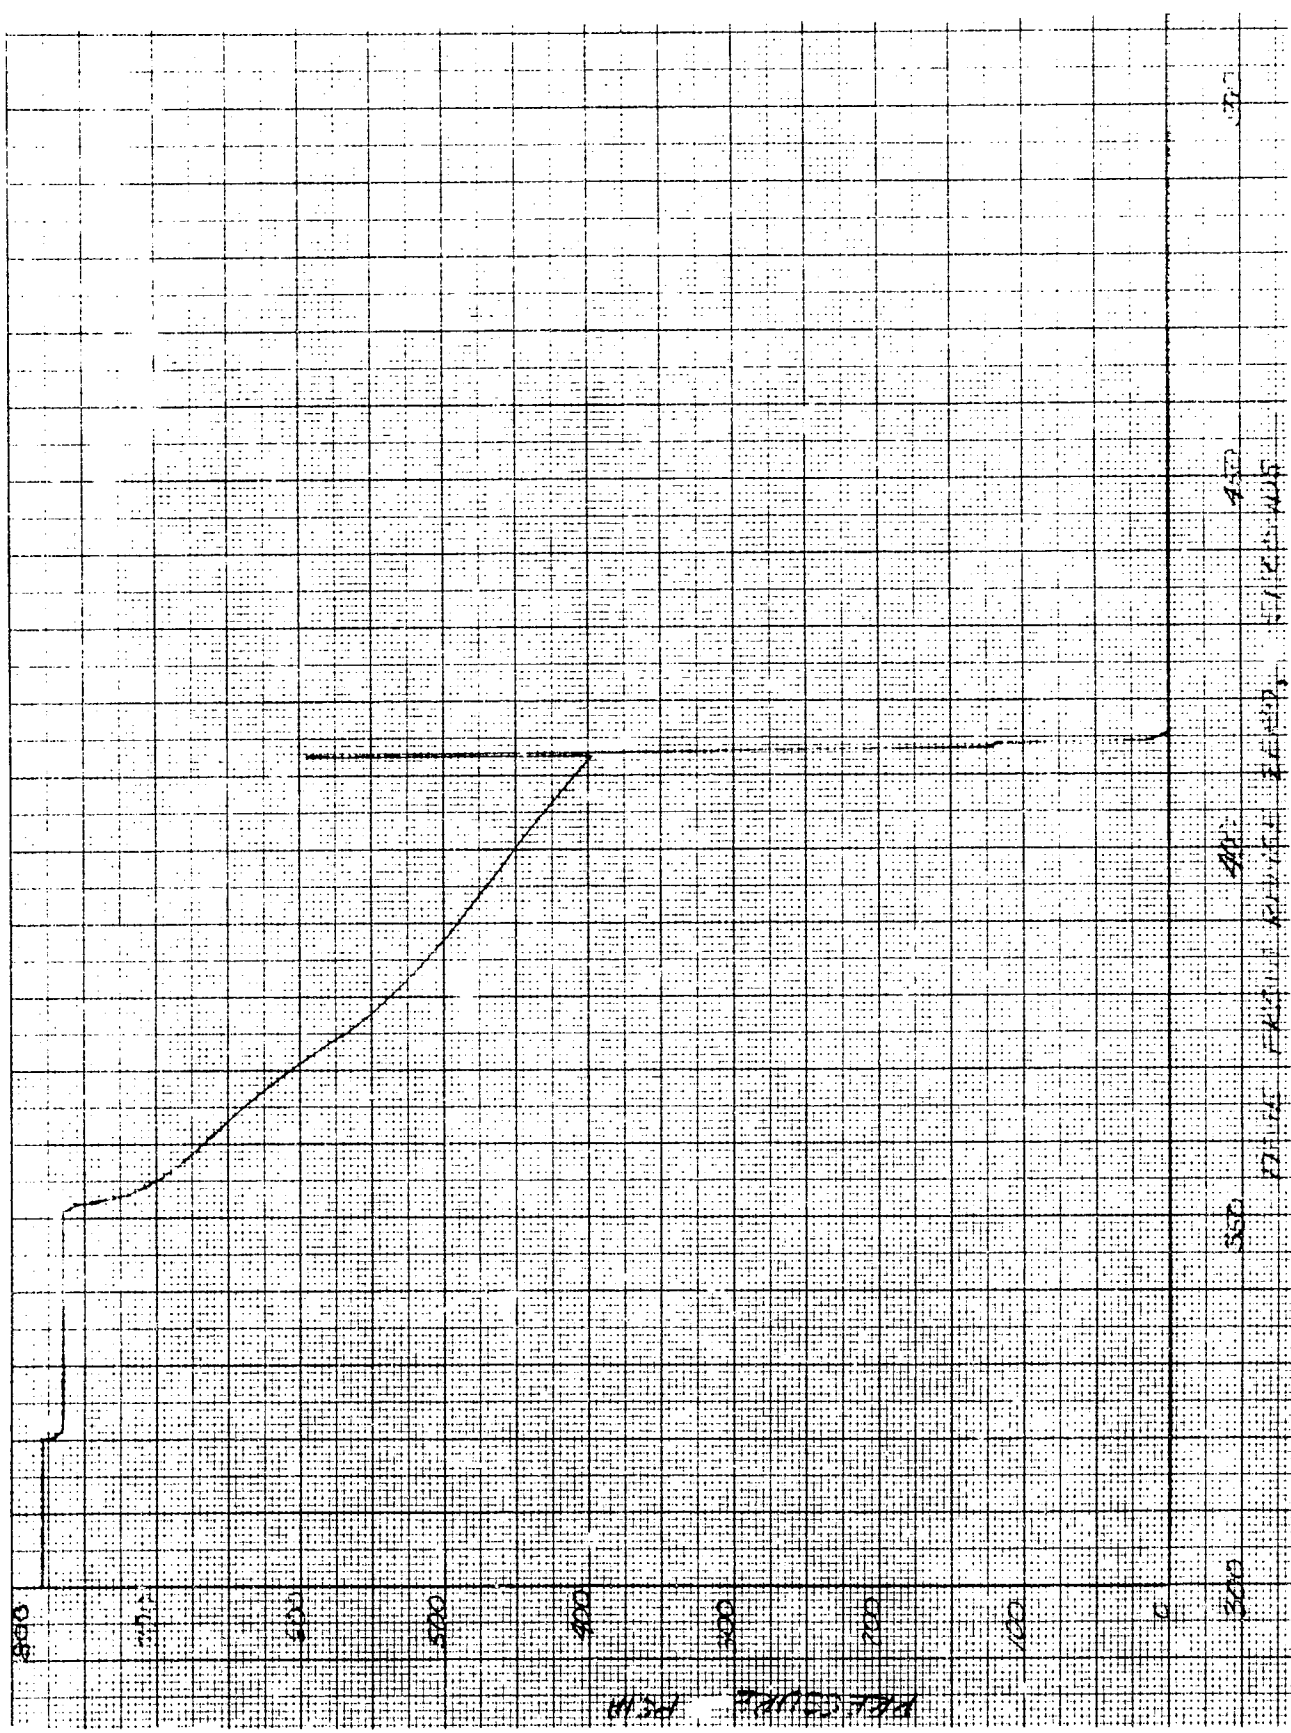
Figure 131. Engine 202 Gas Generator Oxidizer Injection Velocity

Starting at 350 seconds range time, gas generator oxidizer injection pressure began to decay from 760 psia. All other engine parameters continued at the 350-second levels. By 412.6 seconds range time, gas generator oxidizer injection pressure had decayed to 390 psia. At 412.7 seconds, gas generator oxidizer injection pressure spiked to 590 psia, and then decayed

during the cutoff transient (Fig. 131). During the period in question, engine compartment and engine component temperatures indicated cooling in the area of Engine 202.

Decay of gas generator oxidizer injection pressure resulted from plugging of the gas generator oxidizer injection pressure line, probably with solid oxygen, between the gas generator oxidizer injection manifold port and the tee to the gas generator oxidizer injection pressure transducer. Continued pressure decay resulted from leakage past the gas generator oxidizer purge check valve or from continued cryogenic chilling of the gas generator oxidizer injection pressure line.

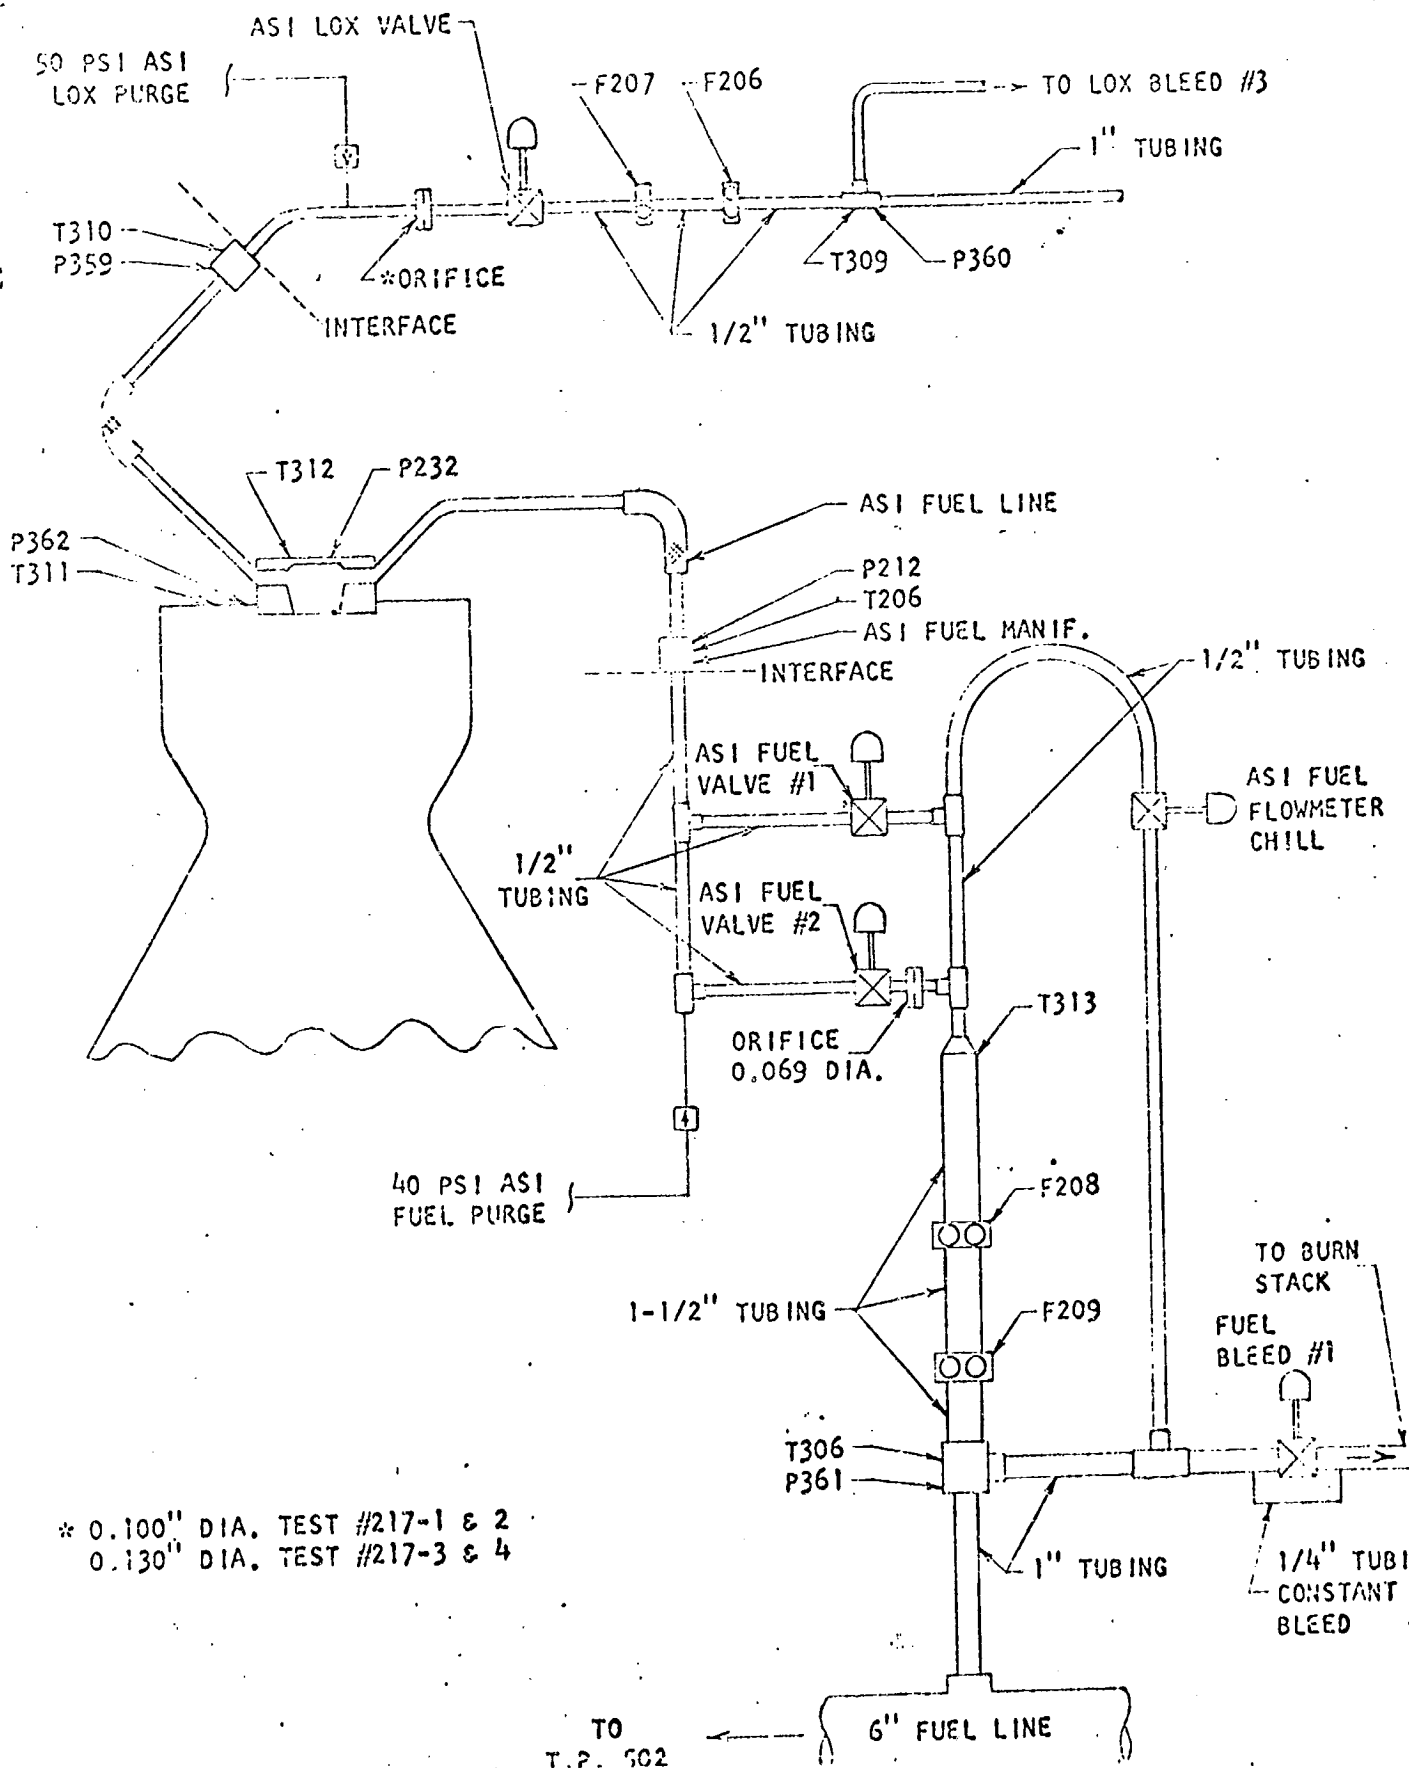
Figure A-4. ASI Feed System Schematic

approximate an ASI fuel line rupture and resultant ASI mixture ratio of 10:1 (o/f). The test setup utilized is illustrated in Fig. A-4.

Significant main injector, main chamber, and ASI seal damage was incurred during test 217-4. A total of 15 oxidizer passages (including two oxidizer "doghouses") were violated by erosion. Very intense continuous main injector burning and erosion began immediately after the No. 1 ASI fuel valve (Fig. A-4) was ramped closed; the burning continued until approximately 3 seconds prior to cutoff at which time the burning appeared to diminish slightly. Two thrust chamber tubes in the lower nozzle were ruptured during test 217-4; analysis of test data and instrumentation motion pictures and appearance of the ruptured tubes indicate that the damage was caused by ejected injector material striking the nozzle interior
