J-2 ENGINE AS-502 (APOLLO 6)

FLIGHT REPORT

VOLUME 3: S-IVB STAGE FAILURE ANALYSIS

DATE 17 June 1968

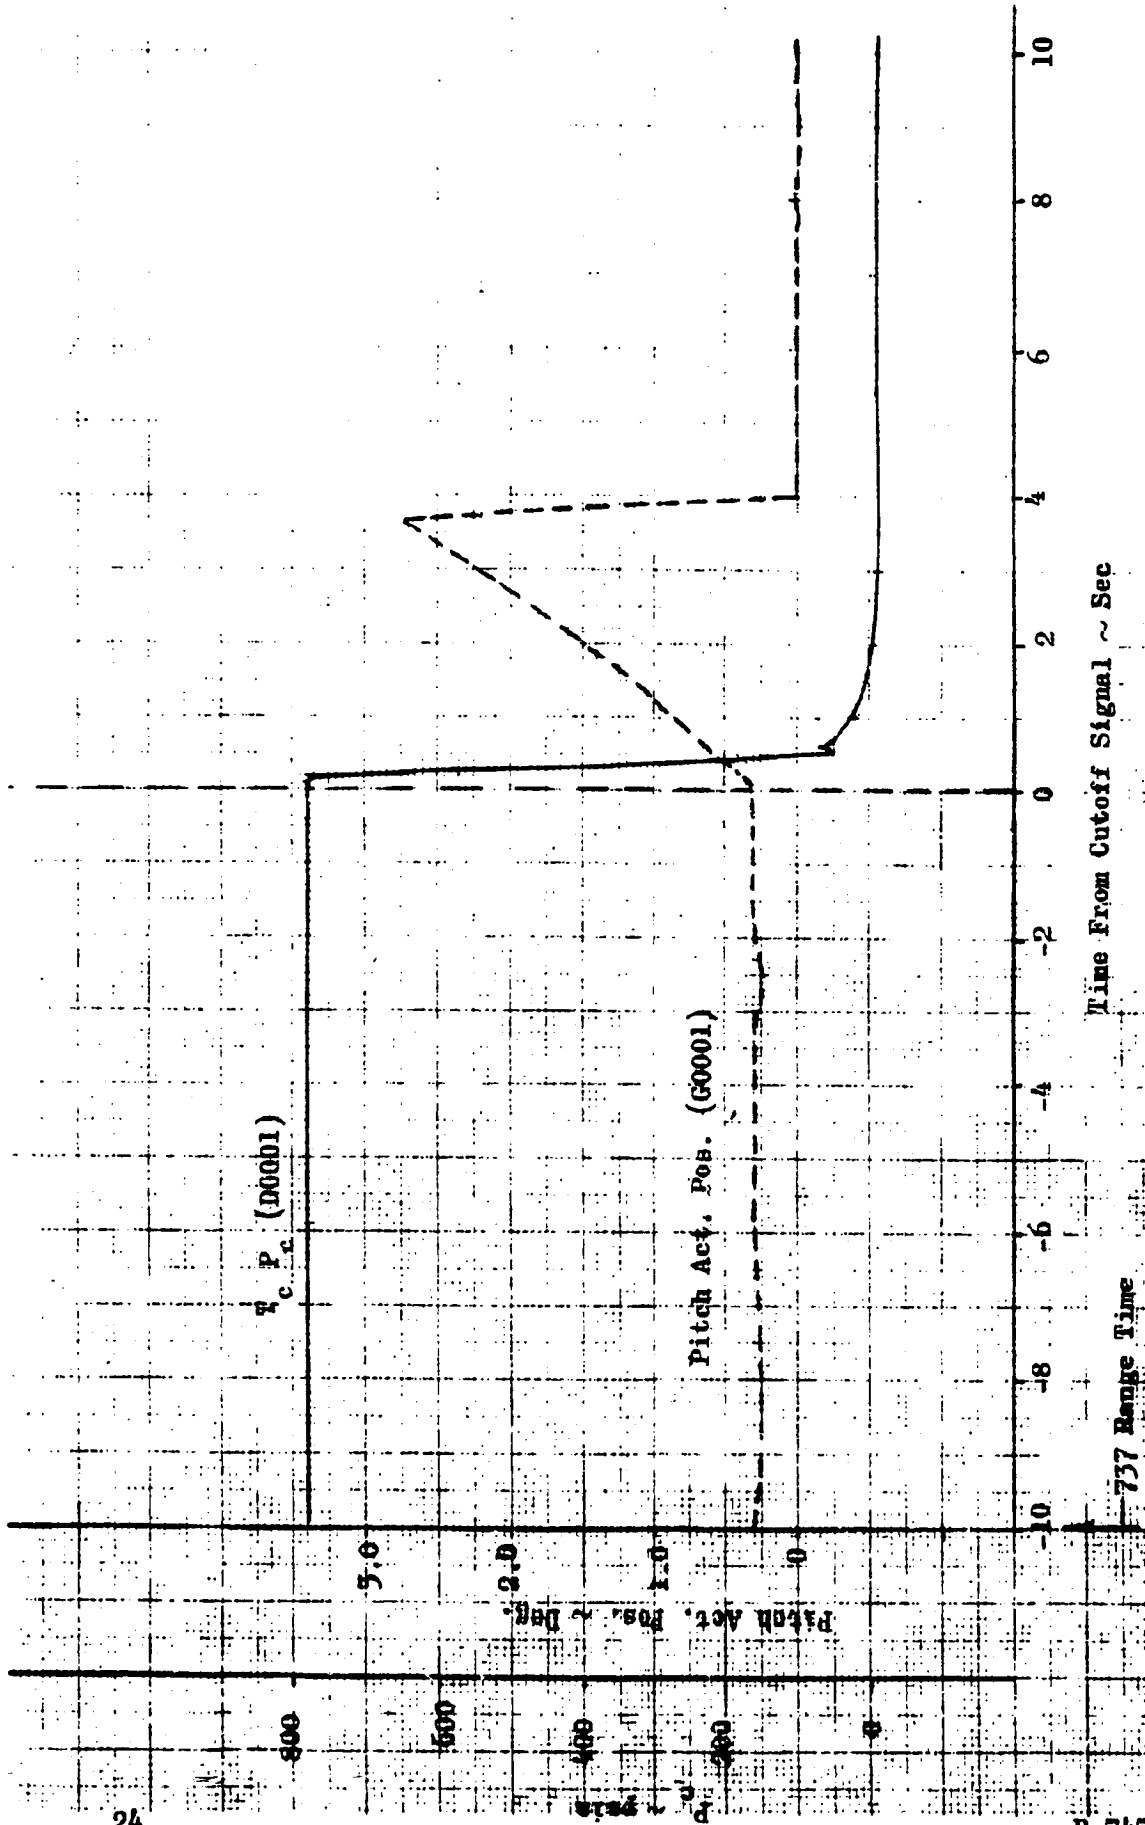
Figure 12. Pitch Actuator Position and Thrust Chamber Pressure vs Time From Cutoff Signal, AS-502 S-IVB, First Burn

The pitch transient at cutoff was induced by the vehicle and was a normal system behavior. Chi (χ) freeze guidance mode began 8 seconds prior to S-IVB stage engine cutoff, as intended. This mode locks out guidance and helps reduce the transients going from burn to coast. When this occurred, a substantial error signal was still being impressed by guidance to the flight control servosystem. The abrupt removal of the command signal produced a momentary imbalance in the servosystem, together with the thrust tailoff, resulted in the displacement of the pitch actuator. "S-IVB Burn Mode Off" at 750.8 seconds subsequently returned the pitch actuator to the null position, as intended.

No hardware damage resulted from the gimbal transient at cutoff, as evidenced by the normal engine start operation during subsequent restart.

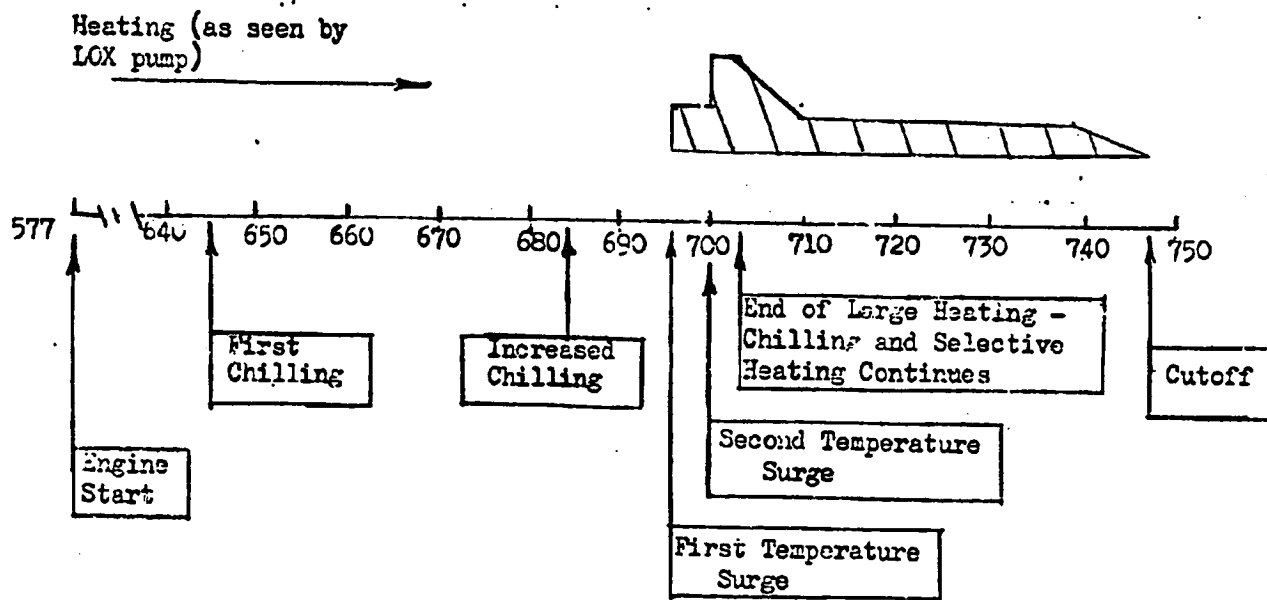
Figure 13. First-Burn Thermal Environment

1. A small cryogenic hydrogen leak started at 645 seconds and substantially increased in magnitude at 684 seconds.
2. The leak was downstream of the main fuel valve. (This includes the ASI fuel line.)
3. The location of greatest chilling was in the area of the upper ASI fuel line.
4. Two heating surges were seen; one at 696 seconds and the other at 700 seconds.
5. A low level of heating continued on the oxidizer pump side of the engine (until nearly cutoff) as a result of hot-gas leakage from the ASI; chilling resumed on the fuel pump side of the engine because of the liquid hydrogen leakage from the ASI fuel line.

The first heating surge was most likely associated with the rupture of the J-2 engine ASI fuel line at the break interface and the second heating surge with the resulting ASI failure caused by back flow from the ASI.

1. Engine compartment temperature decrease starting at 645 seconds and increasing in magnitude at 684 seconds.
2. Engine compartment heating at 696 and 700 seconds.
3. Chilling and selective heating following 703 seconds.

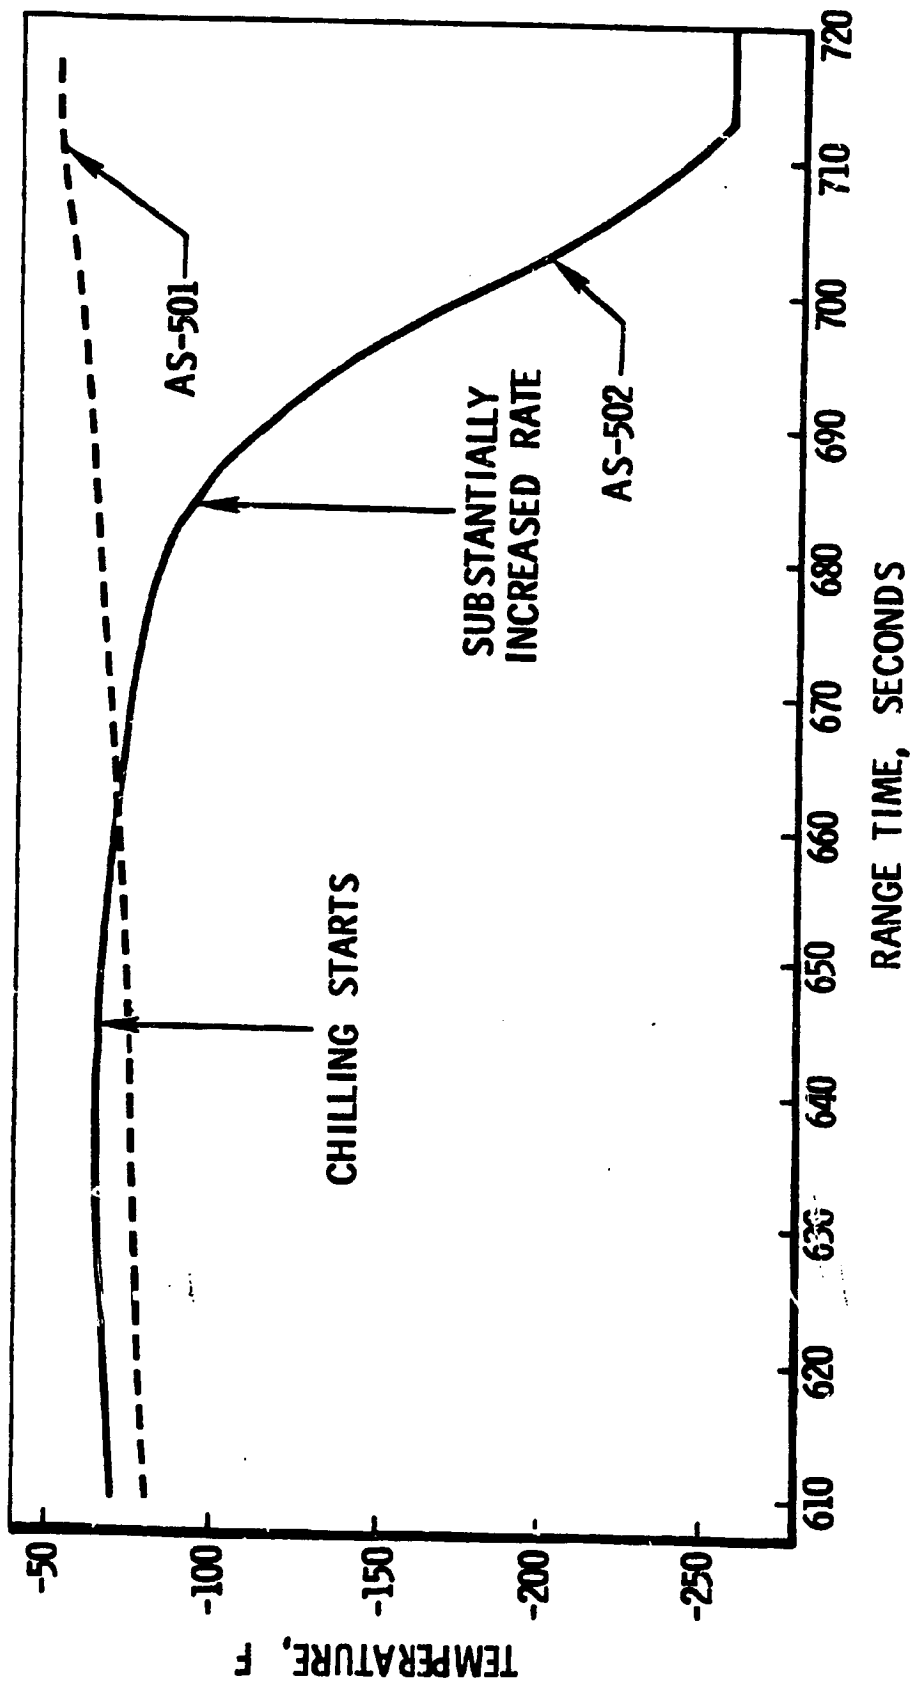
Figure 15. First-Burn MOV Closing Control Line Temperature, S-IVB Engine J2042

Data. MOV closing control line temperature (Fig. 15) is representative of the engine compartment chilling that started at 645 seconds and was noted on at least six other low thermal mass parameters. At 684 seconds, the chilling rate substantially increased and was noted on at least five additional measurements.

Analysis. A comparison of the AS-501 and AS-502 MOV closing control line temperature (Fig. 15) demonstrates that, on AS-502, a chilling of the measurement began at 645 seconds. At least six other low thermal mass measurements also showed chilling at this time. This is indicative of a small cryogenic leak. The leak rate increased substantially at 684 seconds, as indicated by the increased chilling rate on the smaller thermal mass components and the beginning of chilling of larger thermal mass components. Some of these parameters are the MOV actuator (Fig. 16), gas generator valve position indicator (gas generator valve position shifts), and gas generator fuel inlet wall (Fig. 17). These parameters are located on the fuel pump side of the engine (Fig. 14).

From the temperature decrease observed (to less than -260 F on the MOV closing control line), it is known that the leak is cryogenic in nature. Both engine helium usage and the hydrogen and helium pressurization flows from the engine were normal during the first burn and, therefore, it is known these systems are not responsible for the leakage.

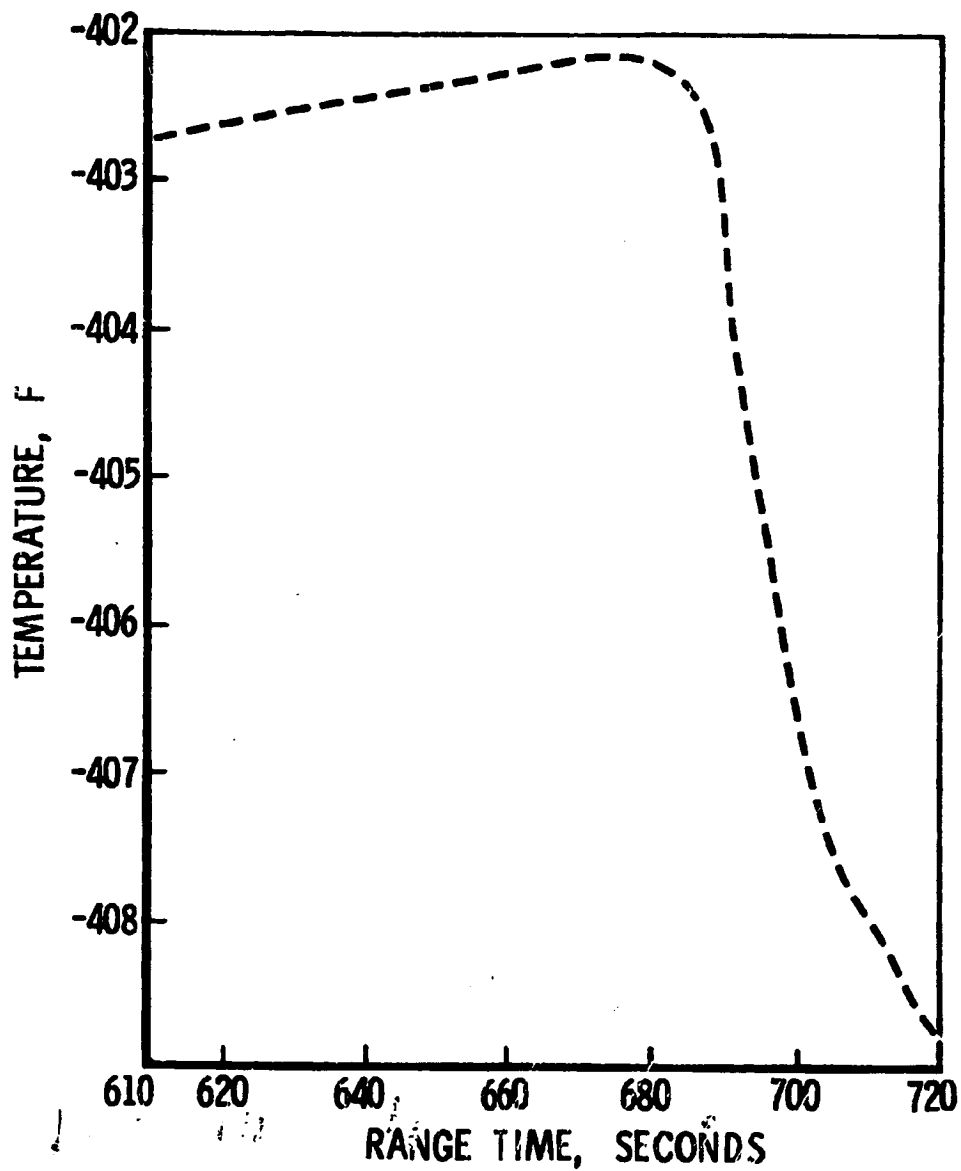
Figure 17. Gas Generator Fuel Inlet Wall Temperature, S-IVB Engine J2042

possible with oxygen expansion (-380 F is the minimum temperature for the vacuum environment encountered). The gas generator fuel inlet wall temperature (Fig. 17) attained -409 F, and from this it was concluded the leak source was hydrogen rather than oxygen. By knowing the properties as a function of distance of the expanding liquid in a vacuum, and the rate of chill of different components, it was possible to locate the general area of the leak source as the upper section of the ASI fuel line.

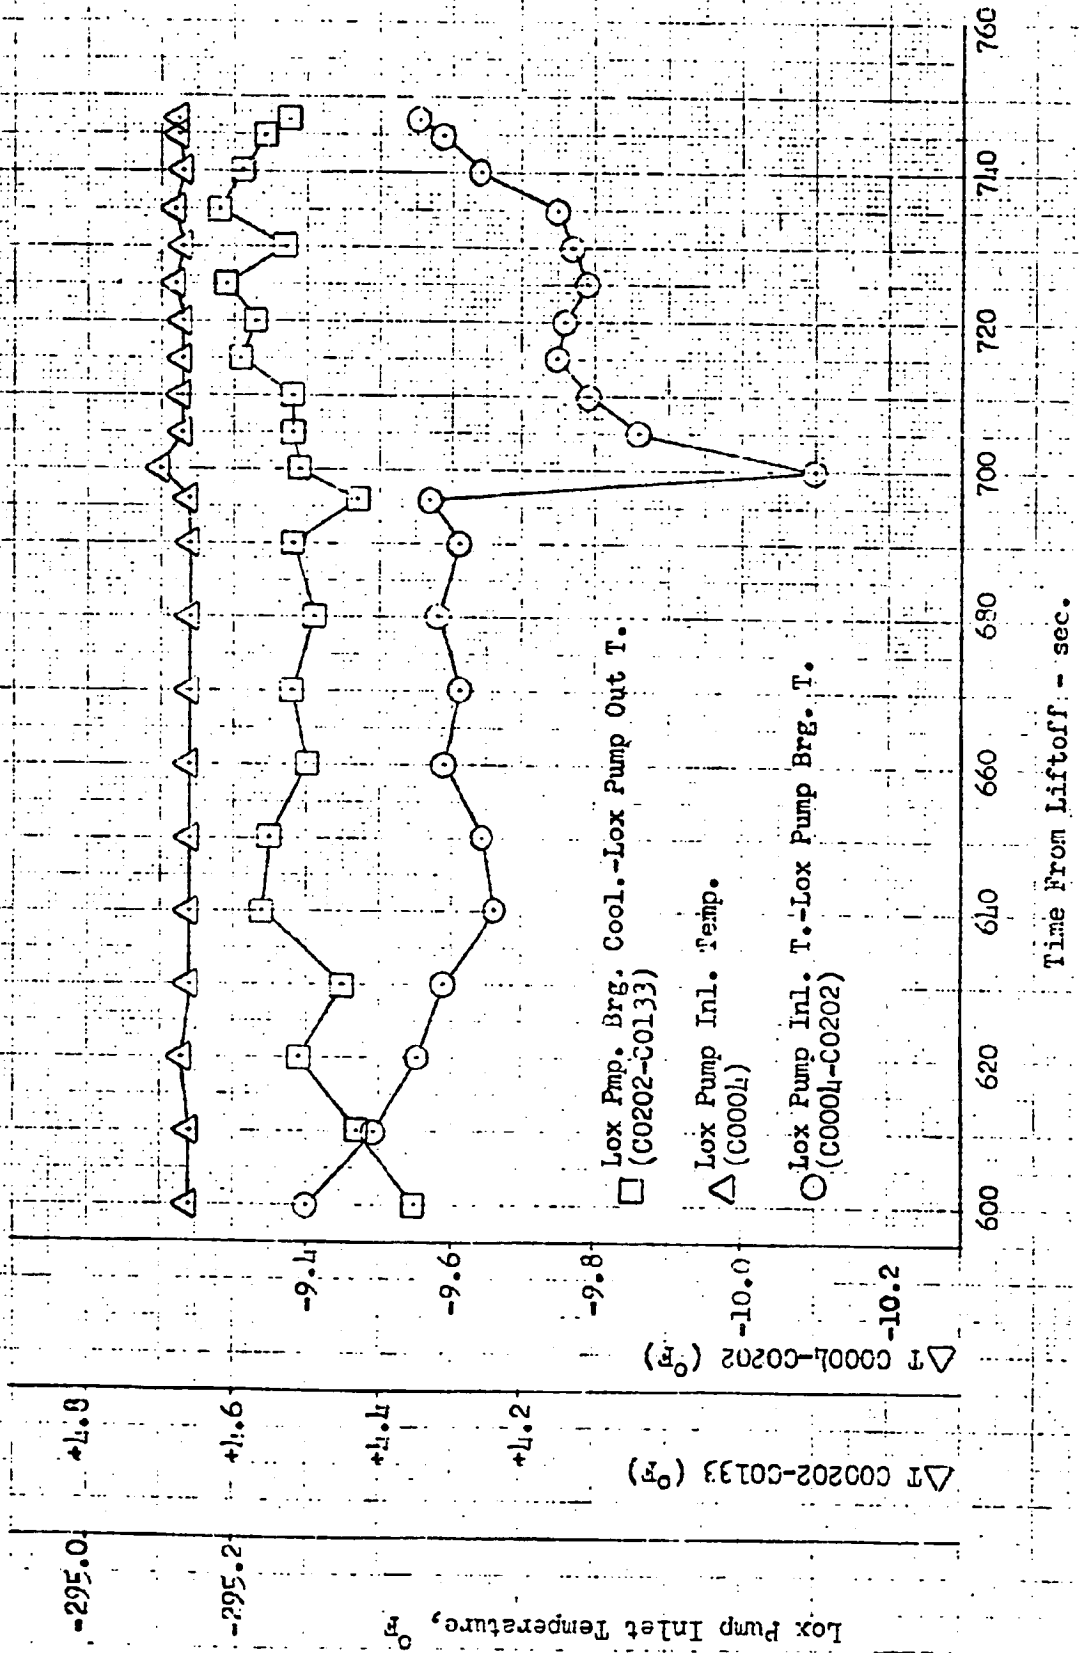
Figure 20. AS-502 S-IVB First Burn, Oxidizer Pump System Temperatures

oxidizer system was found (Fig. 20). The pump inlet-to-bearing coolant change in temperature yields the heating across the pump, whereas any heating to the pump discharge ducting would be reflected in the bearing coolant-to-pump discharge measurement. A small temperature increase was seen at the oxidizer pump inlet (0.04 F maximum with a sustained level of 0.01 F), but the largest temperature increase was seen between this measurement and the oxidizer pump bearing coolant (0.5 maximum with a sustained level of 0.15). No heating was seen on the discharge ducting. Therefore, some small heating persisted after the initial temperature surge to the oxidizer pump inlet ducting until nearly cutoff.

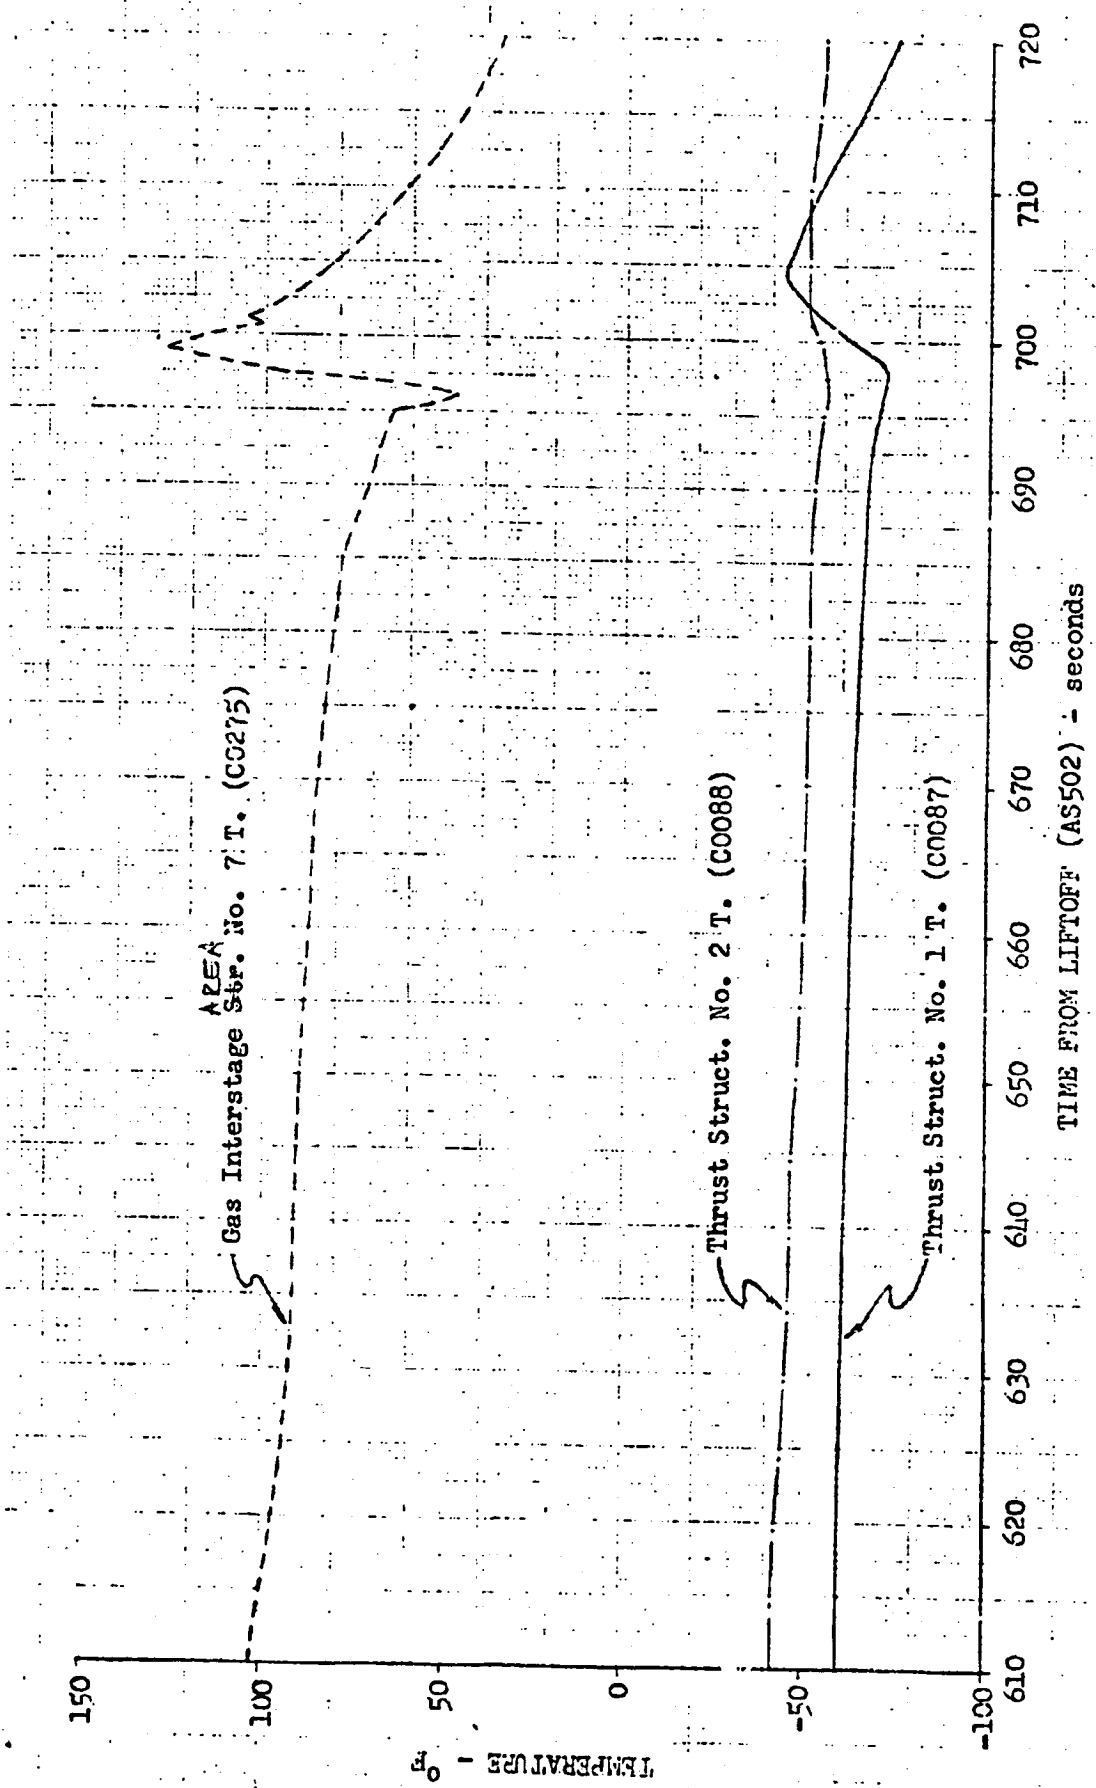
Figure 21. AS-502 S-IVB First Burn

the fuel pump side of the engine showed heating until 703 seconds but, after this time, chilling was observed to be the predominant thermal effect (Fig. 21). Hot gas undoubtedly was present on the fuel side of the engine, but the chilling effect of the hydrogen was dominant. This would be expected with failure of the ASI fuel line because of the large liquid hydrogen leak flow.

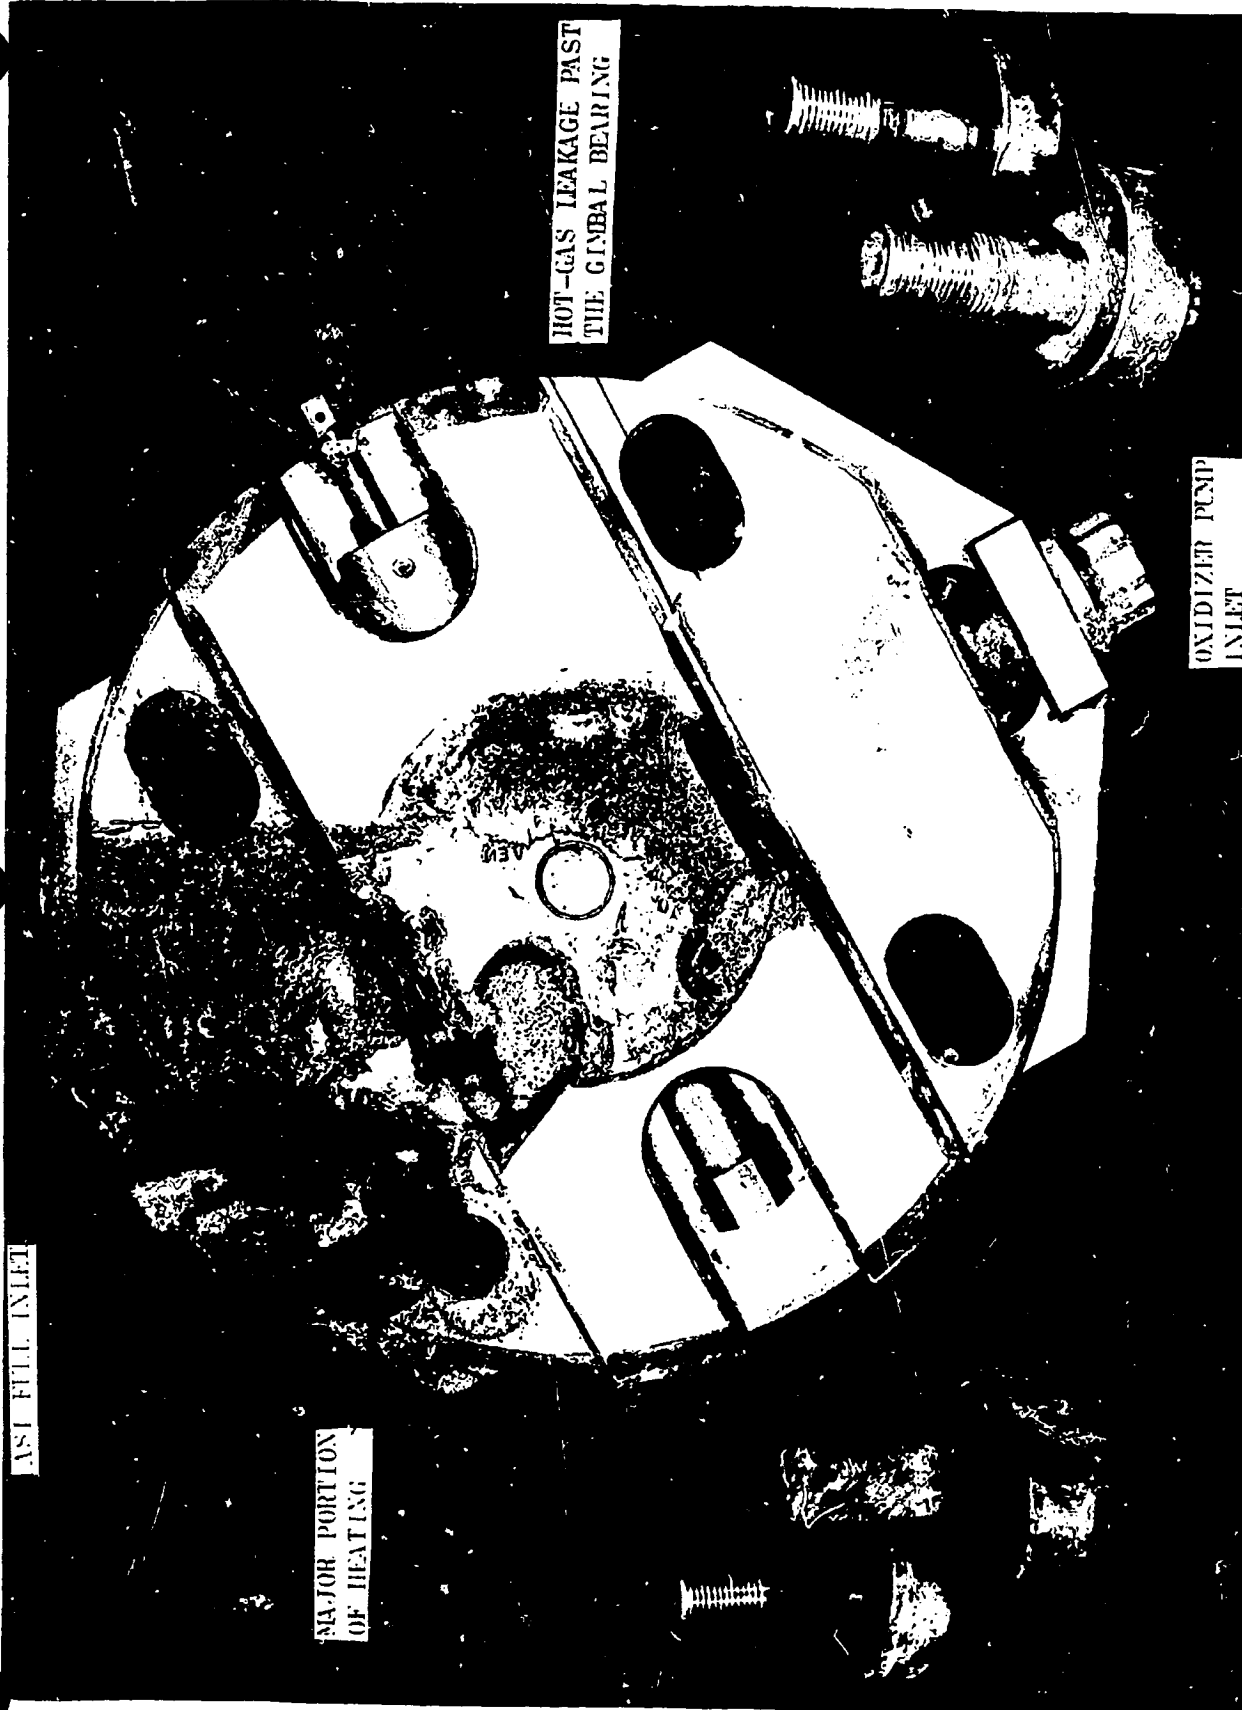
Figure 22. J016-4 Posttest 313-041 Engine Side of Gimbal Bearing Showing Heating From ASI Hot Gas

Heating of the oxidizer pump side of the engine was experienced on engine J014-6 partially because of hot-gas leakage past the gimbal bearing (Fig. 22). This would account for the similar condition that was present during flight. The difference between the oxidizer pump inlet and oxidizer pump bearing temperature for the test on engine J016-4 was 0.5 F during the time of sustained heating. This substantiates the fact that heating to the oxidizer side of the engine can occur from ASI fuel-side hot-gas leakage. (The magnitude of heating cannot be compared because the conditions encountered on flight were not present.)

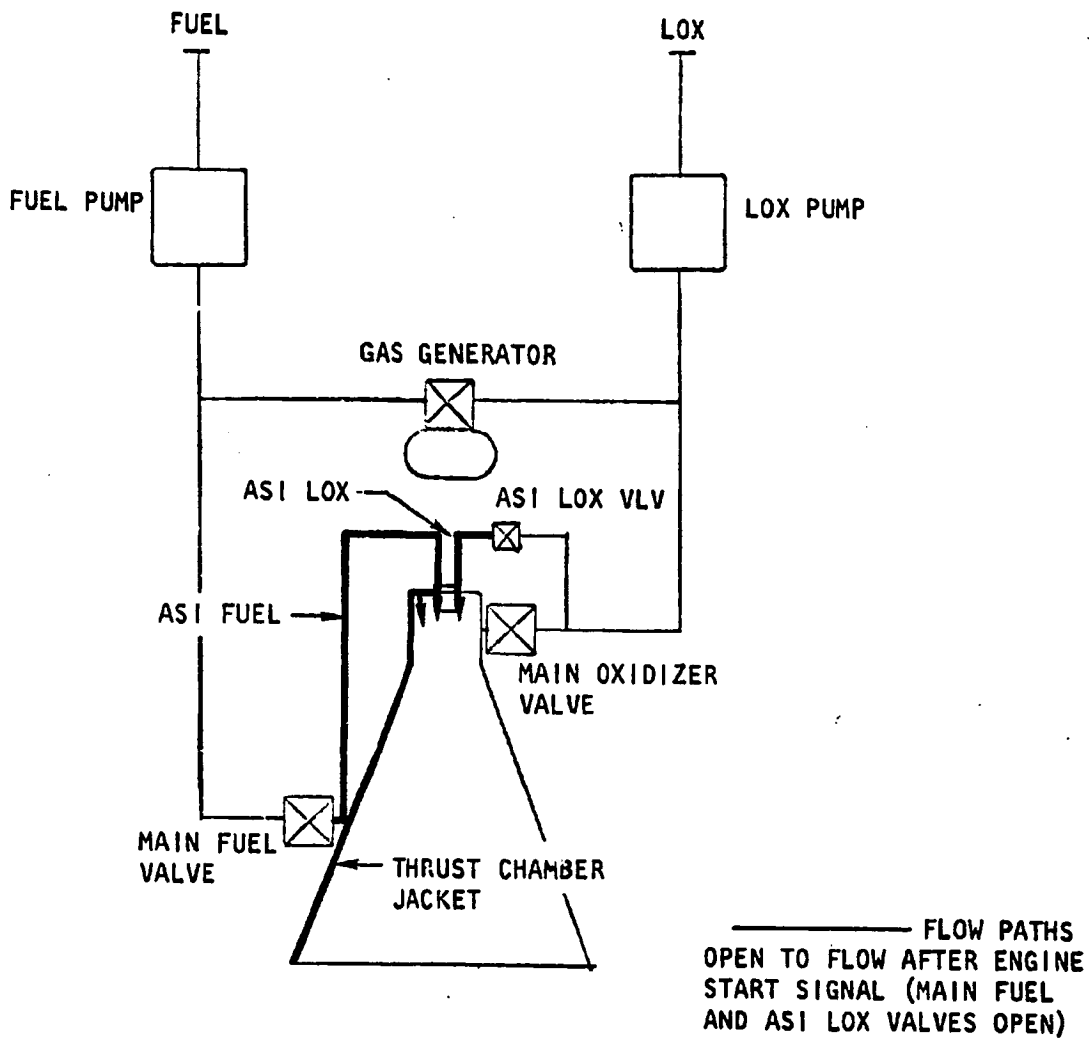
Figure 24. J-2 Engine System Leakage Paths Open Between Engine Start and STDV Signal

Figure 23 shows the MOV line temperature measurement is not chilled until after engine start command. Because propellants are down to all engine valves prior to engine start, it must be concluded that the source of leakage is in the areas shown in Fig. 24. either downstream of the MFV, including the ASI fuel line, or downstream of the ASI oxidizer valve. Other engine parameters showed chilling after mainstage signal when the pumps have developed sufficient pressure to produce the flows required to chill these parameters. No parameters showed heating, thus eliminating the gas generator and exhaust system as the source of hot gas. These data support the earlier hypothesis of failure of the ASI fuel line.

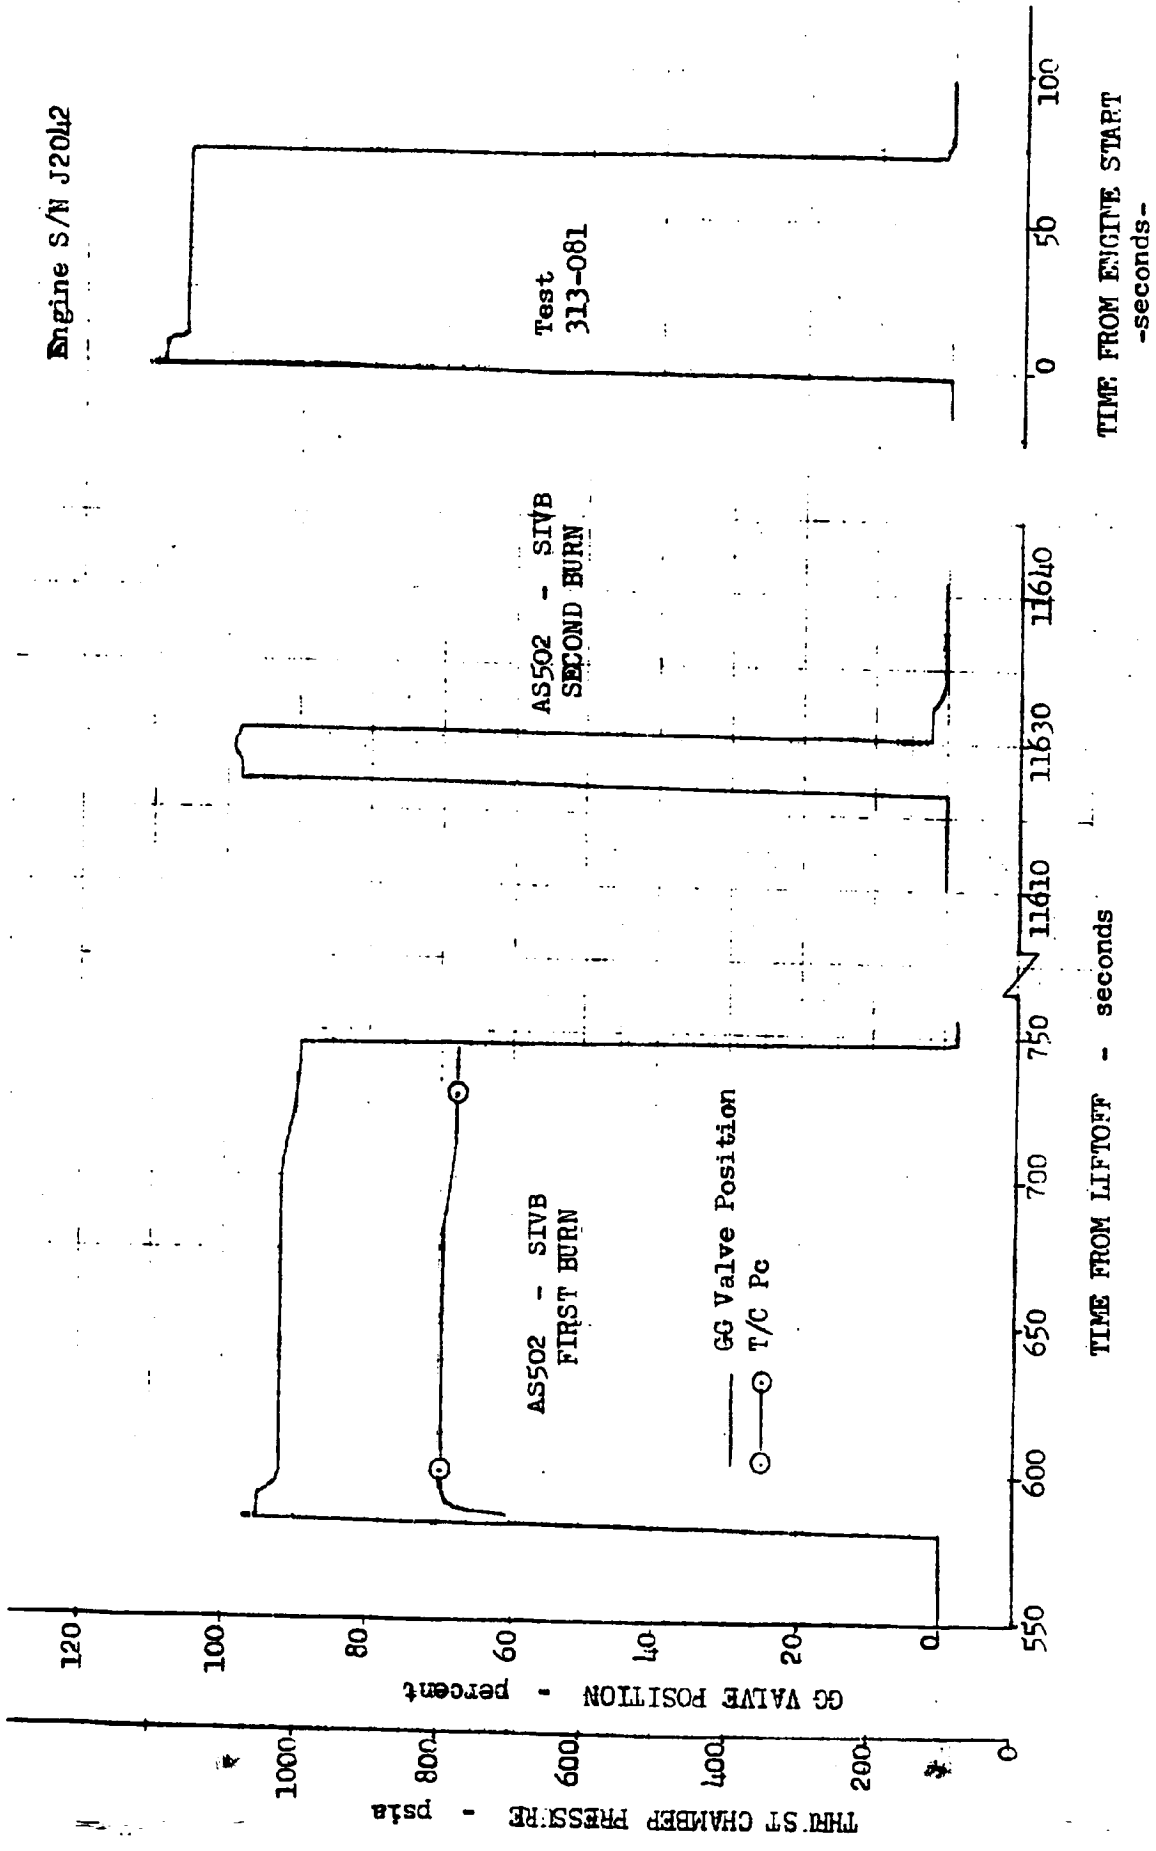
Figure 25. Gas Generator Valve Position Comparison

In the time span between 680 and 745 seconds from liftoff, the gas generator valve position trace indicated an abnormal drift of 3.2 percent toward closed (Fig. 25). Because the drift was coincident with the engine performance changes and the other anomalies, a study was conducted to determine its cause, and to establish if it could have contributed to gas generator and engine performance decay.

A plot of gas generator valve position and chamber pressure versus time from liftoff for S-VB first and second burn is shown in Fig. 25. On the first burn, the valve position exhibited the typical overshoot at start, held at 92 percent until 685 seconds, and then drifted toward closed. At engine cutoff (747 seconds), the valve had drifted to 89-percent open and the position versus time trace still was trending closed. A plot of valve position versus time for a typical firing also is plotted in Fig. 25.

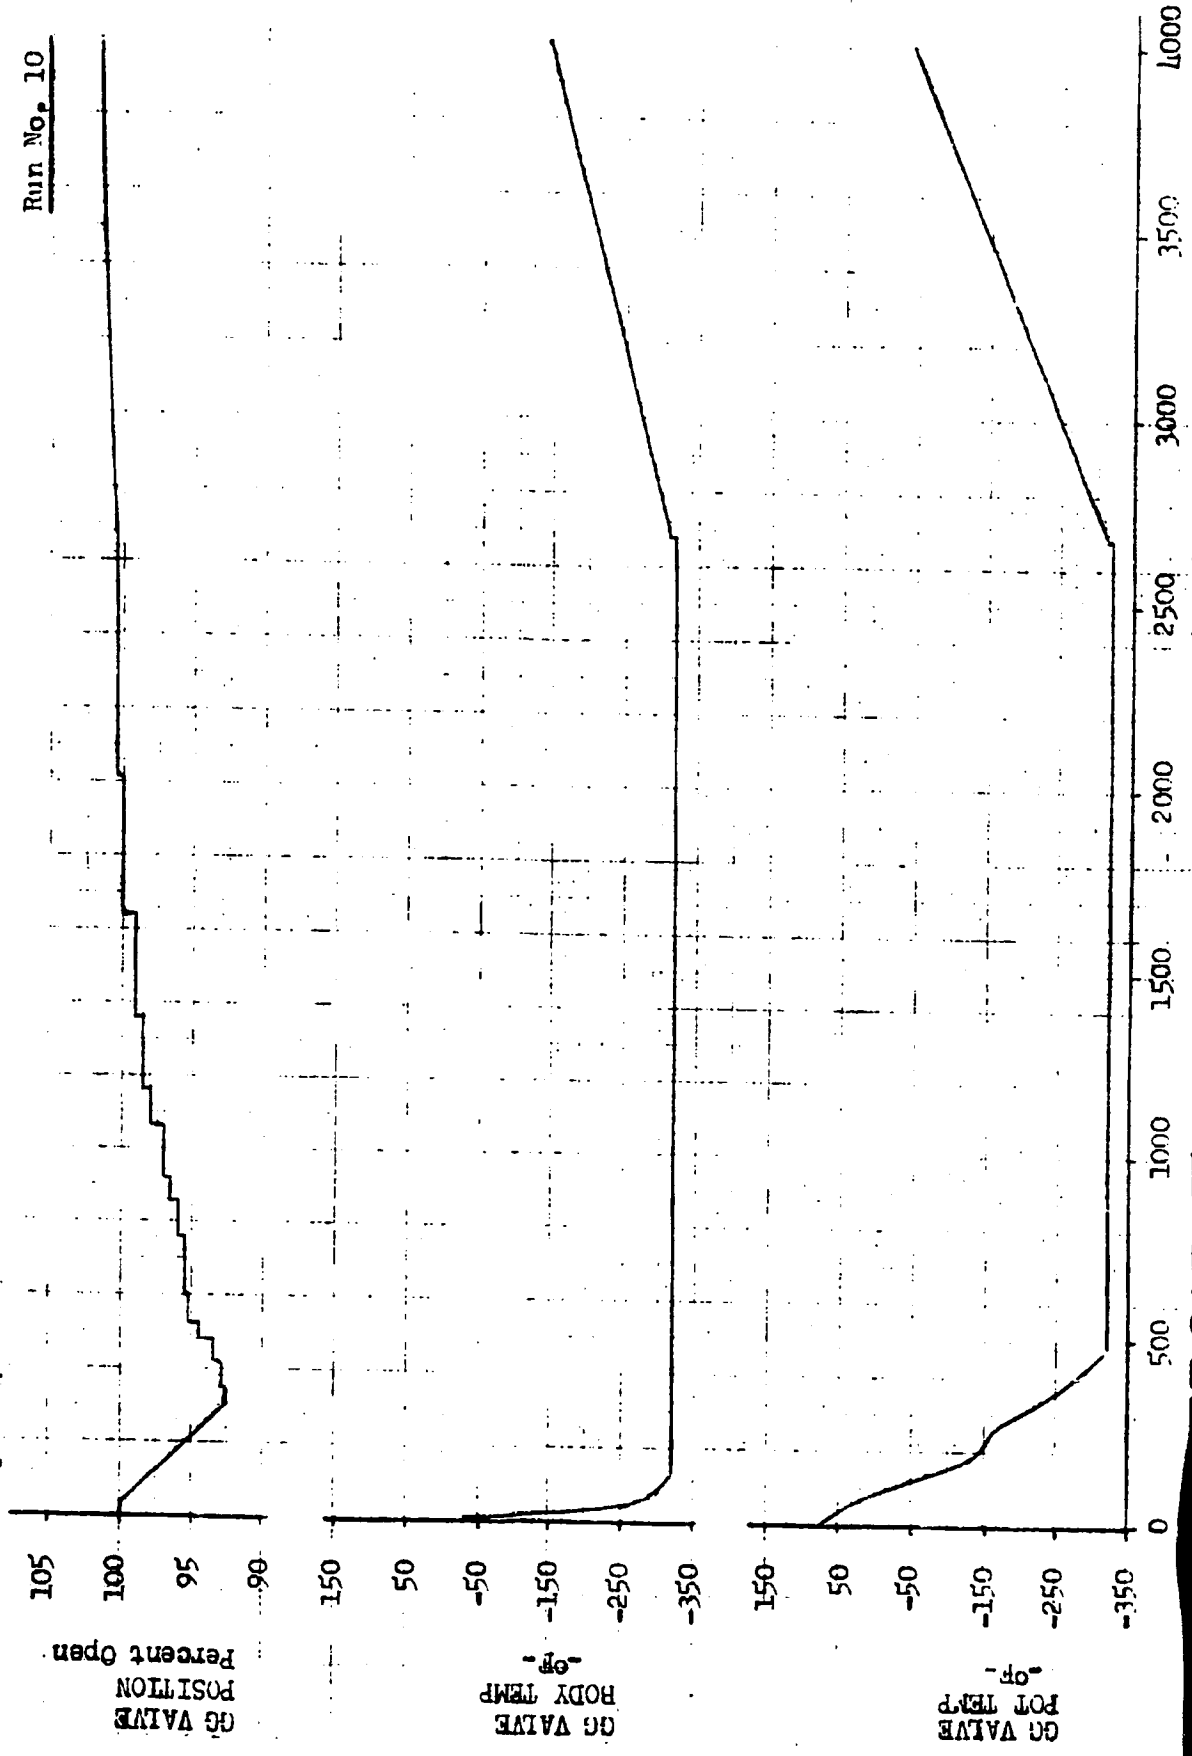
Figure 29. Gas Generator Valve Position and Valve Body Temperature vs Time

The apparent valve motion is the result of differential contraction between the housing and internal components, caused by chilling from the external cryogenic leak. As illustrated on test No. 11, very rapid chilling of the potentiometer alone will not cause the motion. It is caused by temperature difference between the body and internal components. As chilling continues, the internal components finally chill and the motion reverses itself as shown in Fig. 29.

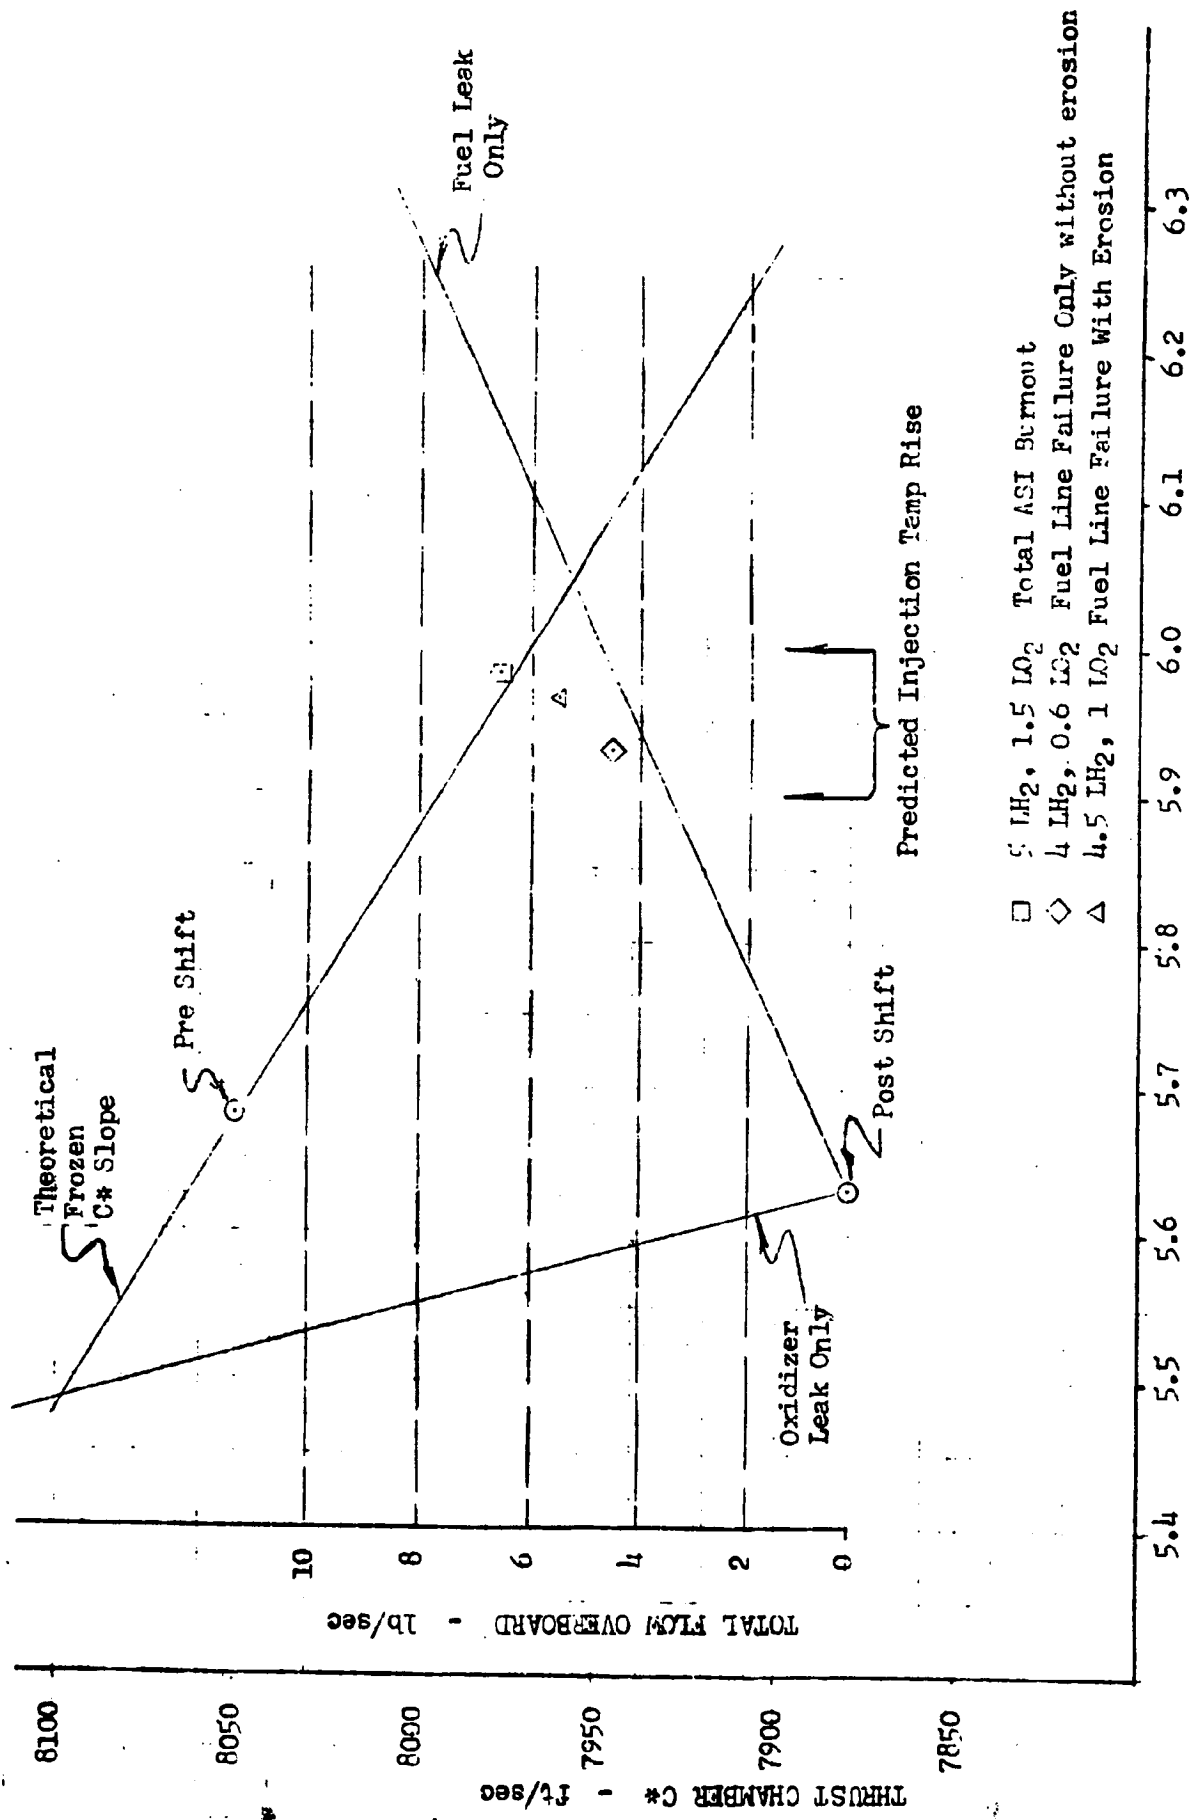
Figure 42. AS-502 S-IVB First Burn, Thrust Chamber Performance

Figure 42 depicts the indicated thrust chamber c^* versus thrust chamber mixture ratio before and after the total shift of 684 to 702 seconds range time, as determined by the PAST 641 ALTITUDE REDUCTION program. The c^* after the shift can deviate from the theoretical frozen equilibrium slope (known to be an adequate description of engine operation over the range in question) because of loss of flow overboard downstream of the engine flowmeters, which can be represented by a total fuel, oxidizer, or combination of leakage varying the mixture ratio, or by a real c^* loss because of physical degradation of the injector. As noted in the figure, an oxidizer-only leak of 15 lb/sec or 5.5 lb/sec fuel-only leak is required to match the theoretical slope. From Fig. 41 (which charts the flows for a total break at various points in the ASI propellant feed system) such leakages would require, in the oxidizer case, a leak at the ASI oxidizer valve or, in the fuel case, a leak upstream of the second ASI line flex section. As previously discussed, an oxidizer leak only does not correlate with the indicated temperature phenomenon, i.e., the increase in main injection temperature, and the leak magnitude is not supported by oxidizer system pressure drops at constant mass flowrate. A fuel-only leak does not correlate with the indicated temperature phenomenon because the required source of leakage is well below the dome area and would predict a greater than observed increase in fuel injection temperature. A combination leakage of primarily fuel and some oxidizer flow overboard was, therefore, the most legitimate match both for the c^* slope and expected fuel injection temperature rise.

oxidizer overboard, associated with total ASI burnout, represents the other extreme of no loss of c^* because of main injector degradation, but would provide gas temperatures explaining the engine area heating. The best estimate, as discussed below, of 4.5 lb/sec hydrogen and 1.0 lb/sec oxidizer overboard during the flight also is shown in Fig. 42.

Based on the engine J016-4 test results, it is expected that the total fuel flow overboard for AS-502 S-IVB was approximately 4.5 lb/sec. This includes approximately 4 lb/sec from the failed fuel feed line which, based on SSFL results, would have been burned off upstream of the third flex section once complete backflow is established, and 0.5 lb/sec thrust chamber fuel backflow. Although the oxidizer feed line was not severed, the ASI fuel manifold burnout would have permitted approximately 1.0 lb/sec oxidizer overboard. It is expected that some real c^* efficiency loss in the main injector also was incurred, as indicated in Fig. 42.
