J-2 ENGINE AS-502 (APOLLO 6)

FLIGHT REPORT

VOLUME 3: S-IVB STAGE FAILURE ANALYSIS

DATE 17 June 1968

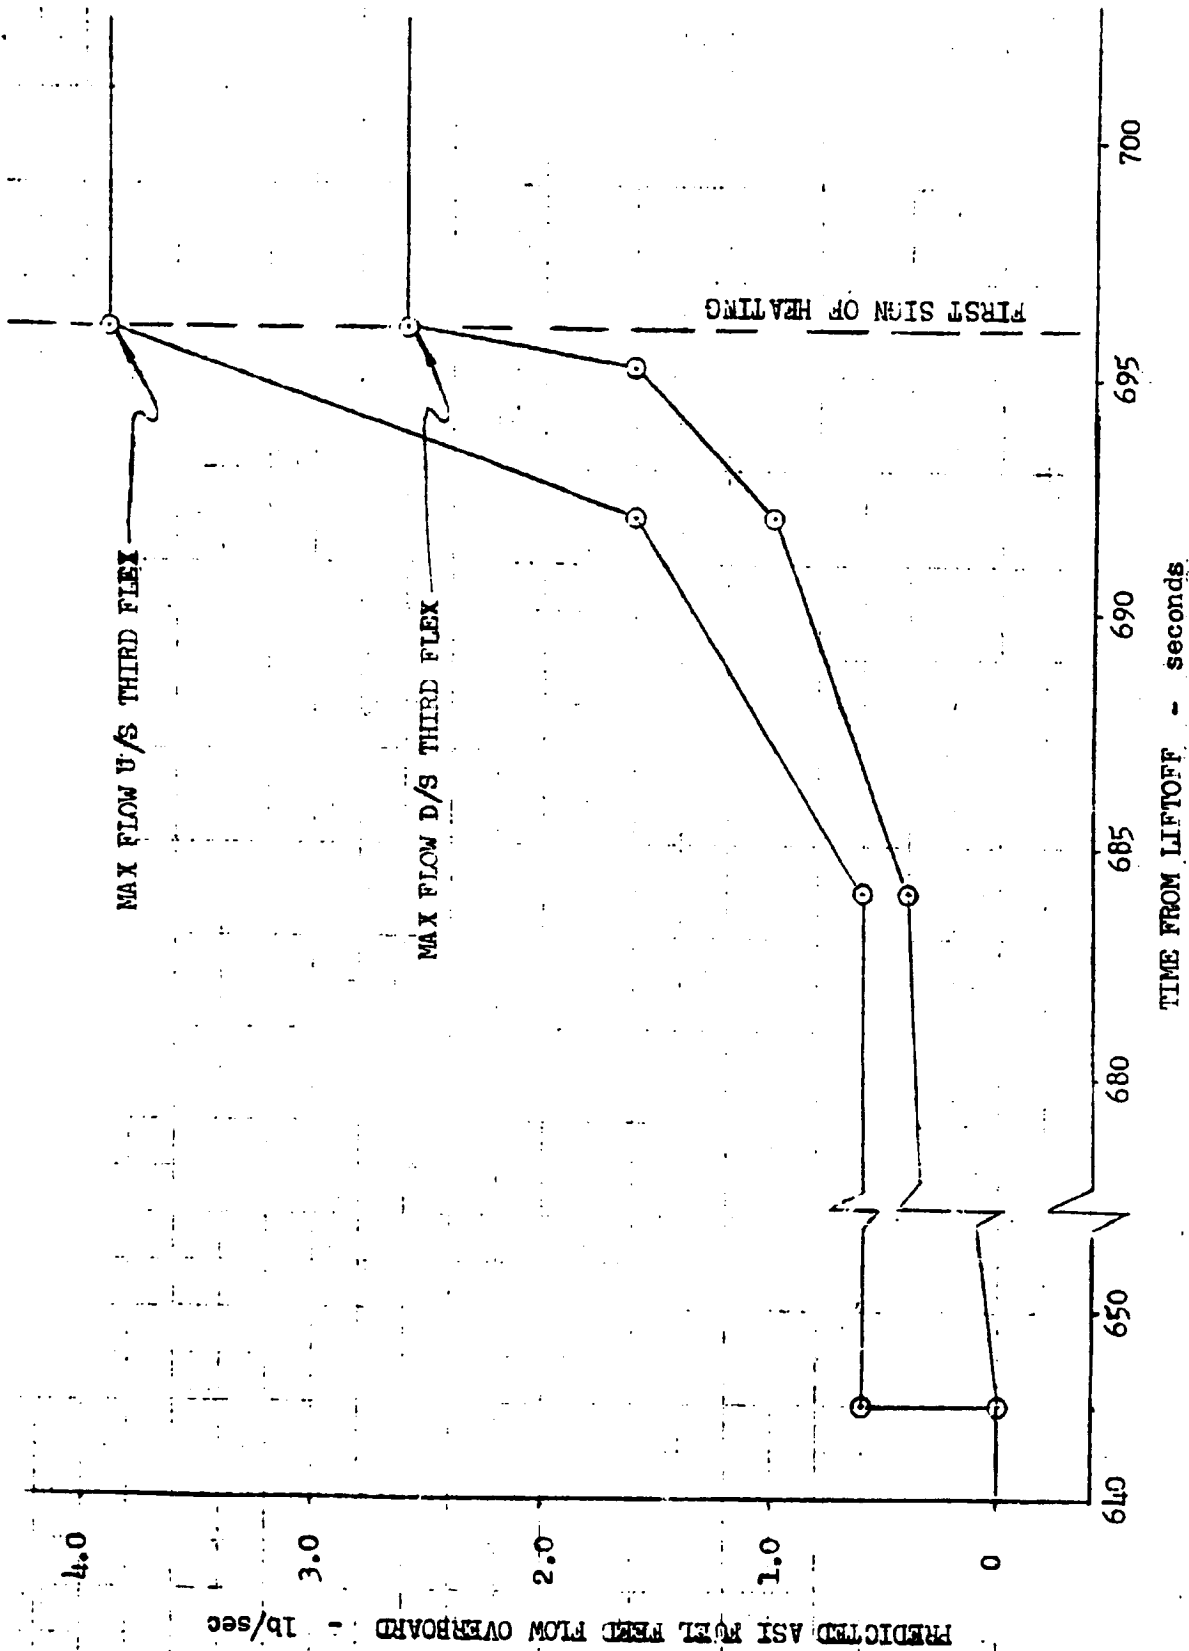
Figure 43. AS-502 S-IVB First Burn, ASI Fuel Feed Flow Overboard

Test Verification of Hypothesis. Figure 43 depicts the predicted range of fuel feed flow overboard versus time for AS-502 S-IVB in which minimum to maximum limits were picked by matching the following sequence of events:

1. Between 645 and 684 seconds range time, a constant or gradually increasing hydrogen leakage flow overboard between 0.4 and 0.6 lb/sec would be sufficient to cause chilling of the engine area without detectably affecting performance.
2. Between 684 and 692 seconds range time, a flowrate between 1.1 and 1.5 lb/sec would be sufficient to match performance as well as the increased chilling.
3. After 696 seconds range time, the first sign of heating indicating total line failure allows overboard flow between 2.6 and 3.9 lb/sec.

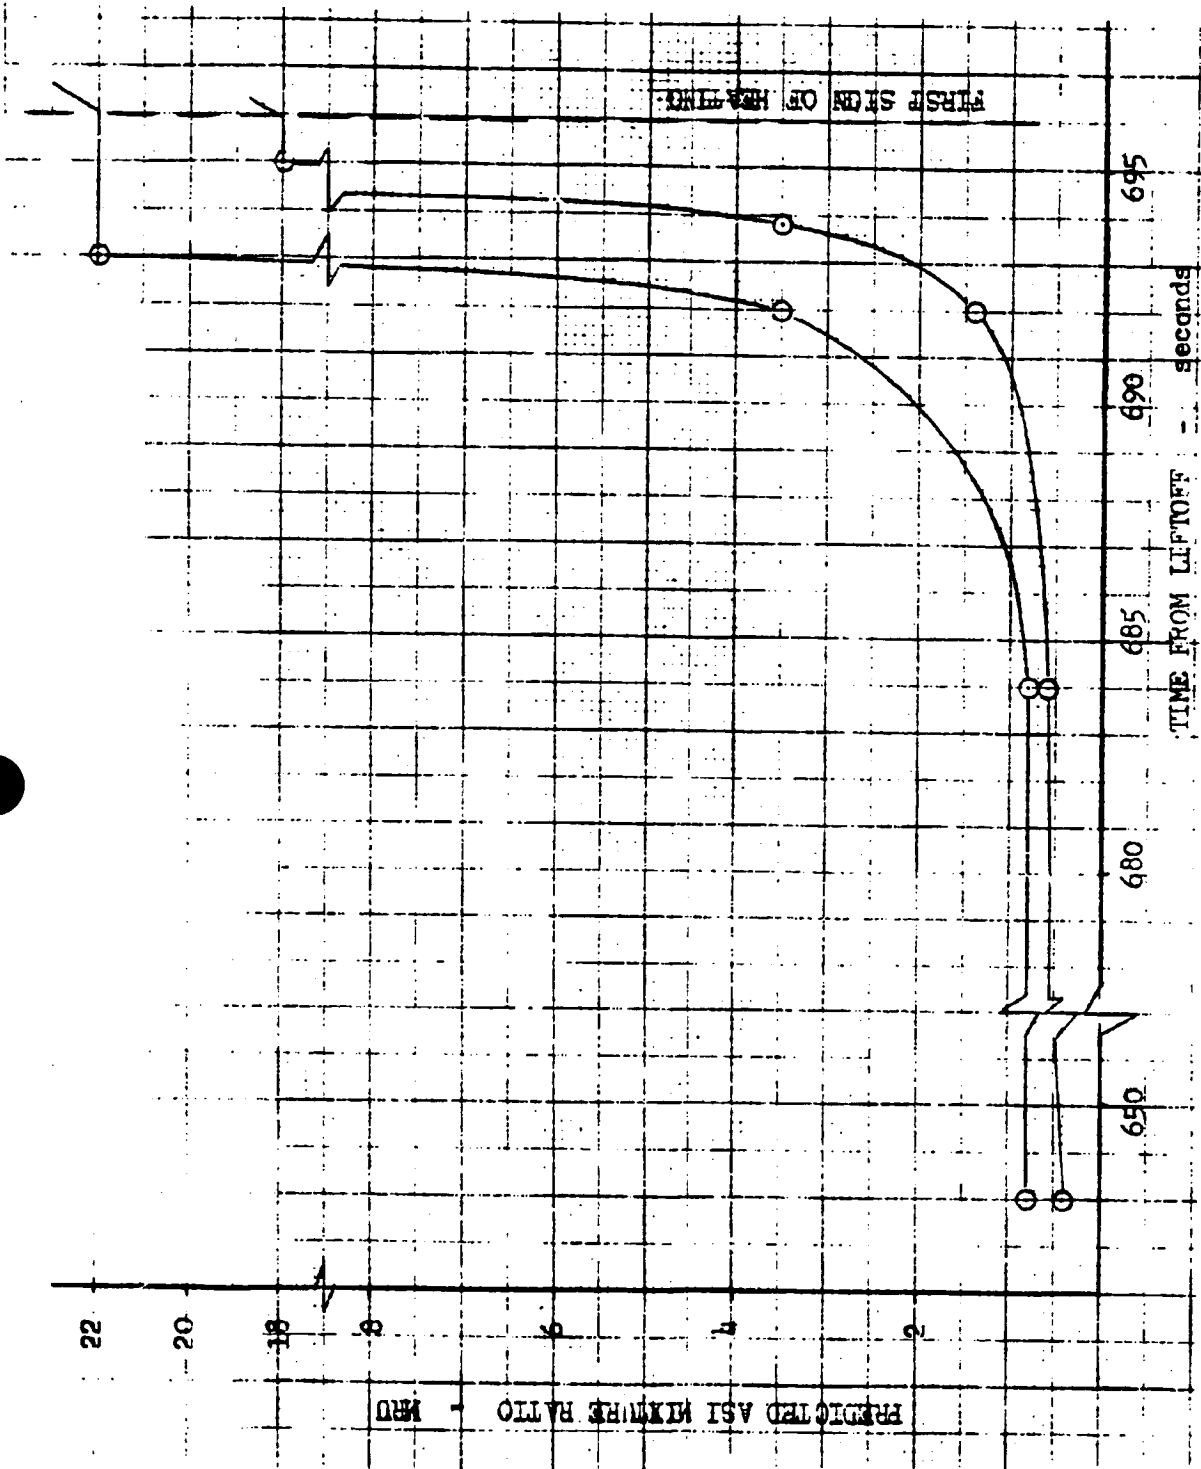
Figure 44. AS-502 S-IVB First Burn, ASI Mixture Ratio

These limits resulted in the predicted mixture ratio limits shown in Fig. 44 for the AS-502 flight which were utilized to program a simulated test at SSFL on engine J016-4 (Verification Testing section). The most important factors of the failure hypothesis to be verified or disproved by the test were the following:

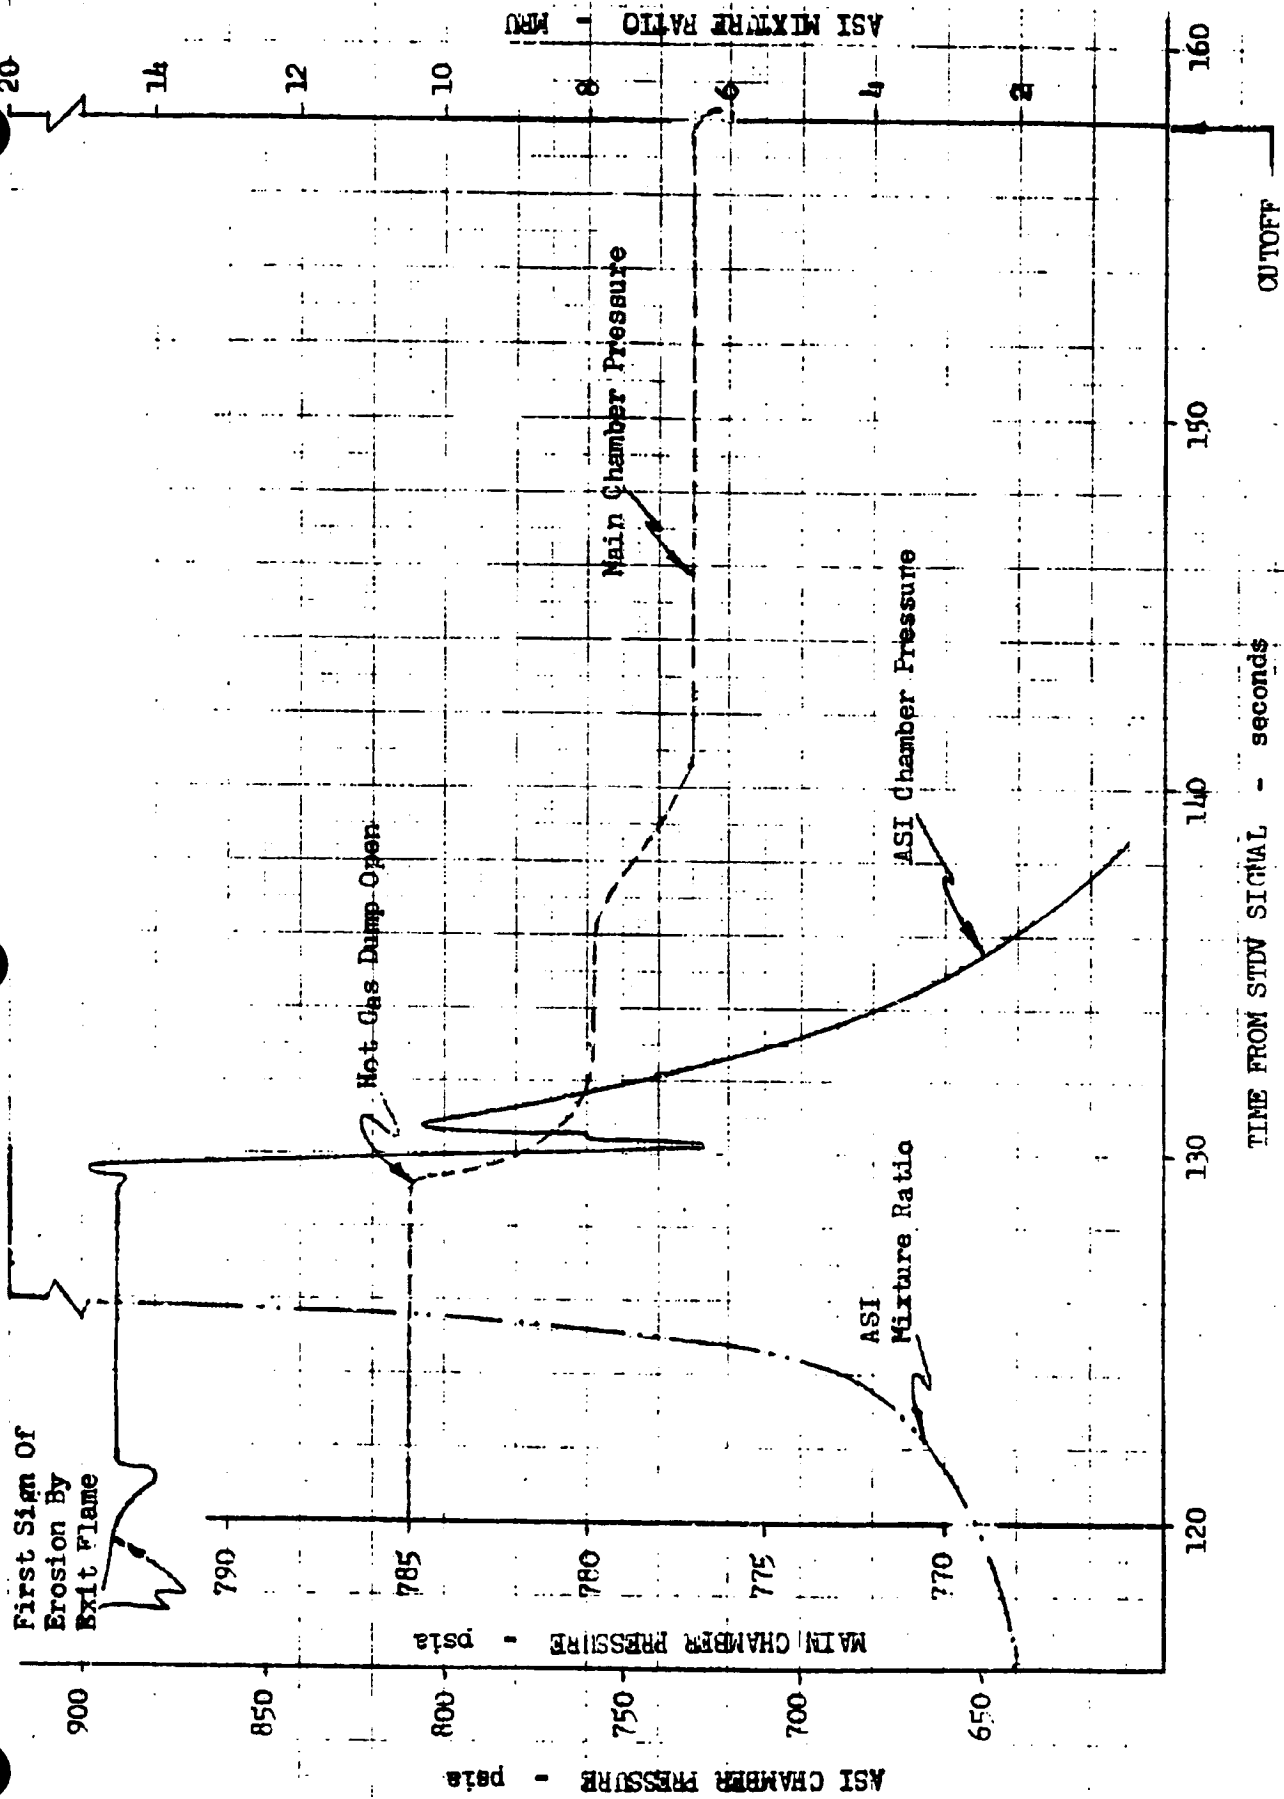
Figure 45. AS-502 S-IVB Failure Mode Simulation (Engine J016-4, Test 313-041)

As summarized in the Verification Testing section, the physical sequence of events hypothesized for AS-502 S-IVB were verified. Figure 45 summarizes the performance during the high mixture ratio operation of the R&D test engine (J016-4). Main injector erosion prior to backflow simulation produced no detectable effect on performance. Following hot-gas dump valve opening (simulated line failure), the continued erosion of the injector and ASI assembly caused a total loss in performance over 12 seconds of 8 psi in main chamber pressure. Although heating of the engine flight instrumentation packages because of the subsequent fire tends to reduce the quality of the data, calculation of the maximum backflow from the burned out ASI is sufficient to explain only part of the performance loss. The additional loss is attributed to a c^* efficiency degradation of the main injector of approximately 0.5 percent because of the damage (described in the Verification Testing section), which was incurred during the test.

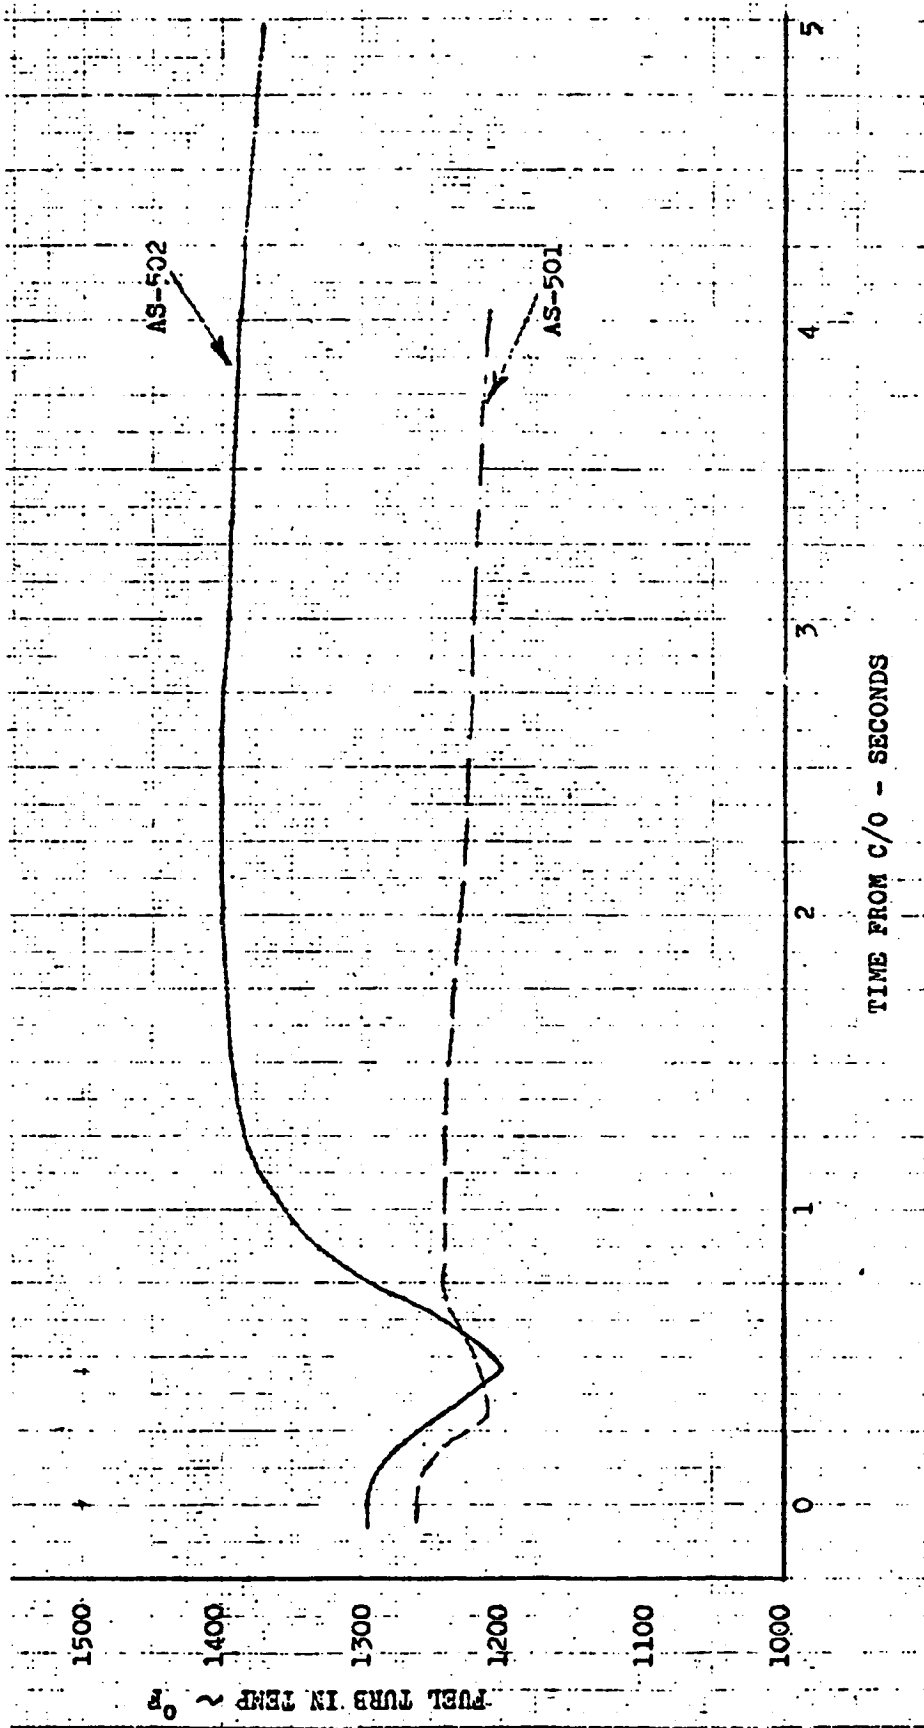
Figure 46. AS-501 and AS-502 Comparison of Fuel Turbine in Temperature Characteristics at First-Burn Cutoff

A 100 F temperature overshoot (Fig. 46), as measured by the fuel turbine inlet temperature bulb, occurred 2 seconds after cutoff (749 seconds range time).

The most probable cause of the temperature overshoot was a quality and density change of the oxygen entrapped in the GG oxidizer purge system (brought about by chilling of the purge and GG oxidizer injection pressure lines during engine operation and subsequent injection of the more-dense oxygen into the GG following engine cutoff).

Improper sequencing of the stage-supplied GG fuel purge may have had a contributory effect to the temperature overshoot. However, another

serious consequence of the improper purge sequence could have been the degradation of the GG fuel injection system due to icing. This problem could prevent a successful restart (although GG operation at restart was proper). Corrective action must be taken on future S-IVB flights to prevent recurrence of the stage purge sequencing problem.

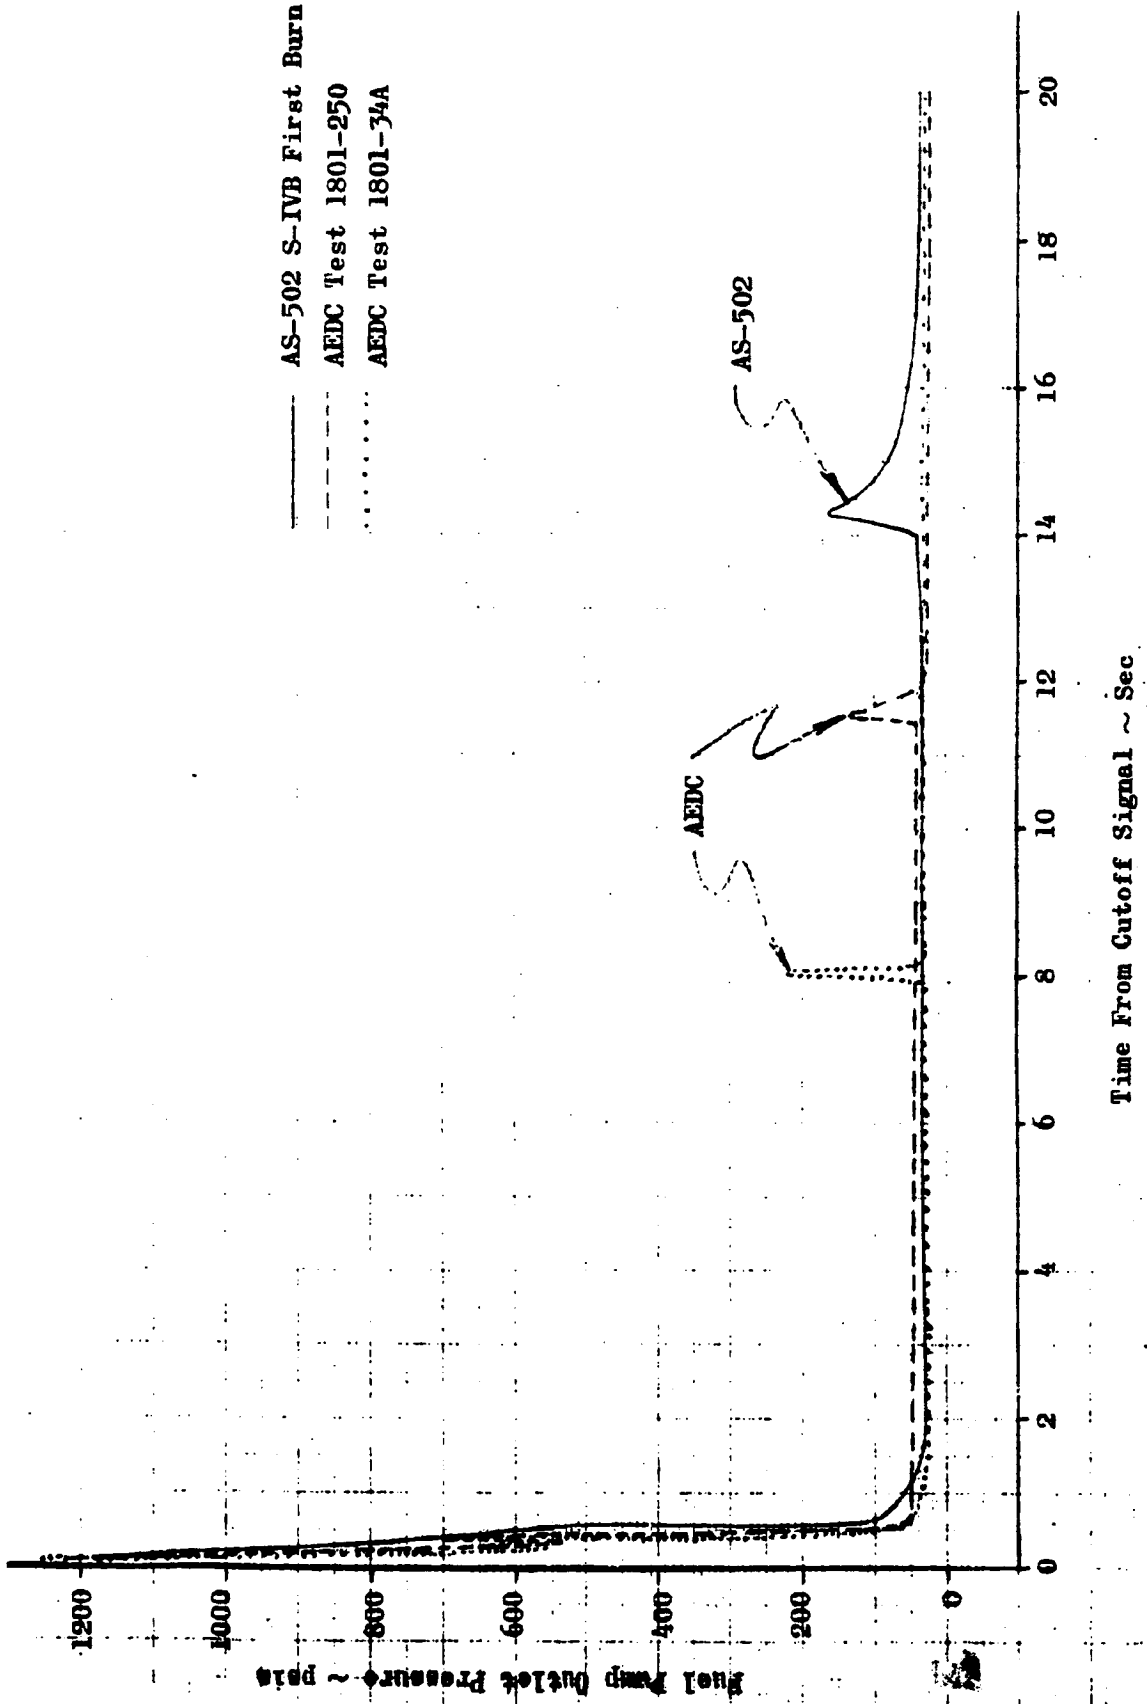
Figure 49. AS-502 S-IVB First Burn, Fuel Pump Outlet Pressure Surge After Engine Cutoff

Fourteen seconds after the engine cutoff of the S-IVB first burn, a surge occurred in fuel pump discharge pressure. The magnitude of the spike exceeded 150 psia and conceivably could cause damage to the fuel recirculation return system. Figure 49 is a plot of fuel pump discharge pressure during the period following engine cutoff showing the anomaly as it appeared in the flight data. Also, similar fuel pump discharge pressure data from simulated altitude tests at AEDC are superimposed to illustrate similarity of pressure surges observed in ground test data.

A pressure spike produced in this manner could possibly jeopardize the integrity of the recirculation return system of the S-IVB stage because it occurs after the engine bleed valves have reopened. The possibility of a serious pressure spike is minimized if the stage pre valve and recirculation discharge valve are closed during the cutoff sequence, as was done during the flight of AS-501. No relationship was established between this pressure spike anomaly and the major AS-502 flight malfunctions.

The problem is associated with the fuel feed and recirculation systems and it has been seen on the S-IVB battleship stand at AEDC (Fig. 49).

Although the McDonnell-Douglas Corporation has been advised to return to the prevalve sequencing utilized on AS-501, rather than leaving these valves open as was done on the AS-502 vehicle, AEDC data indicate that closing the prevalve and recirculation discharge valve at cutoff does not guarantee that a surge will not be produced. Figure 49 shows two AEDC tests which had a surge even though the prevalve and recirculation discharge valve were closed immediately after cutoff.

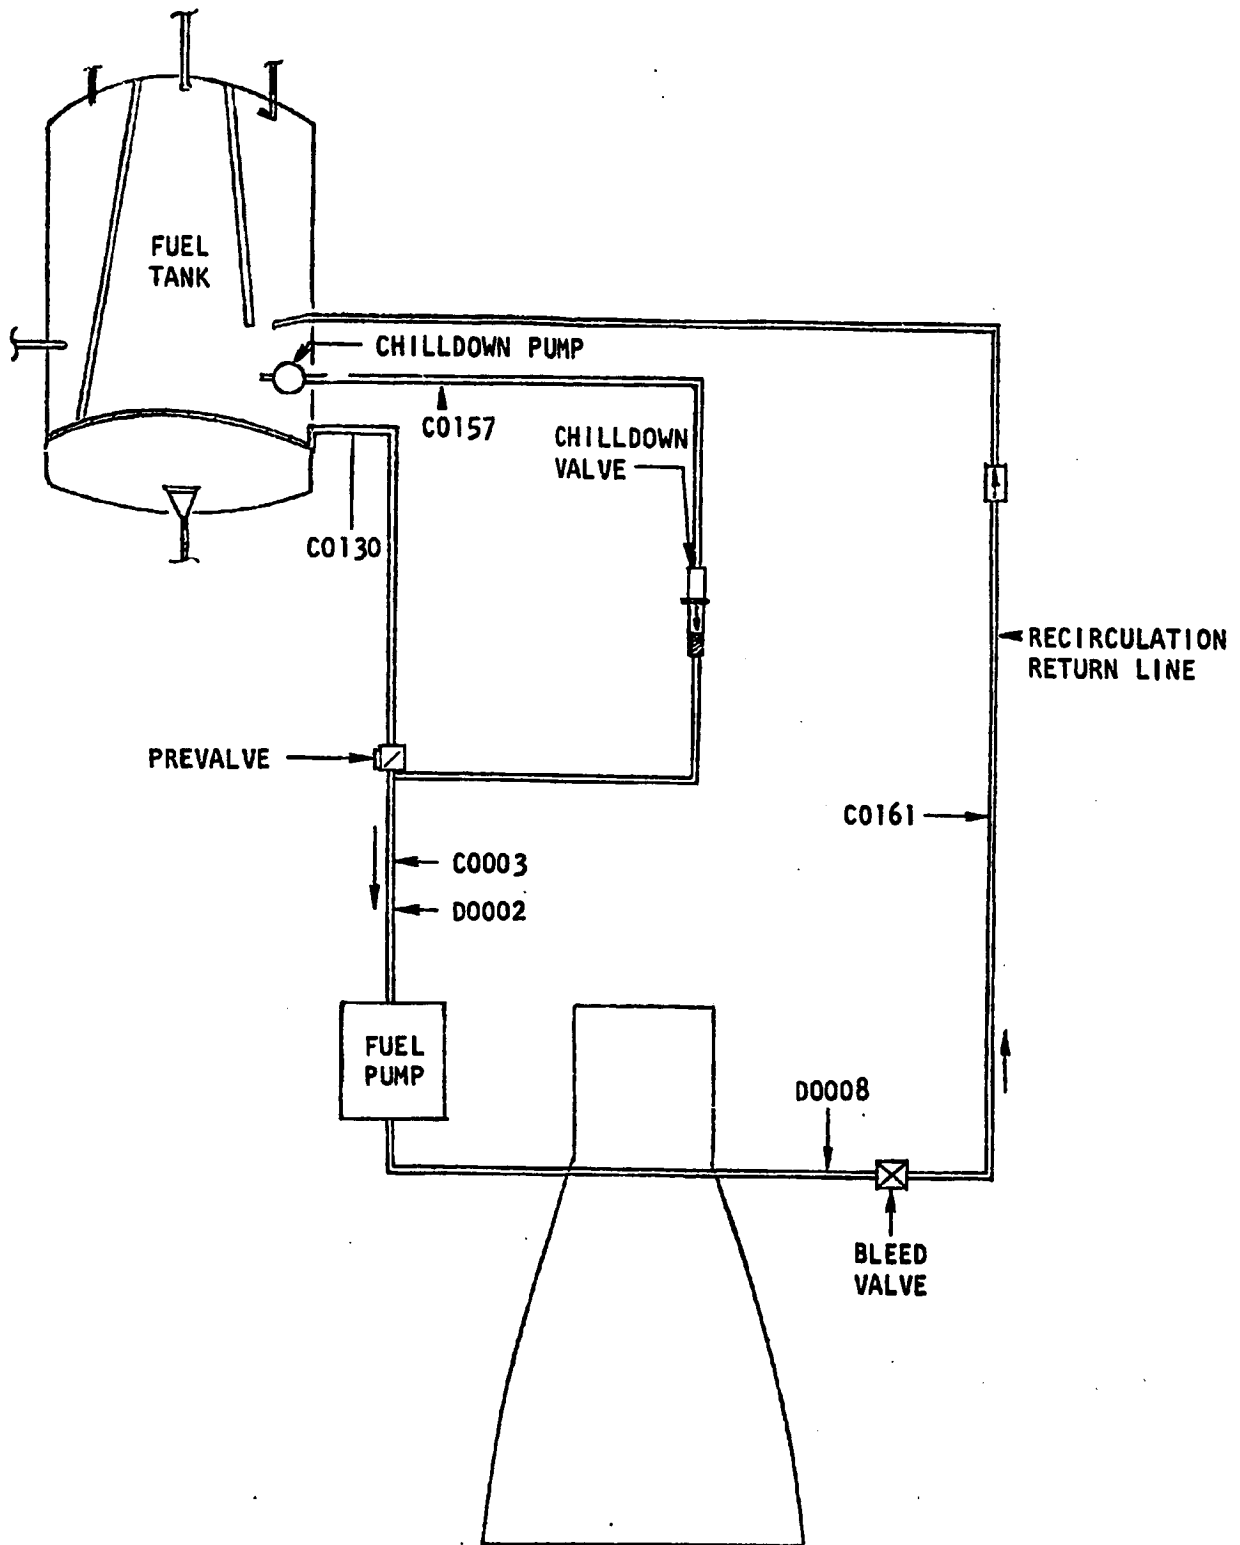
Figure 50. Fuel Feed and Recirculation System

Figure 50 is a schematic of the fuel feed and recirculation system. At AS-502 cutoff, the fuel prevalve and recirculation discharge (chilldown) valve remained open. The engine bleed valve opens about 4 seconds after cutoff.

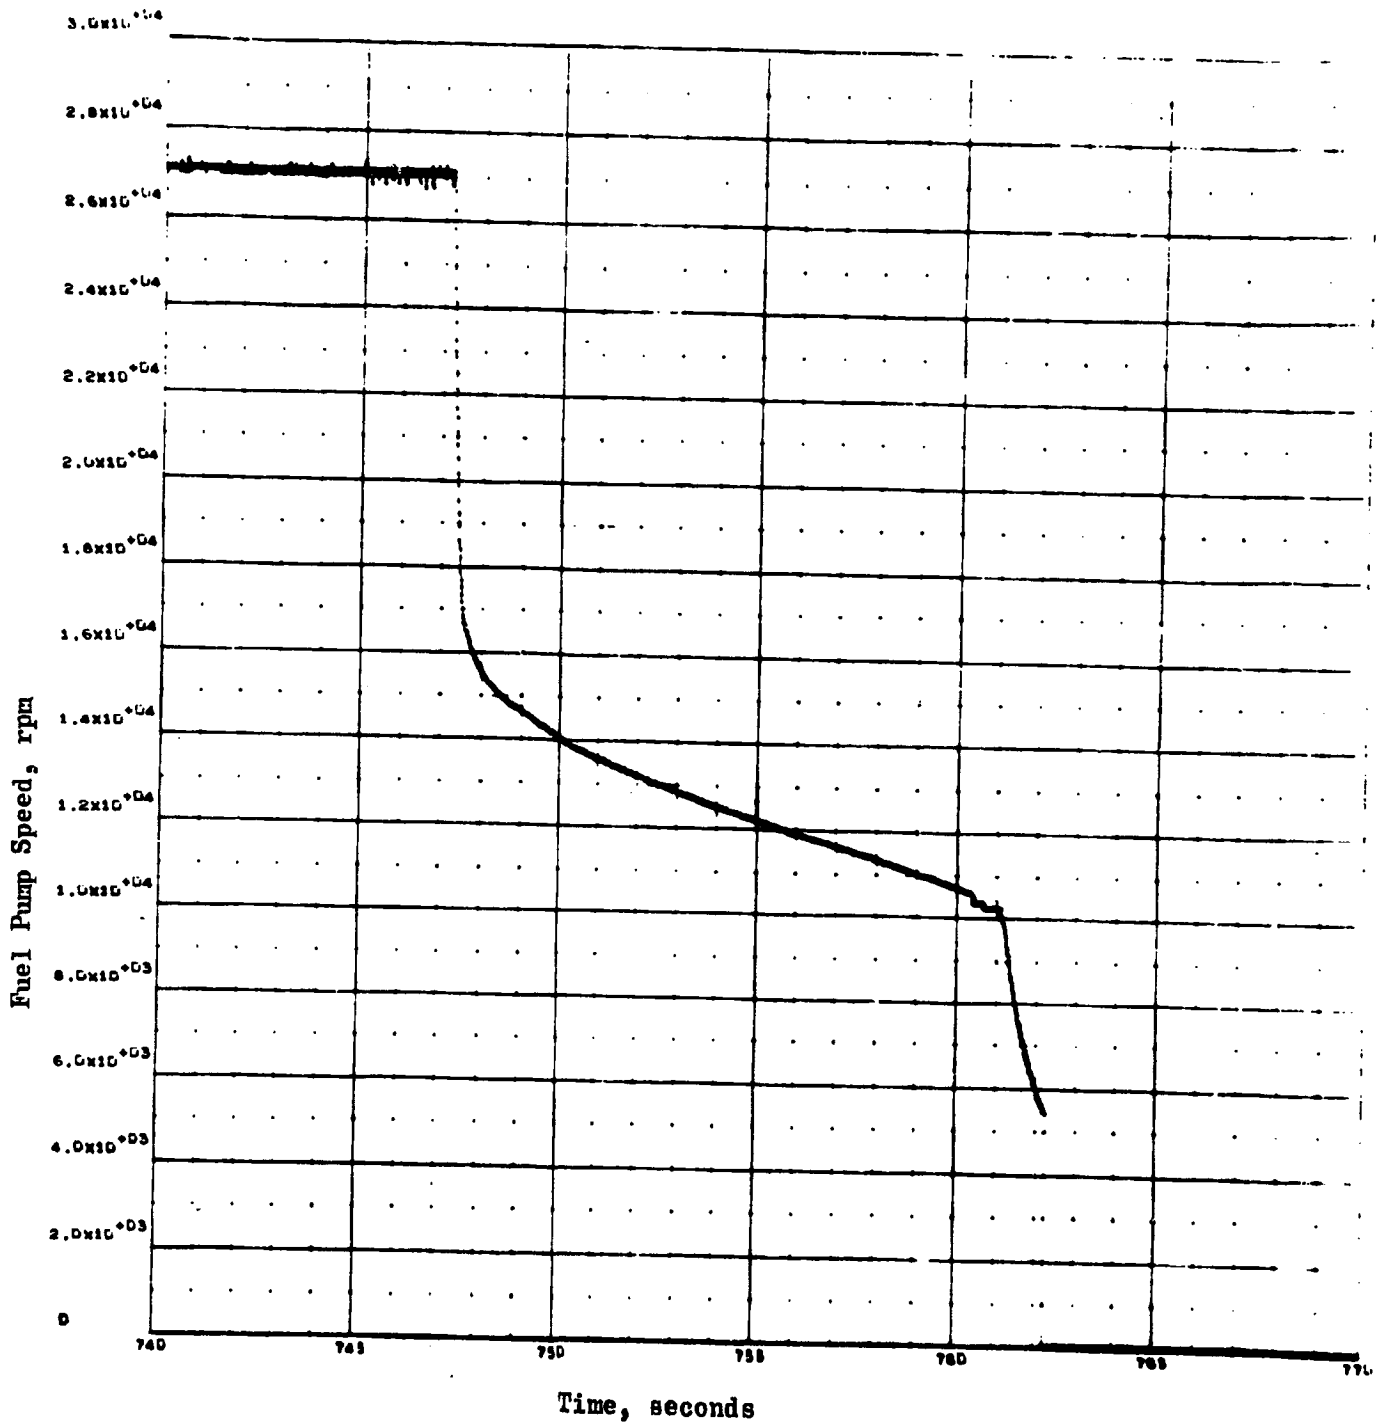
Figure 51. Fuel Pump Speed

After cutoff, the fuel pump continues to turn for 15 seconds (Fig. 51). With cutoff signal, the fuel pump inlet temperature increases (as gaseous conditions are reached), while the fuel tank outlet temperature remains cold (liquid), as shown in Fig. 52. When liquid re-enters the engine, a pressure surge results.

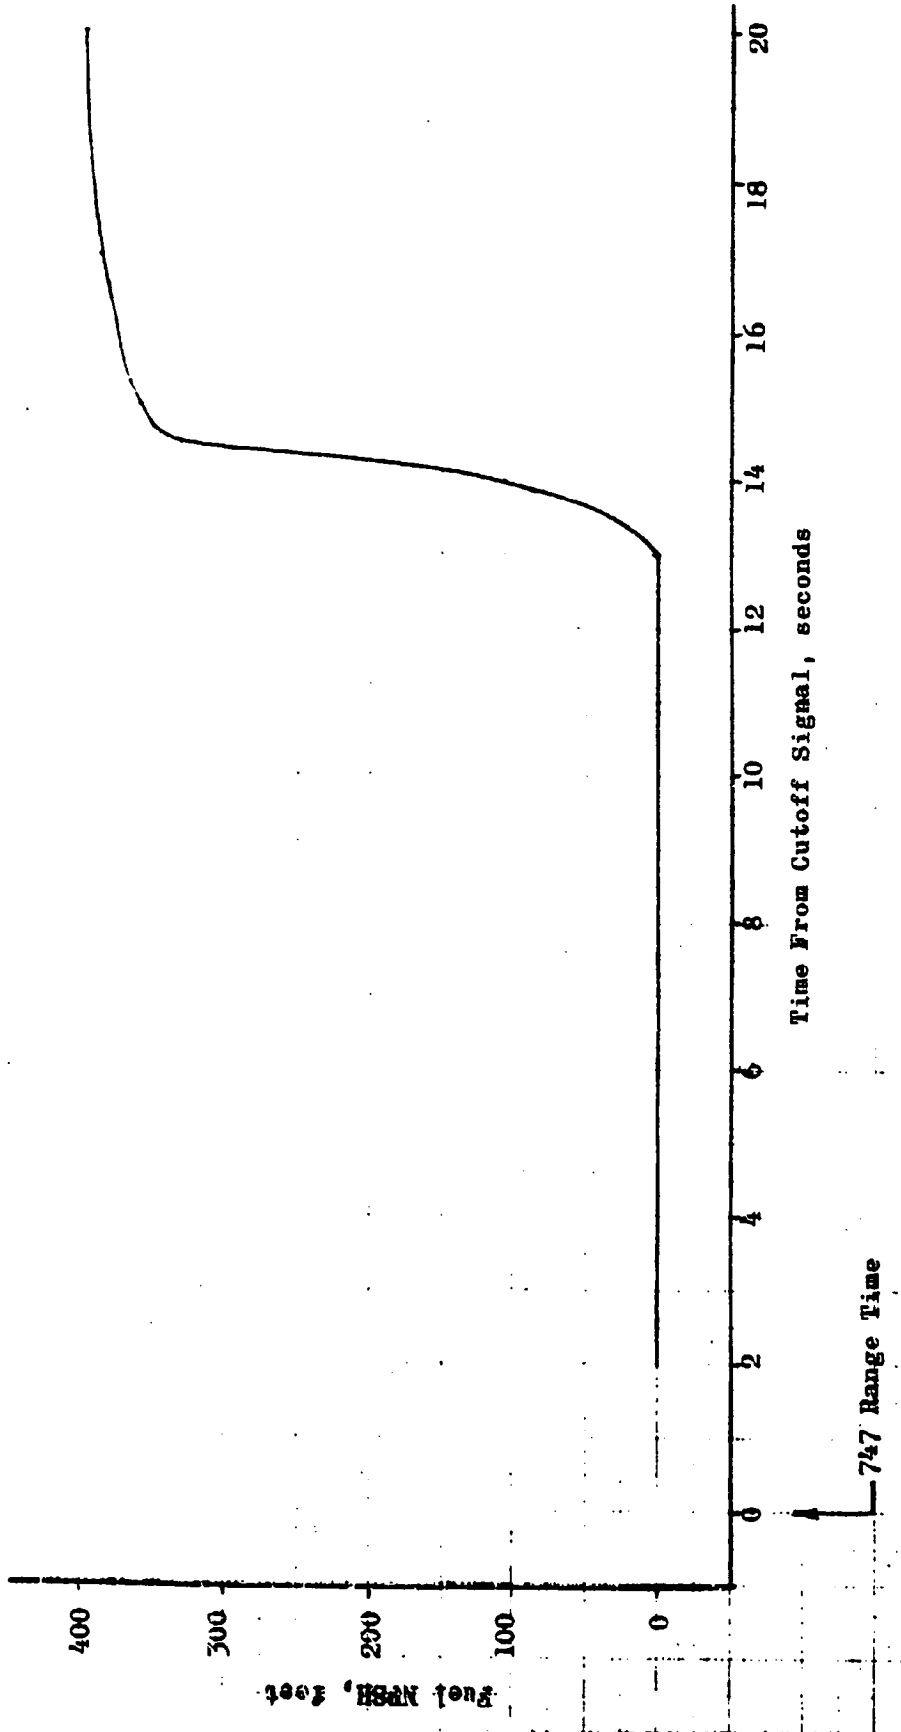
Figure 53. AS-502 S-IVB First Burn, Fuel NPSH After Cutoff

The NPSH at the fuel pump inlet after cutoff is shown in Fig. 53. This is an indicator of fuel quality (a positive value is subcooled liquid).

At the time of the surge, the NPSH at the pump inlet becomes sufficient for the pump to develop head again with its remaining speed. Therefore, it is thought that a gas bubble forms at the pump inlet after cutoff and, when this bubble collapses, liquid again is introduced to the pump.

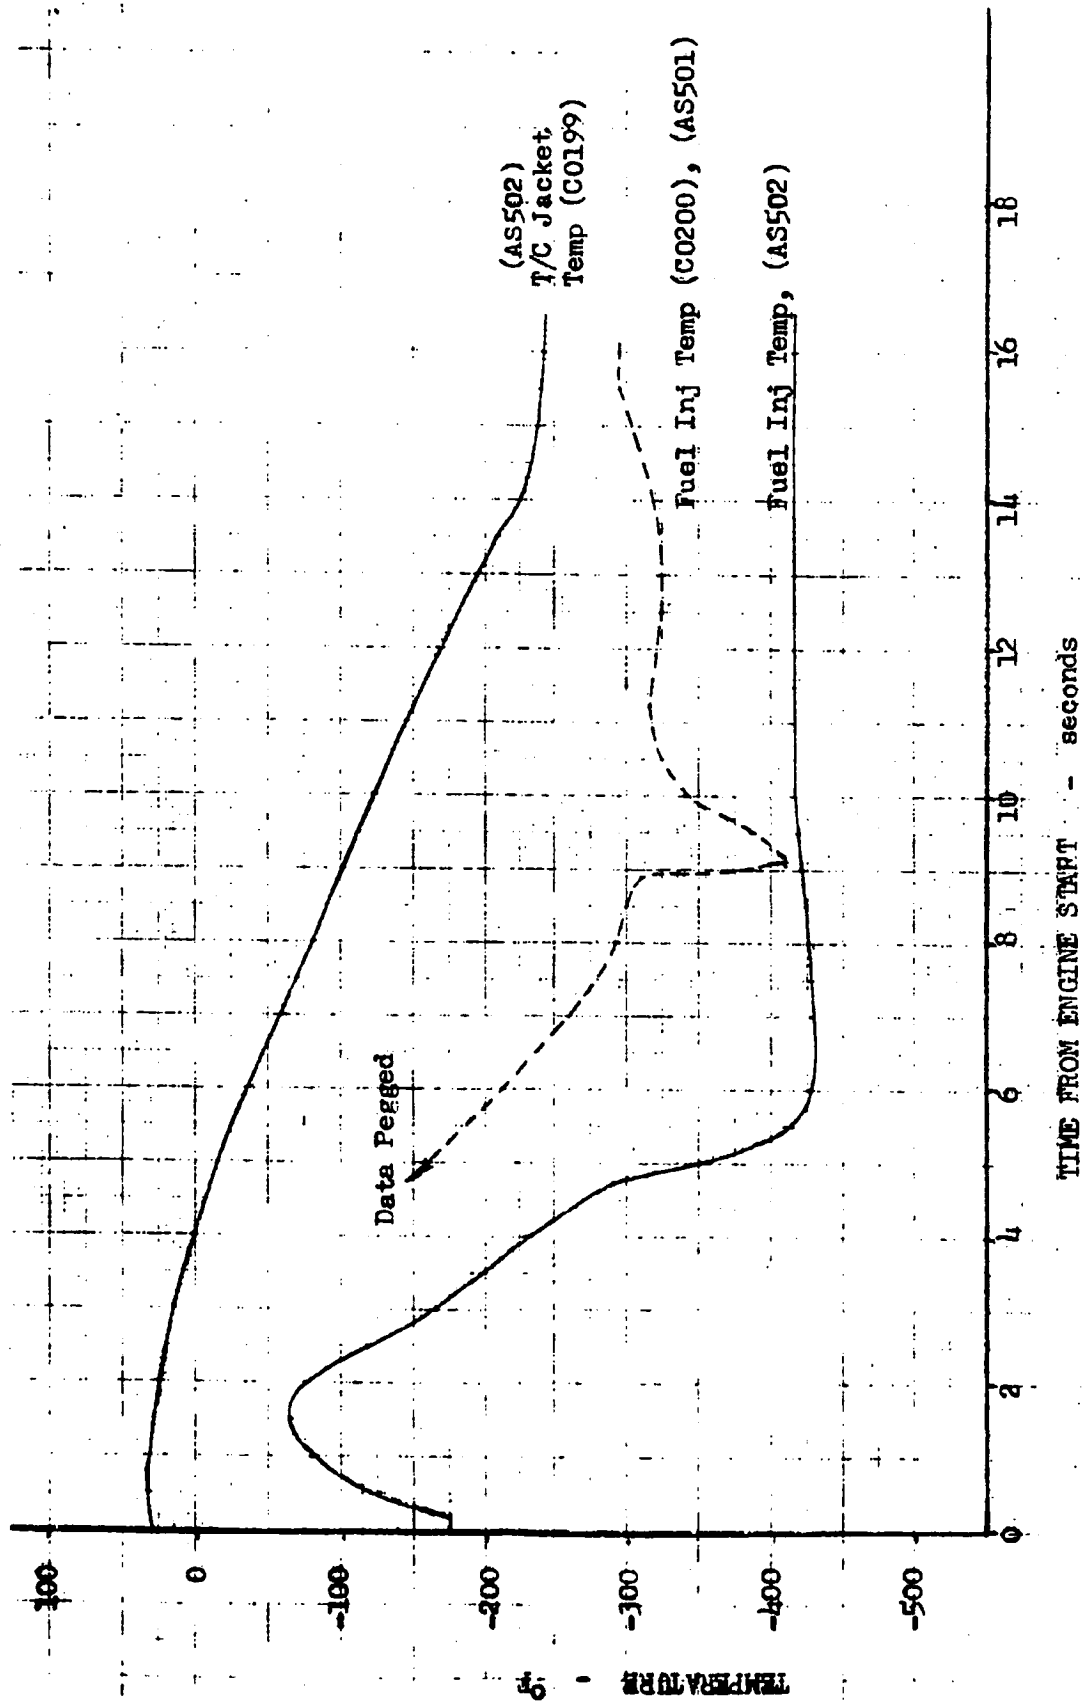
Figure 55. Comparison of AS-501 and AS-502 S-IVB Second Burn, Thrust Chamber Jacket Temperature and Fuel Injection Temperature vs Time

The thrust chamber and fuel injection temperatures indicate that the 8-second fuel lead was normal. Figure 55 shows these temperatures on AS-502 and fuel injection temperature on AS-501.

Normally, after the main oxidizer valve opens and main propellant ignition has occurred, the main fuel injection temperature increases from liquid hydrogen temperatures to the mainstage operating temperature (approximately 280 F), as it did on AS-501 (see Fig. 55). On AS-502, the fuel injection temperature remained below 415 F from STDV until cutoff.

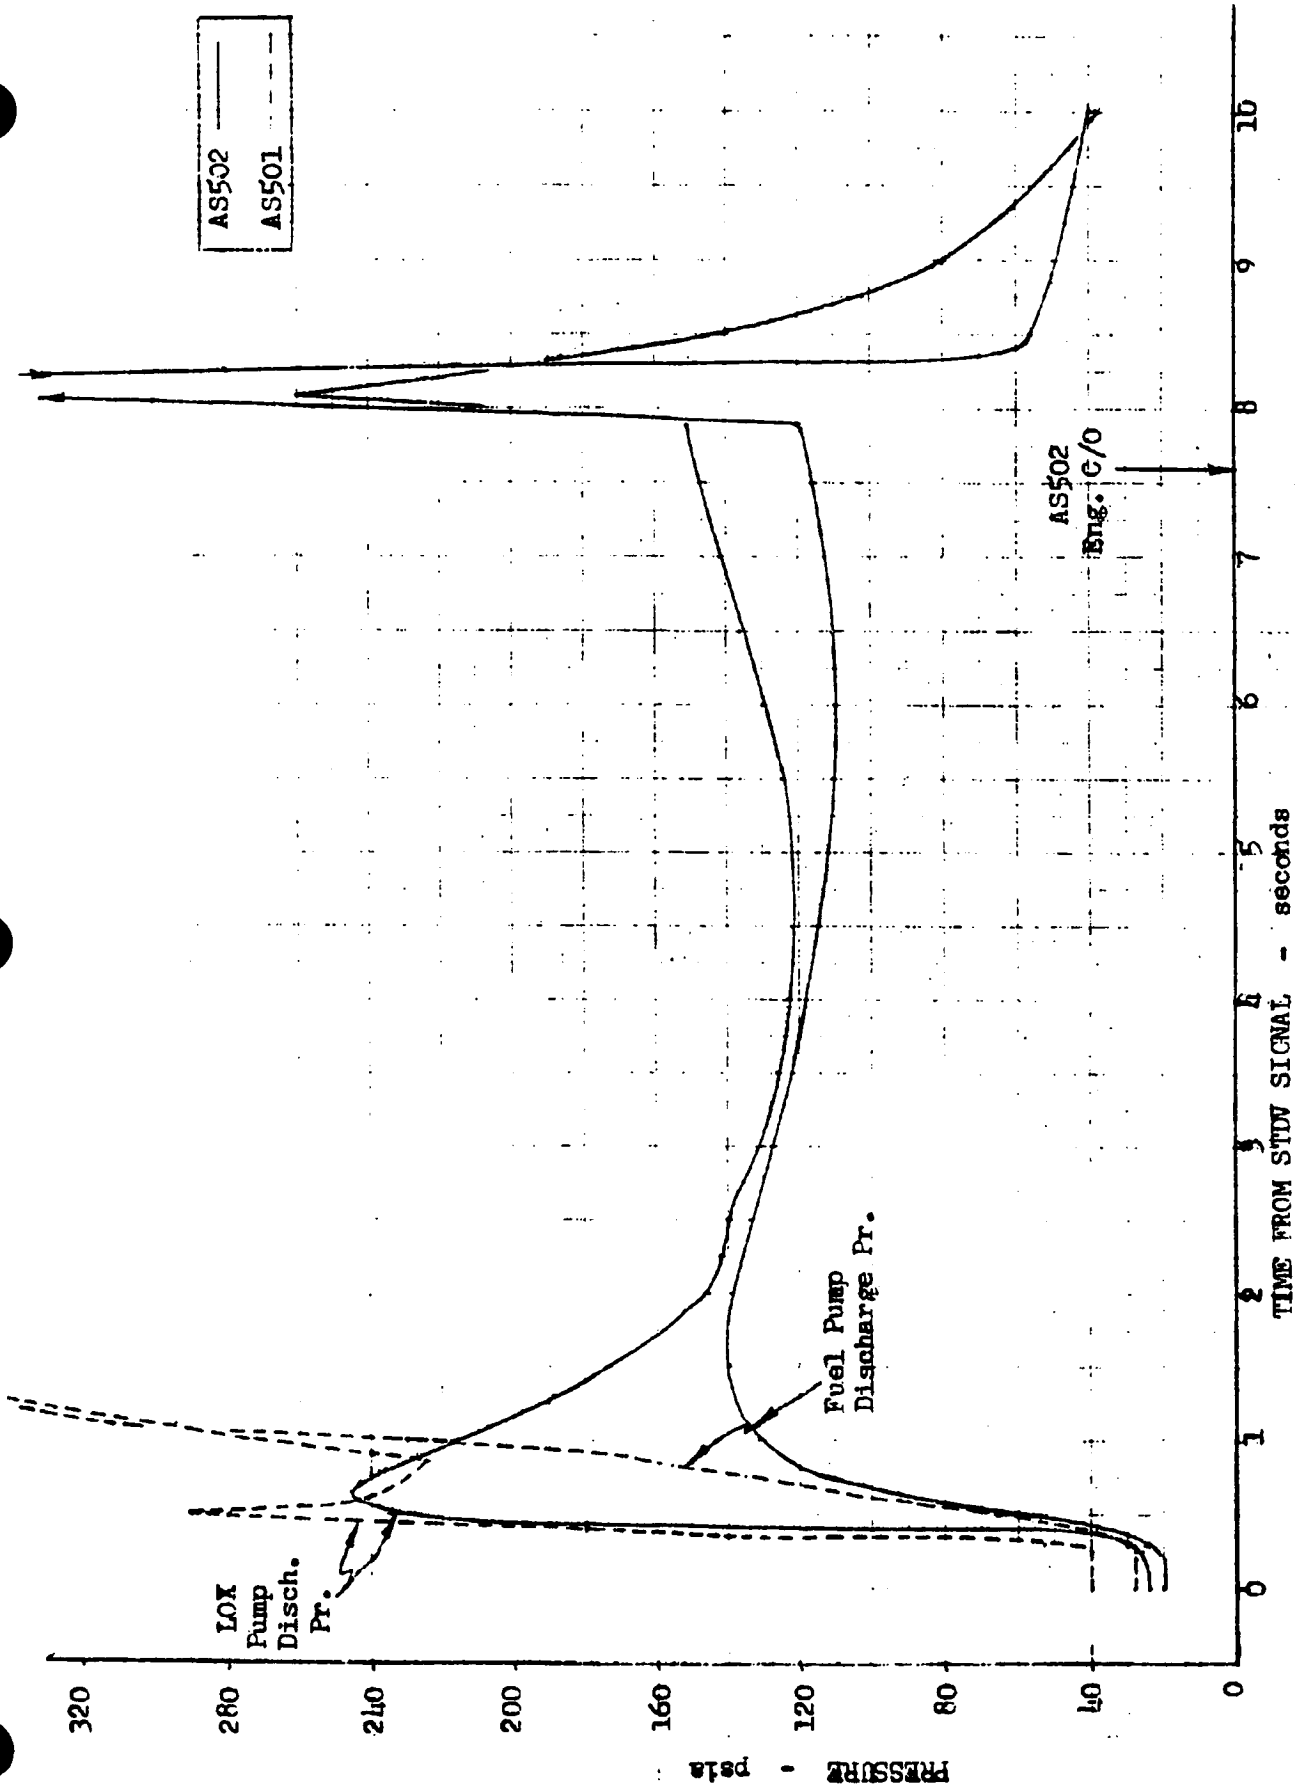
Figure 56. Comparison of AS-501 and AS-502 S-IVB Second Burn, Pump Discharge Pressures vs Time

Start tank discharge valve position, start tank pressure, pump speeds, main flows, and pump discharge pressures all indicated that the start tank blowdown and turbopump acceleration were normal. The pump discharge pressures from AS-502 are compared with those of AS-501 in Fig. 56.
