J-2 ENGINE AS-502 (APOLLO 6)

FLIGHT REPORT

VOLUME 3: S-IVB STAGE FAILURE ANALYSIS

DATE 17 June 1968

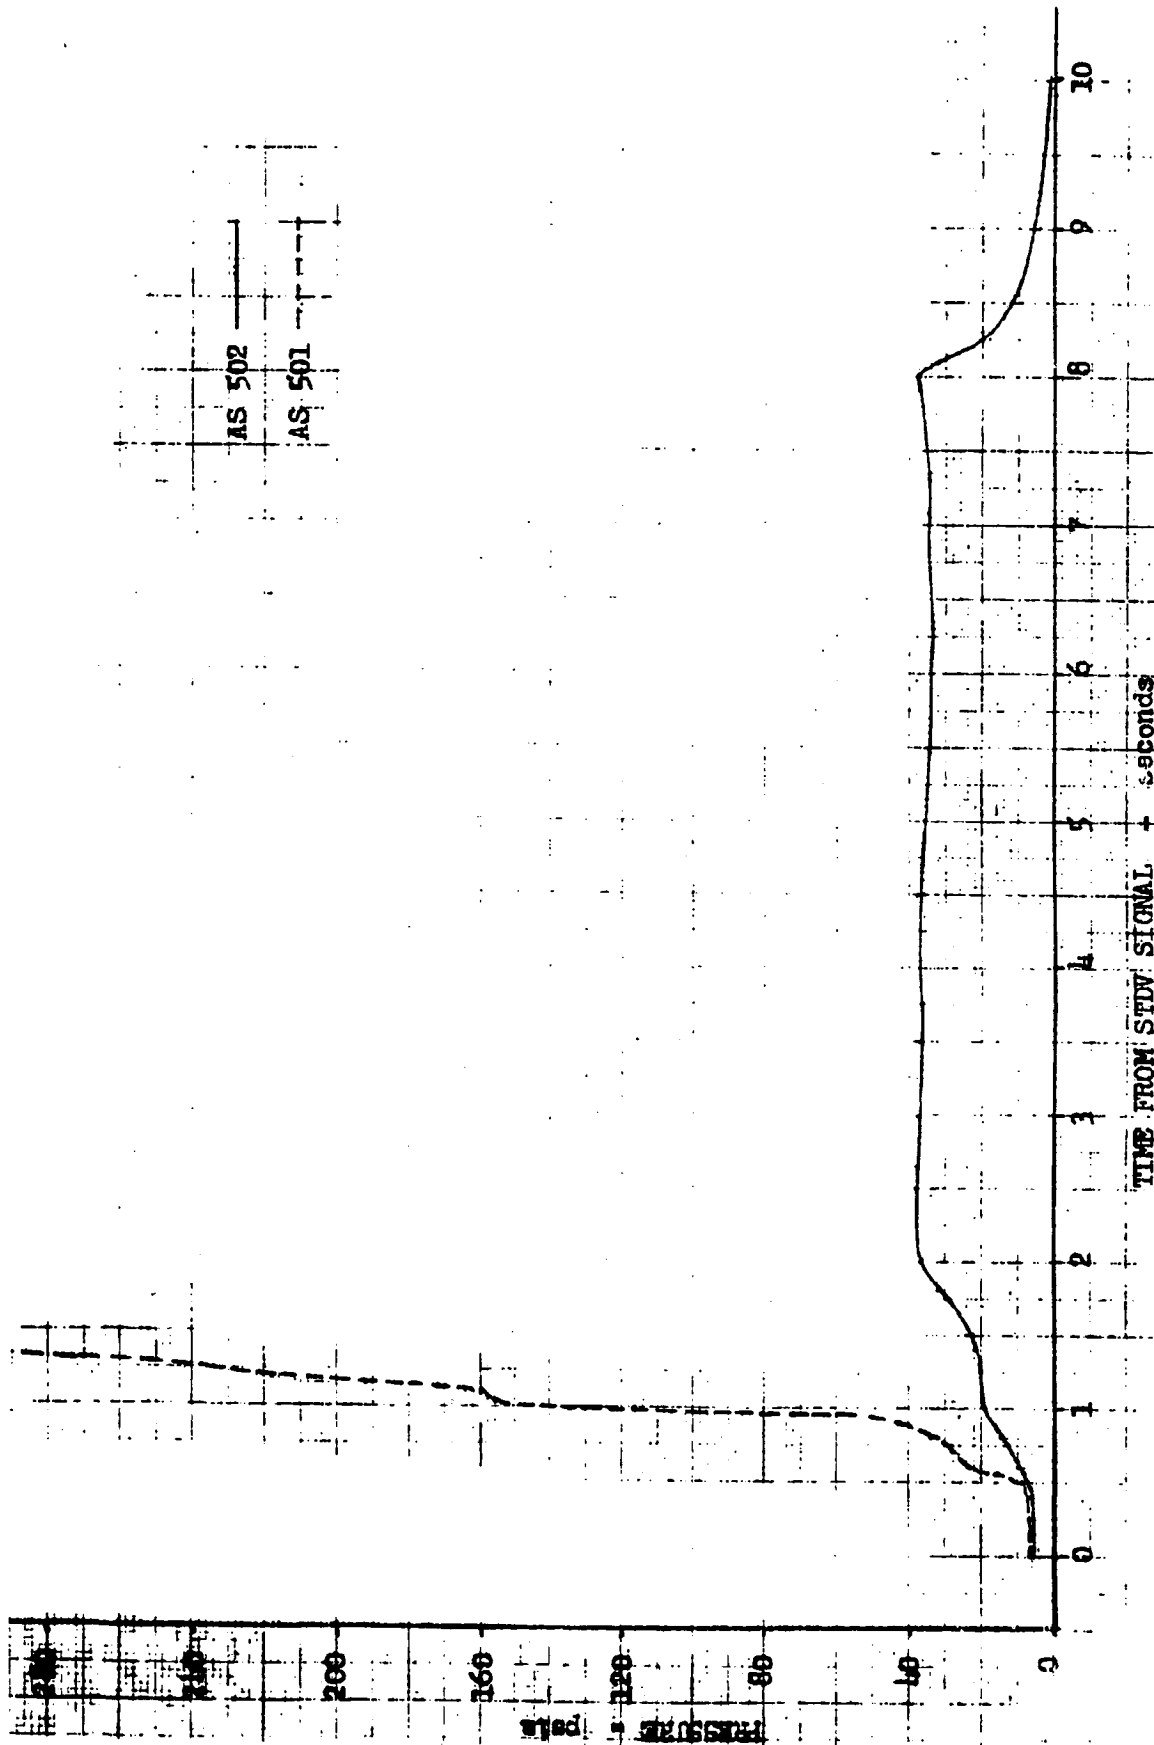
Figure 58. Comparison of AS-501 and AS-502 S-IVB Second Burn, Thrust Chamber Pressure vs Time

The main oxidizer position indicated proper valve actuation, but main chamber pressure did not respond normally when the main oxidizer valve moved to the first position. Main chamber pressure normally rises from 6 or 7 psia, which it attains during the fuel lead, to approximately 30 psia when the main oxidizer valve moves to the first position (14 degrees). On AS-502 restart, main chamber pressure was only 10 psia. Main chamber pressure continued to increase gradually, reaching 38 psia 2 seconds after STDV. Figure 58 illustrates a normal chamber pressure transient (AS-501) and the abnormal one experienced on AS-502.

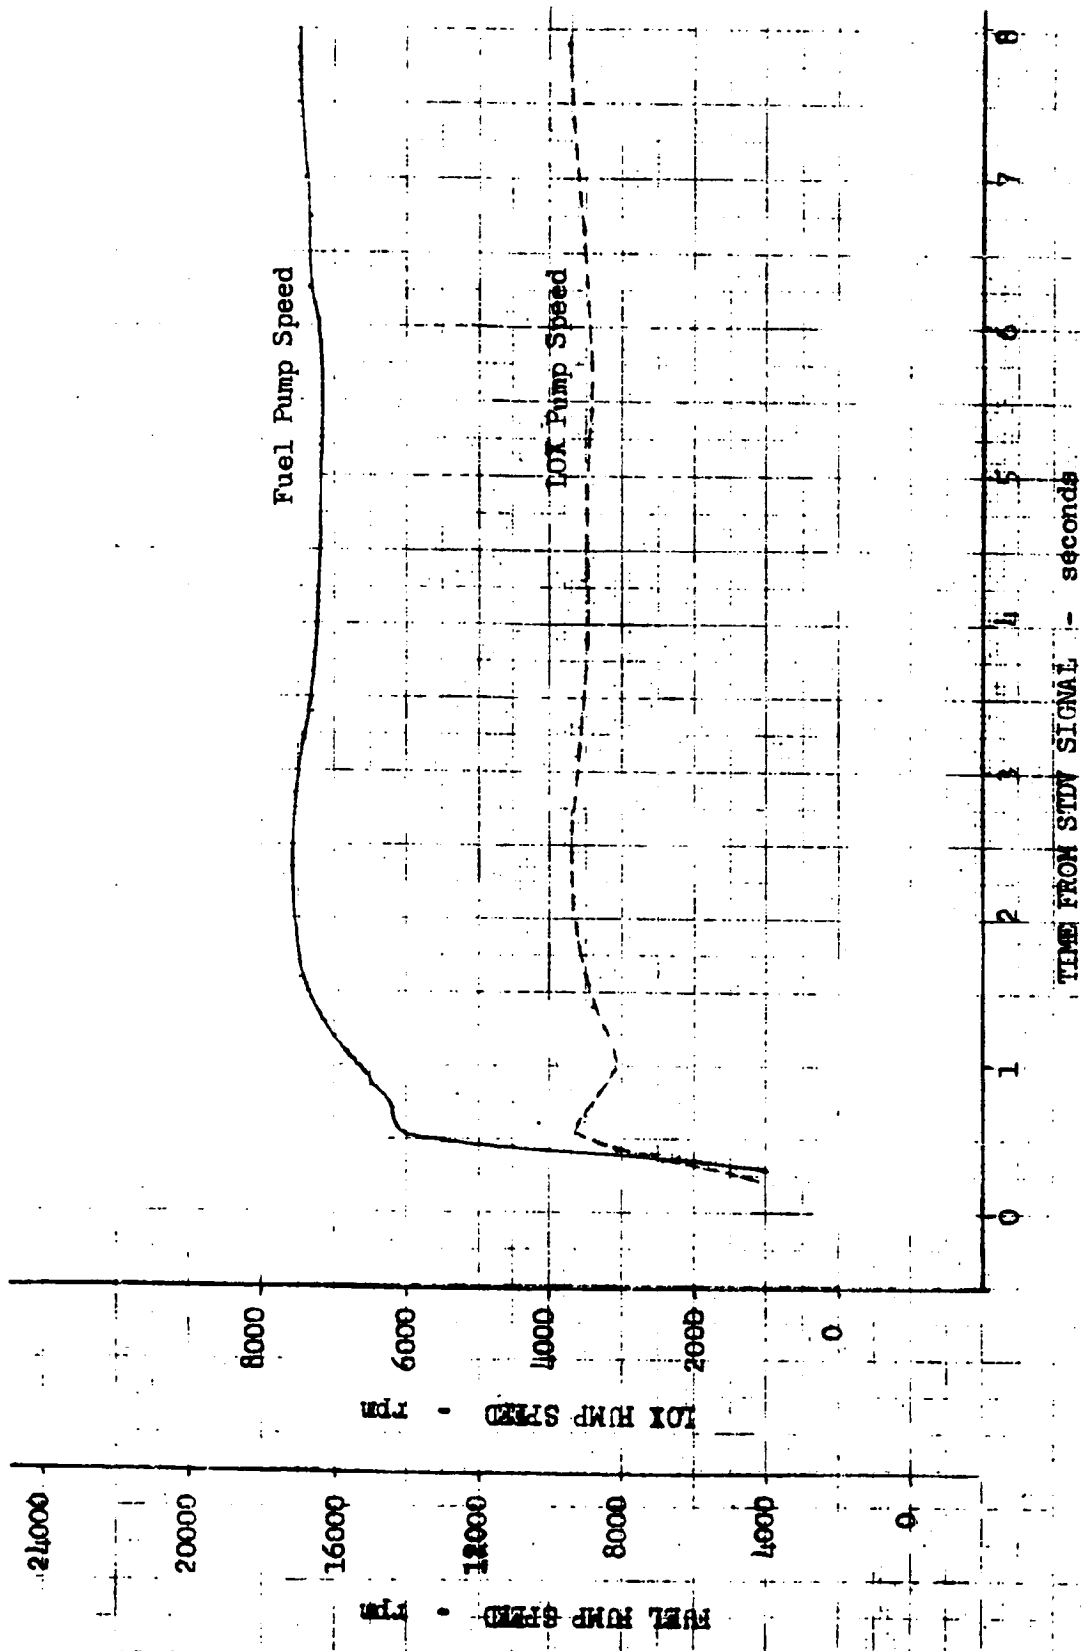
Figure 59. AS-502 S-IVB Second Burn; Pump Speeds vs Time

start. Pump speeds are shown in Fig. 59. Insufficient power from the start tank was ruled out as a possible failure mode.

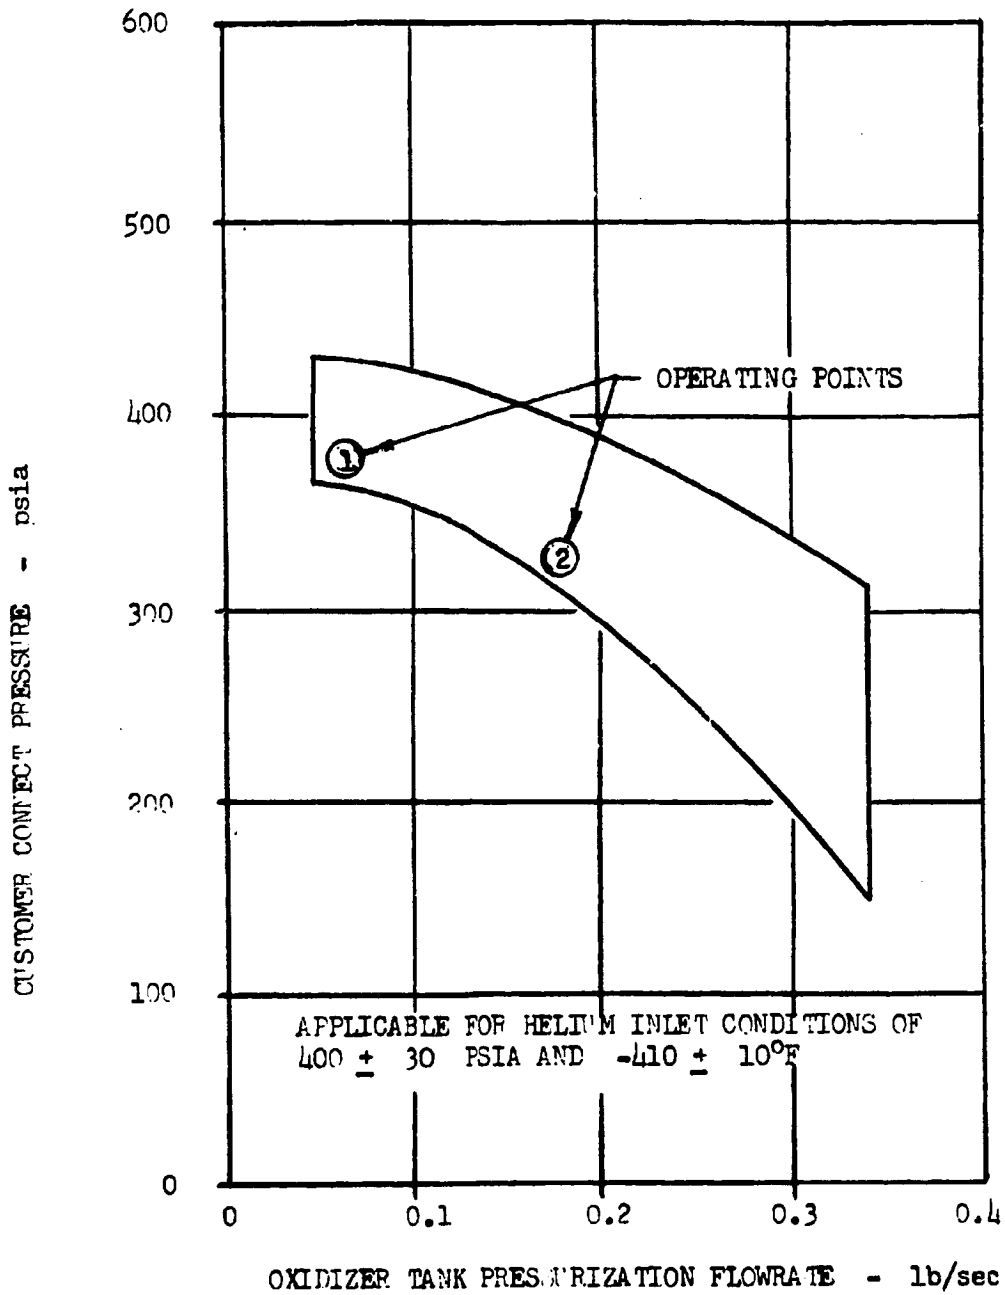
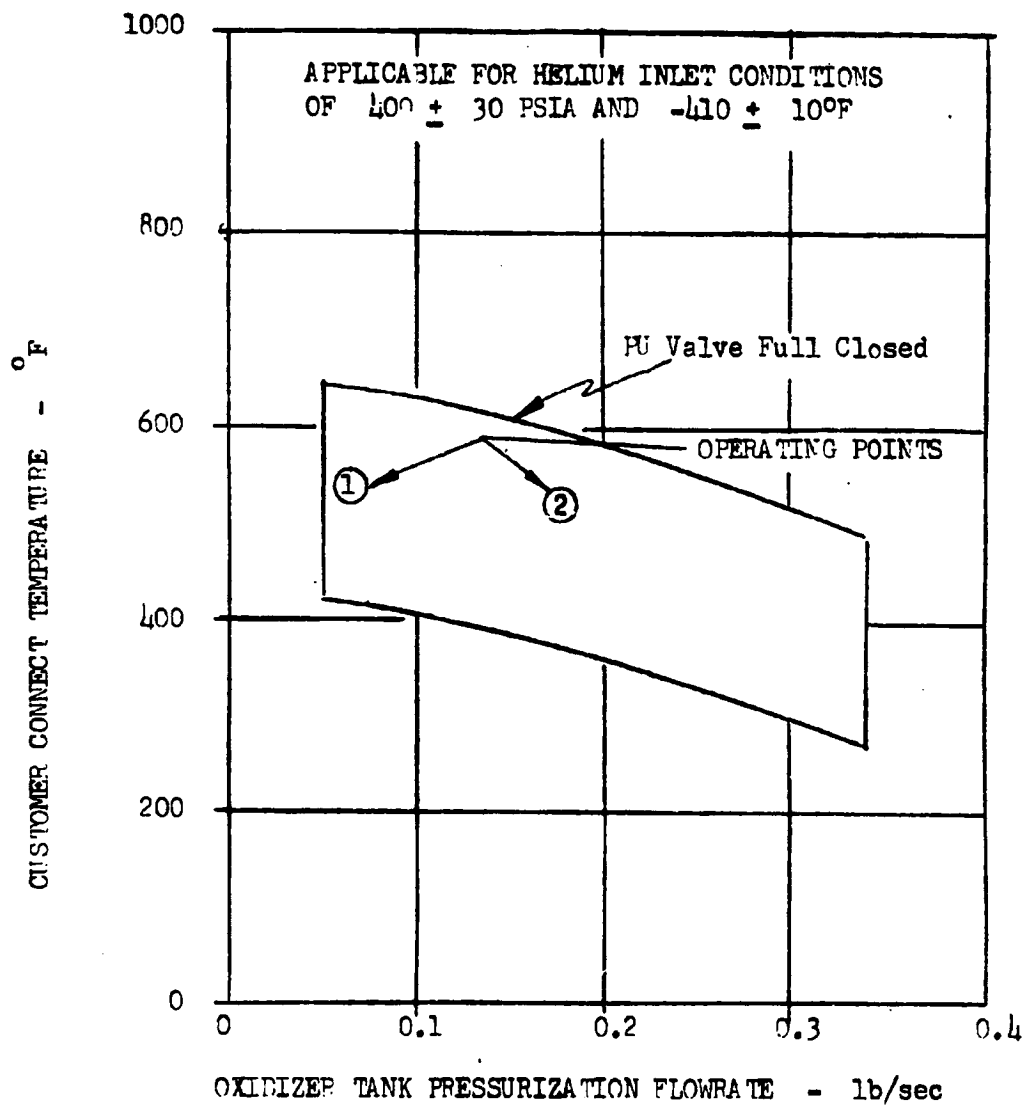
On AS-502 flight, the heat exchanger operated within model specification limits of flow, discharge pressure, and discharge temperature throughout first burn. The heat exchanger operating envelopes are shown in Fig. 65 and 66 with the flight operating points marked. As shown, the outlet pressure was on the low side of the envelope.

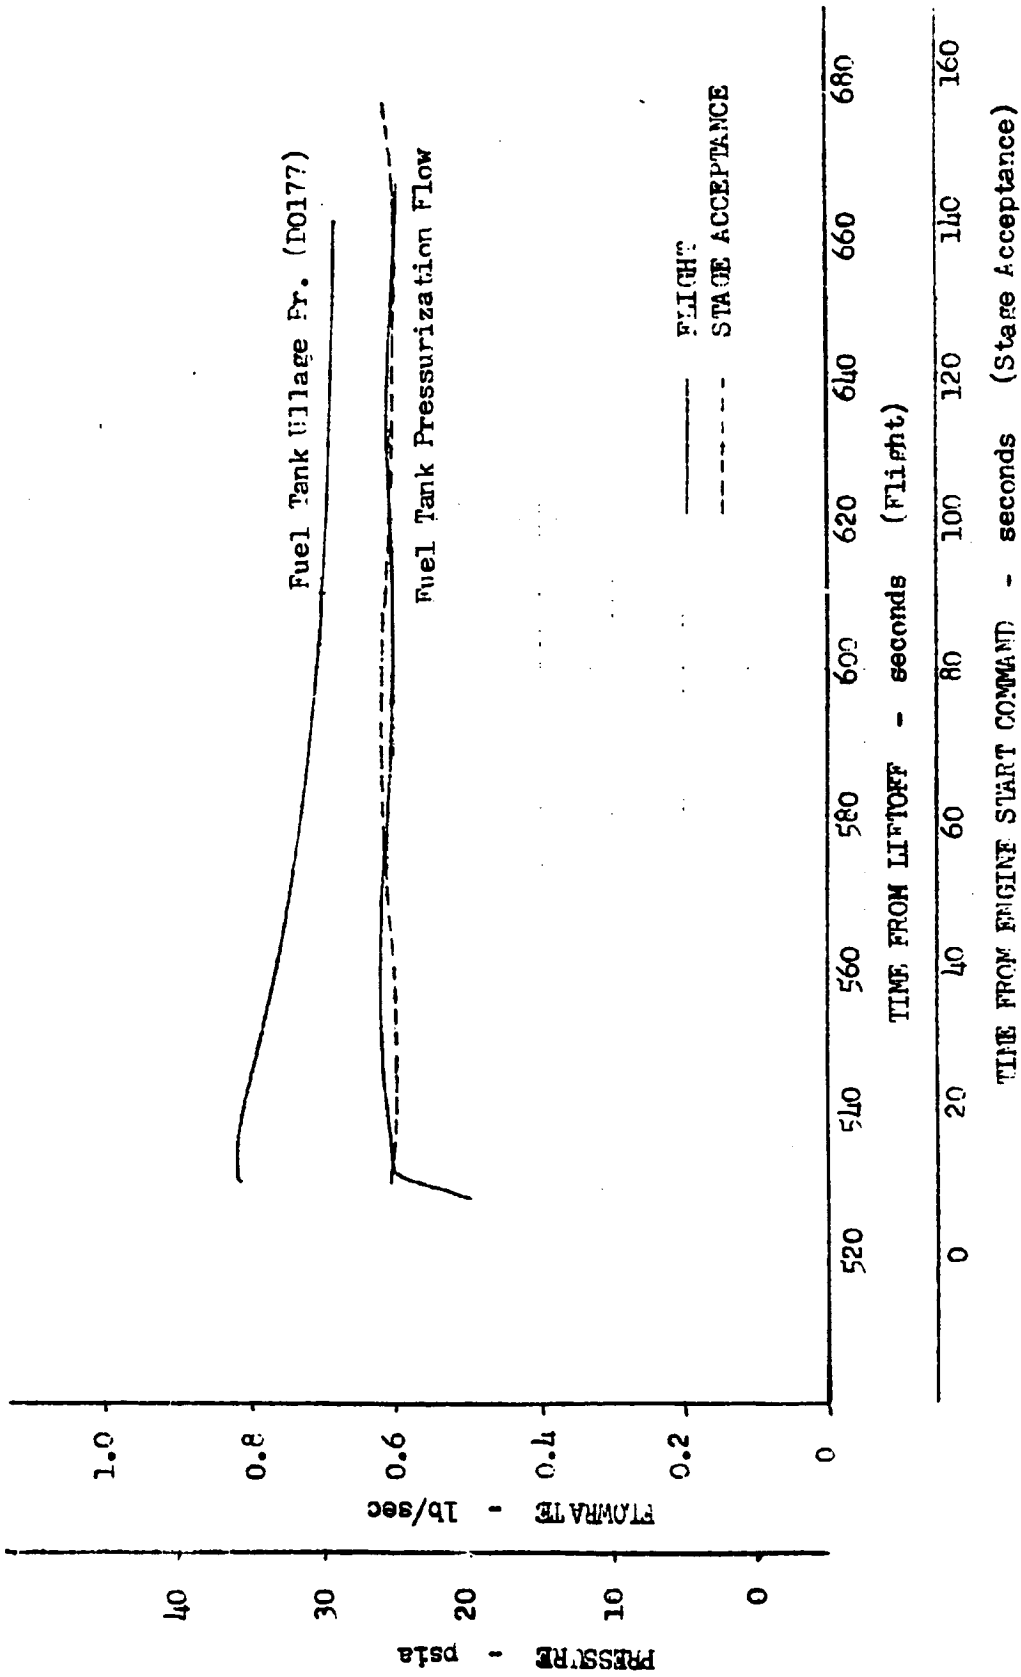
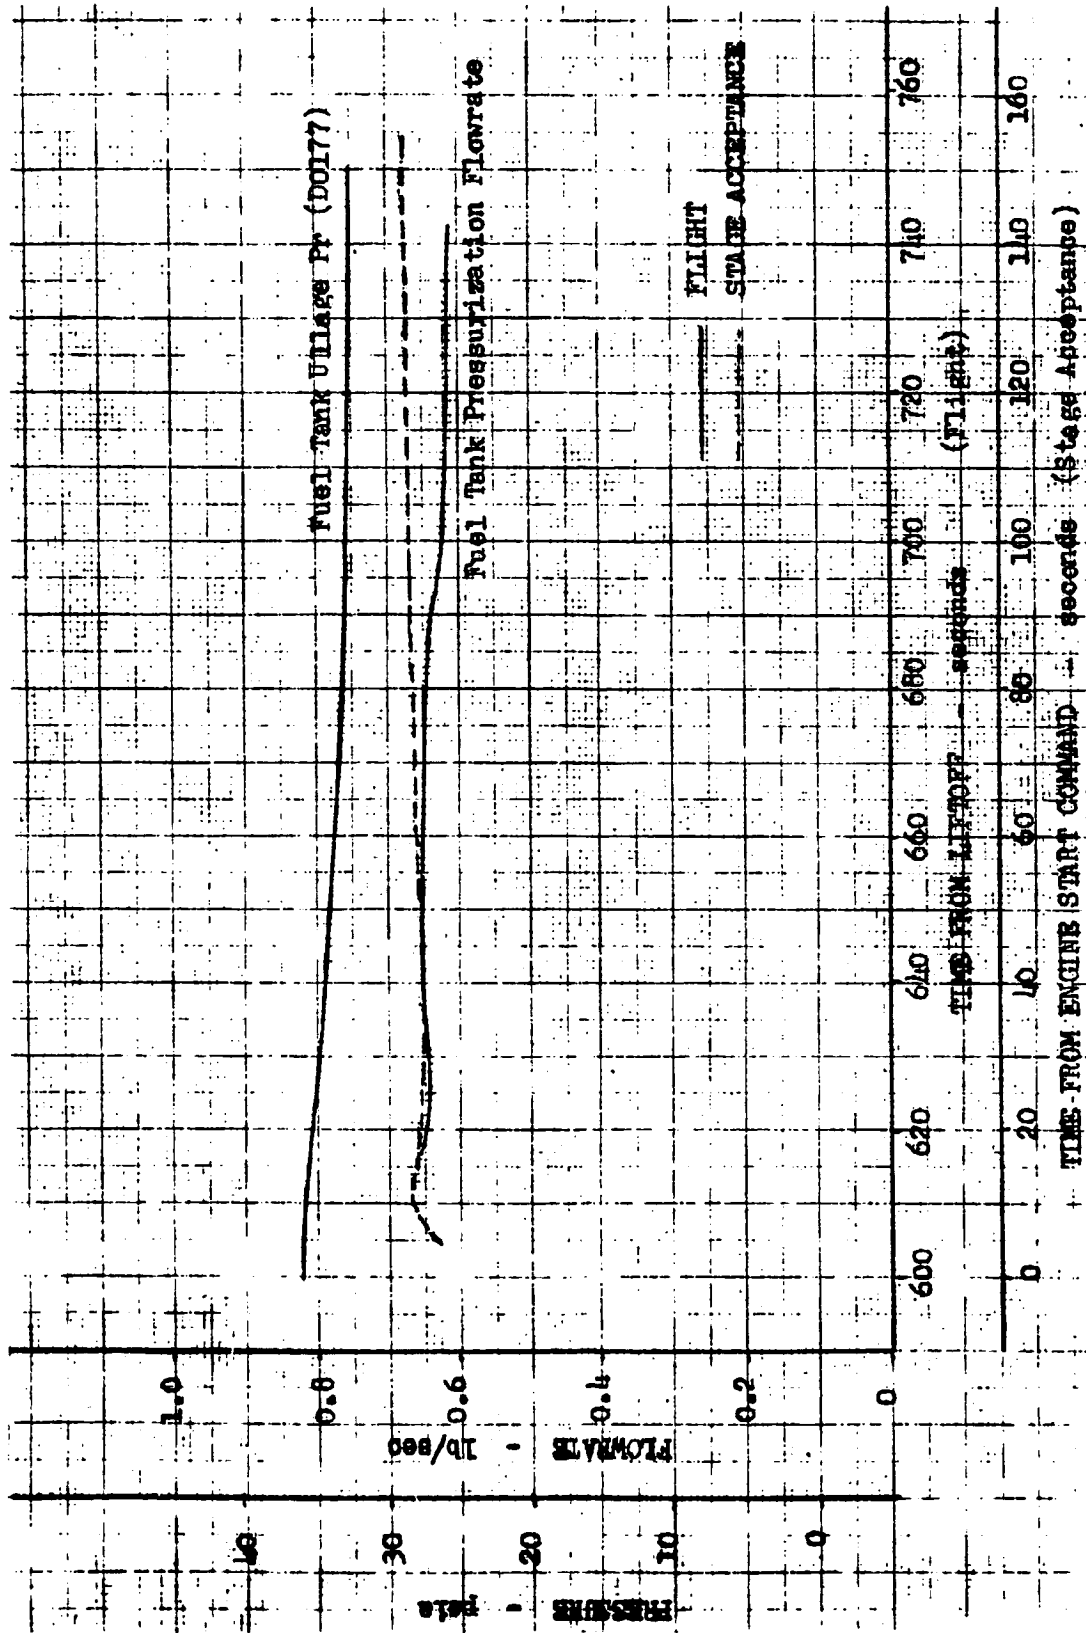
On AS-502 flight, the fuel tank pressure was 36 psia at first-burn engine start and steadily decayed to 32.6 psia by engine cutoff. The secondary valves were closed at 5 seconds and tank pressure never dropped low enough to signal reopen. The same events occurred on AS-501 flight first burn, on AS-501 stage acceptance, and on AS-502 stage acceptance firing. Plots of fuel tank pressure for AS-501 and AS-502 flight first burn are given in Fig. 68 and 69.

Pressurization flow on stage acceptance and flight for AS-502 and AS-501 are presented in Fig. 68 and 69. Prior to the engine performance decay at 685 seconds, the flow during flight was the same as during stage acceptance. The flow decrease correlated with the thrust decay and fuel injection temperature increase, and the shifts are explained by the engine performance changes.

As shown in Fig. 68 and 69, fuel pressurization module inlet temperature was higher than fuel injection temperature by about 10 degrees. The same phenomenon occurred on stage static firing. This indicates a temperature increase in the fuel pressurization line and, if true, comes as a result of a heat flux of 20 Btu/sec into the line. Analysis has proved that no such heat source is available, even with the fire in the engine area. Because this temperature increase occurred on AS-501 also, it is not believed associated with the failure.

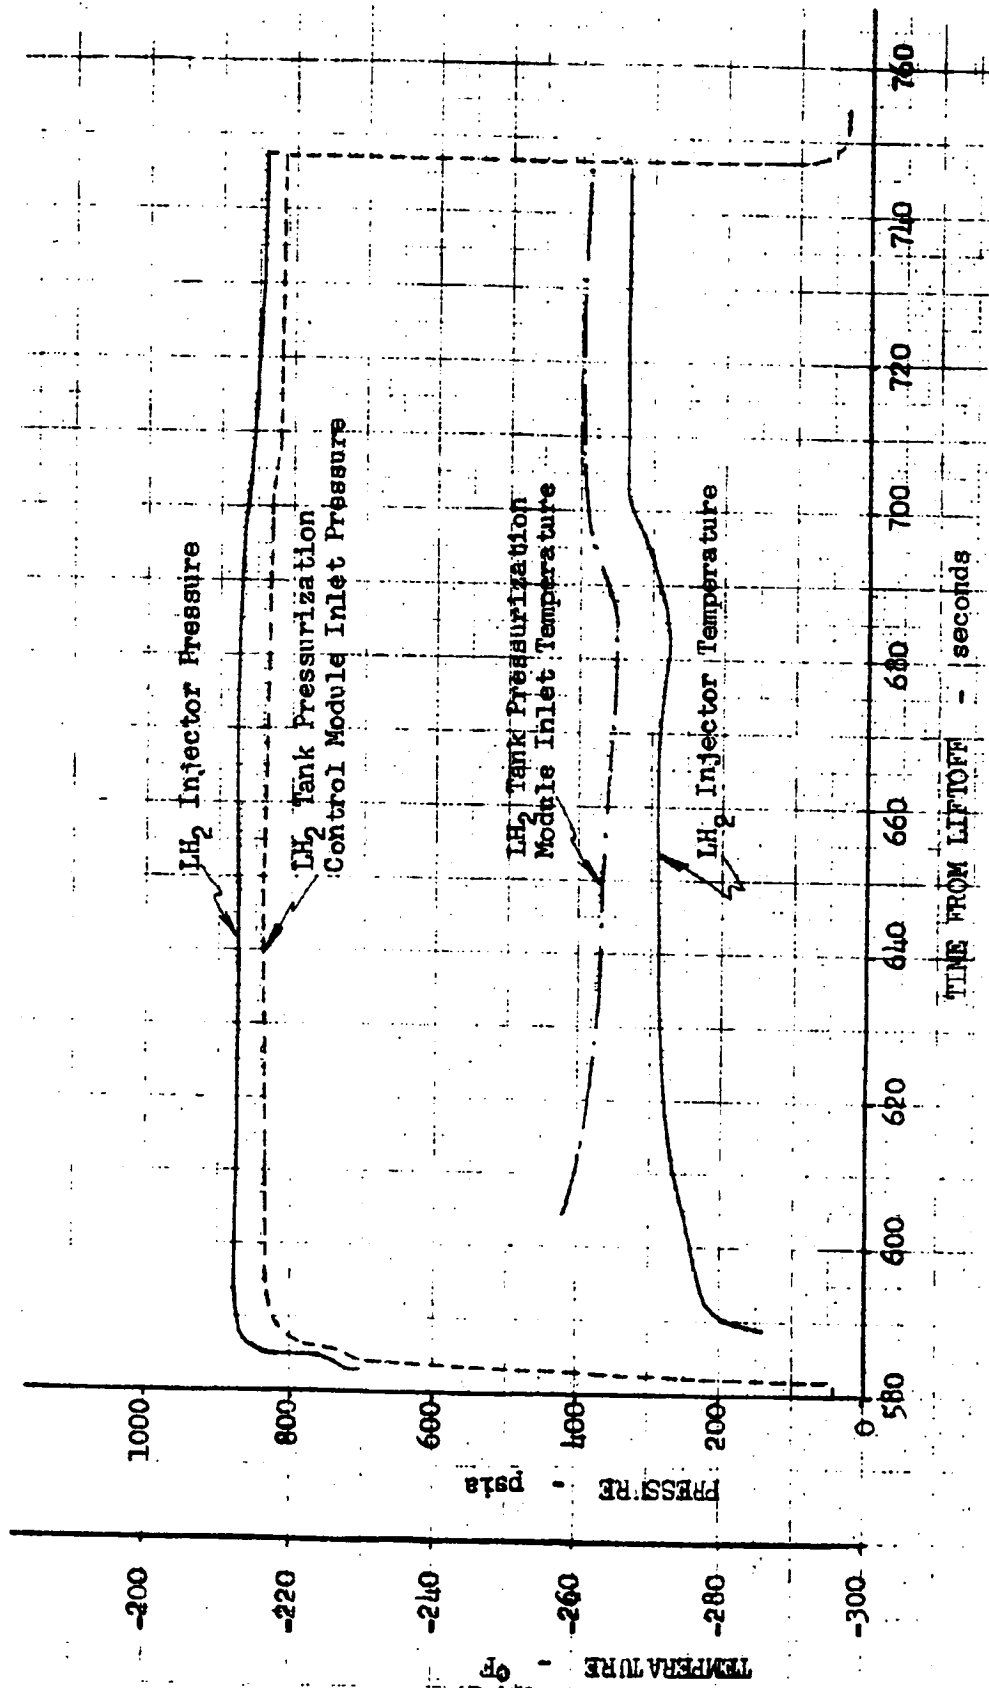
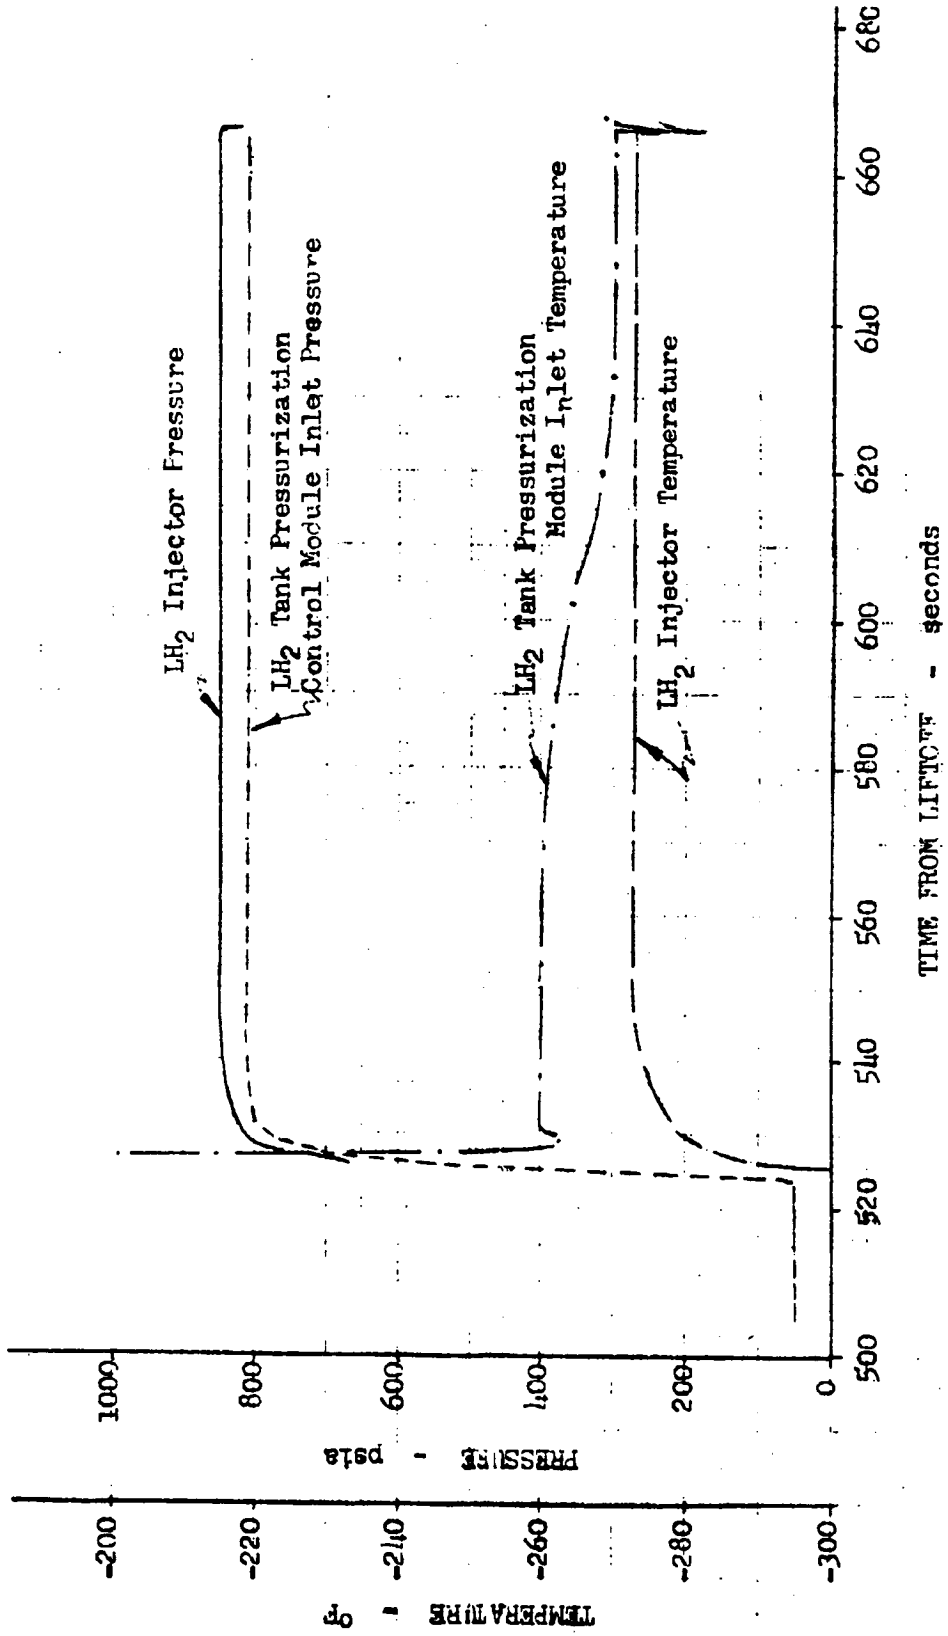
Plots of pressurization system operation are presented in Fig. 68 through 71. If leakage occurred in the system down to the fuel pressurization module, this would appear as an increase in the pressure drop between engine fuel injection manifold (D0004) and pressurization module inlet pressure (D0104). No such pressure drop increase occurred. Comparing those pressure differences on AS-502 (Fig. 70) with AS-501 (Fig. 71), the pressure drops are essentially the same on both. On AS-502, the pressurization flow-rate decreased beginning at 680 seconds (Fig. 69), coincident with the engine performance decay and the increased fuel injection temperature, but the line pressure drop remained essentially the same.

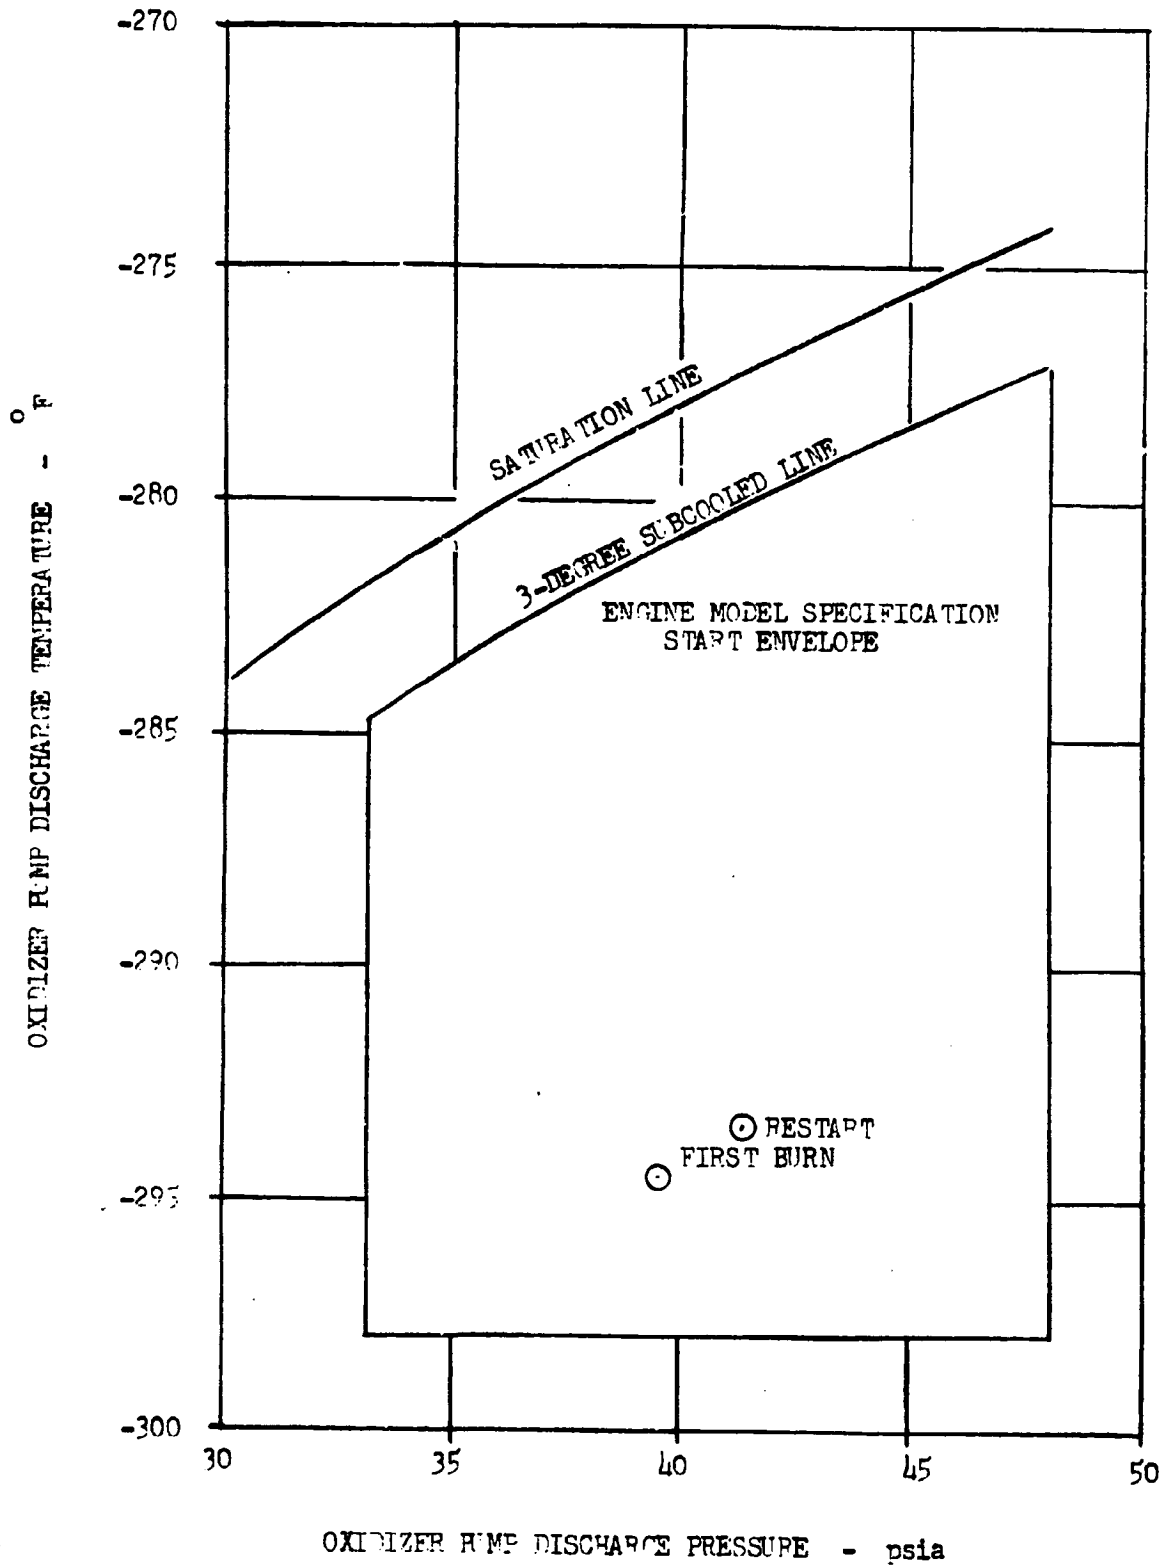
Figure 74. AS-502 S-IVB Oxidizer Pump Discharge Pressure vs Oxidizer Pump Discharge Temperature at Start

Figure 74 presents the engine start bottle conditions at liftoff, first burn, and restart. All values were within the prescribed envelopes.

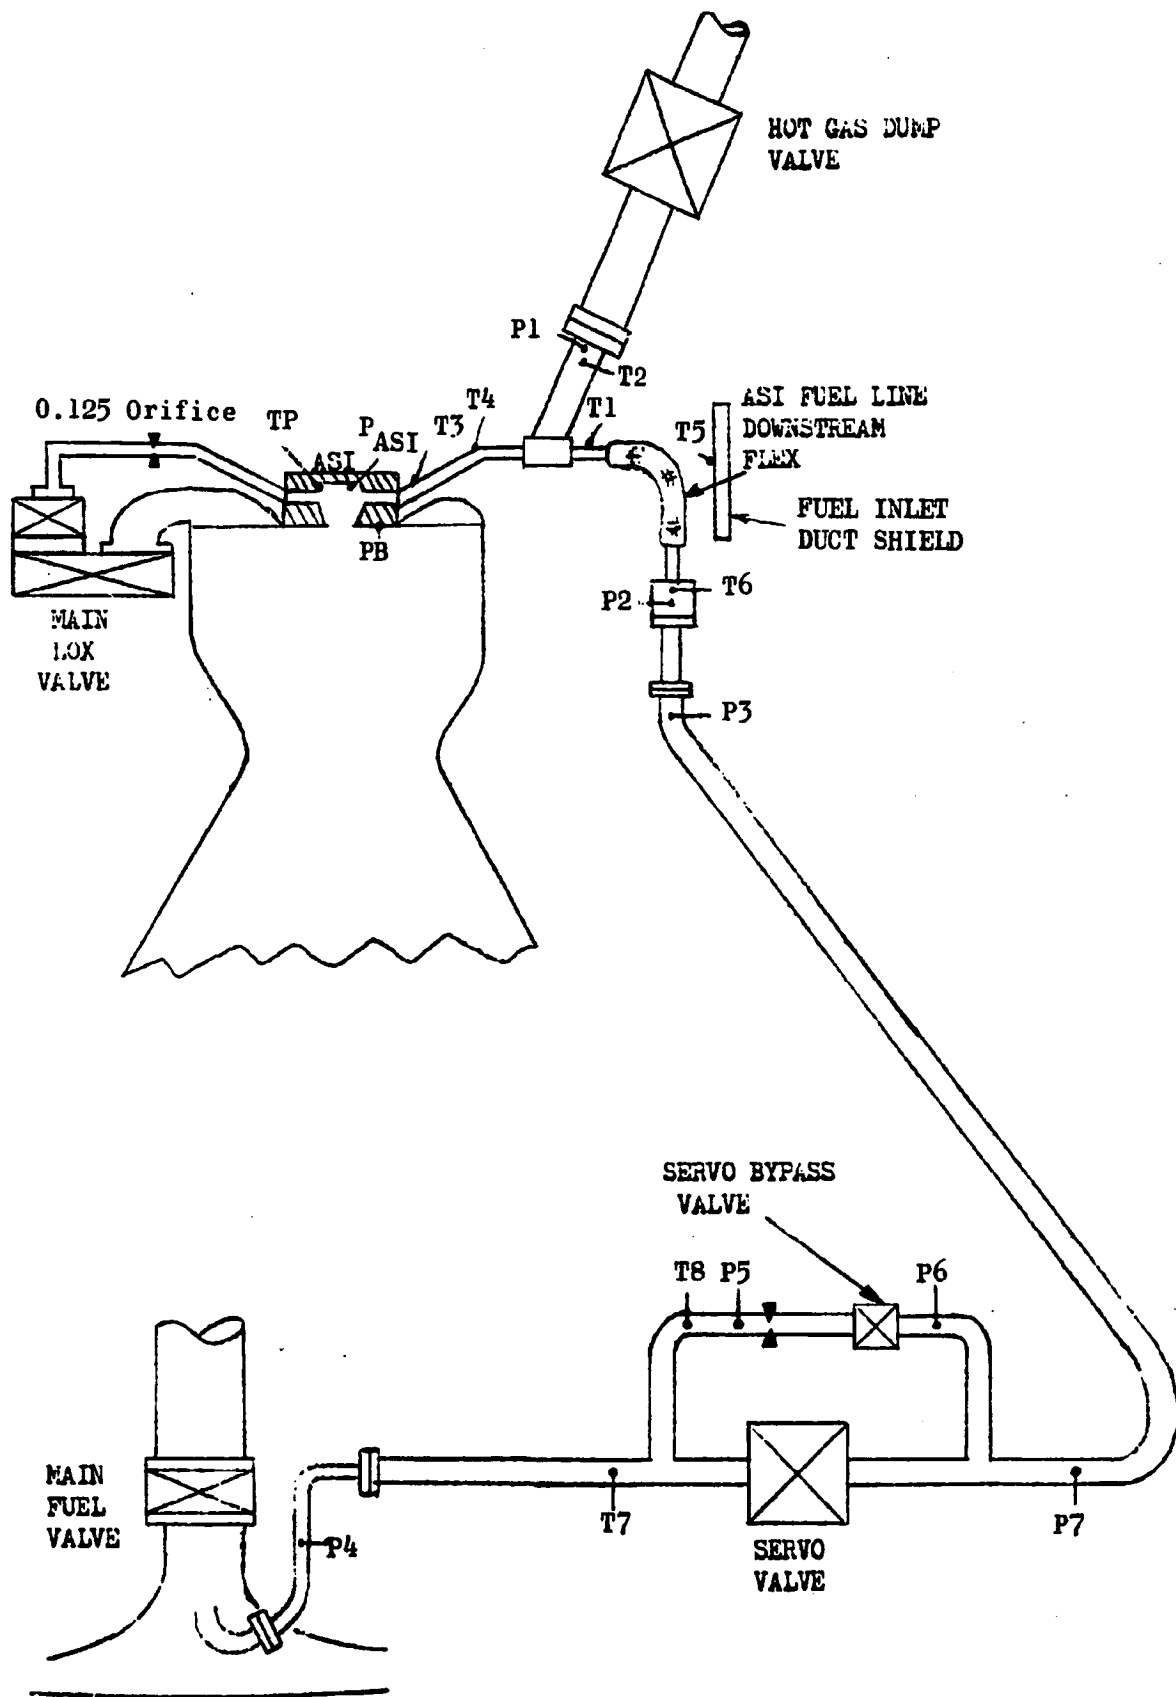
Figure 76. AS-502 S-IVB Failure Simulation Test, Engine J016-4, Test 313-041

A servocontrolled throttle valve was installed in the ASI fuel line so that the ASI fuel flow could be regulated to the desired flowrate as a function of time. The system, including the servovalve, was flow calibrated in liquid hydrogen prior to installation on the engine. A tee was installed in the ASI fuel line immediately upstream of the ASI. The tee led to a low-resistance dump system which could essentially open the ASI fuel system to atmosphere, thus simulating an ASI line failure. These systems are depicted schematically in Fig. 76.

Special instrumentation was installed so that the ASI fuel flow could be measured during the gradual flow decrease, and the temperature of the gas backflowing across the ASI fuel injector could be measured after the hot-gas dump valve was opened. Table 16 lists the special parameters measured, and Fig. 76 shows their locations. ASI fuel flow was measured using the pressure drop from P4 to P3, the density at T7, and the resistance versus valve position curve which had been generated during the ASI fuel system calibration. It was anticipated that the hot-gas temperature could be measured with the hot-gas dump fluid temperature (T2) and the skin temperatures T1, T3, T4, and T5. The ASI ignition detector probe was able to measure a temperature within the ASI chamber. A pressure measurement was installed in the ASI-to-injector seal bleed port to indicate when and if the primary seal burned through.

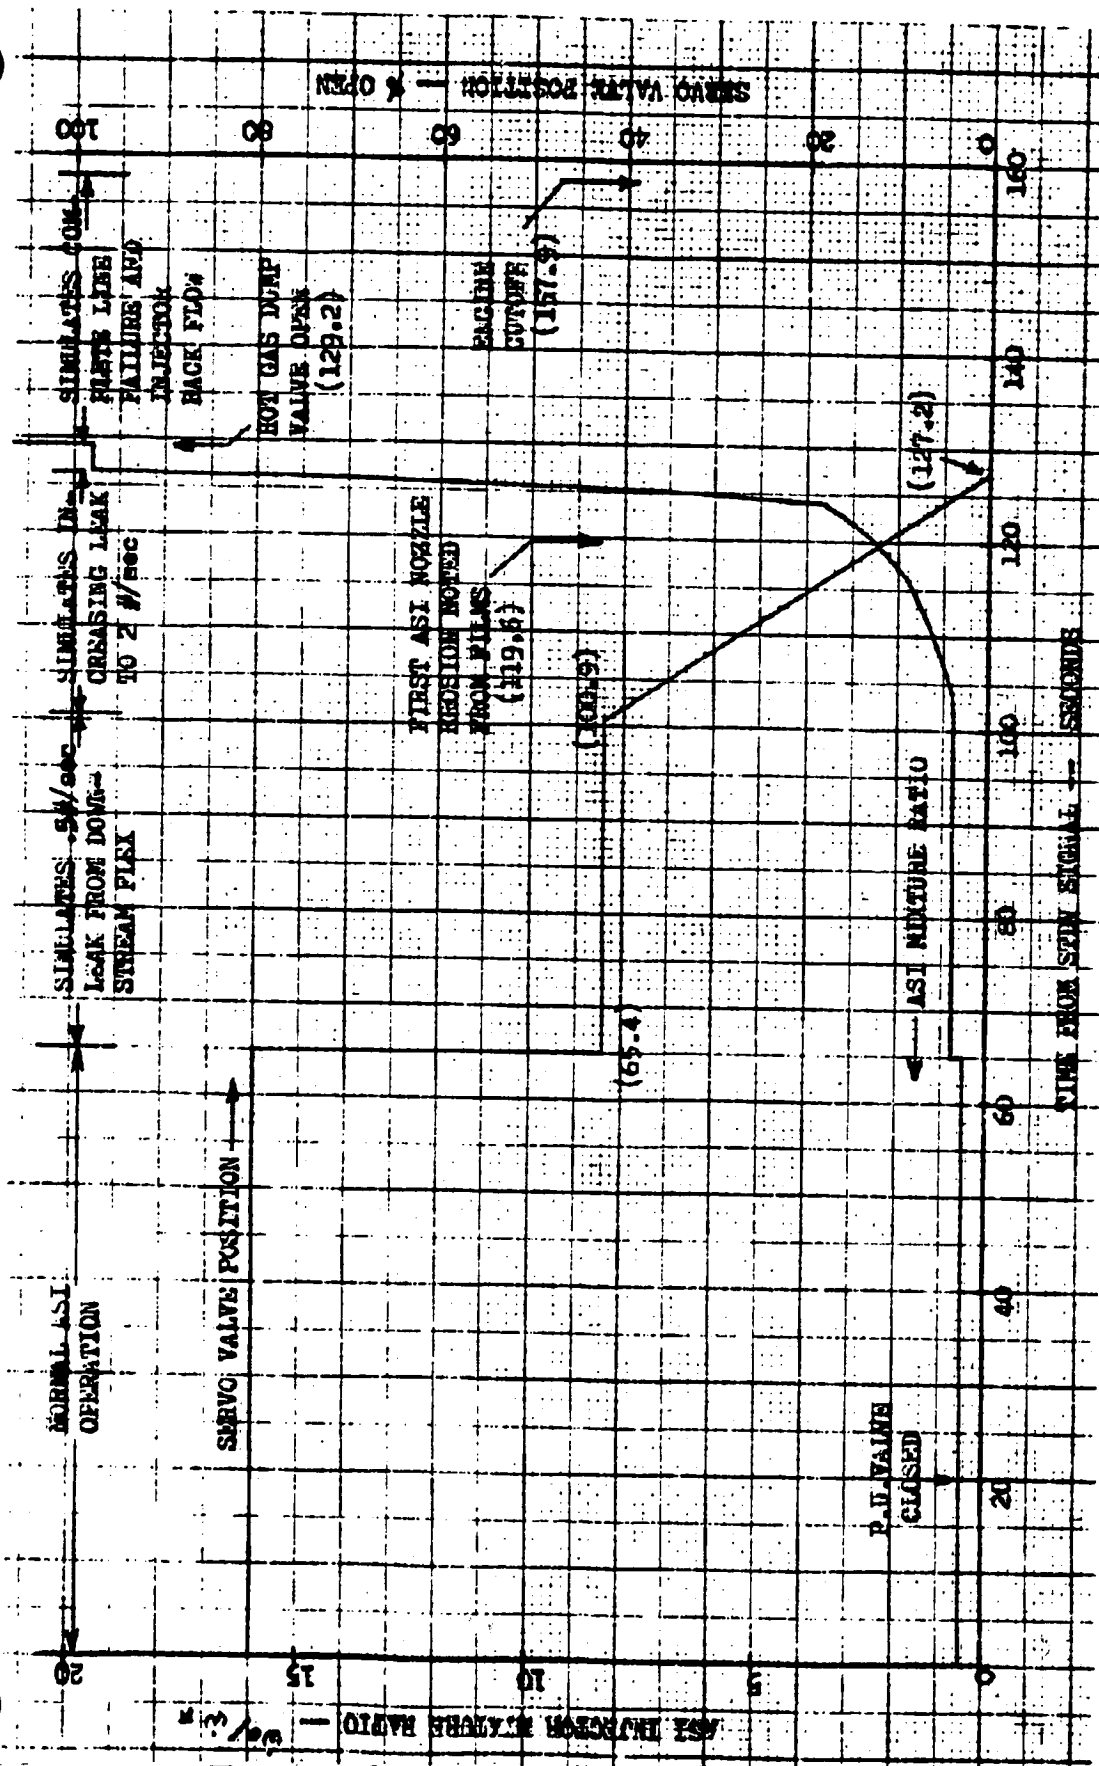
Figure 77. S-IVB Failure Simulation, Engine J016-4

Test 041 events are shown in Fig. 77. After 20 seconds of mainstage, the PU valve was closed to bring engine performance to the level of engine J2042 on AS-502. At 65 seconds, the ASI fuel servovalve was closed to 42 percent, reducing ASI fuel from a nominal 0.9 lb/sec flowrate to 0.6 lb/sec. This results in ASI operation anticipated with an overboard leak of approximately 0.5 lb/sec from the downstream 1/2-inch flex hose in the ASI fuel line. The engine ran for 35 seconds in this situation, simulating

Figure 77 illustrates the servovalve position and the resultant ASI mixture ratio during the entire test. The point of first ASI erosion, as determined from the films, was at an ASI mixture ratio of 2.5.

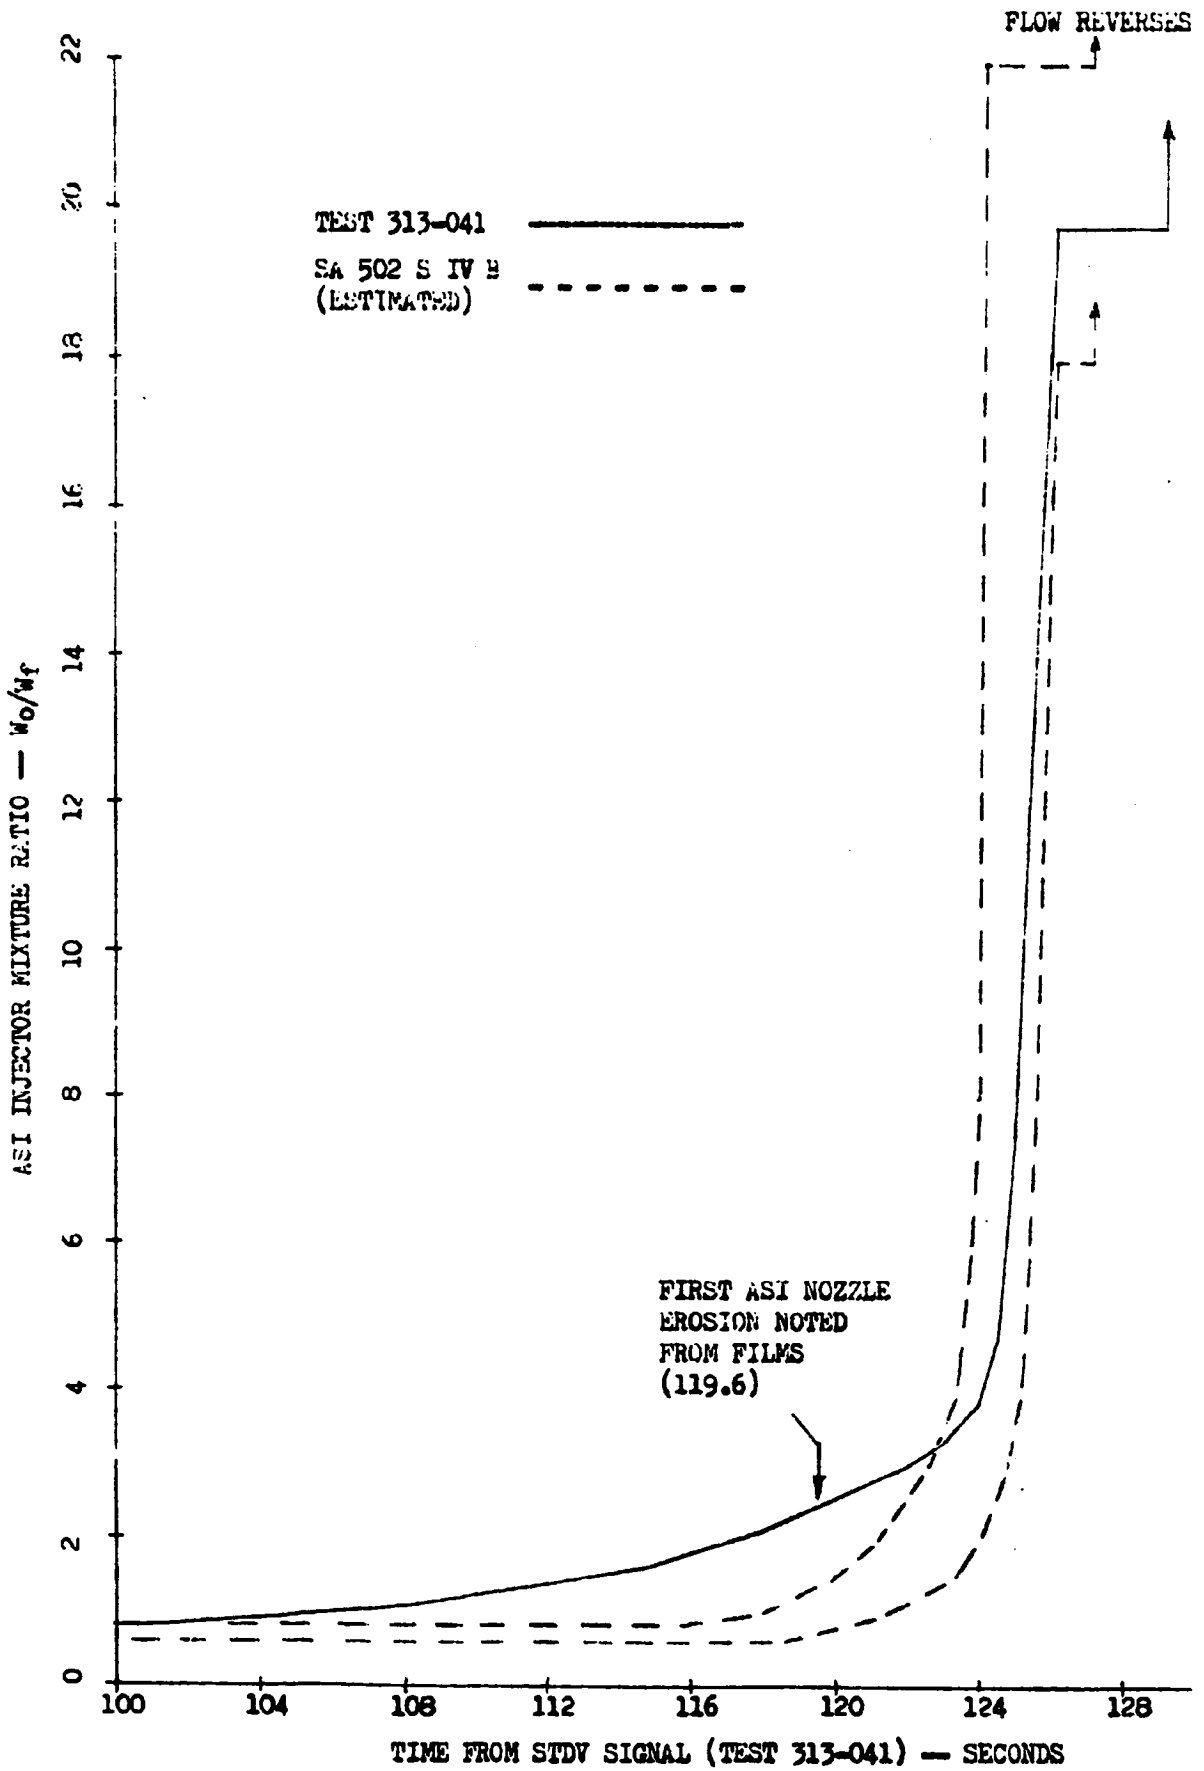
Figure 78. ASI Injector Mixture Ratio

In Fig. 78, the estimated ASI mixture ratio transient on AS-502, which was reconstructed based on the suspected location and magnitude of the ASI fuel system leak, is shown and compared with the results of the failure simulation test.
