REPORT NO. R-4035-46-1

SEPTEMBER 1968

# A PERFORMANCE EVALUATION OF GEOS - II

**PREPARED BY**  
communications & systems, incorporated

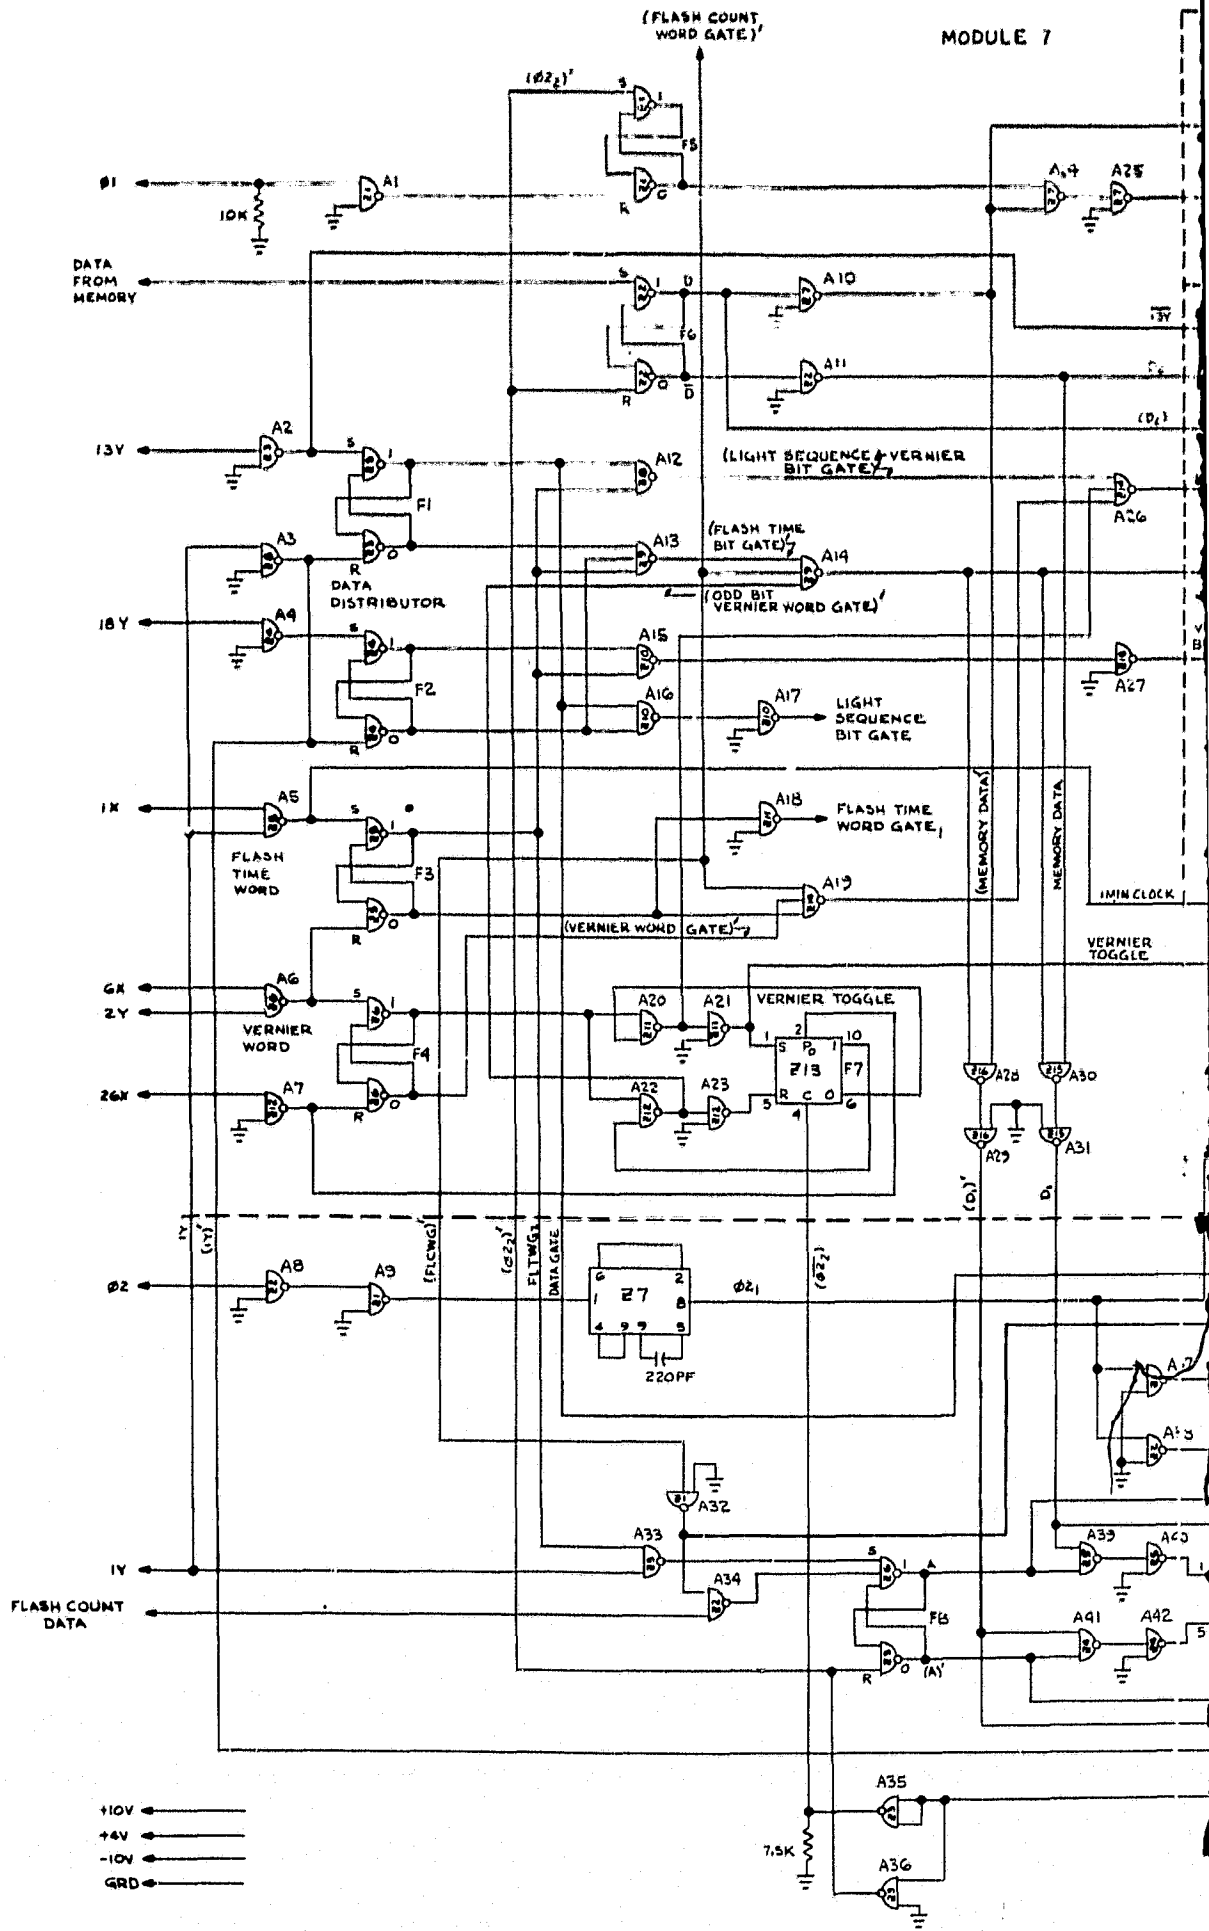
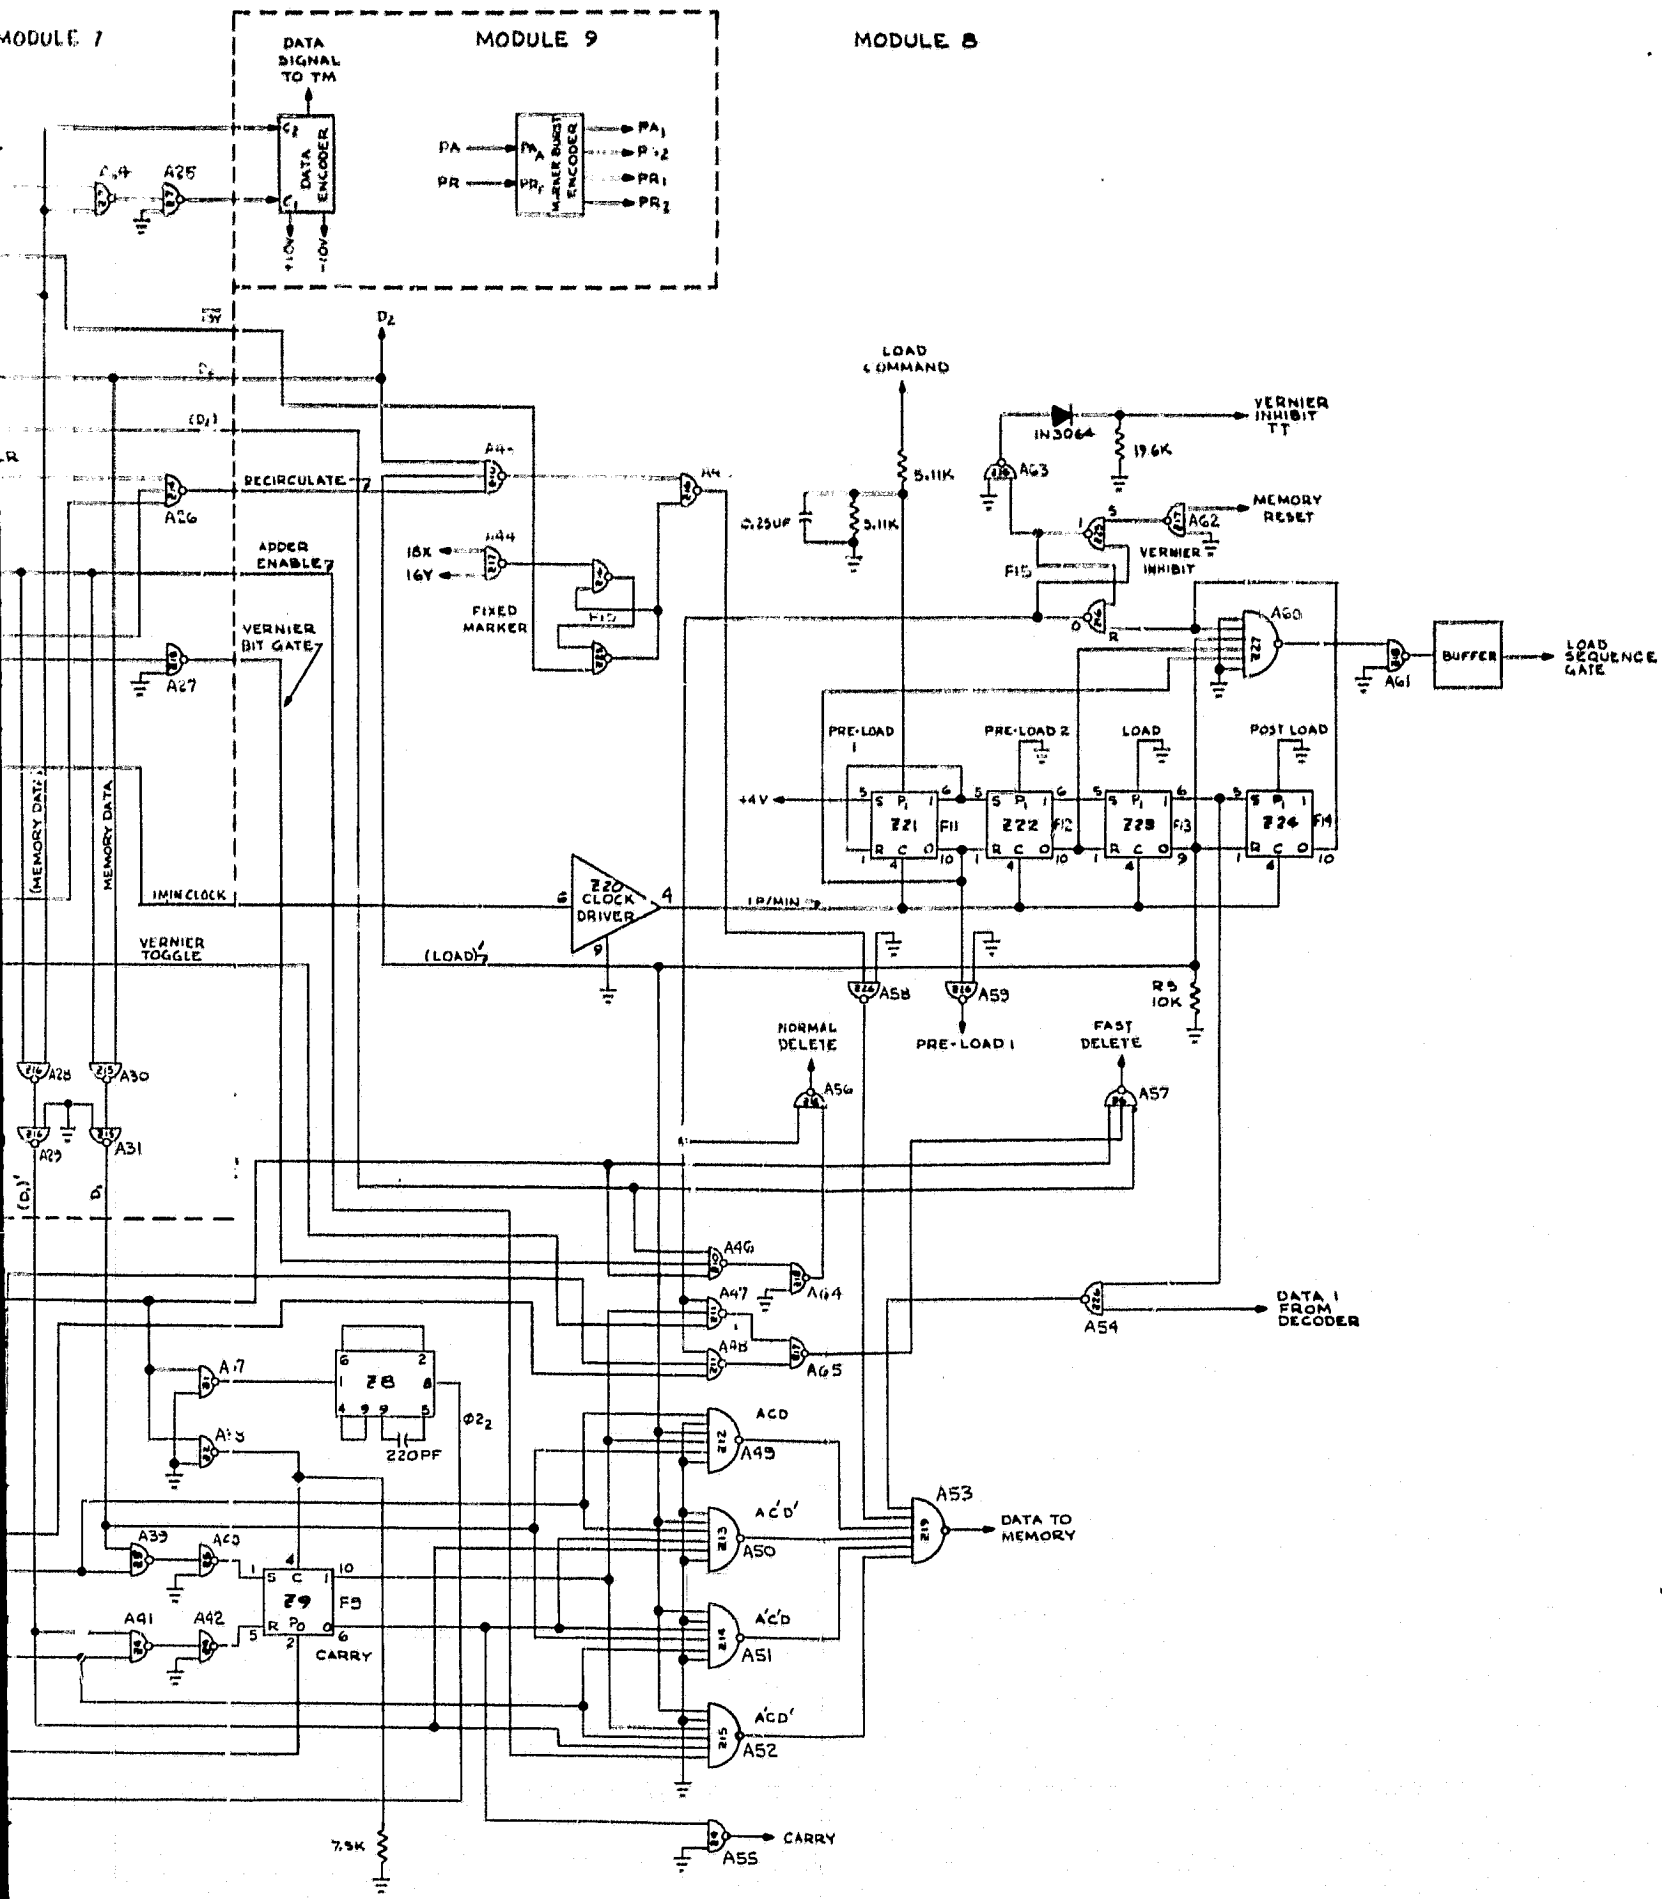
Figure 3-3 Data Handling, Logic Diagram

The mechanism for generating the data 1's in Words 63 and 64 is explained with reference to Figure 3-3 (Data Handling, Logic Diagram extracted from JHU/APL TG-896, April 1967). At memory position 18X, 16Y (coincident with Word 63 Bit 16), the following occurs:

Relating the above logic to the anomaly of Words 24 and 25, one can see that with the exception of the 18X condition, all other conditions are present to generate the fixed marker on any given adjacent words. That is, 16Y occurs at Bit 16 of all words and 13Y occurs at Bit 13 of all words. The unique condition associated with the fixed marker is the occurrence of 16Y and 18X simultaneously. This condition is satisfied only at Word 63, Bit 16. Word 24, Bit 16 is coincident with memory position 16Y, 44X. Position 44X is far removed from 18X; however, it is probable that the 18X condition was satisfied during Word 24, Bit 16 causing the error as previously discussed.

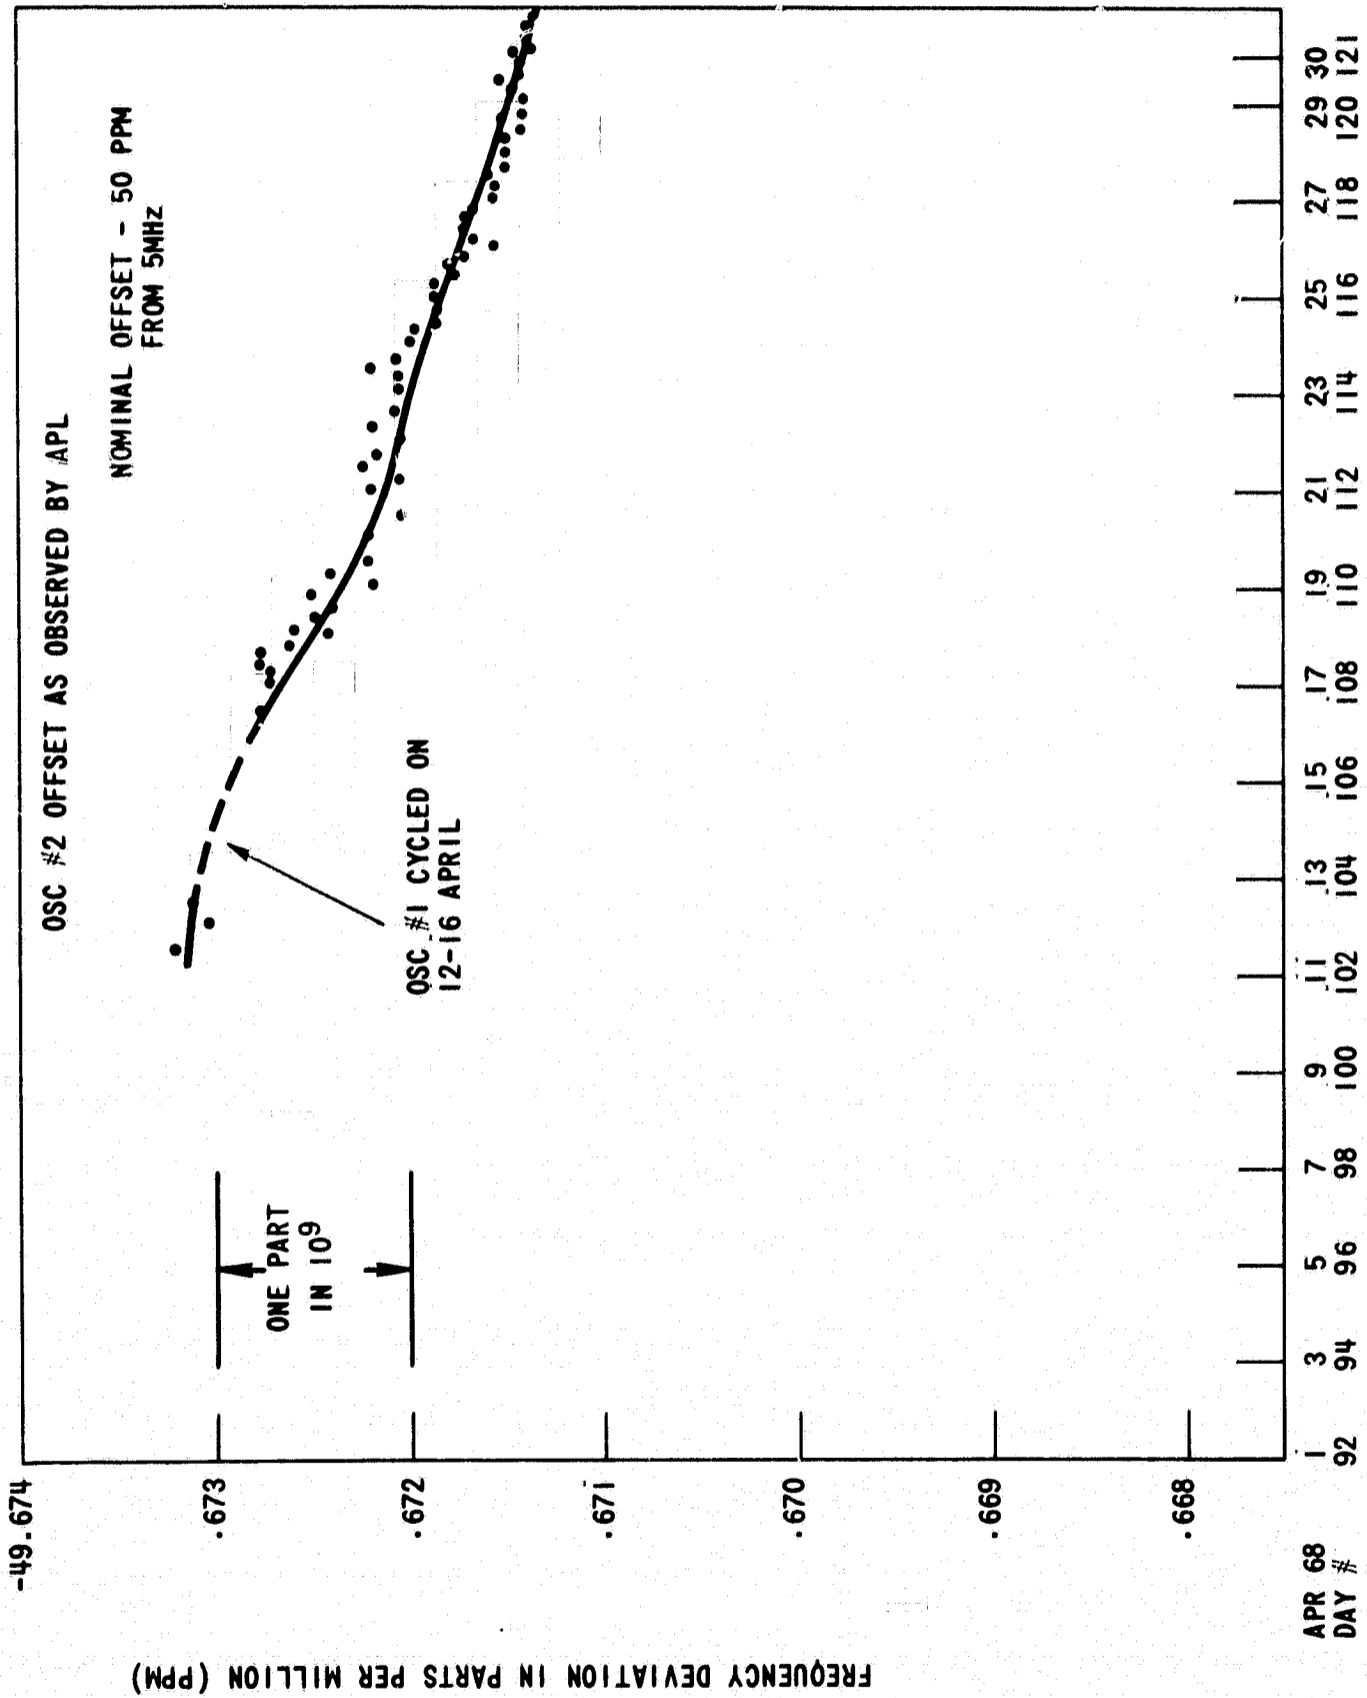
Figure 3-8 Oscillator Number Two Frequency Deviation Versus Time

Figures 3-8 and 3-9 are plots of the 5-MHz oscillator two frequency deviation from 16 April 1968 through 31 May 1968. Again, the data were obtained from reports submitted to the GOCC by APL and are derived from Navy Doppler tracking data.

Oscillator number two has performed very well with a smooth drift rate of about one part in  $10^{10}$  per day. From the day it was put into operation, through the end of this reporting period, frequency predictions for normalization purposes have been more accurately obtained. The drift rate during June and July is typical of that presented in Figures 3-8 and 3-9.
