19. REPORT ON GROOVED RUNWAY EXPERIENCE AT
WASHINGTON NATIONAL AIRPORT

By R. C. McGuire

Federal Aviation Administration

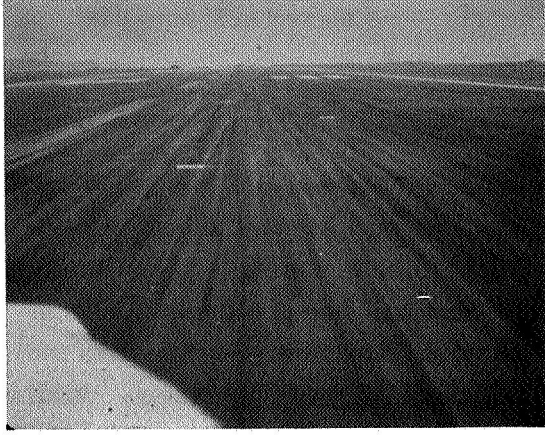
Figure 1

The Washington National Airport grooved runway 18-36 (fig. 1) has been the focal point of the Federal Aviation Administration interest in runway grooving. After observing the drainage of a grooved runway at Farnborough, England, during a heavy rain in December 1965, and discussing British experience with several experts in the Ministries, a research and development project was implemented by the Aircraft Development Service to study and apply the technology to civil airports in cooperation with NASA and ATA. A special committee, representing the airport, engineering, and research branches of the agency, was established in the spring of 1966 to investigate, implement, and monitor the science of runway grooving.

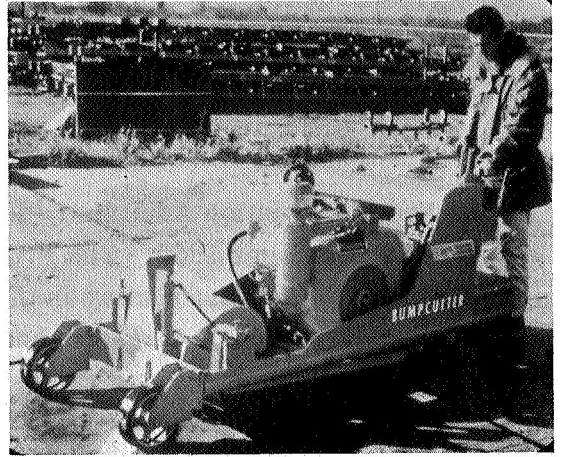
Figure 2

The contractor used Clipper grooving machines (fig. 2). These are small gasoline-engine-driven vehicles capable of sawing 13 grooves at a time. Since the specifications called for completion of the work in 35 days, seven machines were used. Each was assigned a daily task of 35 feet of runway length, 150 feet wide. Approximately 200 feet of runway length were completed per day. The work was done between 11 p.m. and 7 a.m. to minimize interference with traffic. (See figs. 3 to 7.)

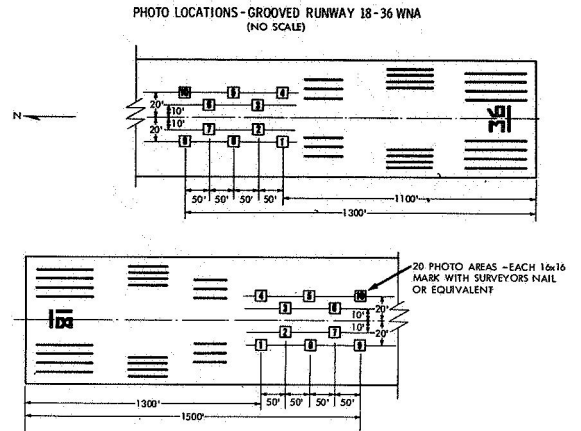
Figure 10

To evaluate the endurance of the grooves, engineering "control" points were established in the touchdown areas to assess wear and tear. (See figs. 10 and 11.) These control points were photographed when the runway was grooved, and were again photographed recently after more than 400 000 operations. Several of these photographs are shown as figures 12 to 15.

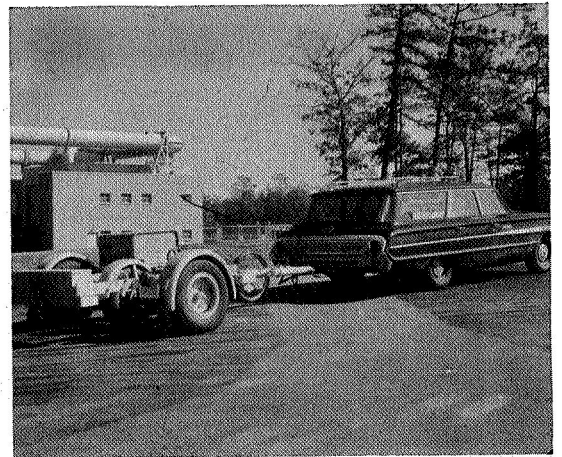
Figure 20

It should be noted that the runway was in very good condition before it was grooved and had no history of slick-runway incidents or accidents. However, some knowledge of the friction characteristics of the runway, dry and wet, before and after grooving was necessary. A Swedish Skiddometer, which the FAA purchased in 1964, was used to obtain these data. This trailer measures the surface drag of a smooth tread ASTM 7.50 × 14 tire at 13 percent slip and records it as a traction number on paper tape in terms of distance and time. The trailer-tow vehicle is also equipped with an FAA-designed 150-gallon water system capable of dispensing 20 000 feet of water film (approximately 0.020 inch thick) in the path of the test tire (fig. 20).

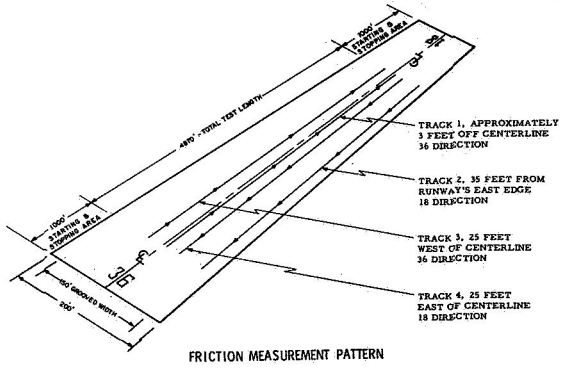
Figure 21

Wet and dry friction surveys of the runway were made at velocities of 10, 30, 50, and 60 miles per hour at locations on the runway centerline, 25 feet each side of the centerline, and along the runway edge. The edge survey was made to compare the friction characteristics of the unused part of the runway with those of the used part. The friction measurement pattern is shown in figure 21.

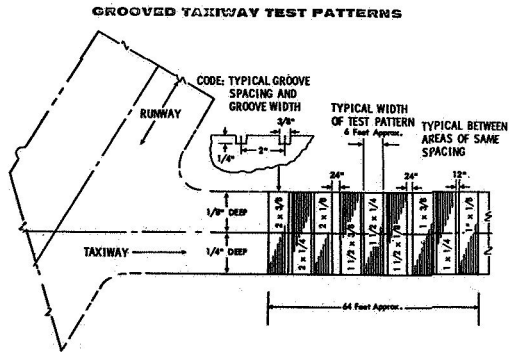
Figure 23

and will serve to evaluate the traffic/wear/environmental effect on 18 groove patterns in concrete and asphalt taxiways. The patterns being tested are in two groups; one being 1/8" deep grooves, the other being 1/4" deep grooves. The spacings are 1", $1\frac{1}{2}$ ", and 2"; the groove widths are 1/8", 1/4", and 3/8". (See fig. 23.)

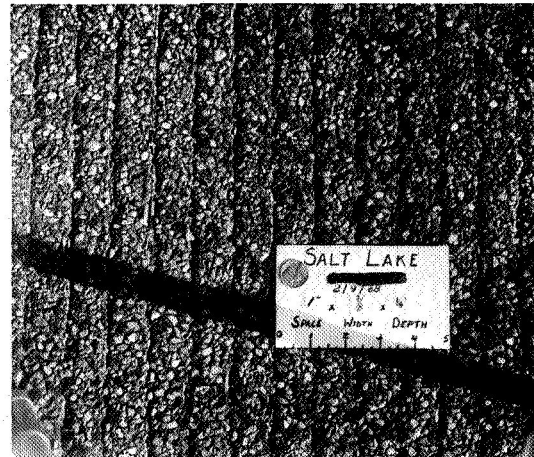
Figure 24

The test grooves were installed in 1967 at Miami, Cleveland, New York City (John F. Kennedy International Airport), Salt Lake City, and Las Vegas airports. Taxiways were used, instead of runways, as test beds because of the experimental nature of the project. A typical view of the surface at Salt Lake City is shown in figure 24.
