## ADVANCED REFRACTORY ALLOY CORROSION LOOP PROGRAM

### QUARTERLY PROGRESS REPORT NO. 13

For Quarter Ending July 15, 1968

prepared by  
R. W. Harrison

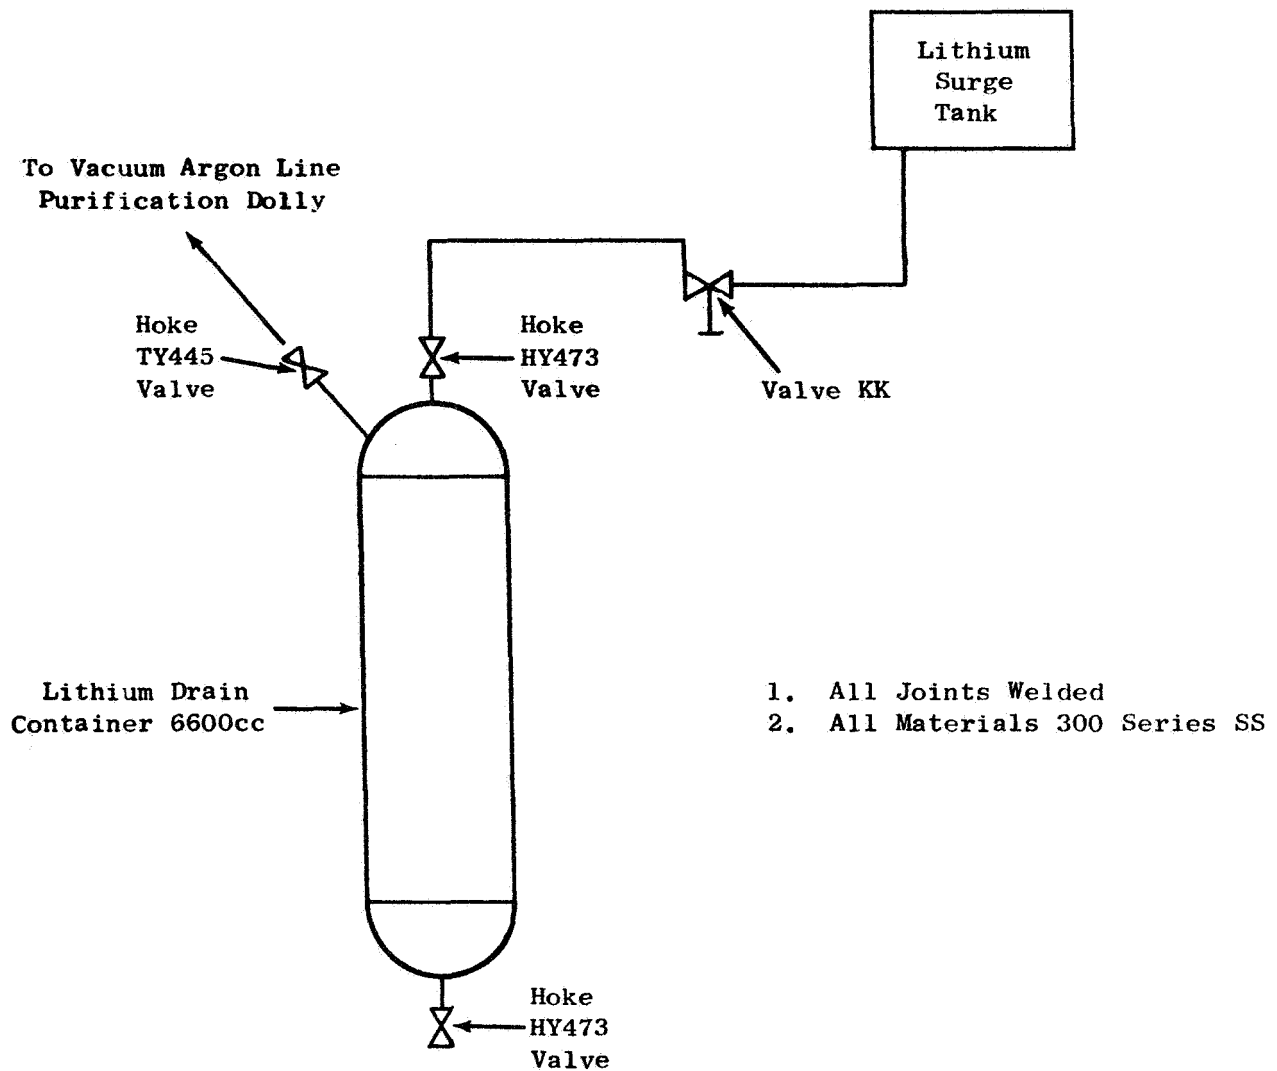
The lithium drain container, shown in Figure 1, was fabricated and attached to valve KK of the primary circuit. This container was fabricated from a 24-inch section of 4-inch, schedule 10, Type 304 stainless steel pipe and 4-inch, Type 304 stainless steel pipe caps, and had a volume of 6600 cc. It was weighed prior to attachment to the drain line and the vacuum-argon line.

Figure 1. Schematic of System Used for Draining Lithium from the Primary Circuit of T-111 Rankine System Corrosion Test Loop.

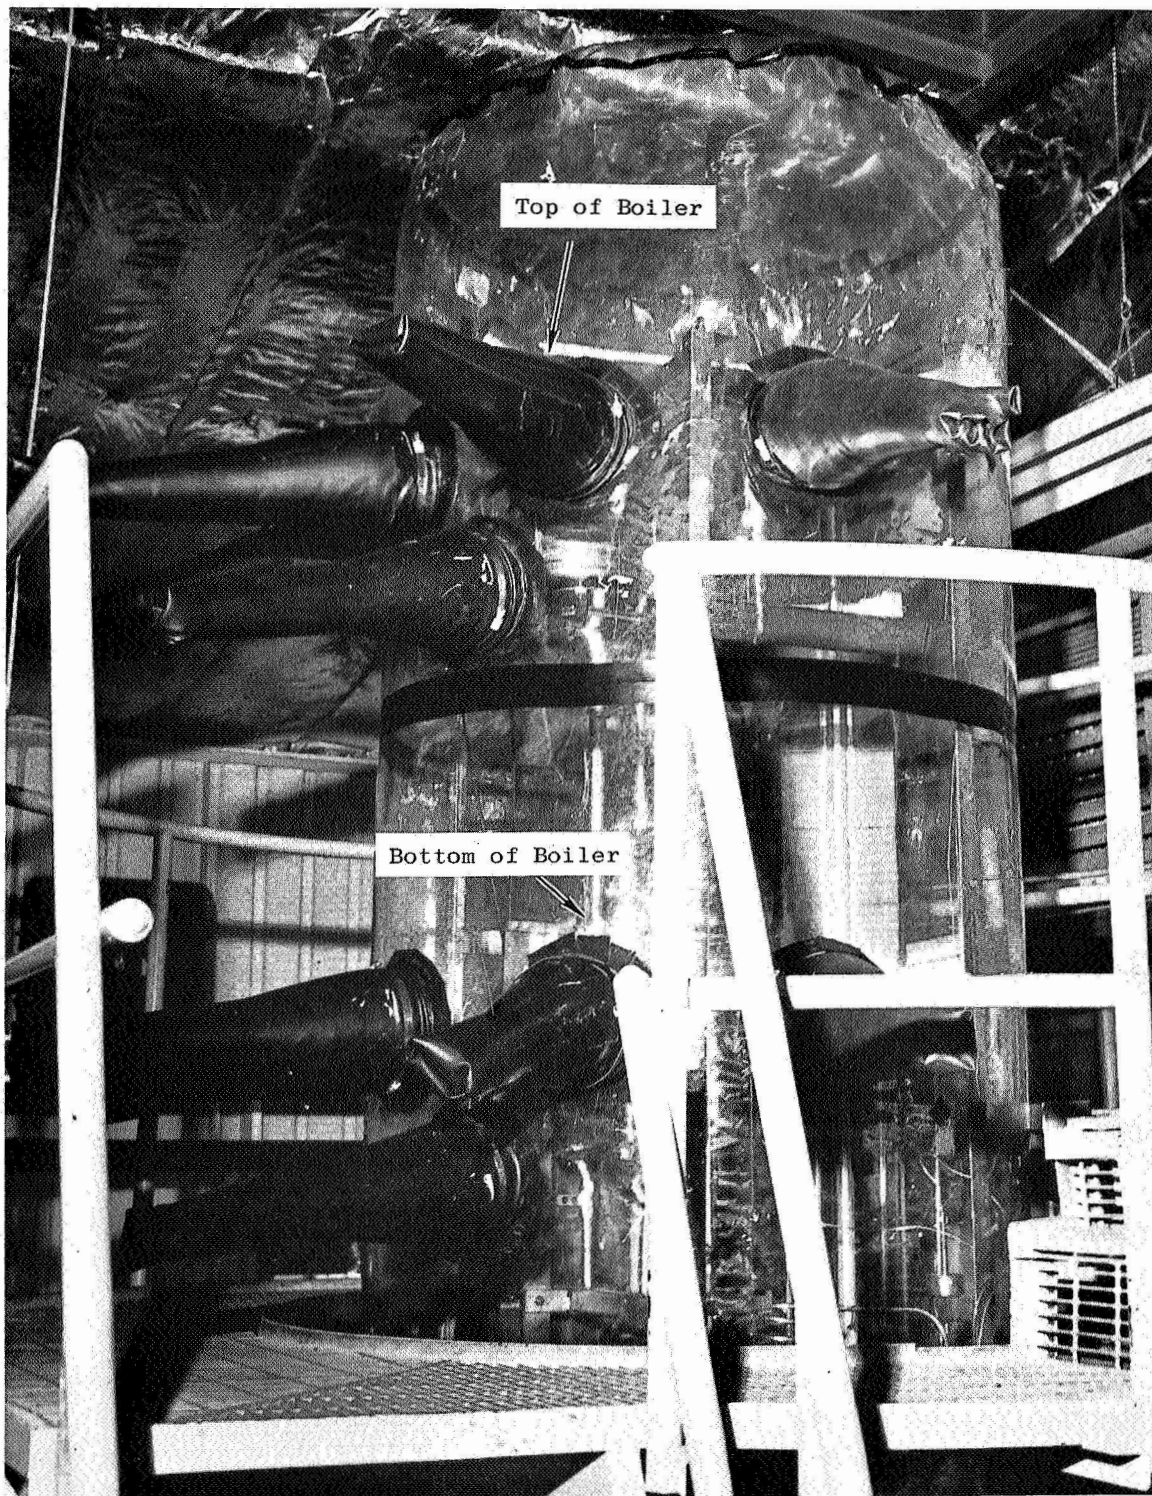
designed, fabricated, and assembled around the loop. The chamber shown in Figure 6 is fitted with neoprene gloves appropriately located for access to the areas to be cut at the top and bottom of the boiler. The chamber was sealed from the atmosphere at its base by a rubber cushioned stainless steel expansion ring pressing the vinyl against the inside of the vacuum chamber spool piece. The vacuum bell jar could therefore be lowered over the vinyl chamber and mate with the spool piece flange without interference at the sealed end of the vinyl chamber. This arrangement provided the capability of evacuating the vinyl chamber inside the bell jar. The annulus between the vinyl chamber and the bell was also evacuated to prevent collapse of the chamber. Following an overnight pump-down the chamber was backfilled with argon. Analysis of the exiting argon was performed with a Beckman Model 80 Trace Oxygen Analyzer and a Model 27901 electrolytic hygrometer shown in Figure 7. Typical analyses of less than 10 ppm oxygen and less than 70 ppm water vapor were obtained. Subsequently the bell jar would be removed and cutting operations would be initiated. Gas analysis was continued during operations in the vinyl chamber. The water vapor concentration in the chamber increased with time but typical analyses indicated maximum concentrations of less than 200 ppm when the gas filled chamber was maintained at ambient conditions. Only small increases in oxygen concentration were noted.

Figure 6. Vinyl Chamber Used for Cutting Operations on Boiler of T-111 Corrosion Test Loop. (C68062842)

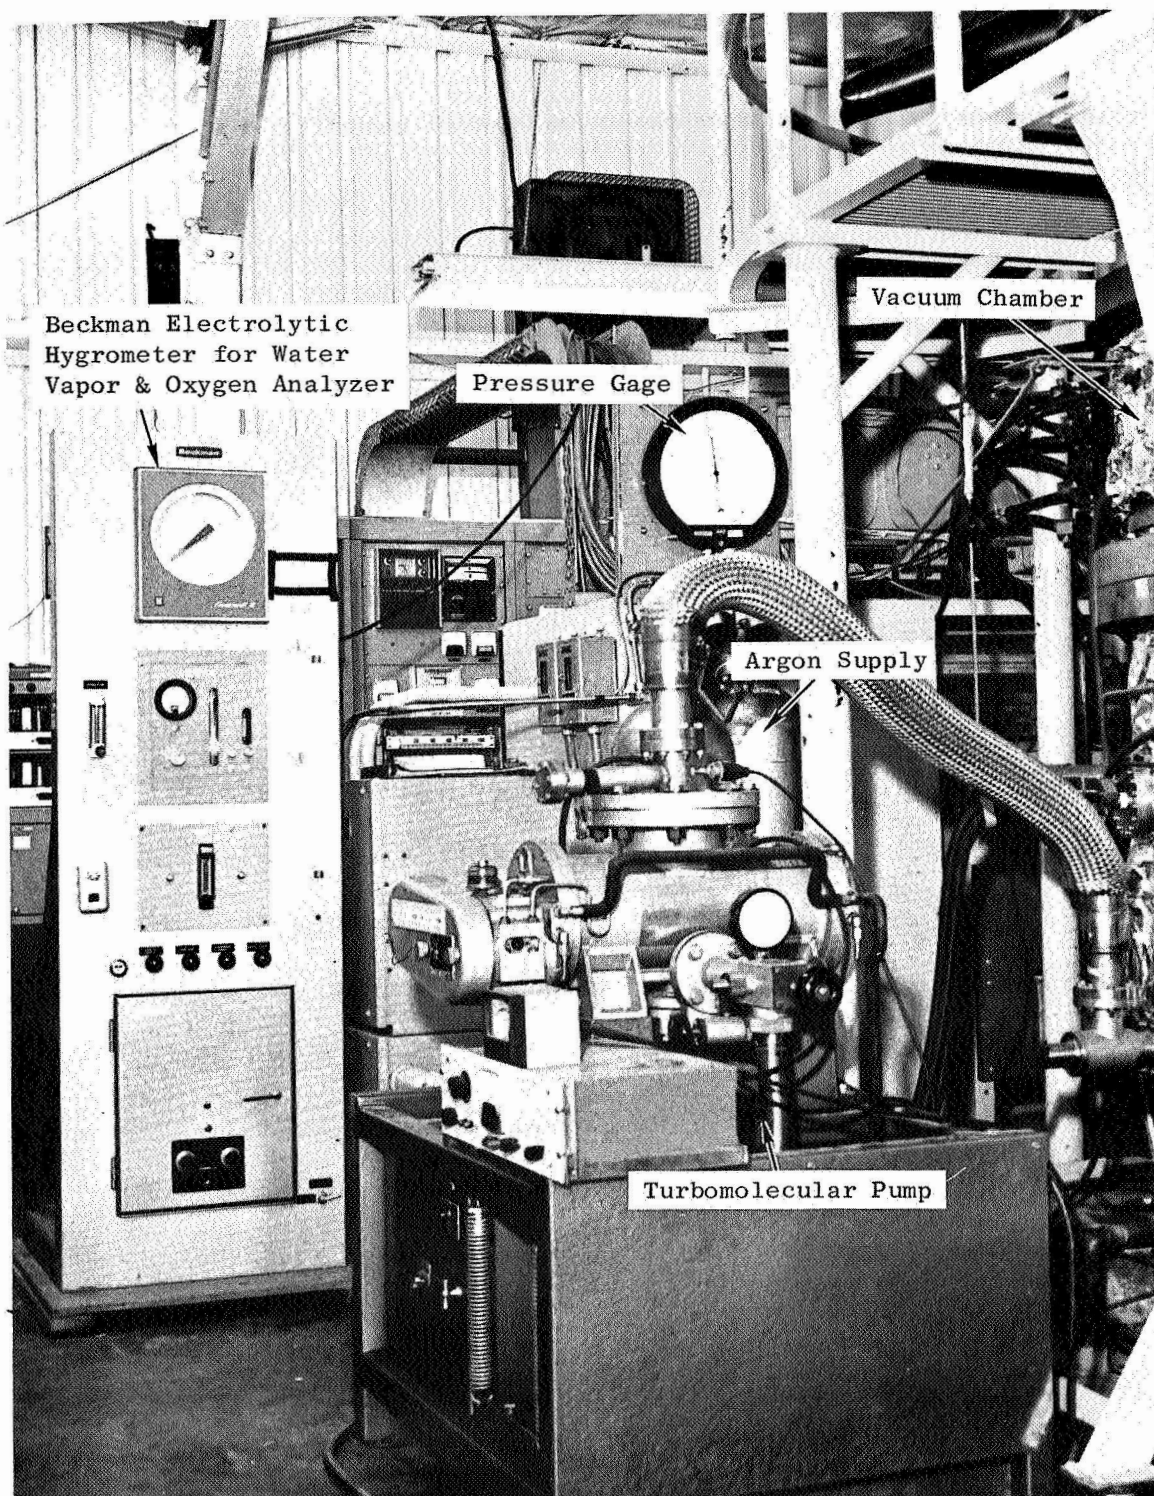
Figure 7. Vacuum Equipment and Instrumentation Used for Evacuation and Backfilling of Vinyl Chamber and Analysis of Exiting Inert Gas. (C68062846)

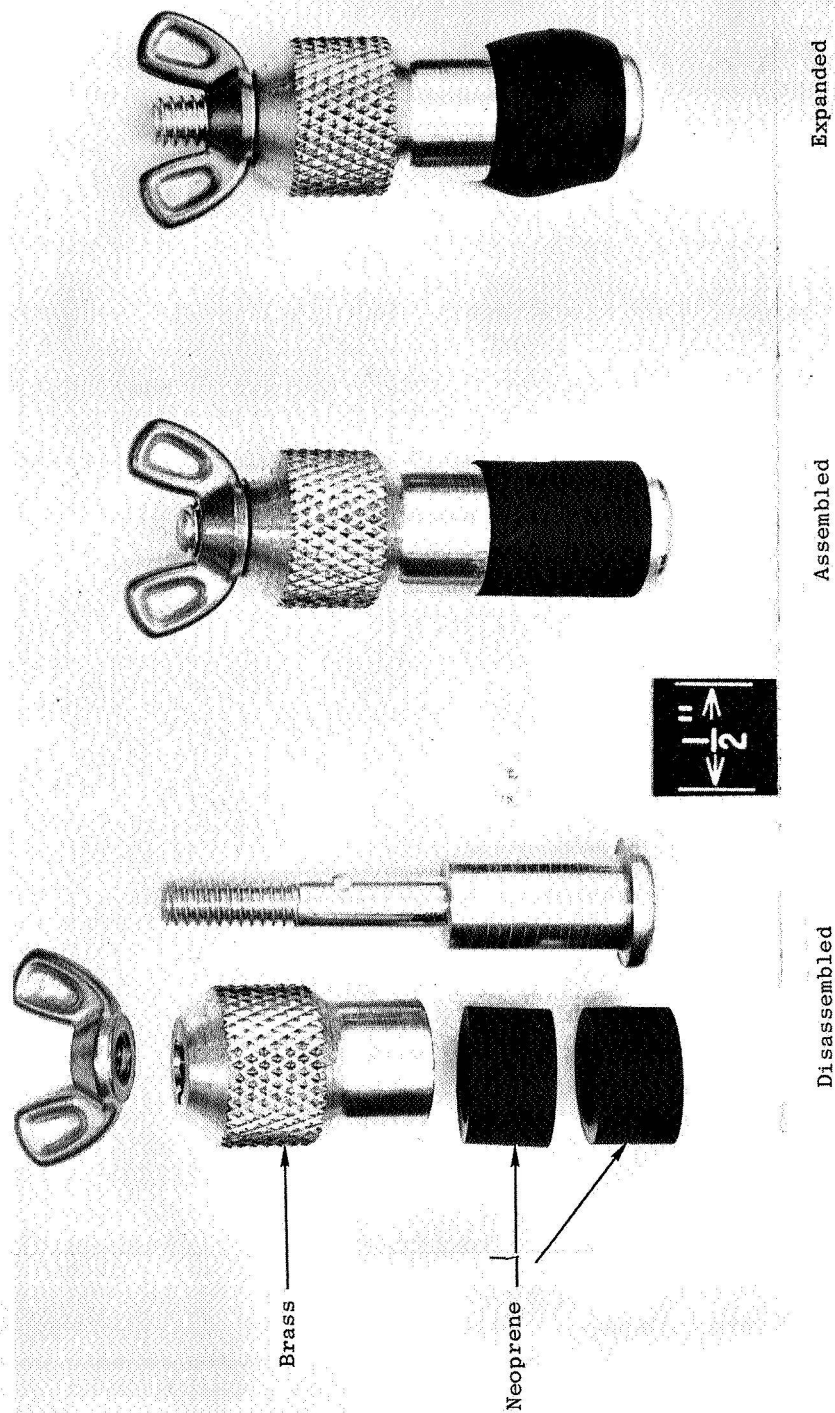
On June 20, 1968 the boiler was cut exposing the top weld. The potassium circuit, which had been under a positive argon pressure was immediately sealed with expandable plugs (Imperial Model 140F Tubing Test Plugs) as shown in Figure 8. The seal is accomplished by a rubber grommet expanded against the inside diameter of the tube by the action of a brass sleeve actuated with the wing nut as shown in Figure 9.

Figure 9. Expandable Plugs Used to Seal T-111 Alloy Corrosion Test Loop Tubing After Cutting. (C680719136)

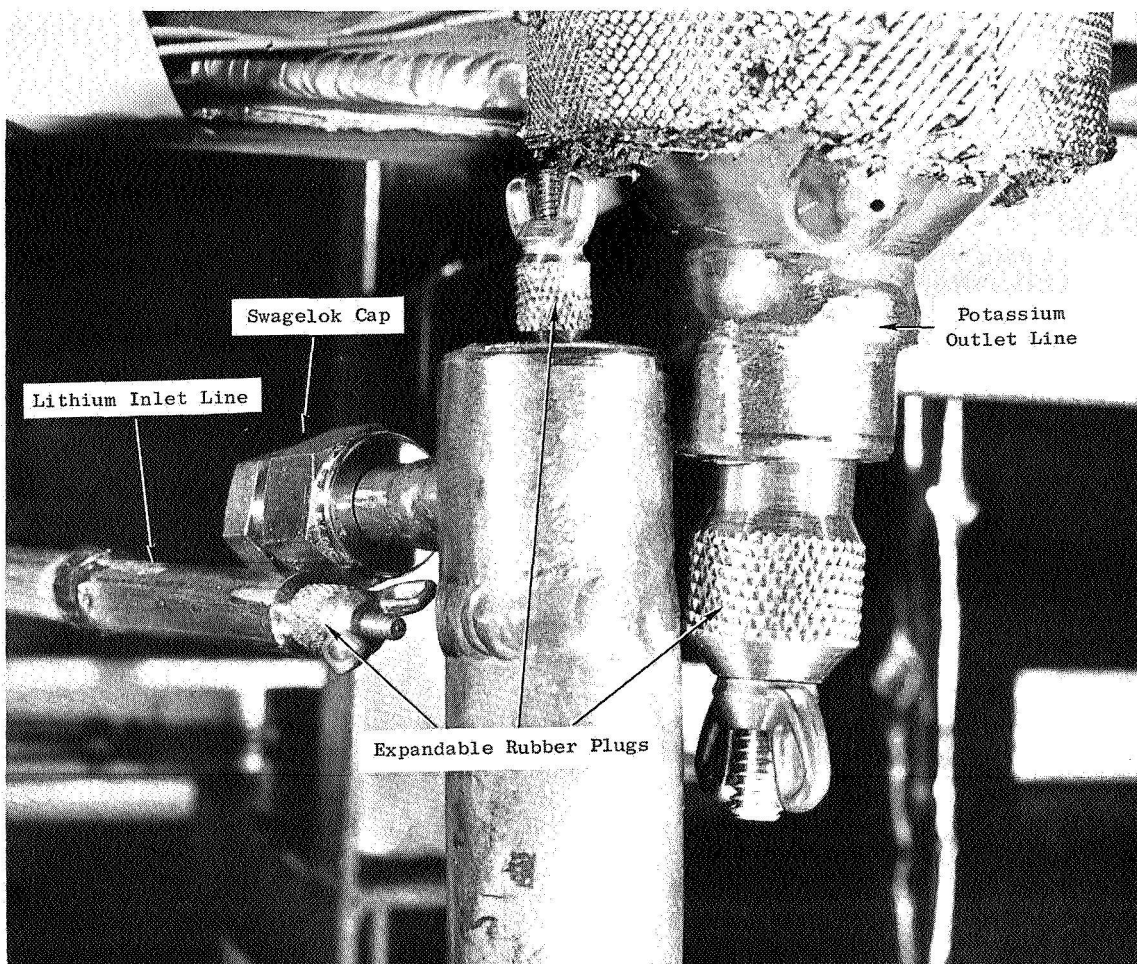
Figure 11. Top of Boiler After Cutting and Sealing Lithium Inlet and Potassium Exit Lines. (C680719137)

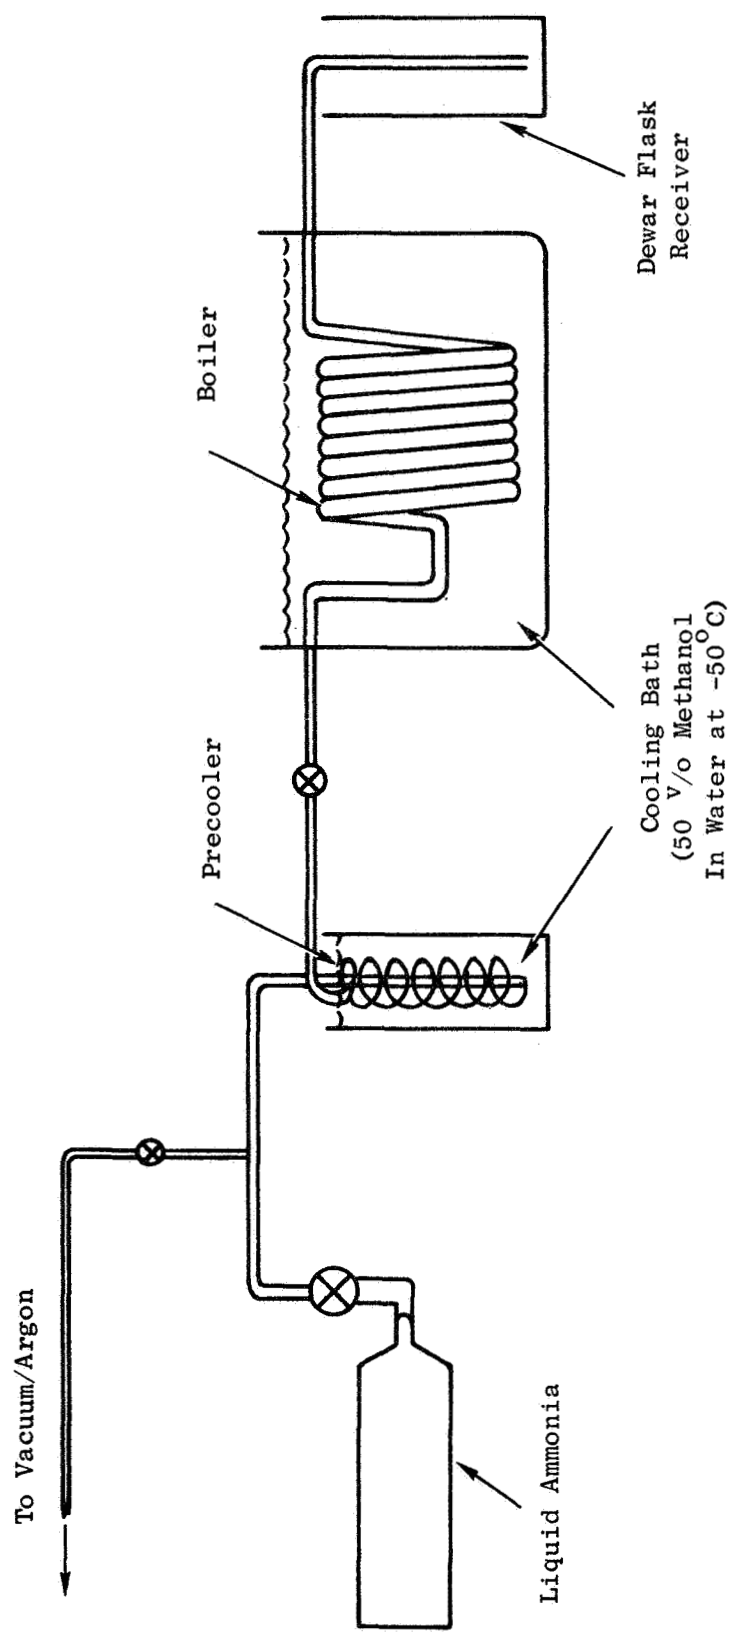
Figure 12. Schematic of Apparatus Used to Remove Residual Alkali Metal from Boiler by Dissolution in Liquid Ammonia.

The proposed method of removing the residual potassium and lithium from the T-111 boiler by flushing with anhydrous liquid ammonia (99.999%,  $< 10 \text{ ppm H}_2\text{O}$ ) was tested by cleaning a simulated boiler constructed of 0.5 inch OD, type 316 stainless steel tubing. This apparatus consisted of two coils and contained a section of 1/8-inch stainless steel rod around which wrapped specimens of 0.060-inch diameter T-111 and Cb-1Zr wire. This special section was included to simulate the plug region of the T-111 loop. The lithium drain container containing the lithium and a small amount of potassium removed from the loop was emptied into another container through the simulated boiler. Argon was then blown through the apparatus so that most of the alkali metal was removed. The residual alkali metal was then flushed out with liquid ammonia using the procedure described below for the actual boiler. The T-111 and Cb-1Zr specimens showed no significant change in carbon, hydrogen, oxygen or nitrogen concentrations as a result of the cleaning operation, thus qualifying the method for cleaning the T-111 boiler.
