## SOLAR SATELLITE PROJECT

INSTRUMENTATION AND FLIGHT  
PERFORMANCE OF HCO HIGH  
RESOLUTION WAVELENGTH  
SPECTROMETER

NASA AEROBEE 4.185 US  
NASA CONTRACT NSR-22-007-067

May 1969

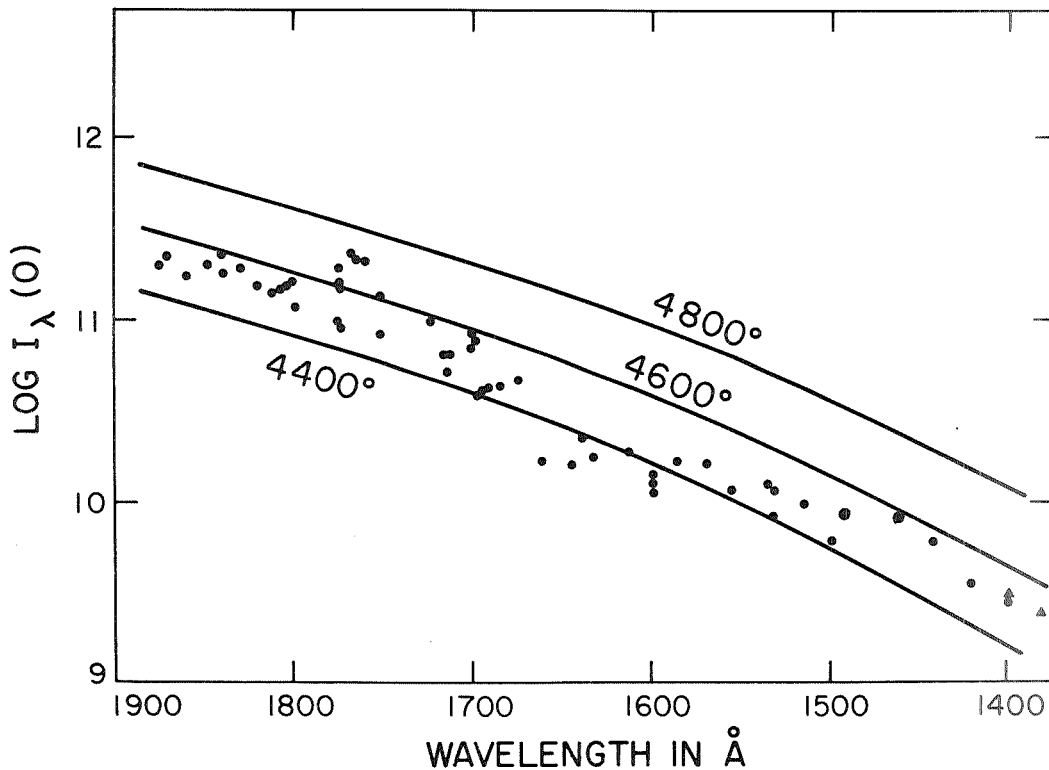
Figure A-1 shows the data ( $\log_{10}$  ergs/cm<sup>2</sup> sec cm steradian) plotted against wavelength. The solid curves represent the values obtained for an equivalent black body of temperature 4400°K, 4600°K, and 4800°K. Included on the graph are two values, indicated by triangles, from

There is clearly an as yet unexplained discrepancy between our observations and those of the NRL group. Our intensities are in general lower by a factor of 3 than the most current estimate by Whiting and Purcell (1969). In the region of the temperature minimum, this represents approximately  $250^{\circ}\text{K}$ . Corroborative observational evidence for the lower temperature minimum have been reported by Eddy, Lena, and MacQueen (1969). Their airborne observations made around 300 microns yield a brightness temperature of  $4300^{\circ}\text{K}$ .
