SUMMARY REPORT  
TASKS VII AND VIII  
JPL CONTRACT No. 951720  
3 JUNE 1969

HYDRAZINE ELECTROLYSIS CELL  
SAFETY LIMITS TESTS

PREPARED BY  
N. E. MORGAN

HUGHES AIRCRAFT COMPANY  
SPACE SYSTEMS DIVISION  
EL SEGUNDO, CALIFORNIA

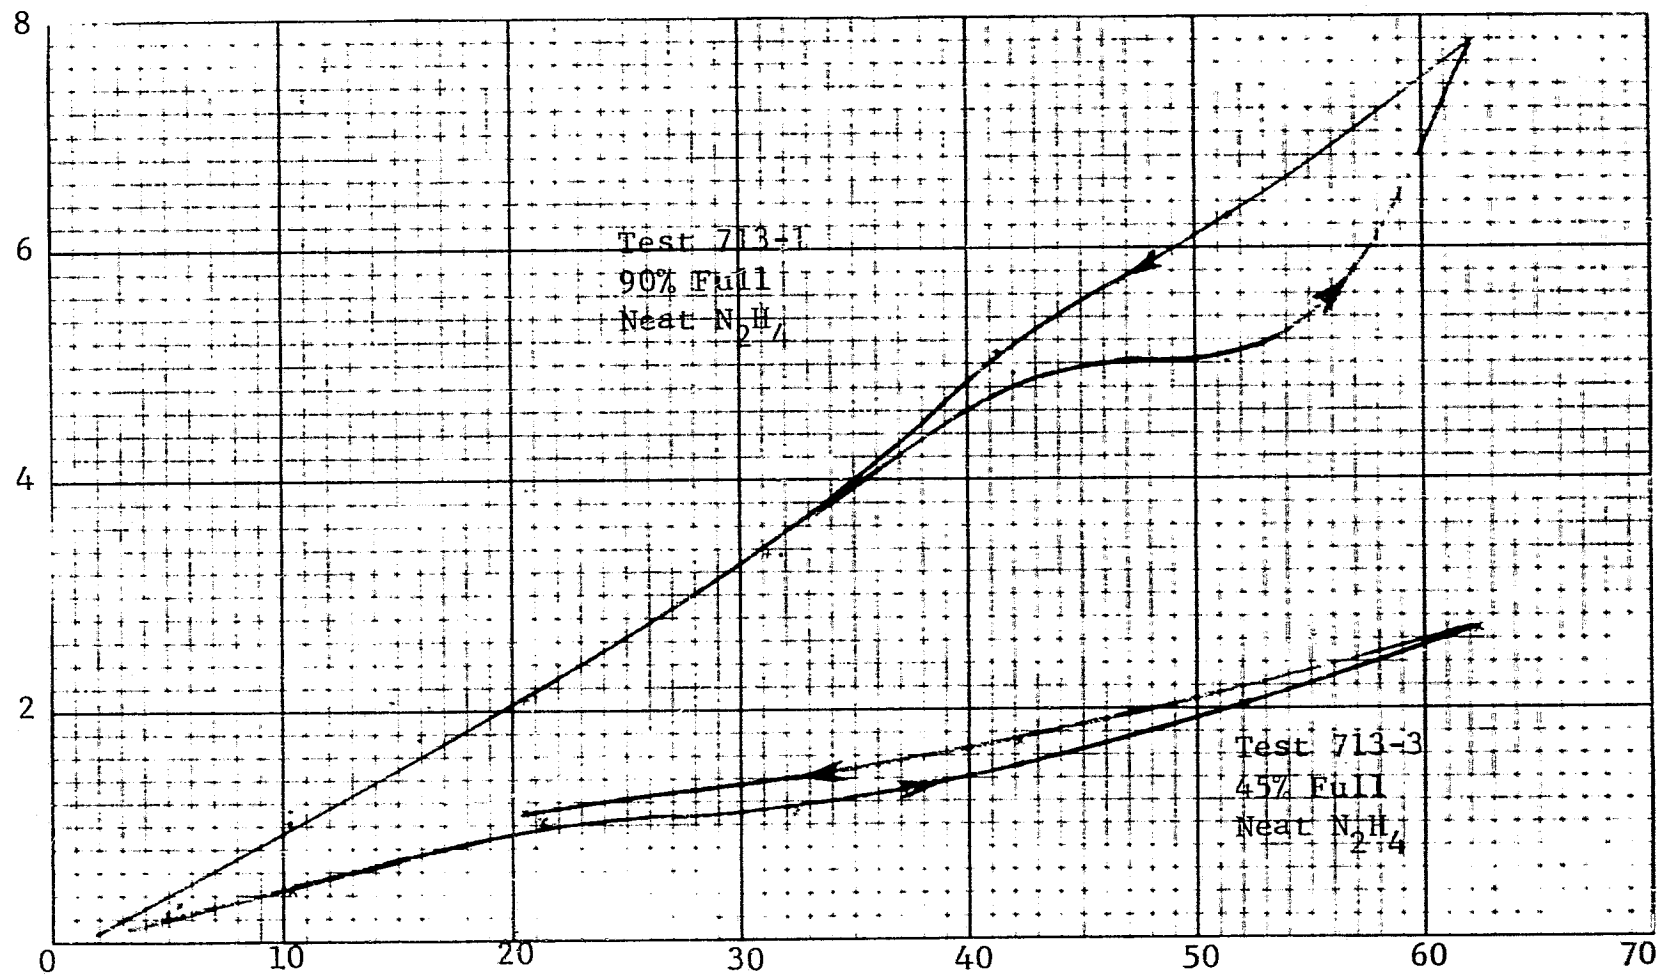
FIGURE 6

In accordance with the test plan, the first test was a survey of voltage-current characteristics with the tank 90% full of neat hydrazine. At this loading the liquid level was approximately one inch below the top of the anode. The data from this test are plotted in the upper curve of Figure 6. The inflection and hysteresis in the curve is not unusual and is caused by polarization characteristics of the electrolysis cell and by variation in effective electrode area due to formation and expulsion of gas bubbles in the wick/electrode interface.

After completion of propellant off-loading and leak testing, the voltage-current survey was started. Voltage was increased in steps up to 60V. Cell operation appeared normal and satisfactory. Data from this test are included in Appendix B, and the current-voltage data are plotted in the lower curve of Figure 6.

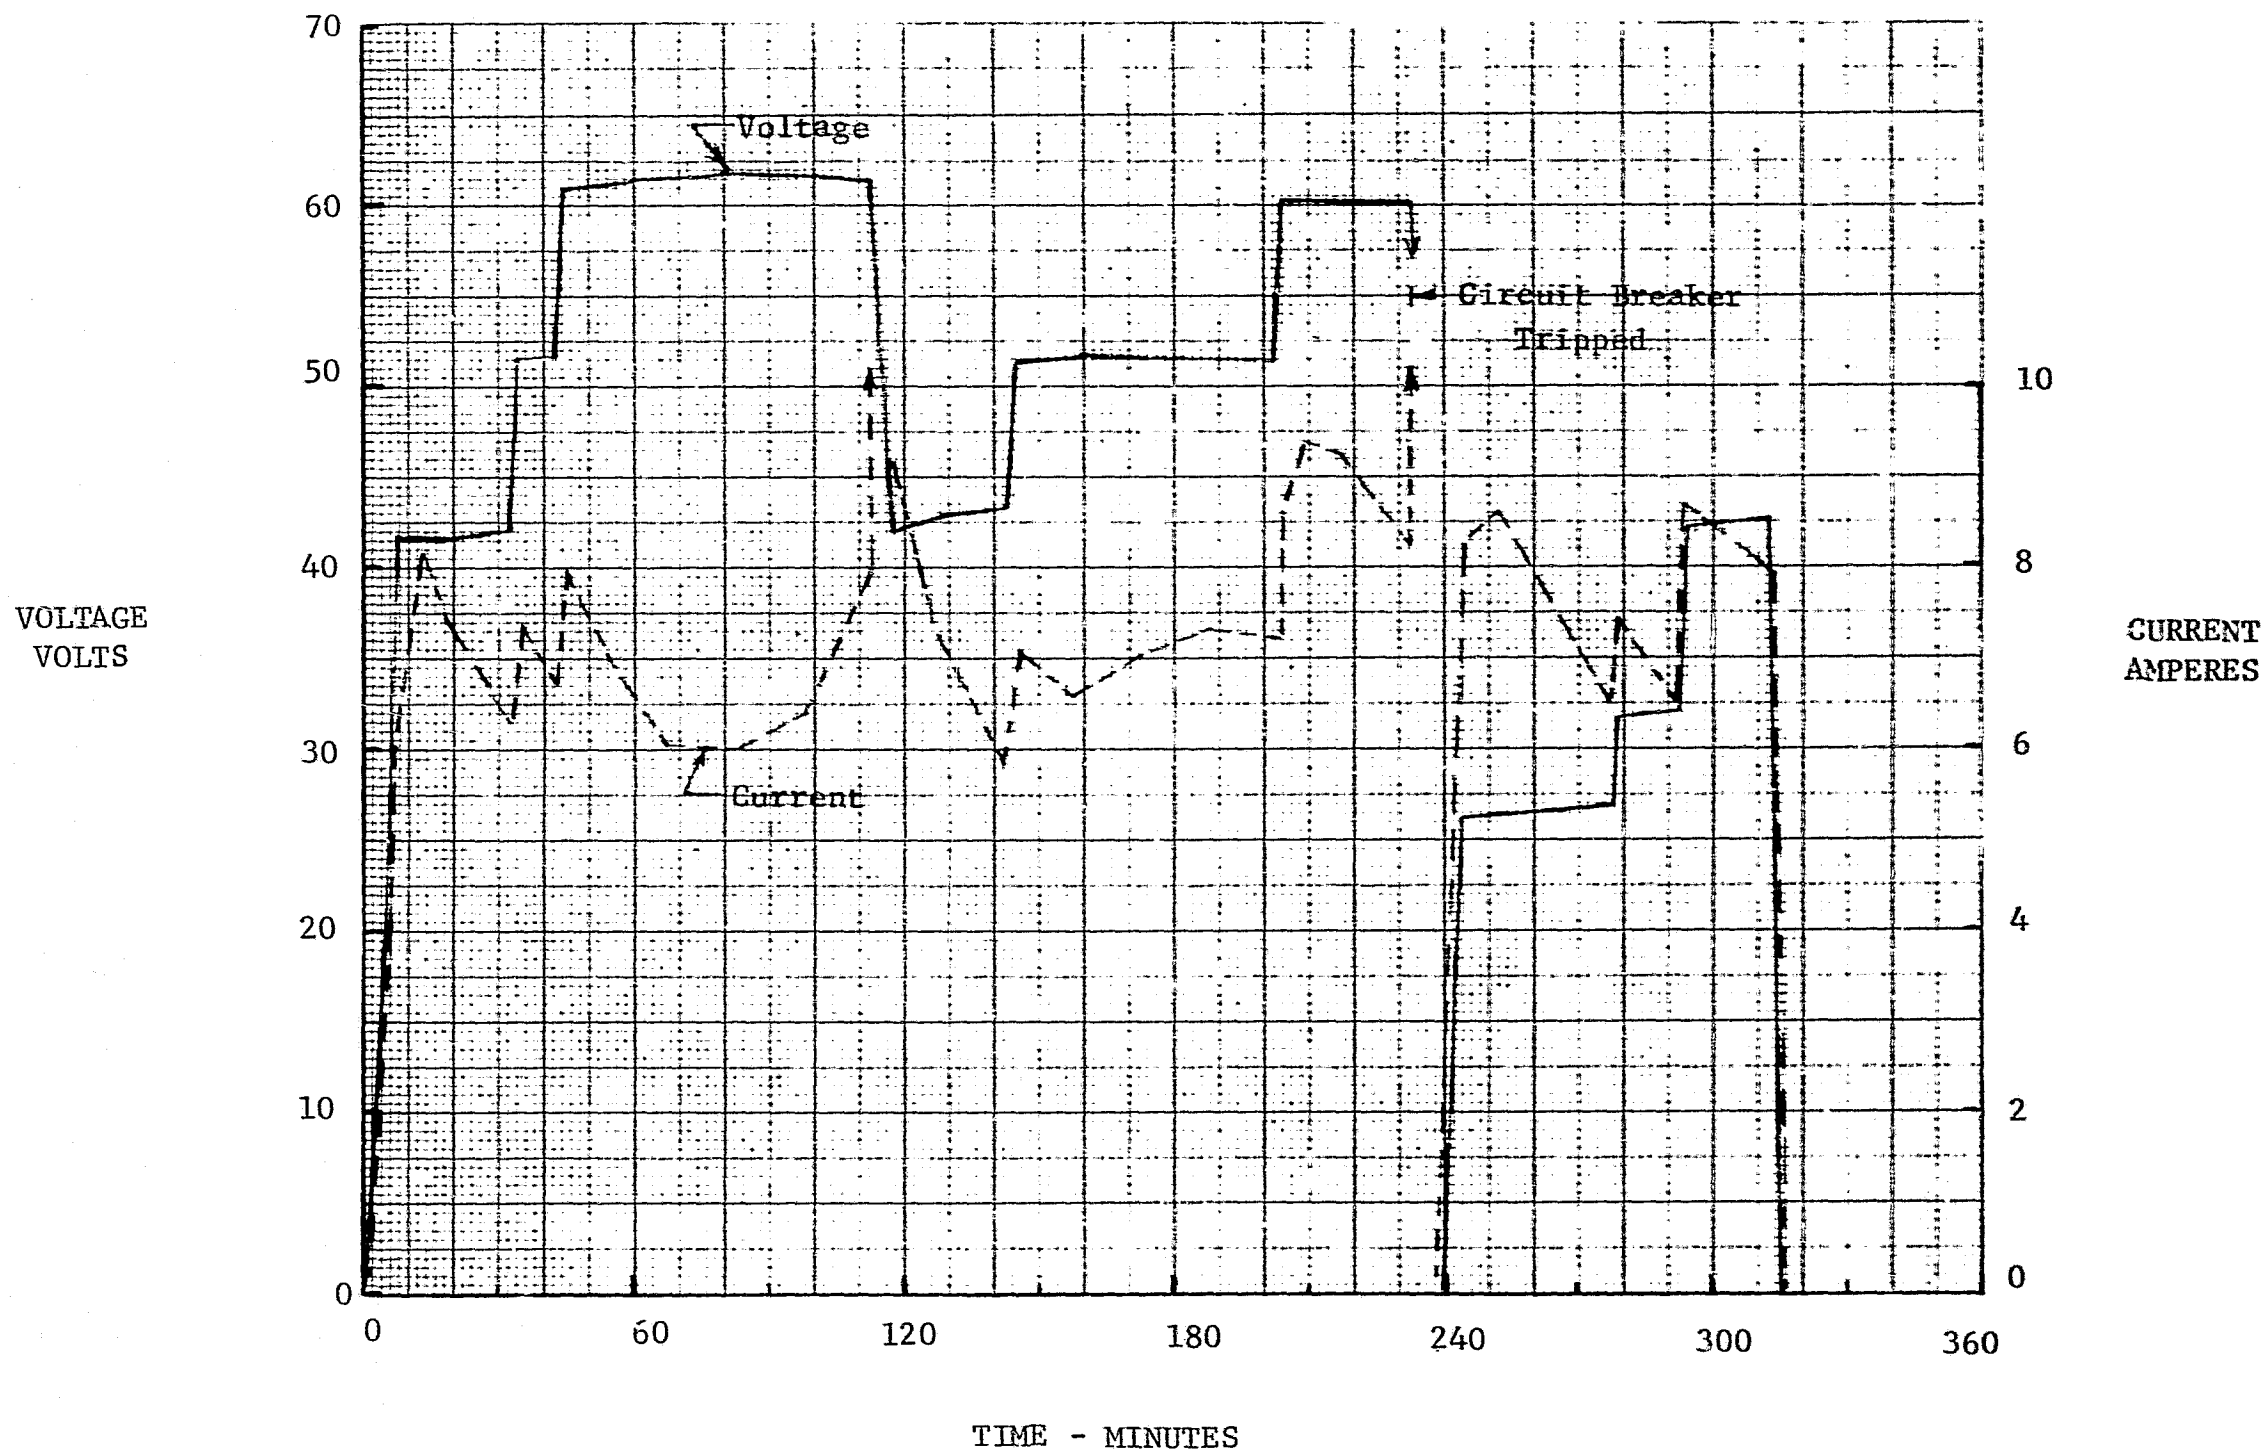
FIGURE 7

On the day following the voltage-current survey, the first electrolysis test at high voltage was conducted in accordance with the test plan. With the tank still 90% full of neat hydrazine, the voltage was increased in steps up to 60V. The voltage, current, temperature and pressure history of this test is shown in Figure 7 & 8. The data acquired during this test is included in Appendix B.

During this test an unexpected current increase occurred on two occasions. After 118 minutes of operation it was noted that the current was increasing and exceeded 10 amperes. This necessitated a reduction of voltage to keep the current below that value. Later in the test, the current suddenly increased and tripped the 15 ampere circuit breaker on the power supply. This current surge was coincident with the first vent cycle of the system relief valve.

These current surges were probable due to the near-short area of the cathode contacting the anode. It could have been caused by higher pressure, deformation of the screen at much higher temperatures, or the action of gas bubbles when the relief valve opened.

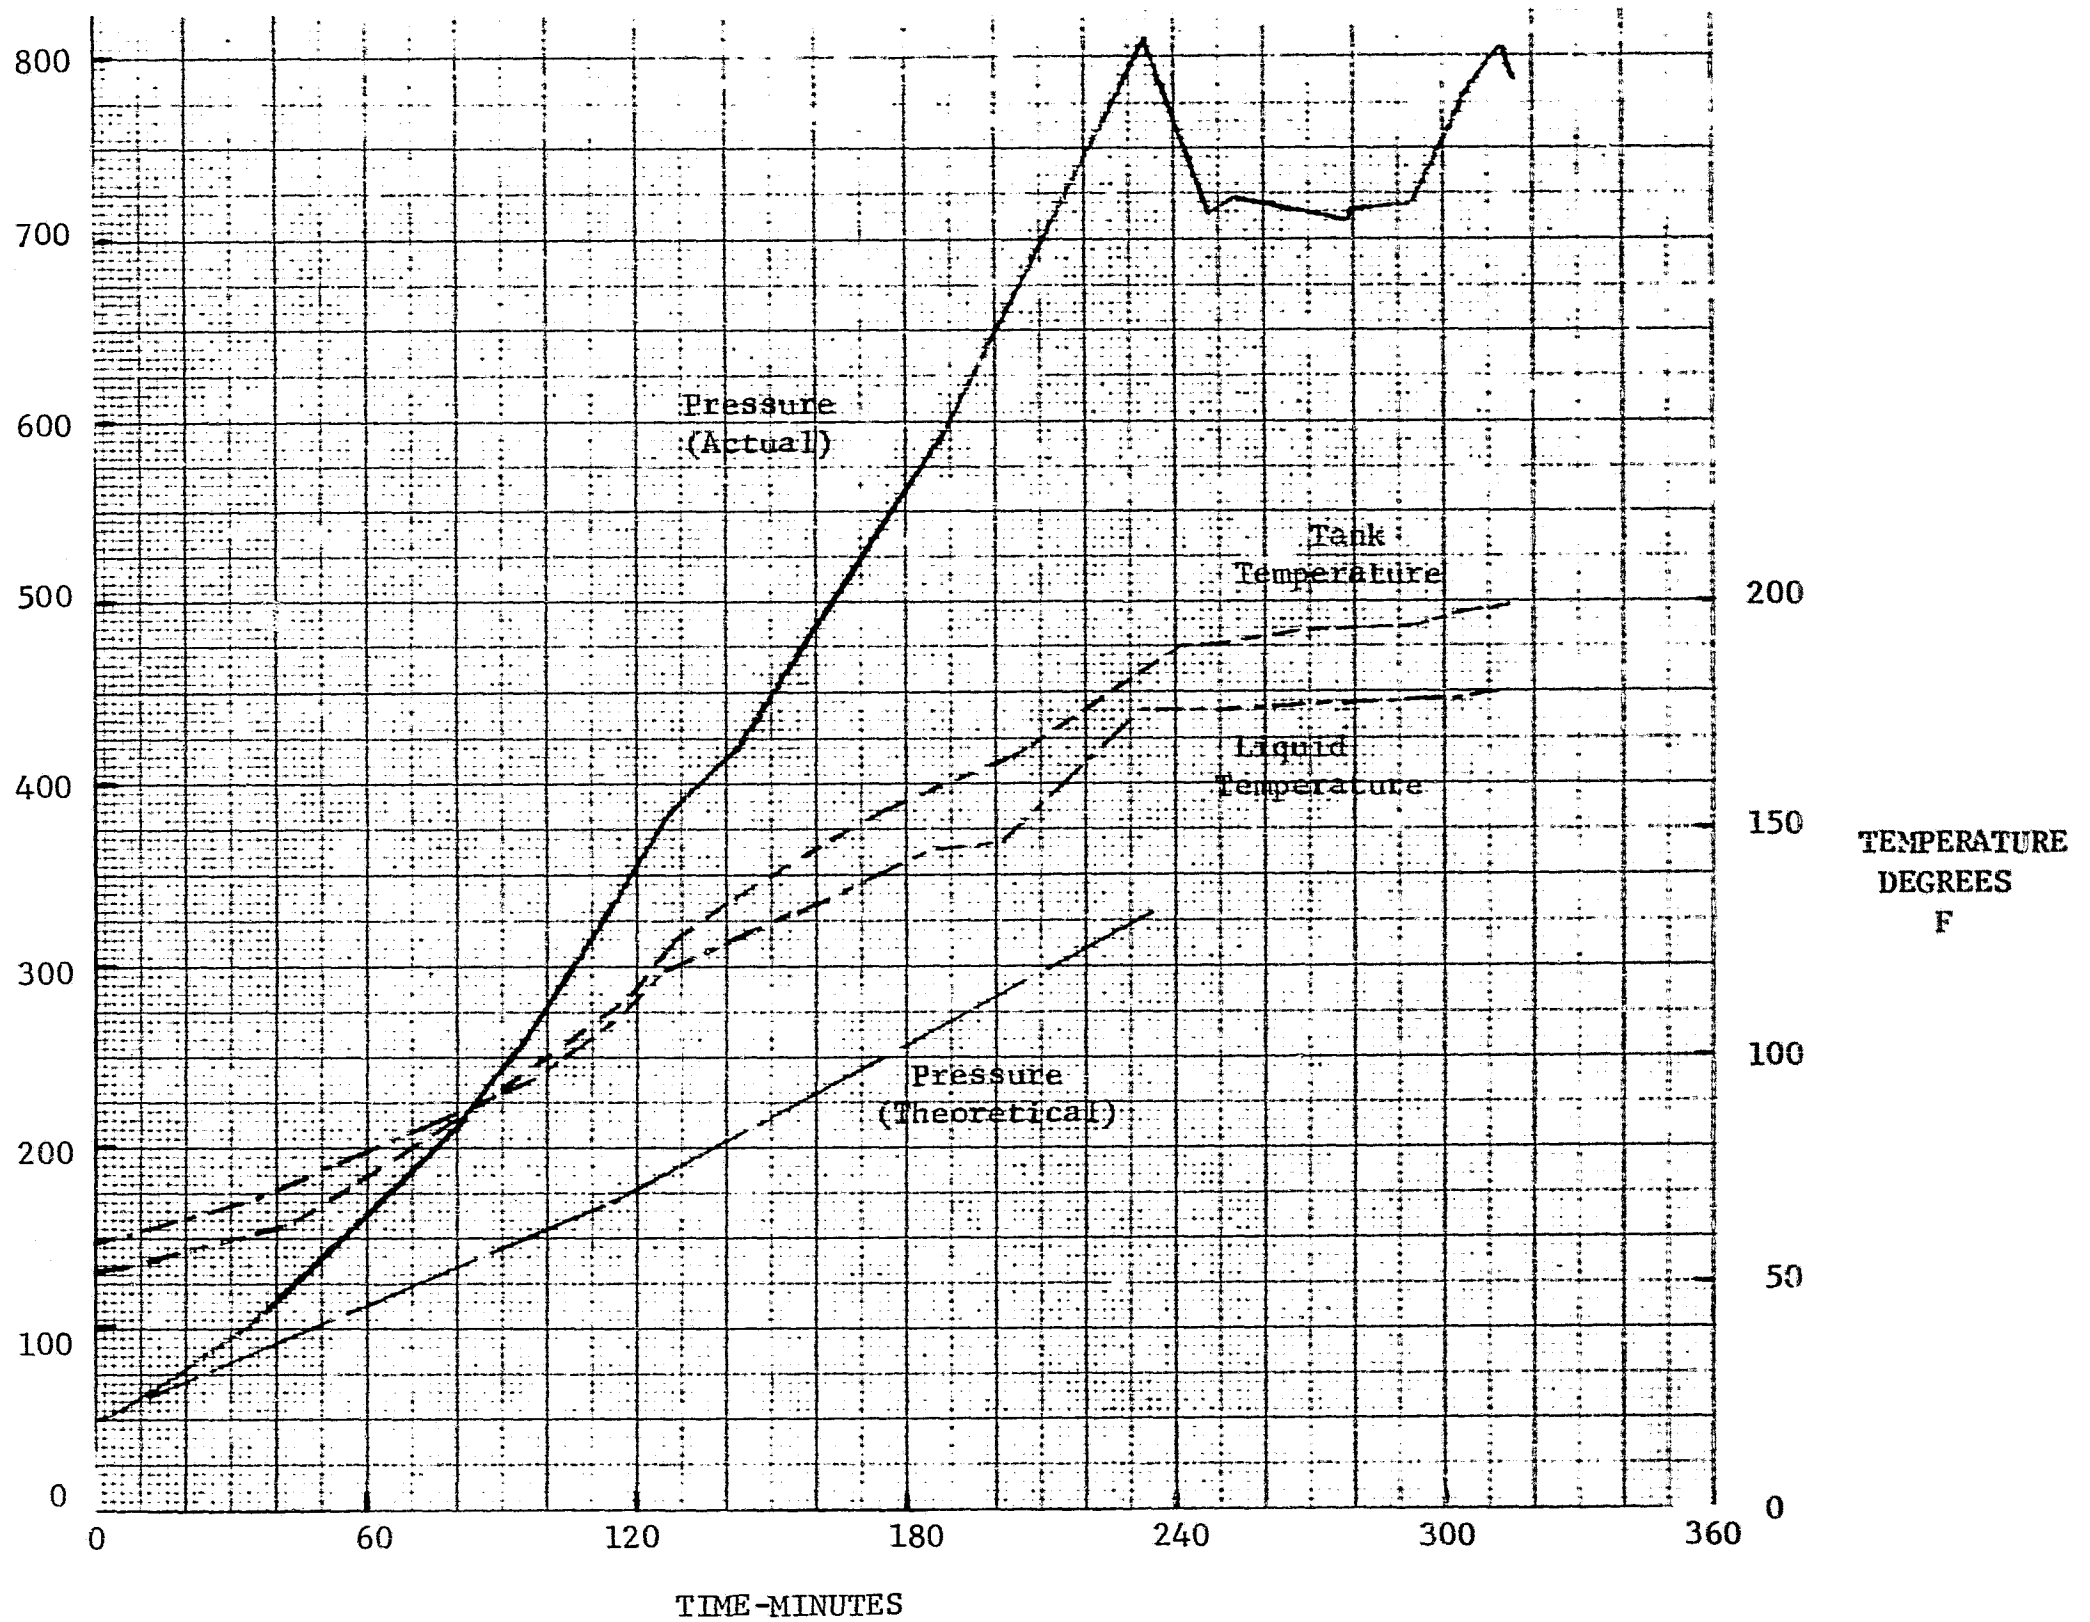
FIGURE 8

Aside from these events the operations of the cell appeared to be normal throughout this test. However, later analysis of the data showed that the actual pressure rise during the first 238 minutes of this test (i.e., up to the time the relief valve first vented) was much greater than could be accounted for by temperature rise and electrolytic gas generation. For reference purposes the pressure increase due to these two factors is plotted in Figure 8. For further discussion of this abnormal pressure rise and current surges see paragraph on "Failure Investigation".

The raw test data from Tests 713-1, and -2 and -3 are plotted in Figure 6, 7 and 8. These raw data do not show any unusual characteristics or departure from anticipated performance of the electrolysis cell at high voltages. However, as previously reported, the actual pressure increase measured during Test No. 713-2 was significantly greater than could be accounted for. Based on the current-time-temperature history recorded for that test, the pressure rise due to gas generation by electrolysis and to temperature rise was calculated as 274 psi. up to the point at which the relief valve first vented. The actual measured pressure rise during the same time period was 757 psi. Applying the same analysis to the meager amount of data obtained during Test 713-3 before failure gave a possible pressure rise of 0.4 psi, whereas the test data showed 7 psi. The gas generation rate, when compared to the predicted rate increased with power level from 150 to 400% during Test 713-2 and to almost 900% immediately prior to failure in Test 713-3. Possible explanations for these discrepancies include:
