HARVARD COLLEGE OSO-IV POINTED EXPERIMENT AN ANALYSIS OF THE MALFUNCTION DURING ORBIT 637

BY: R. Dower N. Hazen J. Rechavi

Technical Report No. 7 NASA Contract NASw-184

February 1969

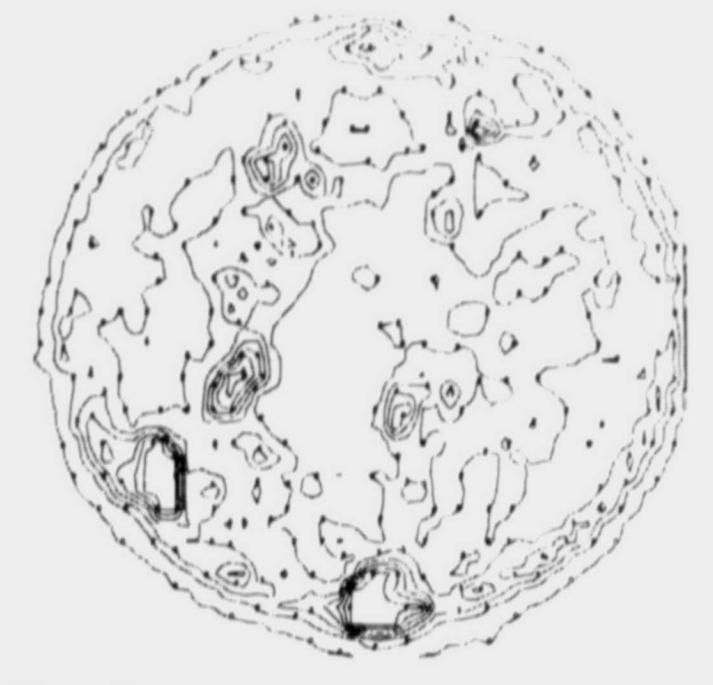
Figure 5A RASTER PLOTS BEFORE UV TERMINATION NE VIII

indicate intensity by the dotted lines of constant intensity (isophotes). The highest data count recorded during each raster is printed above the raster picture as a maximum intensity figure. Raster 2 and raster 3 show the coherent solar images and very close correlation with expected intensities. Raster 4 begins at the top with a good rounded solar image, then the picture suddenly deteriorates as an image of the sun in ultraviolet light. The plots of raster 5 show no apparent relationship to a solar image.
