EVALUATION OF TANTALUM FOR MERCURY
CONTAINMENT IN THE SNAP-8 BOILER

TOPICAL REPORT

AEROJET-GENERAL CORPORATION

November 1969

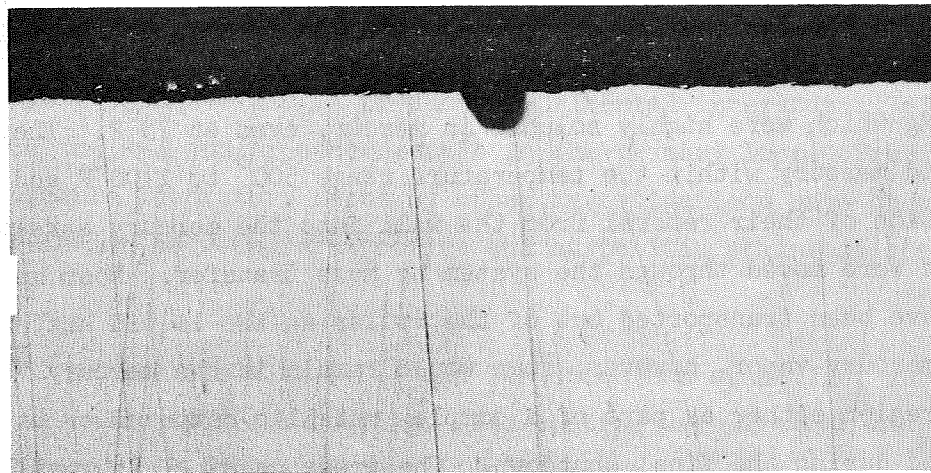
A-2814

The tantalum-10% W wire of Test Section No. 5, contained some indications of attack. It is presently postulated that these are not the result of mercury corrosion. The test section operated for varying periods with air leaks in the system. The leaks occurred at the mercury outlet end of the test section, which was the location of the tantalum-10% W wire attack. Thus, a potential cause of cracking is air contamination. Second, the cracks may have been present in the as-fabricated section, produced by the helical coiling of the wire inside the tube or some other presently unknown operation in the test section fabrication procedure. Finally, laboratory experiments indicate that the ductility of the tantalum-10% W wire is greatly reduced as a result of hydrogen absorption during the chemical cleaning procedure. This hydrogen embrittlement in combination with operating stresses could have resulted in surface cracks giving the appearance of Hg corrosion.
