NASA CR-66946

# CONTINUATION OF NASA ROCKET MOTOR DEFECTS INVESTIGATION

CONTINUATION OF NASA ROCKET MOTOR DEFECTS INVESTIGATION

JUNE 1969 THROUGH MAY 1970

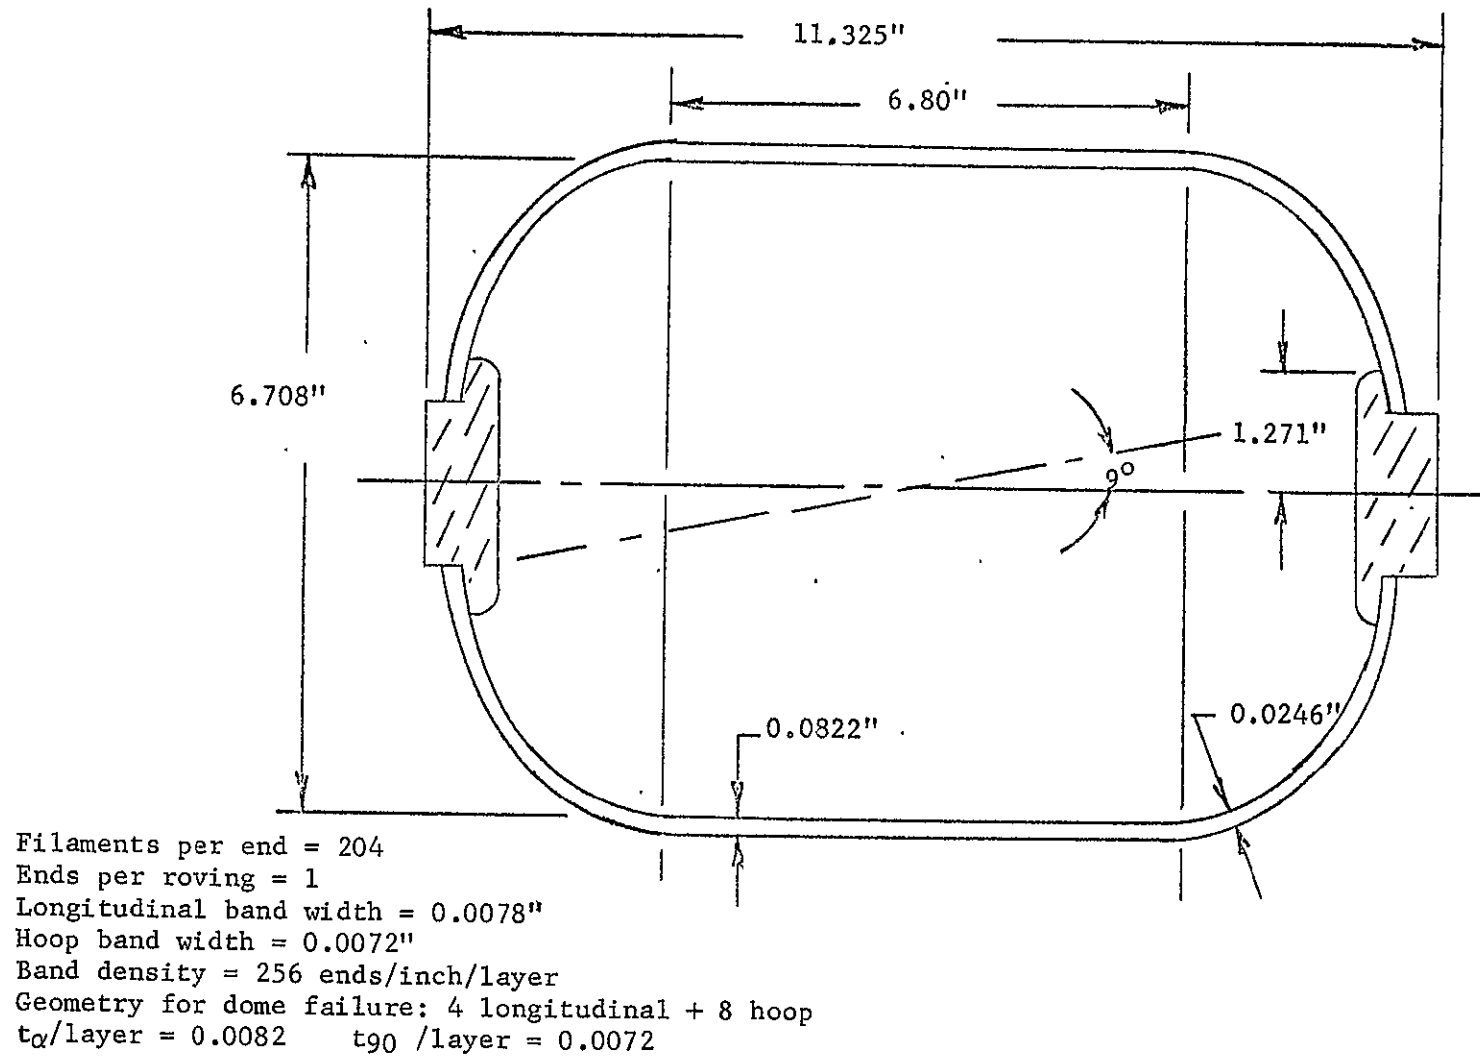
of the shear strength was conducted with 6-in.-diameter bottles. The physical dimensions and winding data for the fabrication of the ten bottles in this task are shown in Figure 1.

Figure 1. Dimensions and Winding Data for Fabrication of 6-In.-Diameter Bottles

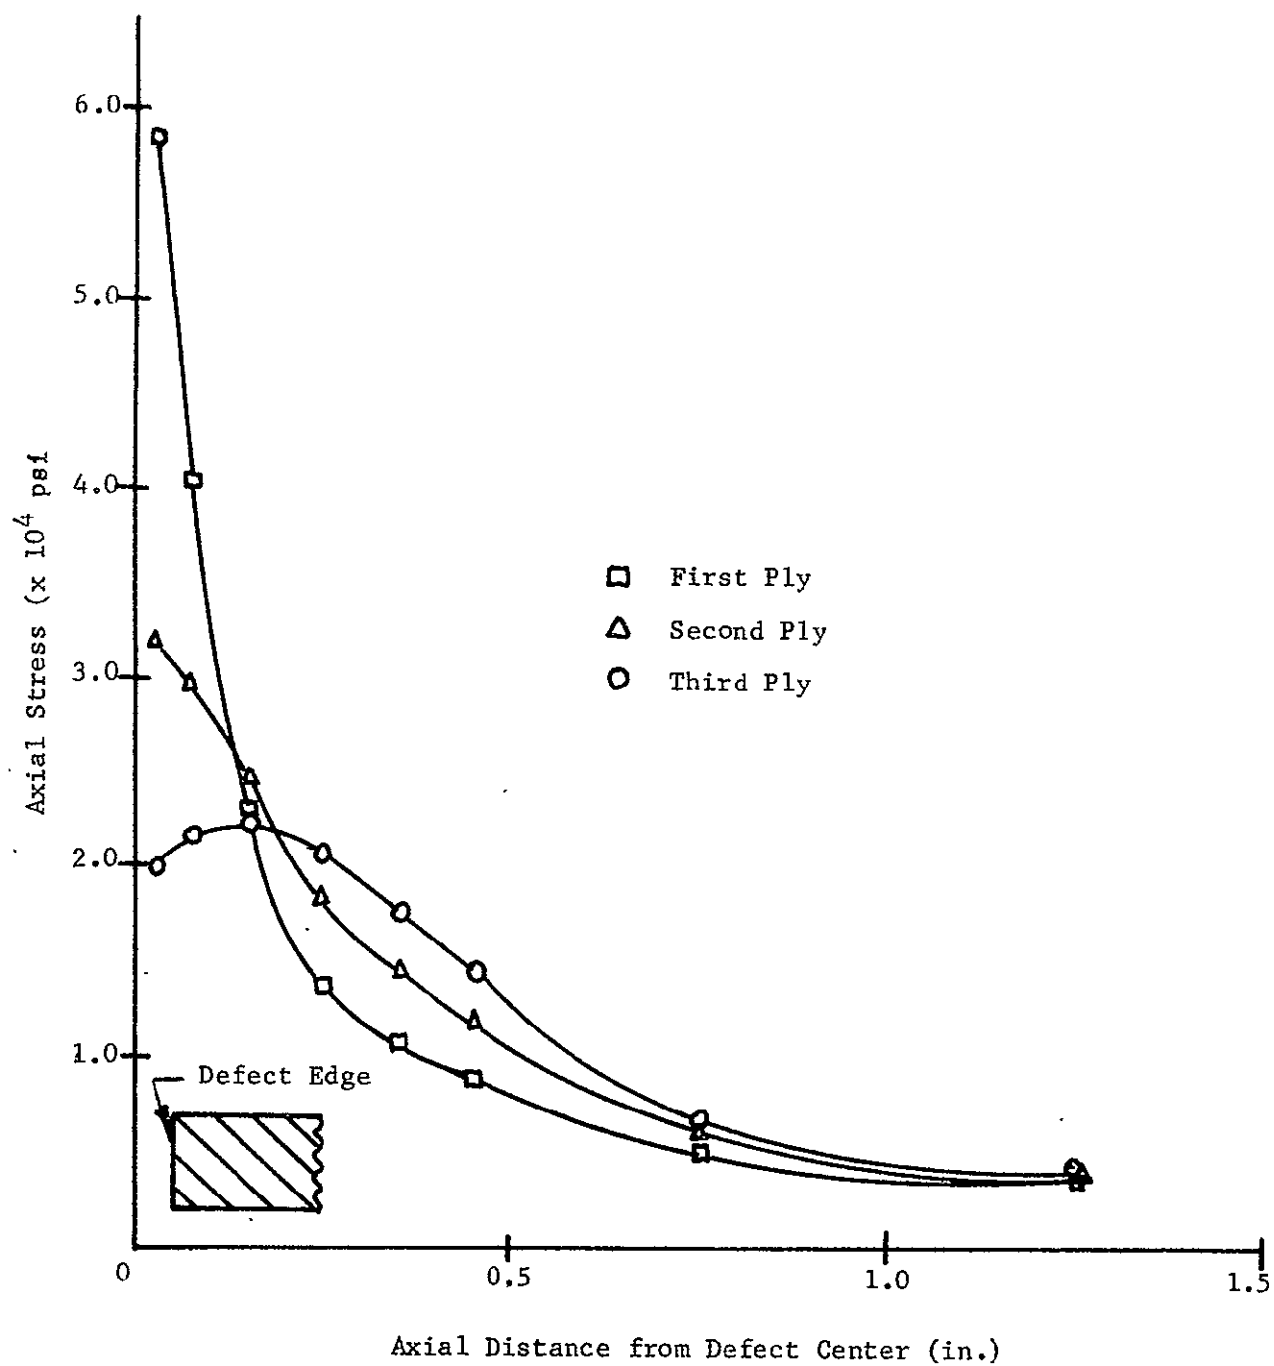
Figure 2. Axial Stress in Three-Ply Patch for 1000 psi Internal Pressure (Axial load = 1600 lb/in.) - Small Bottle Repair

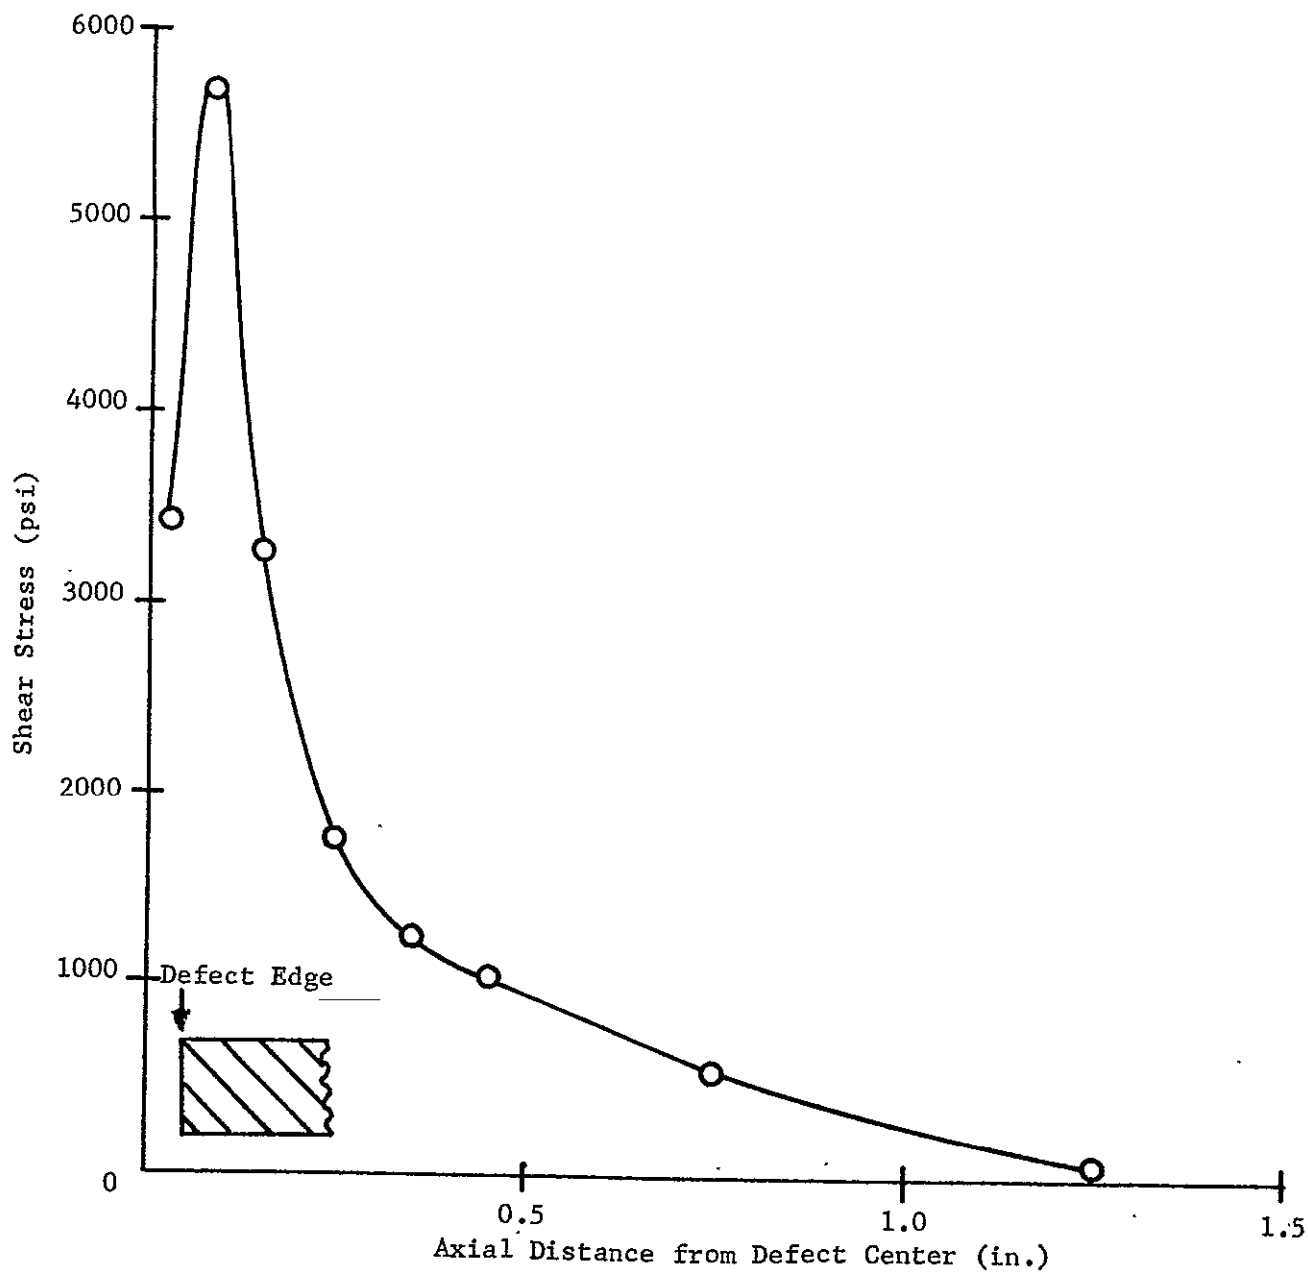
Figure 3. Shear Stress Distribution in Bond Layer for 1000-psi Internal Pressure (Axial load = 1600 lb/in.) - Small Bottle Repair

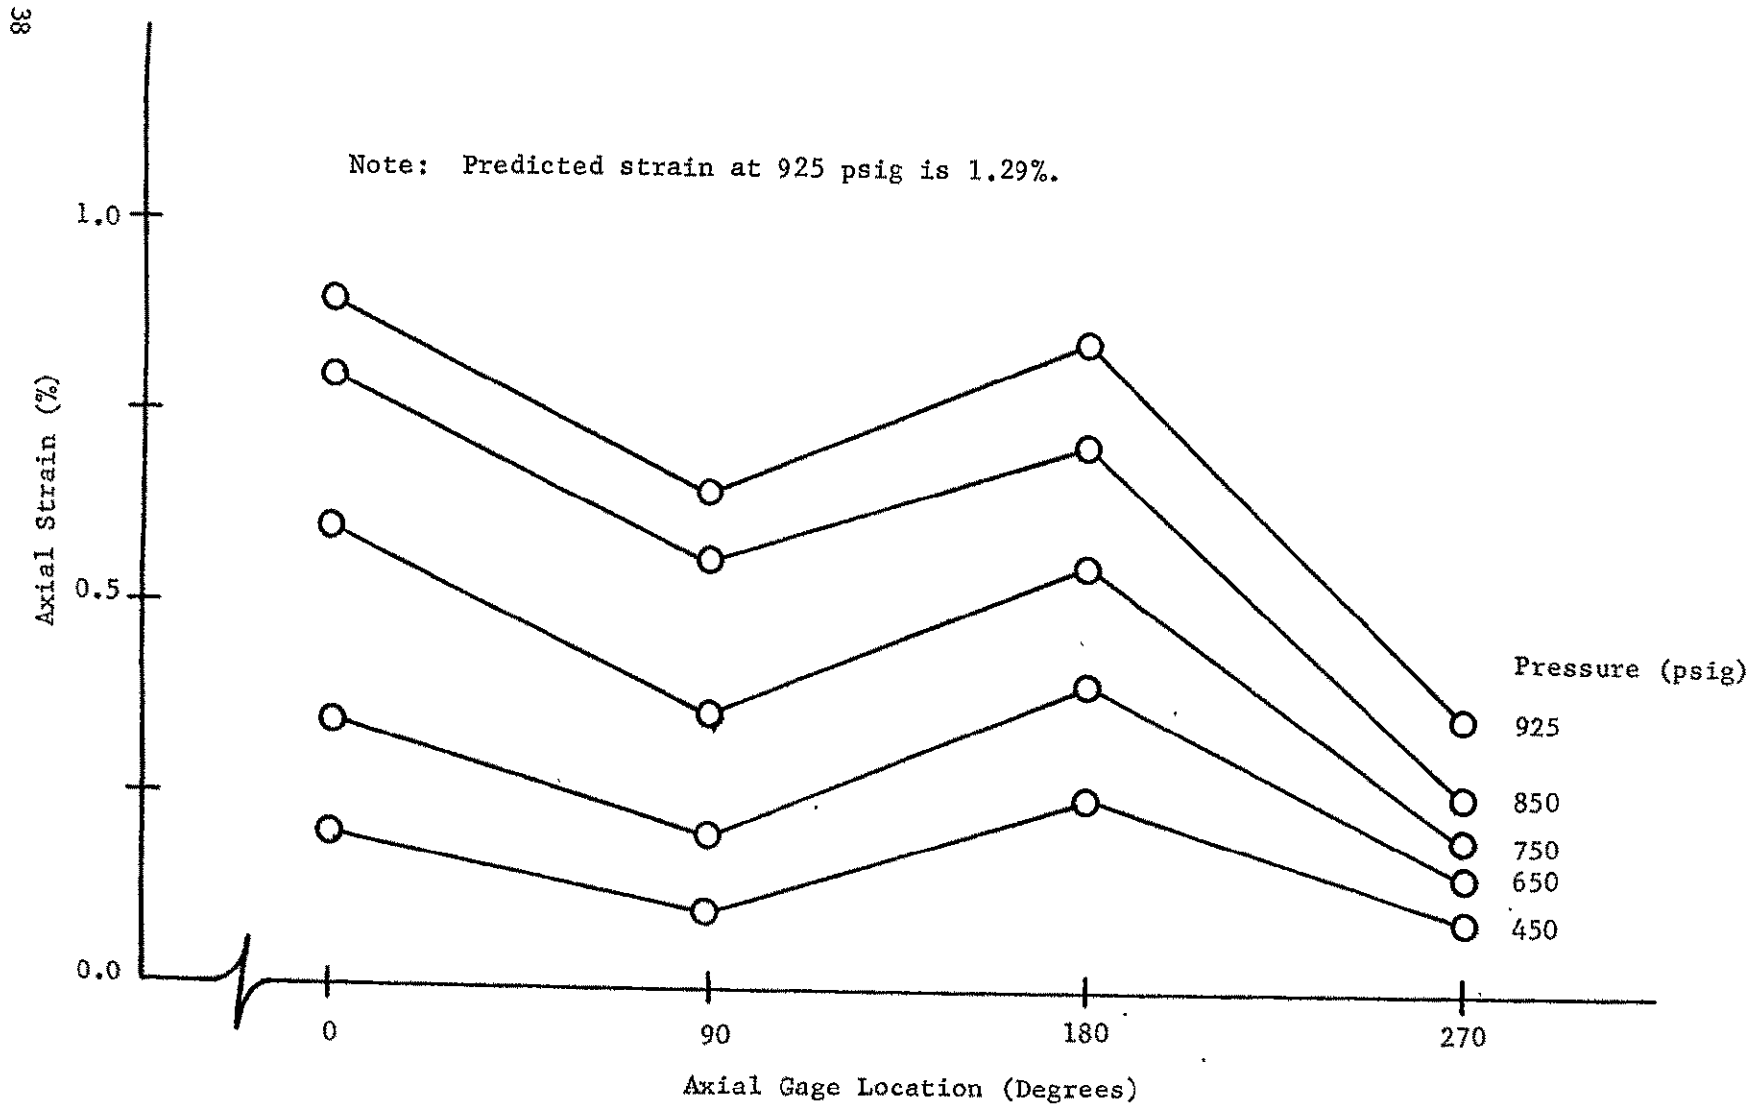
Figure 7. Bottle Test No. 1 - Axial Strain Versus Pressure (Failure at 270°)  
(Maximum Axial Load = 1550 lb/in.)

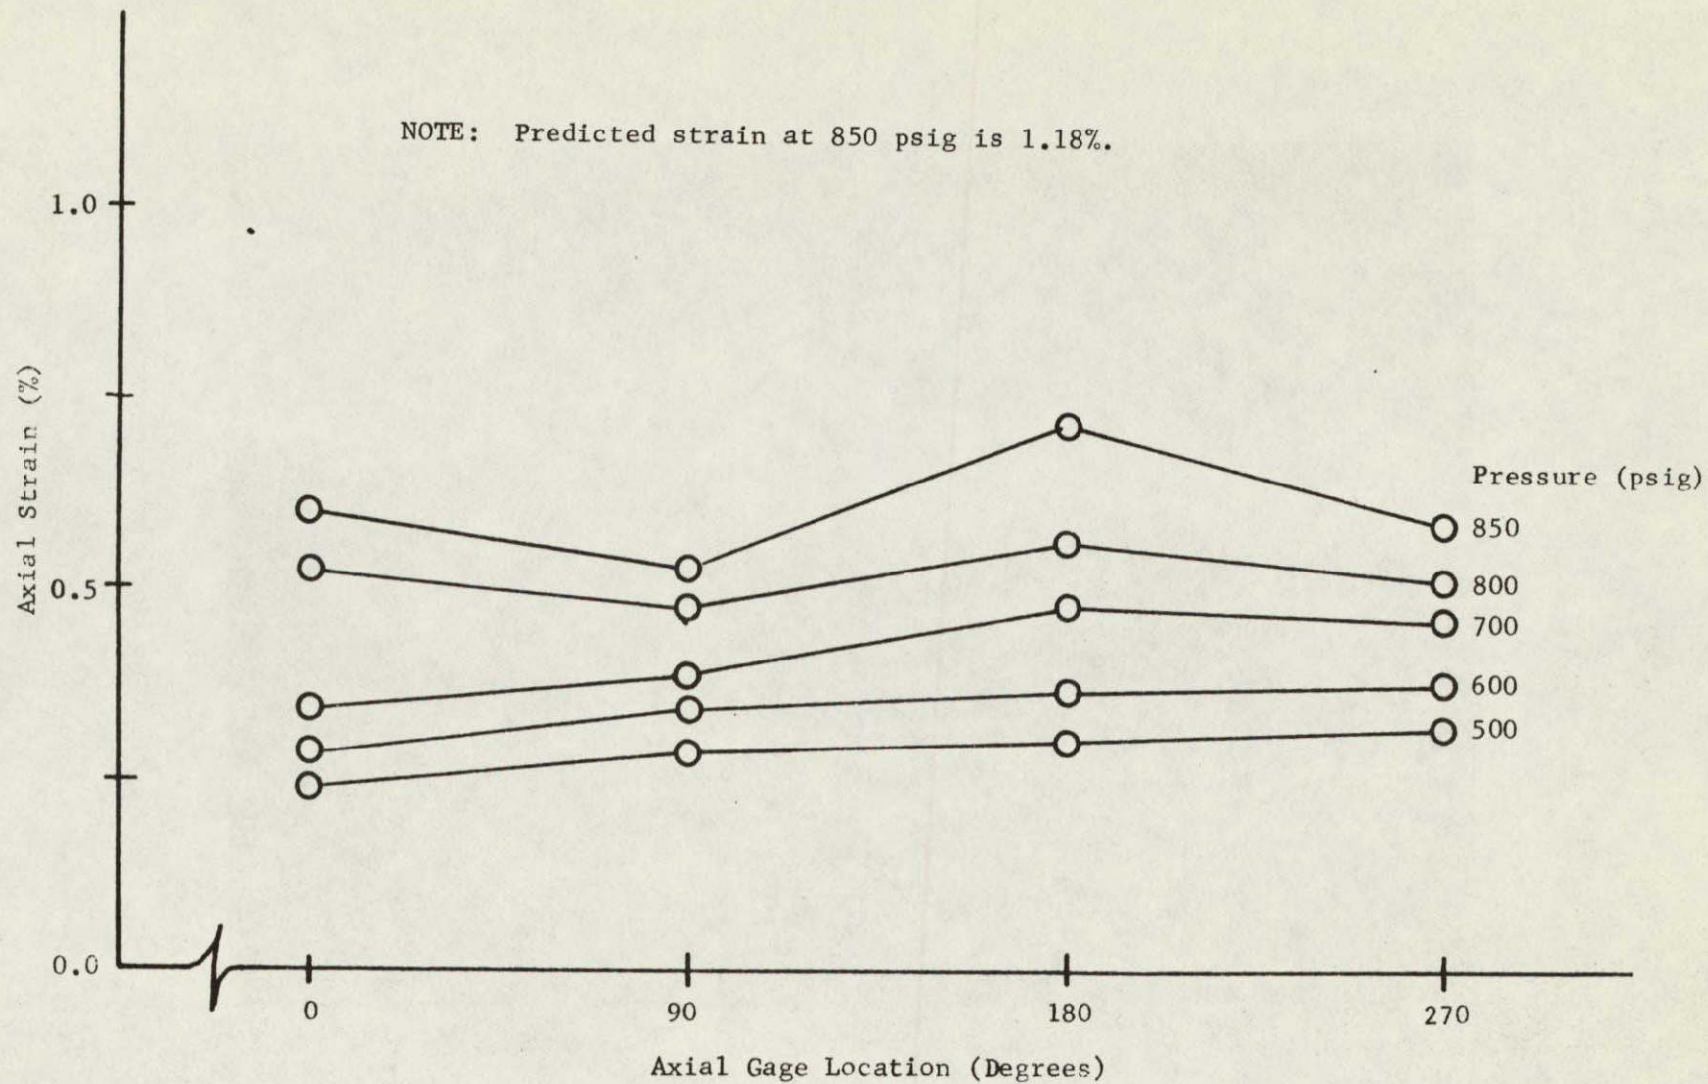
Figure 8. Bottle Test No. 2 - Axial Strain Versus Pressure (Failure at 120°)  
(Maximum Axial Load = 1425 lb/in.)

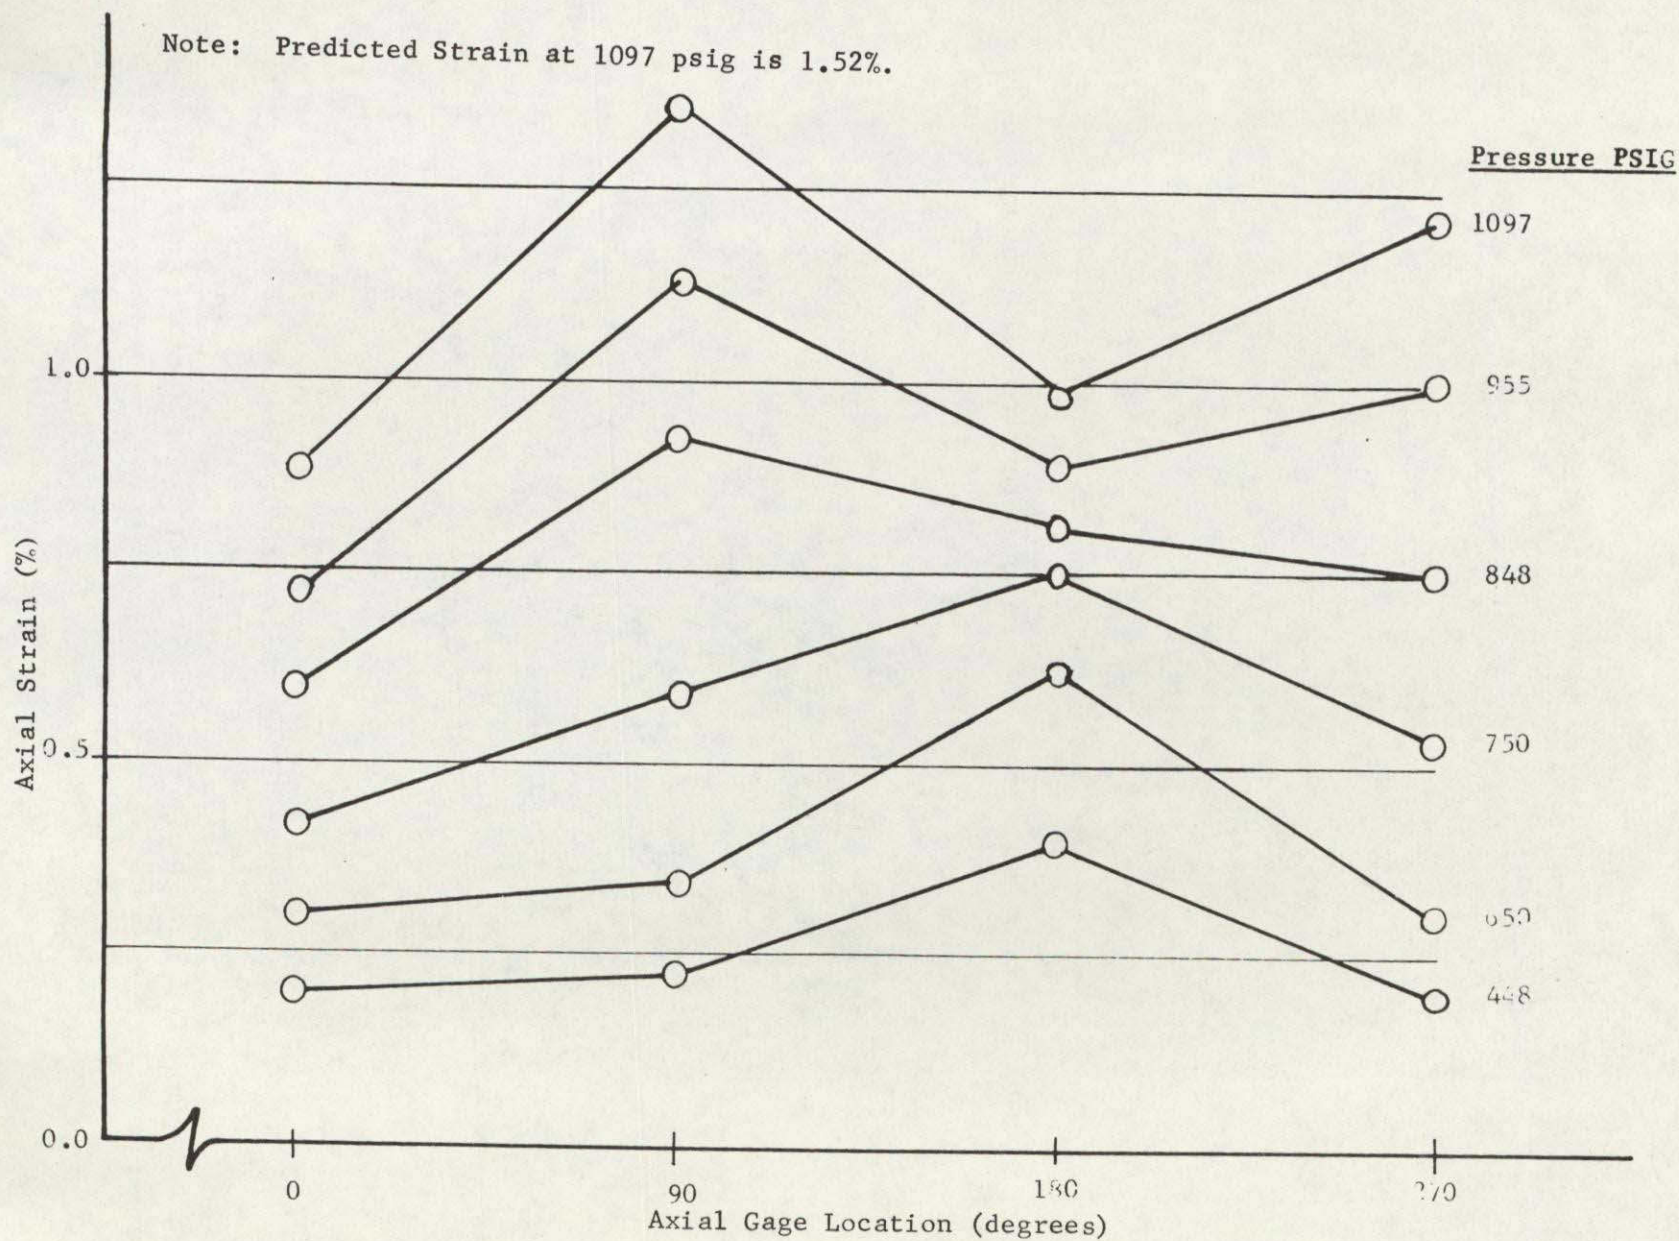
Plots of axial strain versus pressure for Bottles Nos. 3 and 4 are shown in Figures 12 and 13. These values at 1000 psi are lower than indicated by the analysis. The higher strains for the three-ply repair are noted by comparing these two figures.

Figure 12. Bottle No. 3 - Axial Strain Versus Pressure (Maximum Axial Load = 1830 lb/in.) (Failure at 0°)

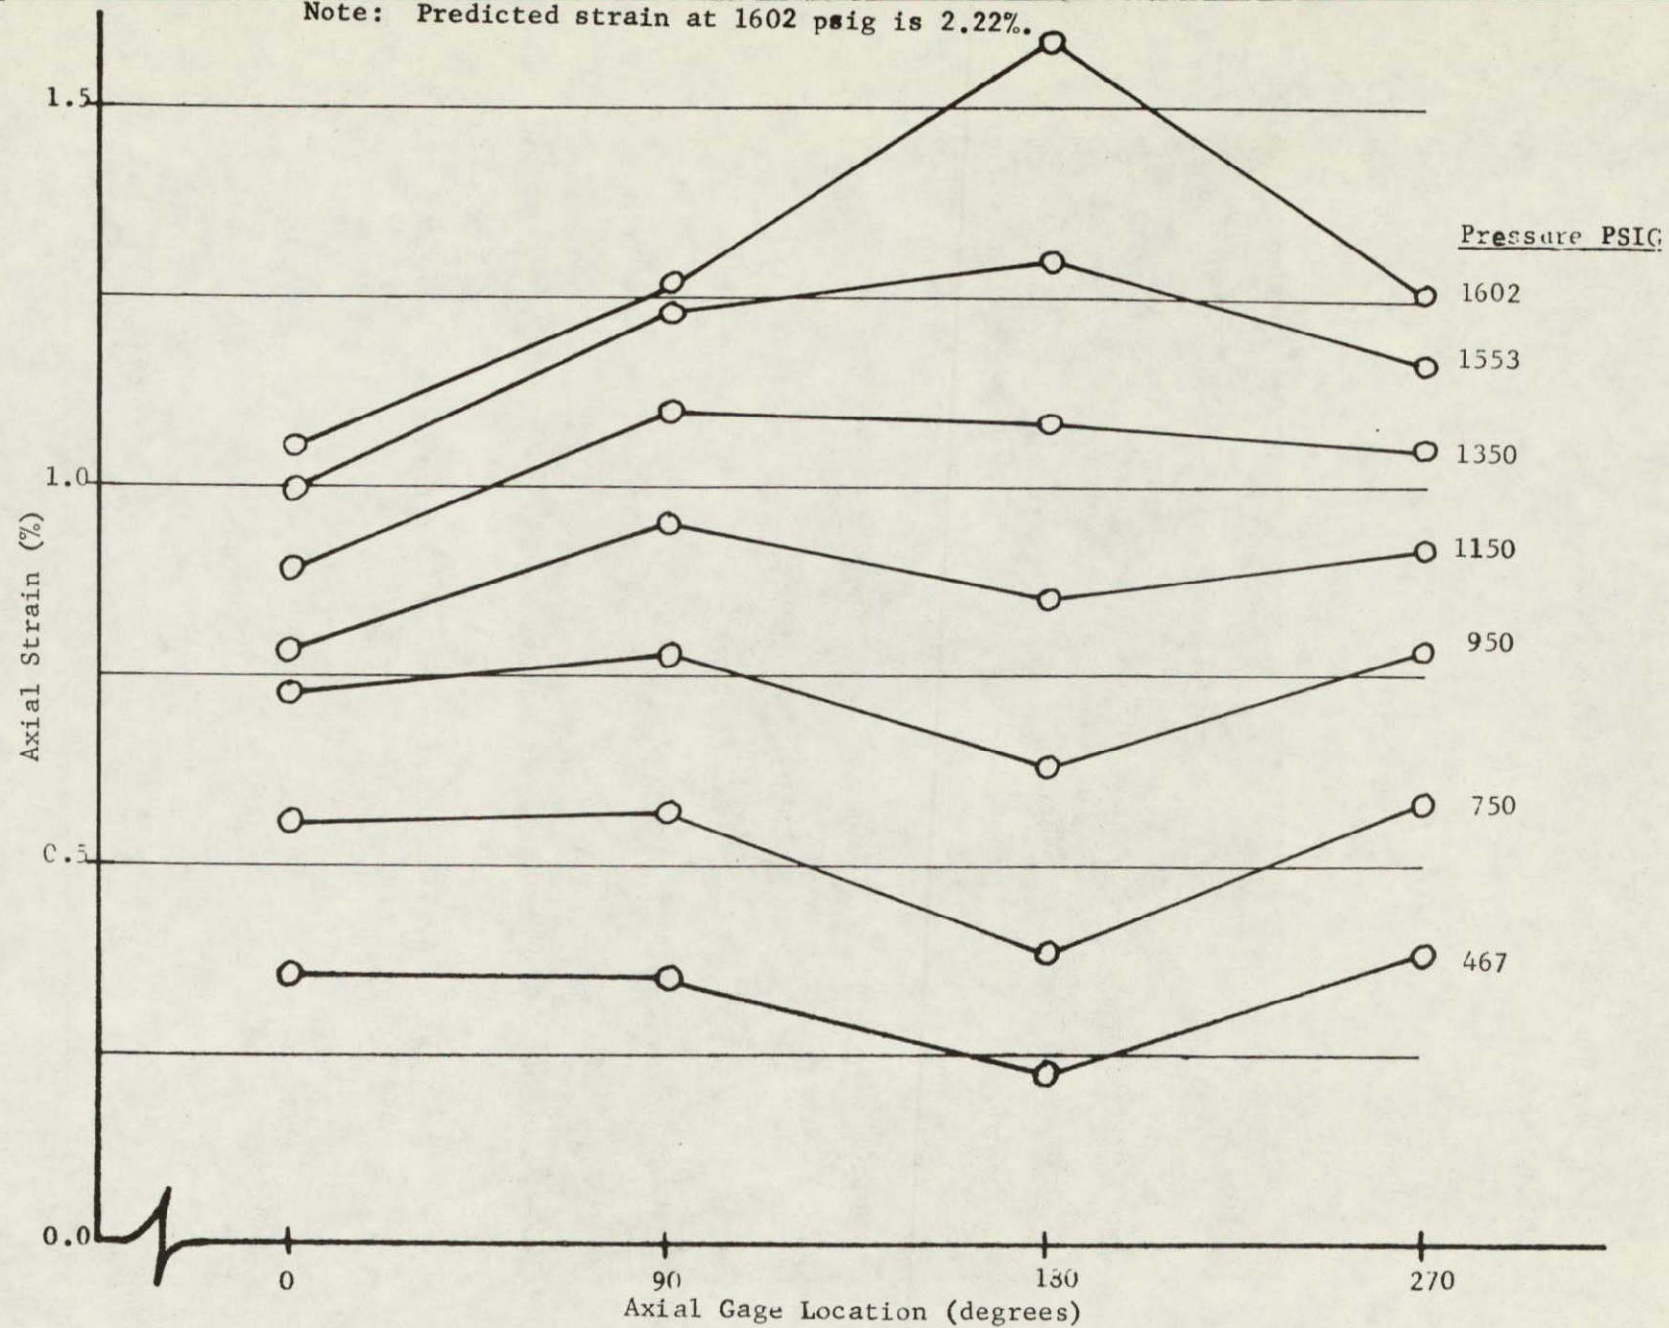
Figure 13. Bottle No. 4 - Axial Strain Versus Pressure (Maximum Axial Load = 2570 lb/in.) (Failure at 180°)

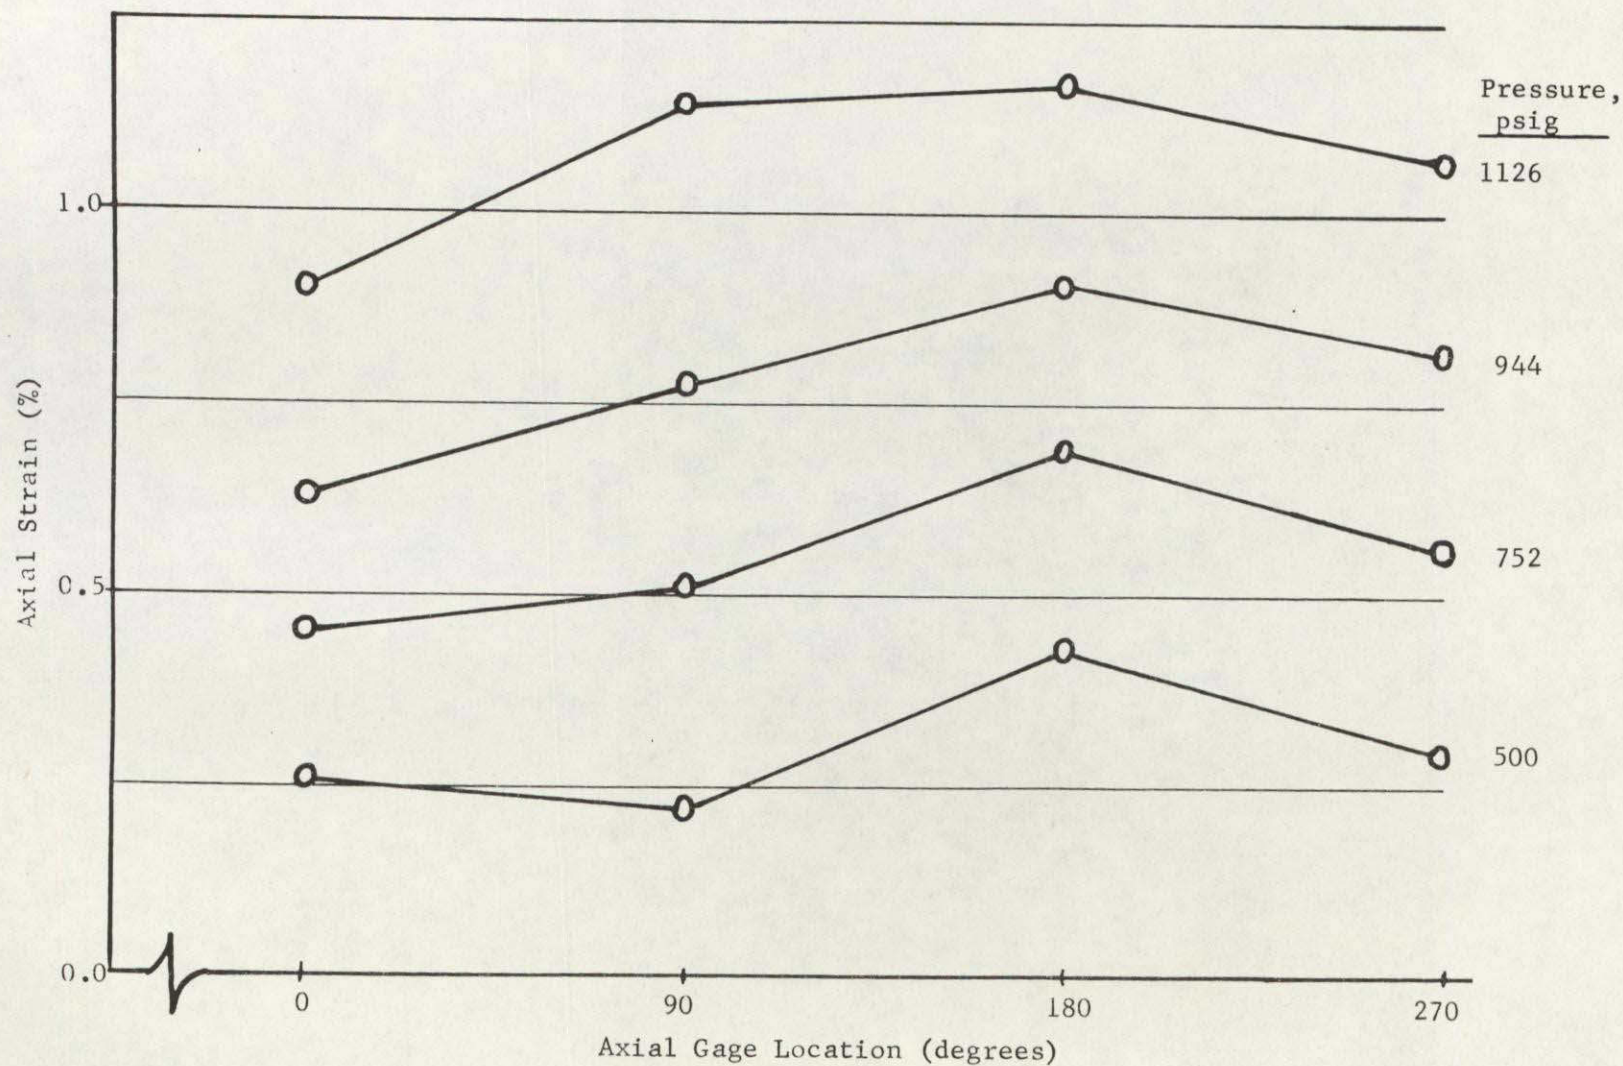
Note: Predicted strain at 1126 psig is 1.57%.

Figure 20. Bottle No. 8 - Axial Strain Versus Pressure (Maximum Axial Load = 1840 lb/in.) (Leak occurred at 180°)

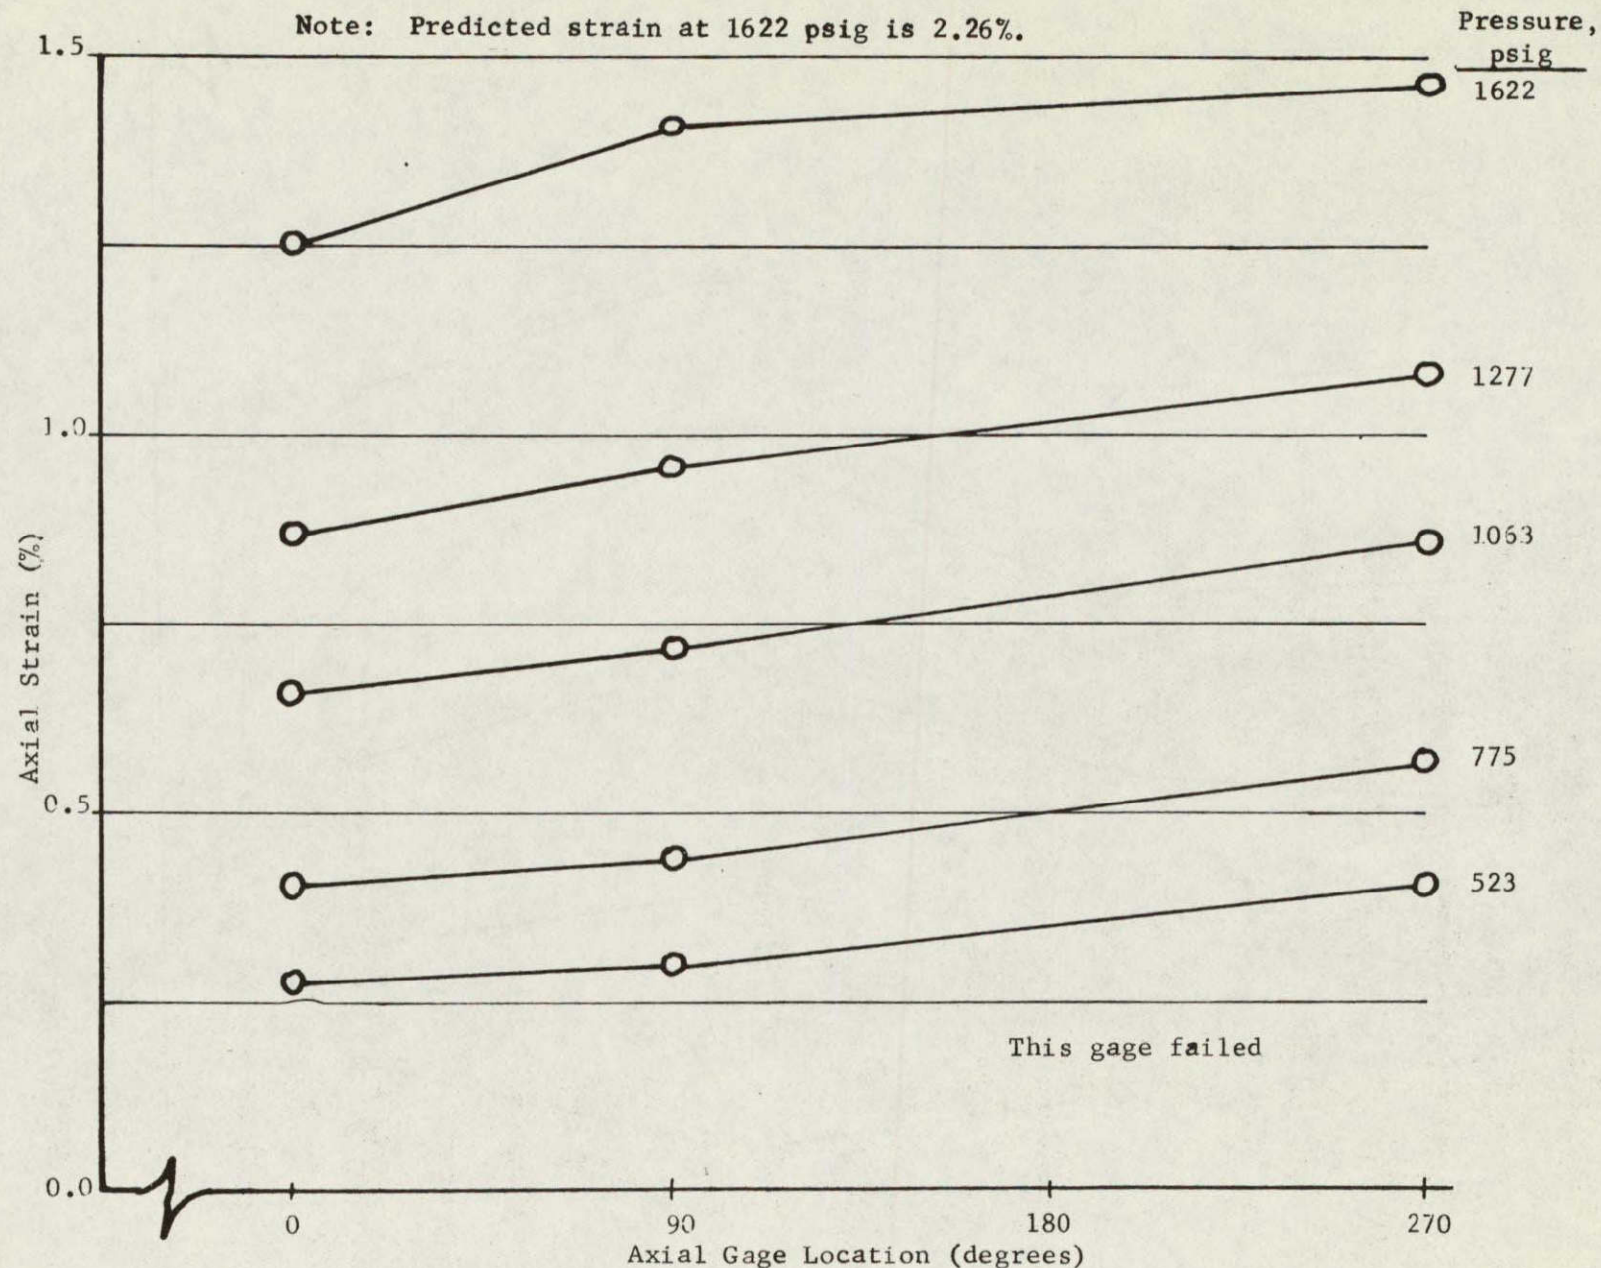
Figure 21. Bottle No. 8 Retest - Axial Strain Versus Pressure for Pressurization Rate of 2750 psi/sec (Maximum Axial load = 2600 lb/in.) (Failure occurred at 180°)

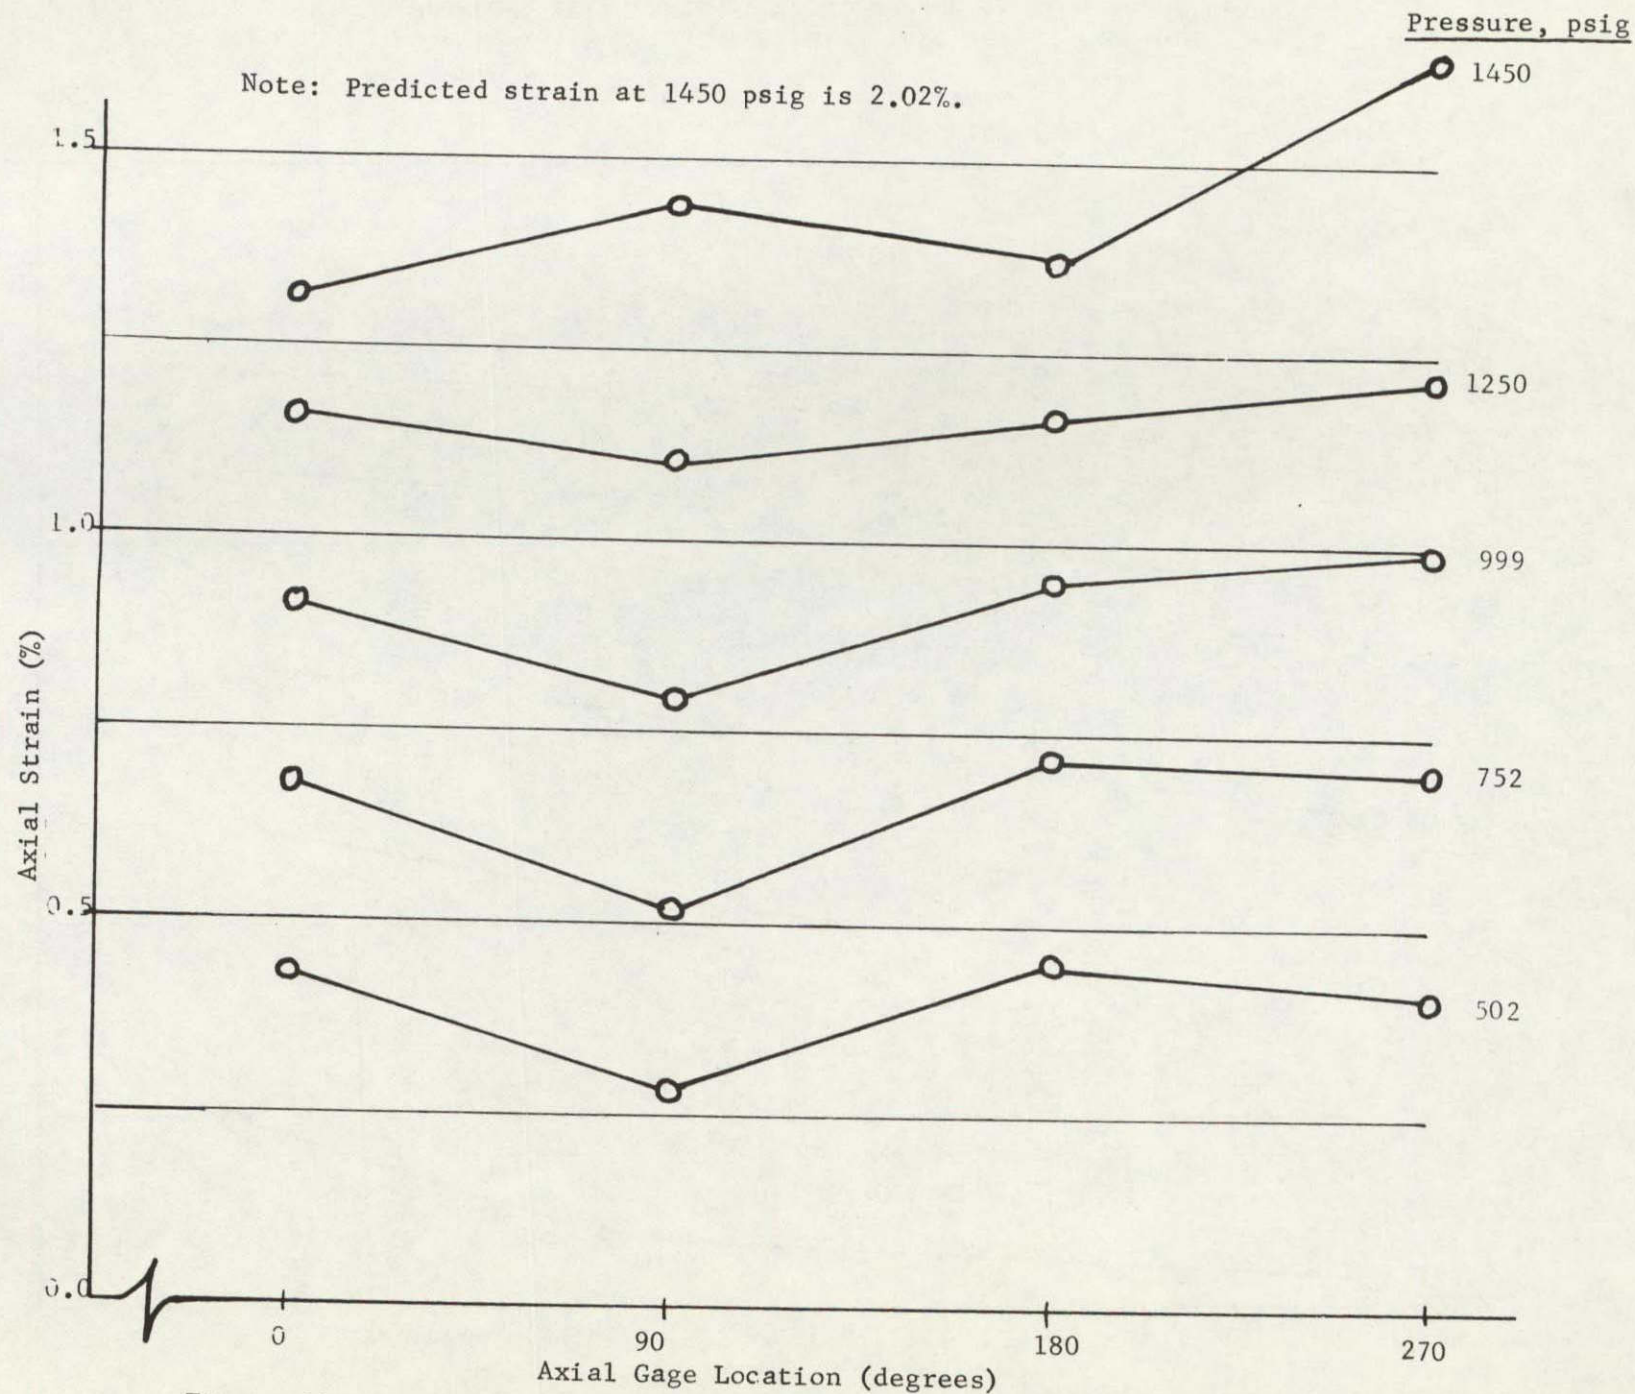
Figure 22. Bottle No. 5 - Axial Strain Versus Pressure (Maximum Axial Load = 2365 lb/in.) (Failure occurred at 270°)

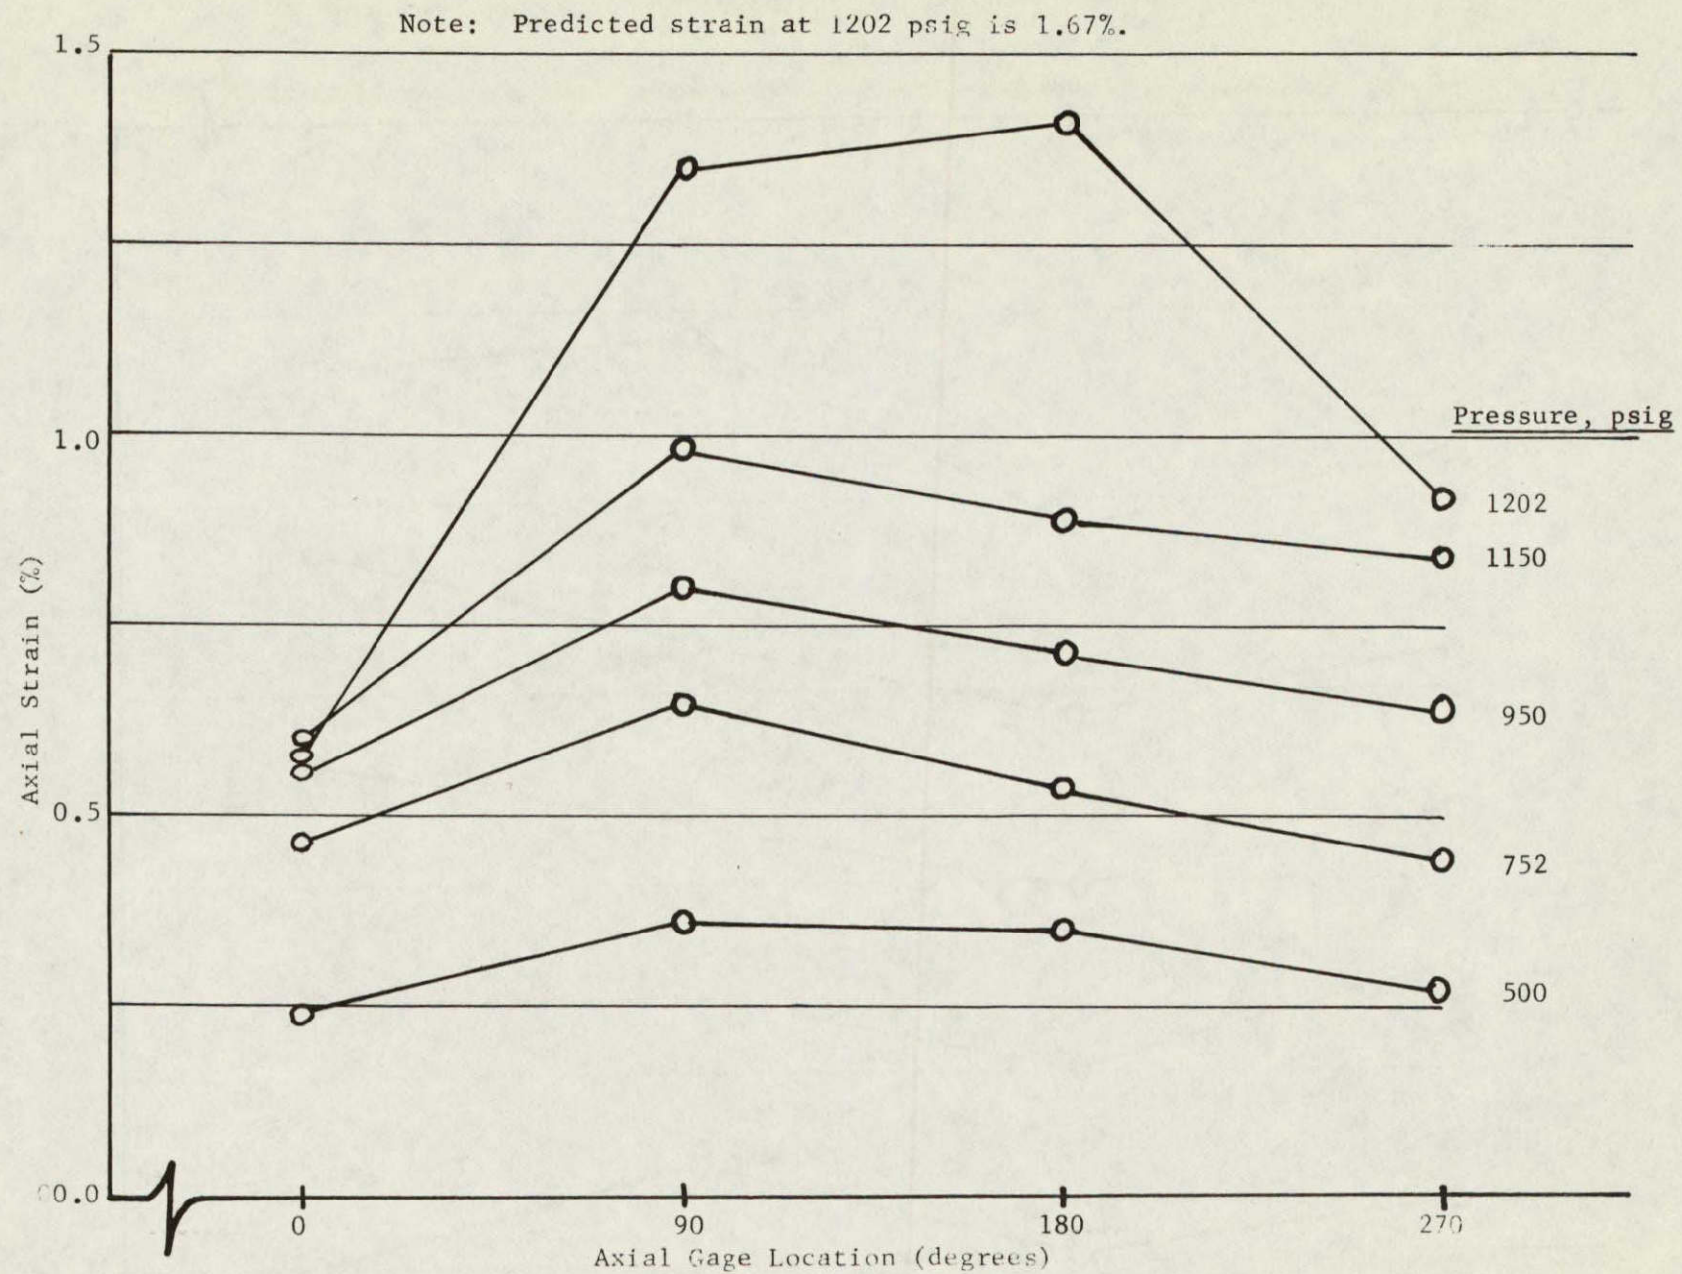
Figure 23. Bottle No. 6 - Axial Strain Versus Pressure  
(Maximum Axial Load = 2035 lb/in.)  
(Failure at 90°)
