NASA CR-66946

# CONTINUATION OF NASA ROCKET MOTOR DEFECTS INVESTIGATION

CONTINUATION OF NASA ROCKET MOTOR DEFECTS INVESTIGATION

JUNE 1969 THROUGH MAY 1970

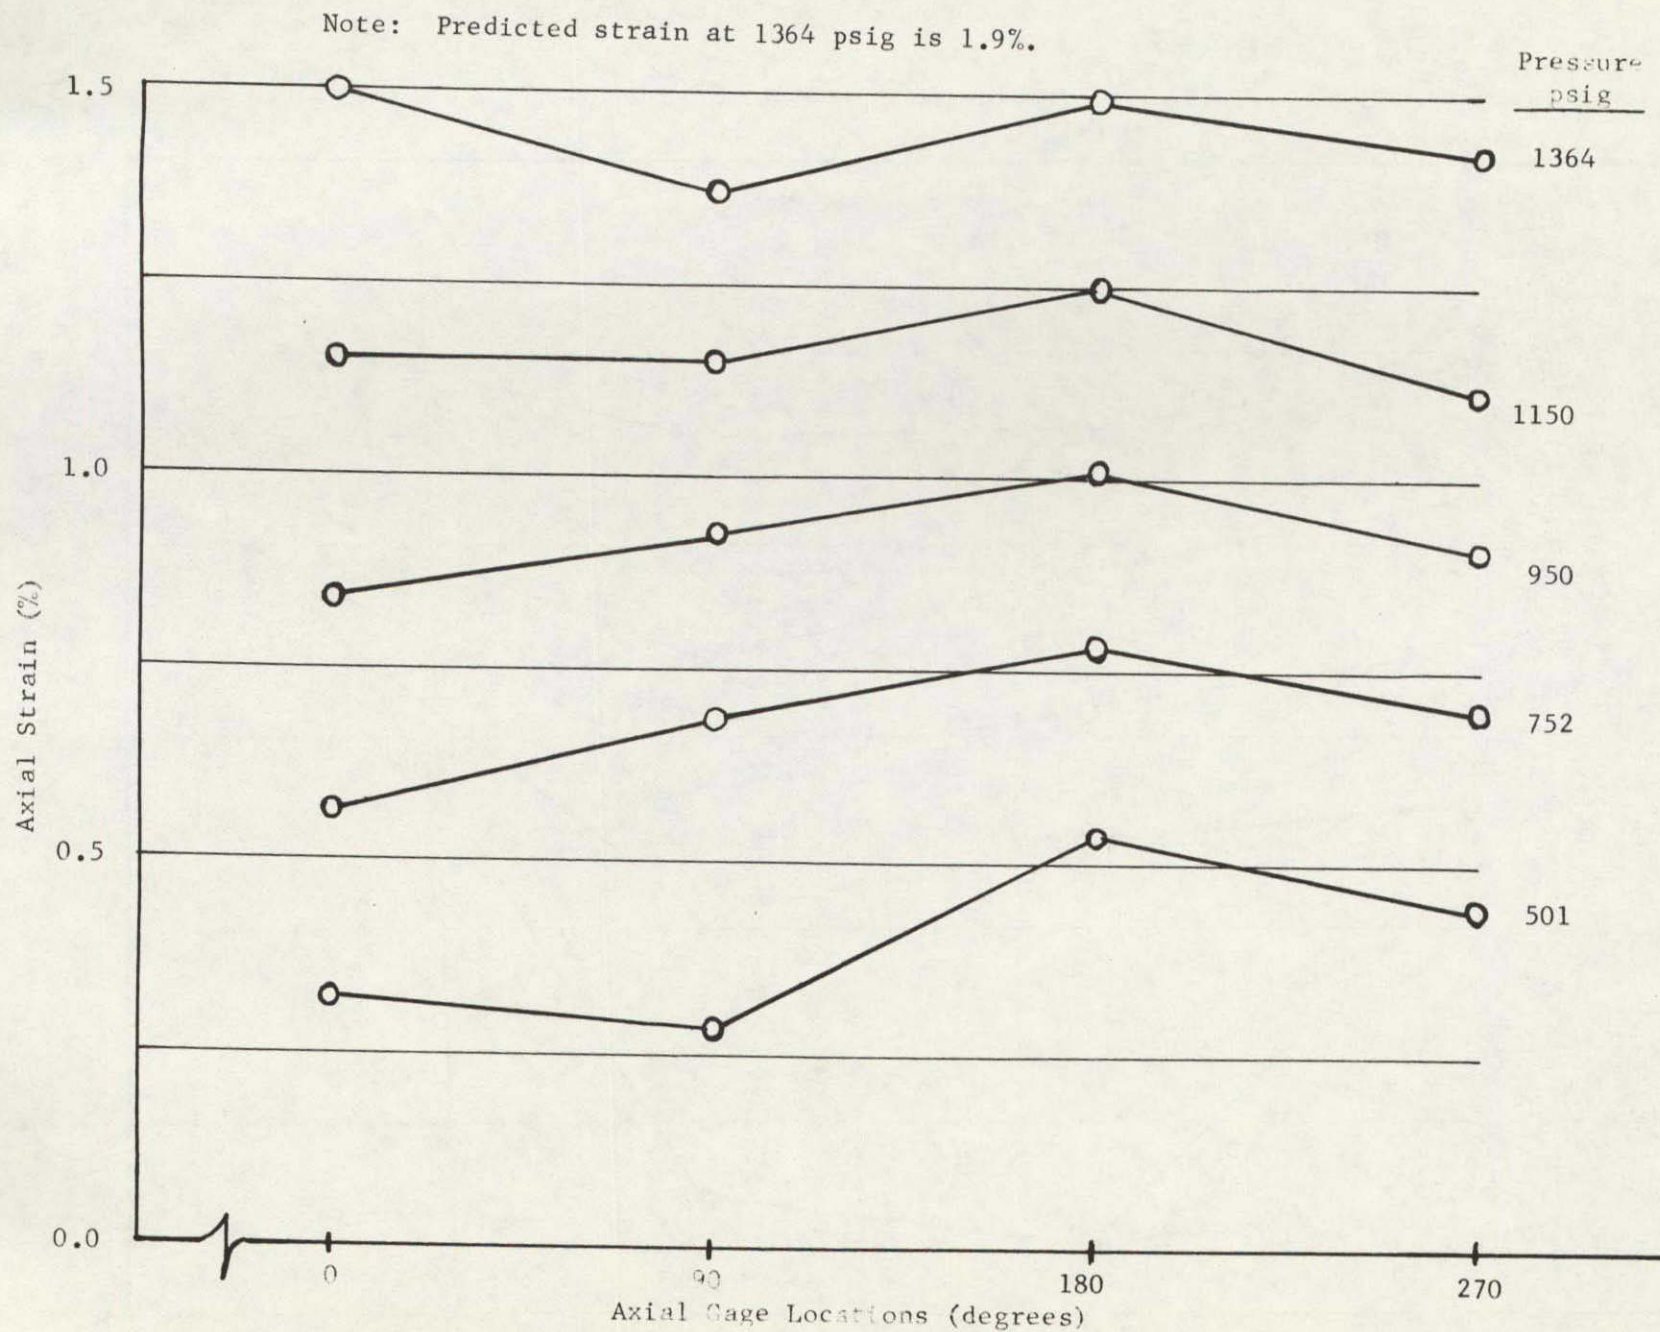
Figure 24. Bottle No. 7 - Axial Strain Versus Pressure  
(Maximum Axial Load = 2160 lb/in.) (Failure at 120°)

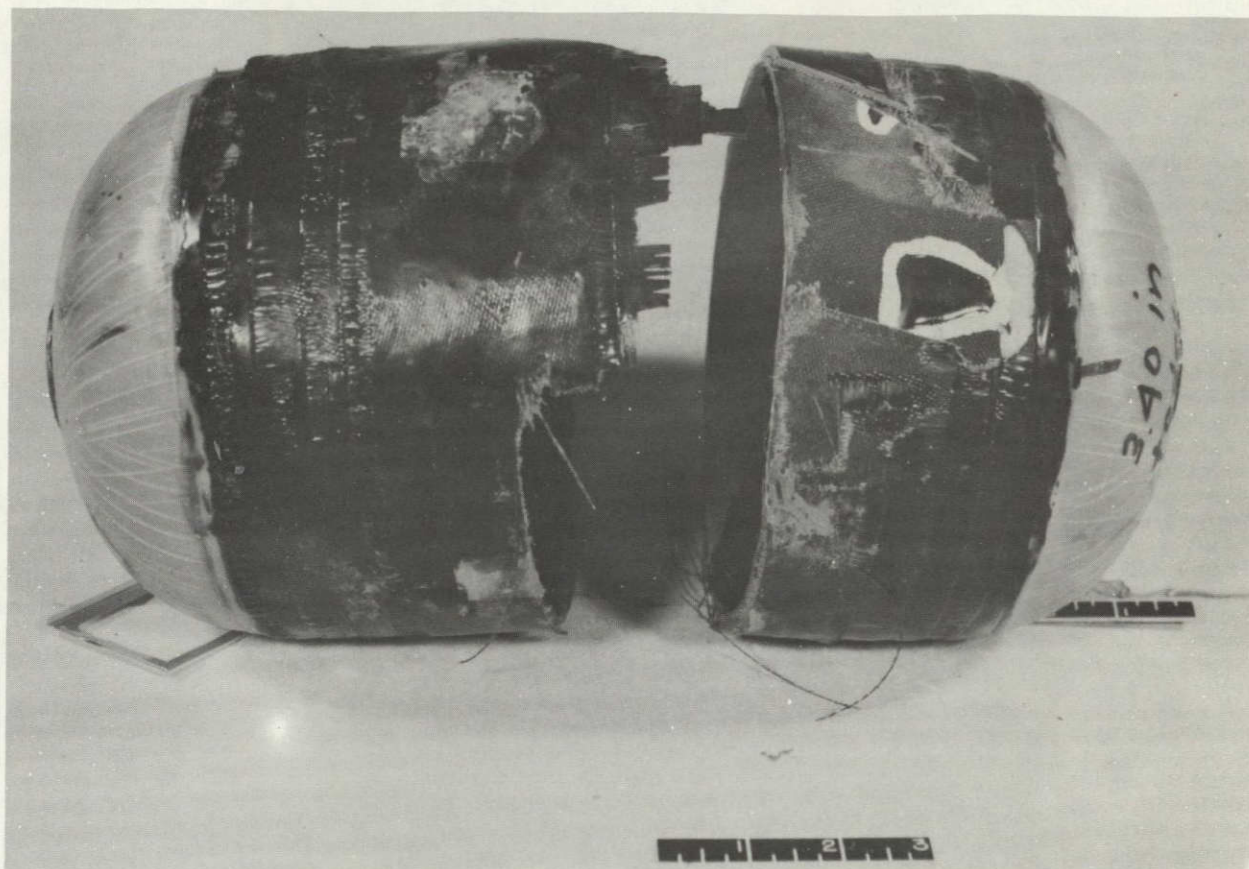
Figure 32. Void Areas in Bottle No. 7 (located inside white boundaries)

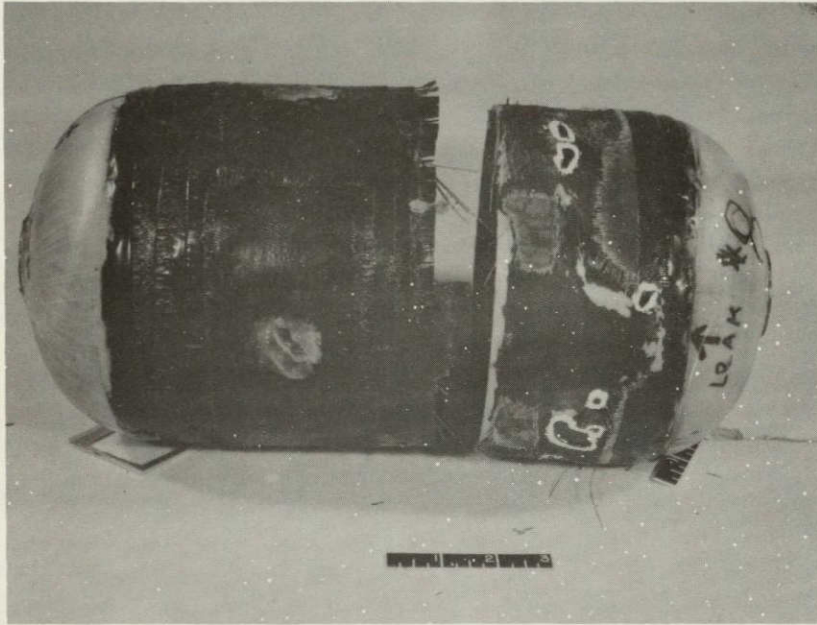
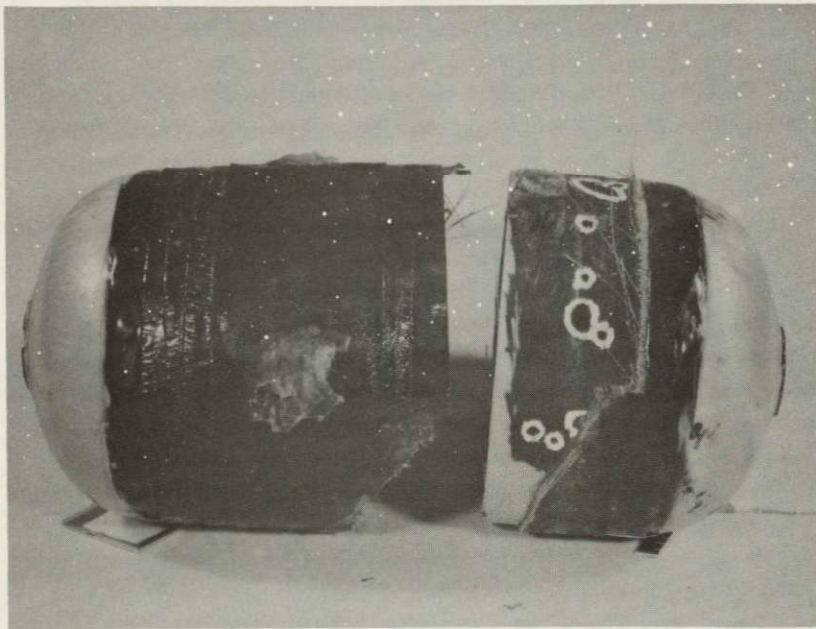
Figure 33. Void Areas in Bottle No. 8  
(located inside white boundaries)

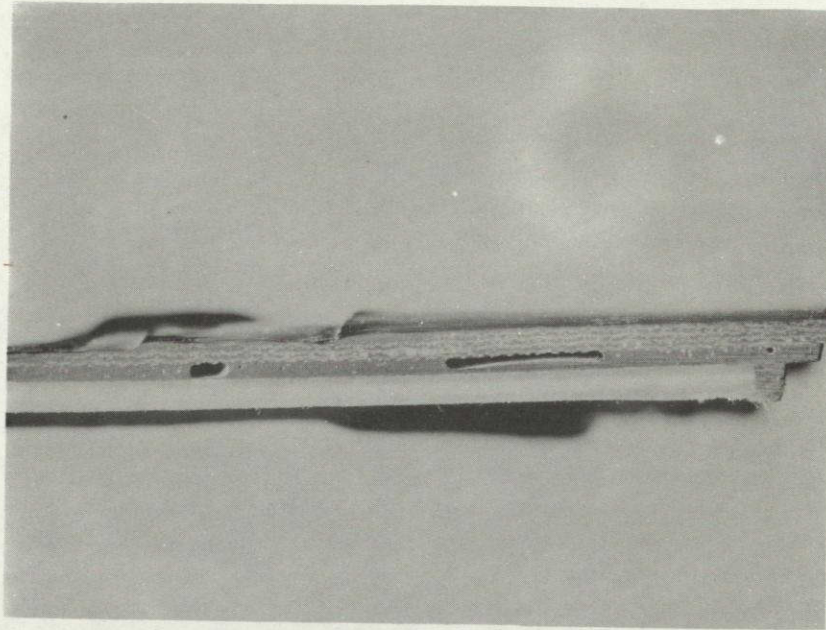
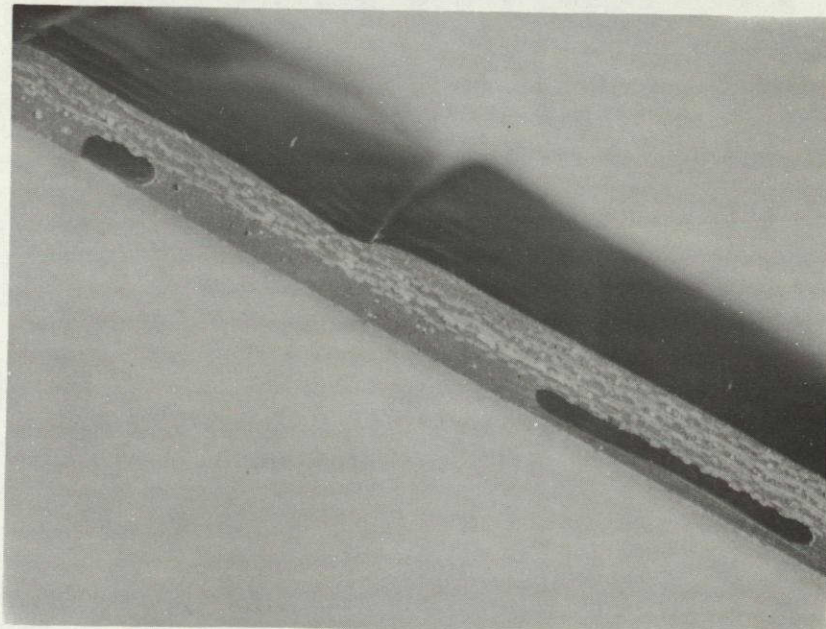
Figure 34. Voids in Bond Line of Bottle No. 6

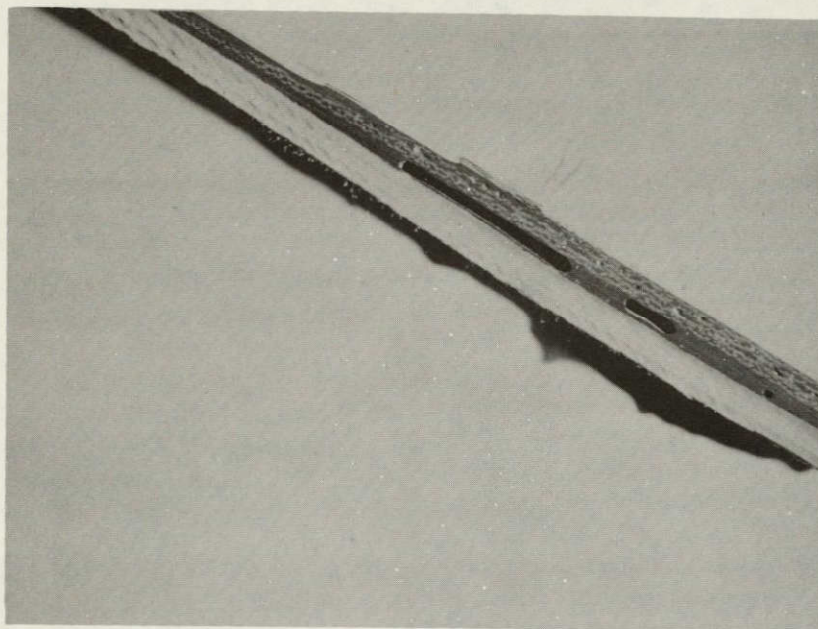
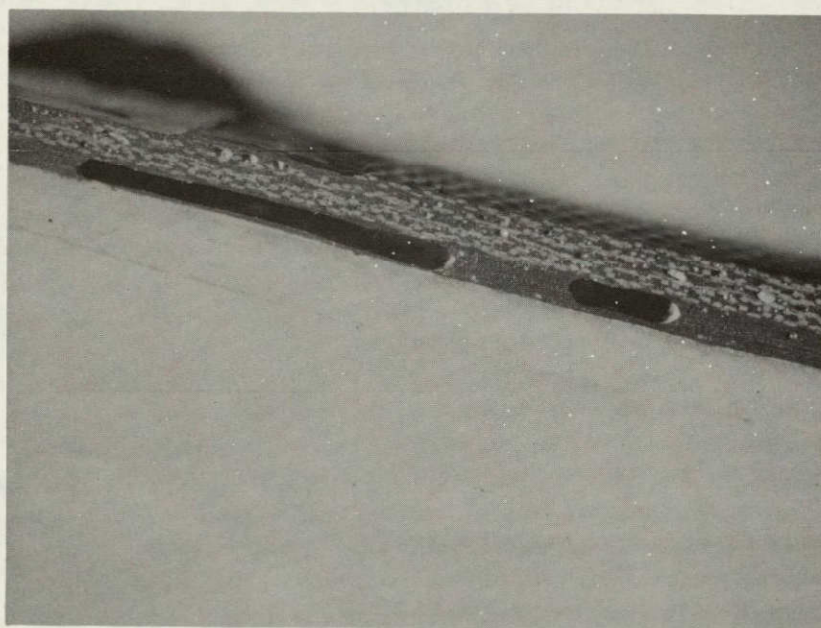
Figure 35. Voids in Bond Line of Bottle No. 6

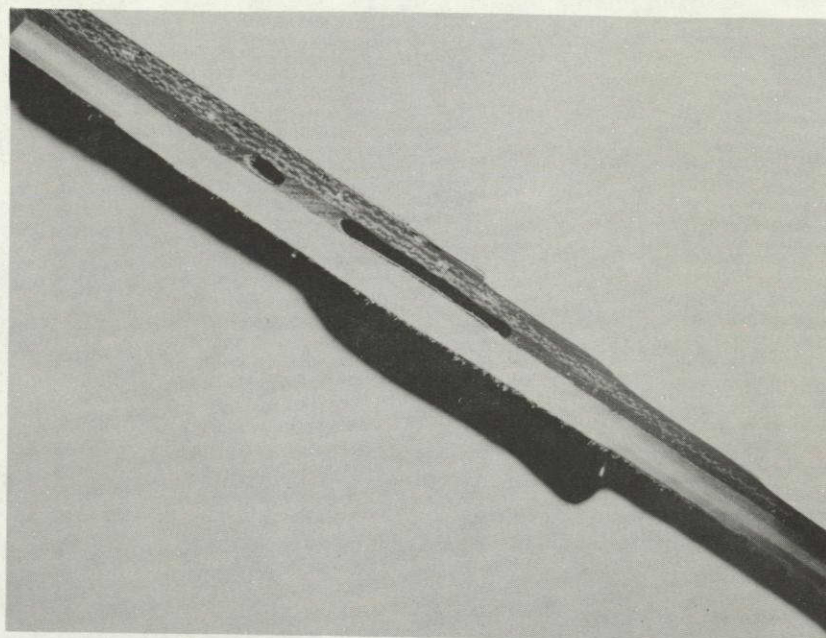
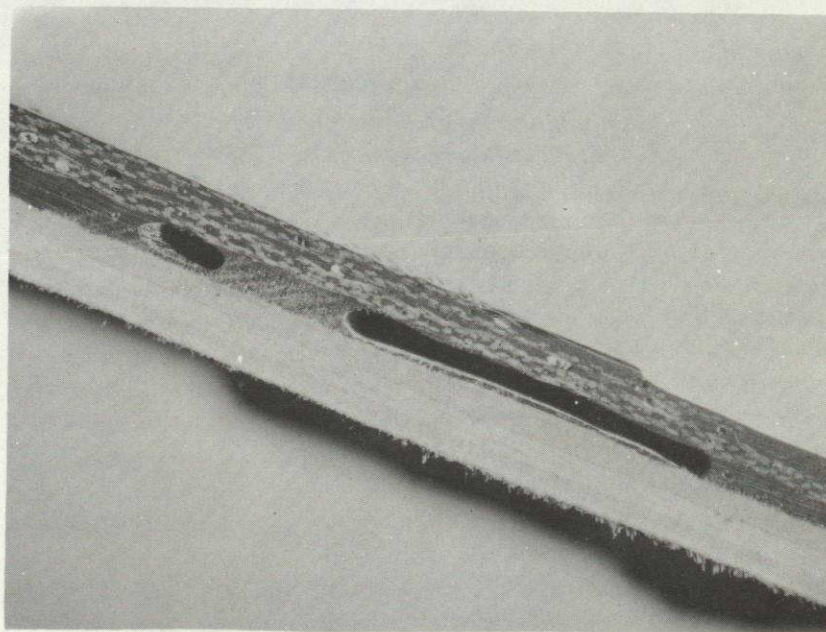
Figure 36. Voids in Bond Line of Bottle No. 6

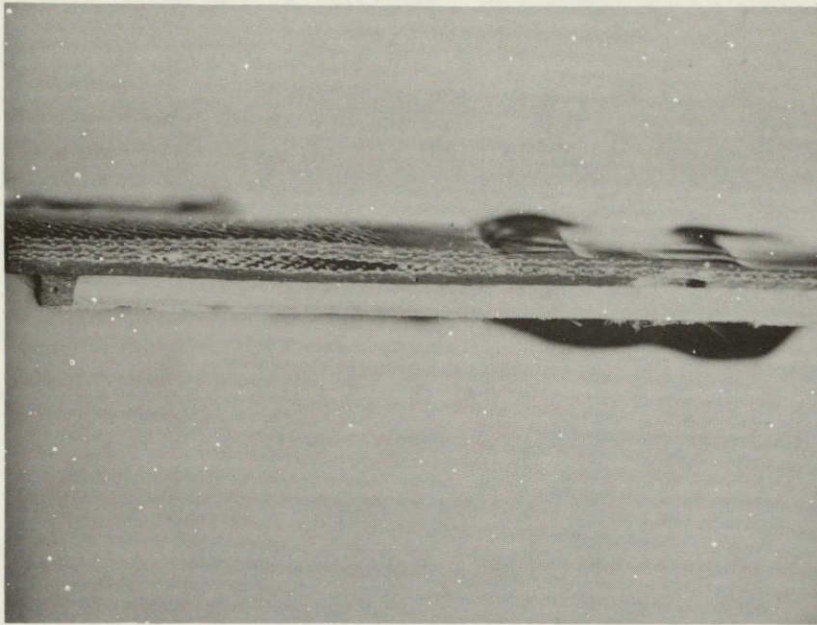
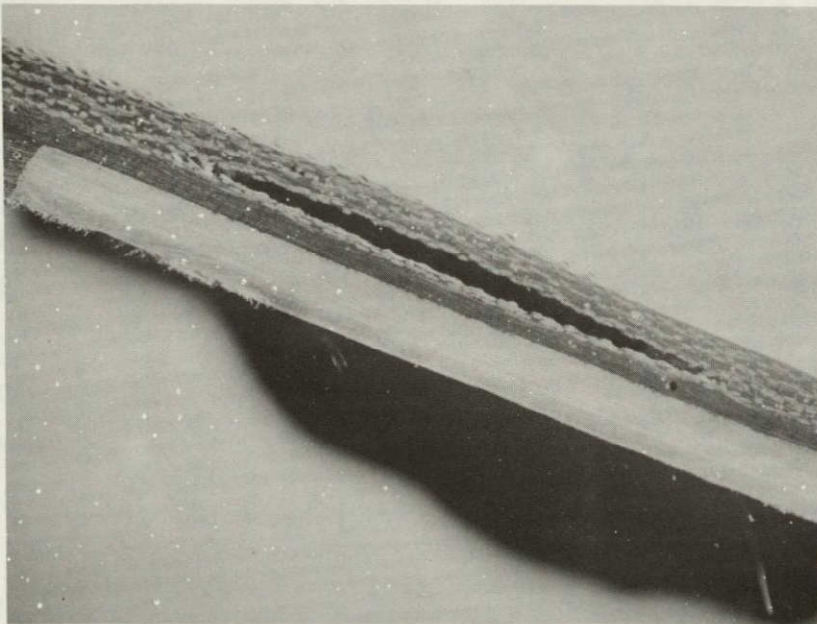
Figure 37. Voids Between Plies of Bottle No. 6

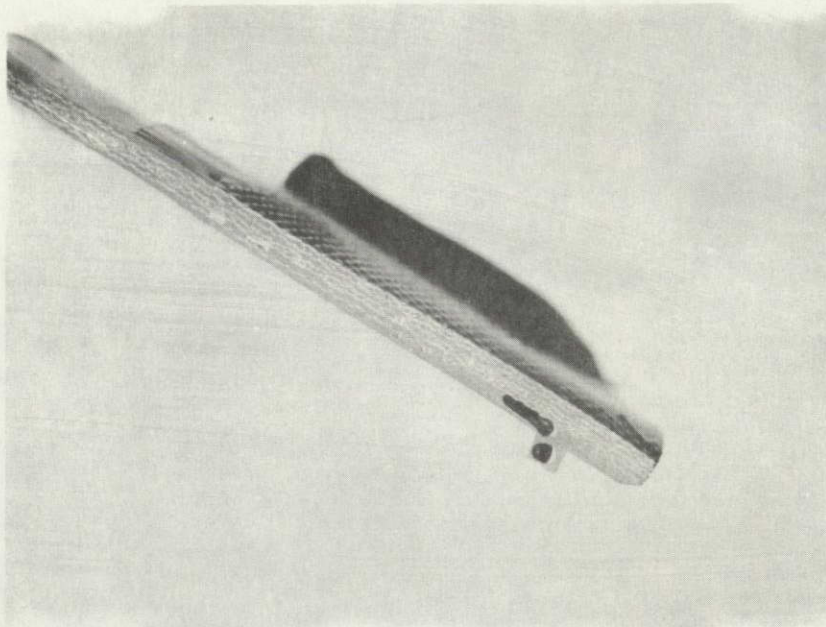
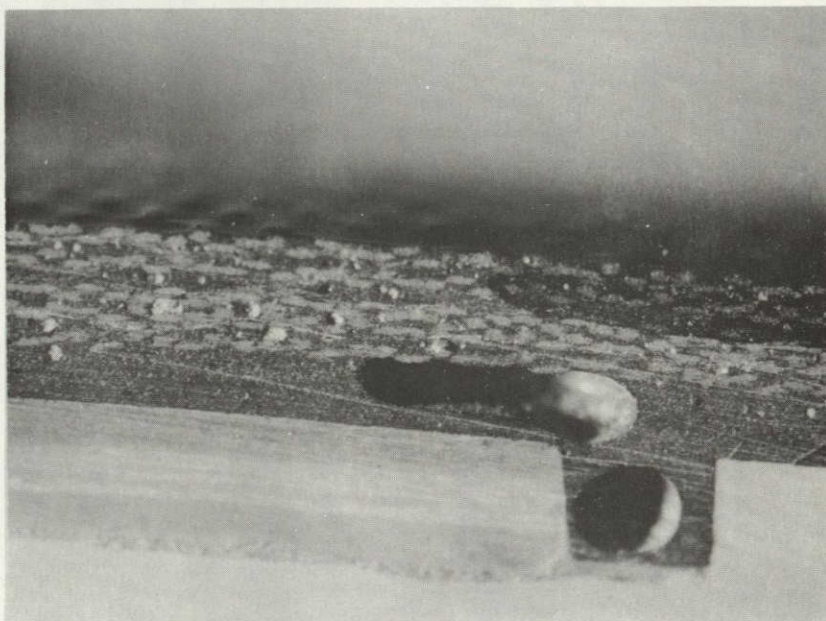
Figure 38. Voids Near Defect Edge of Bottle No. 6

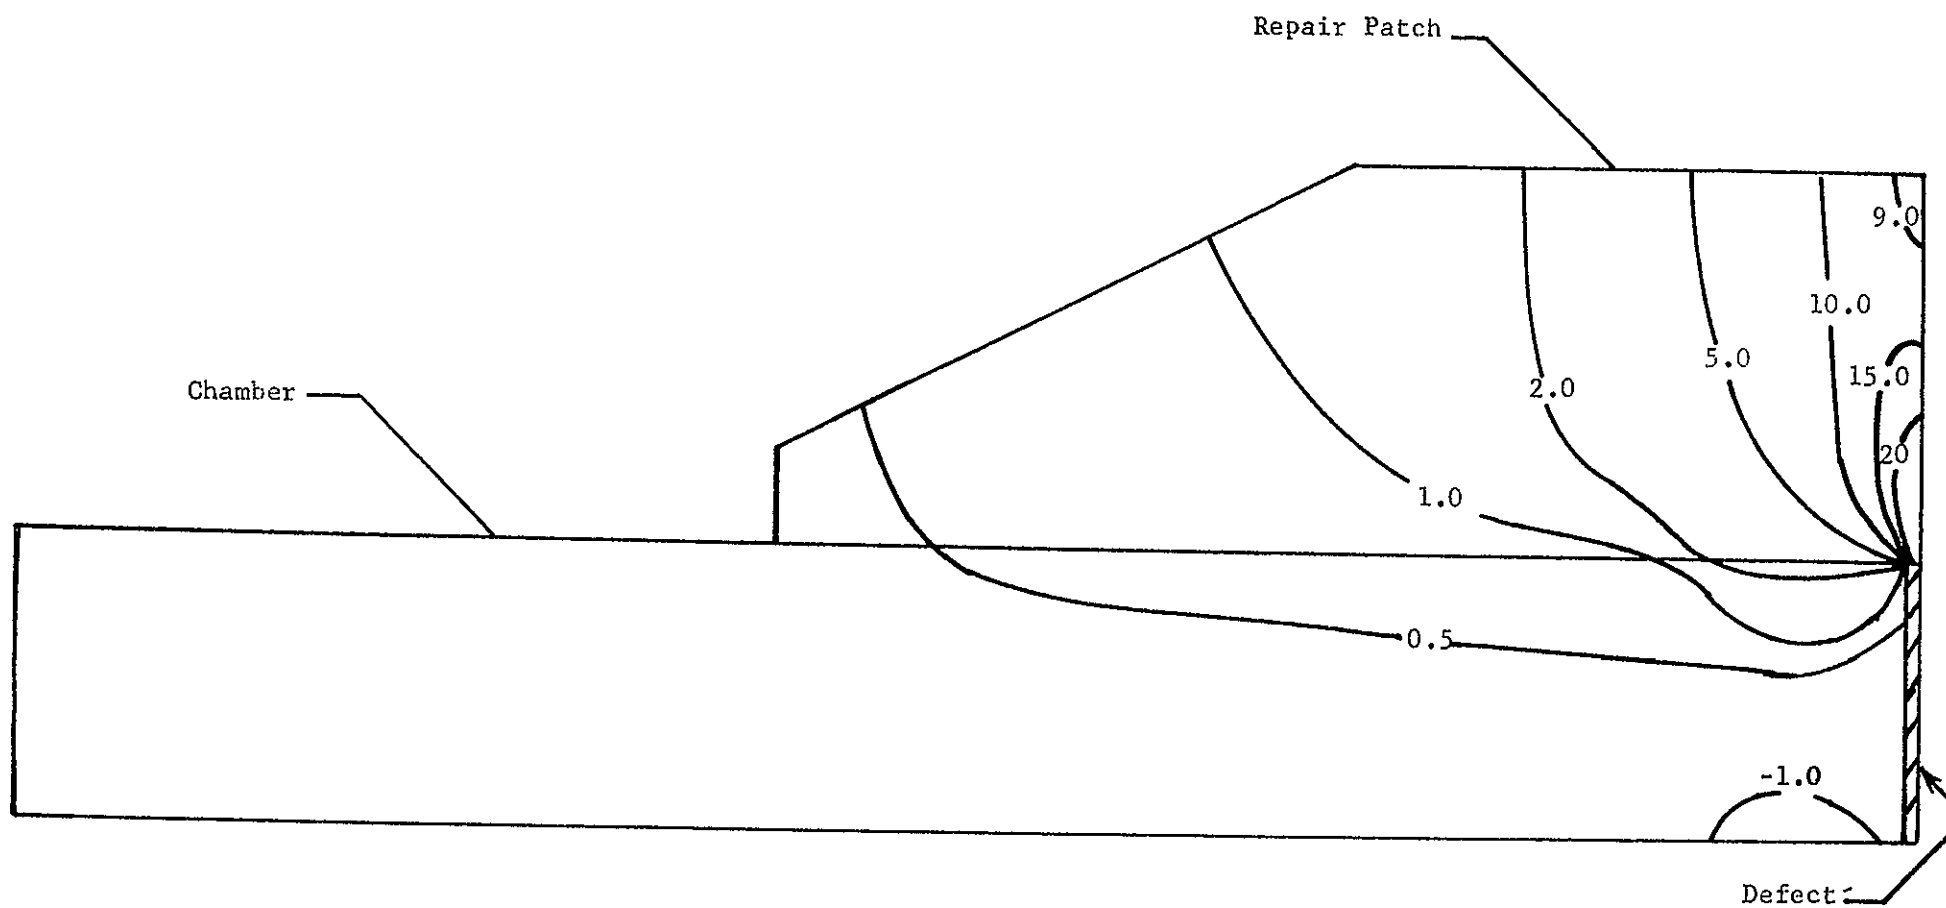
Figure 40. Axial Strain (%) Distribution in a Four-Ply Patch for a 30.0-In.-Diameter Chamber Subjected to 1000 psi Internal Pressure (7500 lb/in. Axial Load)

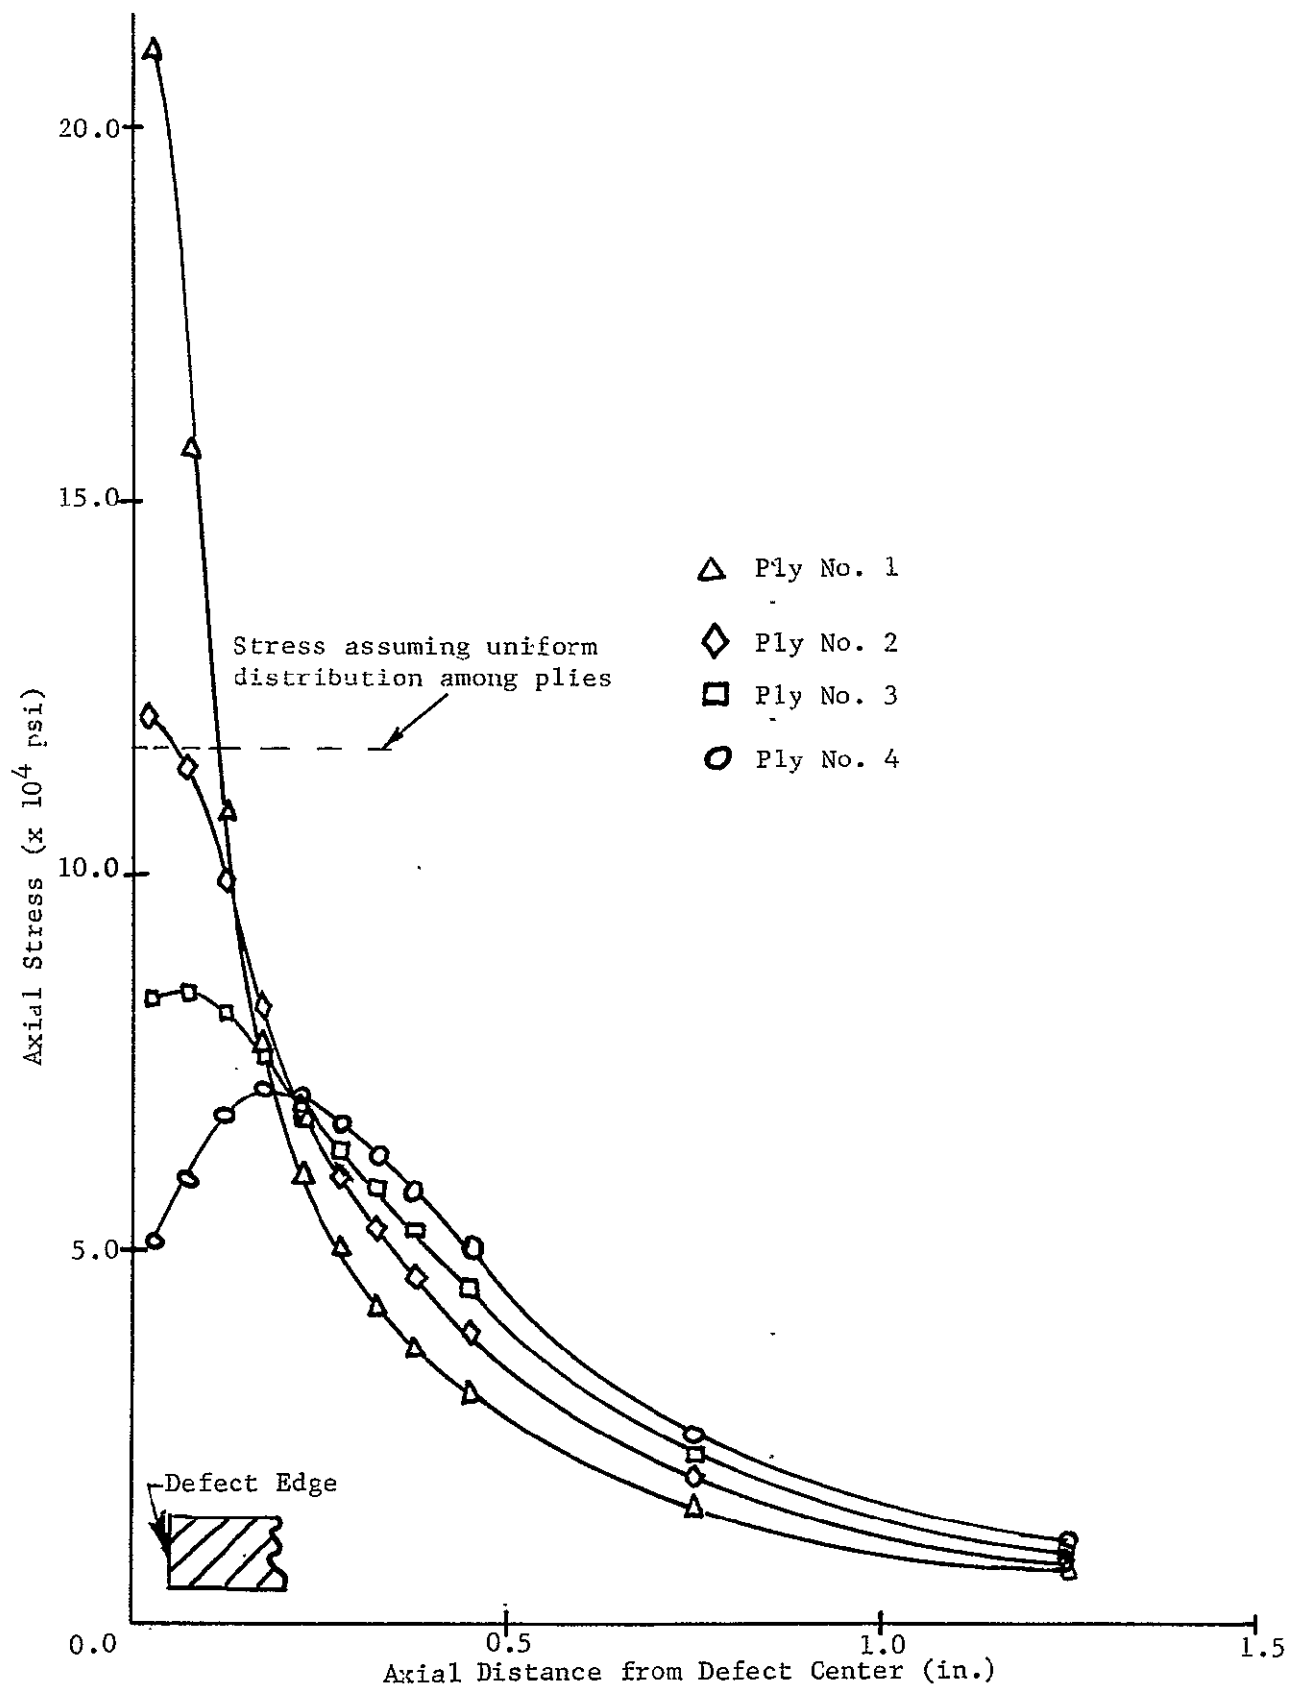
Figure 41. Axial Stress Distribution in a Four-Ply Patch for a 30.0-In.-Diameter Chamber Subjected to 1000 psi Internal Pressure (7500 lb/in. Axial Load)

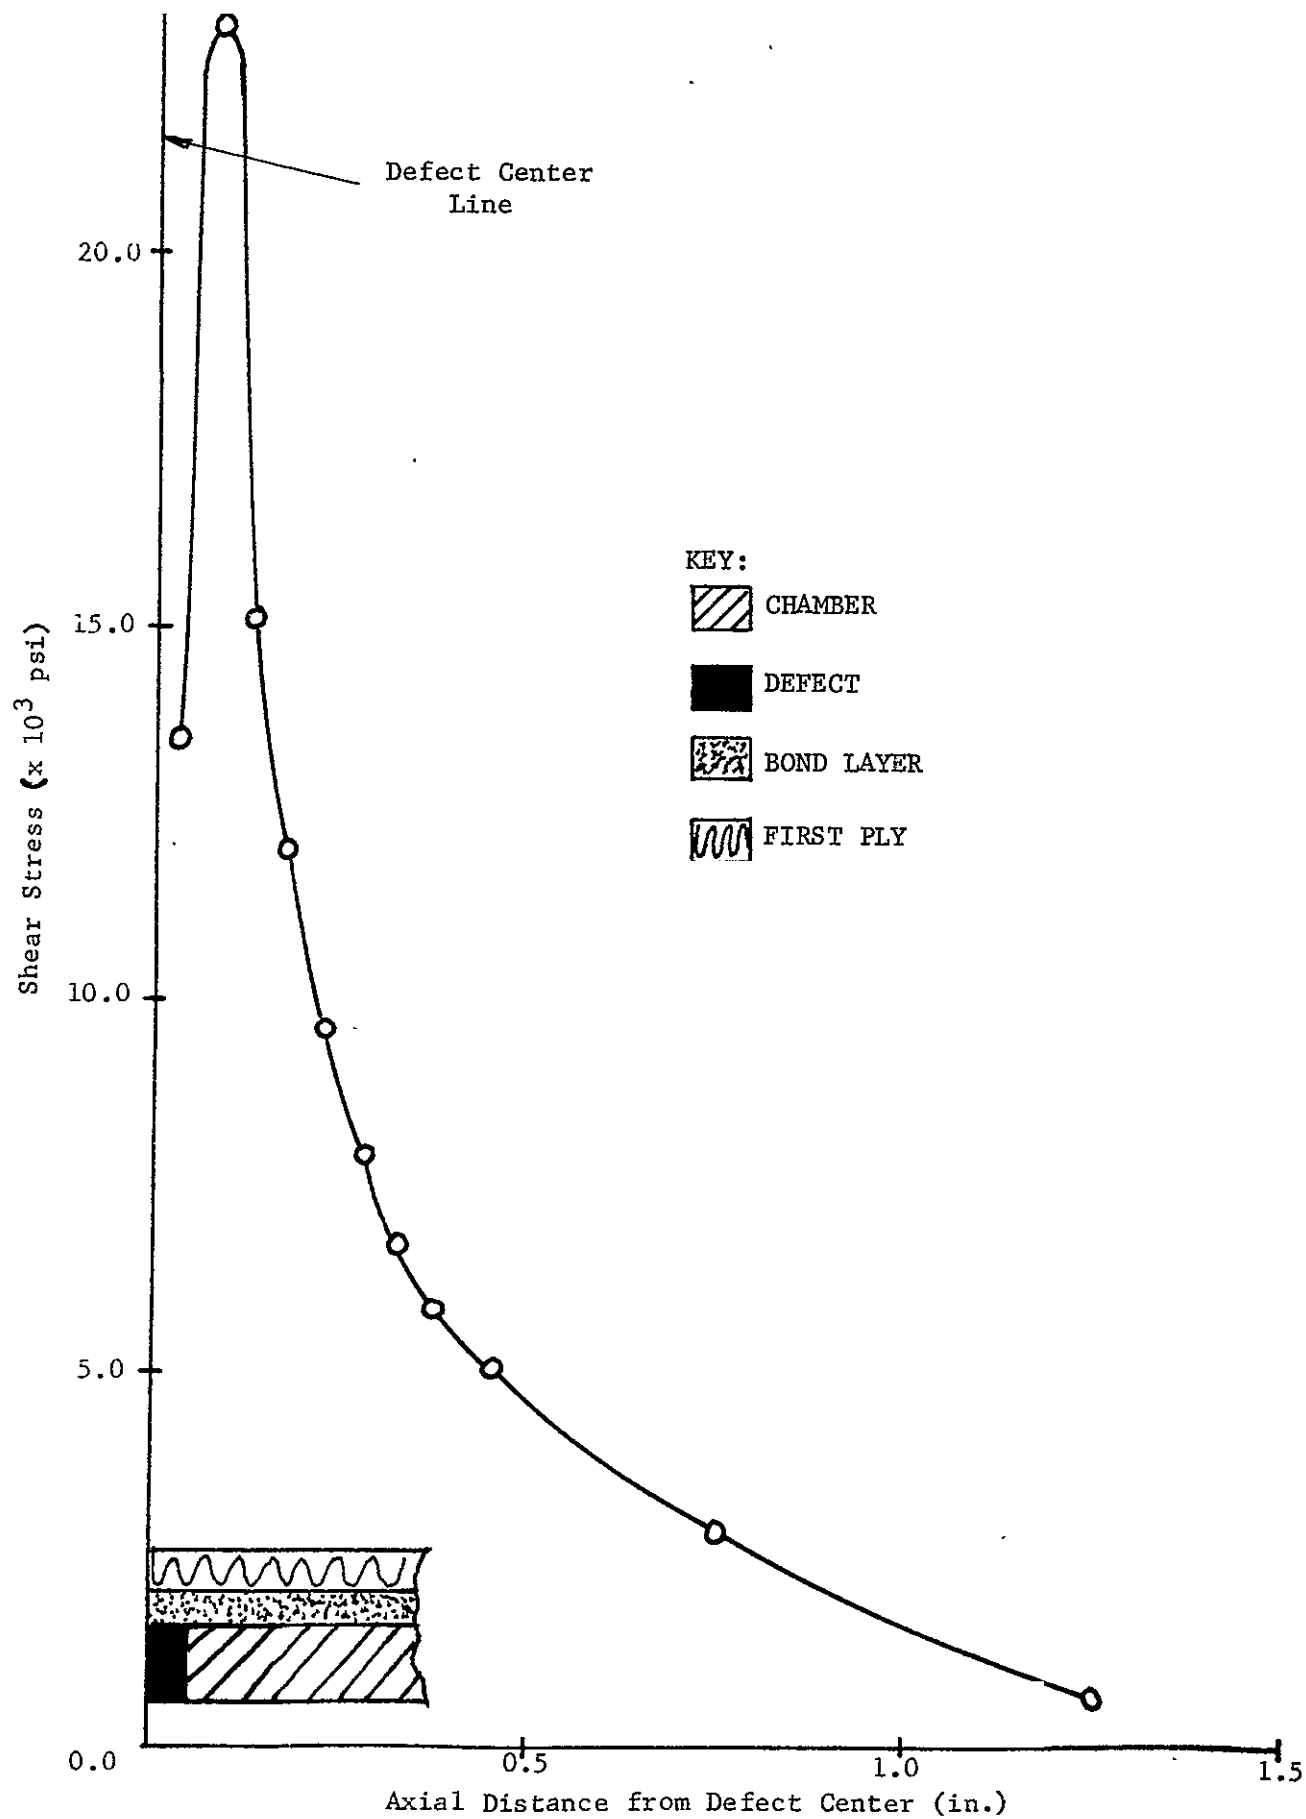
Figure 42. Shear Stress Distribution in Bond Layer Elements Near-  
 est the Chamber Wall of a Four-Ply Patch for a 30.0-  
 In.-Diameter Chamber Subjected to 1000 psi Internal  
 Pressure (7500 lb/in. Axial Load)

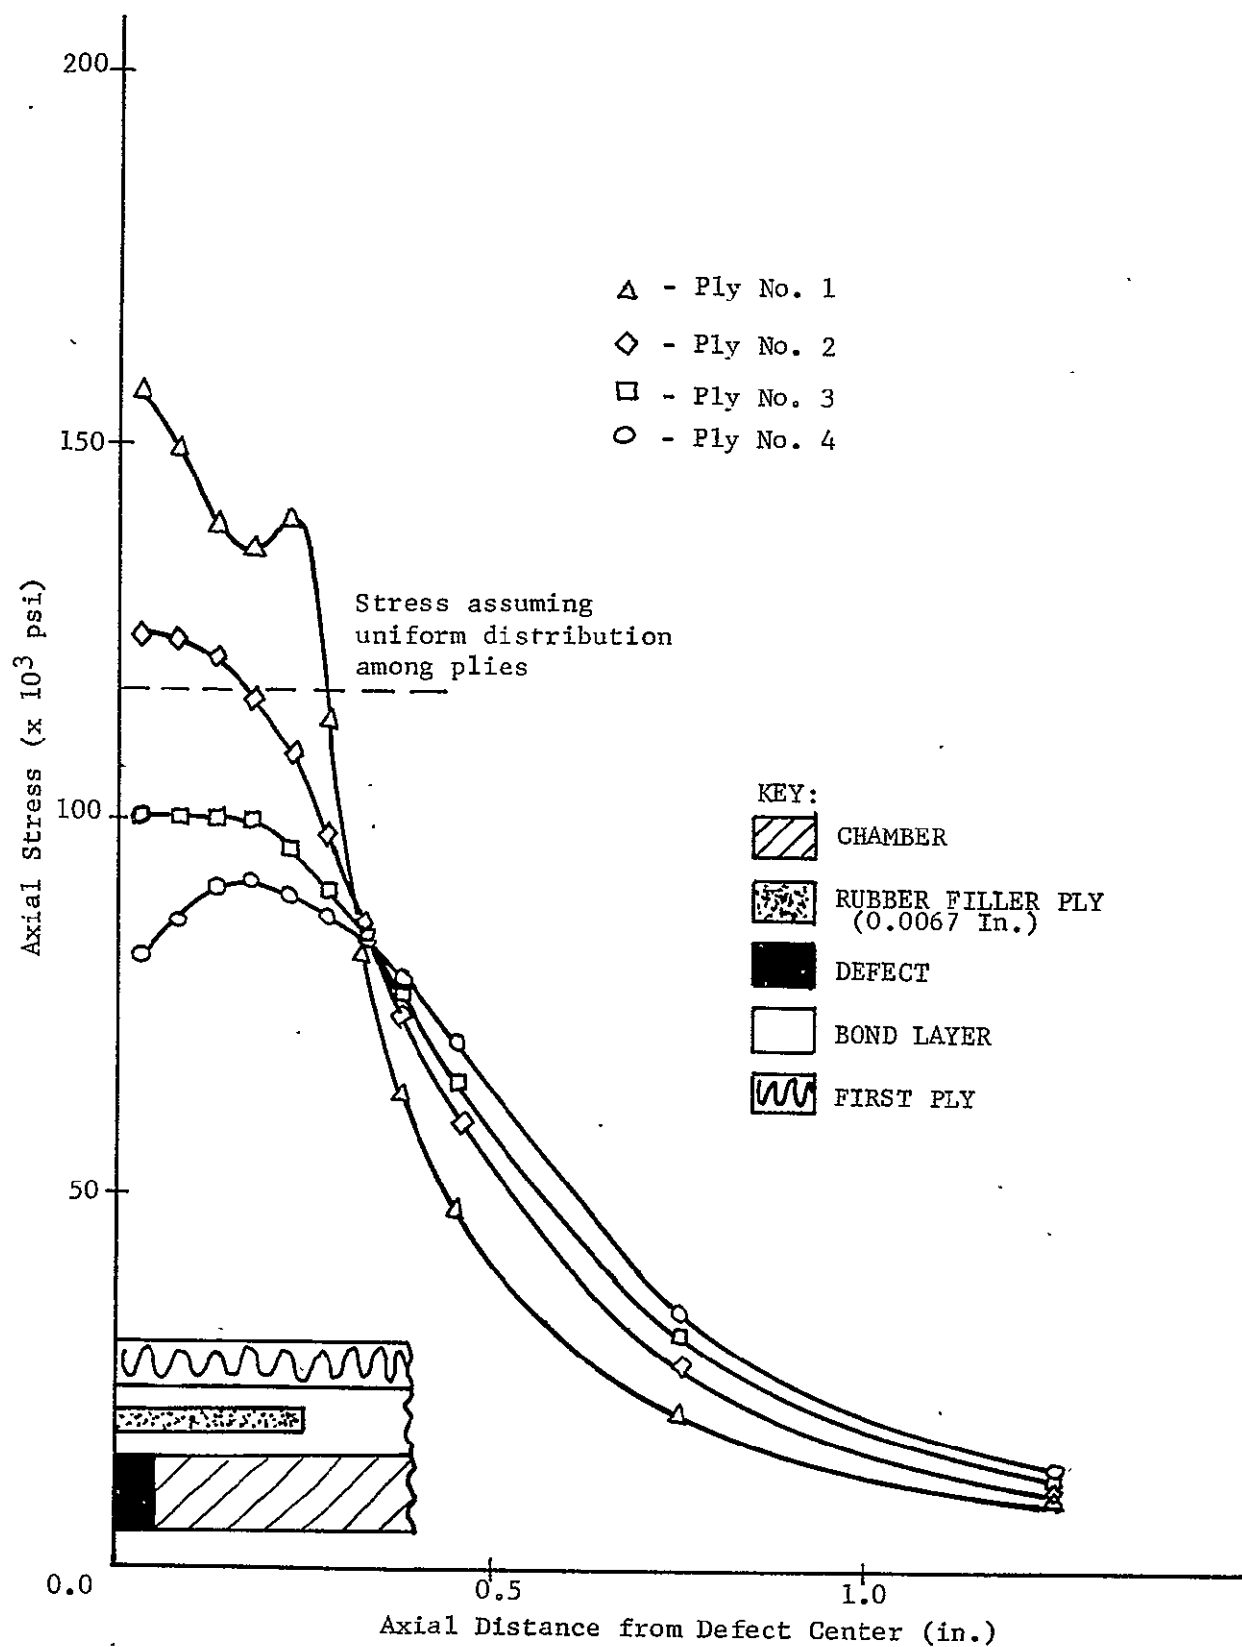
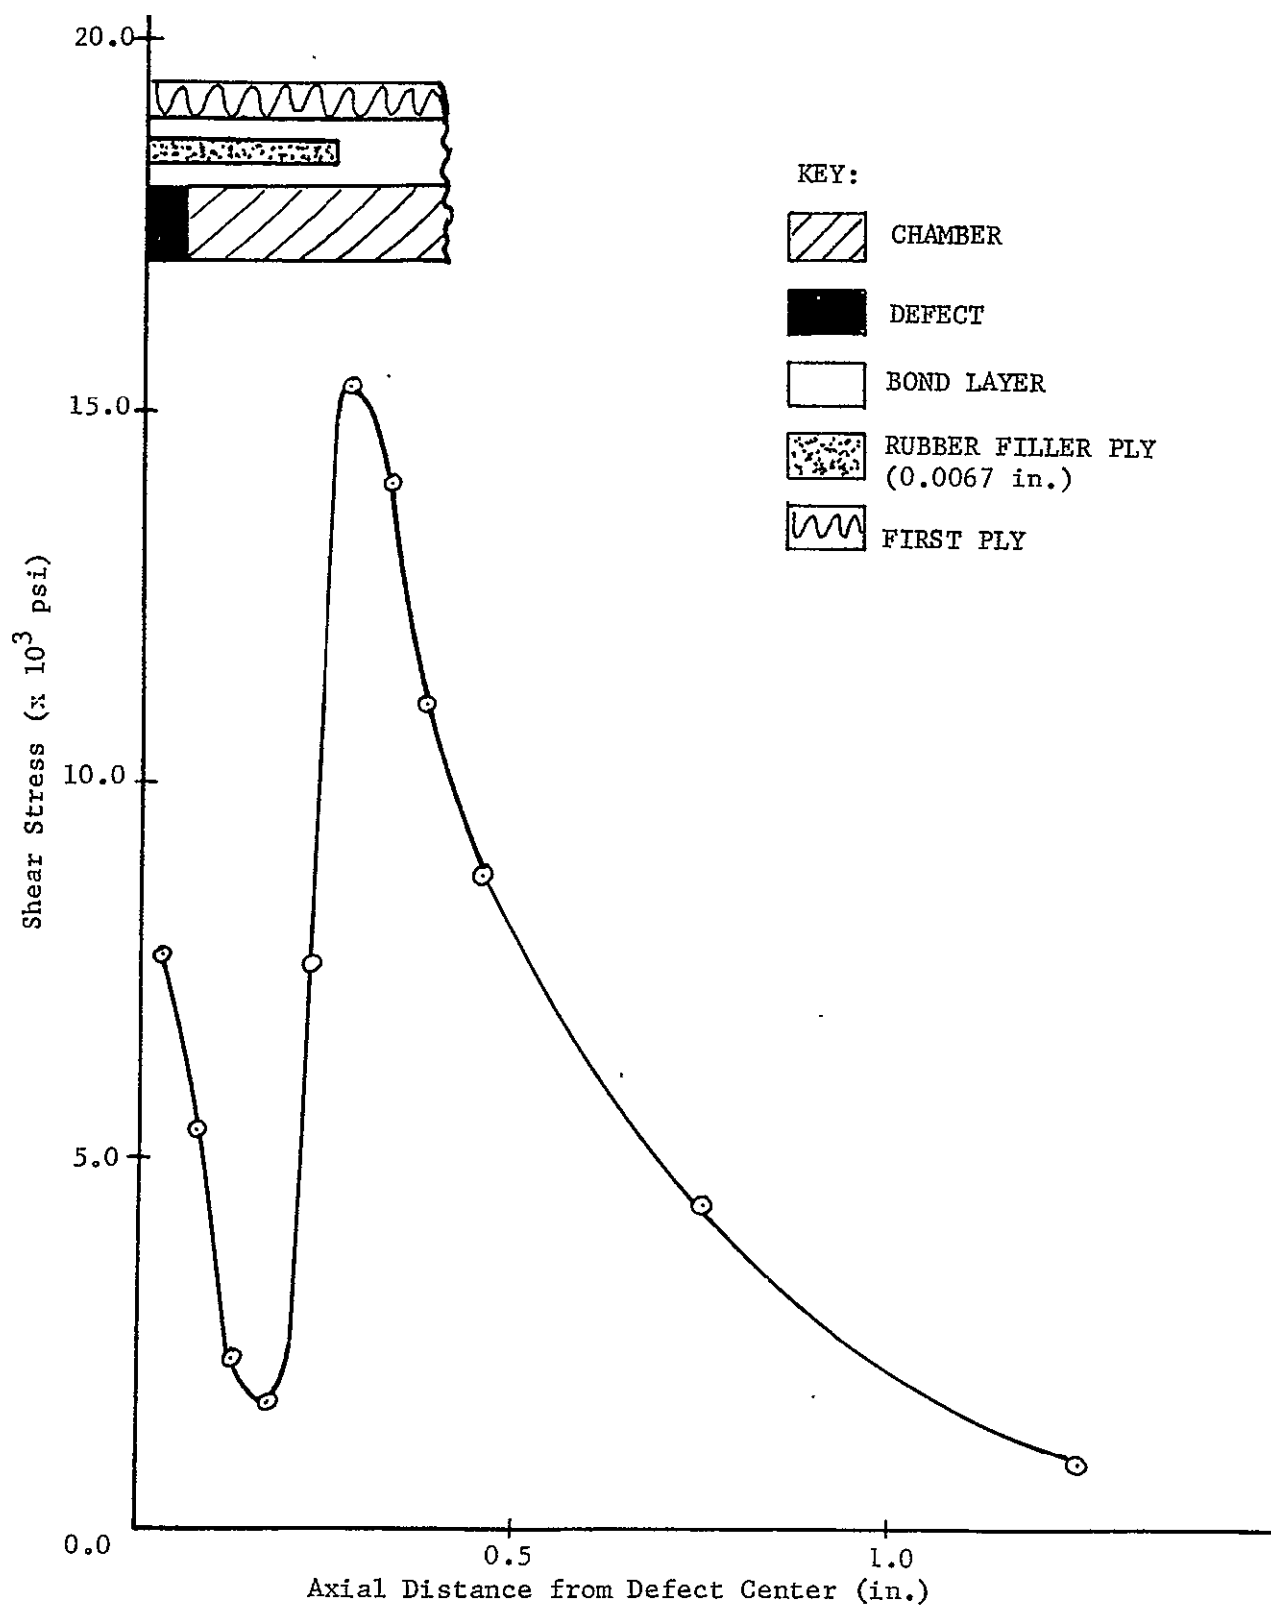
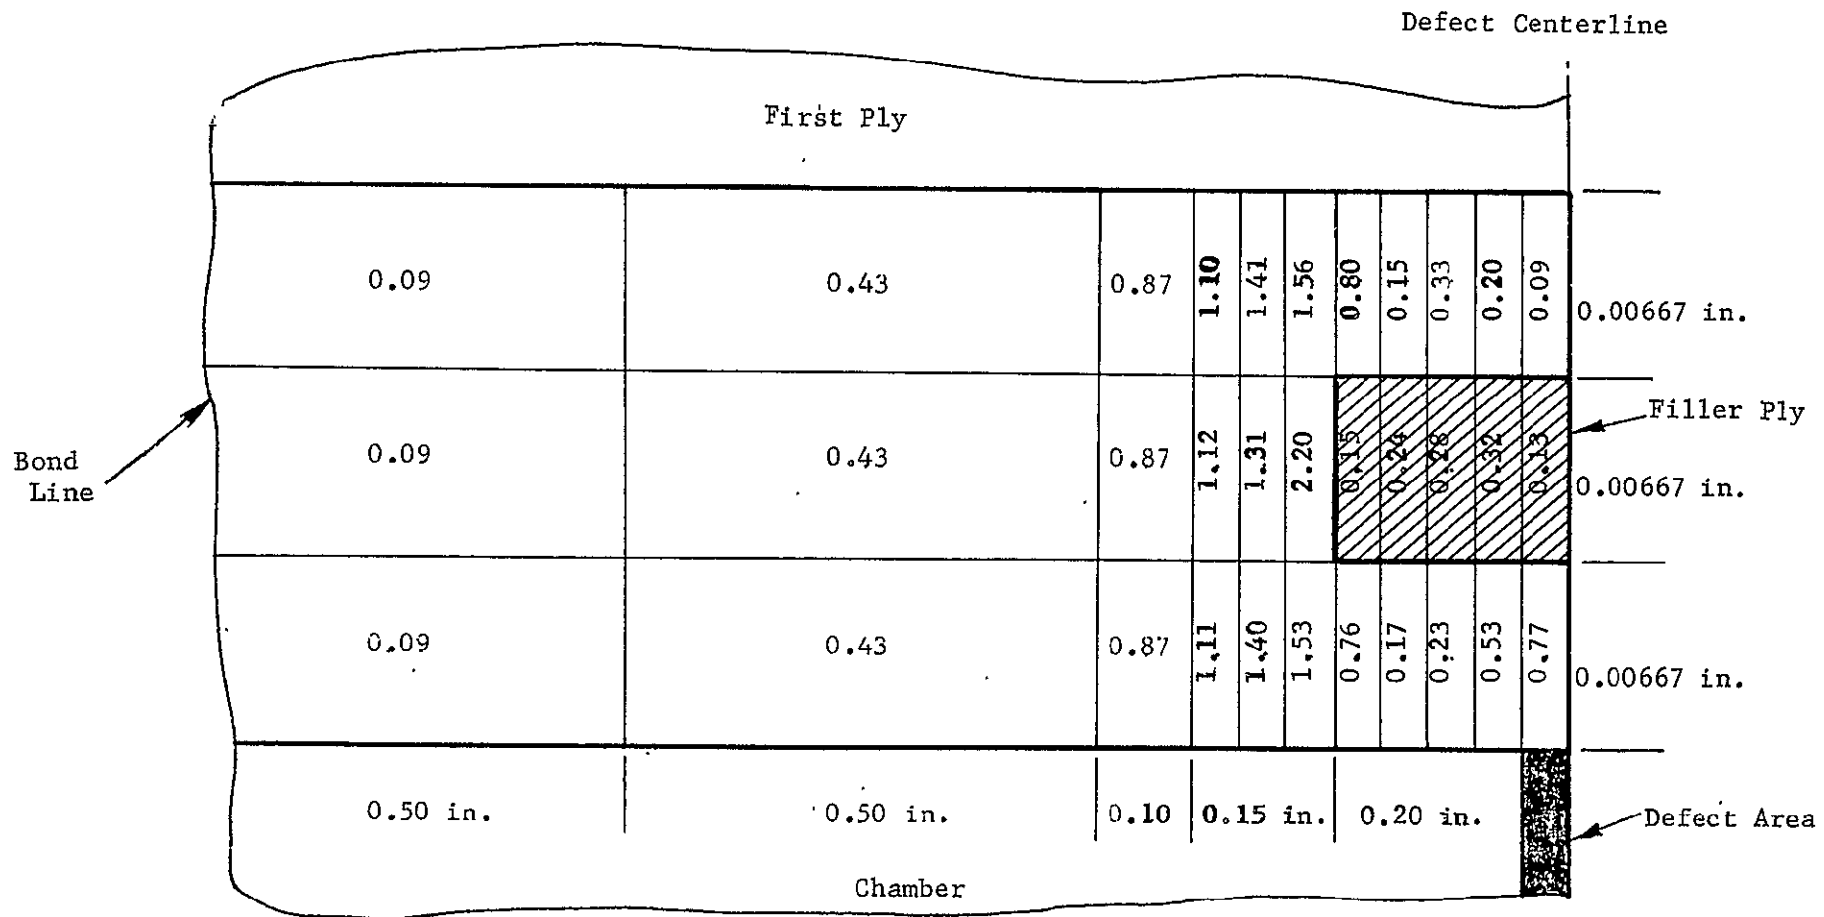
The second type of filler ply consisted of a 0.0067-in.-thick rubber material with a low modulus (i.e., 1000 psi). Plots of the axial strain distribution, axial stress distribution per ply, and the shear stress distribution for a rubber filler are shown in Figures 50, 51 and 52. The stress and strain plots indicate that the load to be carried has been more uniformly distributed across the plies. This condition would permit the addition of outer plies of cloth to help reduce the maximum stresses in the first ply. The shear stress distribution plot indicates a significant decrease at the defect edge. The maximum shear stress has been shifted to the edge of the rubber and is about 70% of the maximum for a normal four-ply repair. This analysis has indicated that the use of a rubber

filler material in the bond line can both significantly reduce peak shear stresses and can provide a more uniform distribution in the patch plies. This can be readily evaluated by comparing Figure 52, which shows the shear stress distribution in a bond line with a rubber filler, with Figure 42.
