NASA CR-66946

# CONTINUATION OF NASA ROCKET MOTOR DEFECTS INVESTIGATION

CONTINUATION OF NASA ROCKET MOTOR DEFECTS INVESTIGATION

JUNE 1969 THROUGH MAY 1970

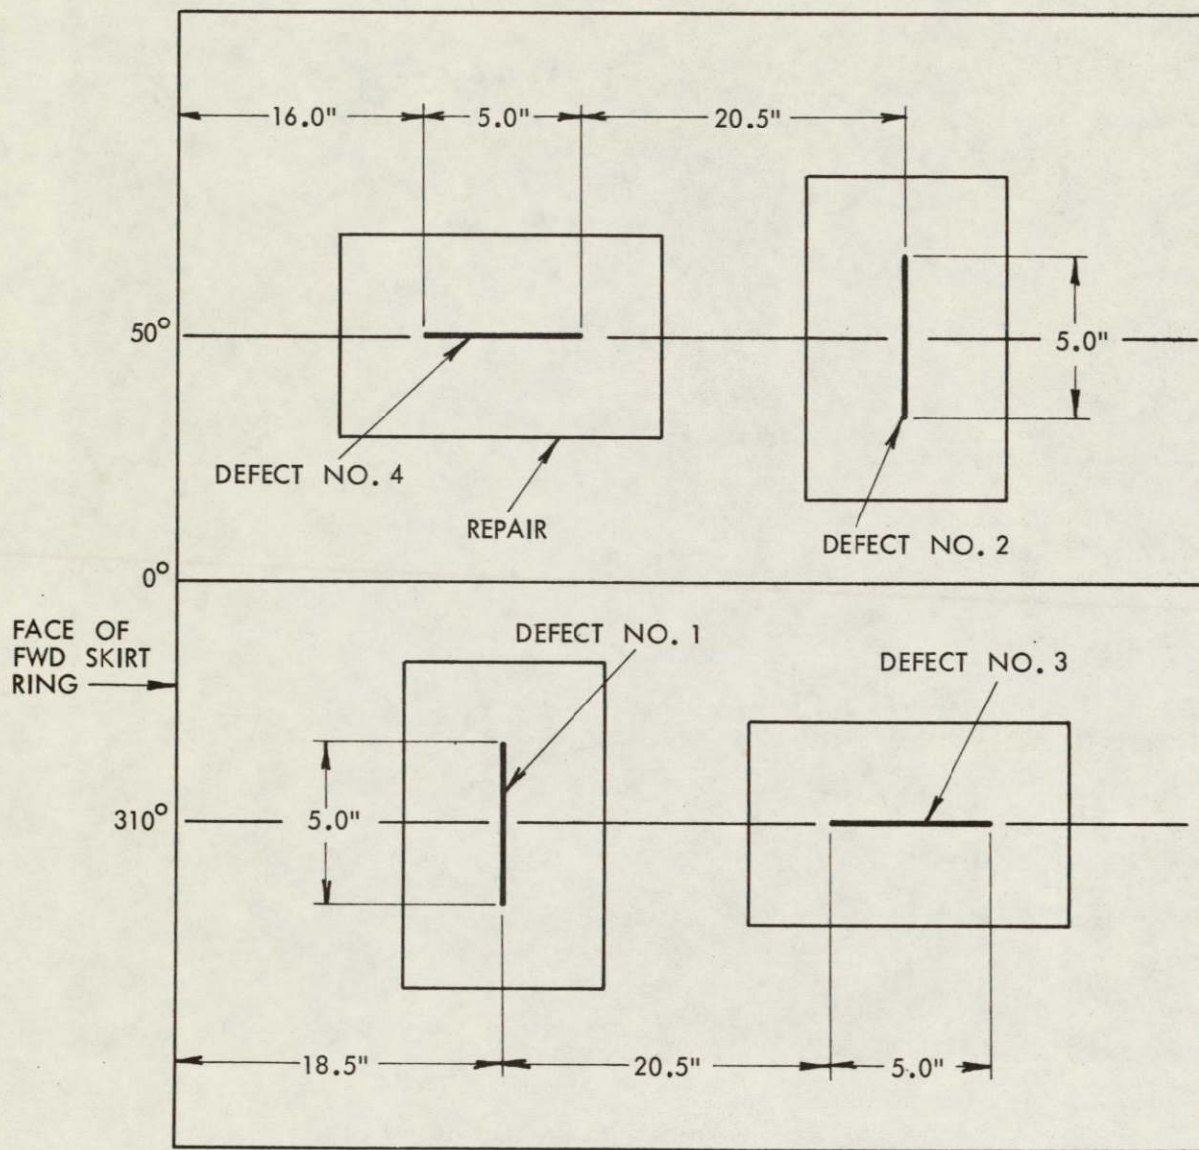
Figure 61. Defect Location on X 259 Cylindrical Section

These defects and their respective locations are shown in Figure 61

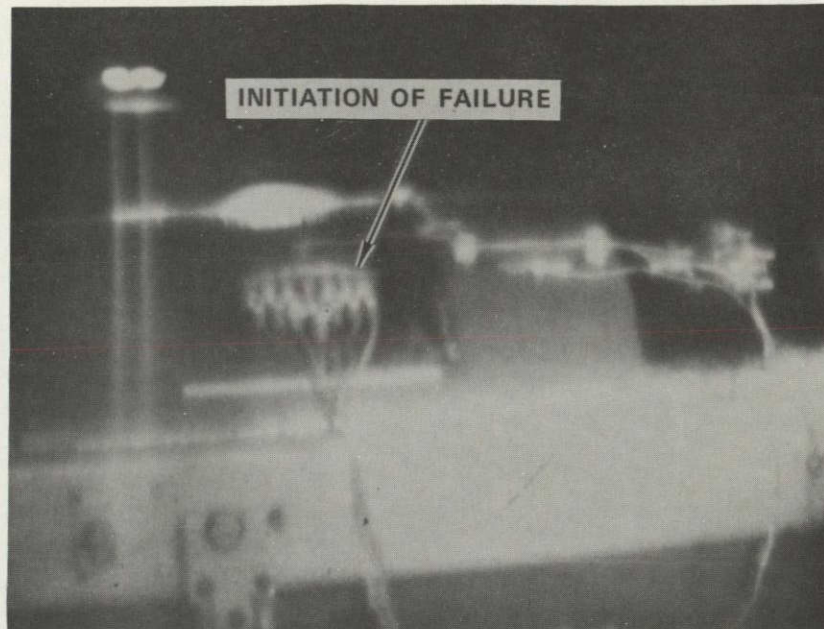
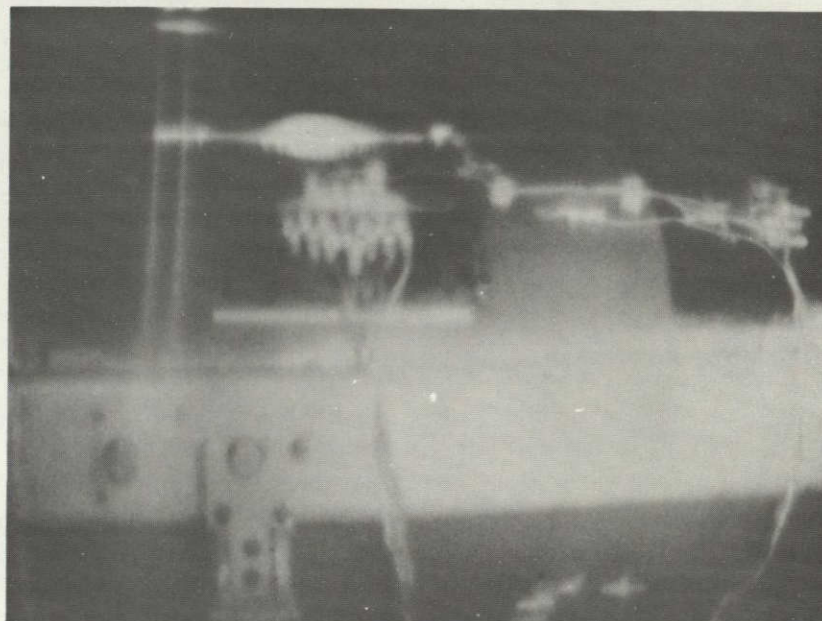
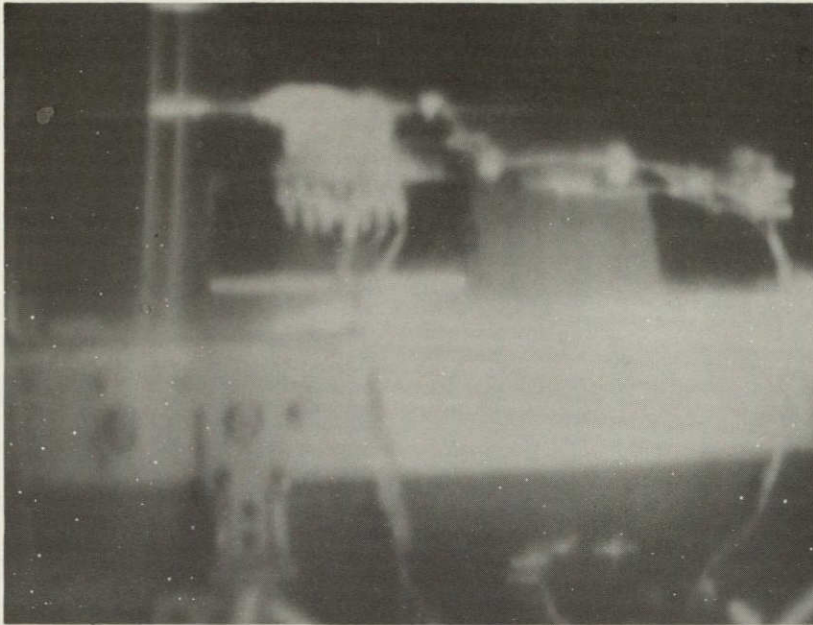
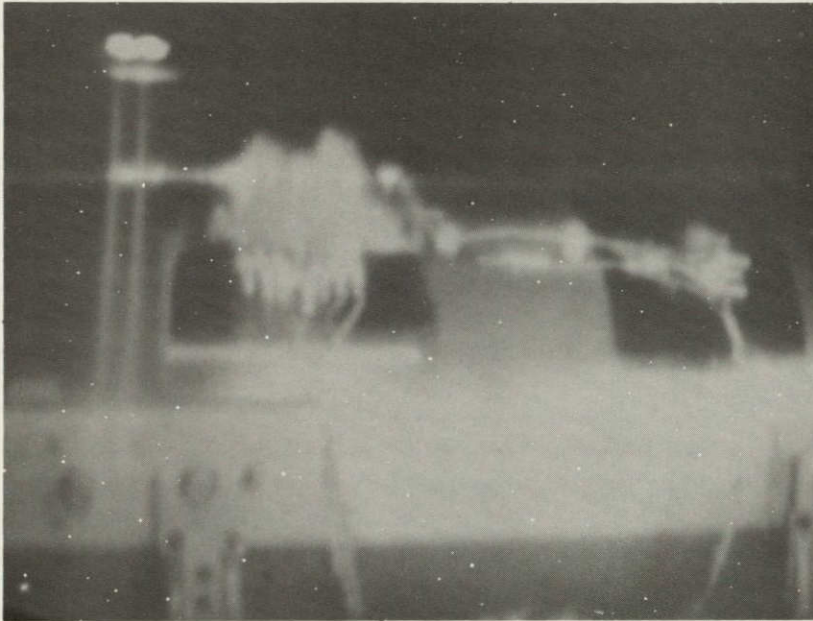
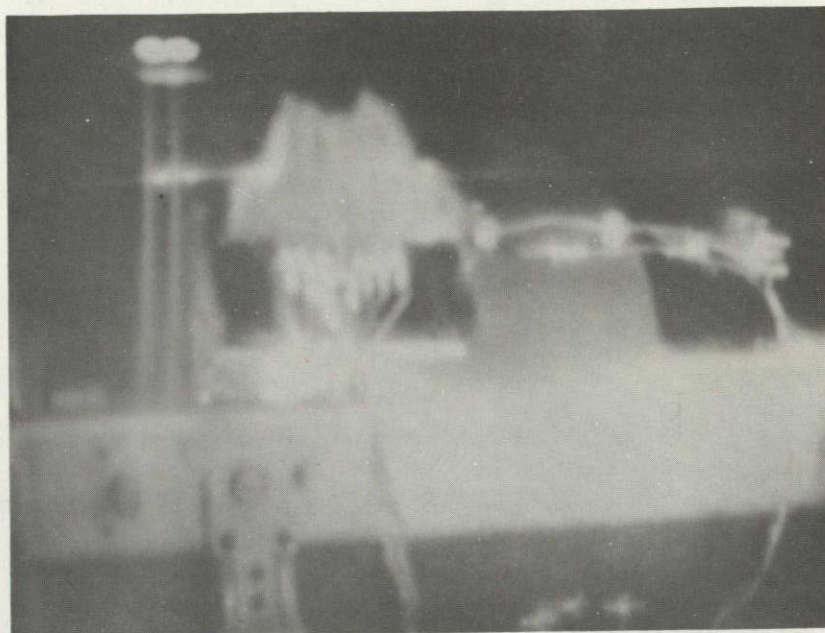
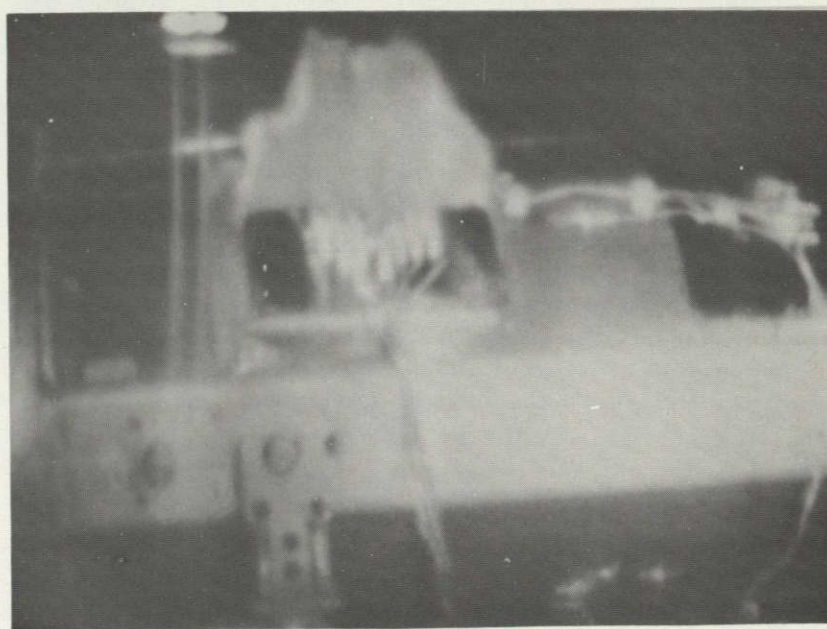
Figure 76. X259 Hydrotest Failure

A review of motion picture films showed the mode and progression of the patch failure. Figures 76A through 76F are motion picture frames from the films of the failure sequence. These pictures, taken at intervals of 1/1000 of a second, illustrate the tension failure in the patch. The escape of water in the defected area shows the progression of the failure along the defect. Subsequent examination of the case showed the rip to be directly over the defect.

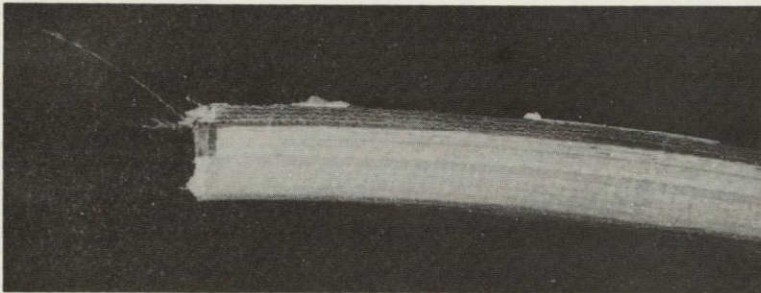
Figure 77. Center Section of Failed Defect (X 1)

For the post-test examination of the unit, the two longitudinal defects were sectioned in one-inch increments. An examination of each section indicated that the patches had good bond thicknesses and contained no voids. The good bond line thickness (0.020 in. minimum in defected areas) and the absence of voids are quite apparent from these photos. The resin in Defect No. 4 was cracked as shown in photomicrographs of several sections (Figures 77 through 80). This cracking was probably due to the high strain in this particular area. Cracks of this type had developed in the bottle tests of Task I at load levels as low as 1350 lb/in. of defect length. The presence of such cracks is not considered to indicate patch failure. However, such cracks must be sealed to prevent leakage of water and possible premature patch failure during hydroburst. In this test, Prestite was used to prevent leakage in the defected areas.

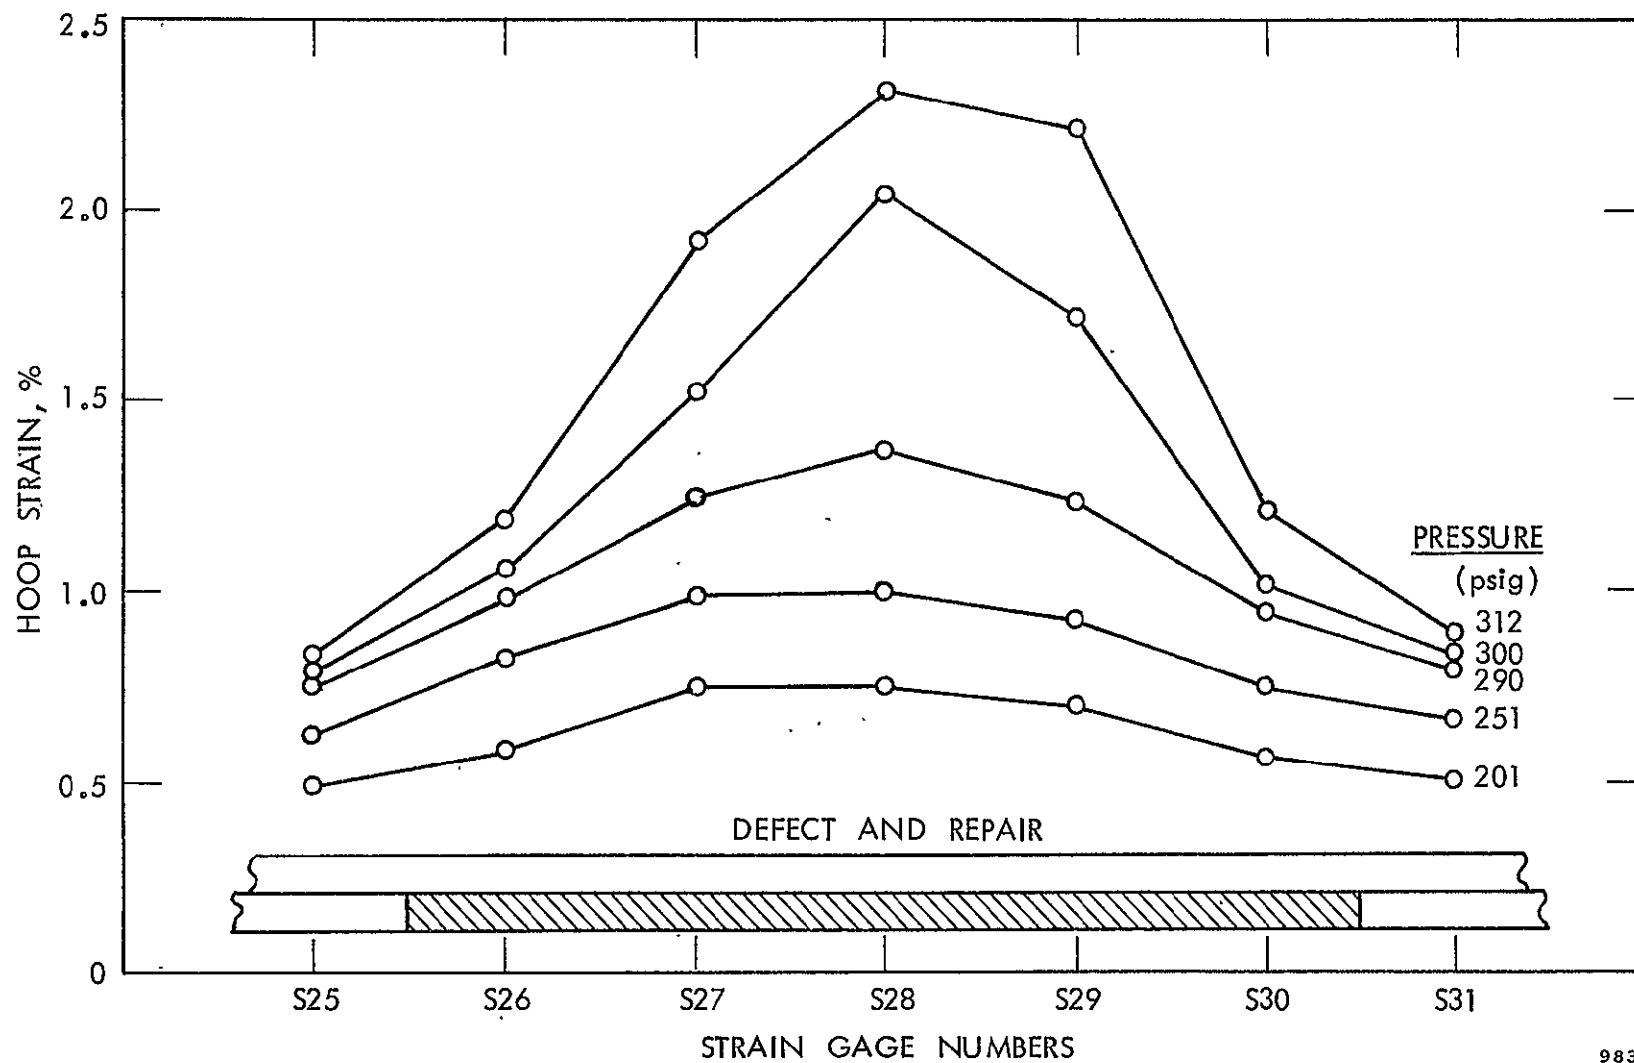
Figure 83. Hoop Strain vs Pressure for Defect No. 3

Plots of the strain versus pressure for strain gages located on the patches are shown in Figures 81 through 84. The plot of hoop strain versus pressure for Defect No. 3 indicates a considerable increase in strain at pressures above 290 psig. It is believed that this was due to the initiation of a failure in the first ply of the patch which would have caused the load to be transferred to the three other plies, resulting in the abrupt increase in strain measurements on the outer ply. The strain data for Defect No. 4 does not reflect this sharp increase. However, the strain data recorded one inch forward of the defect center are higher than those for the center of the patch. This is due partly to a 6° error in the orientation of the center gage. Therefore, an indication of higher loading occurring away from the patch center should not be derived from this plot. The strains over the circumferential defects are considerably lower and are in good agreement with each other. Plots of the strain versus time for all gages are located in Appendix C.

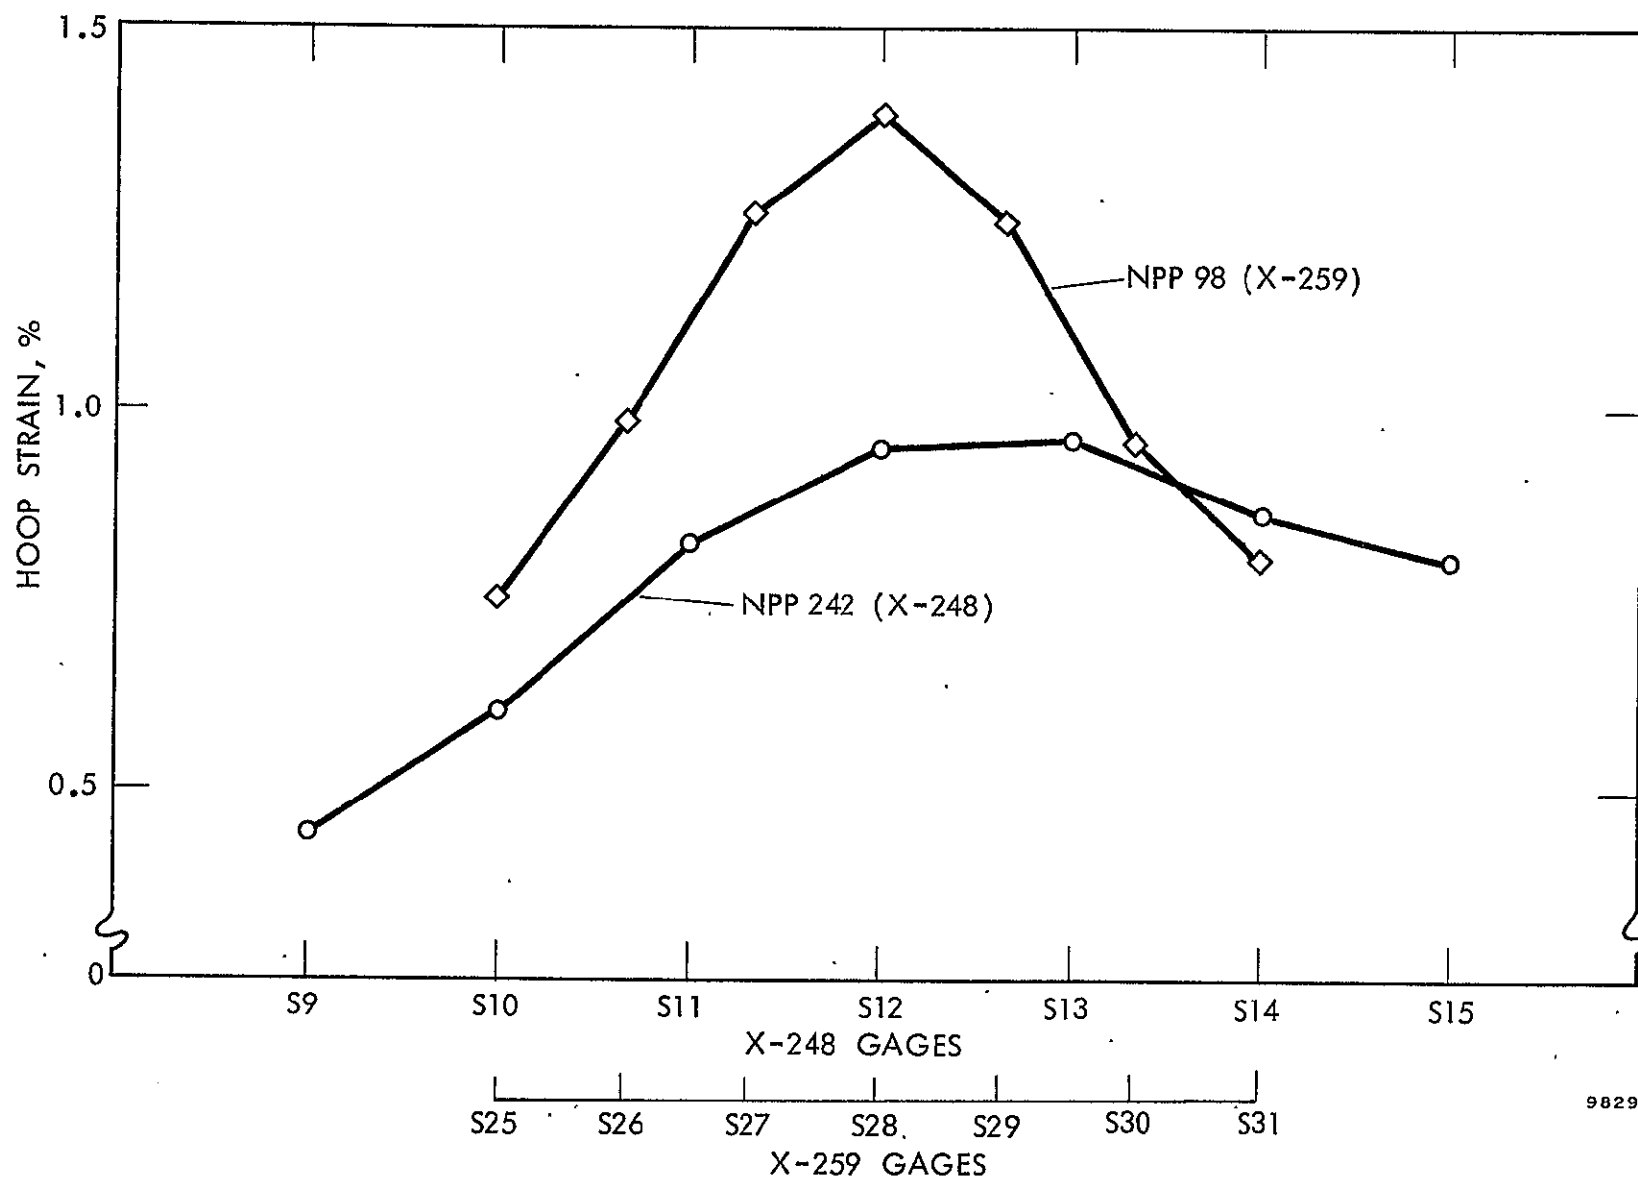
Figure 85. Comparison of Hoop Strain at Equal Pressures (290 Psig) for X 248 and X 259 Repairs

The recorded strains from an X248 test and those for this X259 hydrotest were compared. The X248 (NPP-242) test was of a four-ply repair for a 7.5-in.-long defect. These strain data were compared with strain data from Defect No. 3 in the X259 chamber (NPP-98). The comparisons will not account for the variation between the lengths of the defects. First, strain values were compared at the same pressure, 290 psig (Figure 85). This graph shows that the higher strain values were located in the outer ply of the X259 repair. The maximum strains at the center of the patch are only approximately 1.38 times higher in the X259 repair than in the X248 because of the higher loading at this pressure. This result was expected because of the smaller defect in the X259 chamber and the variations in both wall thickness and winding geometry. Strains were then compared at supposedly equivalent loading conditions in Figure 86. Because the X259 radius is 1.67 times larger than that of the X248, the X248 pressure was 375 psig and the X259 pressure was 224 psig. This dissimilarity resulted in a considerable difference between the strain values. The lower X259 values were probably due to the use of a smaller defect and the first ply bearing much more load than the subsequent plies. The difference in the shape of the curves in Figure 86 seems to indicate a more uniform loading in the X259 repair patch. This could possibly be due to the differences that exist between the two types of chambers (i.e., winding geometry, radius and thickness), as well as the better patches obtained in the X259 tests.

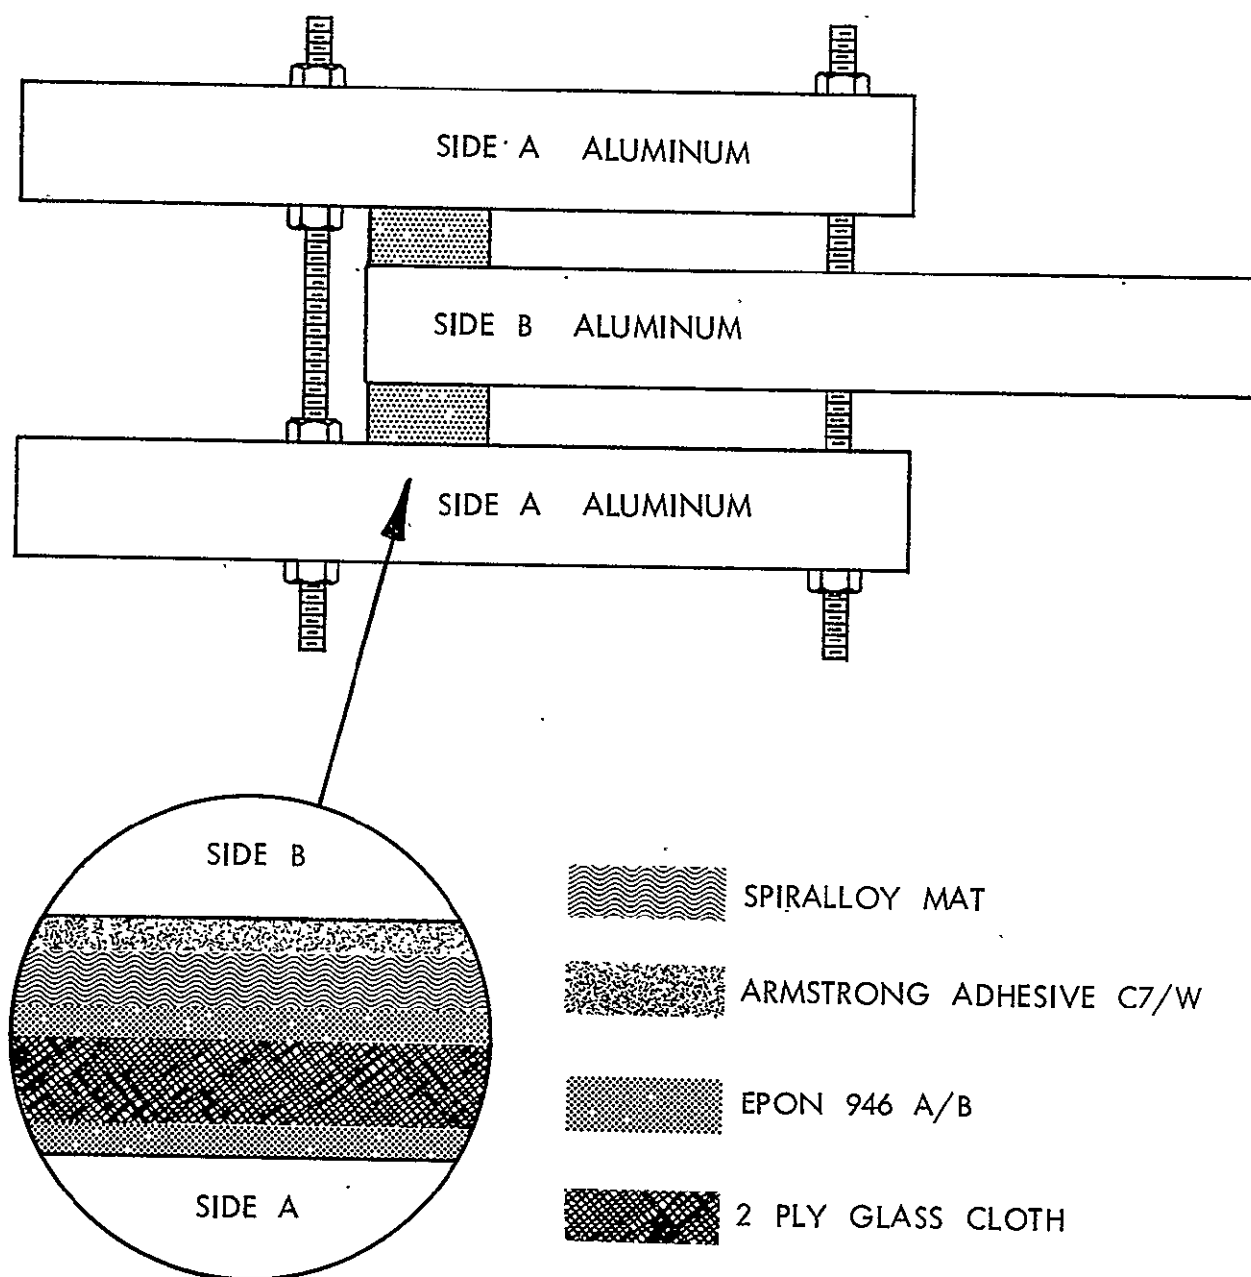
Figure 87. Three-Plate Shear Specimens

The three-plate shear specimen method for determining shear strength has provided consistent results. Variations are due primarily to the complexity of the construction of the specimen (see Figure 87). Considering the complexities, the feasibility of fabricating uniform specimens appears to be quite doubtful. However, the results obtained indicated that of all the specimens fabricated, only a few were of substandard quality.

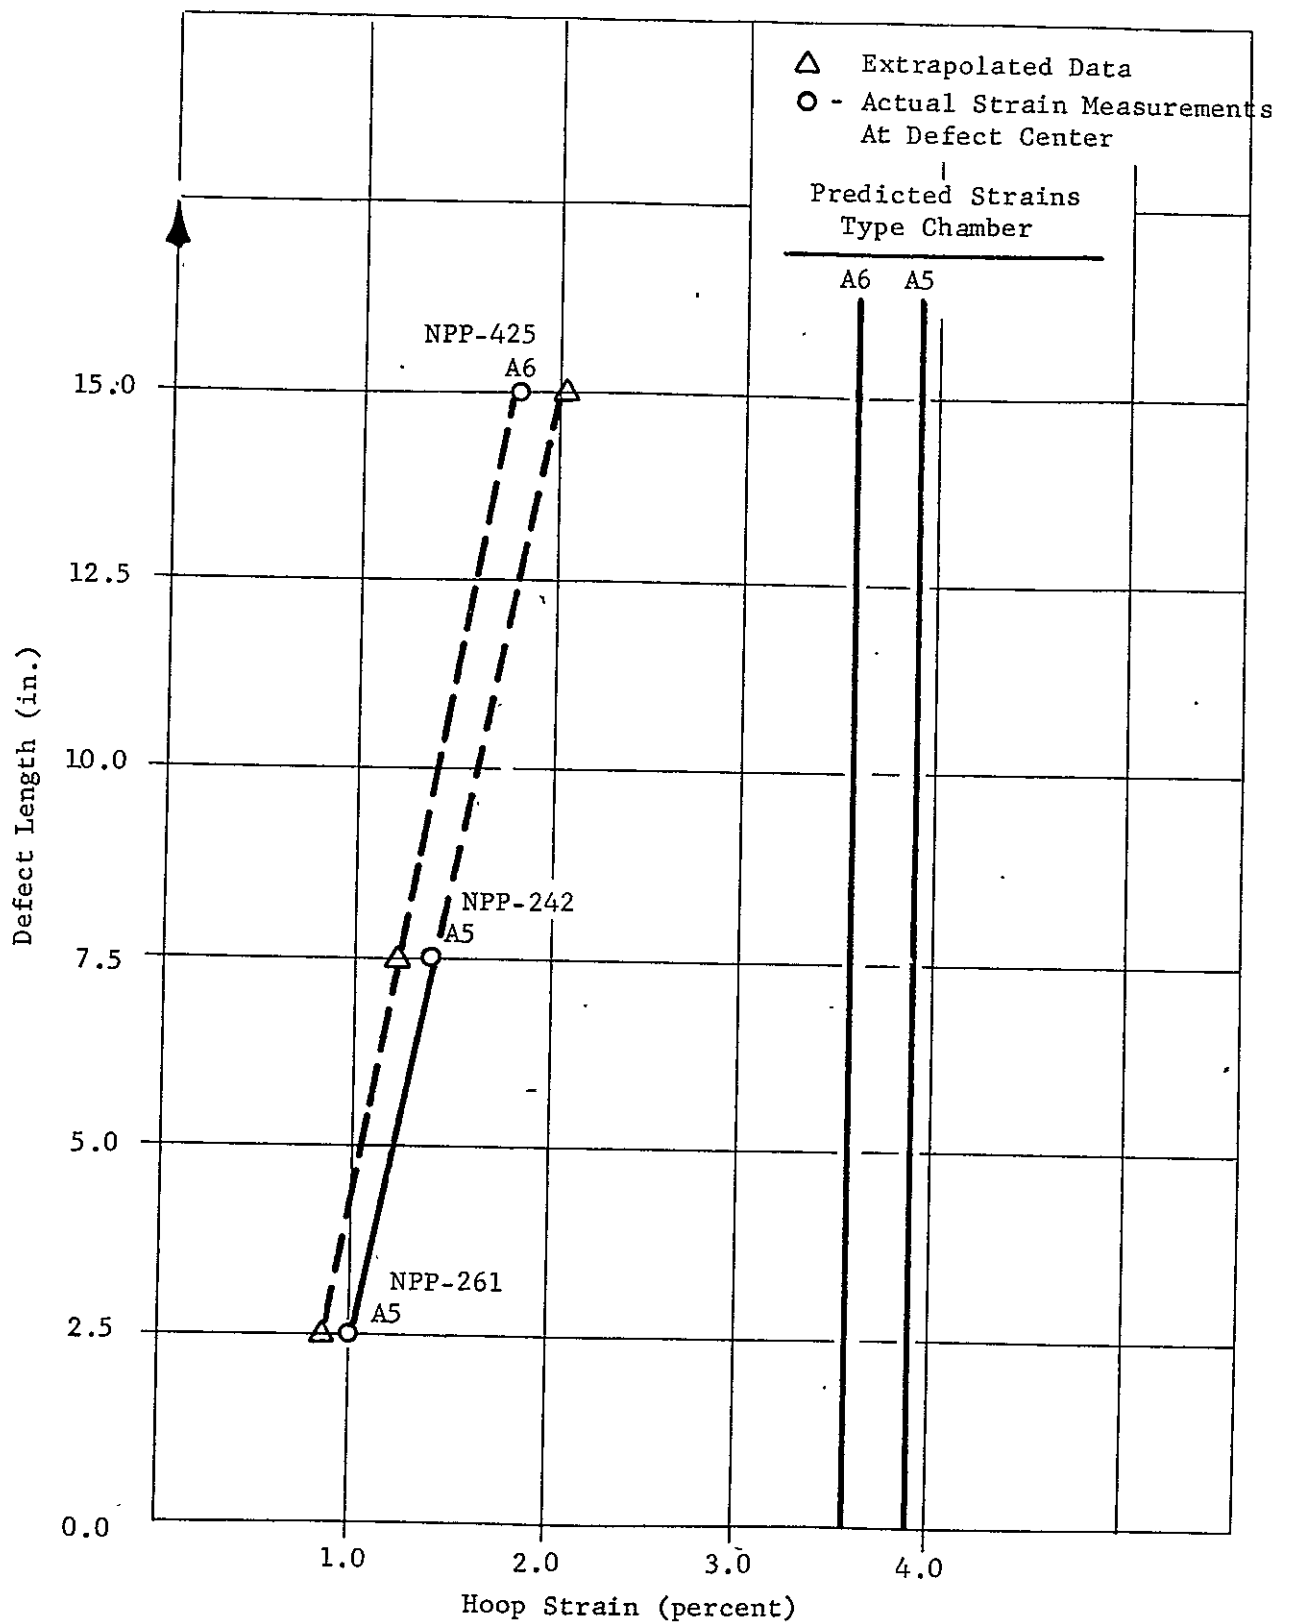
Figure 88. Comparison of Predicted and Actual Strains for a Four Ply Repair of a 0.1-In.-Wide Defect at 350 psia

Treating all defects as having infinite length tends to produce highly conservative solutions for the stress-strain distributions in the models. However, the analyses can still be used to indicate trends in patch parameters which might affect the stress-strain distributions. Test results on the X248 motors indicated that even the maximum-length (15 inch) defect repaired and tested did not load the patch to the degree that the infinite length analysis predicted. See Figure 88. As shown in Figure 89 the analyses did indicate that action was necessary to assure a thickened bond line close to the defect lip.

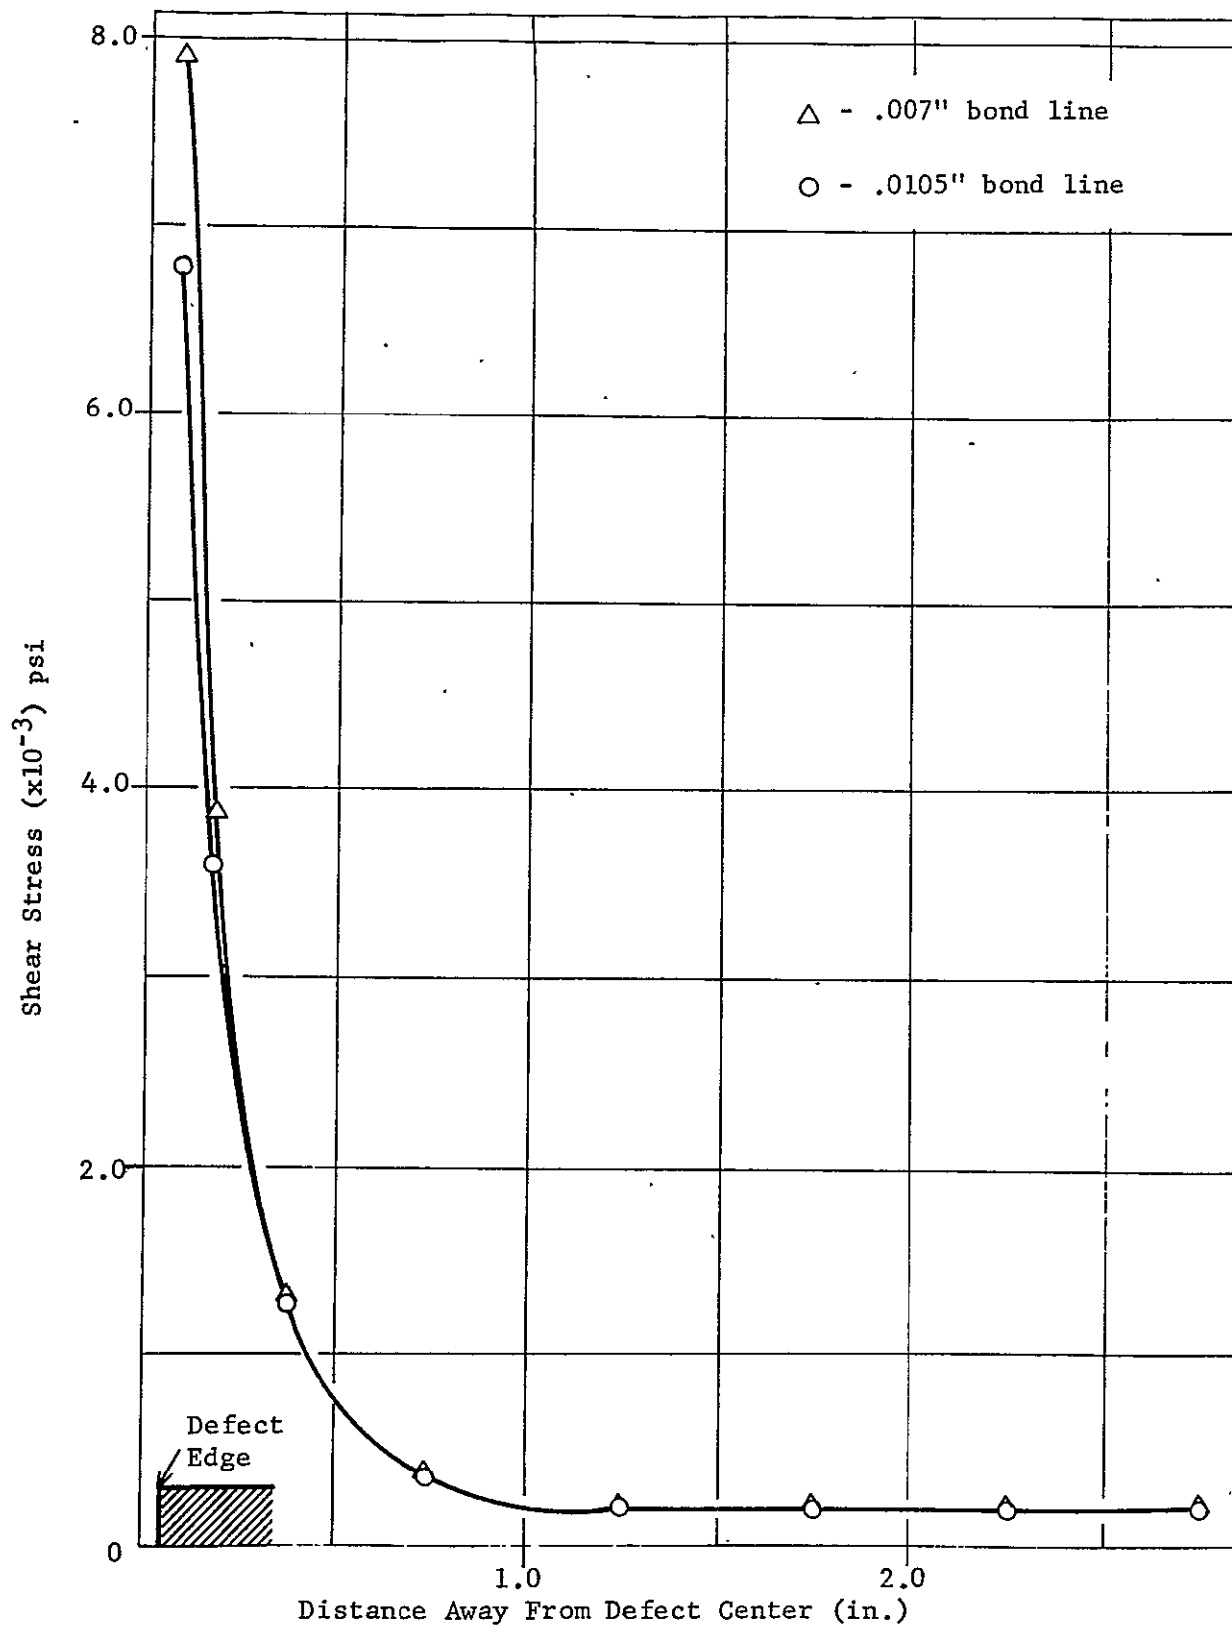
Figure 89. Comparison of Shear Stresses for Two Bond Line Thicknesses

(1) A stress analysis indicated that use of a rubber filler ply in the bond line between the parent case and the first ply can help to reduce peak shear stresses at the defect edge and make the loading in the patch plies more uniform.
