APOLLO PROGRAM

FINAL FLIGHT EVALUATION REPORT APOLLO 5 MISSION

OCTOBER, 1968

APOLLO 5

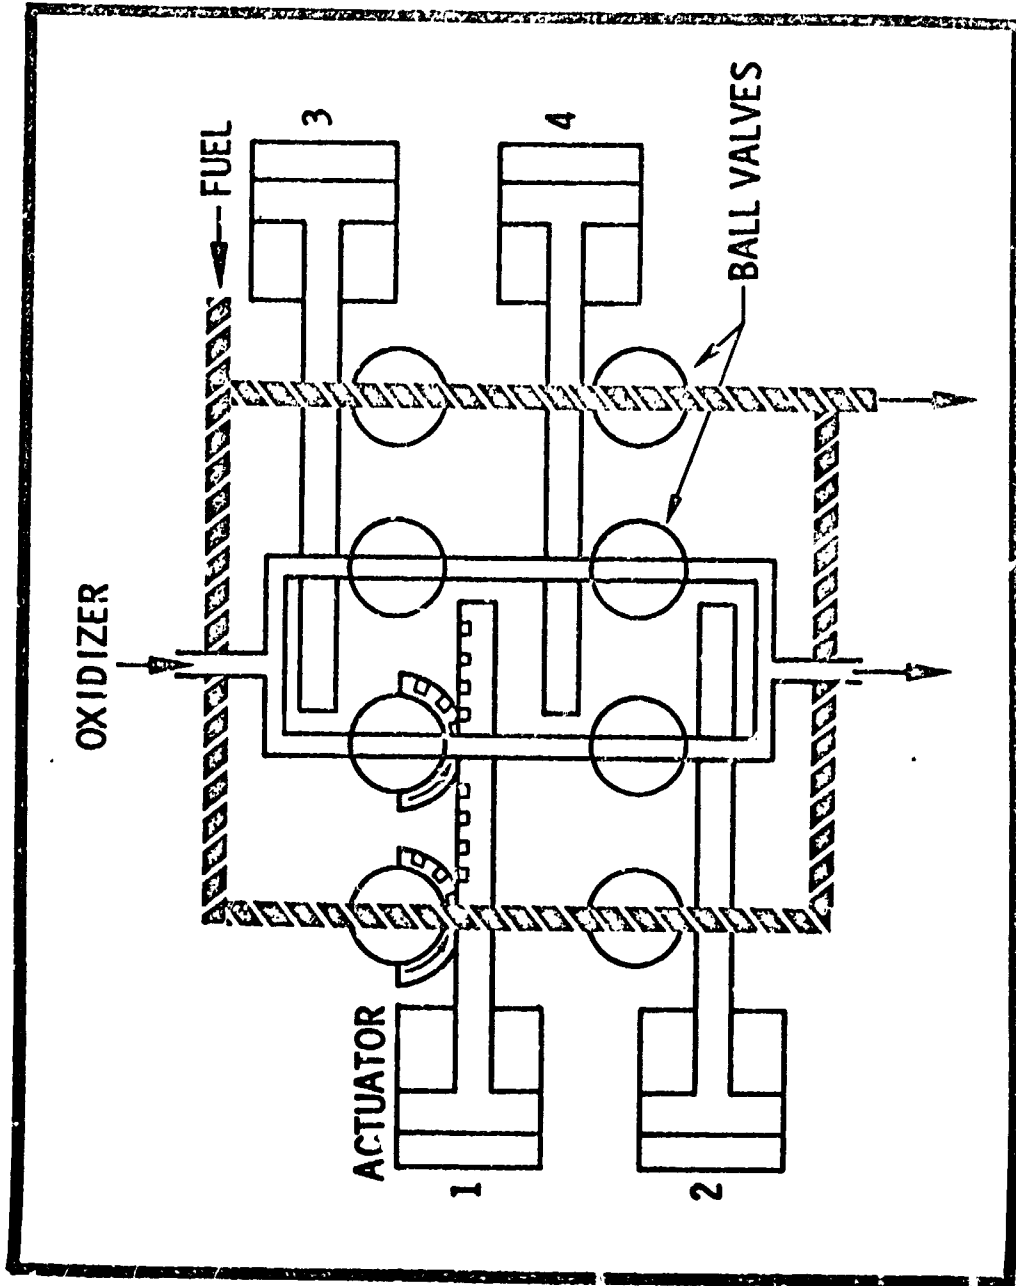
FIGURE 2.1-9

TESTS: Shroud test data from TRW and GAEC indicate the non-uniform rise in chamber pressure (Pc) was probably due to helium dissolved in the propellants. The shutoff valve out-of-phase indication was not supported by the recorded chamber pressure data. The expected effect could have been marked by instrumentation uncertainties. The valve out-of-phase indication was possibly due to a magnetic reed switch malfunction. Ground tests indicated no difference in the pressure transients between closing or not closing one leg of the shutoff valve. This test data is questionable, however, because of an instrumentation problem. A test has been scheduled in September at WSTF to provide additional test data.

CAUSE OF THE ANOMALY: No conclusion can yet be drawn; however, there is a strong indication that the valve did close, as evidenced by the rise in oxidizer and fuel engine inlet pressures. The test results will be included in MSC Anomaly Report No. 3.

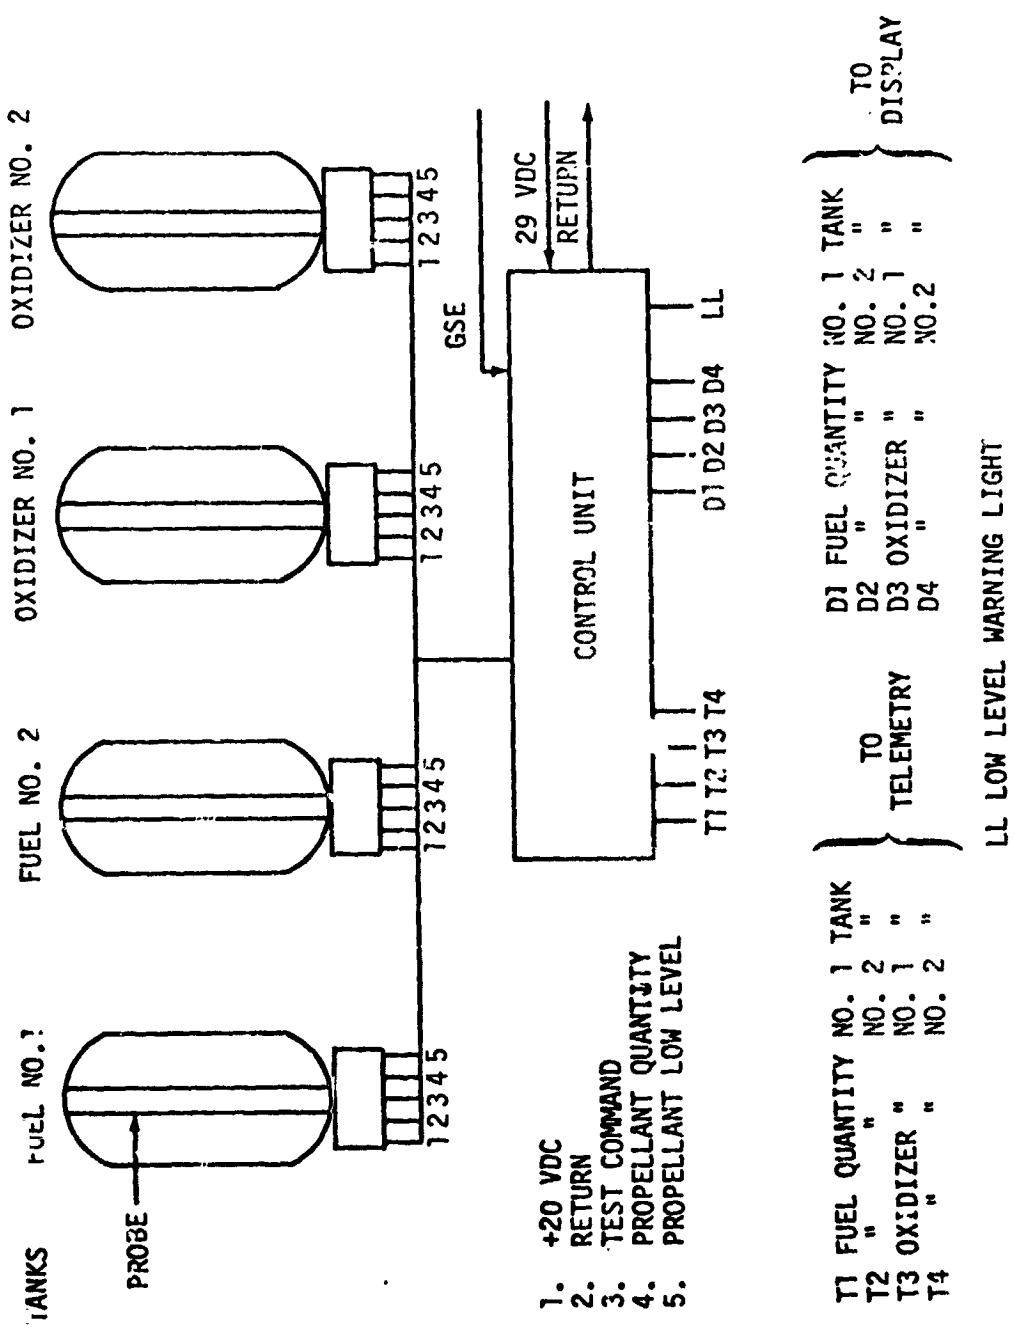
FIGURE 2.1-13

NO. 2.1.13	TITLE: FAILURE OF PROPELLANT QUANTITY GAUGING SUBSYSTEM, NO. 2 TANKS
SYSTEM: LM	MISSION: APOLLO 5
SUBSYSTEM: DPS	EVENT TIME: PRE-LAUNCH
DESCRIPTION:	ERRONEOUS PROPELLANT QUANTITY INDICATIONS FROM NO. 2 FUEL AND OXIDIZER TANKS PRIOR TO AND DURING FLIGHT.
IMPACT:	NONE ON APOLLO 5. NEW GAUGING SYSTEM CONTROL UNIT WILL BE USED ON SUBSEQUENT VEHICLES.
STATUS:	AN MSC FAILURE INVESTIGATION HAS ATTRIBUTED THE FAILURE TO A FAULTY TRANSISTOR WITHIN THE GAUGING SYSTFM. THE GAUGING SYSTEM CONTROL UNIT HAS BEEN RE-CONFIGURED FOR SUBSEQUENT VEHICLES TO UTILIZE HIGH-RELIABILITY PARTS. QUALIFICATION TESTING OF THE NEW CONFIGURATION IS COMPLETE. (SEE ATTACHED FIGURE 2.1-13.)
ACTION:	NO FURTHER ACTION REQUIRED.
ORGANIZATION:	5-2464
REFERENCES:	MSC 10-DAY REPORT, PAGE 11; MSC 60-DAY REPORT, PAGE 6.12-4, ITEM 6.12.6. LED 25-23, LM-3 DCR REPORT
	RESOLUTION: CLOSED
	DATE: 10/4/68
	REV: C
